SECTION 6.0 EXECUTIVE SUMMARY

6.0 LIGHT TOWER

PROJECT
DEMOLITION HAZARDOUS BUILDING MATERIALS
ASSESSMENT AND INVENTORY,
BACALHAO ISLAND LIGHTSTATION
BACALHAO ISLAND, NL

TITLE
LIGHT TOWER SAMPLE LOCATION PLAN

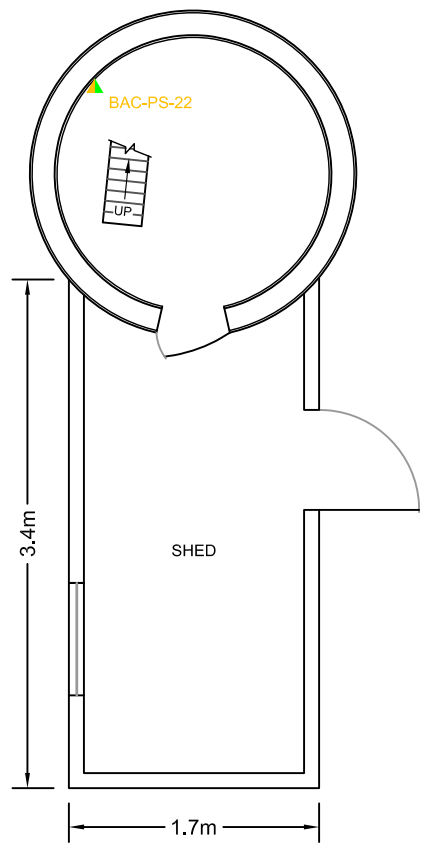
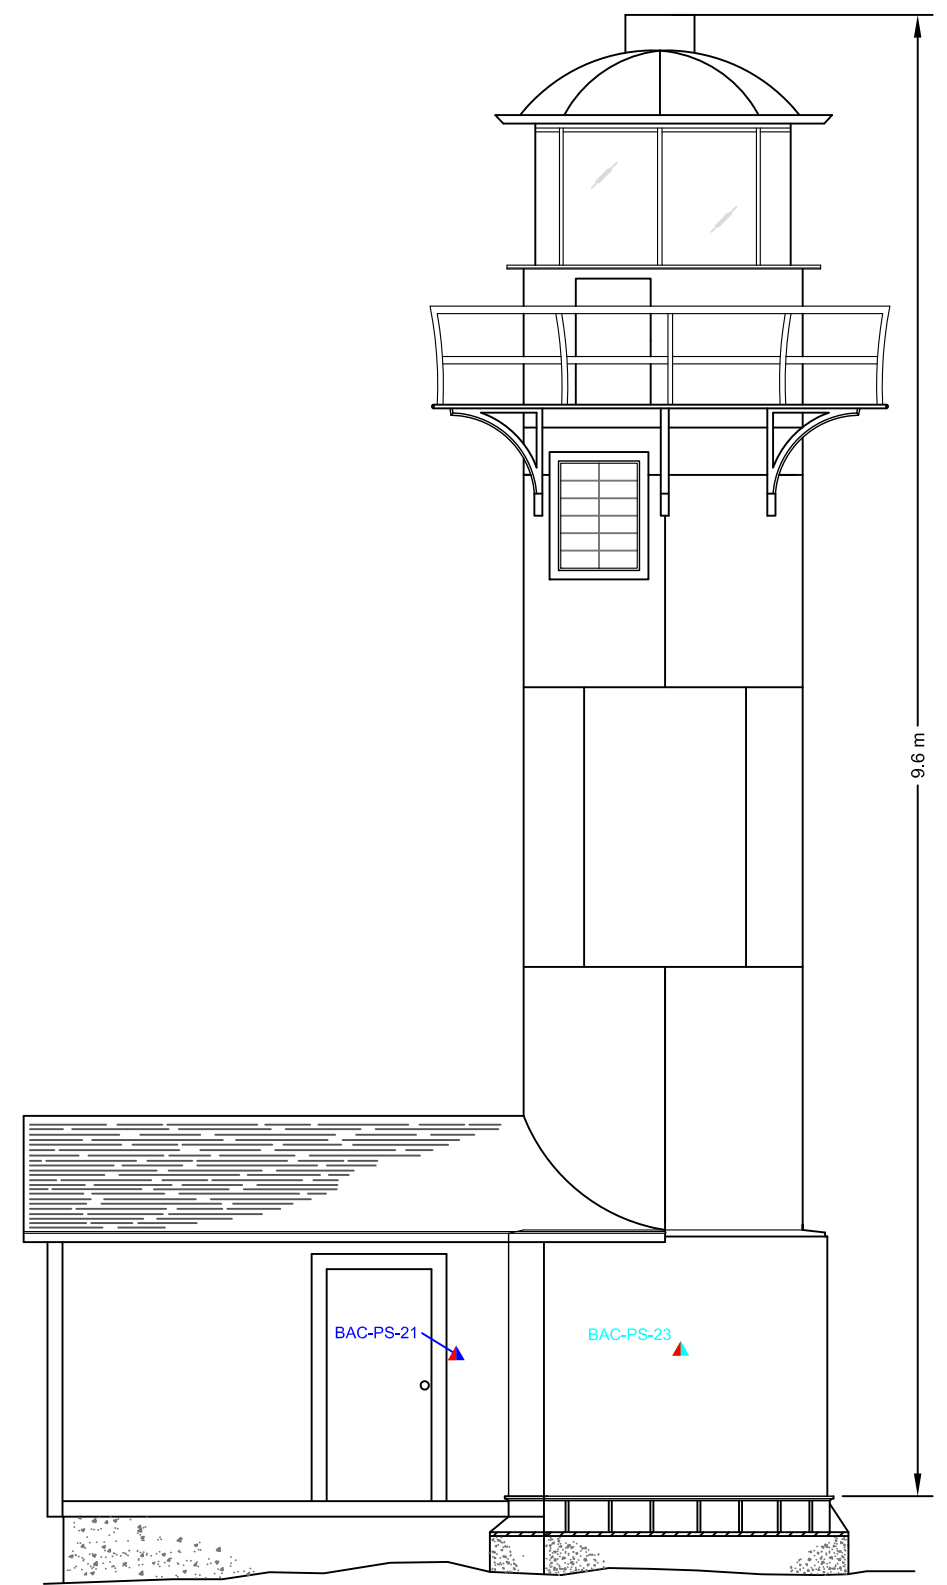
FIGURE No.
6.1

A total of two (2) building material samples (BAC-AS-37 and BAC-AS-38) were collected from the light tower and analyzed for asbestos content (refer to Photos 16 and 17, Appendix B6). Sample descriptions and analytical results are summarized in Table C6-1, Appendix C6. Sample locations and analytical results are graphically illustrated in Figures 6.1, Appendix A6.

A total of four (4) samples (BAC-PS-21 to BAC-PS-24), plus one (1) field duplicate (BAC-PS-DUP-3; duplicate BAC-PS-23), were collected from painted surfaces of the light tower and attached shed and analyzed for lead and mercury content (refer to Photos 18 to 21, Appendix B6). Two (2) paint samples (BAC-PS-22 and BAC-PS-23) were also analyzed for PCB content. Sample descriptions and analytical results are summarized in Tables C6-2 to C6-4, Appendix C6. Sample locations and analytical results are graphically illustrated in Figure 6.1, Appendix A6.

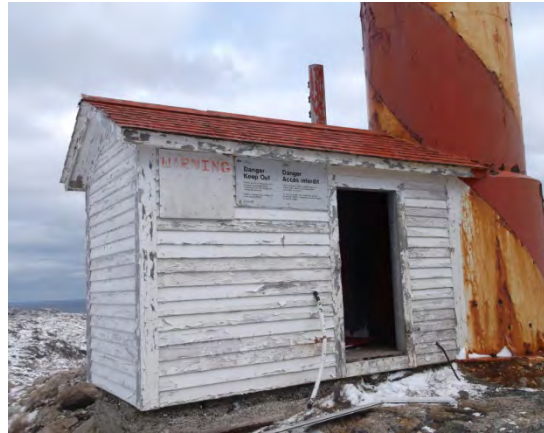
The condition of the paint visible on the interior and exterior of the light tower and attached shed was generally in poor condition (refer to Photos 2, 3, 12, 20 and 21, Appendix B6).

Photo 2: View of the east side of the attached shed.

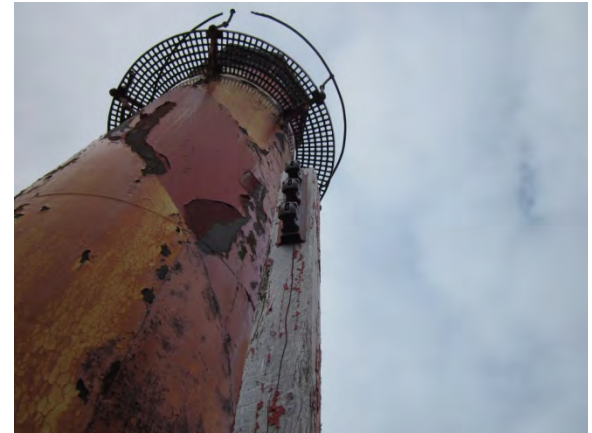
It is important to note that the metal handrail around the platform located at the top of the light tower is in a state of disrepair and several window panes at the top of the light tower are also broken (refer to Photos 3, 13, 14 and 15, Appendix B6).

Photo 3: View of exterior of the light tower.

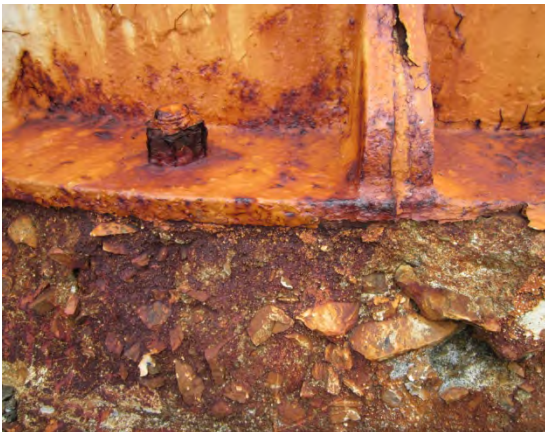
Silica is expected to be present in the concrete used to construct the foundations for the light tower and attached shed. Precaution should be taken to prevent/reduce exposure to silica dust during any disturbance/demolition of silica-containing products.

Photo 4: View of concrete foundation of the light tower.

- Silica is expected to be present in concrete used to construct the foundations of the light tower and attached shed. Precautions should be taken to prevent/reduce exposure to silica dust during any disturbance/demolition of silica-containing products, such as wetting the surface of the materials to prevent dust emissions, donning respiratory protection, and cleaning tools and clothing prior to exiting the work area.

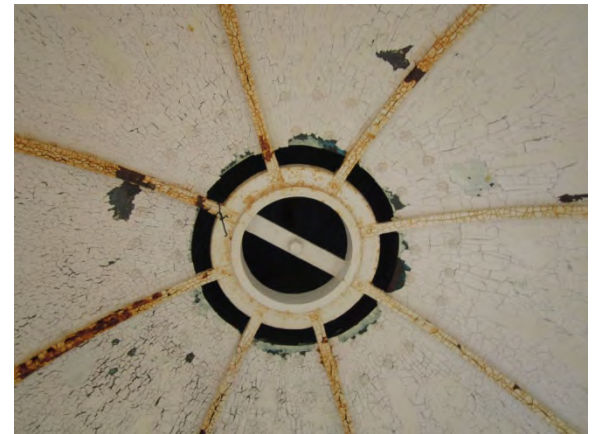
Photo 12: View of ceiling at top of the light tower.

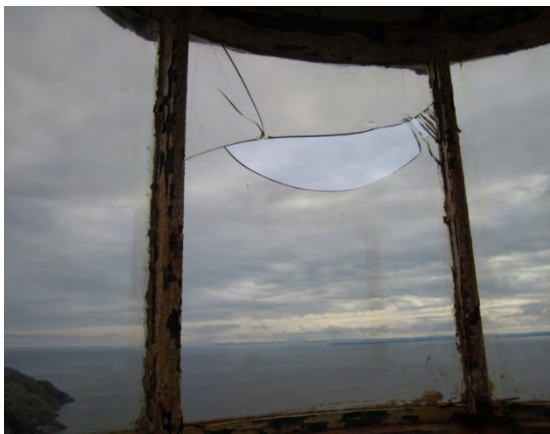
Photo 13: View of broken window pane at top of the light tower.

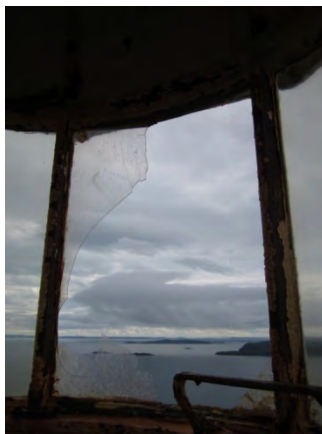
Photo 14: View of broken window pane at top of the light tower.

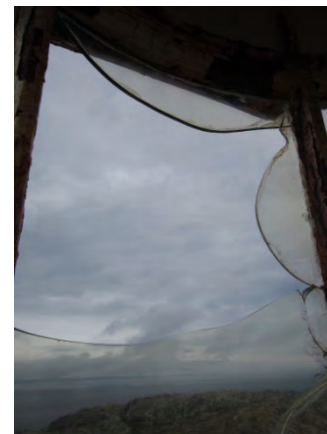
Photo 15: View of broken window pane at top of the light tower.

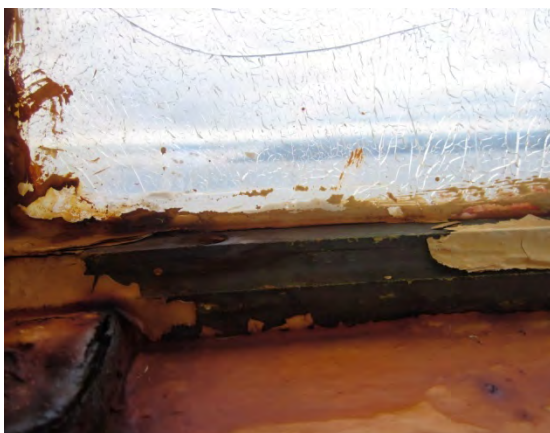
One (1) sample of window caulking (BAC-AS-37) was collected from the interior of the light tower and analyzed for asbestos content (refer to Photo 16, Appendix B6). Asbestos was not detected in the caulking sample collected and submitted for analysis.

Photo 16: View of location of caulking sample BAC-AS-37.

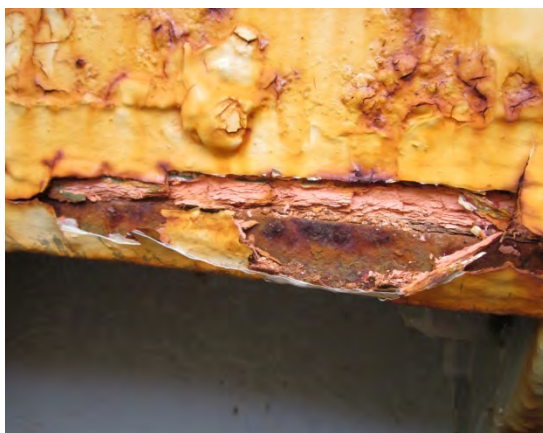
One sample of an unknown deteriorated material (BAC-AS-38) was collected from the seam between metal plates at the top of the light tower and analyzed for asbestos content (refer to Photo 17, Appendix B6). Asbestos was not detected in the unknown material sample collected and submitted for analysis.

Photo 17: View of location of unknown material sample BAC-AS-38.

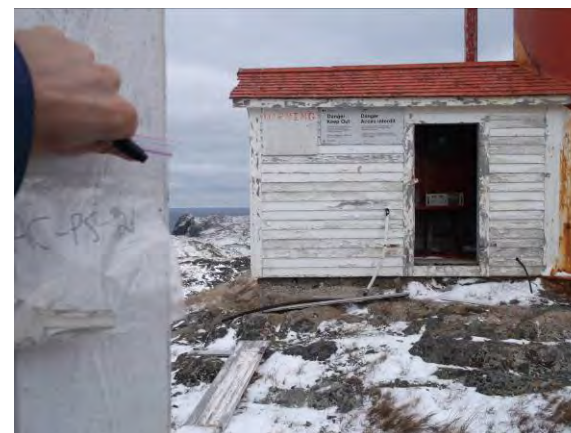
The concentrations of lead in the paint samples ranged from 2,600 mg/kg to 50,000 mg/kg (refer to Table C6-2, Appendix C6). Two (2) of the four (4) paint samples (BAC-PS-22 and BAC-PS-24) contained lead at concentrations above the Federal HPA criterion of 90 mg/kg but below the former Federal HPA criterion of 5,000 mg/kg (refer to Photos 19 and 21, Appendix B6). Two (2) paint samples (BAC-PS-21 and BAC-PS-23), plus one (1) field duplicate (BAC-PS-DUP-3; duplicate BAC-PS-23), contained lead at concentrations above the former Federal HPA criterion of 5,000 mg/kg (refer to Photos 18 and 20, Appendix B6).

The concentrations of leachable lead in paint samples BAC-PS-21 (28 mg/L) and BAC-PS-DUP-3 (83 mg/L) and supplemental paint and wood substrate sample BAC-PS-21A (33 mg/L) were above the Schedule II leachate criterion for lead (5.00 mg/L) provided in the provincial guidance document for leachable toxic waste (GD-PPD-26.1) (refer to Table C6-5, Appendix C2). The paint samples (white paint) and supplemental paint and wood substrate sample were collected from metal on the exterior of the light tower and from siding on the exterior of the attached shed. The paint (red and white paint) on the exterior of the light tower and attached shed (covering an area of approximately 80 m²) was generally in poor condition and flaking. Since the concentrations of leachable lead in the paint samples and the paint and wood substrate sample are at levels considered to be hazardous, these materials (painted metal and painted wooden siding), if removed from the Site, must be disposed of at a hazardous waste treatment facility and/or a metal recycling facility.

Photo 18: View of paint sample BAC-PS-21.

- The white paint exceeding the lead leachate criterion is deteriorated (i.e. peeling and flaking) therefore in order to help prevent impacts to the environment, priority should be given to the removal of this deteriorated paint.

- In areas of minor peeling or flaking the paint should be removed using wet scraping techniques.
 - In areas of extensive peeling and flaking the paint should be removed and more extensive particulate control measures may be required.

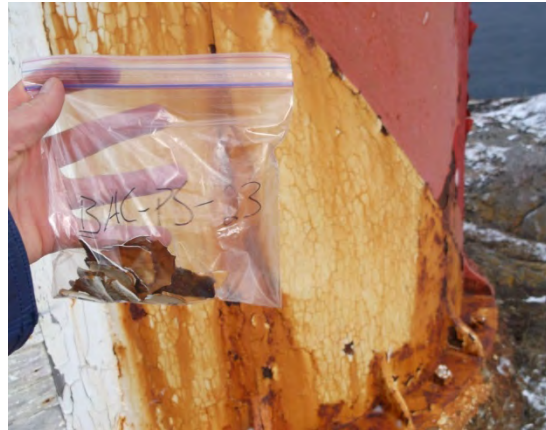
The concentration of leachable mercury in paint sample BAC-PS-23 (0.00025 mg/L) was below the Schedule II leachate criterion for mercury (0.10 mg/L) provided in the provincial guidance document for leachable toxic waste (GD-PPD-26.1) (refer to Table C6-6, Appendix C6). The paint sample (white paint) was collected from metal on the exterior of the light tower. The paint on the exterior of the light tower was generally in poor condition and flaking. The concentration of leachable mercury in this paint is not at a level considered to be hazardous; however, this paint was leachable for lead. Therefore, if removed from the Site, these materials (painted metal and painted wooden siding) must be disposed of at a hazardous waste treatment facility and/or a metal recycling facility.

Photo 20: View of paint sample BAC-PS-23.

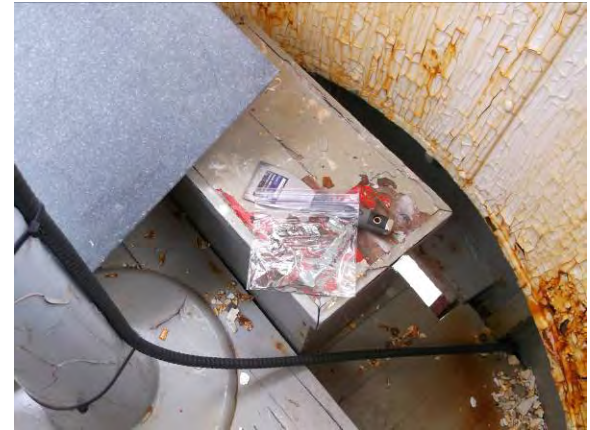
Photo 21: View of paint sample BAC-PS-24.

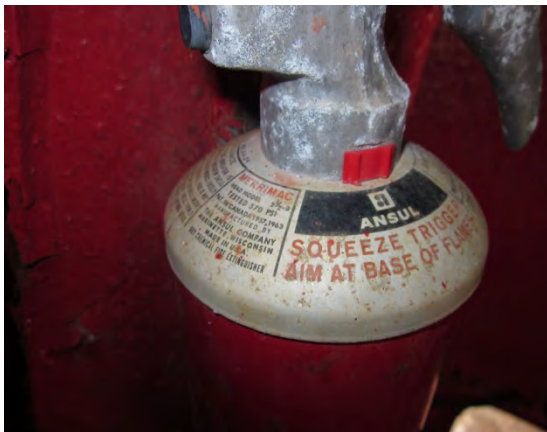
One (1) fire extinguisher was identified in the light tower; however, the label on this unit did not indicate the presence of halon or other ODS ingredients (refer to Photo 22, Appendix B6). The fire extinguisher appeared to be in poor condition.

Photo 22: View of fire extinguisher inside the light tower.
