SECTION 5.0 EXECUTIVE SUMMARY

5.0 VIDEOGRAPH BUILDING

PROJECT	DEMOLITION HAZARDOUS BUILDING MATERIALS ASSESSMENT AND INVENTORY, BACALHAO ISLAND LIGHTSTATION BACALHAO ISLAND, NL
TITLE	VIDEOGRAPH BUILDING SAMPLE LOCATION PLAN

DATE	February 2014
PROJECT No.	TF13076513
REV. No.	0
FIGURE No.	5.1

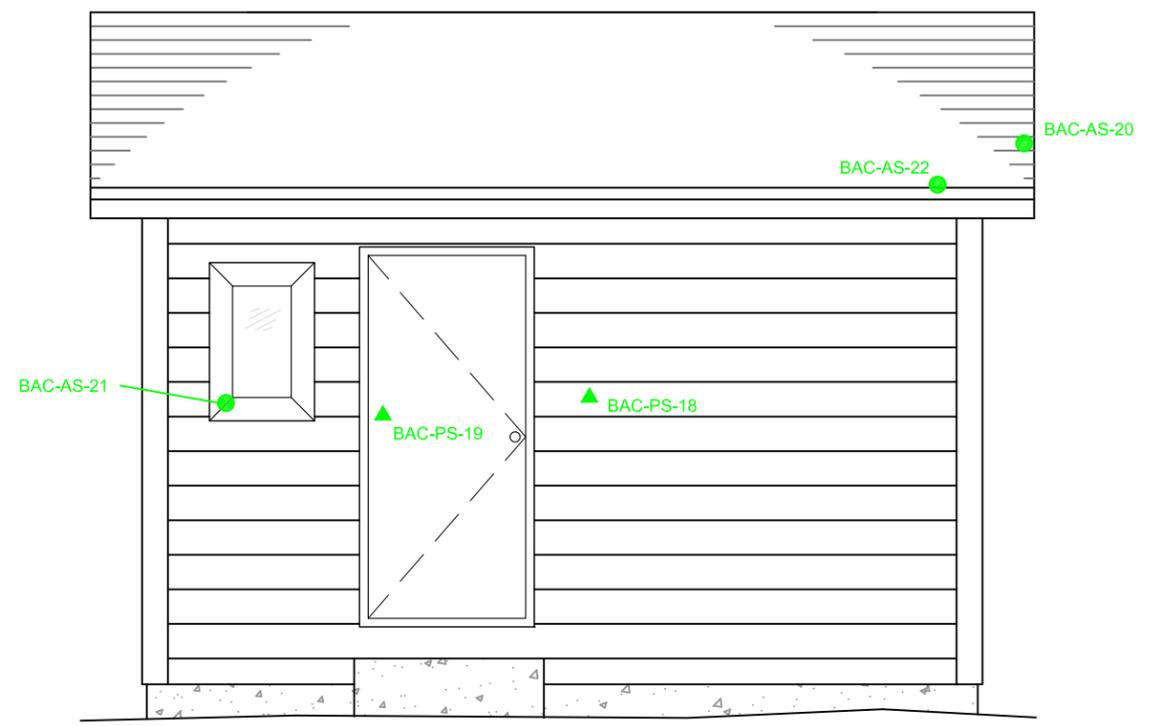
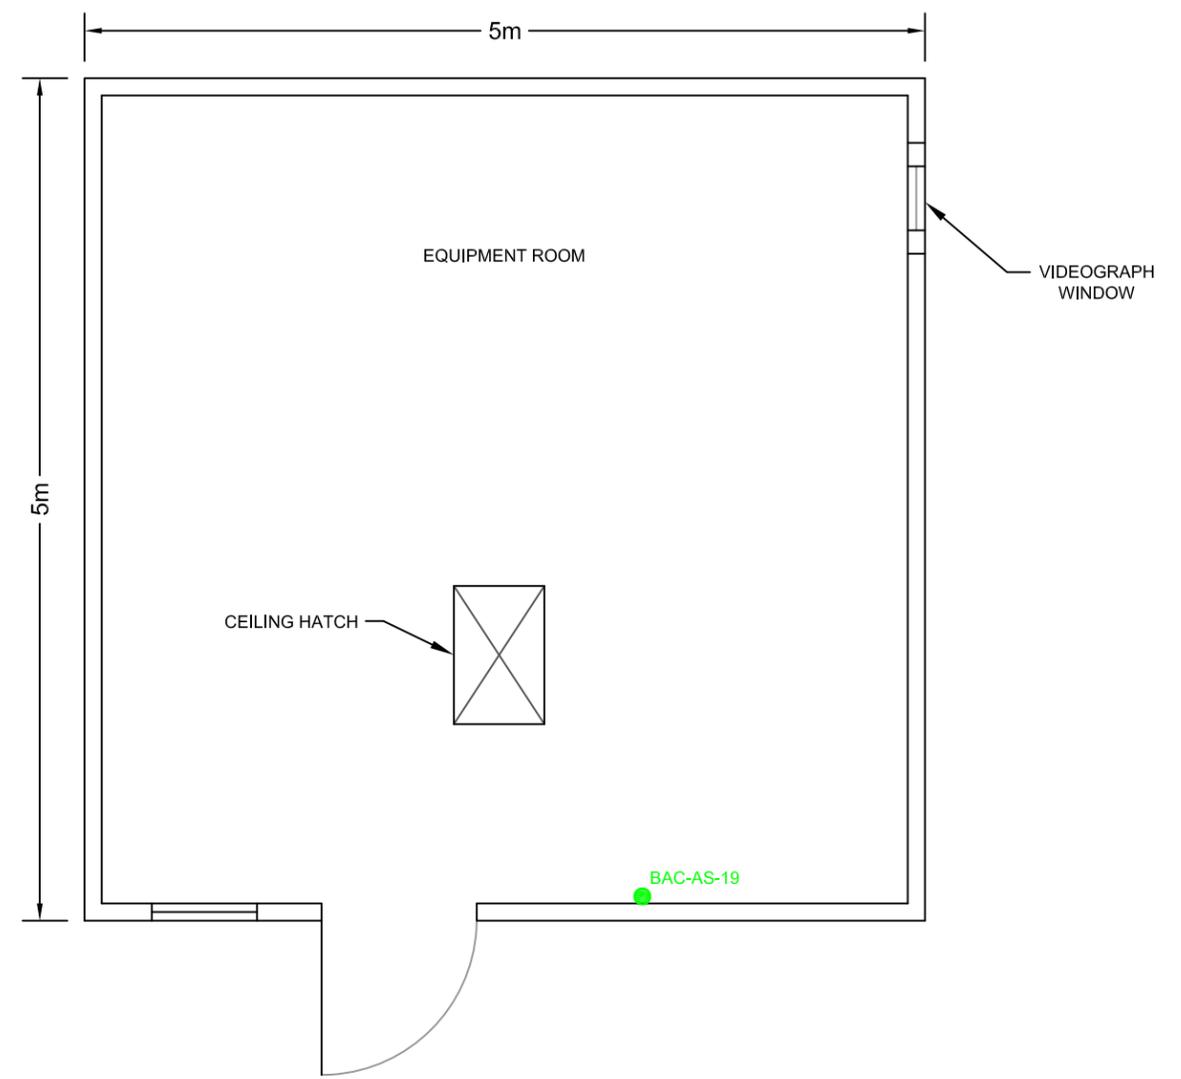
A total of four (4) building material samples (BAC-AS-19 to BAC-AS-22) were collected from the videograph building and analyzed for asbestos content (refer to Photos 5, 6 and 7, Appendix B5). Sample descriptions and analytical results are summarized in Table C5-1, Appendix C5. Sample locations and analytical results are graphically illustrated in Figure 5.1, Appendix A5.

A total of two (2) samples (BAC-PS-18 and BAC-PS-19) were collected from painted surfaces of the videograph building and analyzed for lead and mercury content (refer to Photo 8, Appendix B5). Sample descriptions and analytical results are summarized in Tables C5-2 and C5-3, Appendix C5. Sample locations and analytical results are graphically illustrated in Figure 5.1, Appendix A5.

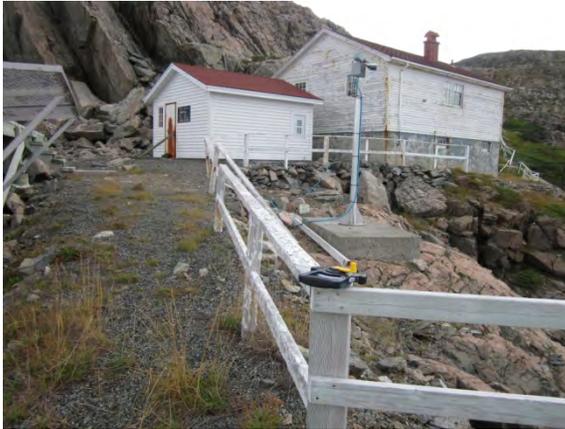
Photo 1: View of north and west sides of videograph building and dwelling.

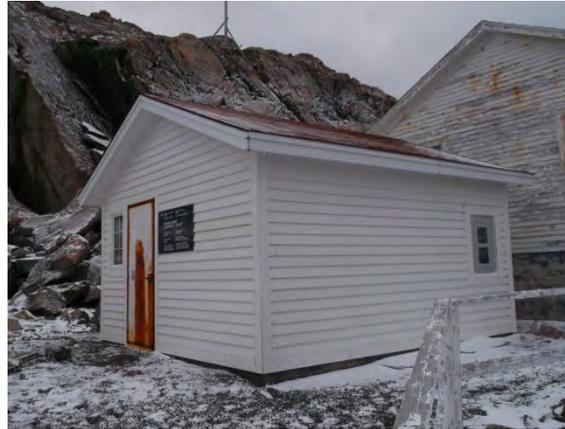
Photo 2: View of north and west sides of videograph building.

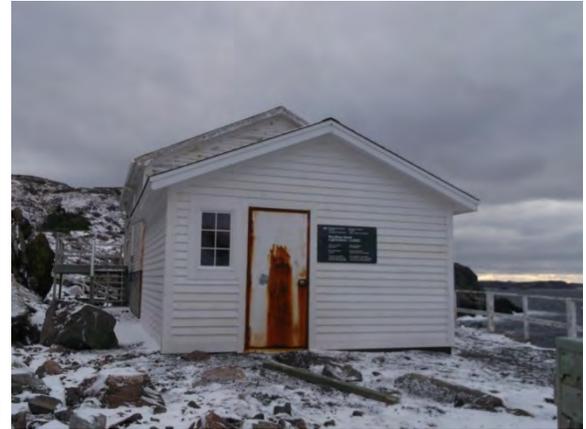
Photo 3: View of north side of videograph building.

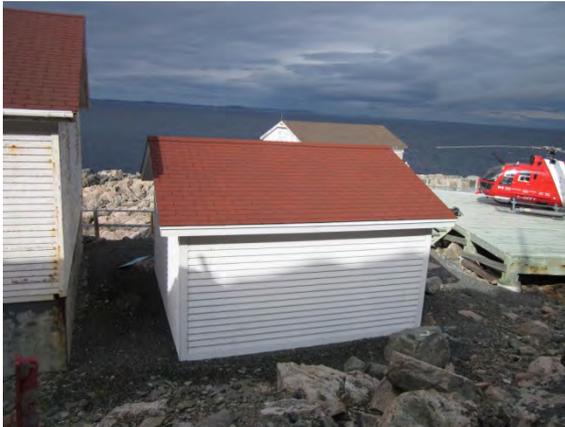
Photo 4: View of east side of videograph building.

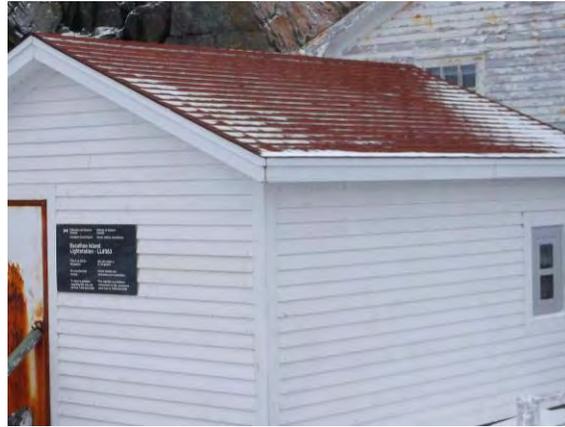
One (1) sample of asphalt shingle roofing material (BAC-AS-20) was collected from the roof of the videograph building and analyzed for asbestos content (refer to Photo 5, Appendix B5). Asbestos was not detected in the asphalt shingle sample collected from the videograph building.

Photo 5: View of location of asphalt shingle sample BAC-AS-20.

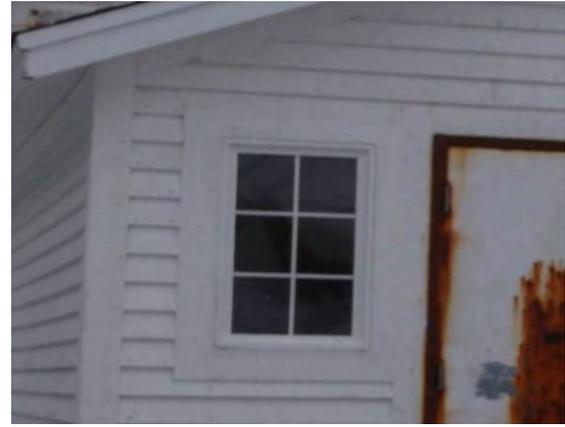
Two (2) samples of caulking (BAC-AS-21 and BAC-AS-22) were collected from the exterior of the videograph building and analyzed for asbestos content (refer to Photos 6 and 7, Appendix B5). Asbestos was not detected in the caulking samples collected from the videograph building.

Photo 6: View of location of window caulking sample BAC-AS-21.

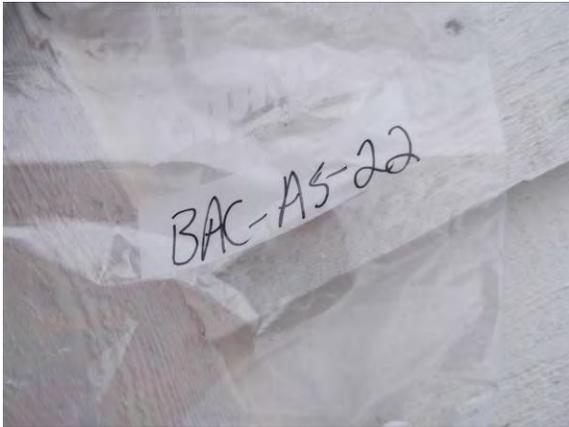
Photo 7: View of caulking sample BAC-AS-22.

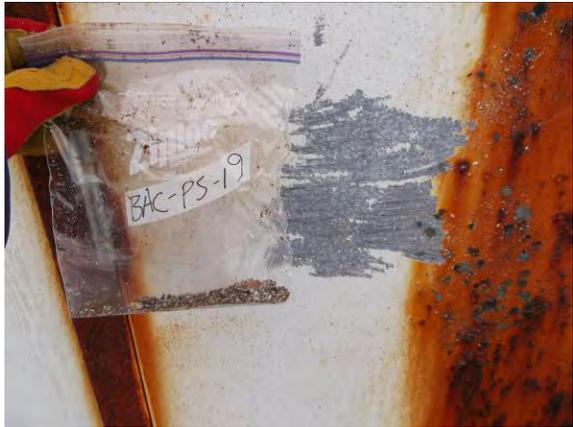
The condition of the paint visible on the interior and exterior of the videograph building varied from good to poor condition. The paint on the exterior metal door was deteriorated due to corrosion (refer to Photo 8, Appendix B5).

All of the paint samples analyzed for lead were non-detect (<5.0 mg/kg) and therefore did not exceed the Federal HPA criterion of 90 mg/kg or the former Federal HPA criterion of 5,000 mg/kg for lead in paint (refer to Table C5-2, Appendix C5).

All of the paint samples analyzed for mercury were non-detect (<1.0 mg/kg) and therefore did not exceed the Federal HPA criterion of 10 mg/kg for mercury in paint or the CCME CSQG of 24 mg/kg for mercury in soil at a commercial site (refer to Table C5-3, Appendix C5).

Photo 8: View of paint sample BAC-PS-19.
