## 4.0 TRAMWAY STORAGE SHED

**Project:** DEMOLITION HAZARDOUS BUILDING MATERIALS  
ASSESSMENT AND INVENTORY,  
BACALHAO ISLAND LIGHTSTATION  
BACALHAO ISLAND, NL

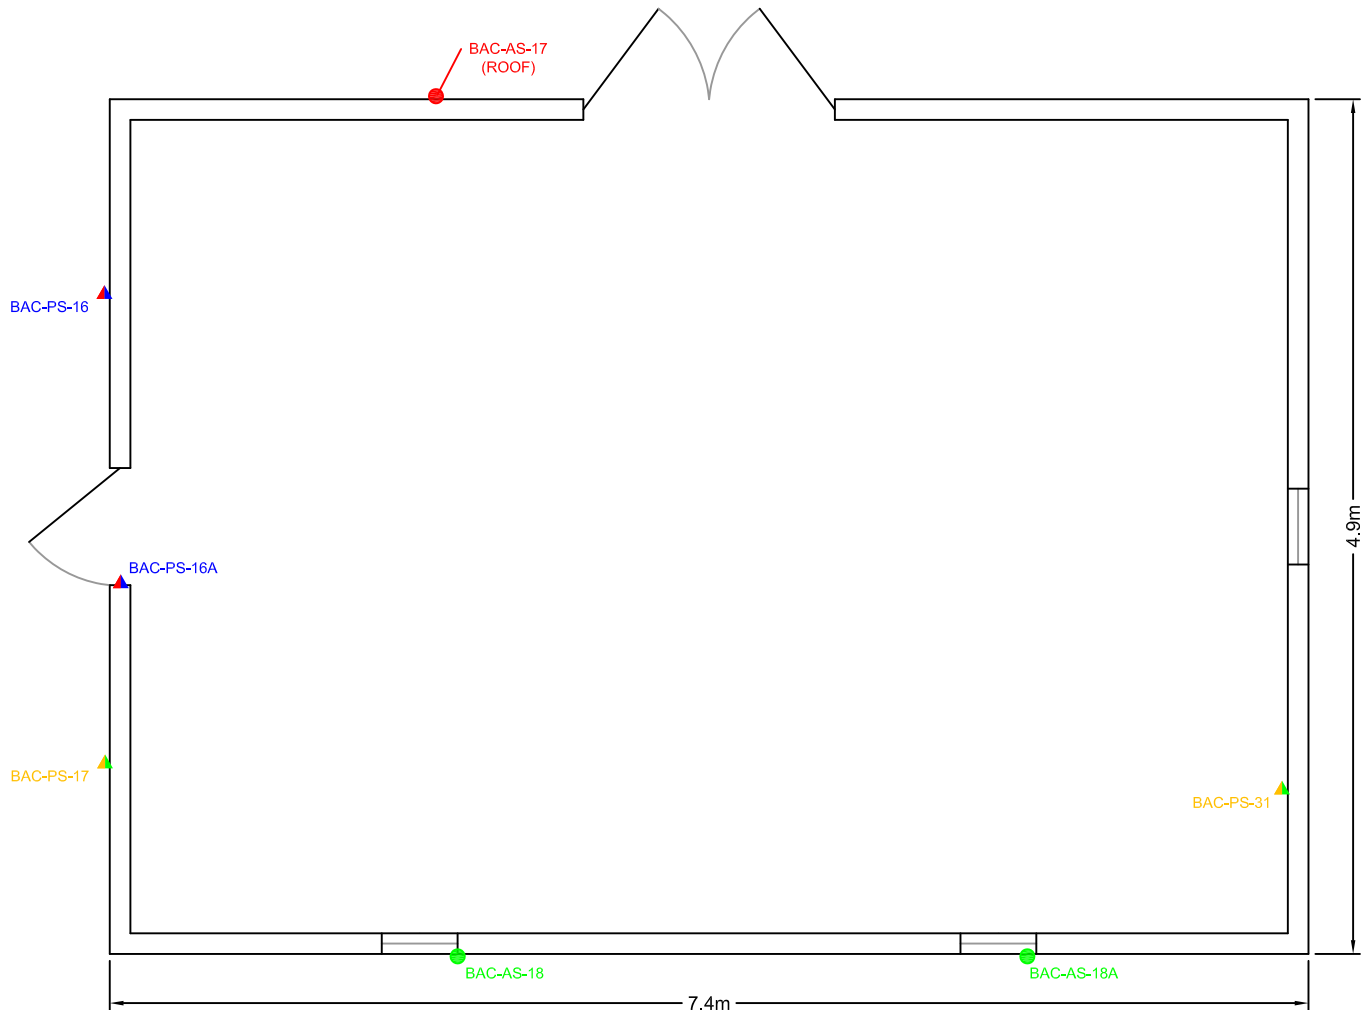
4.1

A total of three (3) building material samples (BAC-AS-17, BAC-AS-18, BAC-AS-18A) plus one (1) field duplicate sample (BAC-AS-DUP-2; duplicate of BAC-AS-18) were collected from the tramway storage shed and analyzed for asbestos content (refer to Photos 9, 10 and 11, Appendix B4). Sample descriptions and analytical results are summarized in Table C4-1, Appendix C4. Sample locations and analytical results are graphically illustrated in Figure 4.1, Appendix A4.

A total of three (3) samples (BAC-PS-16, BAC-PS-17 and BAC-PS-31) were collected from painted surfaces of the tramway storage shed and analyzed for lead and mercury content (refer to Photos 12, 13 and 14, Appendix B4). Sample descriptions and analytical results are summarized in Tables C4-2 and C4-3, Appendix C4. Sample locations and analytical results are graphically illustrated in Figure 4.1, Appendix A4.

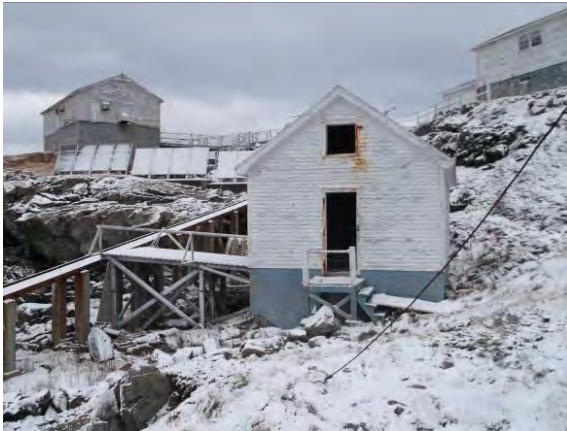
The condition of the paint visible on the exterior of the tramway storage shed varied from fair to poor condition. Peeling and flaking paint was observed on the exterior siding and foundation of the tramway storage shed (refer to Photos 1, 10, 12 and 13, Appendix B4).

Photo 1: View of the south side of the tramway storage shed.

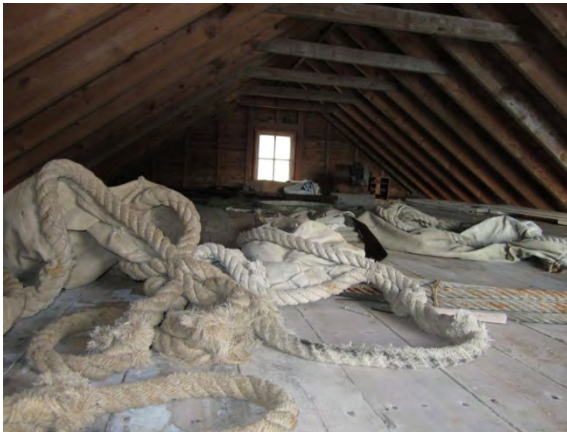
Various items were observed in the attic of the tramway storage shed, including but not limited to, canvas sails and rope, cardboard boxes, and various pieces of wood and metal; there also appeared to be an old electrical motor or generator in the attic (refer to Photo 4, Appendix B4).

Photo 4: View of attic in tramway storage shed.

- Various items were observed in the attic of the tramway storage shed, including but not limited to, canvas sails and rope, cardboard boxes, and various pieces of wood and metal; there also appeared to be an old electrical motor or generator in the attic
- The miscellaneous items and solid waste in the attic of the tramway storage shed should be properly disposed of in accordance with applicable regulations.

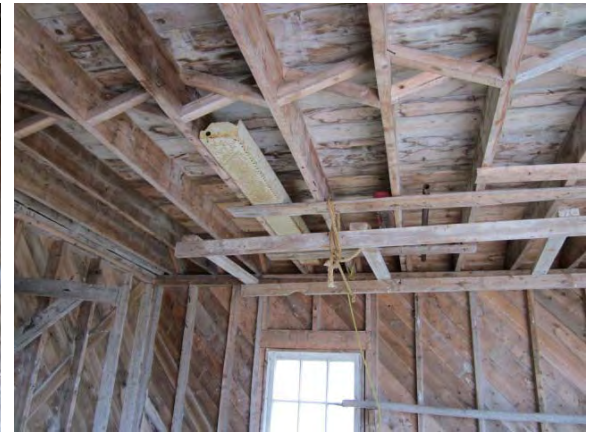
One (1) fluorescent light fixture appeared to be stored in the ceiling rafters of the tramway storage shed (i.e. the fixture did not appear to be connected to a power source). An attempt was made to inspect the light ballast(s) in the fixture for the presence or absence of PCB-

containing dielectric fluid; however, an inspection of the internal components of the fixture was not possible due to safety concerns related to the size, weight and location of the fluorescent light fixture. The casing of the light fixture appeared to be in poor condition and rusted. Since it could not be determined from the inspection if the ballast(s) are either non-PCB or potential-PCB, the light ballast(s) within the fluorescent light fixture that is stored inside the tramway storage shed should be treated as PCB-containing ballast(s).

Photo 6: View of fluorescent light fixture stored in ceiling of tramway storage shed.

- One (1) fluorescent light fixture was observed in the tramway storage shed. Based on similar building materials, the shed may have been constructed around the same time as the dwelling and equipment building (i.e. 1975-1980); therefore, the light ballast(s) may contain PCBs since the use of PCBs in light ballasts was not discontinued until the early 1980s. It could not be determined from the inspection if the ballast(s) are either non-PCB or potential-PCB; therefore, all ballasts should be treated as PCB-containing ballasts.

- The PCB content in all light ballasts should be confirmed prior to disposal. All ballasts that are removed should be placed in a proper storage container(s). Leaks or stained areas should be cleaned and/or removed in accordance with applicable regulations or industry standards.
- All PCB-containing equipment should be handled, decontaminated, transported and disposed of as per current Federal and Provincial acts and regulations. Any PCB-containing equipment requiring removal from the tramway storage shed should be transported and disposed of by a registered hazardous waste transporter in accordance with applicable regulations.

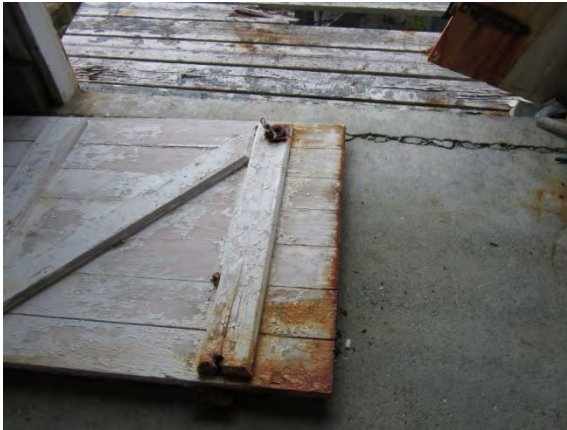
It is important to note that the wooden stairs to the tramway storage shed and the wooden platform located between the tramway storage shed and the tramway are in a state of disrepair (i.e. rotted wood, damaged/missing handrail, etc.) (refer to Photos 7 and 8, Appendix B4).

Photo 7: View of wooden stairs and door to tramway storage shed.

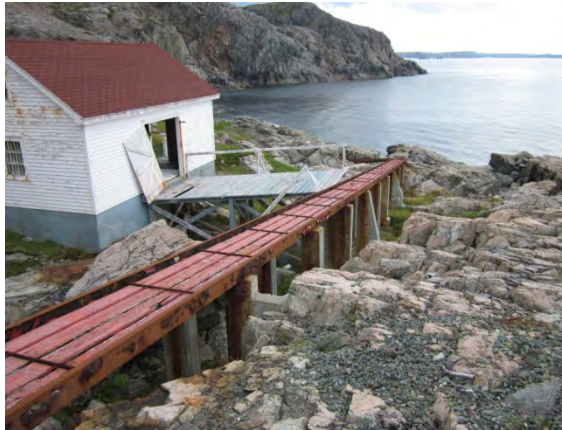
Photo 8: View of wooden platform between tramway storage shed and tramway.

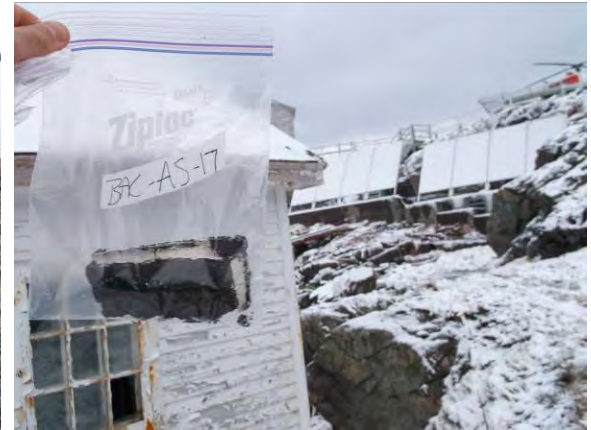
One (1) sample of asphalt shingle roofing material (BAC-AS-17) was collected from the roof of the tramway storage shed and analyzed for asbestos content (refer to Photo 9, Appendix B4). Chrysotile asbestos (1.2%) was detected in sample BAC-AS-17 (i.e. red/black asphalt shingle collected from the tramway storage shed) at a level above the applicable *NL Asbestos Abatement Regulations (111/98)* (i.e., >1%). Therefore the roofing materials on the tramway storage shed are considered to be ACMs.

The asphalt shingles visible on the roof of the tramway storage shed (covering an area of approximately 50 m<sup>2</sup>) as observed from the ground surface and the helicopter appeared to be generally intact and in good condition.

Photo 9: View of asphalt shingle sample BAC-AS-17.

- Results of the asbestos sampling and analytical program revealed that there are building materials containing greater than 1% asbestos by dry weight, which are considered to be ACMs. Non-friable asbestos is present in the form of asphalt shingles.

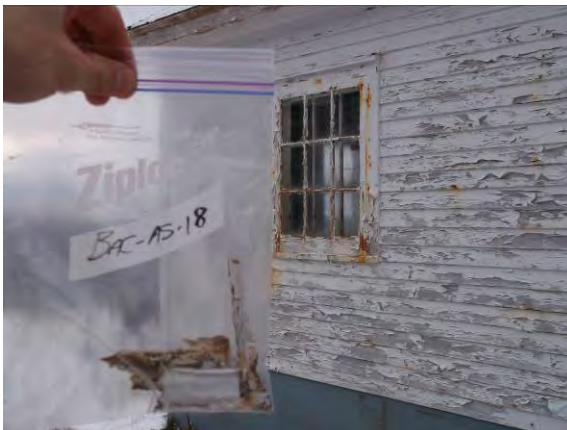
Two (2) samples of caulking (BAC-AS-18 and BAC-AS-18A) plus one (1) field duplicate sample (BAC-AS-DUP-2; duplicate of BAC-AS-18) were collected from the exterior of the tramway storage shed and analyzed for asbestos content (refer to Photos 10 and 11, Appendix B4). Prior to analysis, sample BAC-AS18A was separated by the laboratory into two (2) sub-samples (BAC-AS-18A-Caulking and BAC-AS-18A-Weathered Caulk). Chrysotile asbestos (ranging from 0.84% to 1%) was detected in samples BAC-AS-18 and BAC-AS-18A-Weathered Caulk at levels below the applicable *NL Asbestos Abatement Regulations (111/98)* (i.e., >1%). Asbestos was not detected in any of the other caulking samples collected and submitted for analysis.

The window caulking observed on the exterior of the tramway storage shed (approximately 15 m) appeared to be weathered and varied in condition from fair to poor. Therefore, due to the potentially friable nature of the window caulking, it is recommended that this material be treated as an ACM.

Photo 10: View of window caulking sample BAC-AS-18.

- Results of the asbestos sampling and analytical program also revealed that there is window caulking containing less than and equal to 1% asbestos by dry weight. The window caulking observed on the exterior of the tramway storage shed appeared to be weathered and varied in condition from fair to poor. Therefore, due to the potentially friable nature of the window caulking, it is recommended that this material be treated as an ACM.

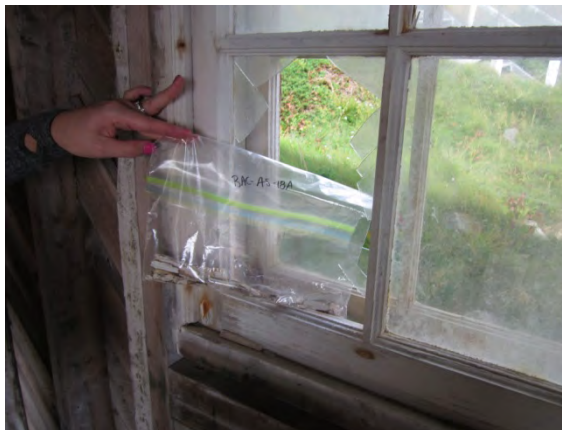
Photo 11: View of window caulking sample BAC-AS-18A.

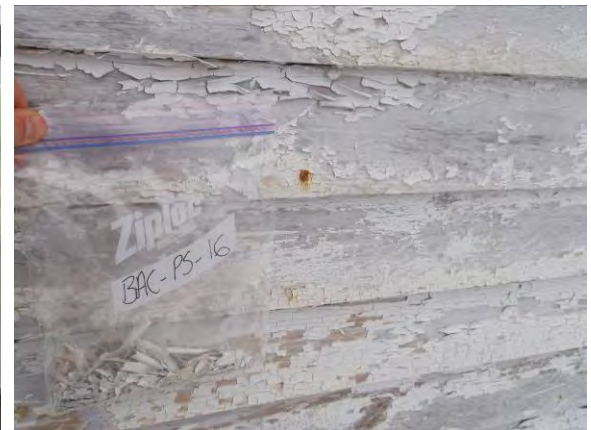
The concentrations of lead in the paint samples ranged from 1,000 mg/kg to 11,000 mg/kg (refer to Table C4-2, Appendix C4). Two (2) of the three (3) samples (BAC-PS-17 and BAC-AS-31) contained lead at concentrations above the Federal HPA criterion of 90 mg/kg but below the former Federal HPA criterion of 5,000 mg/kg (refer to Photos 13 and 14, Appendix B4). One (1) paint sample (BAC-PS-16) contained lead at a concentration above the former Federal HPA criterion of 5,000 mg/kg (refer to Photo 12, Appendix B4).

The concentrations of leachable lead in paint sample BAC-PS-16 (12 mg/L) and supplemental paint and wood substrate sample BAC-PS-16A (13 mg/kg) were above the Schedule II leachate criterion for lead (5.00 mg/L) provided in the provincial guidance document for leachable toxic waste (GD-PPD-26.1) (refer to table C4-4, Appendix C4). Paint sample BAC-PS-16 (white paint) and supplemental paint and wood substrate sample BAC-PS-16A were collected from siding and a door frame on the exterior of the tramway storage shed. The paint on the exterior wood siding (covering an area of approximately 70 m<sup>2</sup>) was generally in poor condition and flaking. Since the concentrations of leachable lead in the paint sample and the paint and wood substrate sample are at levels considered to be hazardous, these materials (painted wooden siding and wooden framing), if removed from the Site, must be disposed of at a hazardous waste treatment facility.

Photo 12: View of paint sample BAC-PS-16.

- The concentrations of leachable lead in one (1) paint sample and one (1) supplemental paint and wood substrate sample collected from siding and a door frame on the exterior of the tramway storage shed were above the Schedule II leachate criterion for lead (5.00 mg/L) provided in the provincial guidance document for leachable toxic waste (GD-PPD-26.1). Since the concentrations of leachable lead in the paint sample and the paint and wood substrate sample are at levels considered to be hazardous, these materials (painted wooden siding and wooden trim), must be disposed of at a hazardous waste treatment facility.

- The white paint exceeding the lead leachate criterion is deteriorated (i.e. peeling and flaking) therefore in order to help prevent impacts to the environment, priority should be given to the removal of this deteriorated paint.

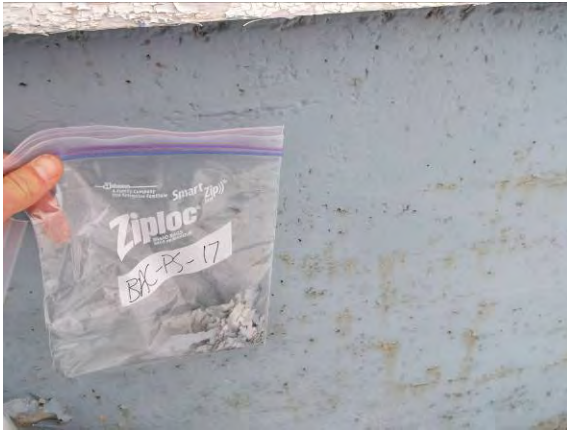
Photo 13: View of paint sample  
BAC-PS-17.

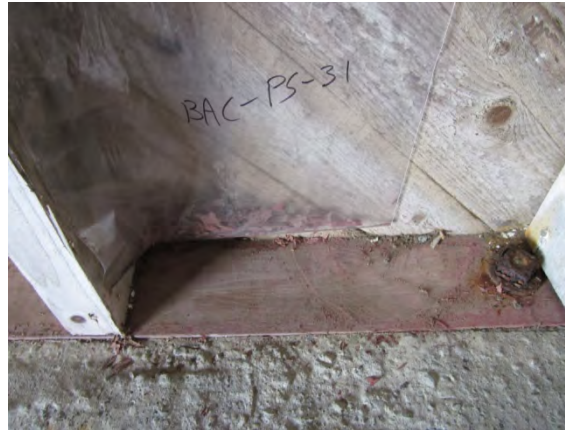
Photo 14: View of paint sample  
BAC-PS-31.

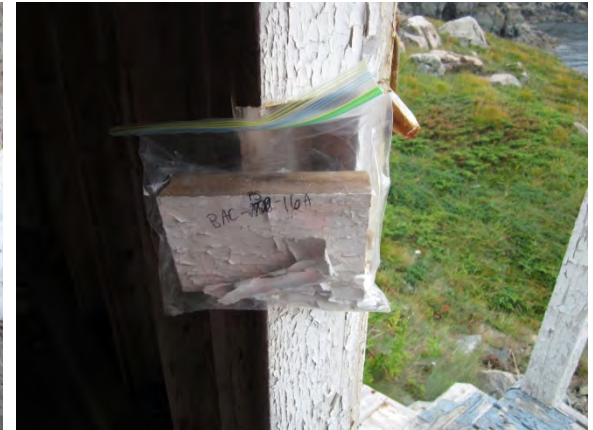
Photo 15: View of paint sample  
BAC-PS-16A.
