## 10.0 CLOSURE AND LIMITATIONS

**Proj:** Tf12076457 BACALNAO ISLAND HAZMAT

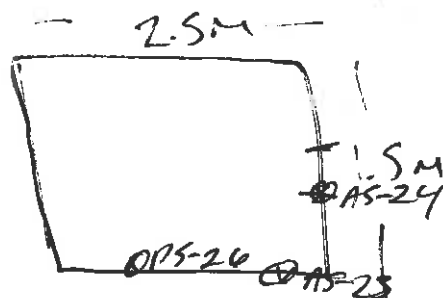
BAC-AS-23 - red/black  
Shingle  
BAC-AS-24 - white door  
caulk.  
BAC-PS-26: white on  
plywood wall.

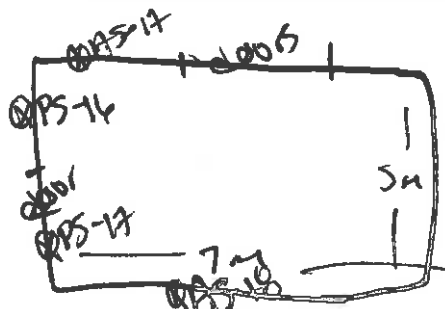
BAC-AS-17  
red shingles

BAC-AS-18  
white window caulking  
(BAC-AS-Dup-2)

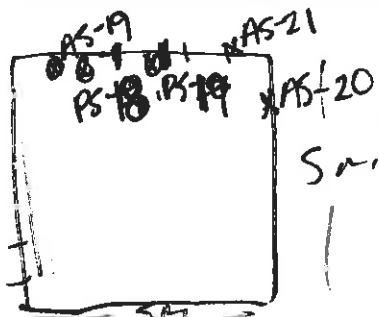
BAC-AS-20 - red shingles  
BAC-AS-21 - white caulk  
on window

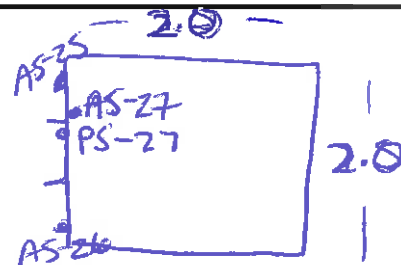
external  
 white painted wood panel siding  
 BAC-AS-25 - Black tar paper. (BAC-AS-PVP-3)  
 BAC-AS-26 - white caulking on sides  
 BAC-AS-27 Vapor barrier paper.  
 BAC-PS-27 - white on ~~ply~~ wood panel siding
