SECTION 2.0 EXECUTIVE SUMMARY

2.0 DWELLING

The dwelling (or lightkeeper's residence) is located on the main site area of the Bacalhao Island Lightstation (refer to Figures 1.1 and 1.2, Appendix A1 and Photos 1 and 2, Appendix B1). Based on the Directory of Federal Real Property, the lightkeeper's residence (Building No. 001407) on Bacalhao Island was constructed in 1975.

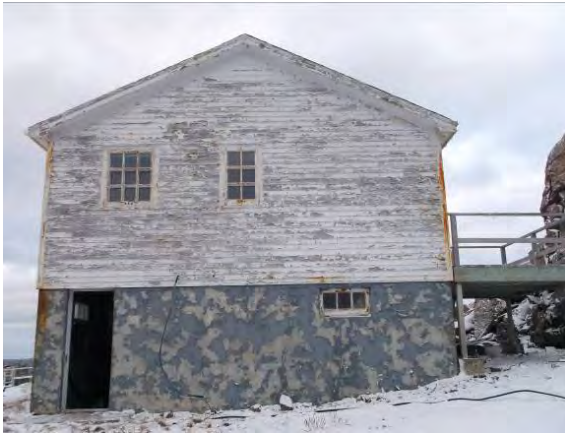
The condition of the paint visible throughout the dwelling varied from good to poor condition. Peeling and flaking paint was observed on the exterior siding and foundation walls and on the basement floor of the dwelling (refer to Photos 1, 16 and 17, Appendix B2).

Photo 1: View of south side of dwelling.

- The white paint exceeding the lead leachate criterion is deteriorated (i.e. peeling and flaking); therefore, in order to help prevent impacts to the environment, priority should be given to the removal of this deteriorated paint.

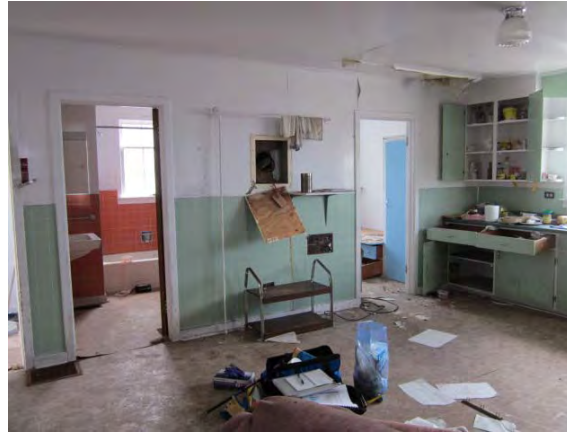
AMEC inspected the interior areas of the dwelling for visual or olfactory evidence of suspected mould. A malodour was noted upon entry into the main level of the dwelling. Peeling and flaking paint that can be a result of building materials compromised by moisture was observed on walls and ceilings of the dwelling (refer to Photo 47, Appendix B2). Areas of SVG and/or water damage were observed in several areas on the interior surfaces of the dwelling (refer to Photo 8, Appendix B2). One (1) sample (BAC-MD-01) was collected from the dwelling living room/kitchen (ceiling) and analyzed for mould growth (refer to Figure 2.1, Appendix A2 and Photo 57, Appendix B2). The laboratory results confirmed that abundant mould growth was present in the sample collected and submitted for analysis (refer to Table C2-7, Appendix C2). The types of mould identified in the sample were *Apergillus* and *Cladosporium*.

Photo 8: View of living room/kitchen in dwelling. Note: SVG on ceiling/cupboards.

- Should the structure not be demolished, prior to occupancy and based on the estimated areas of mould impacted materials observed in the dwelling, the mould impacted materials should be remediated using Level 3 abatement procedures (i.e. more than 10 m²), as outlined in the 2010 Environmental Abatement Council of Ontario (EACO) Mould Abatement Guidelines.

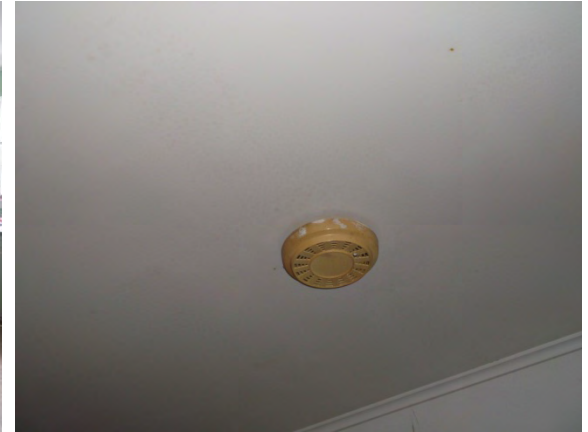
AMEC observed a smoke detector inside the living room/kitchen of the dwelling (refer to Photo 9, Appendix B2). The type of smoke detector observed commonly contains very small amounts of radioactive material (i.e. Americum 241). Smoke alarms that use radioactive material incorporated in an ionization chamber are called "ion chamber smoke alarms". The radioactive material emits alpha particles and low energy gamma rays. The alpha particles are absorbed within the alarm, while most of the gamma rays escape. The alpha particles collide with the air in the ionization chamber to produce charged particles called ions. A low-level electric voltage is applied to the chamber to collect these ions, causing a steady electric current to flow. Smoke or hot air entering the chamber changes the rate of ionization and, therefore the electric current level, which triggers an alarm. Domestic smoke alarms containing radioactive material are completely safe under all residential conditions¹.

Photo 9: View of smoke detector in living room/kitchen in dwelling.

- AMEC observed a smoke detector inside the living room/kitchen of the dwelling. The type of smoke detector observed commonly contains very small amounts of radioactive material (i.e. Americum 241).
- The smoke detector should be removed intact, stored in a properly labeled container and transported, as per TDG regulations, to a licensed disposal facility.

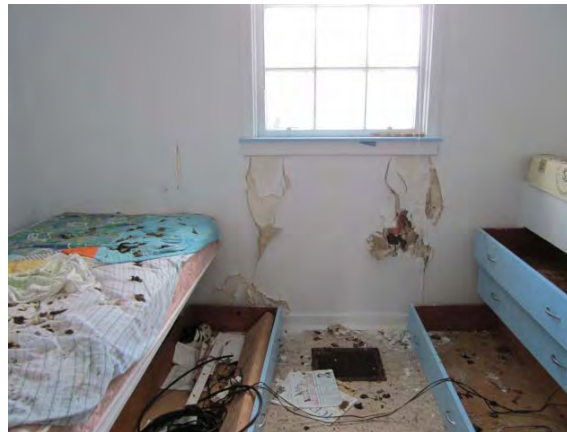
Bird and/or animal droppings/feces were observed in several areas throughout the interior of the dwelling (refer to Photo 11, Appendix B2). Precautions should be taken to prevent/reduce exposure to potential microbiological contaminants (e.g. bacteria, viruses, etc.) often associated with bird or animal droppings/feces while working within the immediate area of the droppings/feces or during any disturbance/ demolition of building materials that may be impacted by the bird or animal droppings/feces.

Photo 11: View of room 3 in dwelling. Note: bird or animal feces.

- Bird and/or animal droppings/feces were observed in several areas throughout the interior of the dwelling. Workers should don proper PPE to prevent/reduce exposure to potential microbiological contaminants (e.g. bacteria, viruses, etc.) often associated with bird or animal droppings/feces while working within the immediate area of the droppings/feces or during any disturbance/demolition of building materials that may be impacted by the bird or animal droppings/feces.

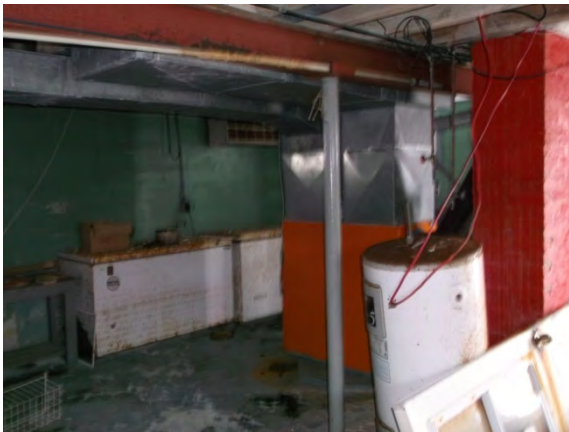
Other potential ACMs were observed and were not sampled due to the nature of the materials and/or hazards associated with sampling these materials. These materials included, but are not limited to, electrical and mechanical components and insulators such as wiring and gaskets inside electrical panels, electronic and/or mechanical equipment. Other possible hidden and inaccessible ACMs have the potential to be present at the Site but were not identified during the Site visits. These possible ACMs could include interior components of the chimney and furnace, packing associated with cast iron pipe joints, fire rated structures or building materials and underground infrastructure and piping (refer to Photos 16 and 18, Appendix B2).

Photo 16: View of furnace in basement of dwelling.

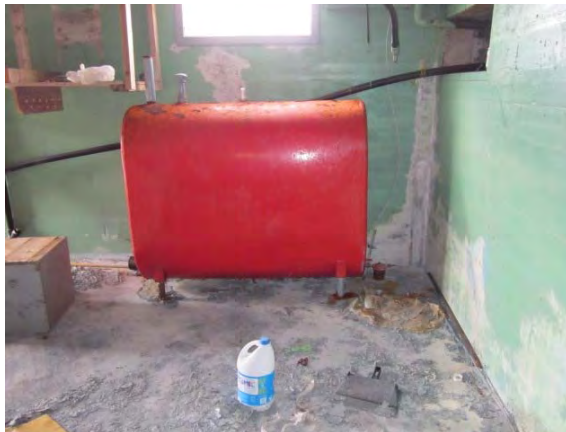
Name	Location	Storage Capacity	Type	Date Installed	Date on ULC Placard	Comments
AST 1: Furnace Oil Storage Tank (Red)	Dwelling Basement	909 L	Steel, horizontal.	Unknown.	Not visible.	Tank appears to be in poor condition (rust visible).

Photo 17: View of 909 L furnace oil AST in basement of dwelling.

- One (1) steel, horizontal, furnace oil AST (909 L) was observed inside the basement of the dwelling during the March 2013 HBMS and the current demolition HMBA.
- The requirements for regulatory compliance of the AST located inside the dwelling have not been determined by this assessment. The tank appeared to be in poor condition (i.e. visible rust); however, the condition and status of the AST can only be confirmed through test methods, such as magnetic testing, pressure testing or visual inspection.
- If the petroleum storage tank is no longer in use or connected to a heating appliance, it should be decommissioned in accordance with applicable regulations (refer to Section 1.4).

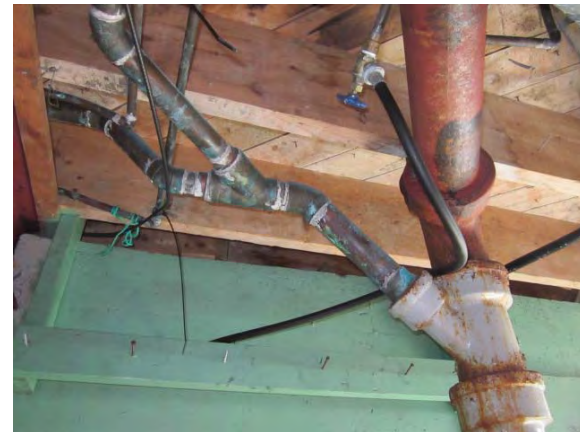
Photo 18: View of cast iron piping in dwelling basement.

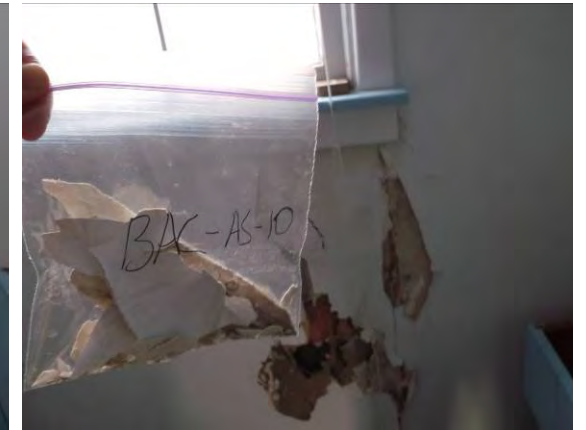
Painted drywall was observed on the walls and ceilings in the dwelling. One (1) sample of drywall joint compound (BAC-AS-10) was collected from an exterior wall in dwelling room 3 and analyzed for asbestos content (refer to Photo 30, Appendix B2). Chrysotile asbestos (2%) was detected in sample BAC-AS-10 at a level above the applicable *NL Asbestos Abatement Regulations (111/98)* (i.e., >1%) and therefore this material (i.e., drywall joint compound collected from the dwelling room 3) is considered to be an ACM.

It should be noted that it is common for the asbestos content in troweled on materials, such as drywall joint compound within older buildings, to vary in concentration depending on the methods used to mix and place these materials. Due to this variability in asbestos content, the drywall joint compound throughout the dwelling should be treated as an ACM.

The condition of the drywall and associated joint compound visible throughout the dwelling (covering an area of approximately 300 m²) varied from good to poor condition.

Photo 30: View of drywall joint compound sample BAC-AS-10.

- Results of the asbestos sampling and analytical program revealed that there are building materials containing greater than 1% asbestos by dry weight, which are considered to be ACMs. Potentially friable asbestos is present in the form of drywall joint compound. Non-friable asbestos is present in the form of asphalt shingles, tile particle board and cement board (i.e. transite) around the stove pipe opening to the chimney. It should be noted that the condition of the drywall and associated joint compound visible throughout the dwelling varied from good to poor condition; therefore, priority should be given to the removal of the

deteriorated joint compound inside these areas of the dwelling.

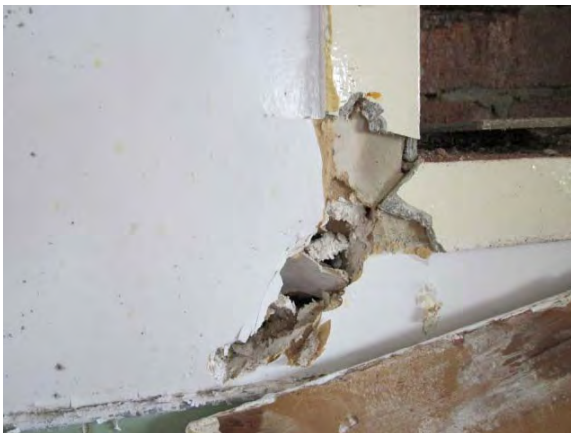
One sample of grey cement board (BAC-AS-34) was collected from the former stove pipe opening to the brick chimney in the dwelling living room/kitchen and analyzed for asbestos content (refer to Photo 40, Appendix B2). Chrysotile asbestos (10%) was detected in sample BAC-AS-34 at a level above the applicable *NL Asbestos Abatement Regulations (111/98)* (i.e., >1%) and therefore this material (i.e., grey cement board collected from the former stove pipe opening) is considered to be an ACM. The cement board (i.e. transite) observed on the former stove pipe opening (covering an area of approximately <1 m²) appeared to be generally intact and in fair condition. It is important to note that additional cement board material may be concealed inside the wall cavity around the chimney.

Photo 40: View of cement board sample BAC-AS-34.

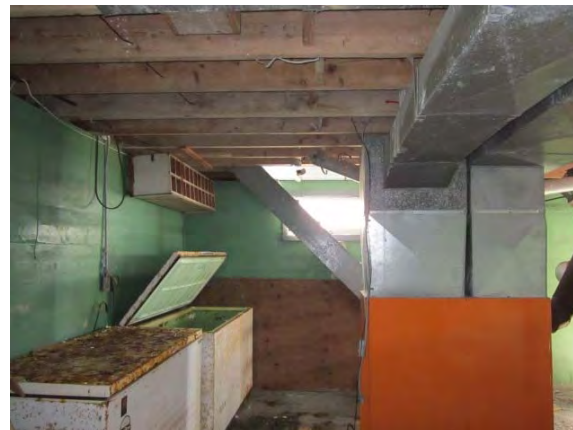
Potential sources of ODSs identified during the previous HBMS included two (2) freezers in the dwelling basement (refer to Photo 59, Appendix B2). The types of refrigerant(s) were not confirmed for the freezers. The freezers appeared to be in poor condition (i.e. rusted, flaking paint).

Photo 59: View of freezers in dwelling basement.
