SECTION 7.0 EXECUTIVE SUMMARY

7.0 SOLAR SHED 1

Date:	Project: DEMOLITION HAZARDOUS BUILDING MATERIALS ASSESSMENT AND INVENTORY, BACALHAO ISLAND LIGHTSTATION BACALHAO ISLAND, NL			
		February 2014	Drawn by:		Title:	
		H. Ryan	SOLAR STORAGE SHED 1 SAMPLE LOCATION PLAN			
Approved by:	Scale:	Project No.:	Figure No.:			
L. Wiseman	As Shown	TF13076513	7.1

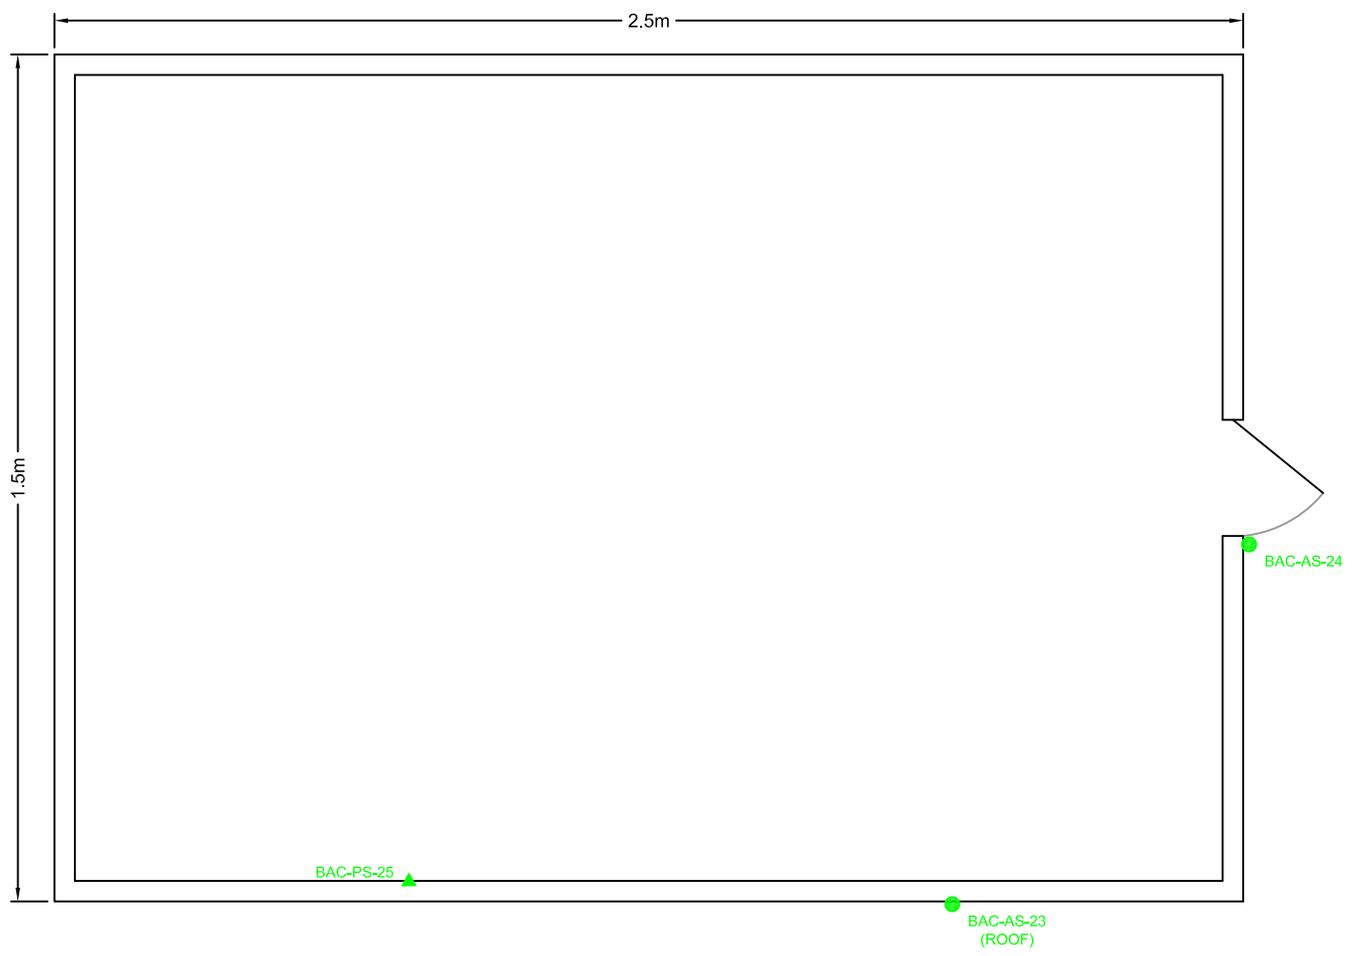
A total of two (2) building material samples (BAC-AS-23 and BAC-AS-24) were collected from solar shed 1 and analyzed for asbestos content (refer to Photos 3 and 4, Appendix B7). Sample descriptions and analytical results are summarized in Table C7-1, Appendix C7. Sample locations and analytical results are graphically illustrated in Figure 7.1, Appendix A7.

One (1) sample (BAC-PS-25) was collected from painted surfaces of solar shed 1 and analyzed for lead and mercury content (refer to Photo 5, Appendix B7). Sample descriptions and analytical results are summarized in Tables C7-2 and C7-3, Appendix C7. Sample locations and analytical results are graphically illustrated in Figure 7.1, Appendix A7.

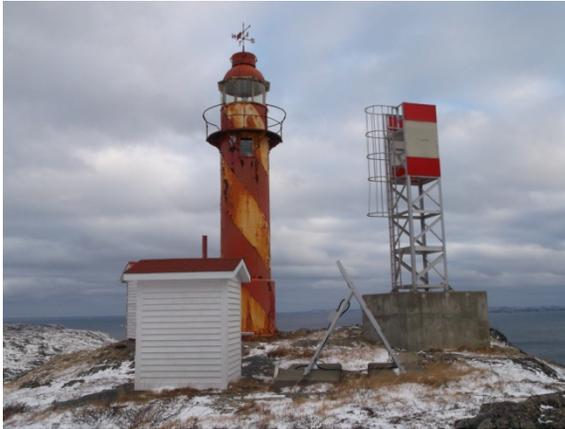
Photo 1: View of solar shed 1 and the light tower in the background.

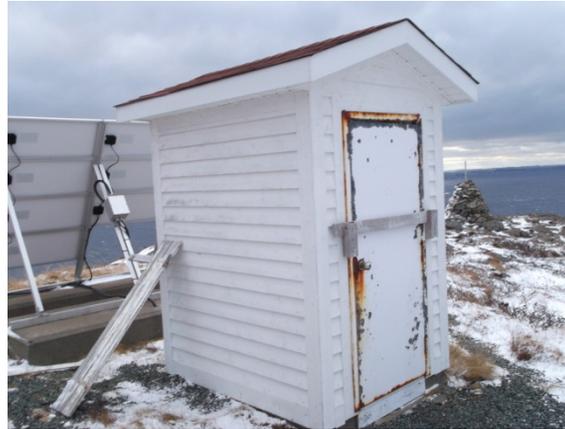
The condition of the paint visible on the interior and exterior of solar shed 1 varied from good to poor condition. The paint on the exterior siding was peeling and flaking and the paint on the exterior metal door was deteriorated due to corrosion (refer to Photos 2 and 3, Appendix B7).

Photo 2: View of solar shed 1.

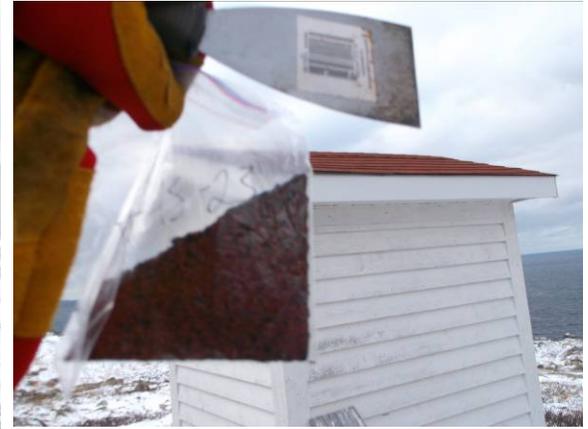
One (1) sample of asphalt shingle roofing material (BAC-AS-23) was collected from the roof of solar shed 1 and analyzed for asbestos content (refer to Photo 3, Appendix B7). Asbestos was not detected in the asphalt shingle sample collected from solar shed 1.

Photo 3: View of asphalt shingle sample BAC-AS-23.

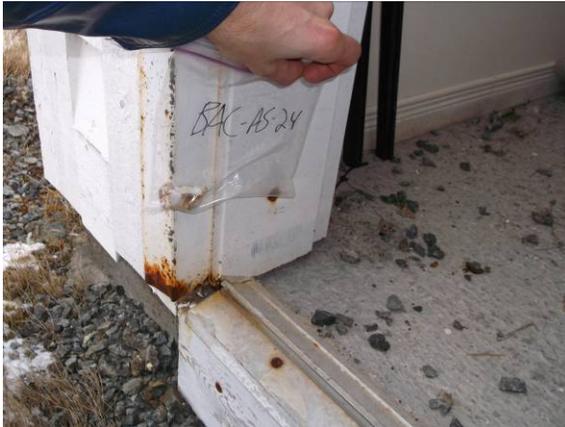
One (1) sample of caulking (BAC-AS-24) was collected from the exterior of solar shed 1 and analyzed for asbestos content (refer to Photo 4, Appendix B7). Asbestos was not detected in the caulking sample collected from solar shed 1.

Photo 4: View of caulking sample BAC-AS-24.

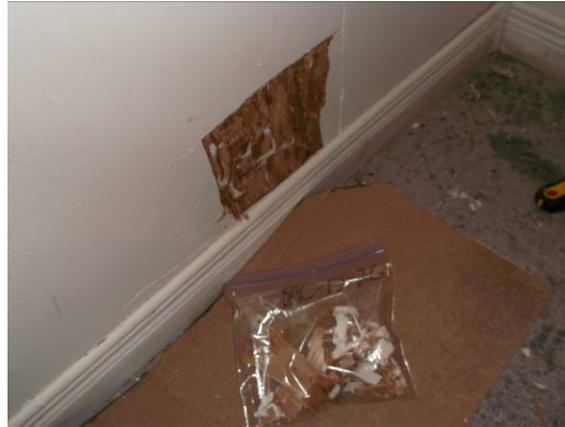
Lead was detected in the paint sample analyzed at a concentration of 8.3 mg/kg (refer to Table C7-2, Appendix C7). Therefore, the paint sample contained lead at a concentration below the Federal HPA criterion of 90 mg/kg and the former Federal HPA criterion of 5,000 mg/kg.

Mercury was not detected (<1.0 mg/kg) in the paint sample analyzed and therefore did not exceed the Federal HPA criterion of 10 mg/kg for mercury in paint or the CCME CSQG of 24 mg/kg for mercury in soil at a commercial site (refer to Table C7-3, Appendix C7).

Photo 5: View of paint sample BAC-PS-25.

- Results of the paint sampling and analytical program revealed that the paint finish sampled during the assessment did not contain lead or mercury at concentrations above the applicable Federal HPA criteria of 90 mg/kg for lead and 10 mg/kg for mercury.
- Paint finishes with a lead concentration of less than 5,000 mg/kg or a mercury concentration of less than 24 mg/kg are not likely to be leachable and therefore may be disposed of at an approved landfill facility, pending landfill and regulatory approval.
- If potential lead or mercury containing paint finishes that were not sampled during the March 2013 HBMS are encountered in the future, samples should be obtained and tested to verify lead and mercury content. This should be done as soon as the paint is encountered and before it is disturbed. This includes materials that are currently concealed by walls and ceiling systems.

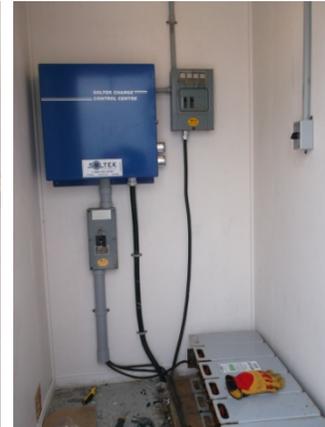
Several potential lead-acid batteries (i.e., solar batteries) were noted inside solar shed 1 at the time of the March 2013 HBMS Site inspection (refer to Photo 6, Appendix B7).

Photo 6: View of solar batteries in solar shed 1.

- Several potential lead-acid batteries (i.e., solar batteries) were noted inside solar shed 1 at the time of the March 2013 HBMS Site inspection.
- The disturbance, control or disposal of lead-containing material/equipment (e.g., batteries, etc.) should be carried out in accordance with applicable criteria/regulations (refer to Section 1.4). The presence/absence of lead in these materials should be confirmed through a contractor or consultant prior to disturbance or disposal of these materials. Typically these materials are sent to a recycling facility and not a landfill.
- If required, removal of lead-containing batteries should be completed in a manner that ensures structural integrity and no loss of fluid from the batteries. Should disposal be

required, disposal of lead-containing batteries should be completed in accordance with hazardous waste procedures/guidelines (i.e. at an approved facility).
