SECTION 3.0 EXECUTIVE SUMMARY

3.0 EQUIPMENT BUILDING

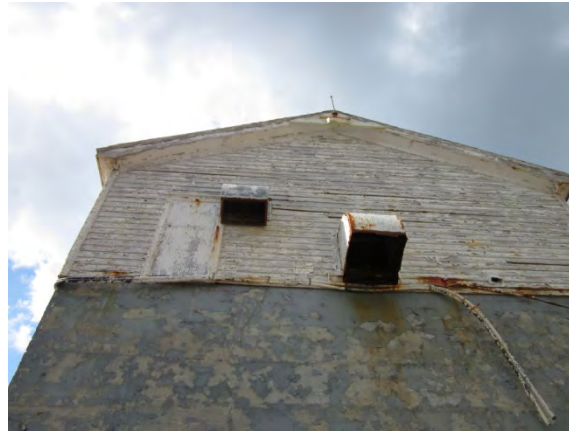
The condition of the paint visible throughout the equipment building varied from good to poor condition. Peeling and flaking paint was observed on interior surfaces and on the exterior siding and foundation of the equipment building (refer to Photos 2, 7, 10, 21 and 24, Appendix B3).

Photo 2: View of the southeast side of the equipment building.

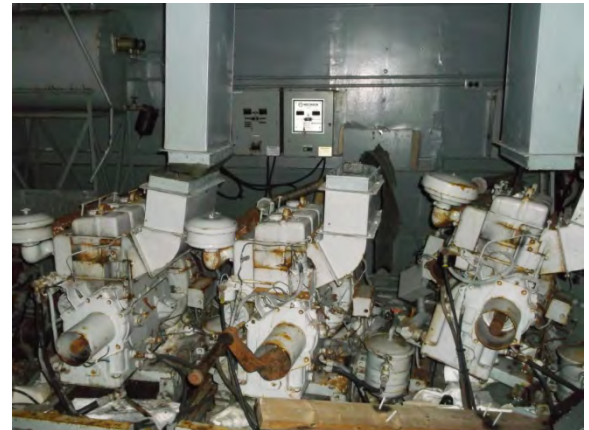
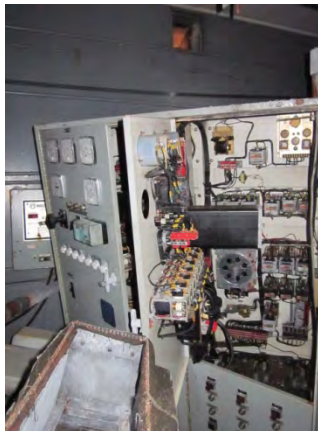
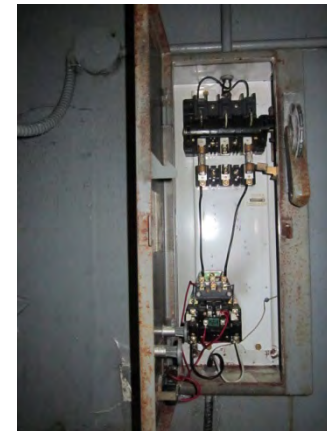
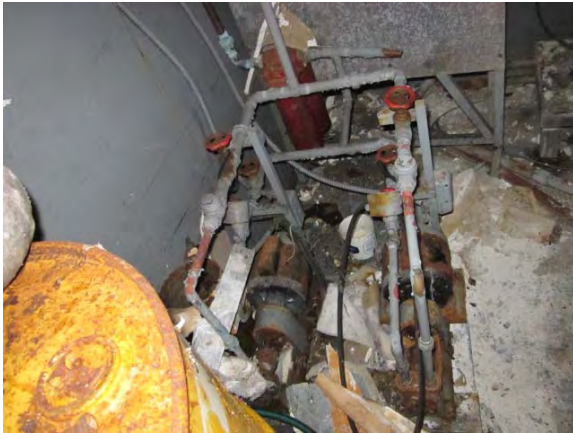
Various types of old electrical and mechanical equipment (generators), cables, pipes and building material debris, including but not limited to wood and drywall, were observed inside the equipment building (refer to Photos 6, 9 and 29 to 31, Appendix B3). A rusted 205-litre metal drum (labeled Shell Jet A-1 47) and several bags (labeled oil absorbent) were observed inside the equipment building (refer to Photos 32 and 33, Appendix B3).

Photo 6: View of room 1 in equipment building (generators).

- Various types of old electrical and mechanical equipment (generators), cables, pipes and building material debris, including but not limited to wood and drywall, were observed inside the equipment building.
- A rusted 205-litre metal drum (labeled Shell Jet A-1 47) and several bags (labeled oil absorbent) were observed inside the equipment building.
- The old electrical and mechanical equipment and solid waste inside the equipment building should be properly disposed of in accordance with applicable regulations.

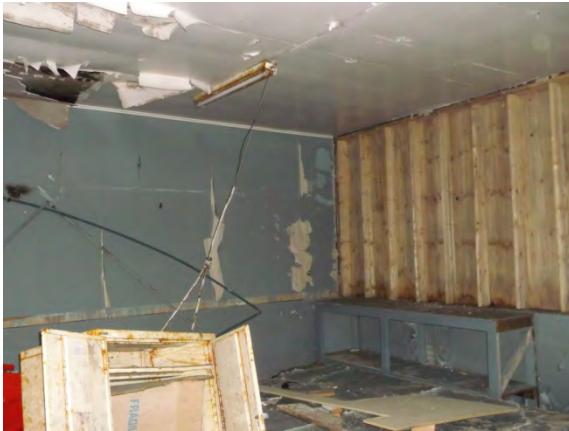
The condition of the drywall and associated joint compound visible throughout the equipment building (covering an area of approximately 265 m²) varied from fair to poor condition. The northwest exterior wall and some of the interior walls of the equipment building were reportedly damaged by waves (refer to Photos 7 and 9, Appendix B3).

compromised by moisture was observed on walls and ceilings of the equipment building (refer to Photos 7, 21 and 23, Appendix B3). Areas of SVG and/or water damage were observed in several areas on the interior surfaces of the equipment building (refer to Photo 24, Appendix B3). The northwest exterior wall and some of the interior walls of the equipment building were reportedly damaged by waves. As a result, the interior of the equipment building was in a state of disrepair at the time of the March 2013 HBMS and the current demolition HMBA. One (1) sample (BAC-MD-02) was collected from the equipment building room 2 (ceiling) and analyzed for mould growth (refer to Figures 3.1, Appendix A3 and Photo 26, Appendix B3). The laboratory results confirmed that abundant mould growth was present in the sample collected and submitted for analysis (refer to Table C3-7, Appendix C3). The types of mould identified in the samples were *Stachybotrys* and *Penicillium*.

Photo 7: View of room 2 in equipment building.

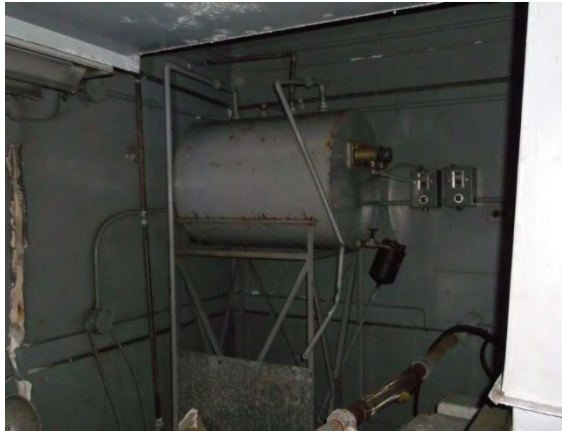
- One (1) steel, horizontal, AST (approx. 1,000 L) was observed inside the equipment building during the March 2013 HBMS and the current demolition HMBA.
- Another AST (approx. 500 L) was identified on a metal frame near three (3) generators inside the equipment building during the March 2013 HBMS and the current demolition HMBA; however, the current and/or former use of this tank is not known
- The requirements for regulatory compliance of the AST located inside the equipment building have not been determined by this assessment. The tank appeared to be in good

Photo 8: View of AST (approx. 500 L) in room 1 of equipment building.

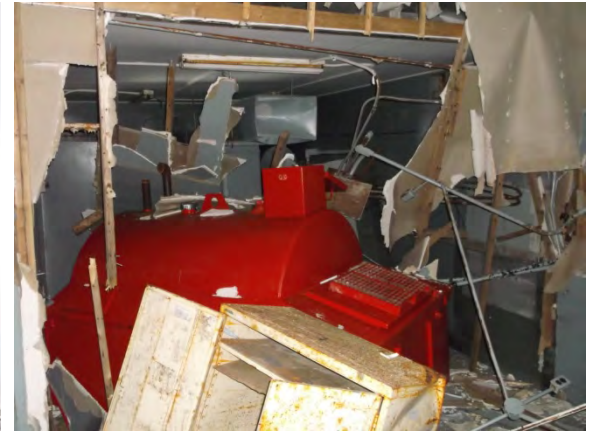
Name	Location	Storage Capacity	Type	Date Installed	Date on ULC Placard	Comments
AST 1: Unknown Storage Tank (Red)	Equipment Building Room 1	1,000 L (Approx.)	Steel, horizontal.	Unknown.	Not visible.	Tank appears to be in good condition; however, tank was only partially visible due to debris in building from wave damage.

Photo 9: View of AST (approx. 1,000 L) in room 1 of equipment building.

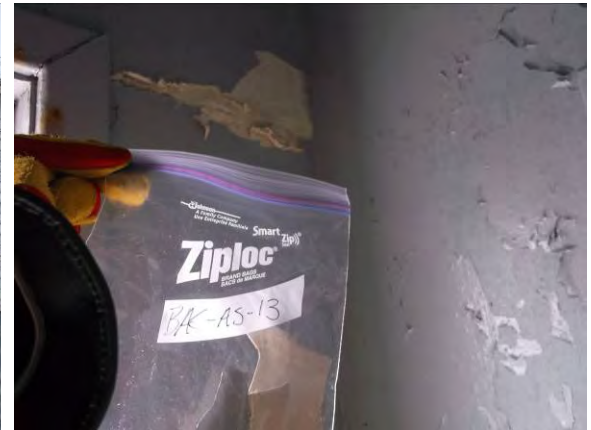
Painted drywall was observed on the walls and ceilings in the equipment building. Two (2) samples of drywall joint compound (BAC-AS-13 and BAC-AS-15) were collected from exterior walls in the equipment building porch and room 2 and analyzed for asbestos content (refer to Photos 12 and 14, Appendix B3). Chrysotile asbestos (3% to 6%) was detected in samples BAC-AS-13 and BAC-AS-15 at levels above the applicable *NL Asbestos Abatement Regulations (111/98)* (i.e., >1%) and therefore this material (i.e., drywall joint compound collected from the equipment building porch and room 2) is considered to be an ACM.

Photo 12: View of drywall joint compound sample BAC-AS-13.

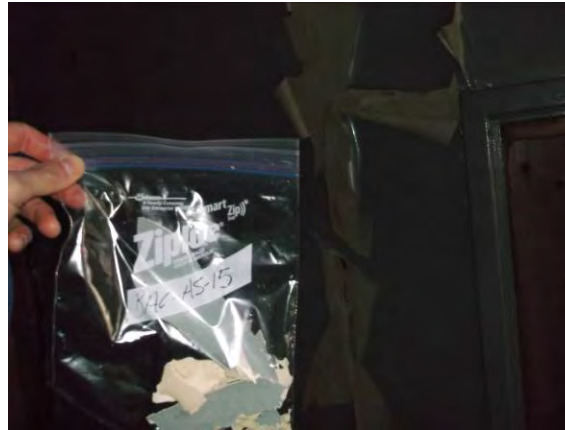
Photo 14: View of drywall joint compound sample BAC-AS-15.

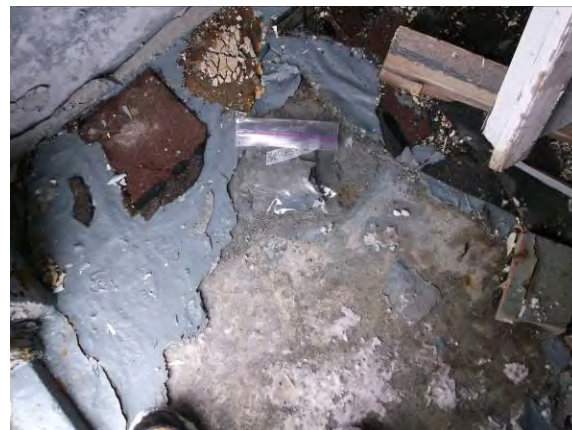
Photo 21: View of paint sample BAC-PS-12.

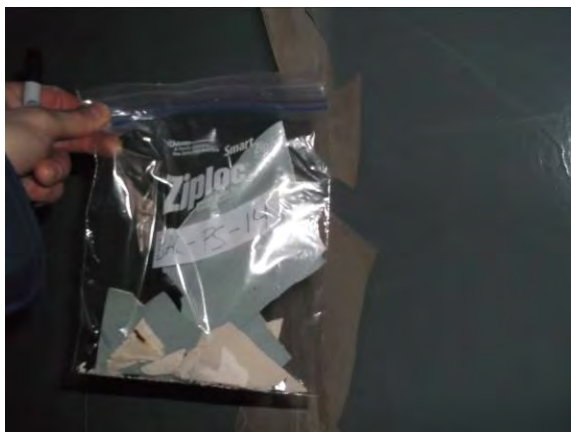
Photo 23: View of paint sample BAC-PS-14.

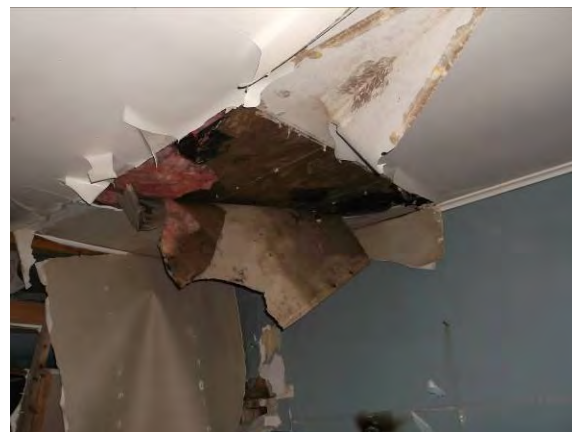
Photo 24: View of paint sample BAC-PS-15.

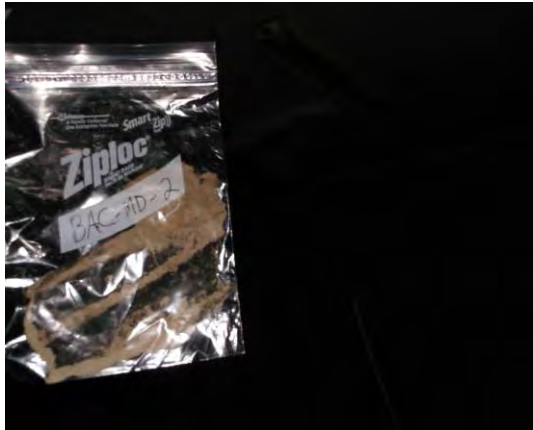
- One (1) sample was collected from the equipment building room 2 (ceiling) and analyzed for mould growth. Results of the mould sampling program revealed that abundant mould growth was present in the sample collected from the interior of the equipment building. Existing conditions in the equipment building (e.g., roof and window leaks, improper ventilation, inadequate building heating, prolonged periods of increased moisture, wave damage, areas open to the environment) may potentially contribute to or enhance mould growth inside the equipment building.

Photo 26: View of mould sample BAC-MD-02.

- Should the structure not be demolished, prior to occupancy and based on the estimated areas of mould impacted materials observed in the equipment building, the mould impacted materials should be remediated using Level 3 abatement procedures (i.e. more than 10 m²), as outlined in the 2010 Environmental Abatement Council of Ontario (EACO) Mould Abatement Guidelines.
- It should be noted that asbestos may be present in drywall joint compound in areas where mould is present on drywall.

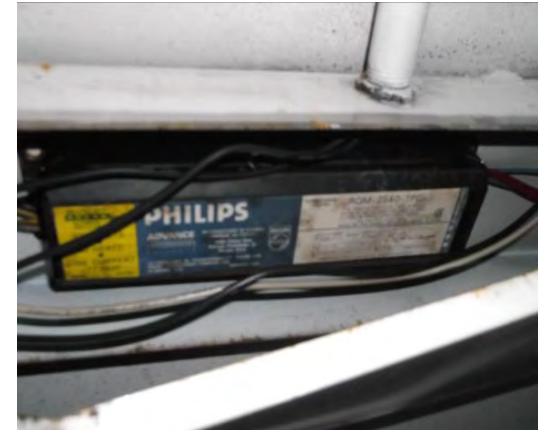
One (1) type of fluorescent light ballast was observed within the equipment building during the Site inspections (refer to Photo 27, Appendix B3). Results of the light ballast inspection are summarized in Table 3-2:

Manufacturer	Cat./Serial No.	Location Observed	No. Inspected	Condition	Potential PCBs (Yes/No)
Phillips Advance	RQM-2S40-TPC	Equipment Building Room 1	1	Poor	Yes

Five (5) fluorescent light fixtures were observed in the equipment building. The light ballasts in four (4) of the five (5) light fixtures at the equipment building could not be inspected for the presence or absence of PCB-containing dielectric fluid due to height restrictions and safety concerns. Due to reported wave damage, the interior of the equipment building was in a state of disrepair at the time of the Site inspections; as a result, access to some of the light fixtures was obstructed by equipment and building material debris. The light fixtures appeared to be in poor condition (refer to Photo 28, Appendix B3). Since it could not be determined from the inspection if the ballasts are either non-PCB or potential-PCB, all light ballasts within the equipment building should be treated as PCB-containing ballasts.

Photo 27: View of Phillips light ballast in equipment building room 1.

- Five (5) fluorescent light fixtures were observed in the equipment building. It could not be determined from the inspection if the ballasts are either non-PCB or potential-PCB; therefore, all ballasts should be treated as PCB-containing ballasts.
- The PCB content in all light ballasts should be confirmed prior to disposal. All ballasts that are removed should be placed in a proper storage container(s). Leaks or stained areas should be cleaned and/or removed in accordance with applicable regulations or industry standards.
- All PCB-containing equipment should be handled, decontaminated, transported and disposed of as per current Federal and Provincial acts and regulations. Any PCB-containing equipment requiring removal from the equipment building should be transported and disposed of by a registered hazardous waste transporter in accordance with applicable regulations.

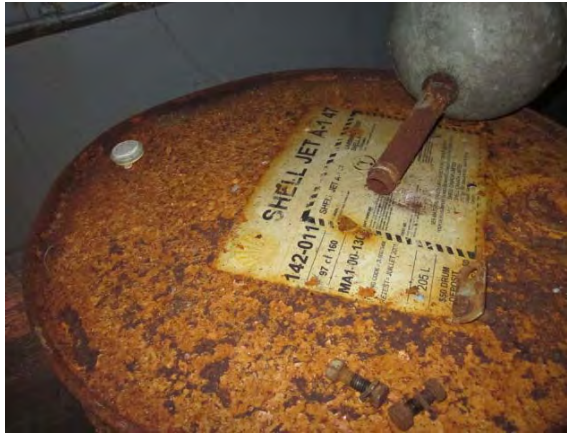
Photo 32: View of 205 litre metal drum inside equipment building.

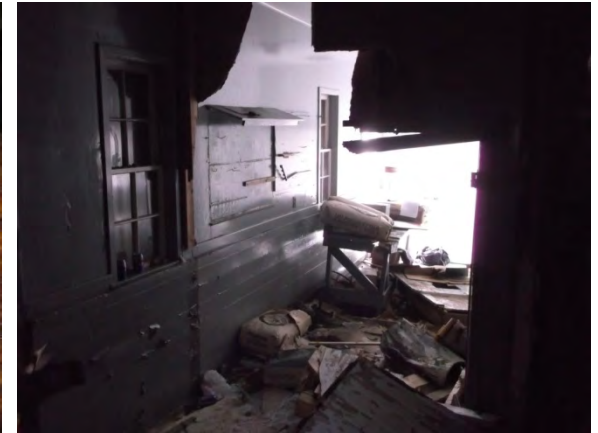
Photo 33: View of bags of oil absorbent material inside equipment building.
