**51 CHARDON DRIVEWAY
TUNNEY'S PASTURE
OCCUPATIONAL HEALTH UNIT (OHU)
MODERNIZATION
SPRINKLER AND LIGHTING SURVEY**

MECHANICAL AND ELECTRICAL REPORT

**GWA 2014-468
September 26, 2014**

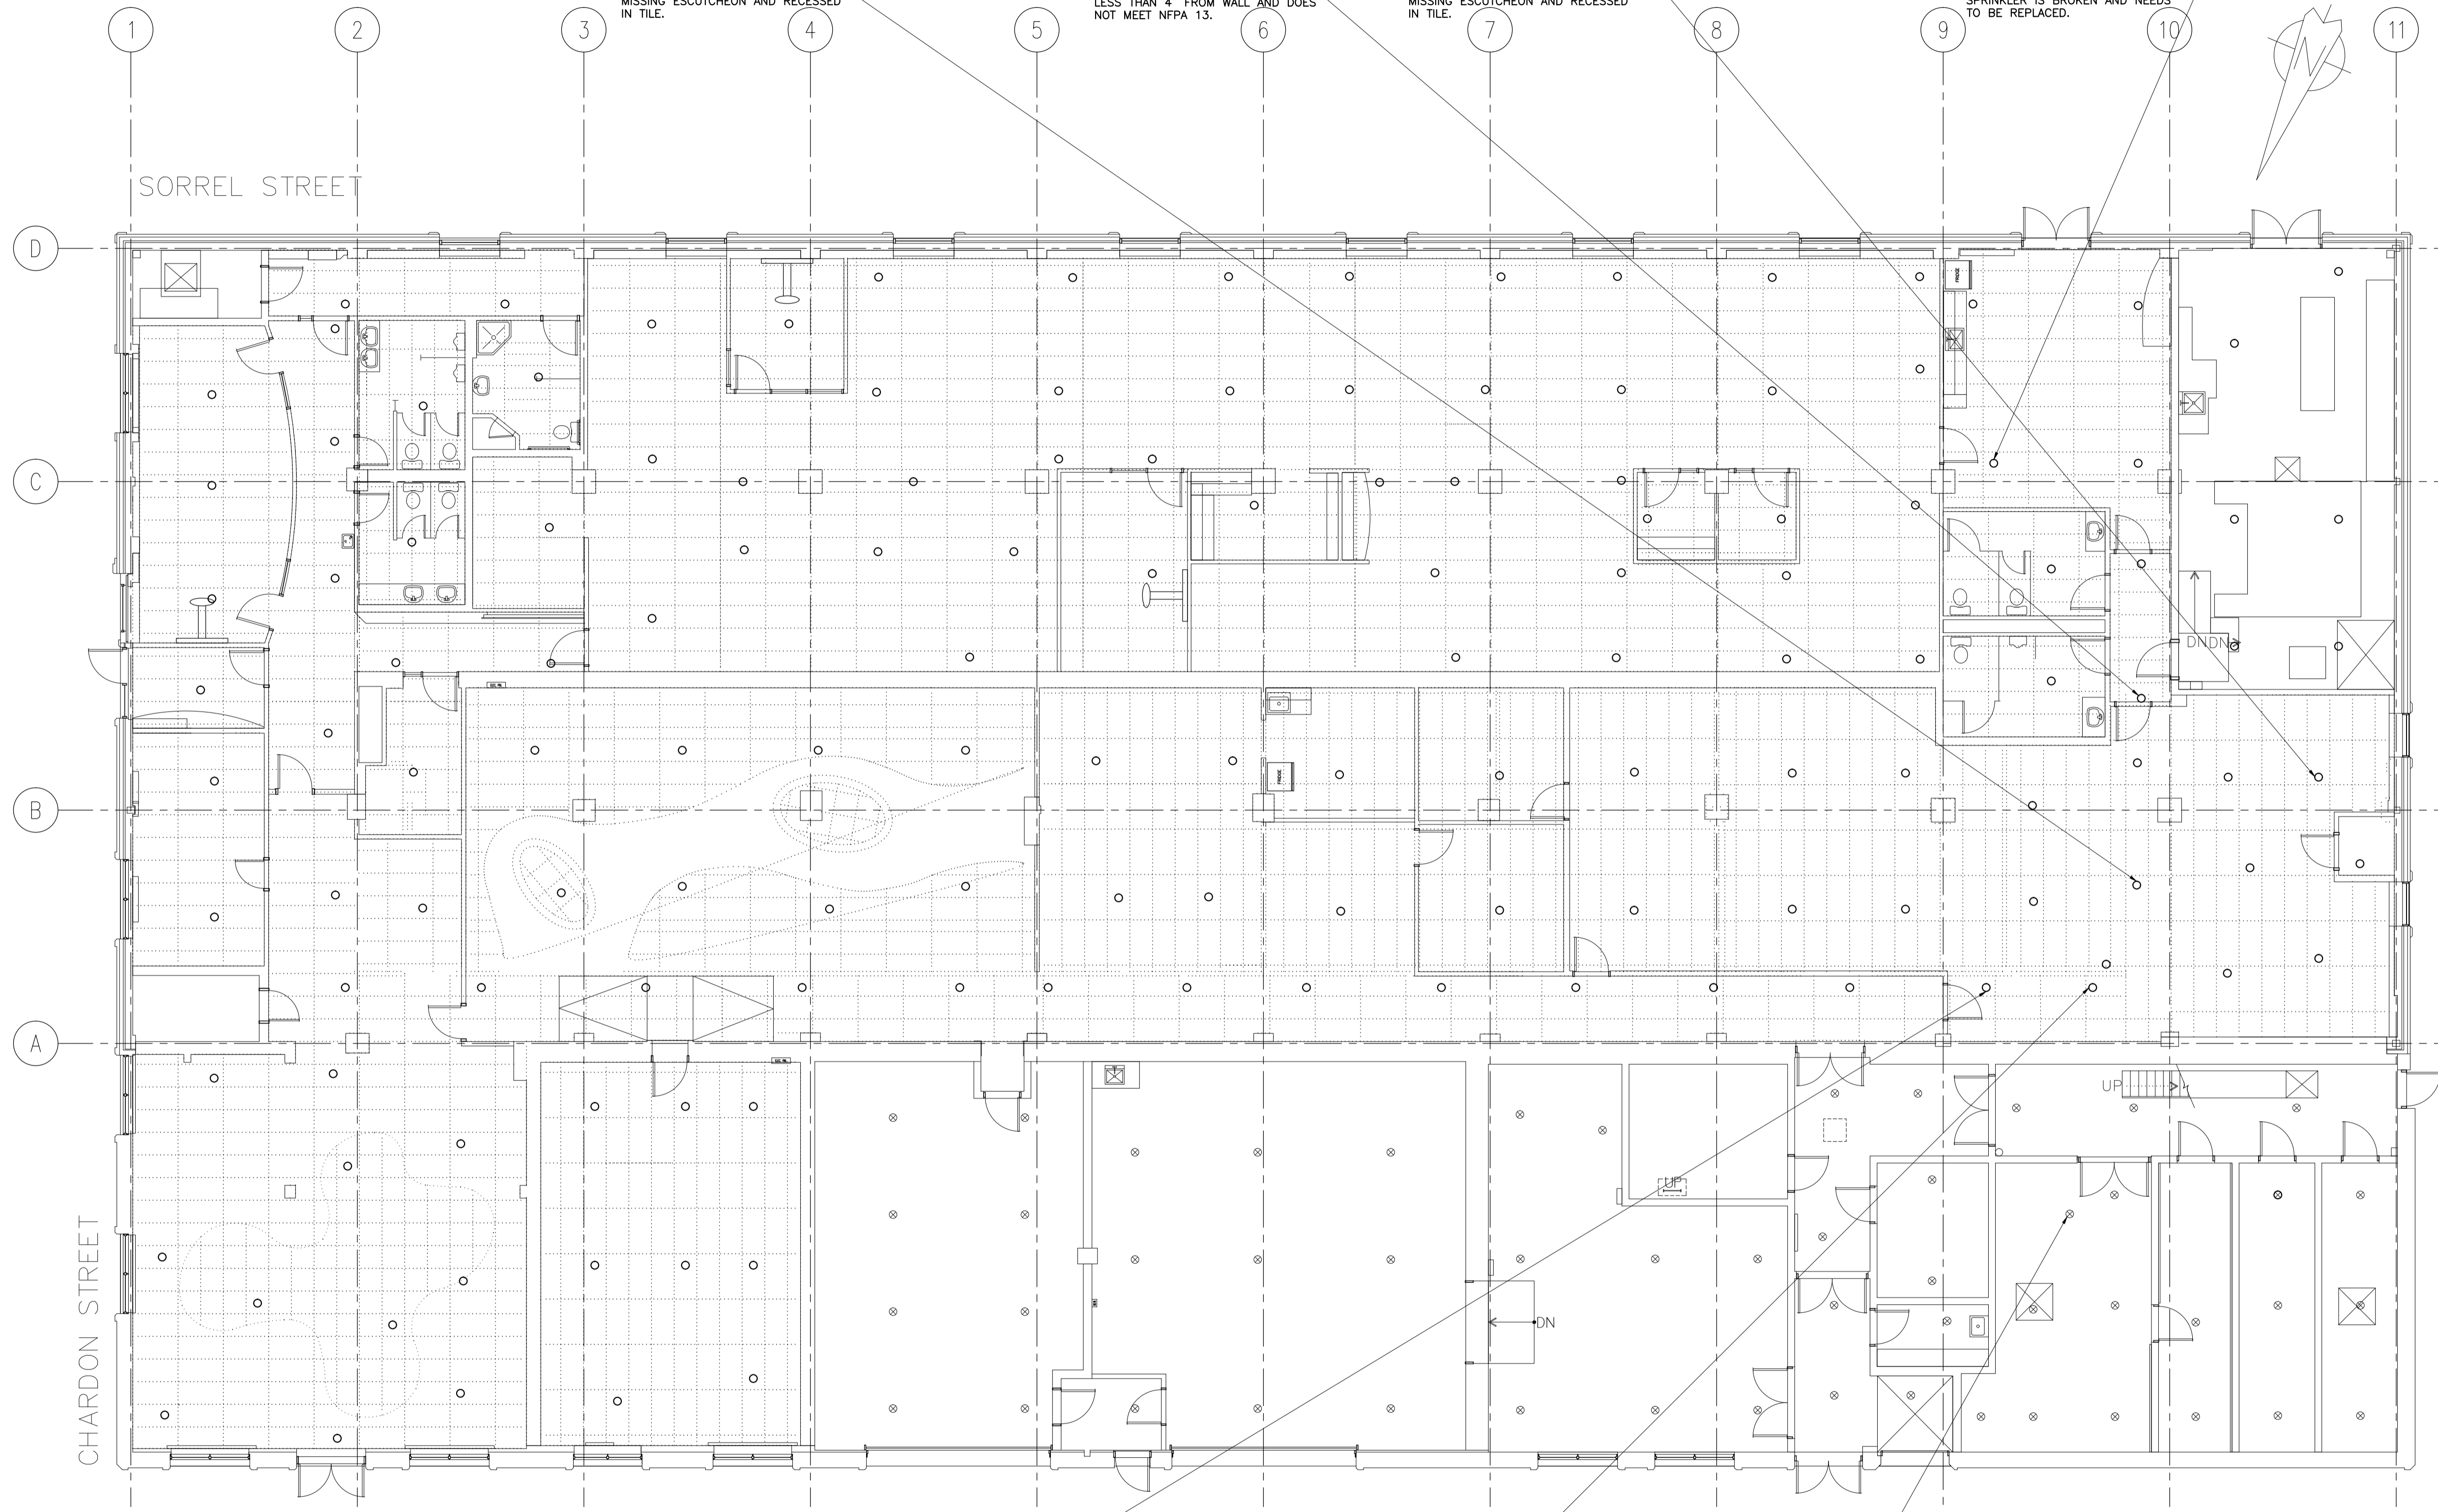
MECHANICAL
EXISTING SPRINKLER
LAYOUT

3 MISSING ESCUTCHEON AND RECESSED IN TILE.

6 LESS THAN 4" FROM WALL AND DOES NOT MEET NFPA 13.

7 MISSING ESCUTCHEON AND RECESSED IN TILE.

10 SPRINKLER IS BROKEN AND NEEDS TO BE REPLACED.

A single sprinkler zone is sufficient for this building as it is one storey and less than the maximum floor area of 52,000 sq.ft. per zone. In general the sprinklers layout is acceptable for a light hazard occupancy with some minor deficiencies that must be corrected. Sprinklers will need to be removed, repaired or replaced as per noted deficiencies. Refer to Figure 1 (Drawing M1) for noted deficiencies.

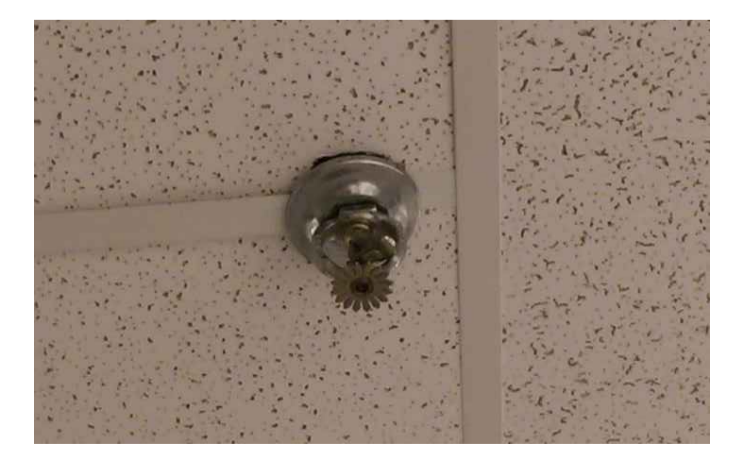
OLD STYLE SPRINKLER SHOULD BE REPLACED TO MATCH NEWER SPRINKLERS.

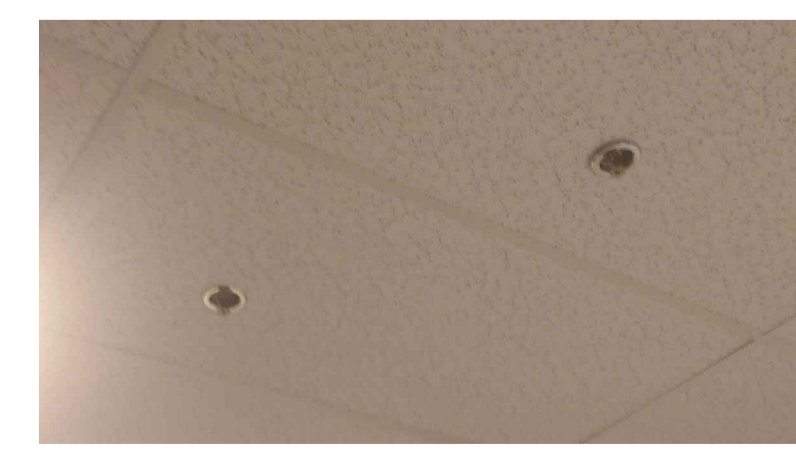
SPRINKLERS ARE LESS THAN 6 FEET APART AND DO NOT MEET NFPA 13 REQUIREMENTS.

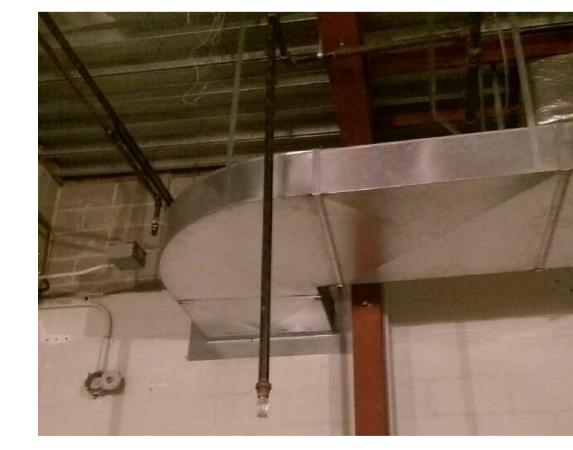
EXISTING HEAD NO LONGER REQUIRED. SHOULD BE REMOVED TO PREVENT ACCIDENTAL DISCHARGE.

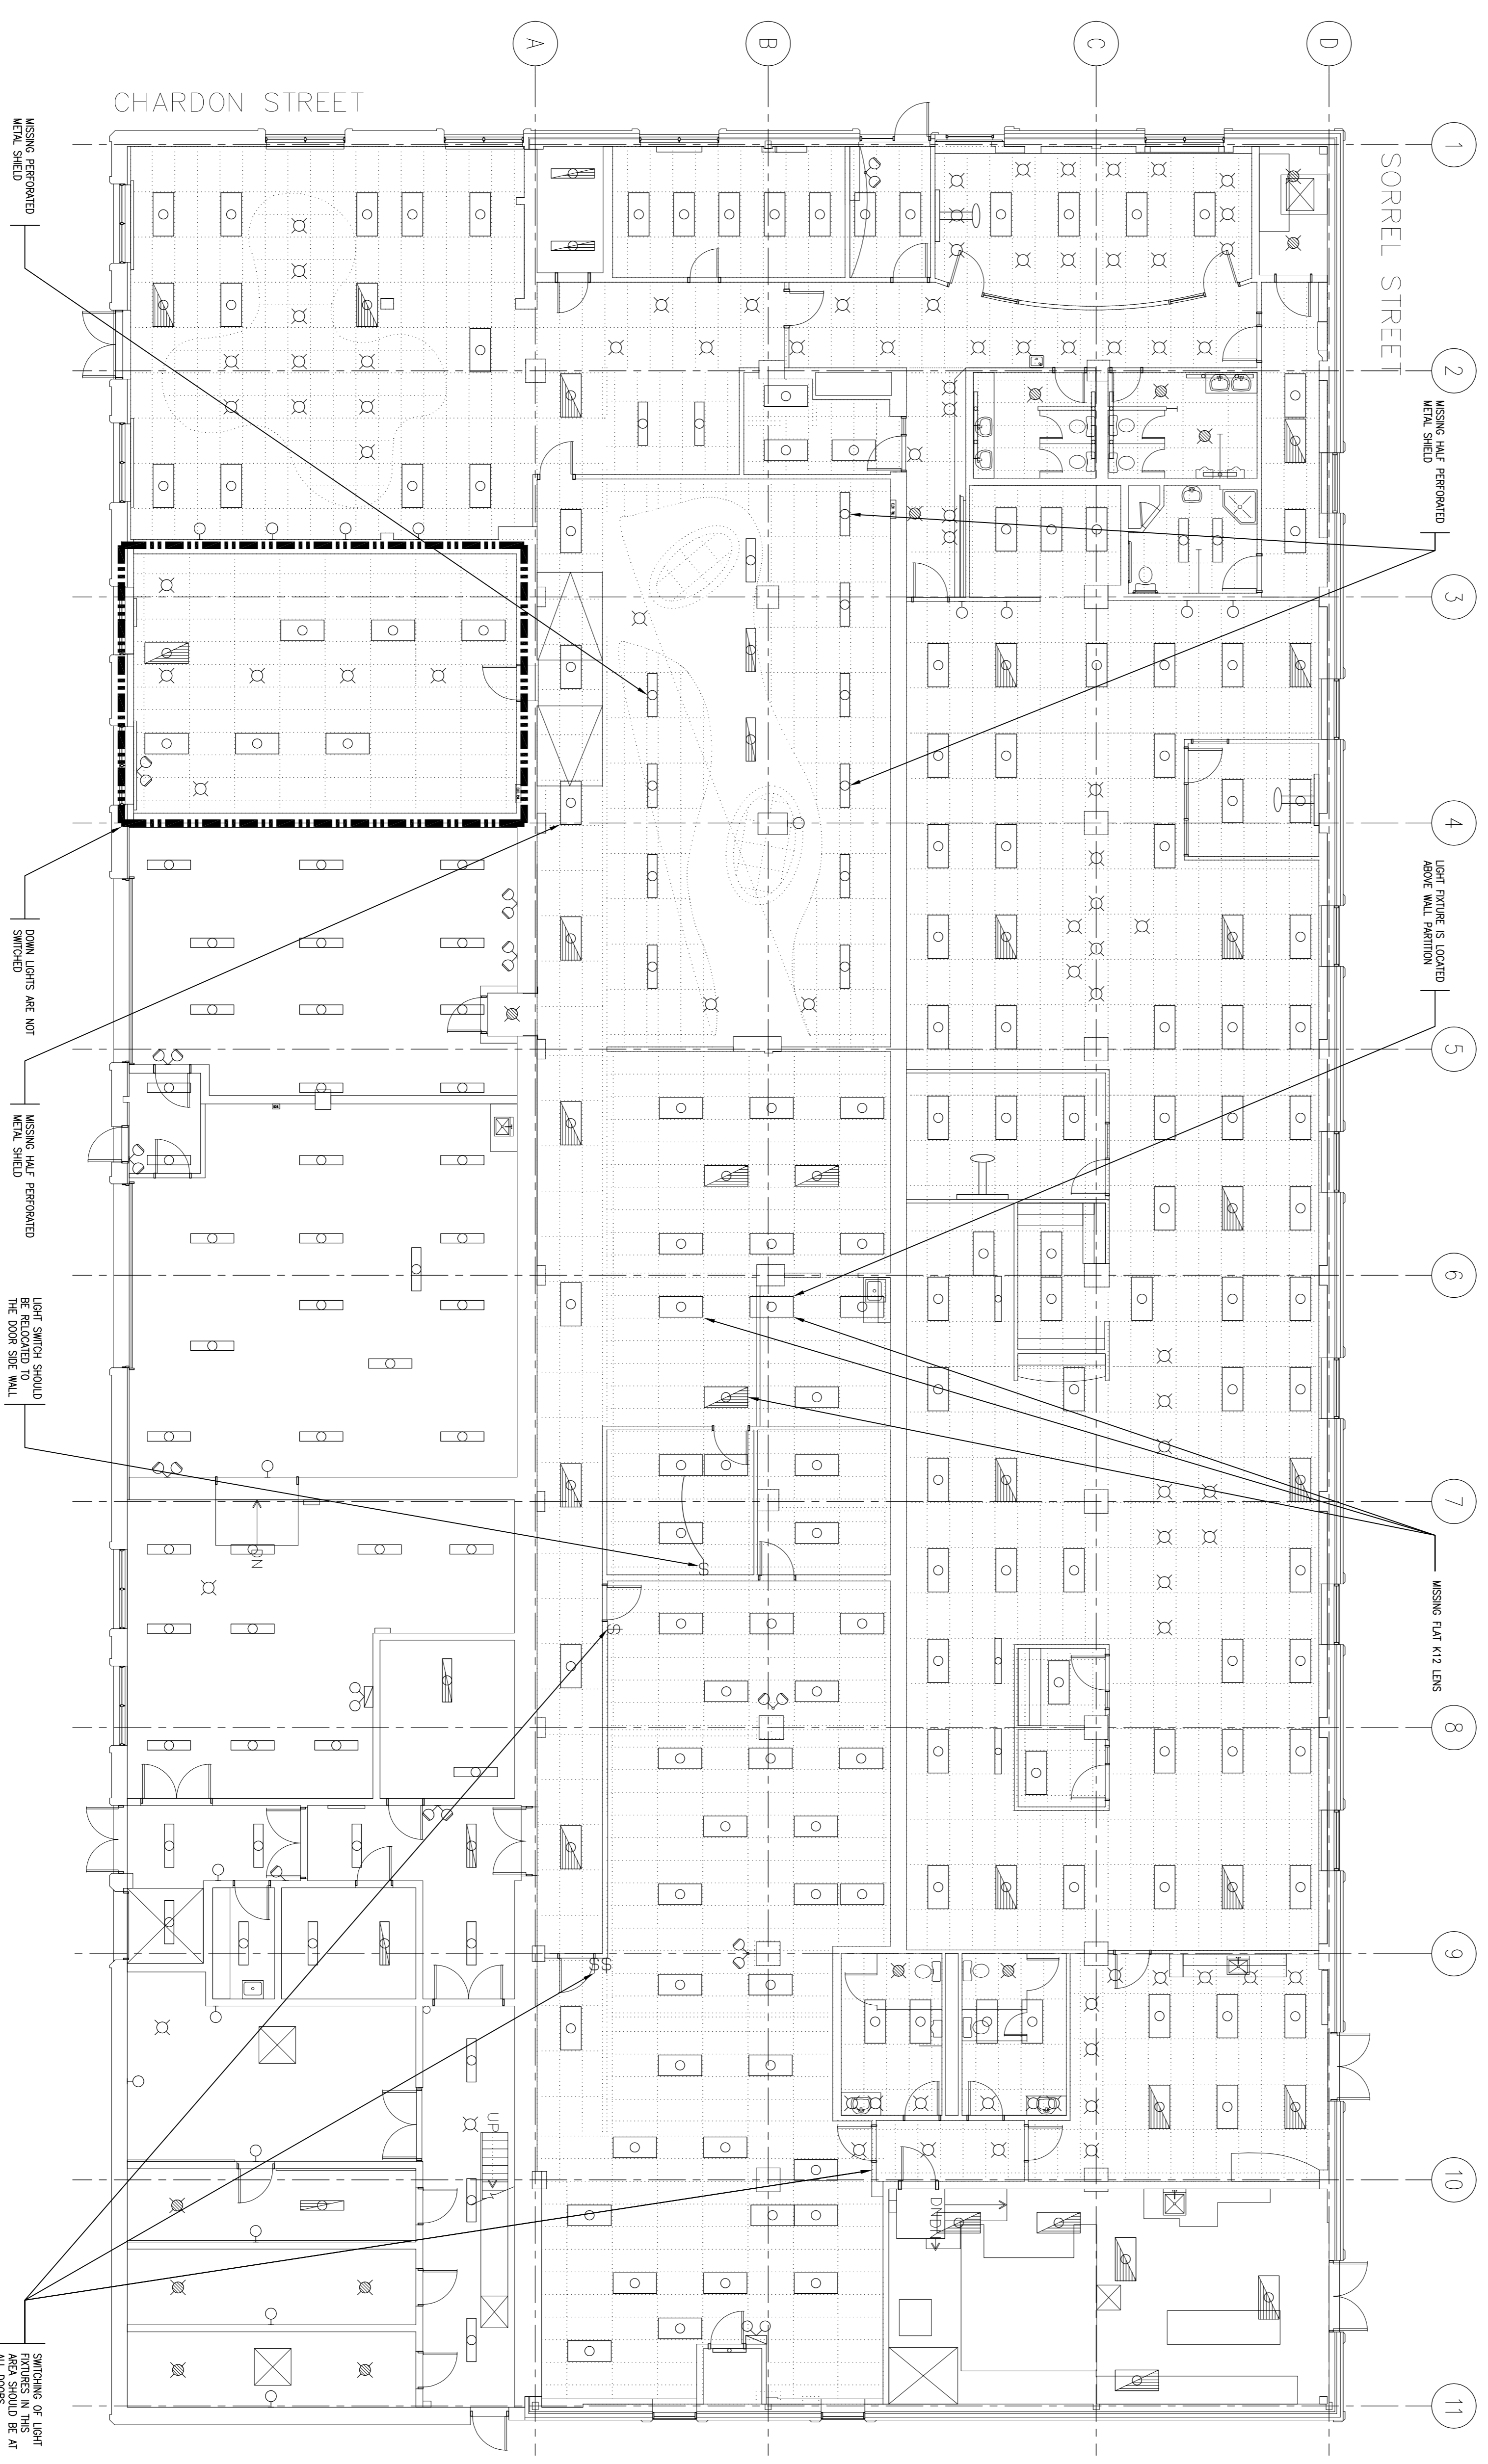
**FIGURE 2: ELECTRICAL
EXISTING LIGHTING
LAYOUT**

The lighting system is an ambient lighting system designed for low glare levels and approximately 250 Lux at the workstations. Task lighting is provided in the furniture systems. The present lighting system delivers between 200 and 300 Lux at the workstations. Lower levels are due to lamp burnout in the area. Sample light levels were measured just before sunset. Industrial type fluorescent fixtures are used in garages, converted labs and mechanical rooms. Existing office lighting systems consists of recessed 2'x4' perforated metal shield linear fluorescent 2-32W (T8), recessed 1'x4' perforated metal shield linear fluorescent 1-32W (T8), recessed 2'x4' flat K12 lens linear fluorescent 2-32W (T8), compact fluorescent downlights and wall sconces. Many of fixtures have damaged or missing lenses. The building lighting is controlled by a low voltage relay system controlled by a timer clock.

The existing emergency lighting is on generator power and battery packs. Approximately seventy-five percent of the building is served by un-switched night lighting with backup generator power that feeds 2'x4' fluorescent light fixtures. While the remaining twenty-five percent is on battery packs feeding double remote heads. Emergency lighting system should be tested.

Overall, the lighting system appears to be functioning adequately for its intended purpose, which is to provide a minimum ambient lighting level, which is supplemented by task lighting at individual workstations. We recommend the following minor deficiencies be rectified: Replace missing 2'x4' and 1'x4' perforated metal shields, and flat K12 lens to reduce unwanted glare from lamps. Disconnect and remove existing 2'x4' light fixture located above wall partition. Relocate/add light switching to make turning on/off of lighting more convenient. Refer to drawing Figure 2 (Drawing E1).
