ENVIRONMENT CANADA MAINTENANCE INSPECTION

12m (40 ft) KNOCK-DOWN SELF-SUPPORT TOWER

WTP Holyrood, NL

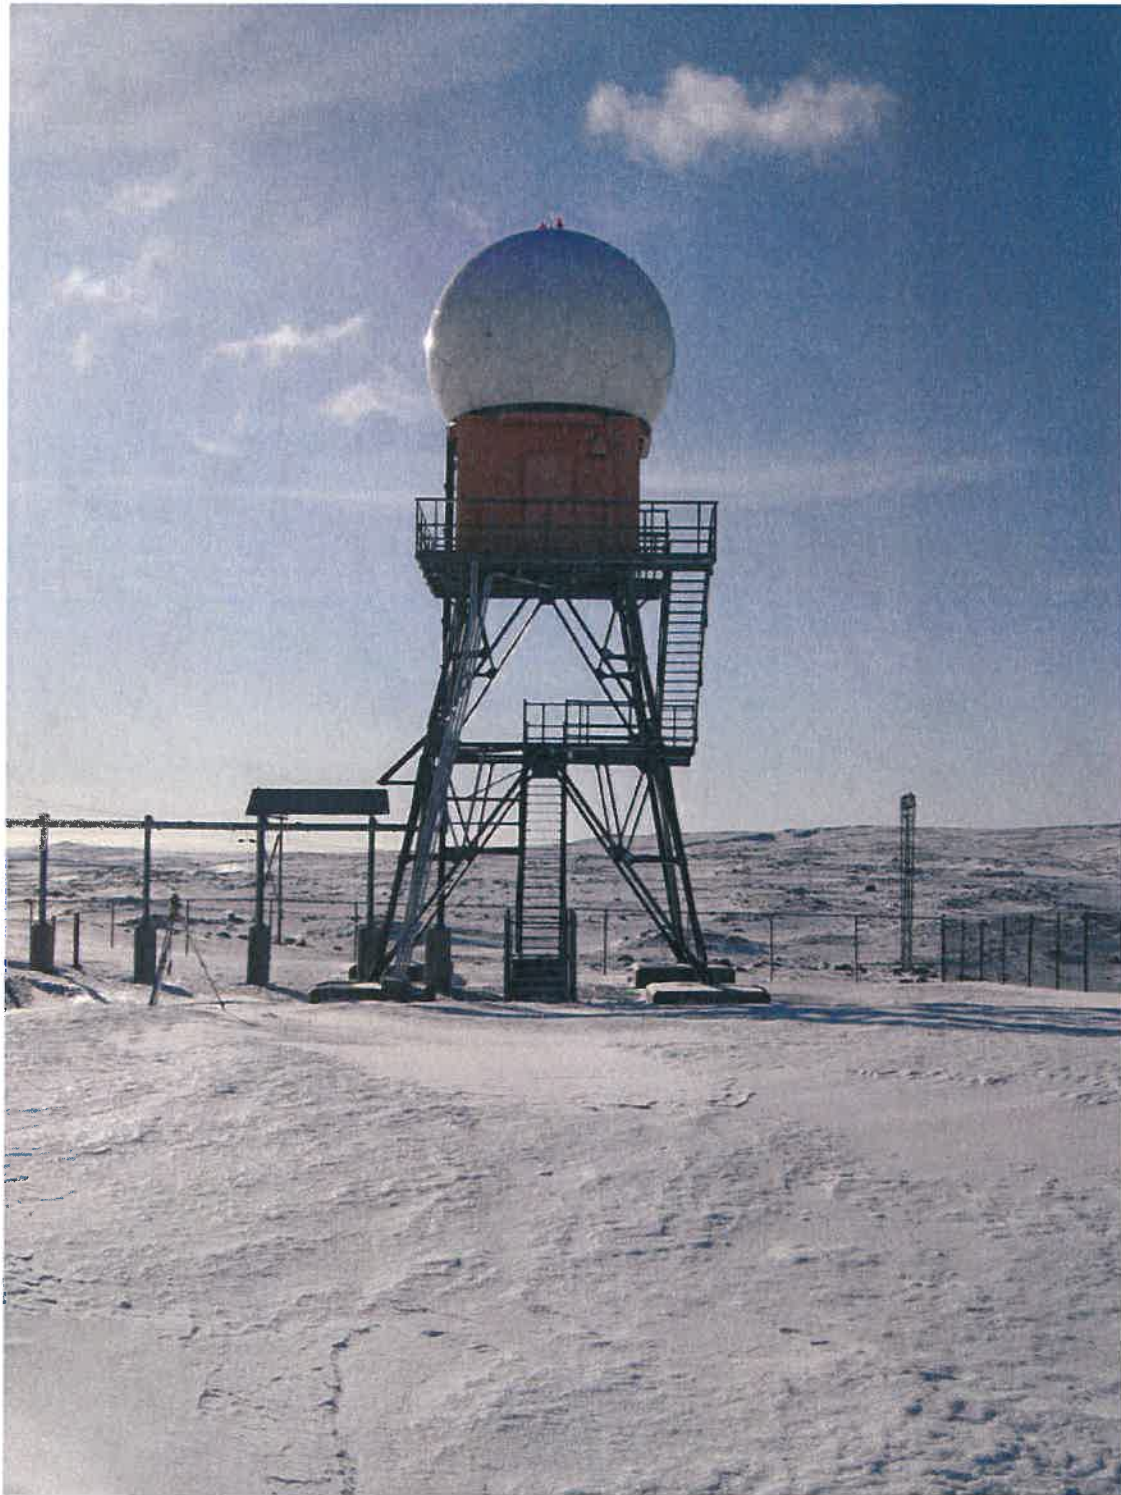
Photo #1: Tower Profile

| A. General: | The compound was snow covered but appeared clear of brush and debris. See Appendix A, Photo #1. |

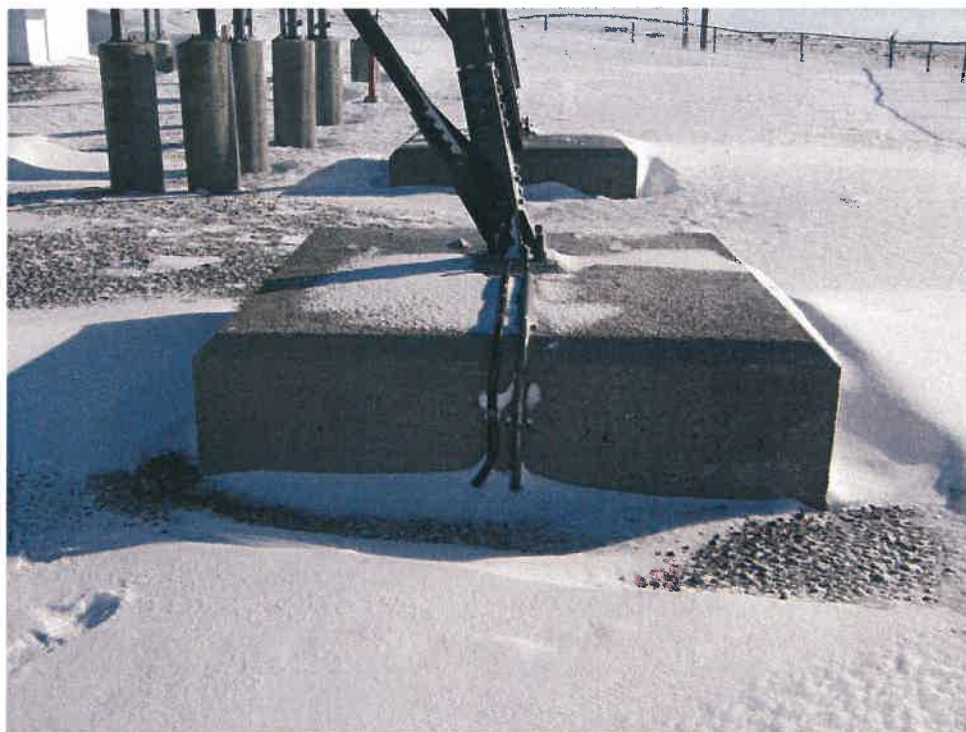
Photo #2: Tower Foundation Typical 4 Locations

| C. Foundations: | <p>The four foundations appear satisfactory. See Appendix A, Photo #2.</p> <p>The grout between the tower legs and tower foundations are deteriorated. See Appendix A, Photo #17.</p> |

The tower grounding appears satisfactory. See Appendix A, Photo #2.

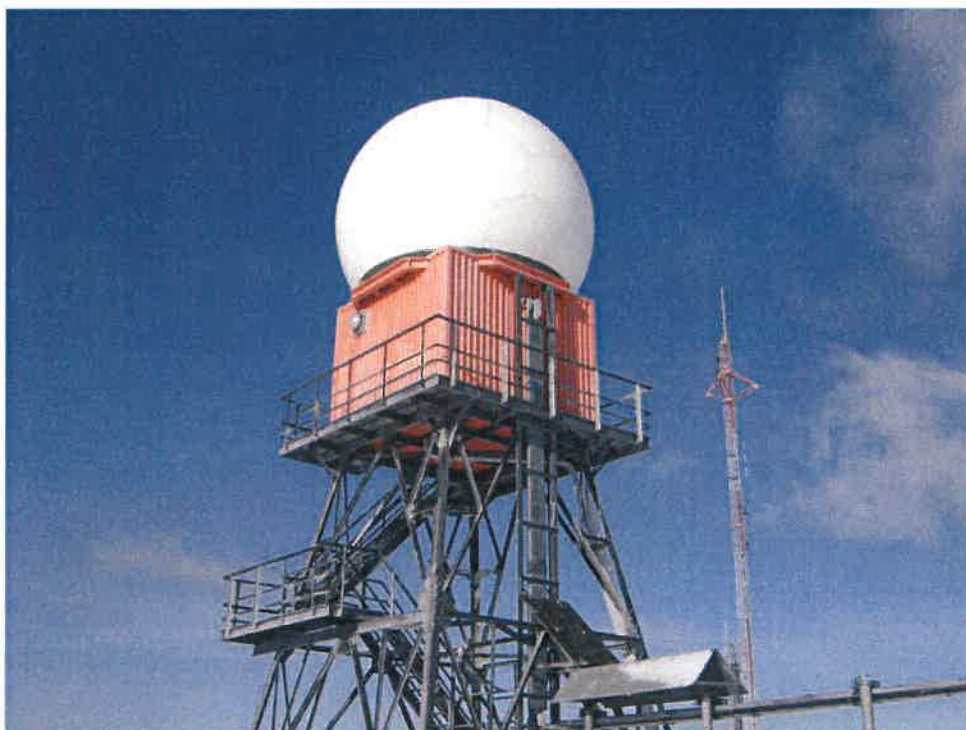
Photo #3: Building and Radome

The 5.5m radome appears satisfactory. See Appendix A, Photo #3.

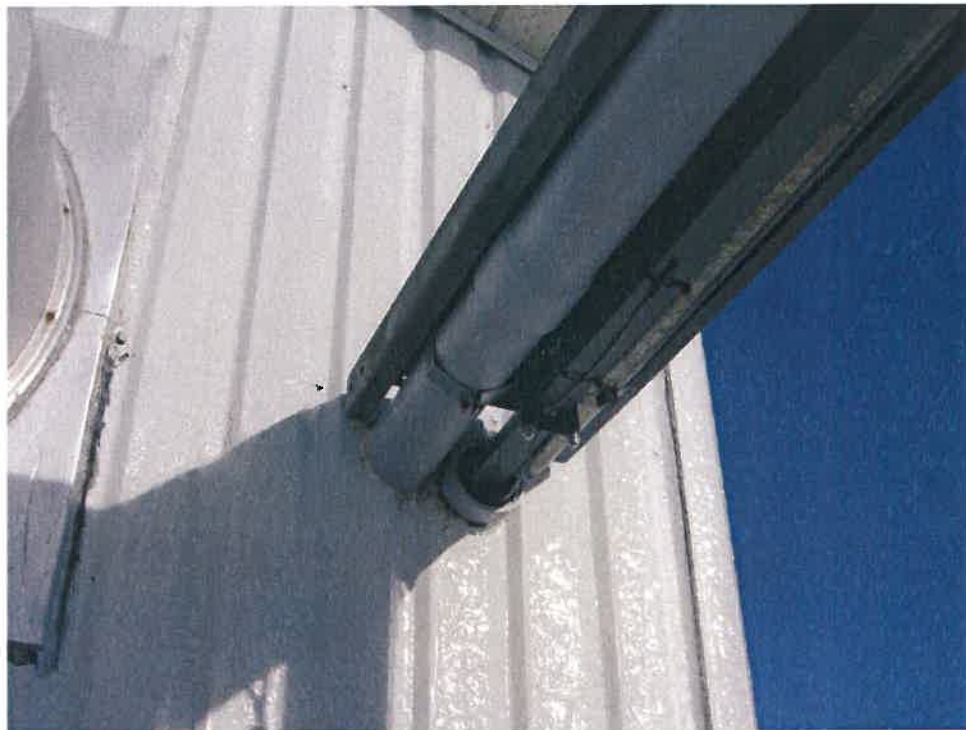
Photo #4: Port Entry

The waveguide port appears satisfactory. See Appendix A, Photo #4.

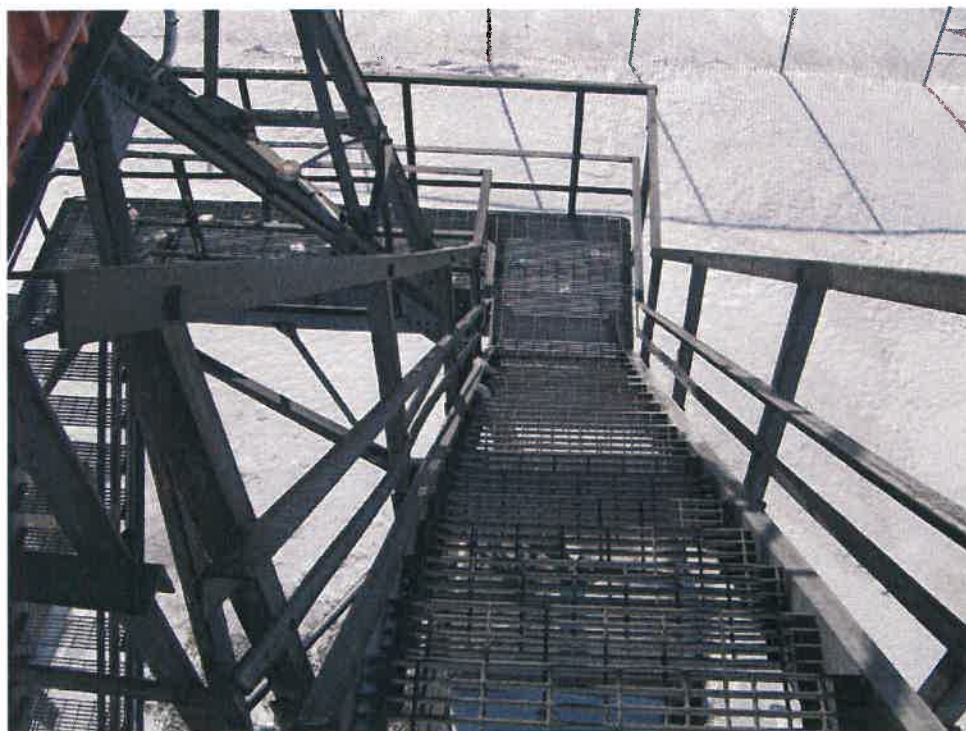
Photo #5: Integral Stairs and Platforms

The tower is not equipped with a fall arrest system. The stairs and platforms are equipped with a hand rail. See Appendix A, Photo #5.

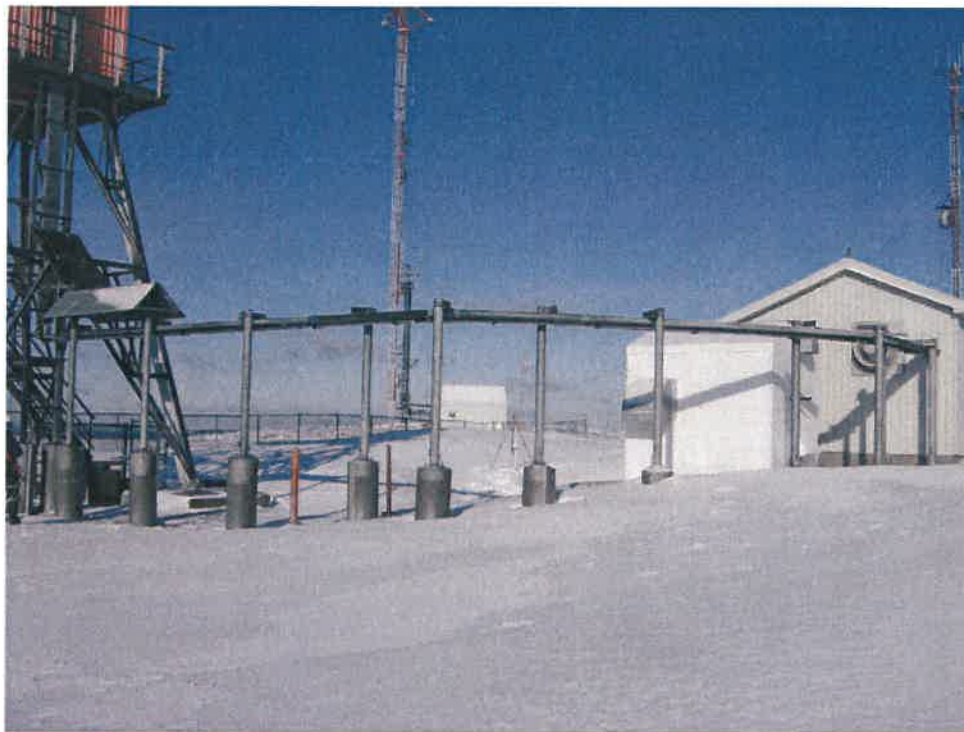
Photo #6: Waveguide Bridge

The waveguide bridge appears satisfactory. See Appendix A, Photo # 6.

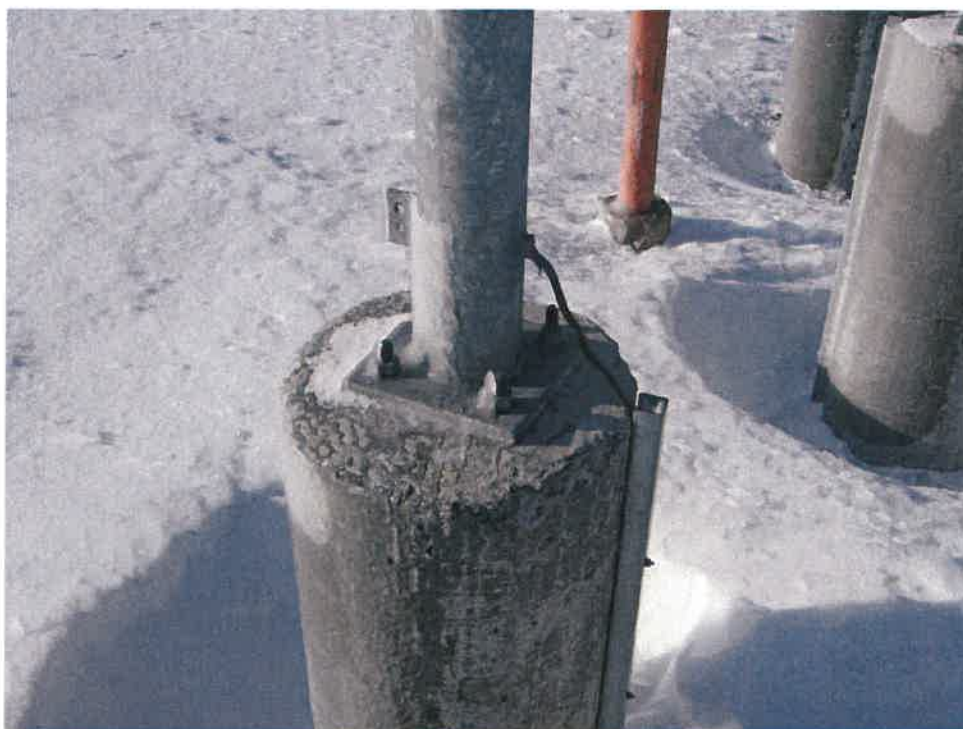
Photo #7: Waveguide Post Grounding Typical

The waveguide post grounding appears satisfactory. See Appendix A, Photo #7.

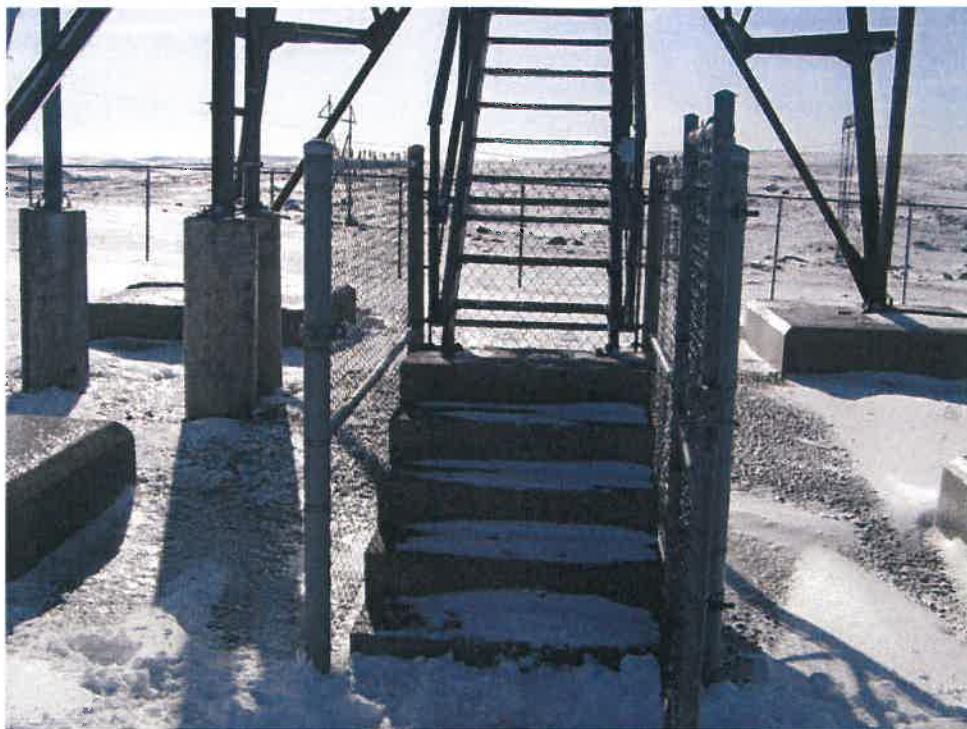
| D. Security: | The anti-climb installed at the base of the tower is ineffective to prevent entry. See Appendix A, Photo #9. |

Photo #9: Anti-Climb

Item	Description	Priority
1	Install or improve engineered anti-climb around base of tower "Use Marion Bridge anti-climb as a reference".	A
2	Replace corroded hardware holding 2 ½ conduit on face 3-4 with stainless steel hardware.	B
3	Install warning signs around perimeter of site, on buildings, and tower.	C
4	Wire brush and cold galvanize surface corrosion on bolts, waveguide post and steel throughout tower.	C
5	Replace corroded connector's at switches, junction boxes and lighting component on tower.	C
6	Replace or repair damaged fencing components on perimeter fence "recommend installing higher fence for site security".	C
7	Clean and repaint building at top of tower.	C
8	Replace wooden frame and exterior door to building at top of tower.	C
9	Wire brush and paint corroded air conditioning control box.	C
10	Clean bleeding rust from siding on power backup building.	C
11	Wire brush and spray exhaust pipe with high heat paint.	C

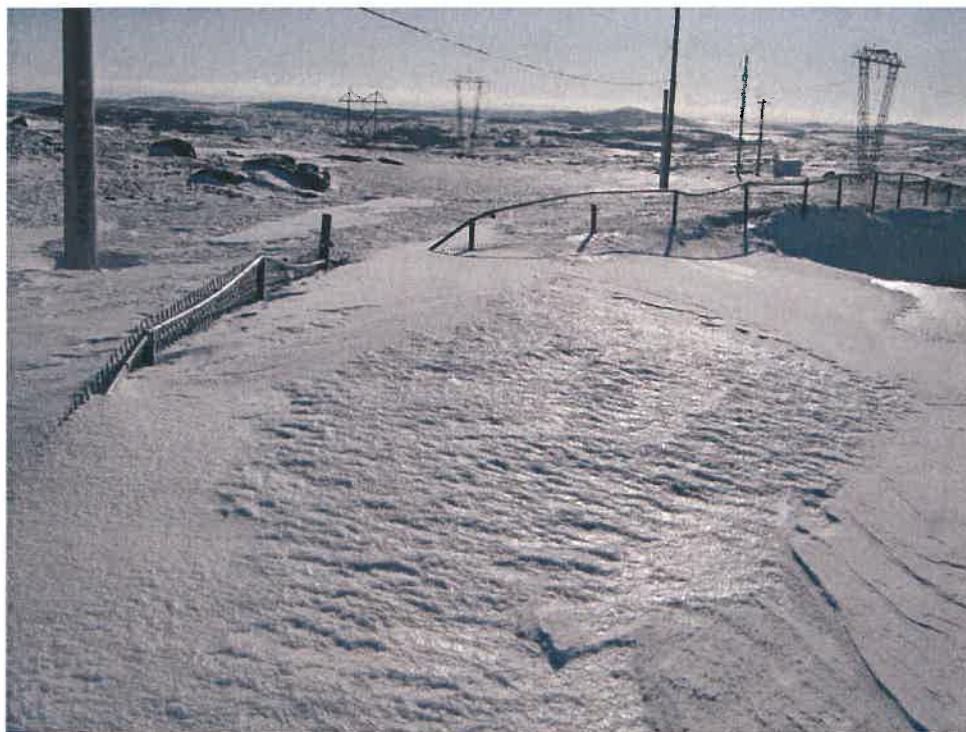
| C. Fencing: | The fence has a high degree of damage to the North side. See Appendix A, Photo #10. The main gates were snow covered and opened at the time of inspection. See Appendix A, Photo #15. The height of the fence is ineffective to prevent site entry. |

Photo #10: Damaged Fencing North Side

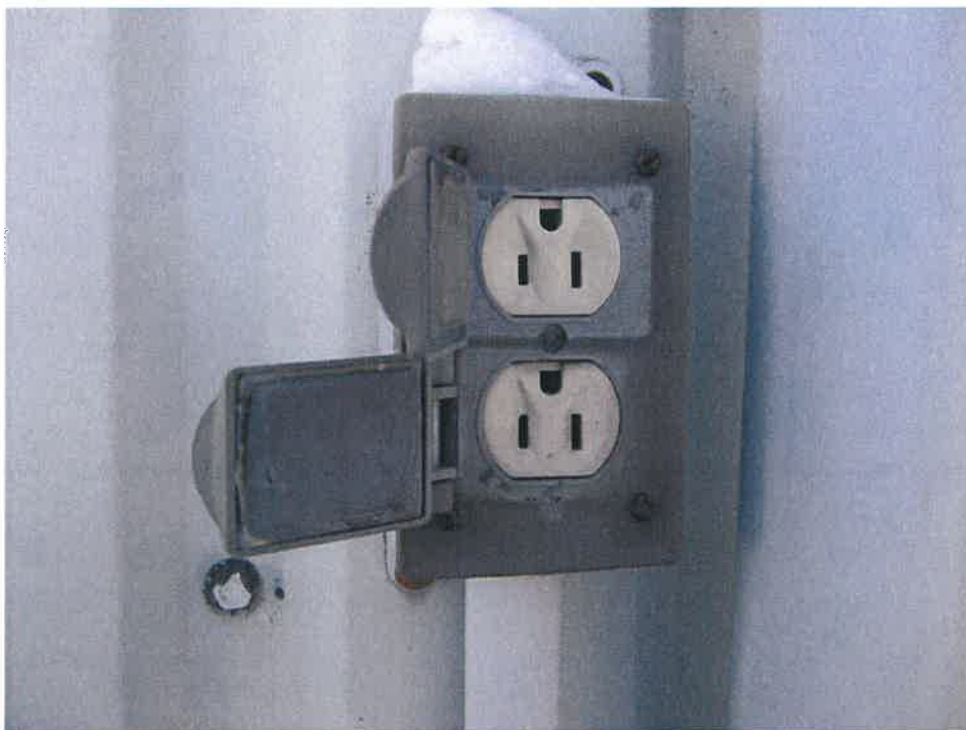
The exterior power outlets are not equipped with GFI plugs.

Photo #11: Outside Outlets

12	Install GFI approved plugs in all exterior outlet	C
13	Relocate photocell to a more accessible location.	C
14	Wire Brush and cold galvanize metal conduit in waveguide bridge.	C
15	Re-lamp access lighting on tower and building.	C
16	Repair damaged grout at base of tower legs.	C
17	Reseal building vent hoods.	C
18	Clean or replace hinges on door to power back-up building.	C
19	Trim top hand rail at base of stairs to be sloped.	C
20	Replace broken conduit bracket at the first level on face 3 – 4.	C
21	Repaint protective post for air conditioning unit.	C
22	Re-glue conduit on wall outside main entrance to building	C

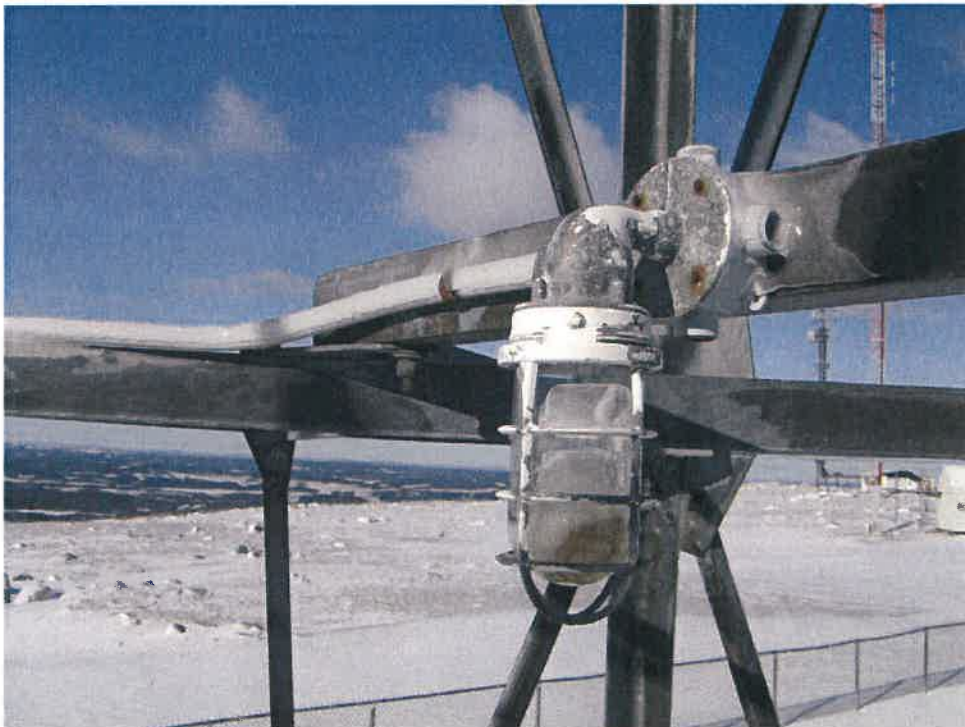
Light	Type/Make	Location	Elev. m (ft.)	Ice Shield (Y/N)	Teck Line (in)
1	D.O.L.	Top	20(65.6)	N/A	Unknown
Comments: D.O.L's were on photo cell located on radome.					
2	Stairs access lighting	3 places		No	In conduit
Comments: One light was located at mid level on tower, bulb was broken. Two more were located on building at top of tower. Bulbs appear to be out.

Photo #13: Access Lighting on Tower

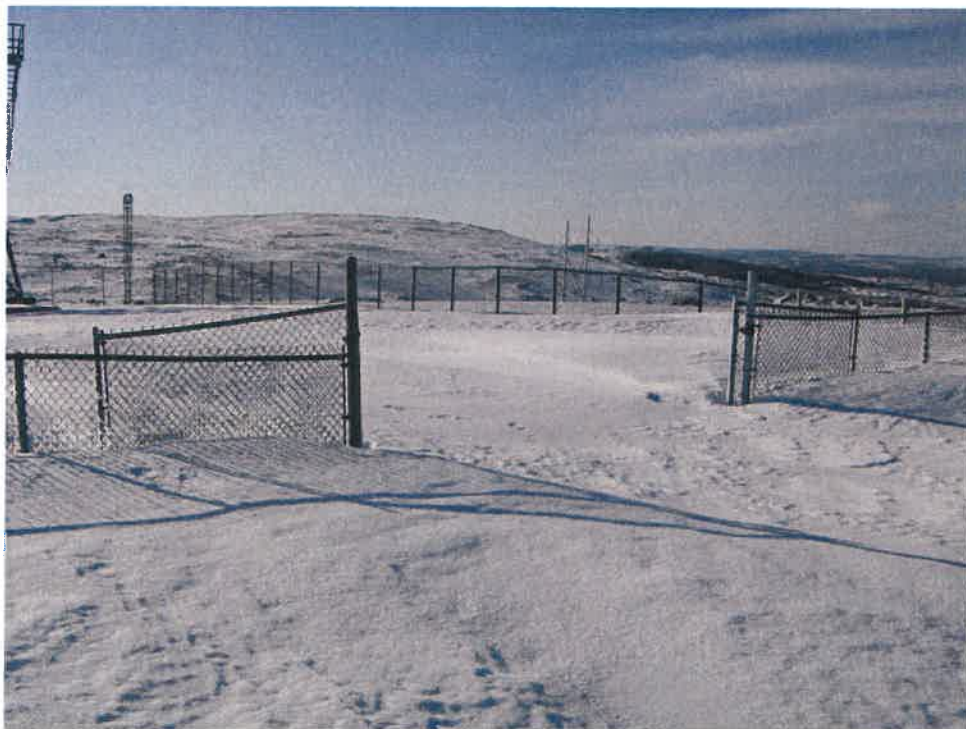
Photo #15: Open Access Gates

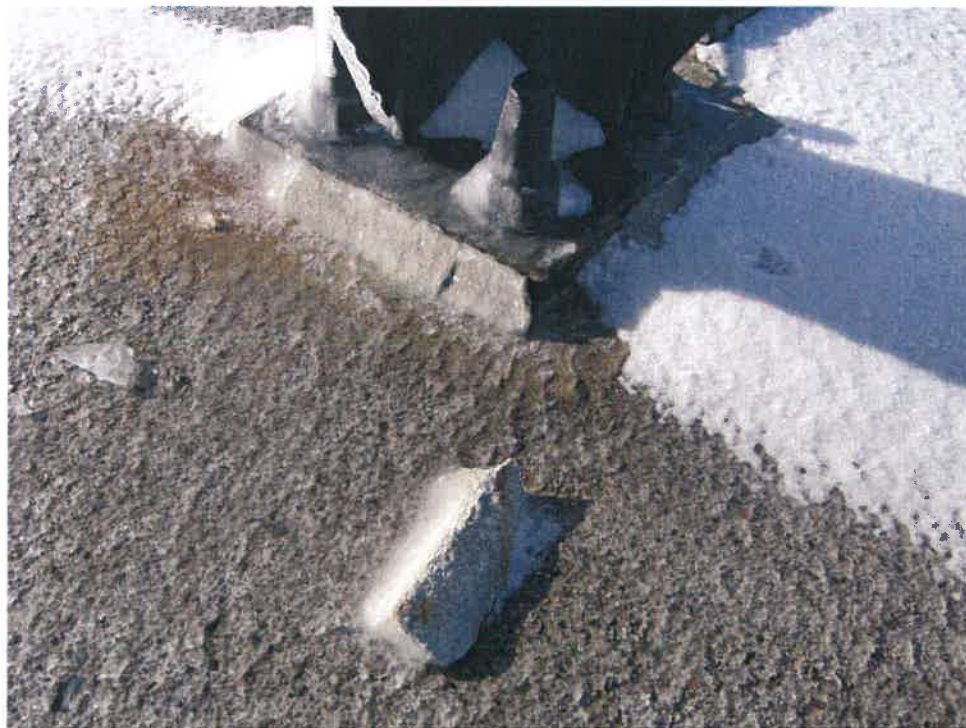
Photo #17: Damaged Grout

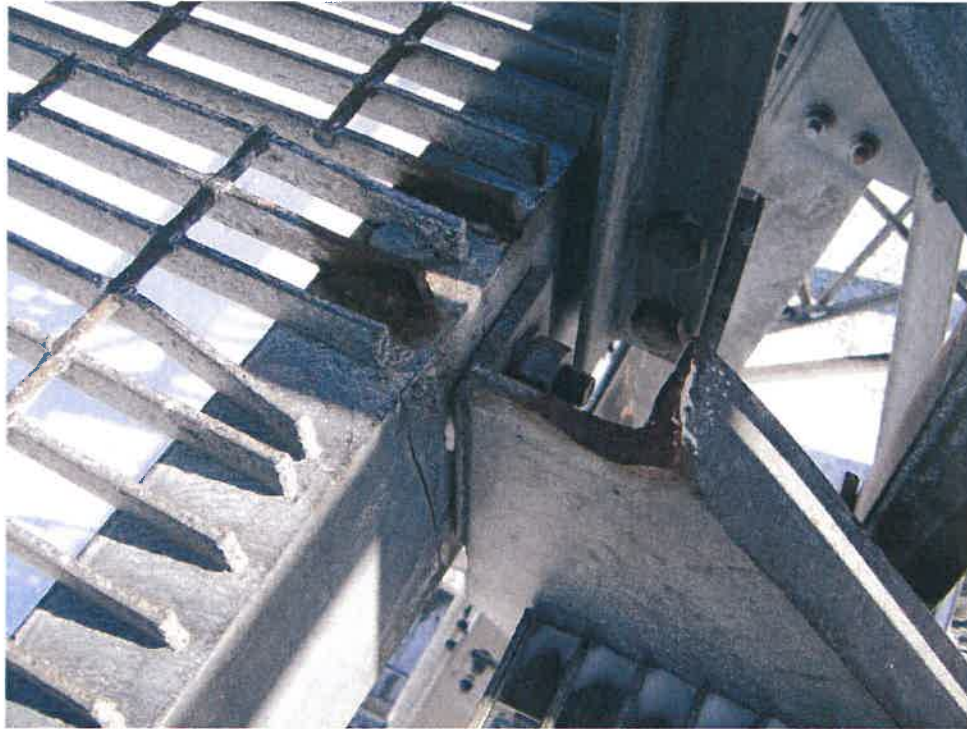
The integral stairs, platforms and safety rails exhibits minor to moderate surface corrosion throughout. See Appendix A, Photo #18.

Photo #18: Surface Corrosion Typical

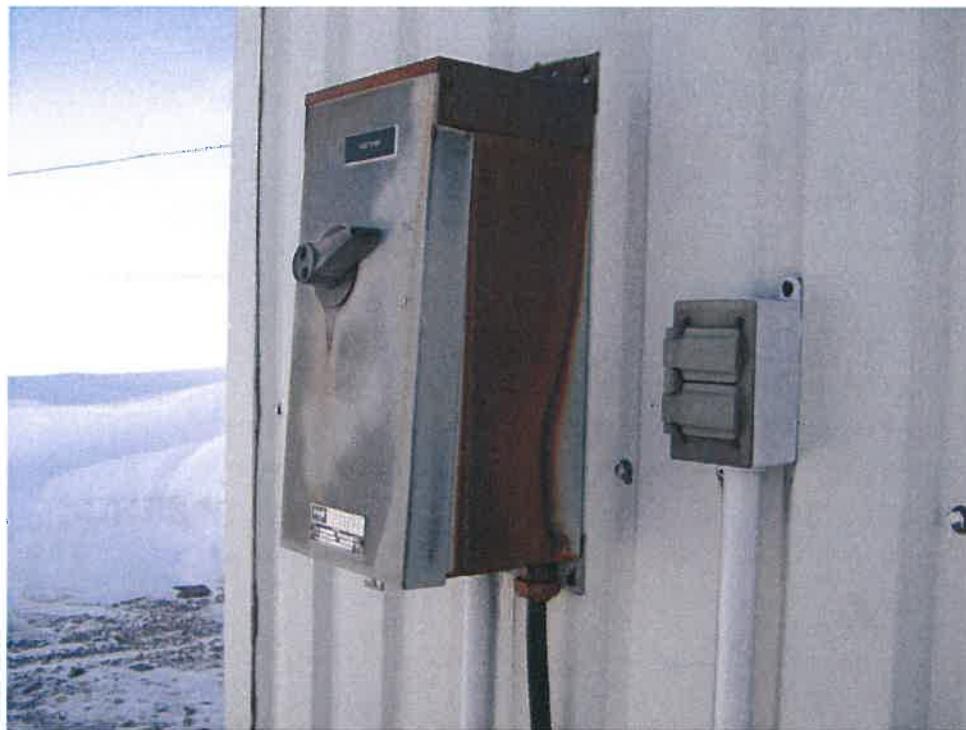
The air conditioning control box exhibits moderate surface corrosion. See Appendix A, Photo #19.

Photo #19: Air Conditioning Control Box

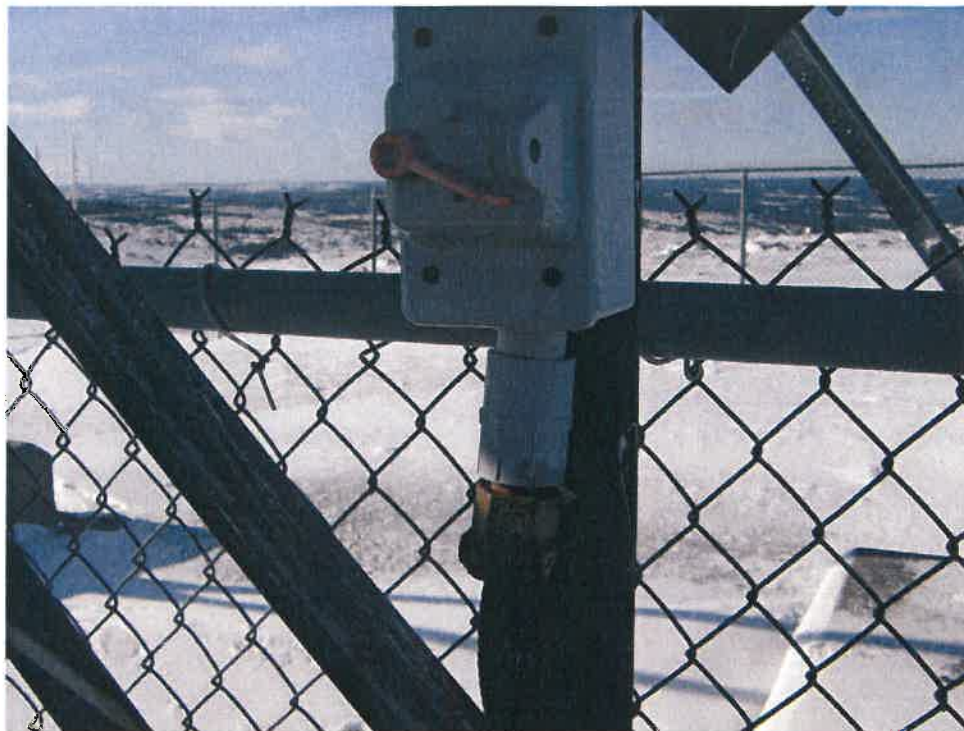
The connector for the switch at the base of the tower exhibits heavy

surface corrosion. See Appendix A, Photo #20.

Photo #20: Corroded Electrical Connection

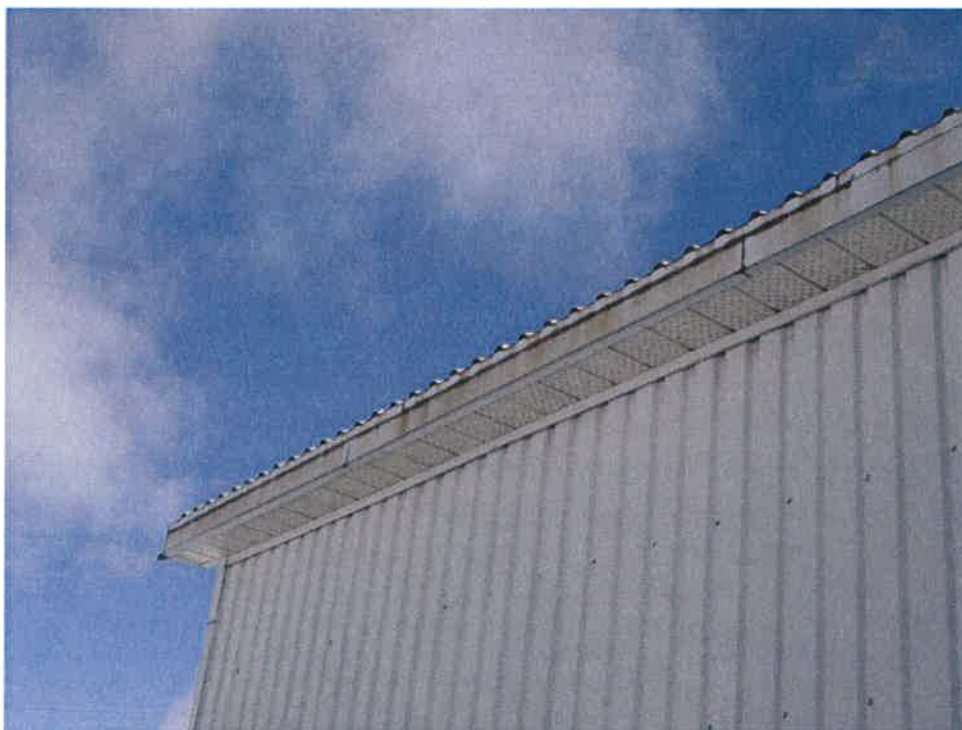
The buildings metal eave covering exhibits minor surface corrosion. See Appendix A, Photo #23.

Photo #23: Surface Corrosion on Eave of Building

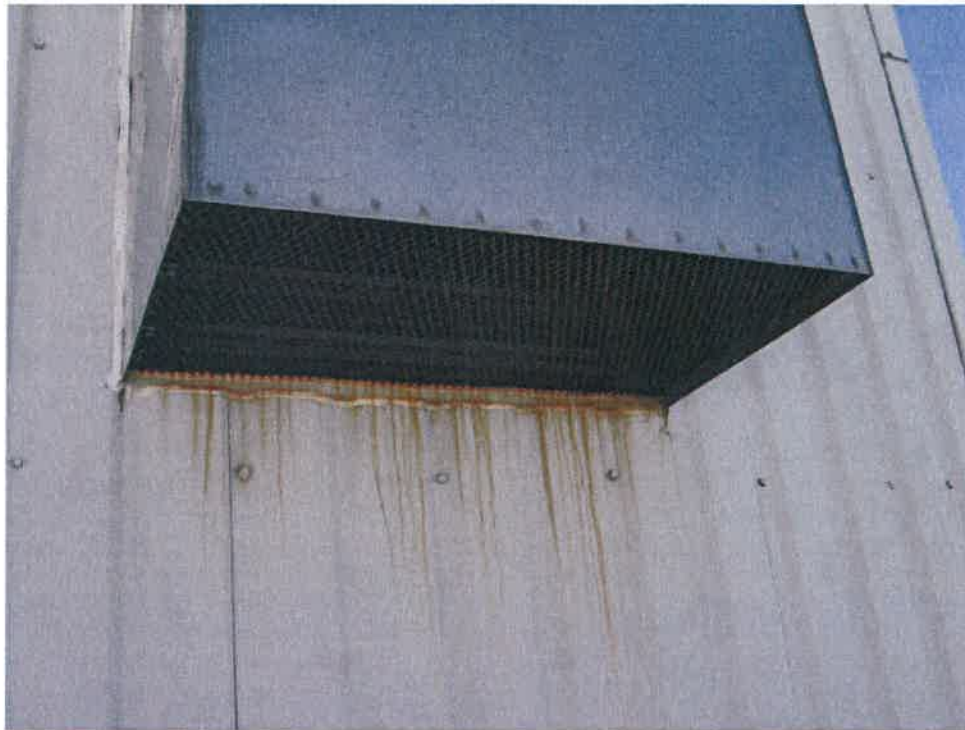
The vent for the power backup building is bleeding rust onto building siding. See Appendix A, Photo #24.

Photo #24: Surface Corrosion from Building Vent

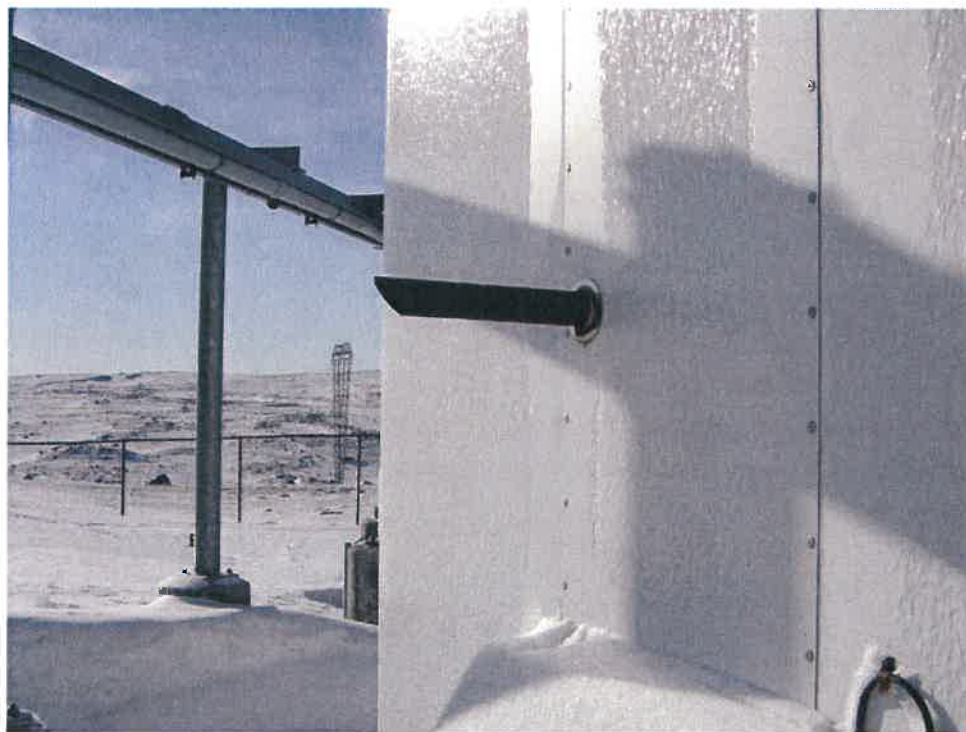
The exhaust pipe for the power backup building exhibits moderate surface corrosion. See Appendix A, Photo #25.

Photo #25: Exhaust Pipe

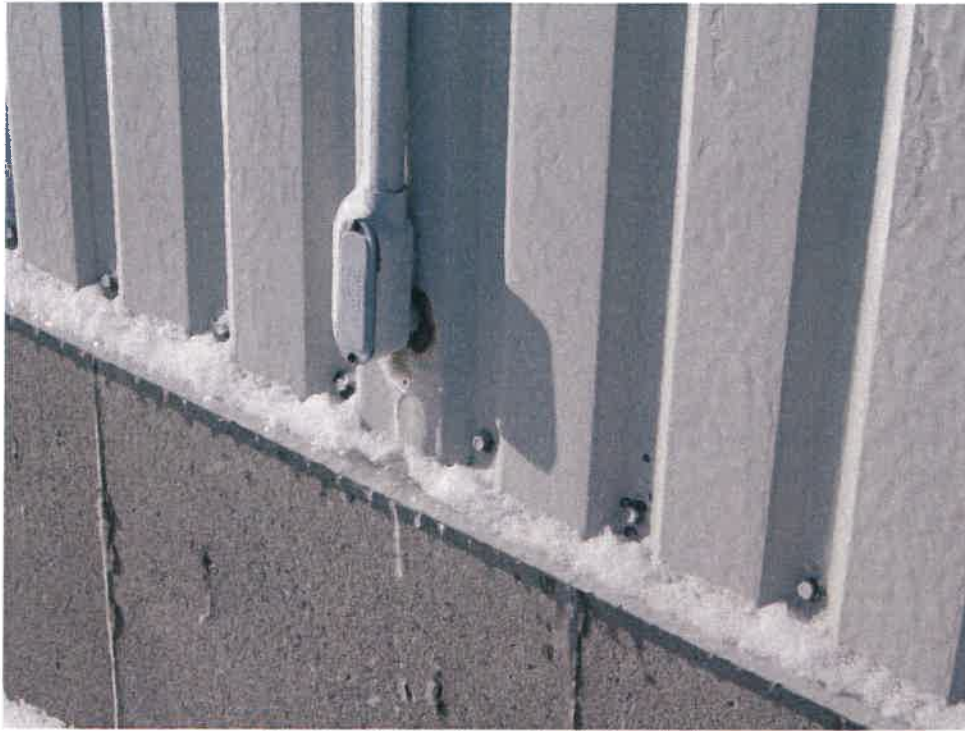
The siding around the electrical service entrance exhibits minor surface corrosion. See Appendix A, Photo #26.

Photo #26: Electrical Conduit

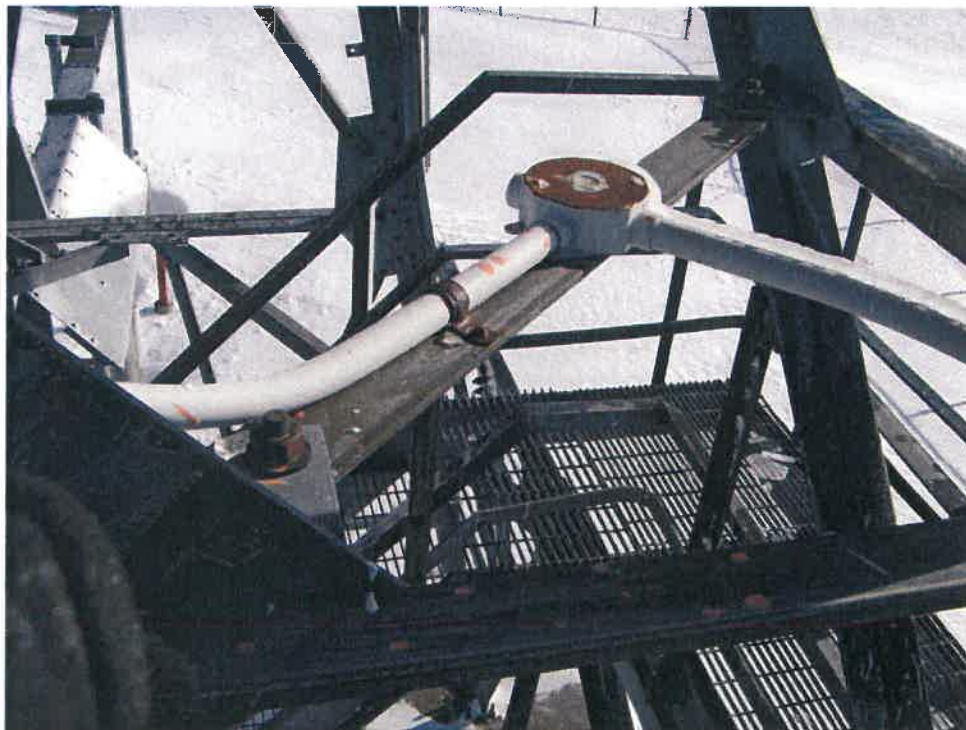
The junction box cover at the top of the tower on leg 3 exhibits minor surface corrosion. See Appendix A, Photo #29.

Photo #29: Corroded Electrical Box

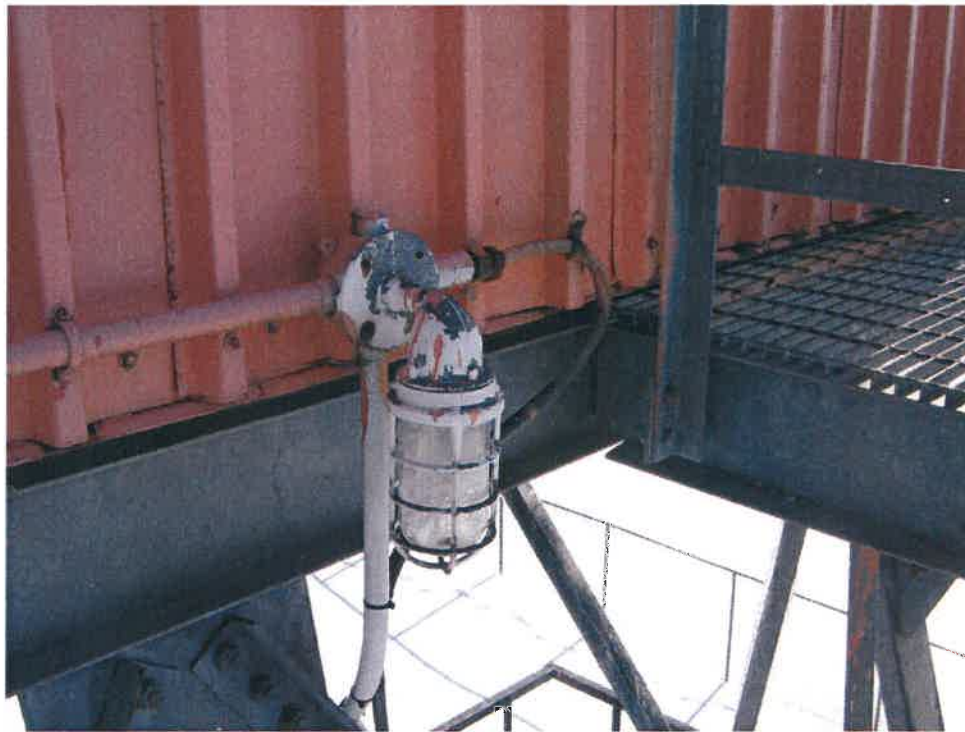
All lighting connector's exhibits moderate to heavy surface corrosion. See Appendix A, Photo #30.

Photo #30: Corroded Electrical Connectors

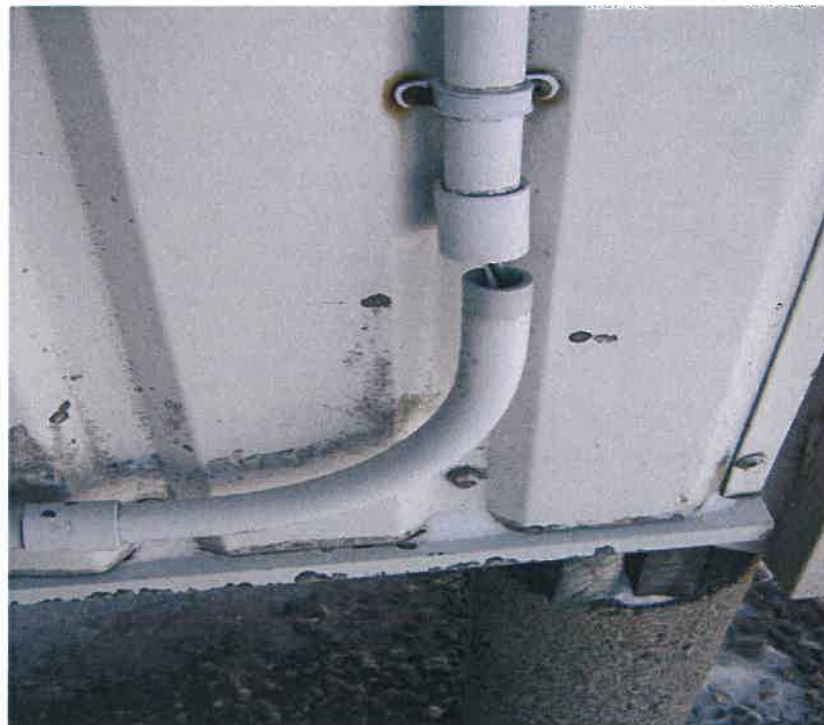
The conduit on the exterior wall to the main building is broken clear. See Appendix A, Photo #31.

Photo #31: Broken Conduit
