ENVIRONMENT CANADA MAINTENANCE INSPECTION

24m (79 ft) KNOCK-DOWN SELF-SUPPORT TOWER

XNC Chipman, NB

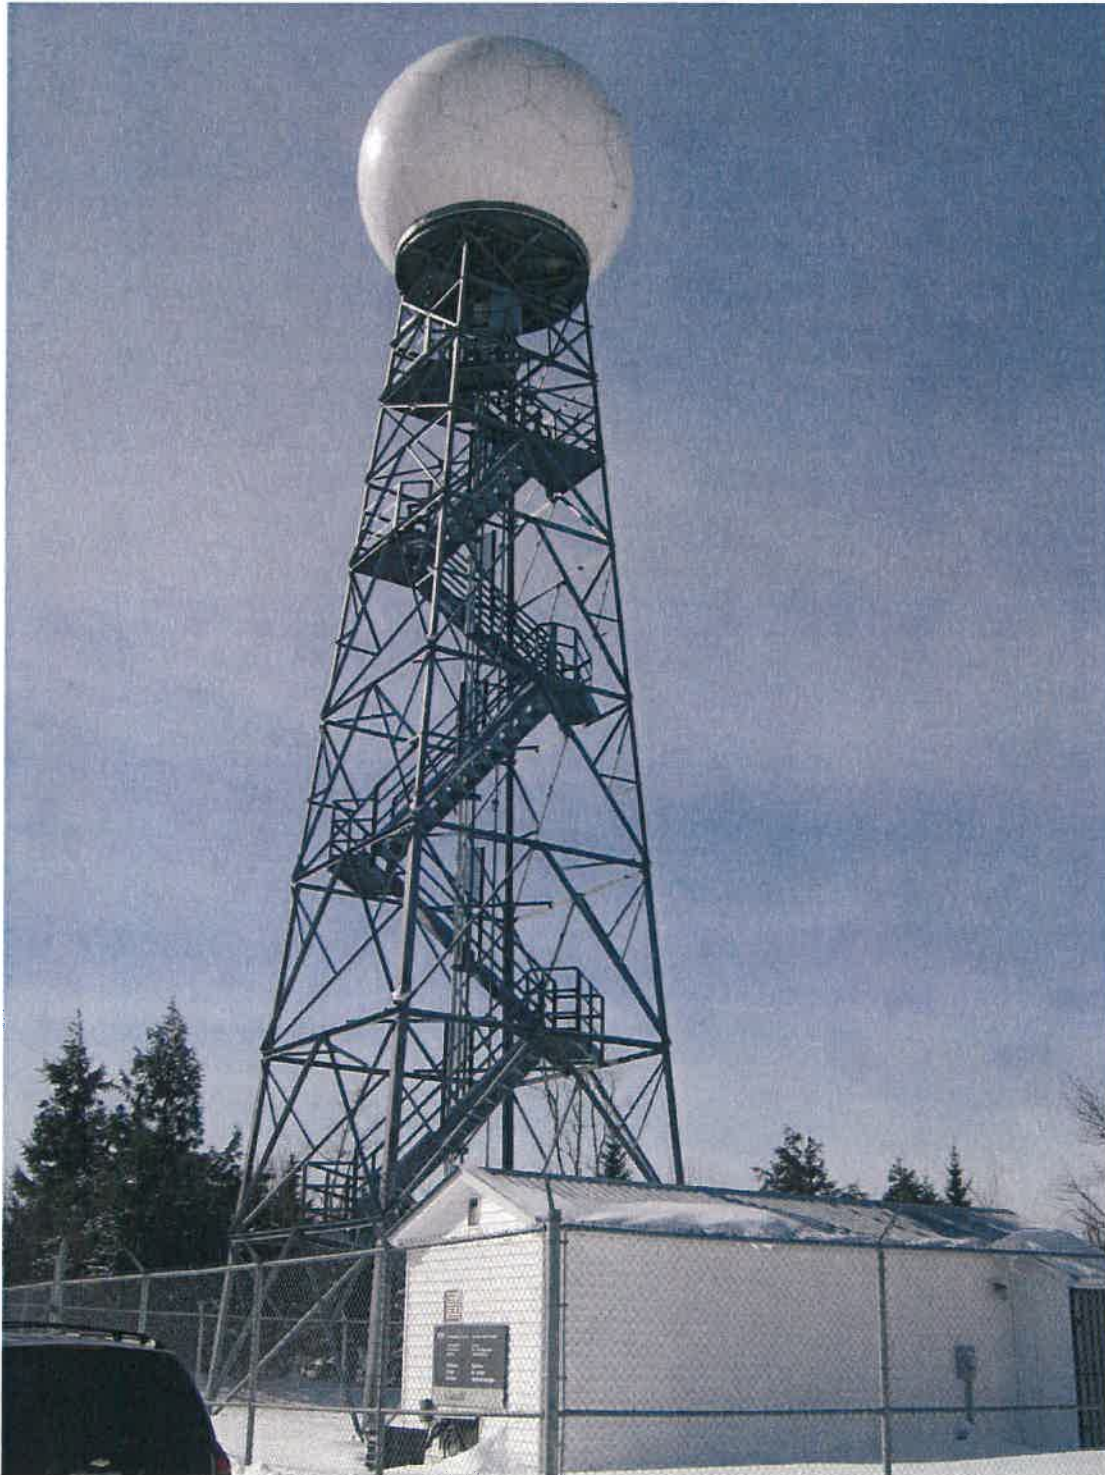
Photo #1: Tower Profile

- A. General:** The compound was snow covered but appeared clear of brush and debris. See Appendix A, Photos #1, #6, and #8.
- B. Access:** The tower access road was snow covered at the time of inspection but appeared satisfactory. The site parking was clear and appeared satisfactory.
- C. Fencing:** The fence appears satisfactory. See Appendix A, Photos #1, and #8.
- The fence had the barbed wire removed.
- There is no grounding installed on fence post.
- There is no grounding installed on the fence gates.
- D. Security:** There was a anti-climb gate installed at the base of the access stairs to the tower. Gate was not locked and was ineffective to prevent entry. See Appendix A, Photo # 9.
- E. Due Diligence:** There is no site warning signage installed on tower compound, or fence. Warning sign on building door and gate at base of tower are satisfactory.

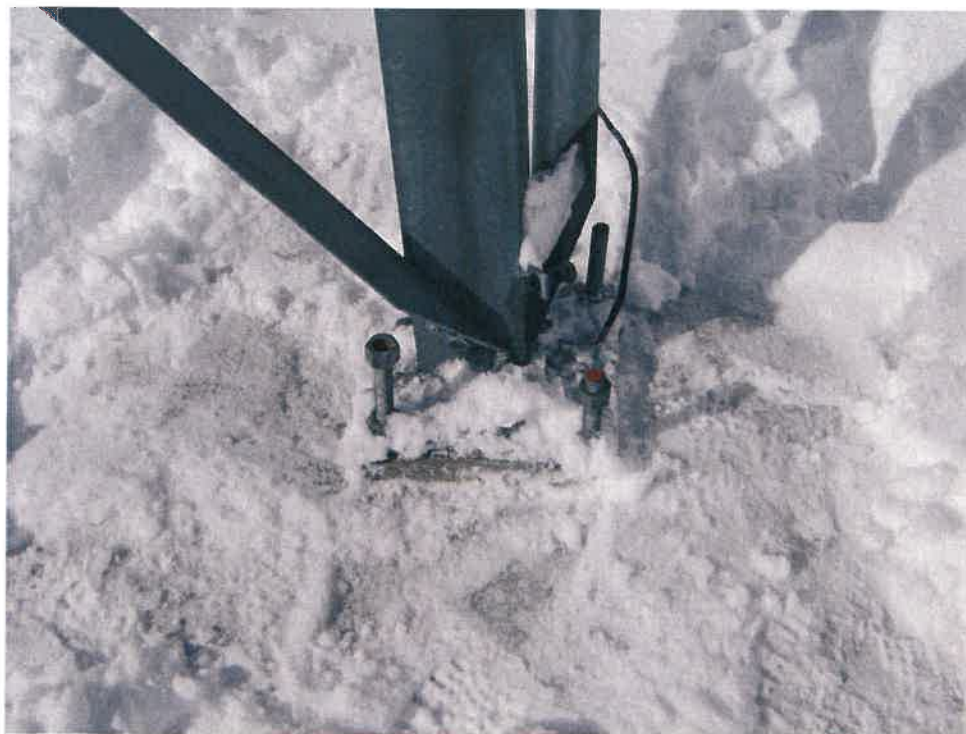
Photo #2: Tower Foundation Typical 4 Locations

The nuts on the foundation anchor bolts are not fully installed. See Appendix A, Photo #2.

The four foundations were snow covered at time of inspections. See Appendix A, Photo #2.

The tower grounding appears satisfactory. See Appendix A, Photo # 2.

The tops of the anchor bolts exhibits minor surface corrosion. See Appendix A, Photo #2.

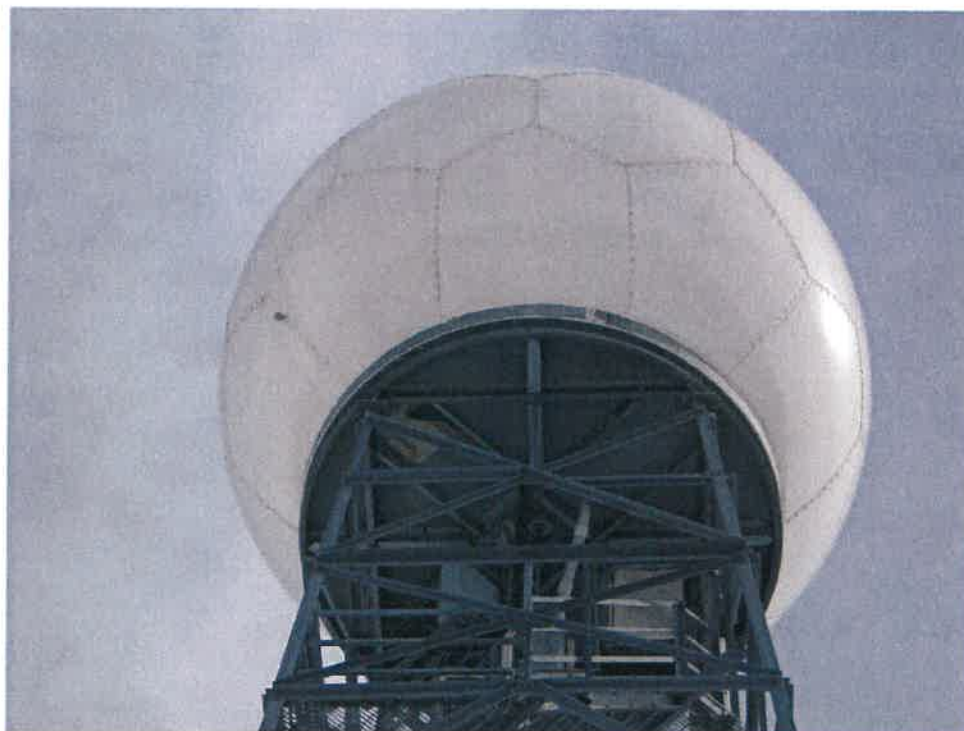
Photo #3: Radome and Photo-cell

The 5.5m radome appears satisfactory. See Appendix A, Photo #3.

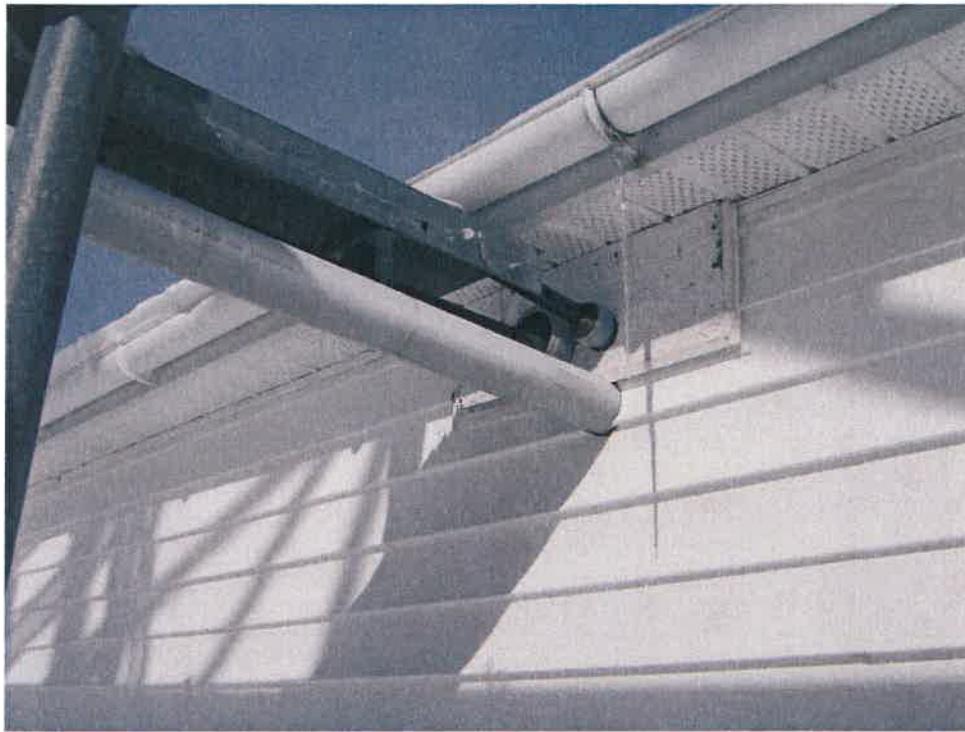
Photo #4: Port Entry

The waveguide port appears satisfactory. See Appendix A, Photo #4.

The PVC pipe entering the building at below the waveguide port is not sealed. See Appendix A, Photo # 4.

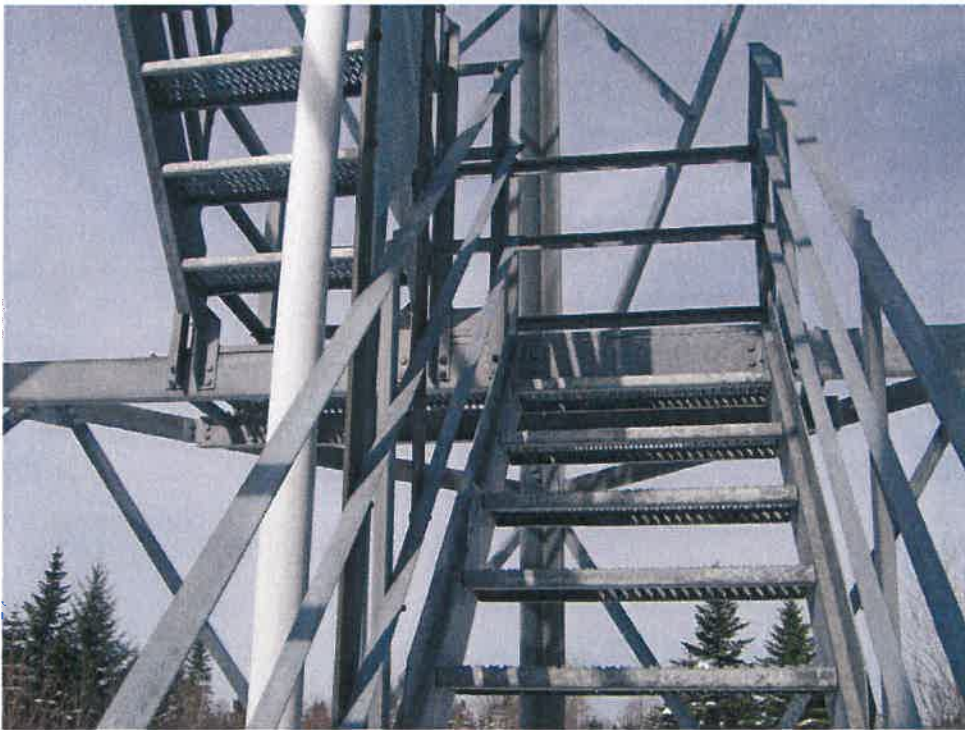
Photo #5: Integral Stairs and Platforms

The integral stairs and platforms appear satisfactory. See Appendix A, Photo #5.

The tower is not equipped with a fall arrest system. The stairs and platforms are equipped with a hand rail. See Appendix A, Photo #5.

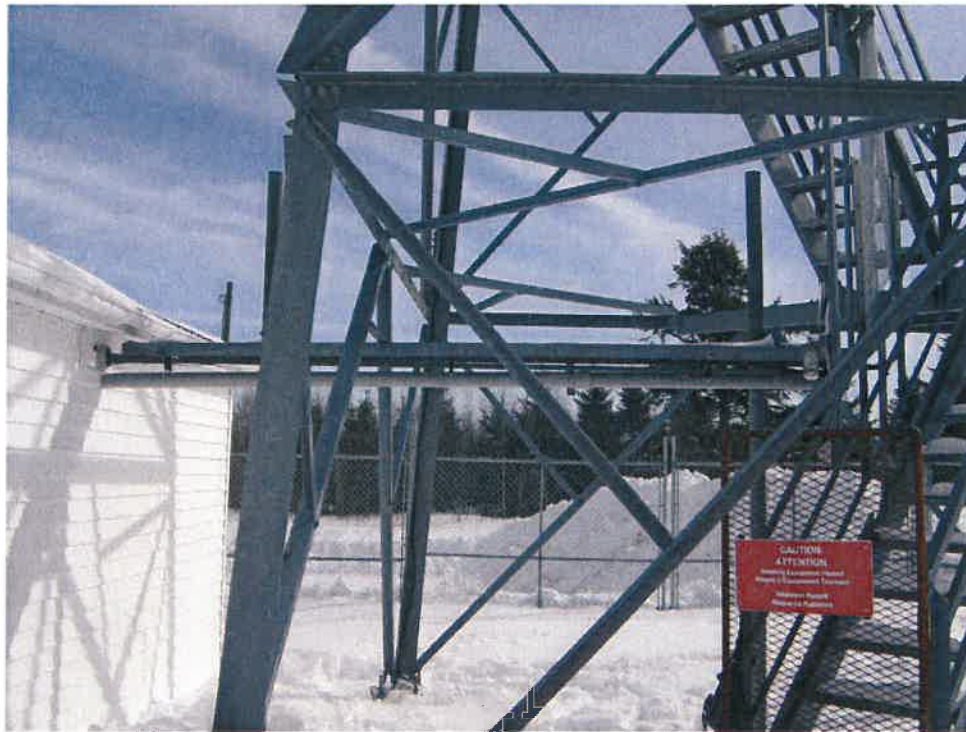
Photo #6: Waveguide Bridge

The waveguide bridge appears satisfactory. See Appendix A, Photo # 6.

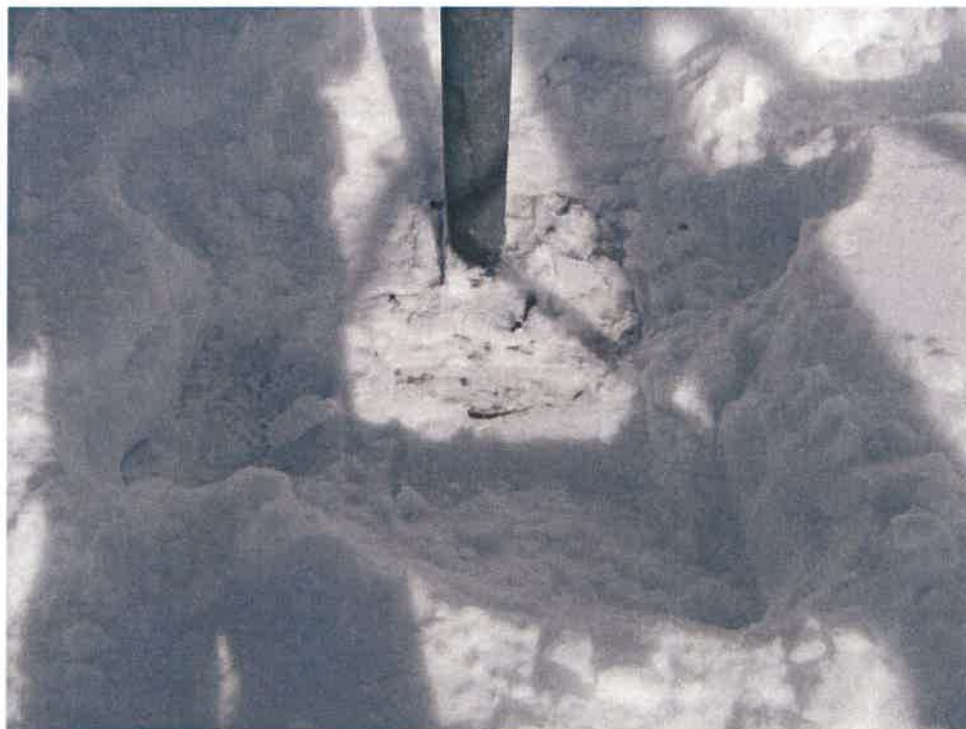
Photo #7: Waveguide Post Grounding Typical

The waveguide posts are not grounded. See Appendix A, Photo #7.

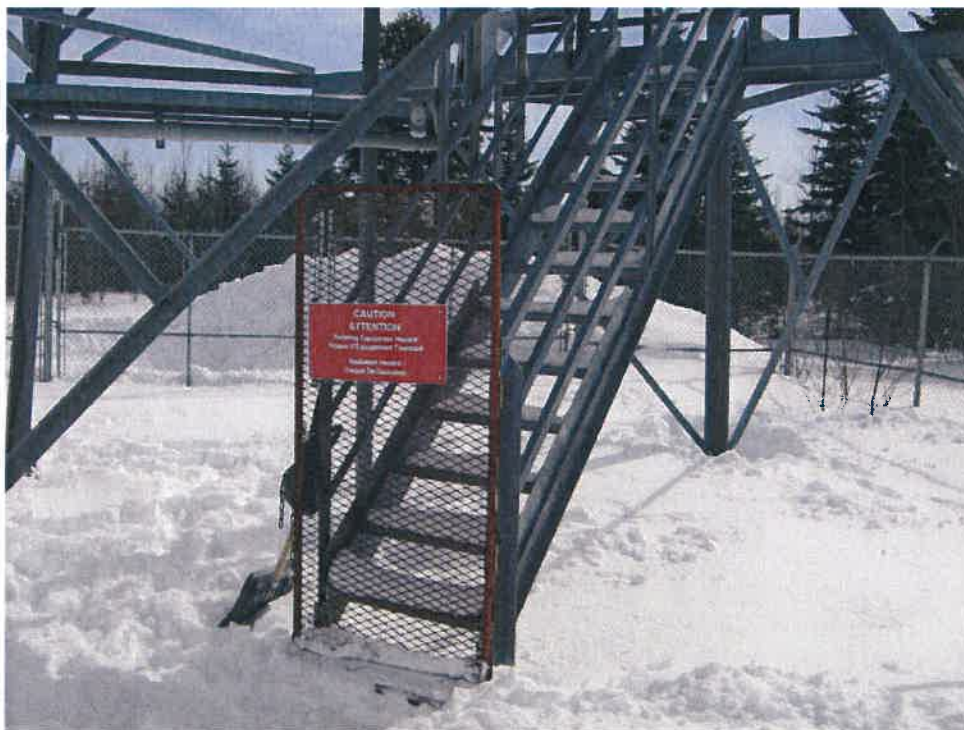
Photo #9: Anti-Climb

The access gate at the base of the tower exhibits heavy surface corrosion. See Appendix A, Photos #9 and #16.

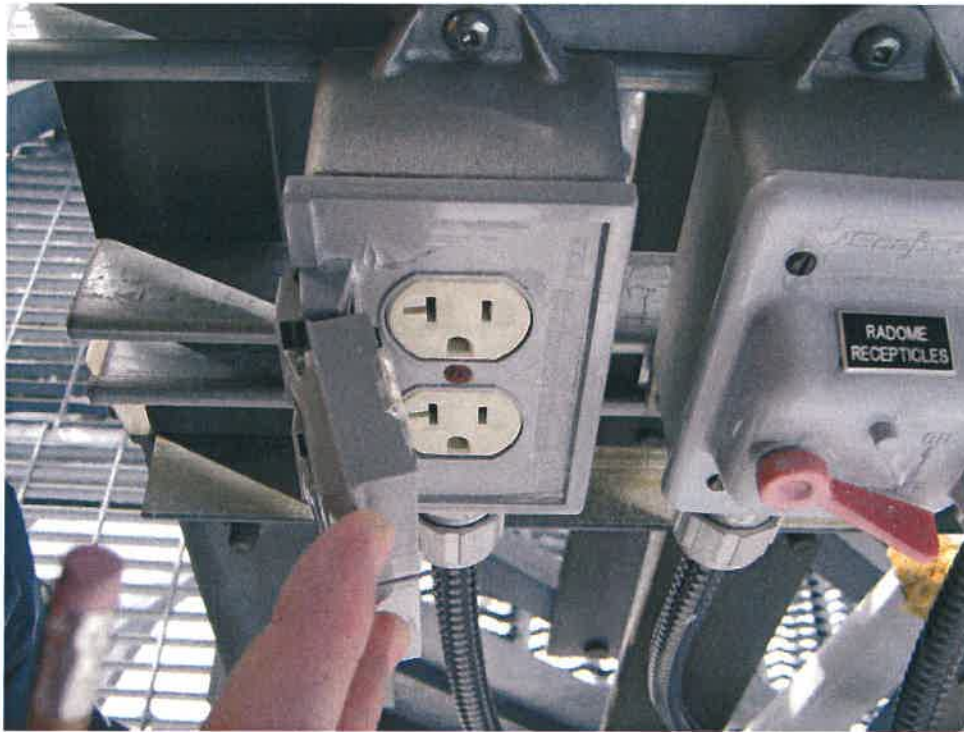
Photo #10: Outside Outlets

The exterior power outlets are not equipped with GFI plugs. See Appendix A, Photo #10.

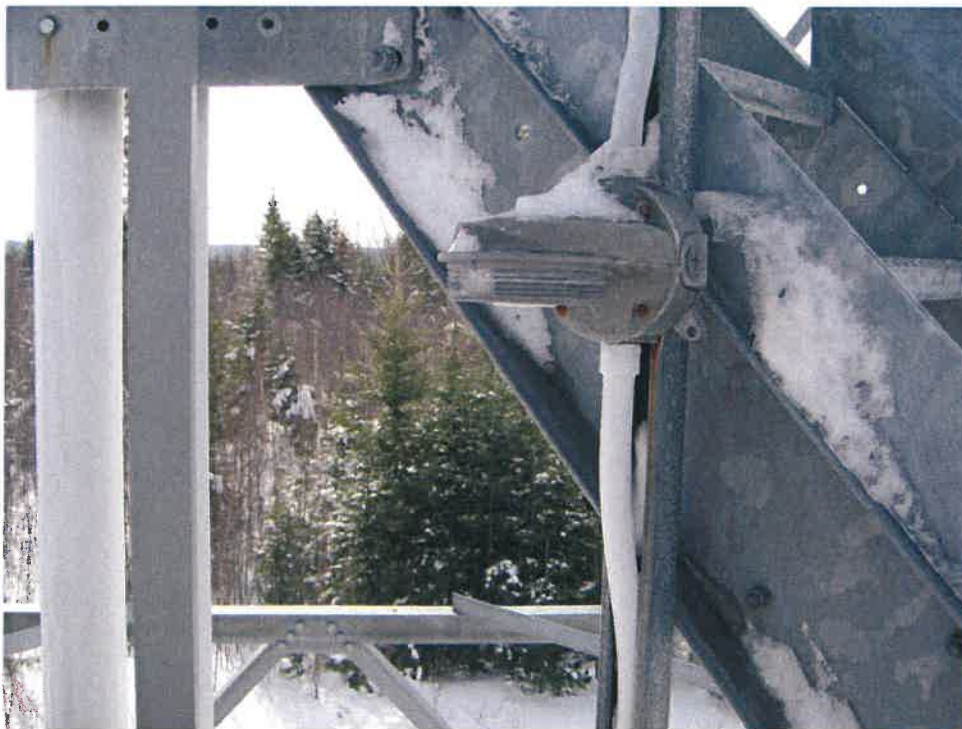
Photo #11: Damaged Access Lighting Level Two

The second level tower access light has a missing globe and bulb. See Appendix A, Photo #11.

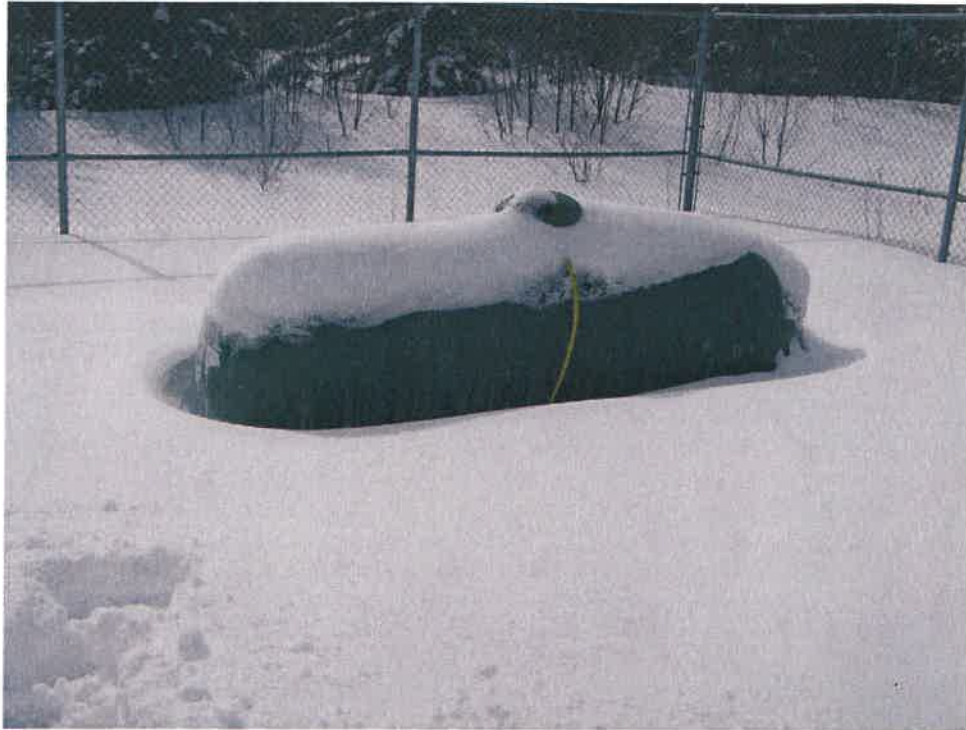
Photo #12: Un-Protected Propane Tanks

- The propane tank is un-protected from falling ice. See Appendix A, Photo # 12.
- The winch and winch mount exhibits moderate surface corrosion. See Appendix A, Photo #19.
- All connectors at base of control box were loose. Retightened by Tiller while on site. See Appendix A, Photo #22.
- Loose teck cable coming from control box. Re-secured by Tiller while on site. See Appendix A, Photo #13.
- Cotter pins in bolts for winch access exhibits moderate surface corrosion. See Appendix A, Photo #24.

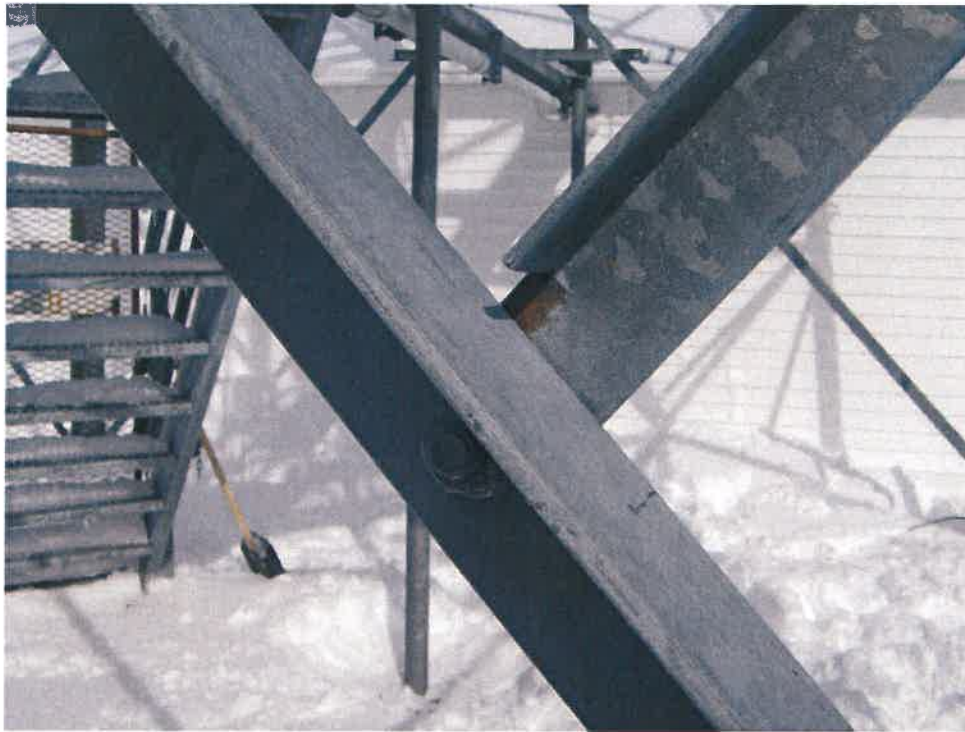
Photo #14: Surface Corrosion Typical Lower Level

Sub-diagonals at 6 feet exhibits minor surface corrosion on all faces. See Appendix A, Photo #14.

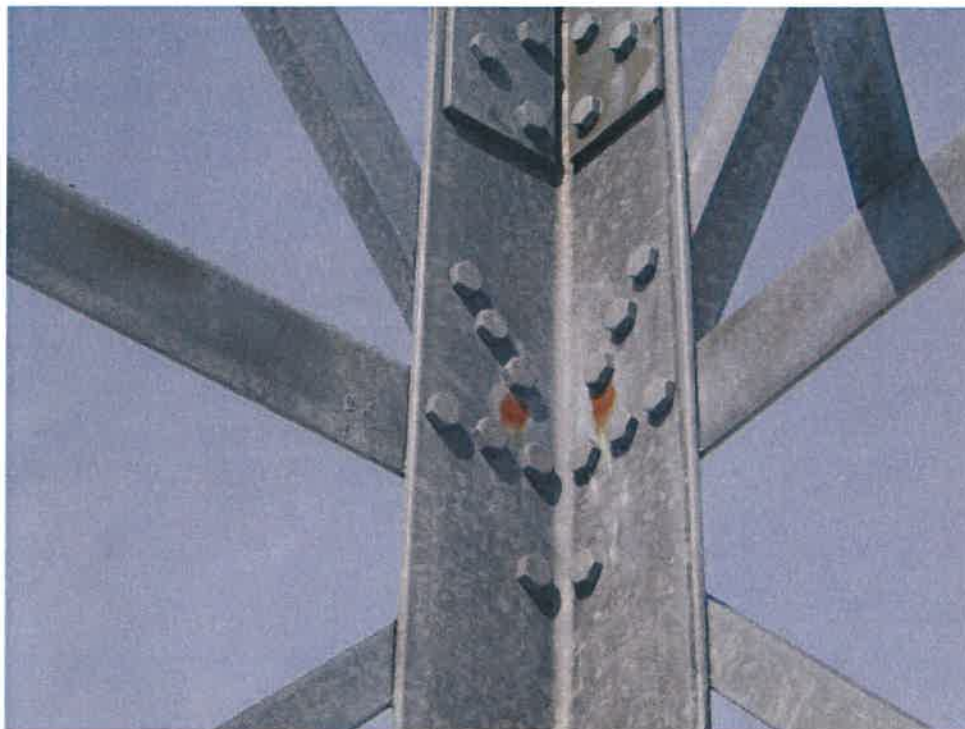
Photo #15: Minor Surface Corrosion Leg 4 @ 20 Feet

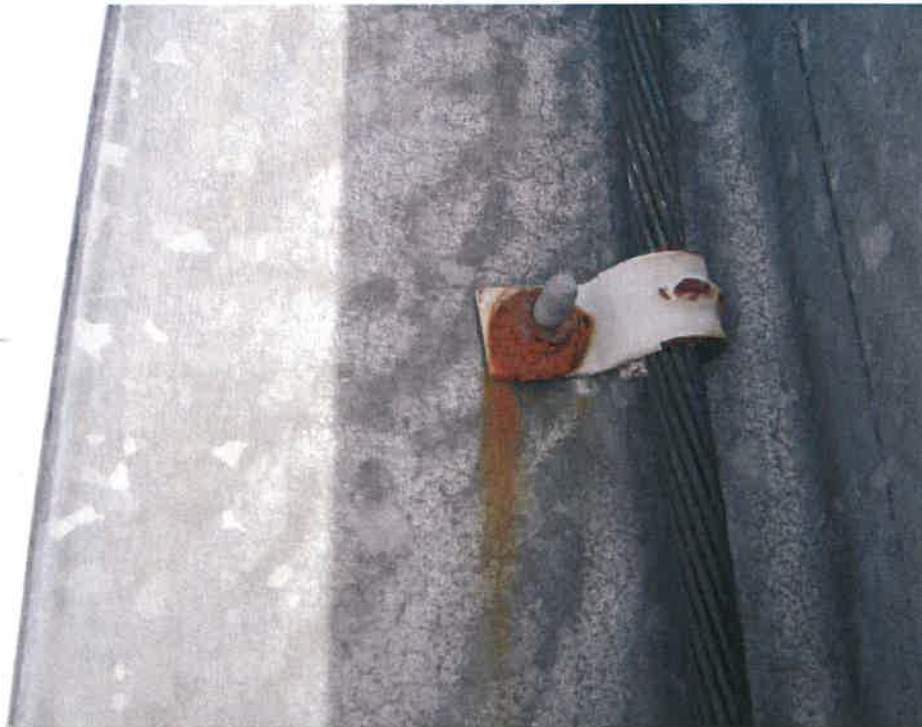
Photo #17: Surface Corrosion on Ground Lead Clips

The bolts and clips for the ground lead secured to leg one exhibits moderate surface corrosion. See Appendix A, Photo #17.

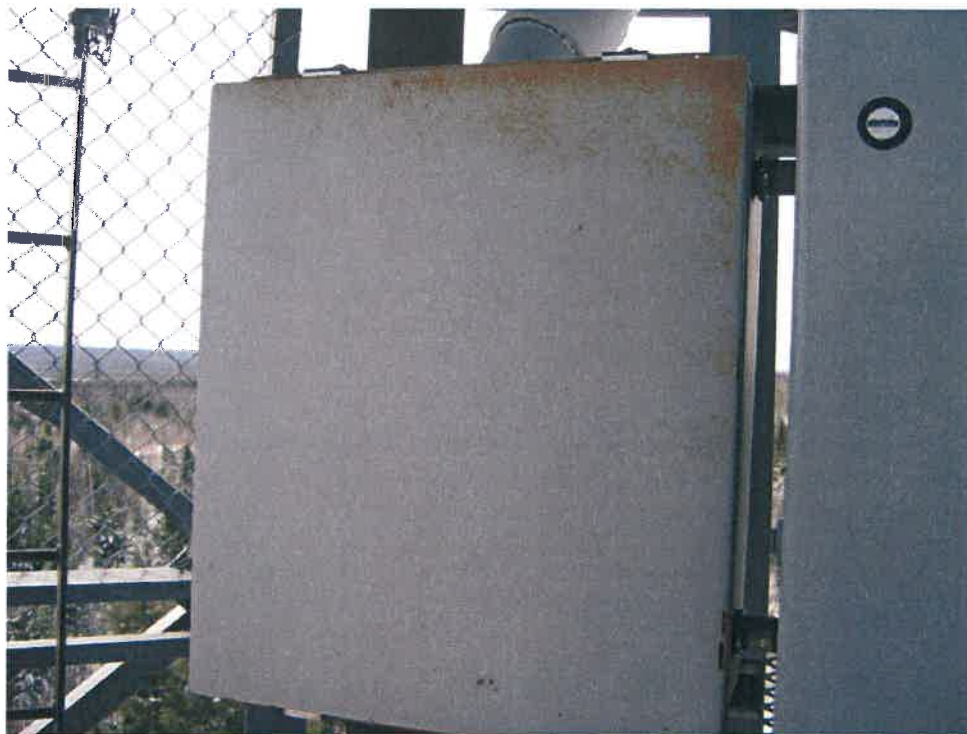
Photo #18: Surface Corrosion on Control Box

Mounting hardware, control boxes and supports for electrical components exhibits moderate surface corrosion. See Appendix A, Photos #18, and #20.

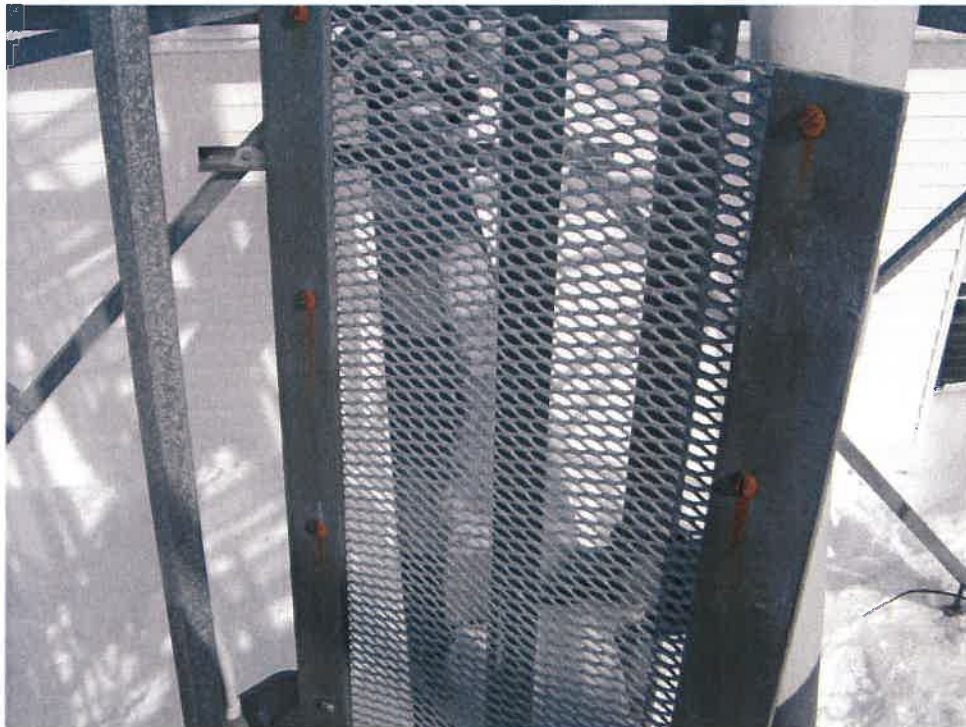
Photo #21: Corroded Bolts Typical

The bolts for the conduit protection plates exhibit moderate surface corrosion. See Appendix A, Photo #21.

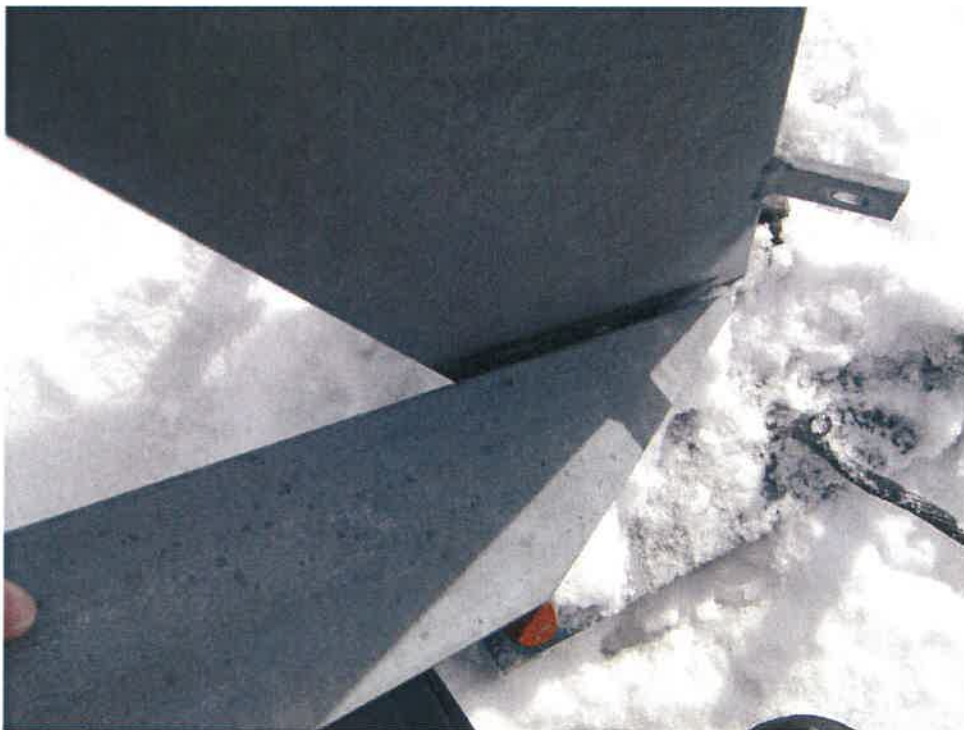
Photo #23: Loose Diagonal Bolts

- A. Tower Members:** Lower diagonal on face 3-4 had three loose bolts at the leg connection. These bolts were tightened by Tiller while on site. See Appendix A, Photo # 23.
- There was a loose bolt on face 3-4 at 25 feet. Bolt was tightened by Tiller while on site.

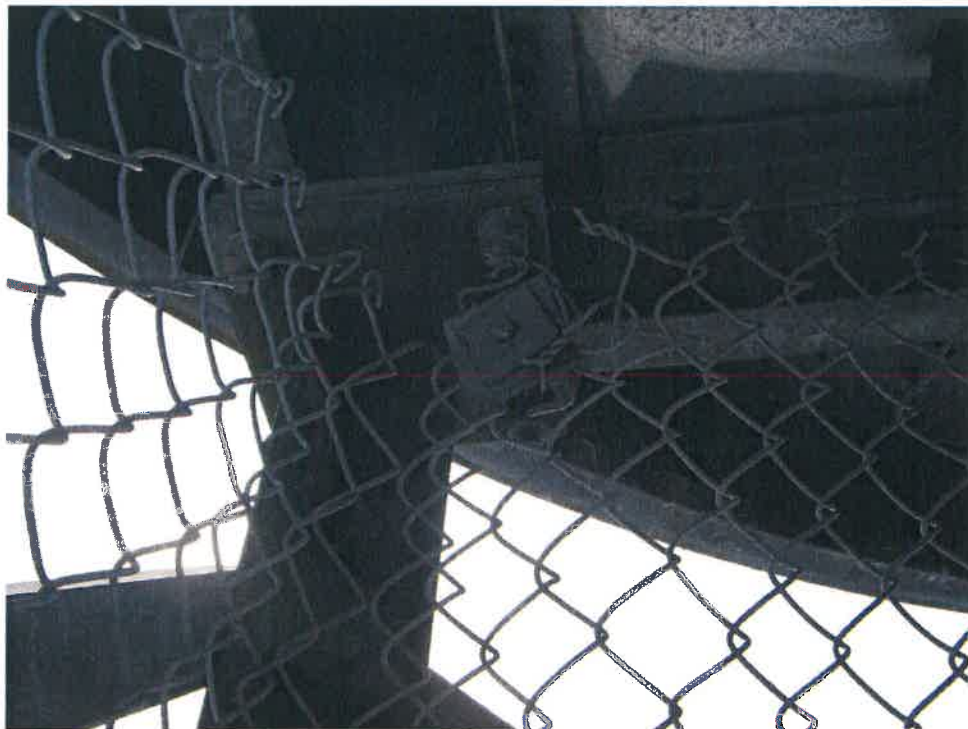
Photo #25: Chain-Link Brackets

Chain-link brackets behind the radome access ladder were off. Reinstalled by Tiller while on site. See Appendix A, Photo #25.

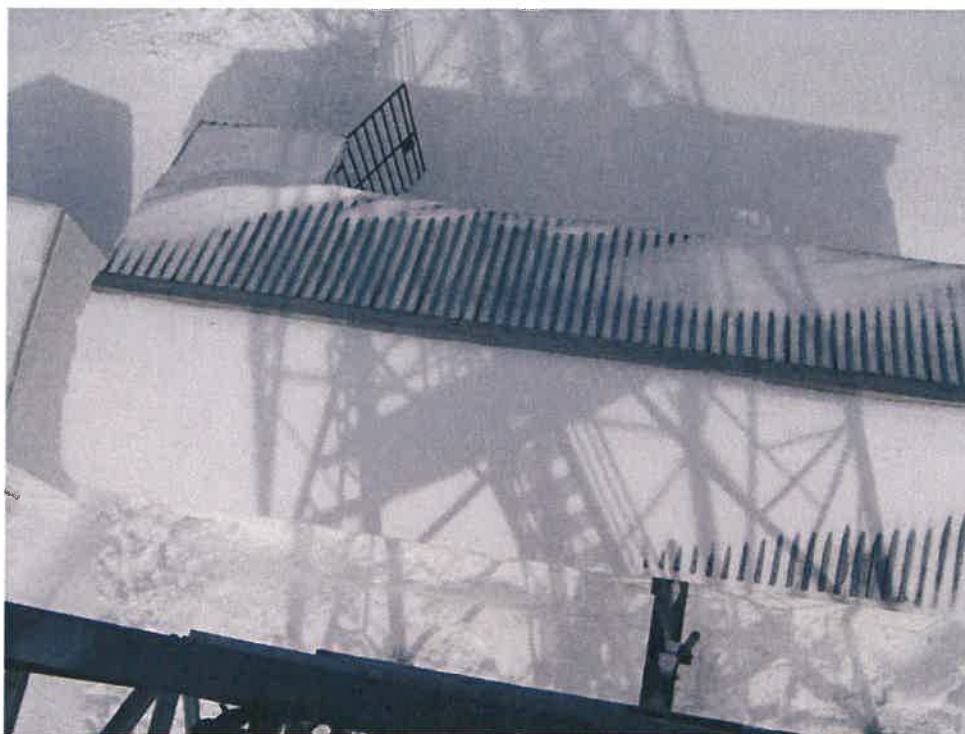
Photo #26: Surface Corrosion on Roof

The metal roofing exhibits minor surface corrosion. See Appendix A, Photo #26.

16	Replace corroded cotter pins.	C
17	Clean surface corrosion on roof of building.	C
