ENVIRONMENT CANADA MAINTENANCE INSPECTION

21m (68.9 ft) KNOCK-DOWN SELF-SUPPORT TOWER

XNI Lasseter Lake, Ontario

Issue Date:	Status:	Project #:	Issued By:	Checked By:	Approved By:
March 14, 2008	R0-Issued to Client	2008 - 15	JP/KM	JW	JW

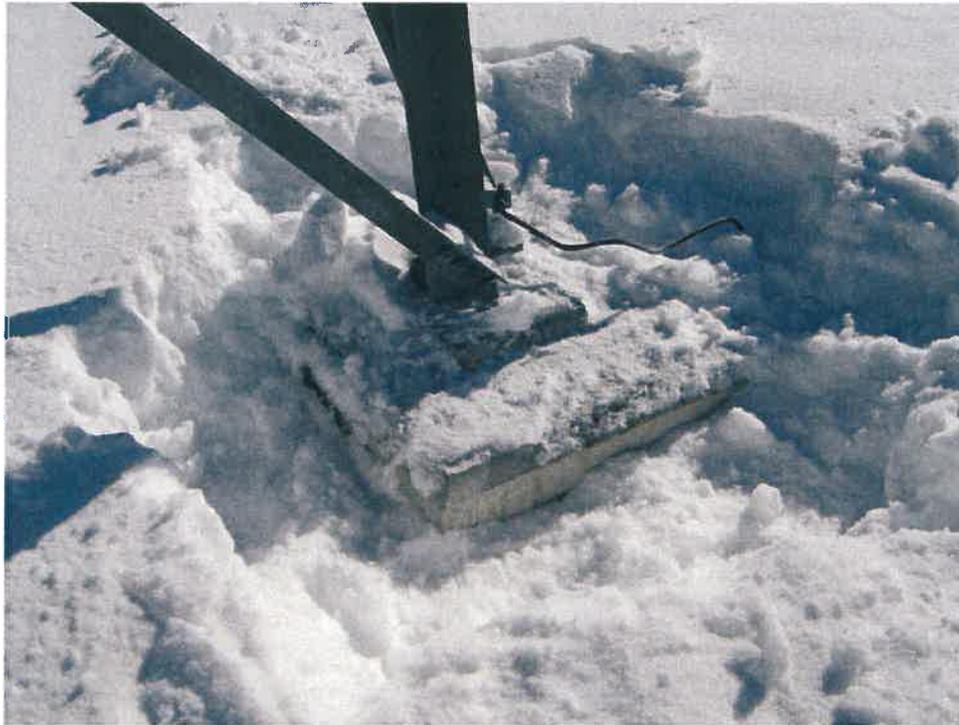
- A. Tower Members:** Diagonal on Face 1-2 at 6 feet has minor damage to galvanizing. See Appendix A, Photo #18.
- All other tower members appear satisfactory.
- B. Connections:** Tower connections appear satisfactory.
- C. Foundations:** The four foundations appear satisfactory. See Appendix A, Photo #2.

Photo #2: Snow Covered Foundations

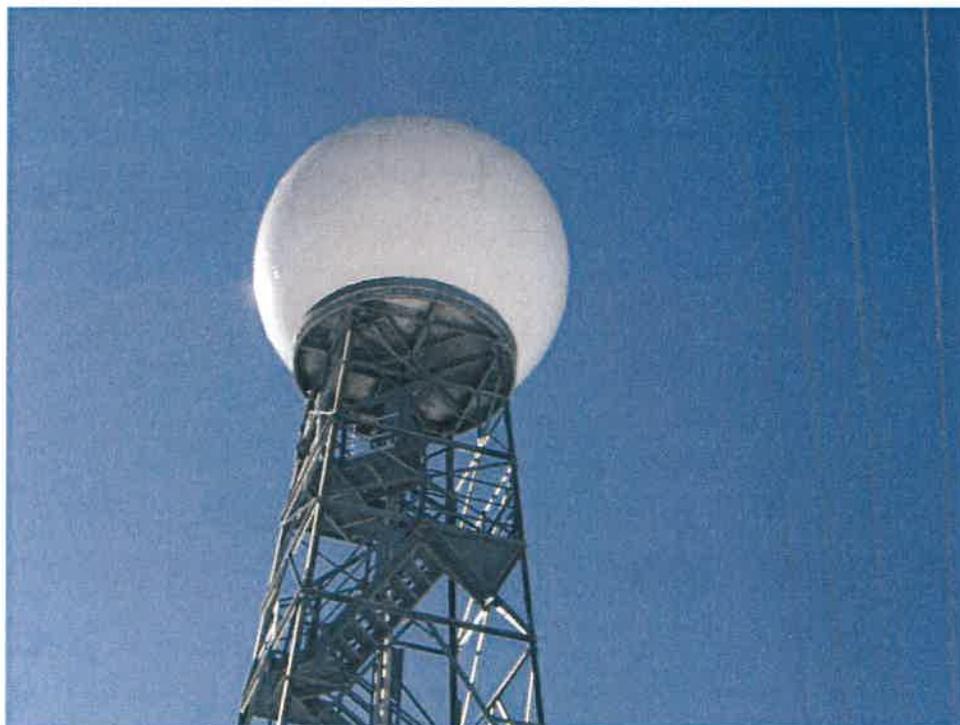
- A. Antennas:** The 5.5m Ticon Radome appears satisfactory. See Appendix A, Photo #3.
- The Yagi antenna on face 2-3 appears satisfactory.
- B. Transmission Line:** The TX line for the Yagi antenna was broken clear from 0 to 20 feet. Ty-wrapped on by Tiller. See Appendix A, Photo #17.
- C. Antenna Building** The tower is not equipped with an antenna building.

Photo #3: Radome

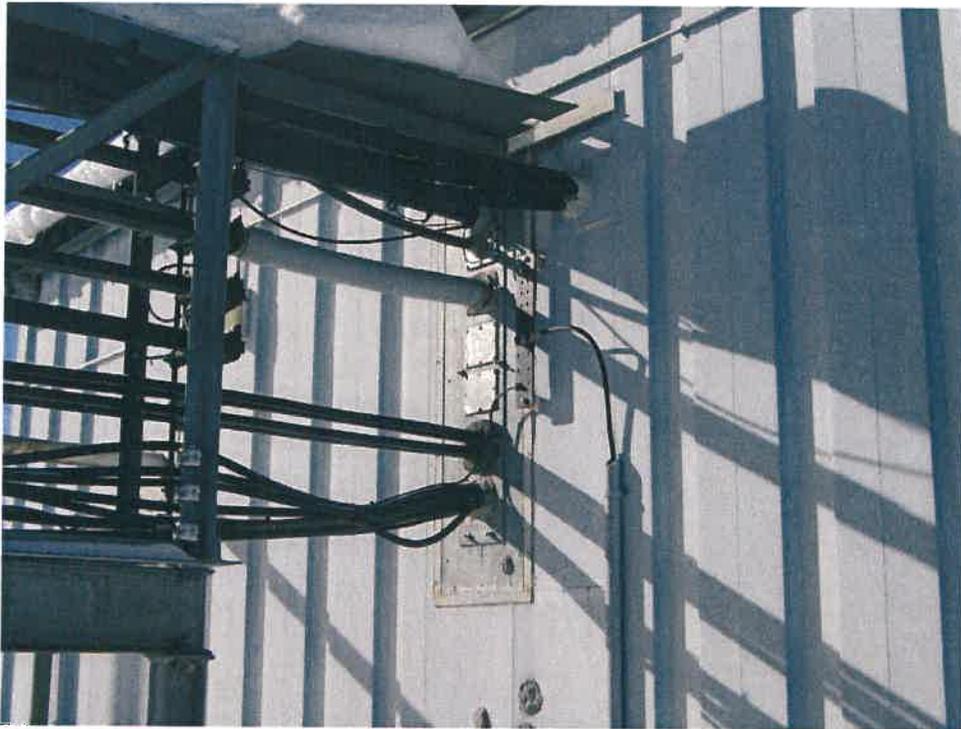
- A. Waveguide Bridge:** The waveguide bridge appears satisfactory. See Appendix A, Photo #5.
- B. Waveguide Port:** Seal is broken on PVC pipe entering building. See Appendix A, Photo #4.

Photo #4: Port Entry

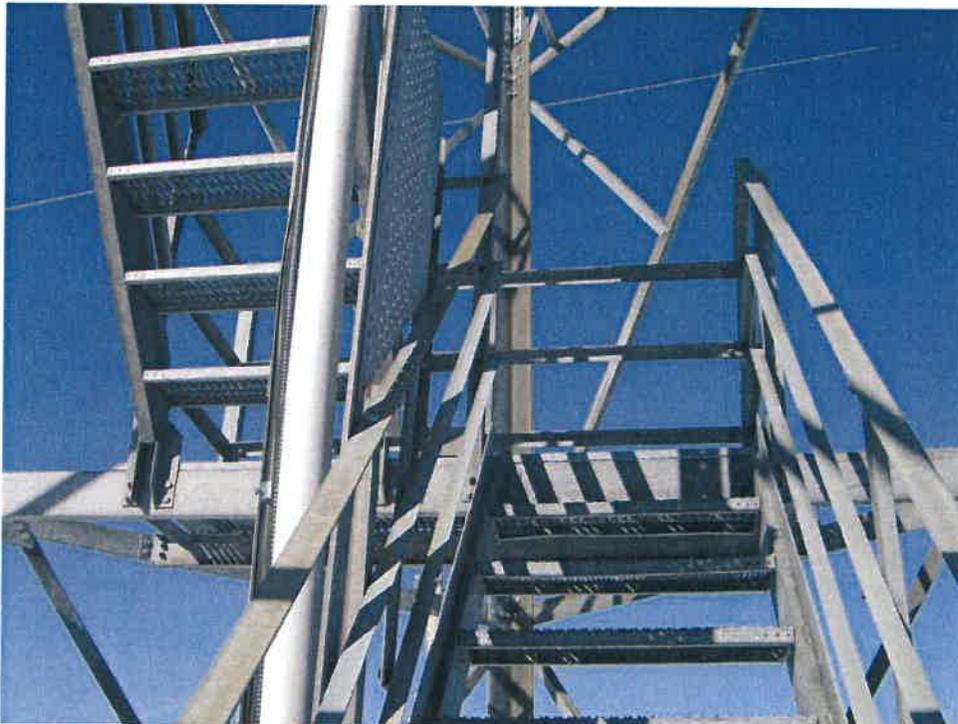
- A. Stairs:** Two bolts were loose in hand rail on fourth level of stairs "tighten by Tiller while on site".
- B. Fall Arrest System:** The tower is not equipped with a fall arrest system. The stairs and platforms are equipped with a hand rail. See Appendix A, Photo #5.

Photo #5: Integral Stairs and Platforms

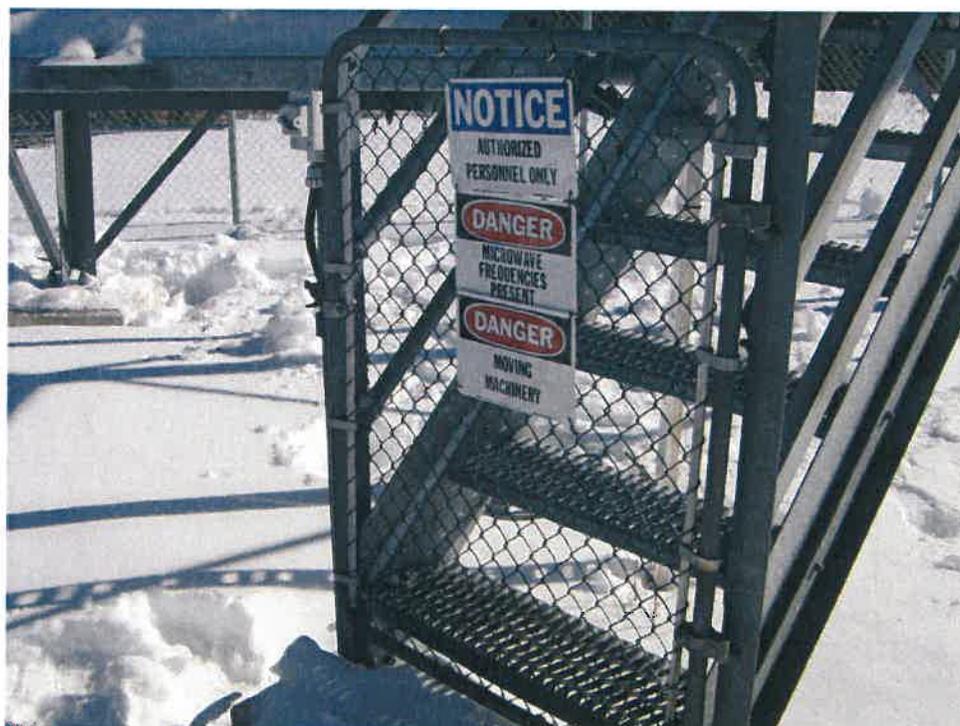
Photo #9: Anti-Climb

Item	Description	Priority
1	Install engineered anti-climb at base of tower access stairs to tower "use Marion Bridge anti-climb as a reference"..	A
2	Install warning signage indicating falling ice and RF hazard on fence perimeter.	A
3	Replace existing exterior outlets with GFI approved outlets.	A
4	Install grounding to the eight (8) waveguide post.	C
5	Install heavy duty Ty-wraps on teck cables going up tower.	C
6	Wire brush and cold galvanize damaged diagonal on face 1-2 at 6 feet.	C
7	Wire brush and cold galvanize corroded handrail at top of tower.	C
8	Replace corroded bolts in grating hold-down clips.	C

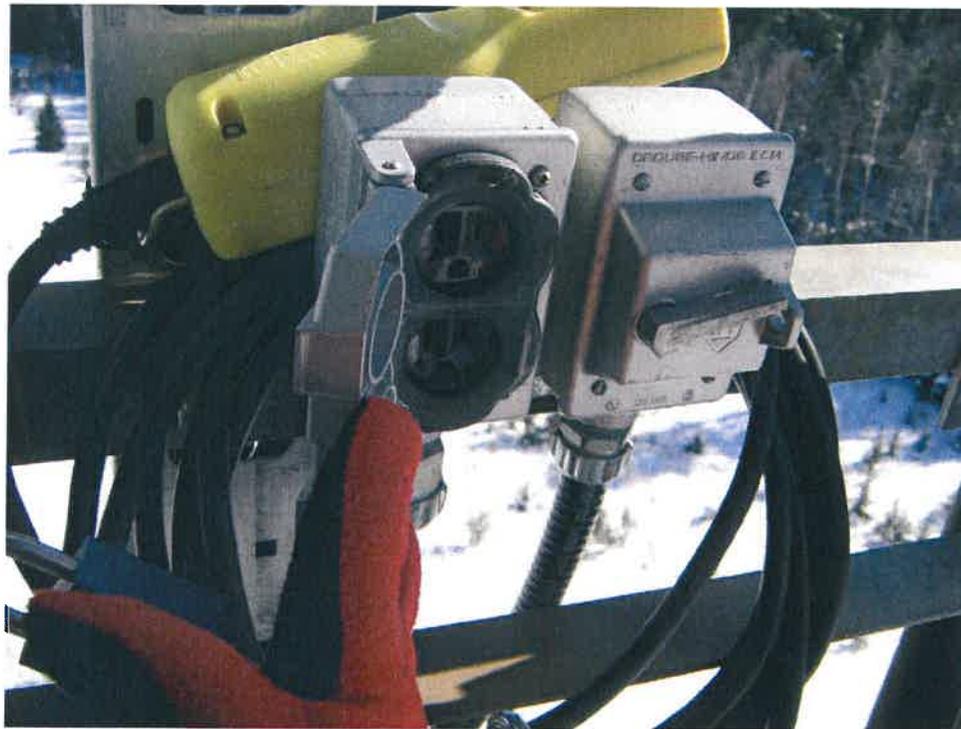
Photo #12: Tower Outlet

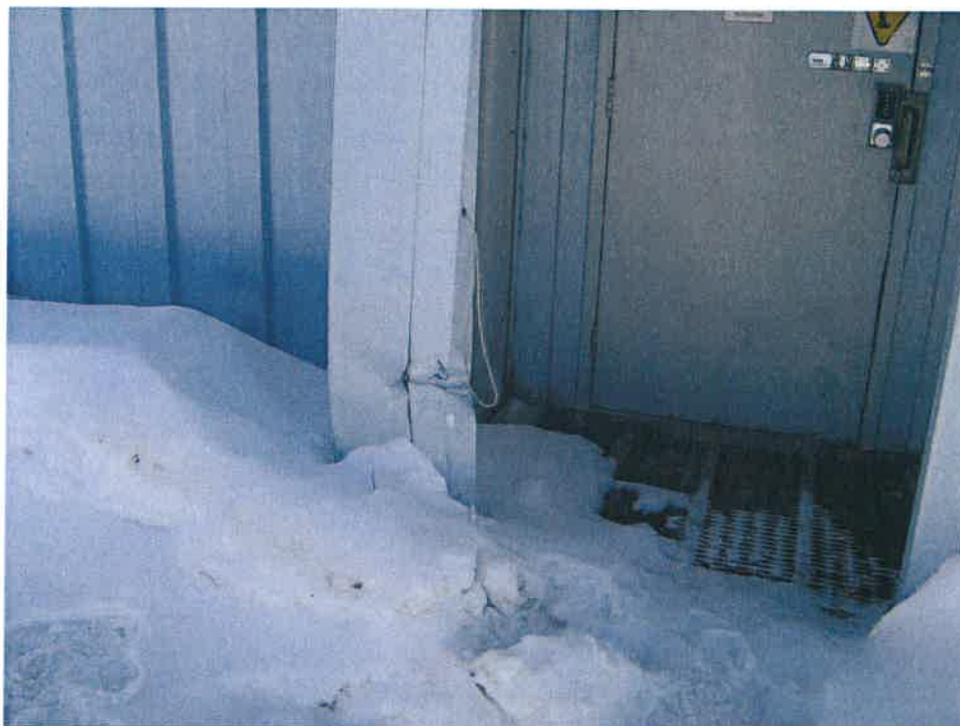
- A. Tower:** The tower grounding on leg two (2) was broken. Repaired by Tiller. See Appendix A, Photos #14 and #15.
- B. Waveguide Post:** The eight waveguide posts were not grounded.
- C. Equipment Shelter:** The wind guard at the main entrance was damaged. See Appendix A, Photo #13. The remainder of the shelter appeared satisfactory.

Photo #13: Damaged Wind Break

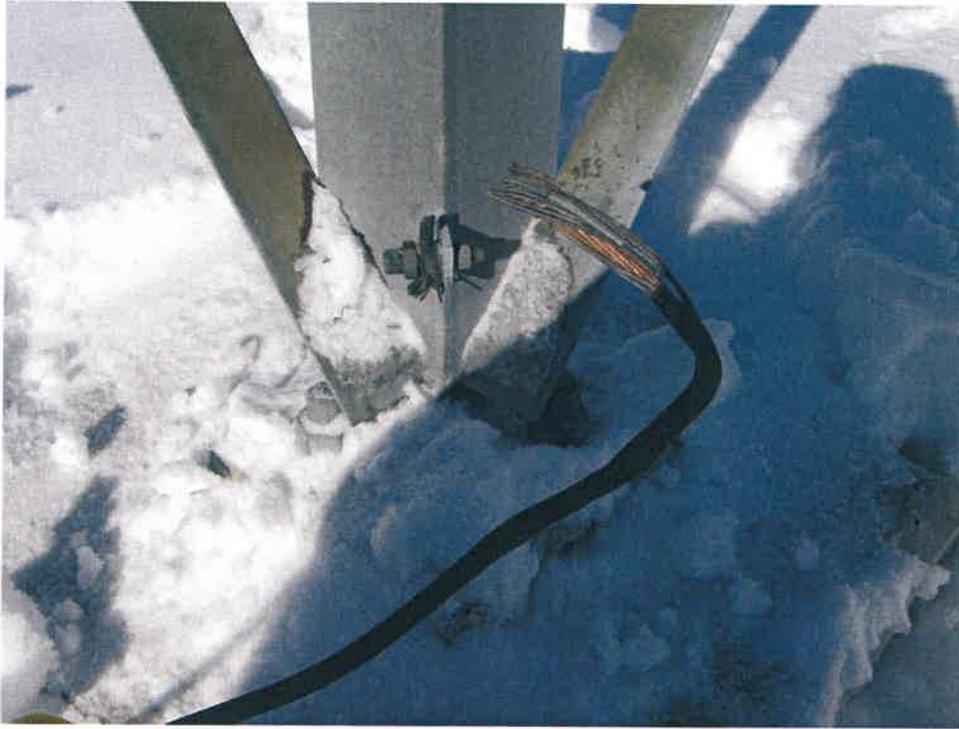
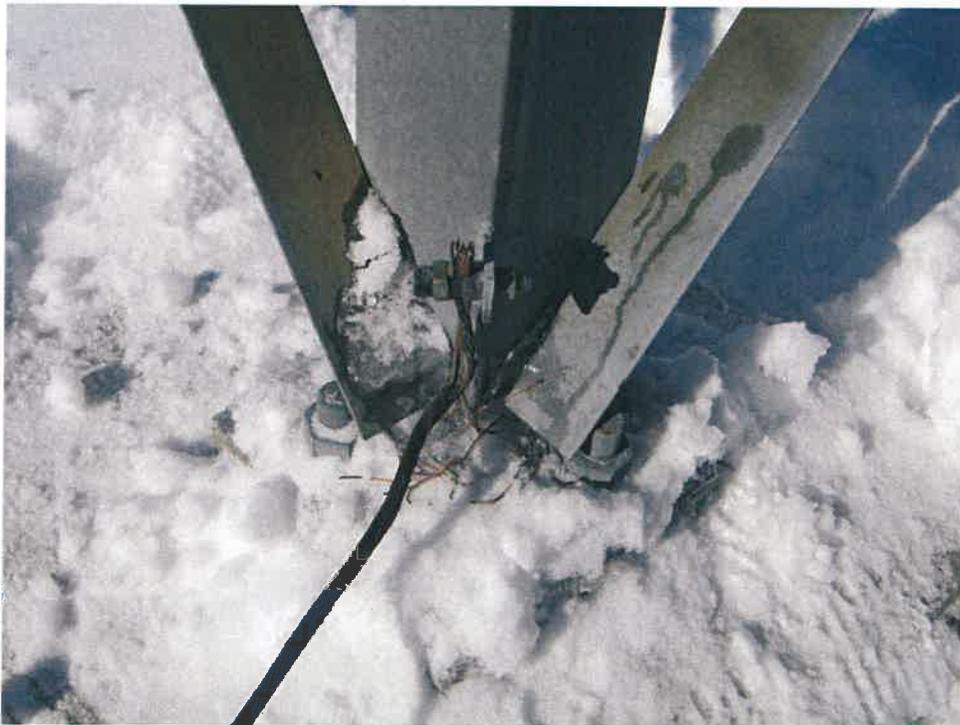
Photo #14: Broken Leg Grounding

Photo #15: Repaired Leg Grounding

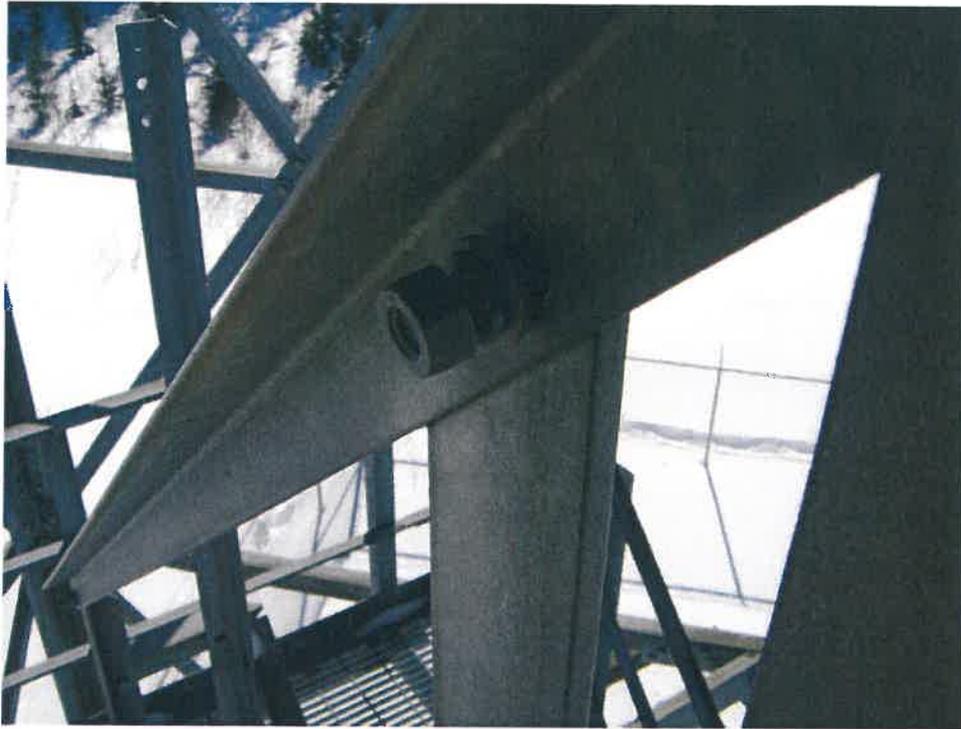
Photo #16: Loose Bolt "Tighten by Tiller"

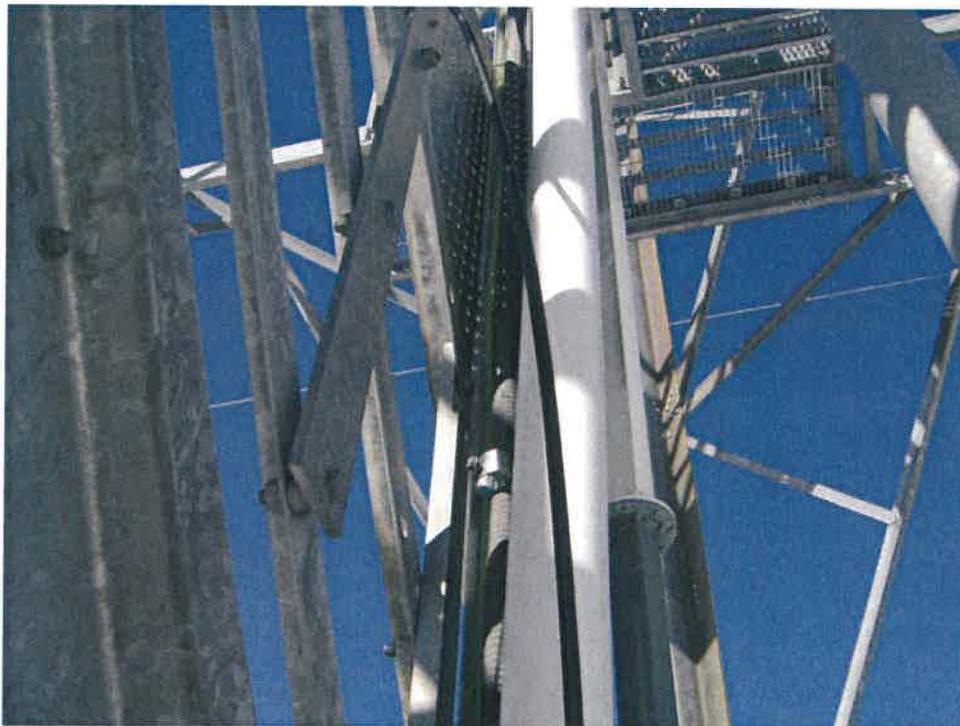
Photo #17: Loose TX Line

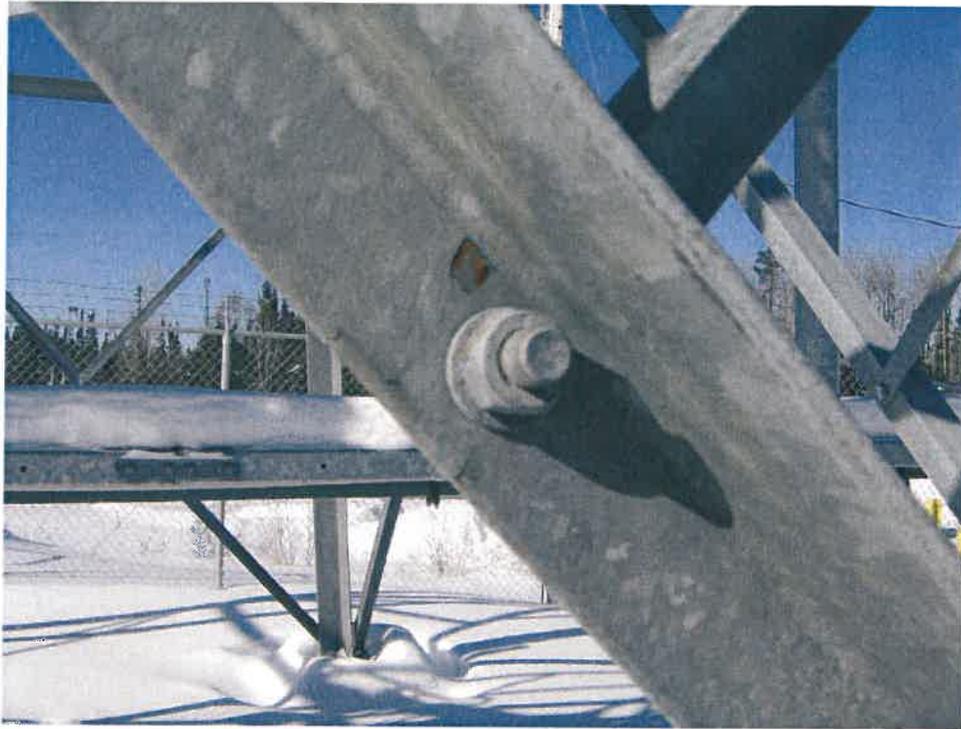
Photo #18: Damaged Diagonal Face 1-2 @ 6 Feet

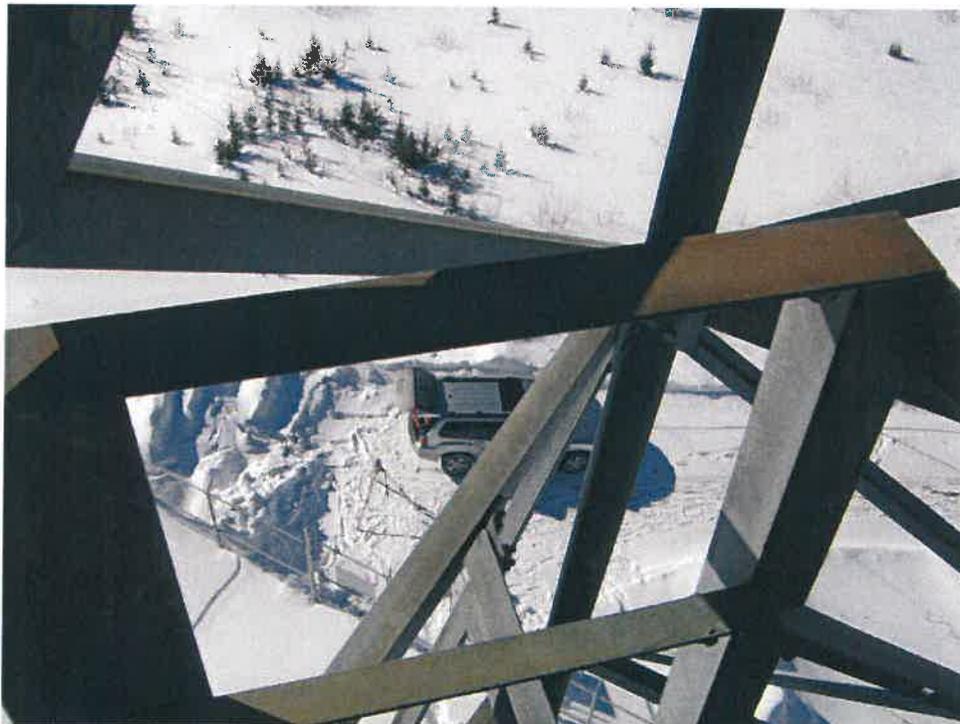
Photo #19: Corroded Hand Rail

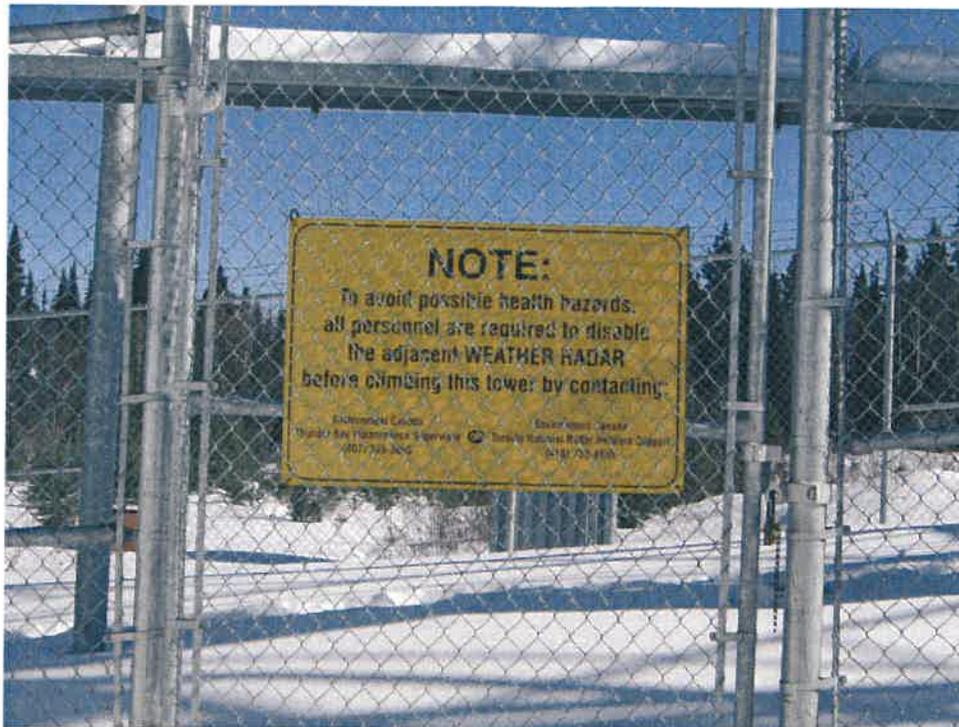
- A. General:** The compound was snow covered but appeared satisfactory. See Appendix A, Photo #6.
- B. Access:** The tower is located approximately 500 feet off the main road. Access road was cleared of snow at time of inspection.
- C. Fencing:** The site fence is shared with Bell Canada. The fence appears satisfactory. See Appendix A, Photos #1 and #6.
- D. Security:** The site has barbed wire installed and locked gates. There is a locked anti-climb gate at the base of the stairs to the tower. The anti-climb gate is inefficient to prevent entry. See Appendix A, Photo #9.
- E. Due Diligence:** There are no site warning signs installed on fence perimeter to indicate falling ice or RF hazards.
- Bell Canada has a sign on gate to indicate shut-down require from Environment Canada before climbing Bell Canada's tower. See Appendix A, Photo #20.

Photo #20: Bell Canada's Safety Sign
