# ENVIRONMENT CANADA MAINTENANCE INSPECTION

## 21.6m (70.9 ft) KNOCK-DOWN SELF-SUPPORT TOWER

WGJ Montreal River Harbour, Ontario

Issue Date:	Status:	Project #:	Issued By:	Checked By:	Approved By:
March 14, 2008	R0-Issued to Client	2008 - 15	JP/KM	JW	JW

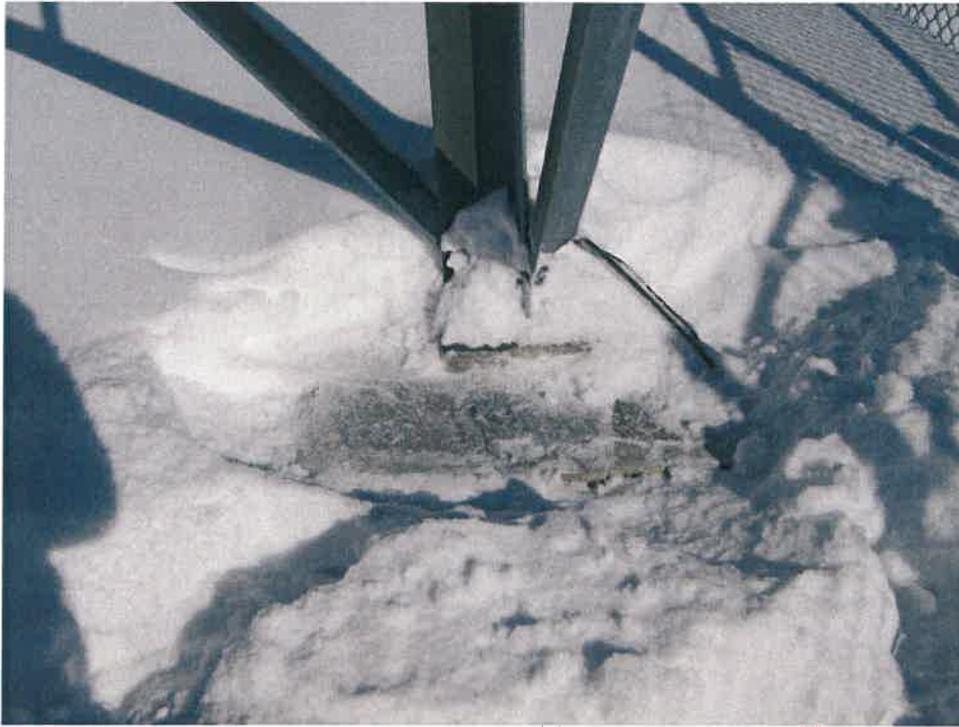
- A. Tower Members:** The tower members located behind the ladder access to the radome exhibits heavy surface corrosion. See Appendix A, Photo #14.
- B. Connections:** The tower connections appear satisfactory.
- C. Foundations:** The four foundations appear satisfactory. See Appendix A, Photo #2.

**Photo #2: Tower Foundations Typical 4 Locations**

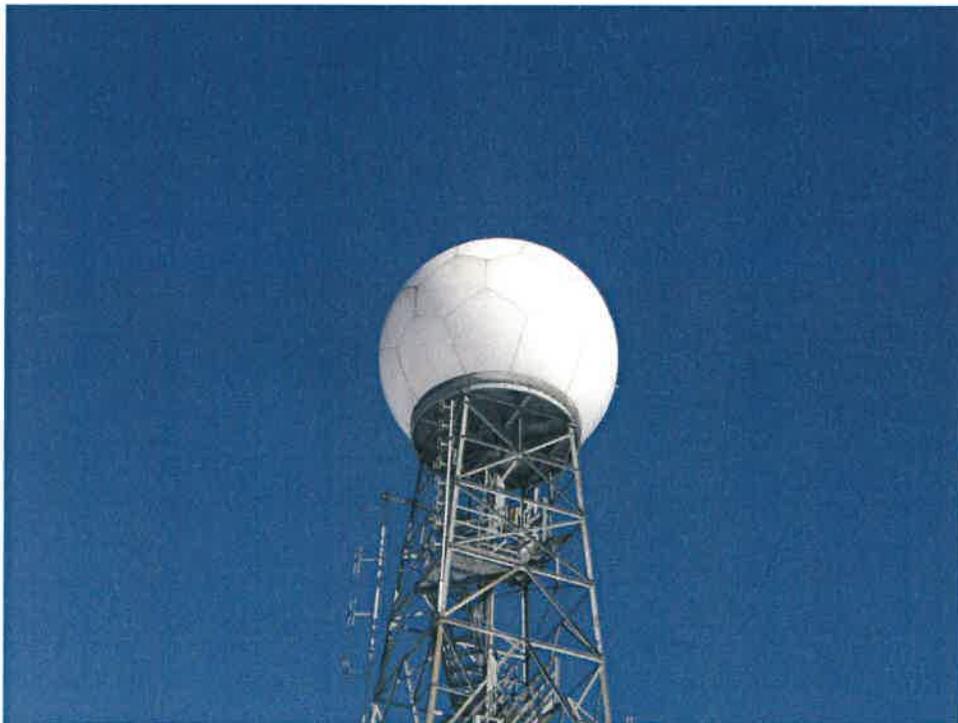
- A. Antennas:** The 5.5 m radome appears satisfactory. See Appendix A, Photo #3.
- The mounting hardware for antenna # 2 exhibits moderate surface corrosion. See Appendix A, Photo #20.
- The second Di-pole on antenna #3 has one missing u-bolt. See Appendix A, Photo #17.
- B. Transmission Line:** All transmission lines are connected with Ty-wraps. The transmission lines are not grounded.
- C. Antenna Building** This tower is not equipped with an antenna building on the tower.

**Photo #3: Radome**

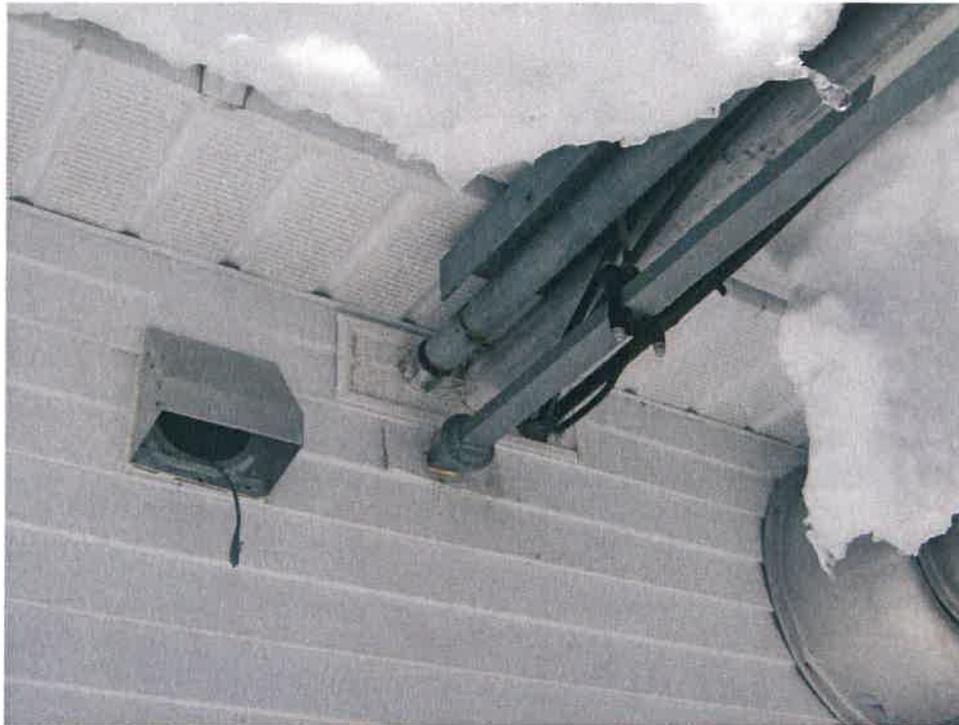
The waveguide port appears satisfactory. See Appendix A, Photo #4.

**Photo #4: Port Entry**

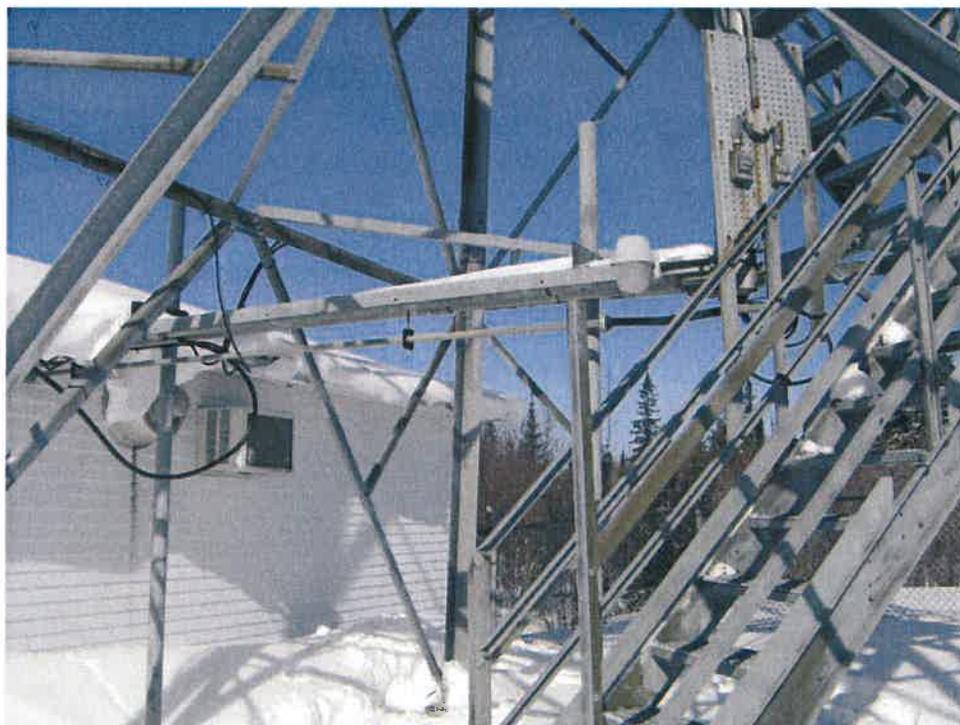
- A. Stairs:** The hand rail and steps exhibits minor surface corrosion. See Appendix A, Photos #11 and #14.
- B. Fall Arrest System:** The tower is not equipped with a fall arrest system. The stairs and platforms are equipped with a hand rail. See Appendix A, Photo #5.

The waveguide bridge appears satisfactory. See Appendix A, Photo #5.

**Photo #5: Wave Guide Bridge**

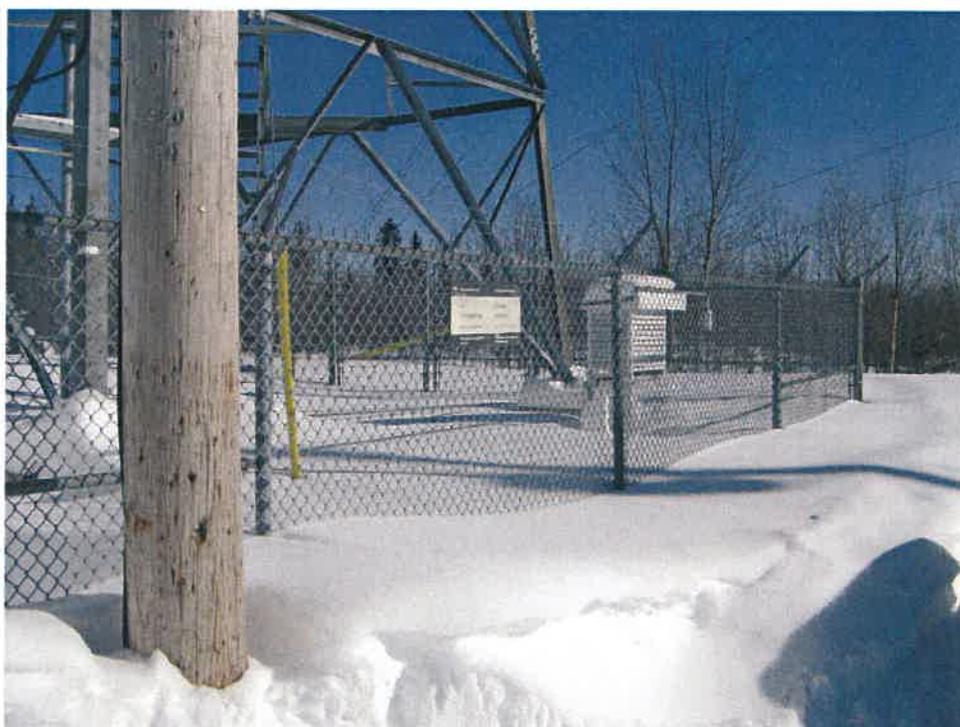
- A. General:** The compound was snow covered but appeared satisfactory. See Appendix A, Photo #7.
- B. Access:** The access road to site was snow covered and steep. A four-wheel drive is required for access.
- C. Fencing:** The site fence exhibits minor surface corrosion on various locations. See Appendix A, Photos #12 and #13.
- Fence grounding connections exhibits moderate surface corrosion. See Appendix A, Photo #12.
- D. Security:** The compound fence has barbed wire installed and a locked gate.
- There is no anti-climb installed at the base of the tower.
- E. Due Diligence:** There is no site warning signage installed on tower compound fence or tower. Warning signs on building doors are satisfactory.

**Photo #7: Fencing**

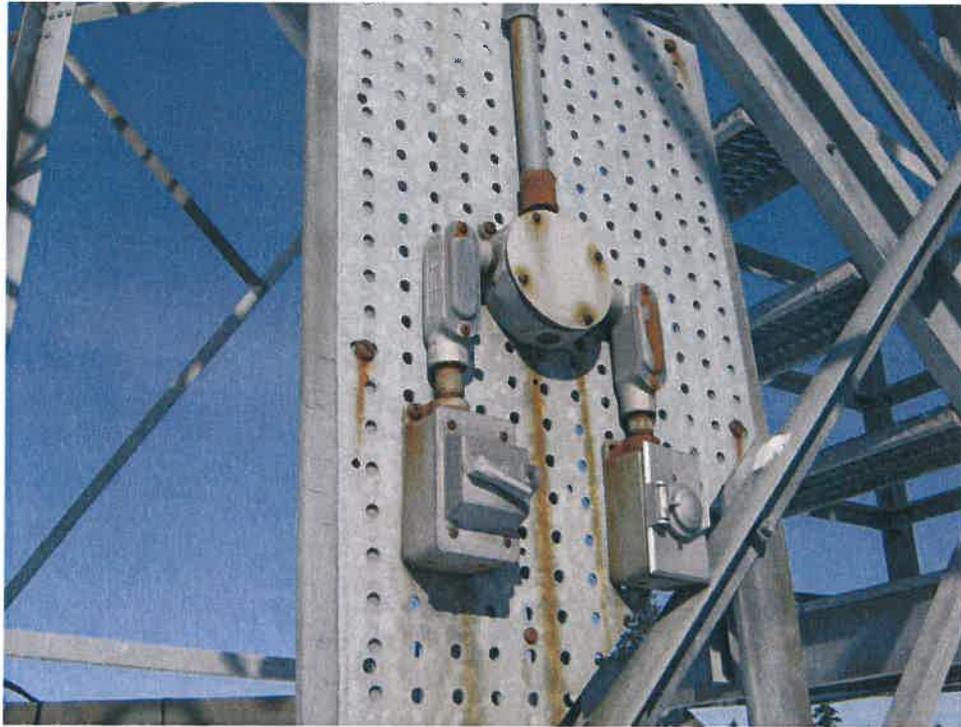
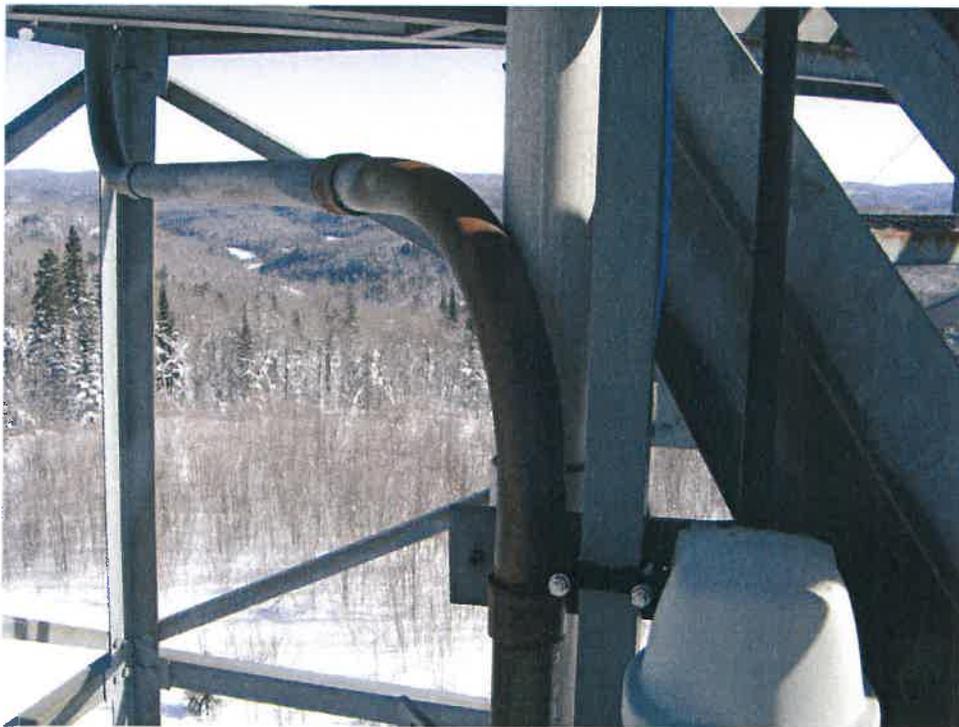
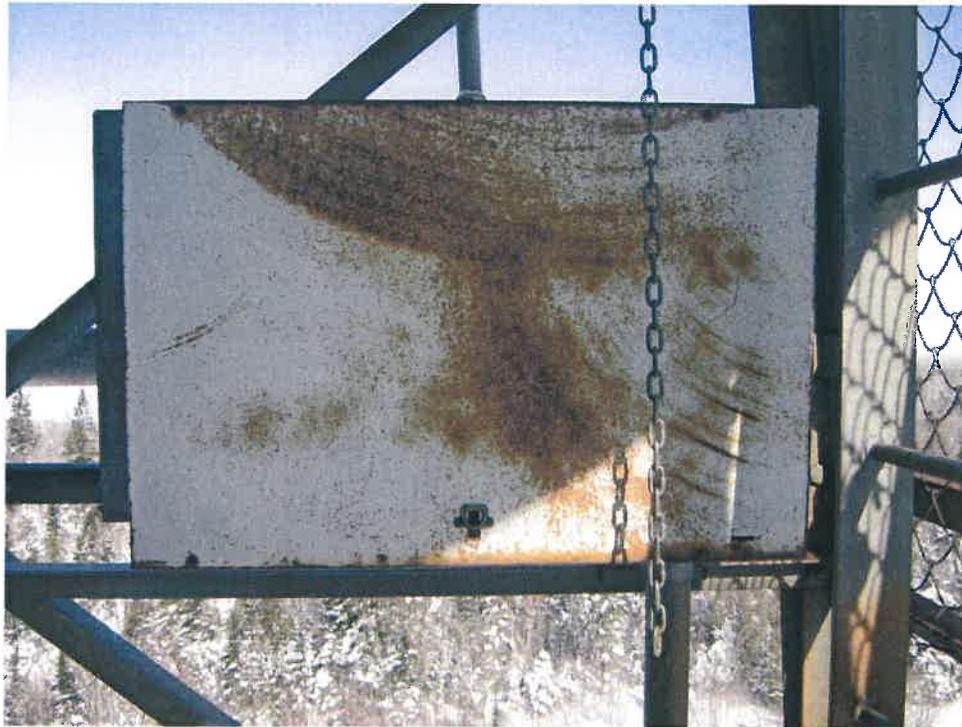
Junction boxes and electrical conduit exhibits moderate surface corrosion throughout the tower. See Appendix A, Photos #8, #9 and #10.

**Photo #8: Corroded Electrical Components**

**Photo #9: Corroded Electrical Conduit**

**Photo #10: Corroded Electrical Control Box**

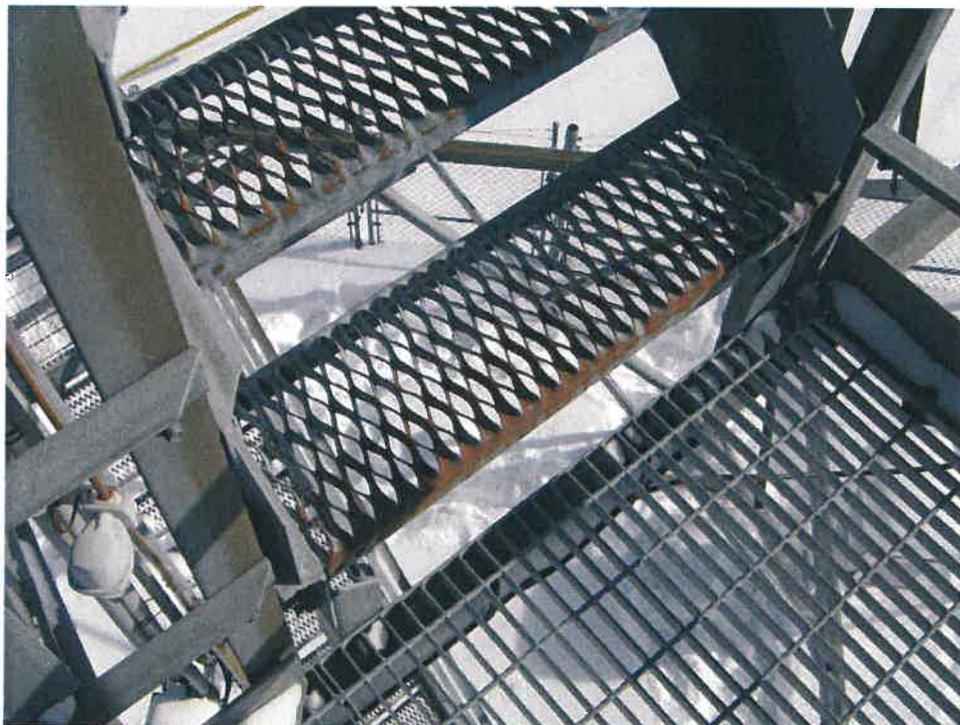
**Photo #11: Corroded Steps**

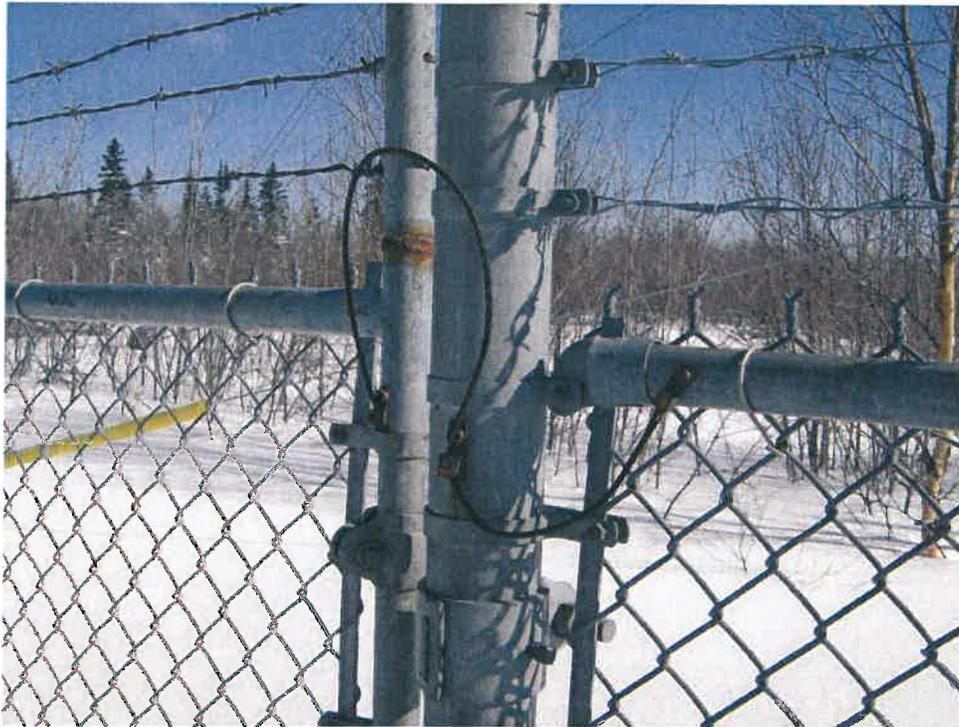
**Photo #12: Corroded Fencing Components**

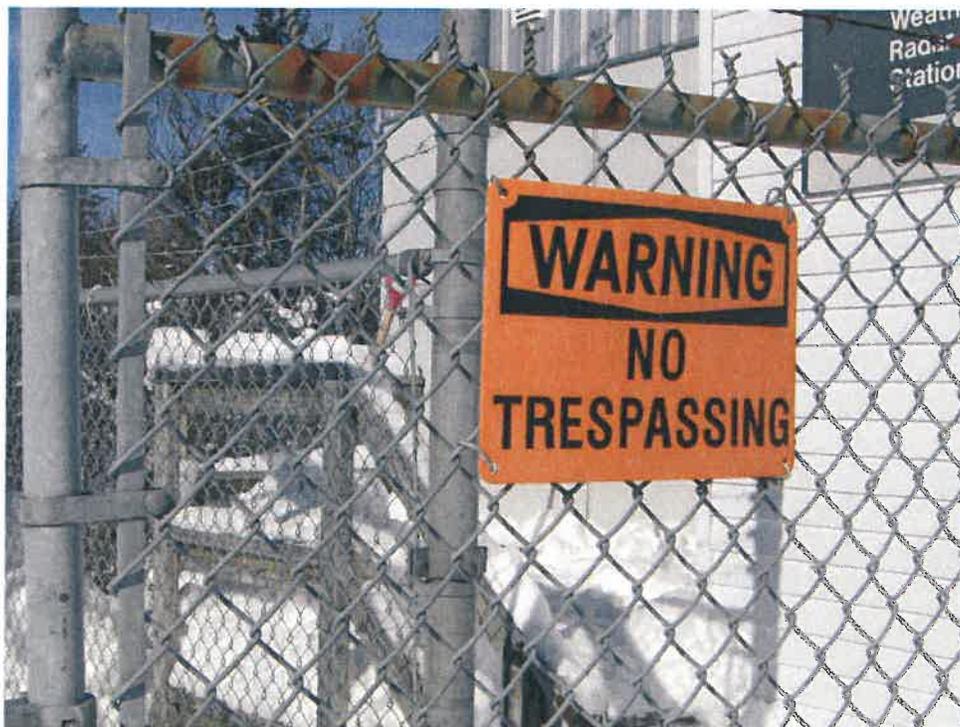
**Photo #13: Corroded Fencing Components #2**

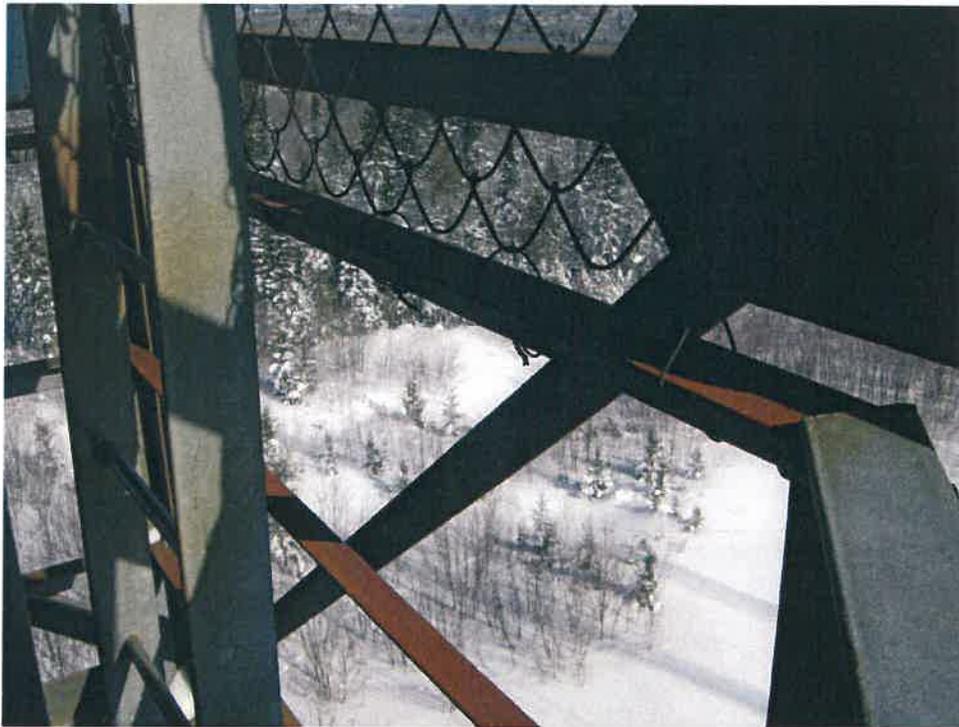
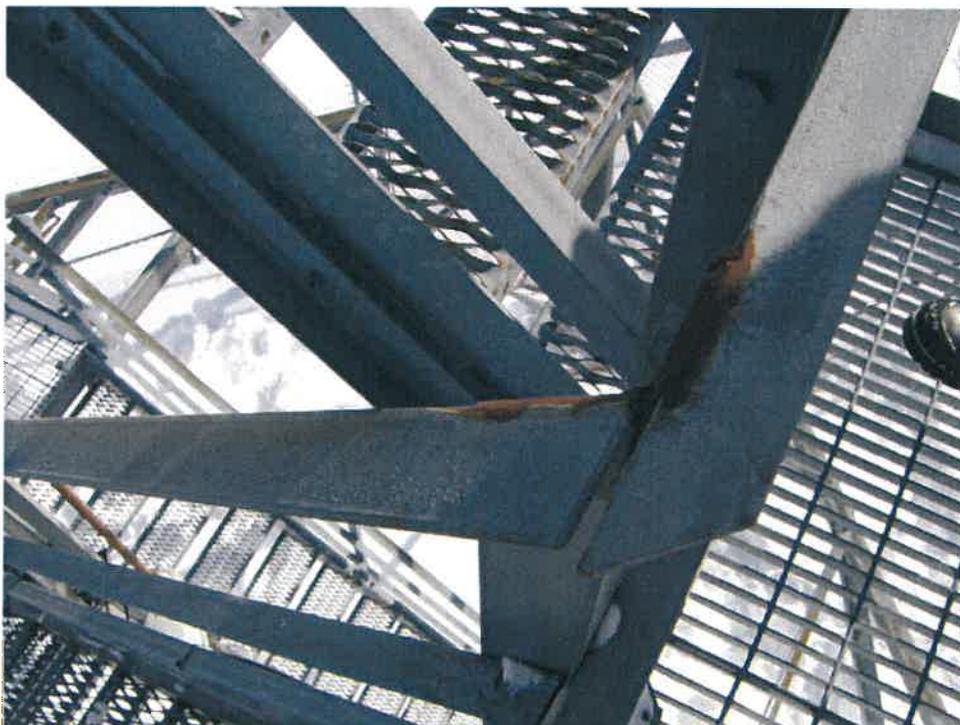
**Photo #14: Corroded Tower Members**

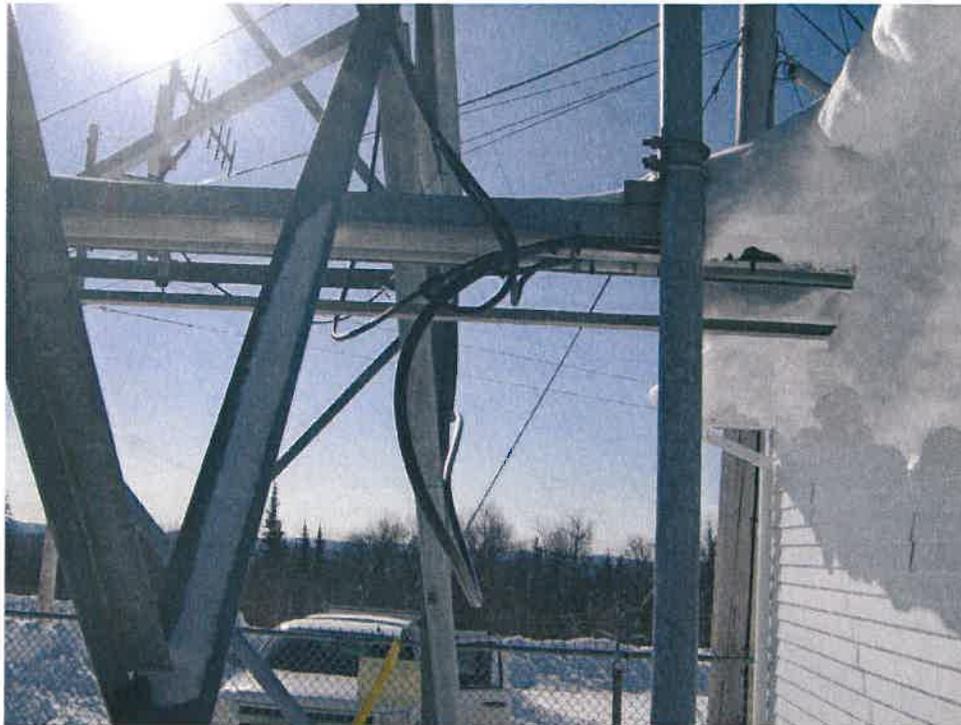
**Photo #15: Un-secured TX Lines**

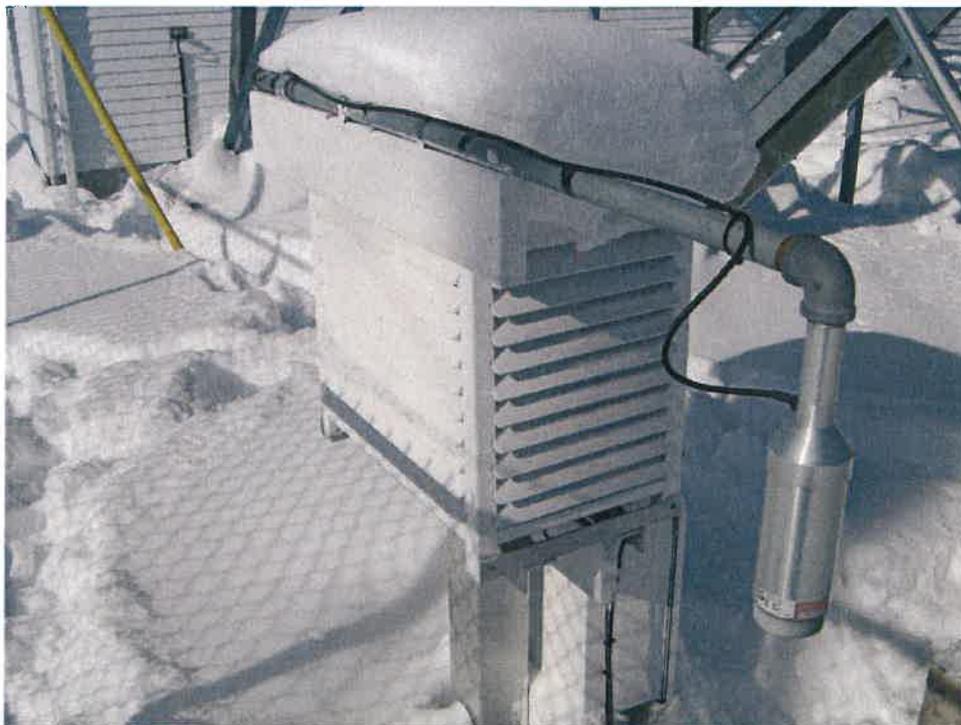
- There is a snow meter located at the base of the tower with no protection from falling ice. See Appendix A, Photo #16.

**Photo #16: Un-Protected Snow Meter**

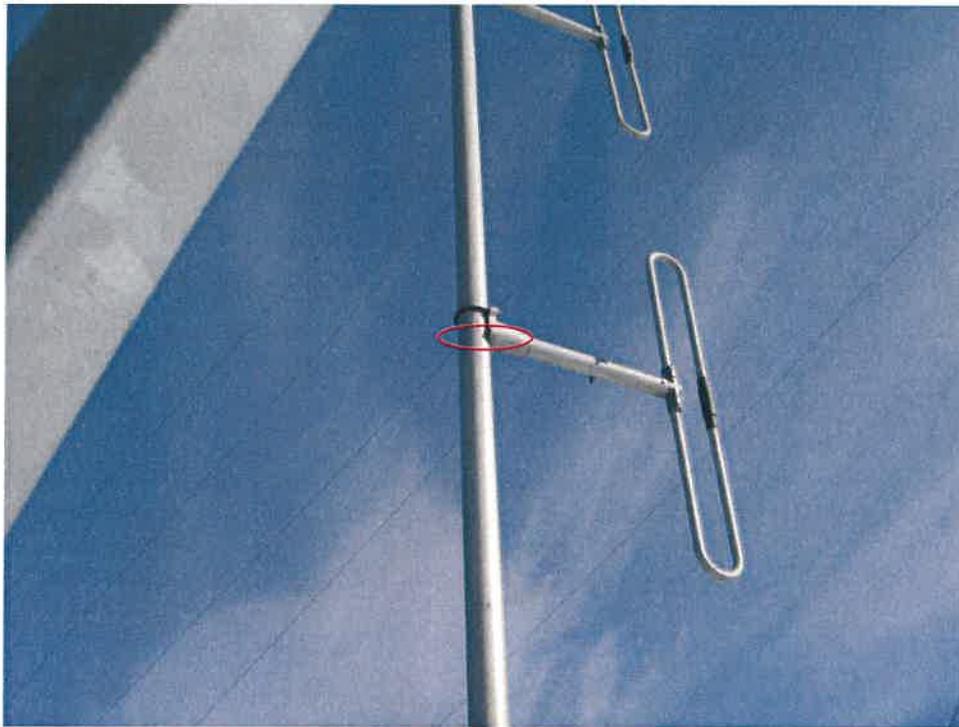
**Photo #17: Missing U-Bolt**

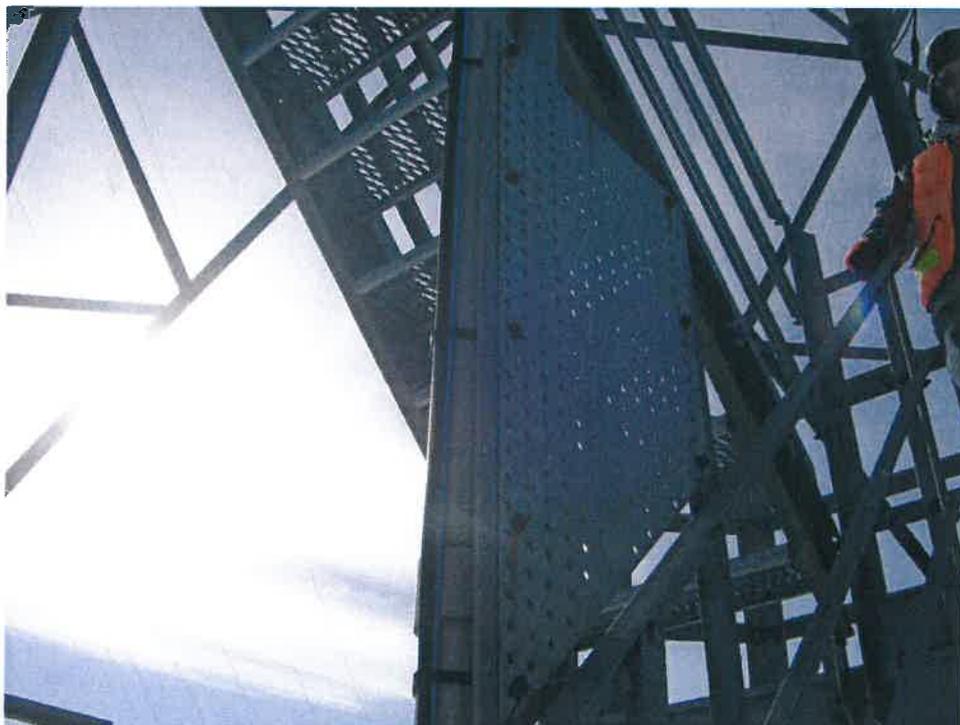
**Photo #18: Corroded Plate Bolts**

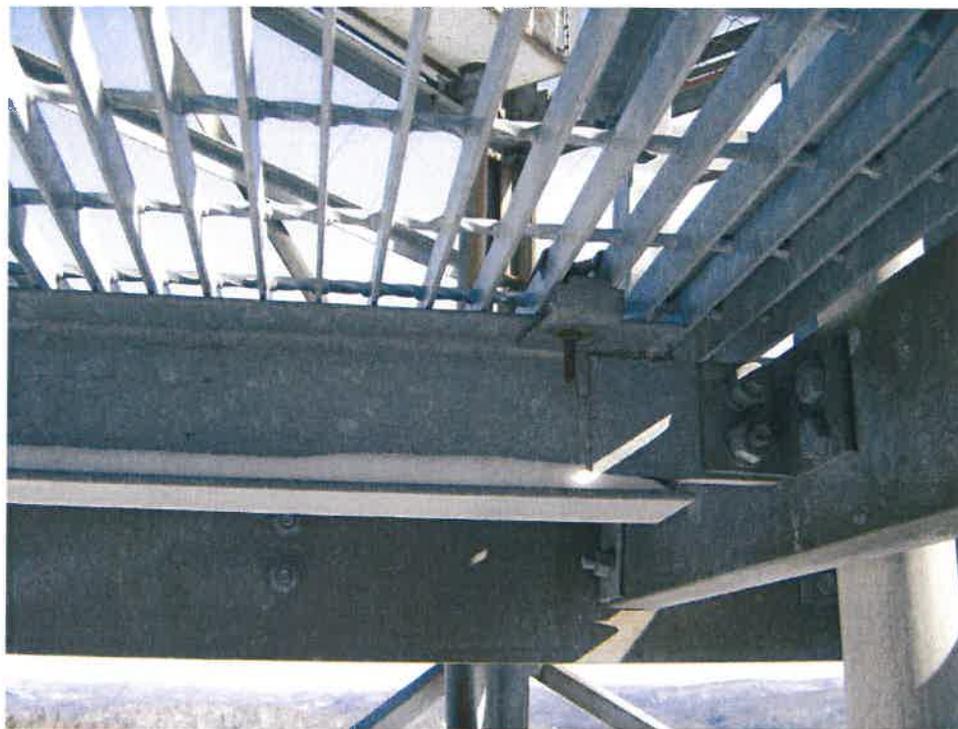
**Photo #19: Corroded Grating Bolts**

14	Replace corroded bolts in the platform grating.	C
15	Replace corroded bolts in grounding connections on site fence.	C
16	Relocate photocell to a more accessible location.	C

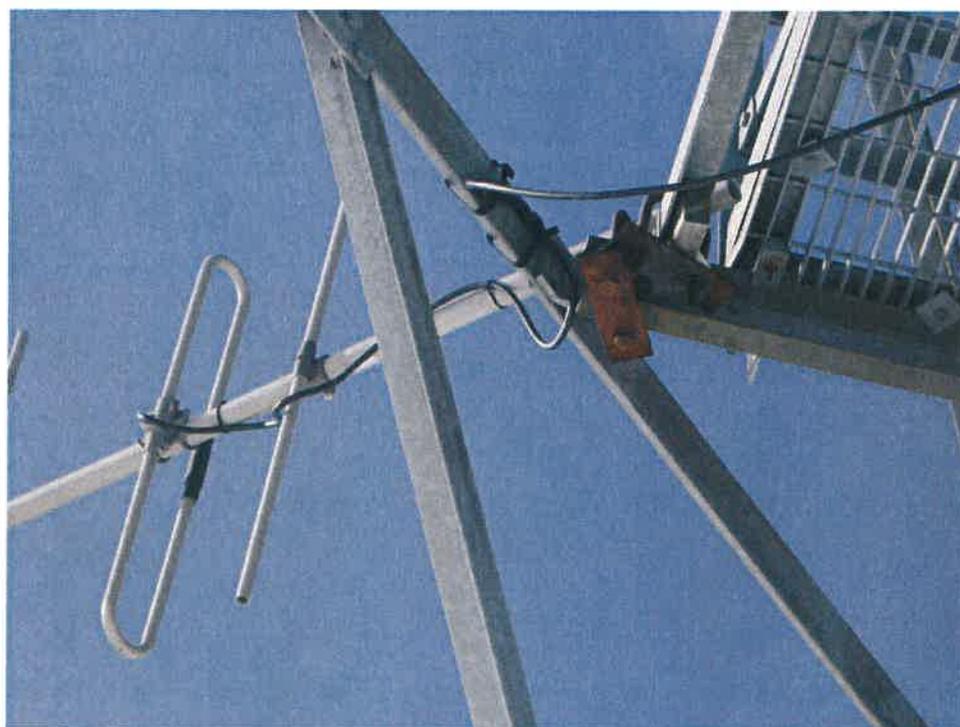
**Photo #20: Corroded Antenna Mount**
