ENVIRONMENT CANADA MAINTENANCE INSPECTION

18m (60 ft) KNOCK-DOWN SELF-SUPPORT TOWER

XMB Marion Bridge, NS

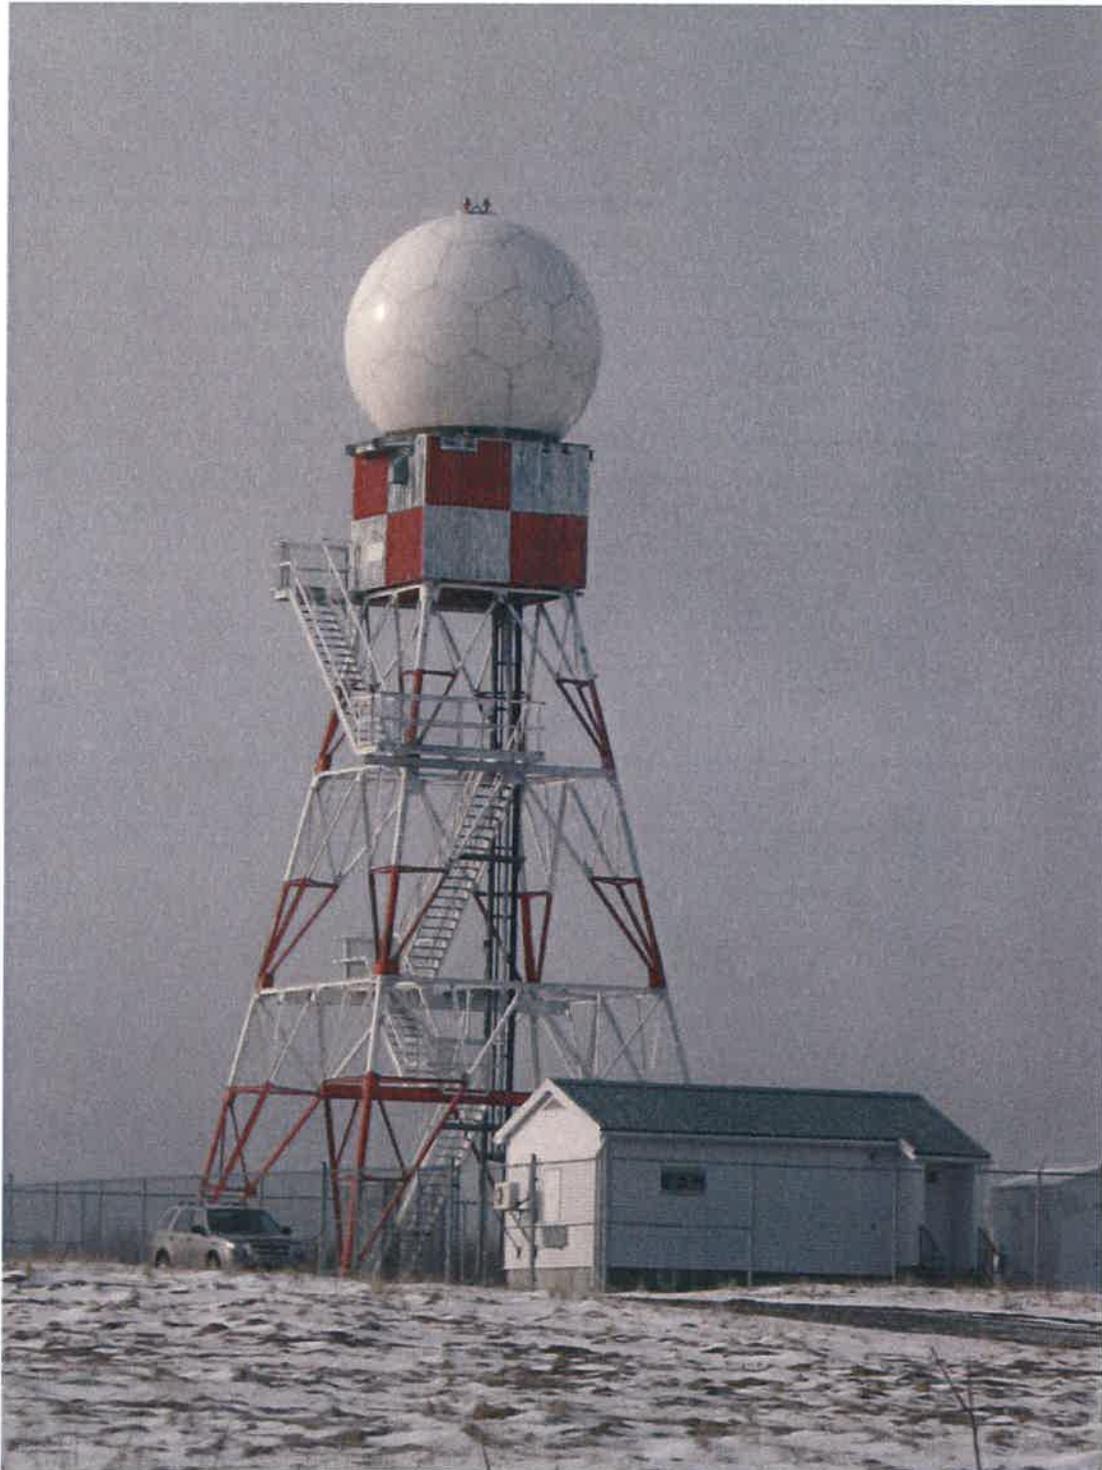
Photo #1: Tower Profile

The tower paint is faded and flaking. See Appendix A, Photo #1.

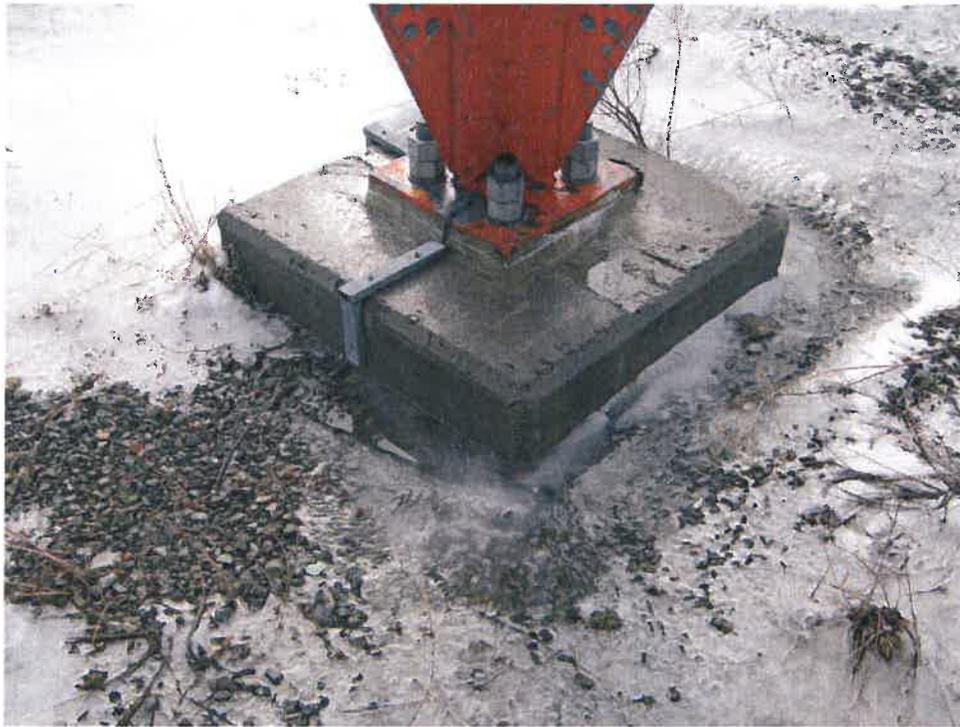
Photo #2: Tower Foundation Typical 4 Locations

A. Tower: The tower grounding appears satisfactory. See Appendix A, Photo #2.

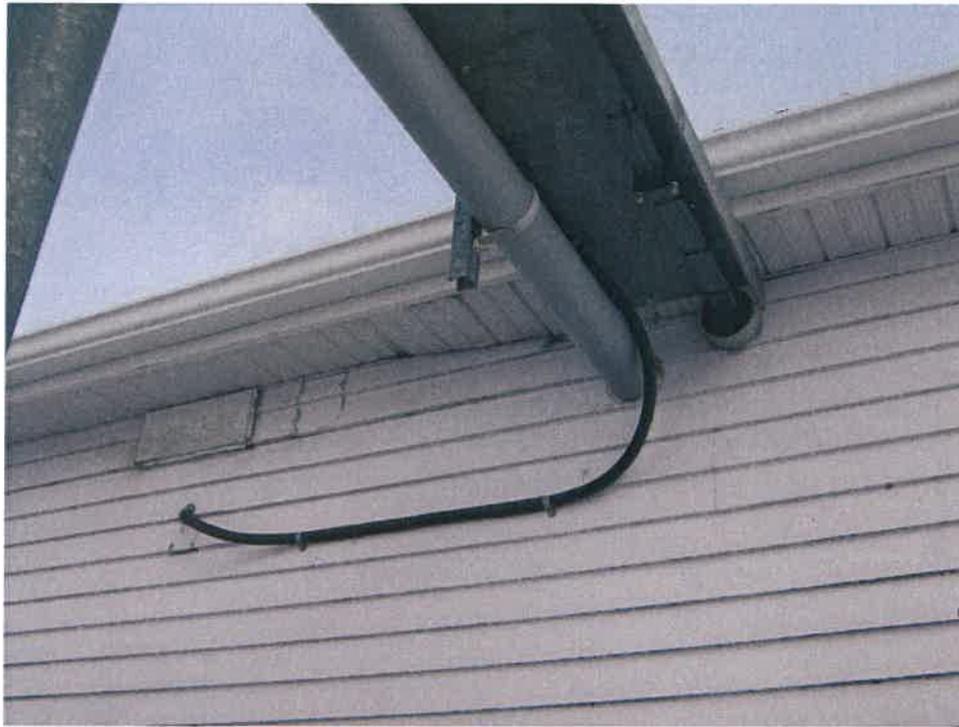
Photo #4: Port Entry

The seal is broken around the PVC pipe entering building. See Appendix A, Photo #4.

The buildings soffit above the waveguide port is out of the siding trim. See Appendix A, Photo # 4.

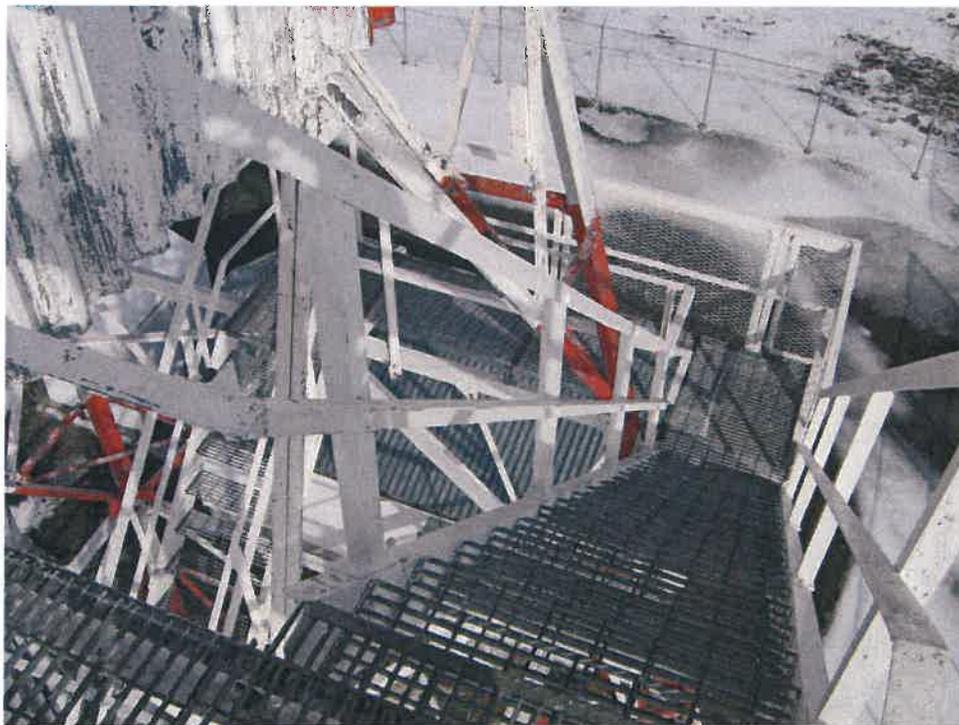
Photo #5: Integral Stairs and Platforms

A. Stairs: The integral stairs and platforms appear satisfactory. See Appendix A, Photo #5.

B. Fall Arrest System: The tower is not equipped with a fall arrest system. The stairs and platforms are equipped with a hand rail. See Appendix A, Photo #5.

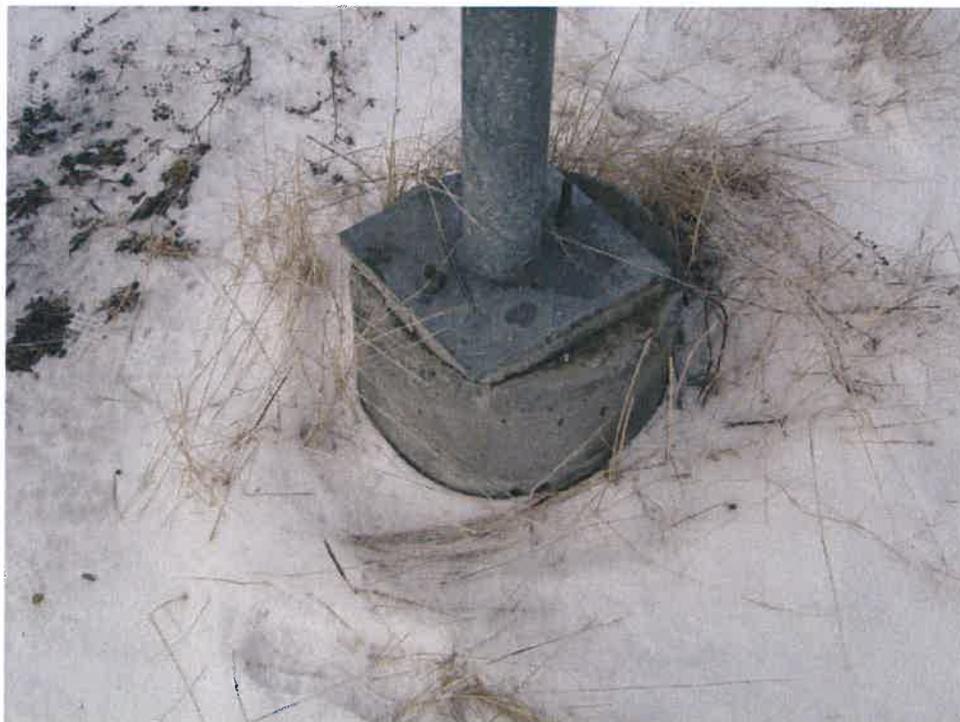
Photo #7: Waveguide Post Grounding Typical

B. Waveguide Post: The waveguide posts are not grounded. See Appendix A, Photo #7.

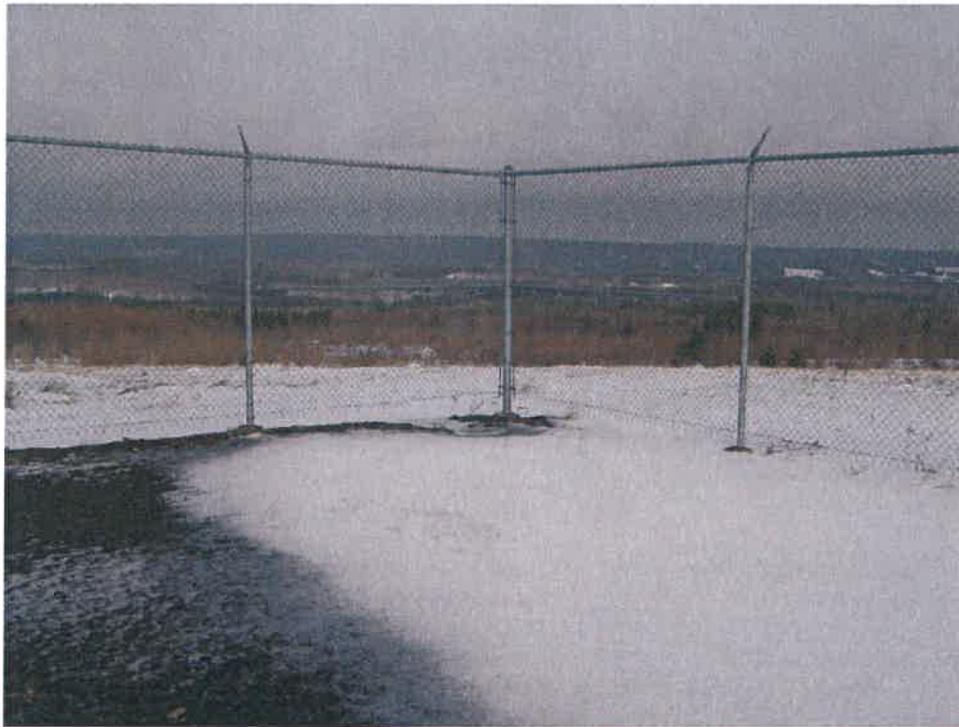
- C. Fencing:** The fence appears satisfactory. See Appendix A, Photo #1, #10, and #16.
- The north corner of fence was approximately one foot above ground level. See Appendix A, Photo #10.

Photo #10: Damaged Fencing North Side

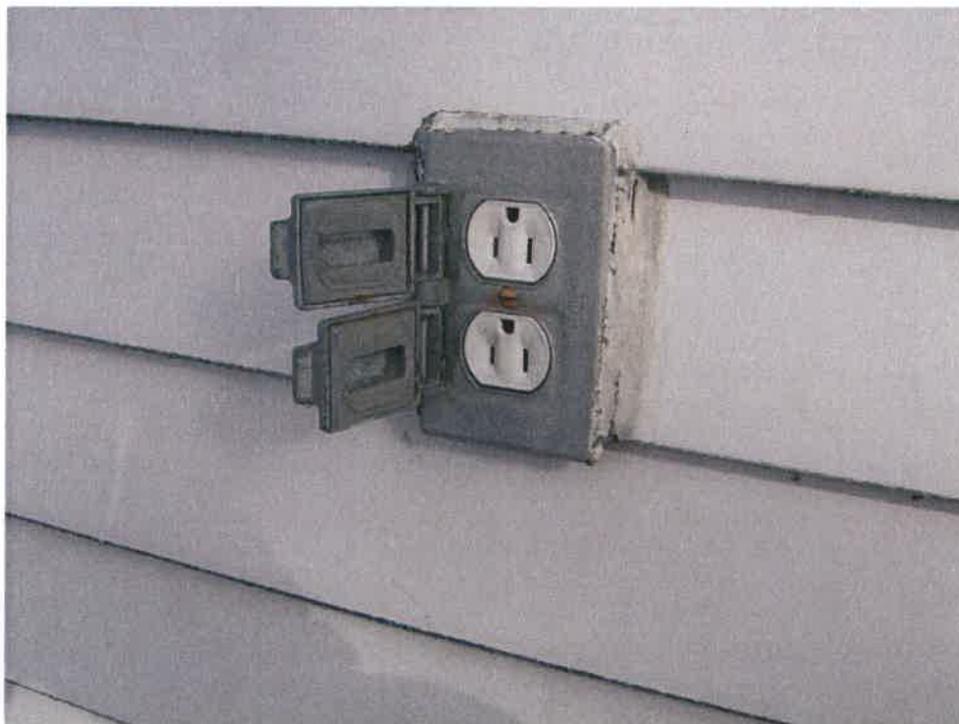
Photo #11: Outside Outlets

The exterior power outlets are not equipped with GFI plugs. See Appendix A, Photo #11.

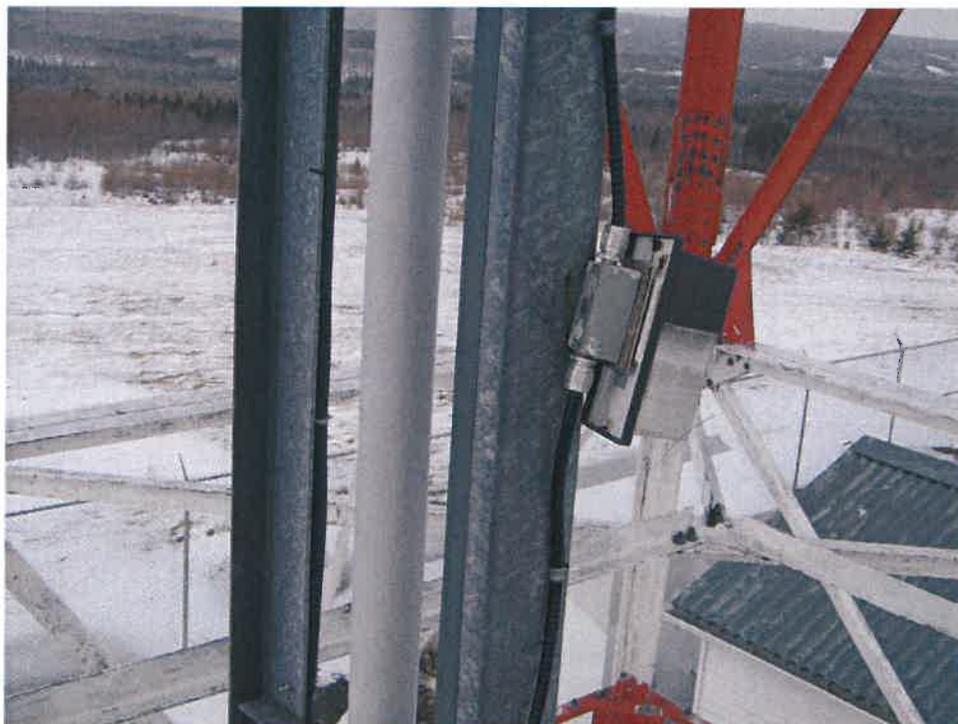
The first level tower access light is broken clear of its connection. See Appendix A, Photo #13.

Photo #13: Damaged Access Lighting Level One

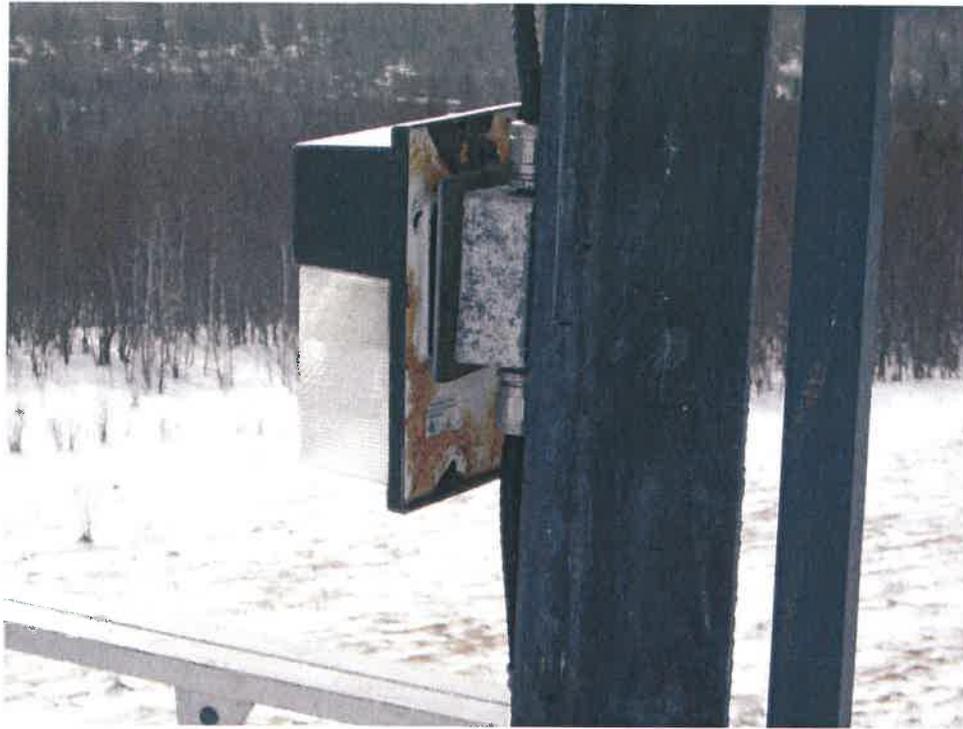
Photo #14: Access Lighting Level Two

The second level tower access light exhibits heavy corrosion on back mounting bracket. See Appendix A, Photo #14.

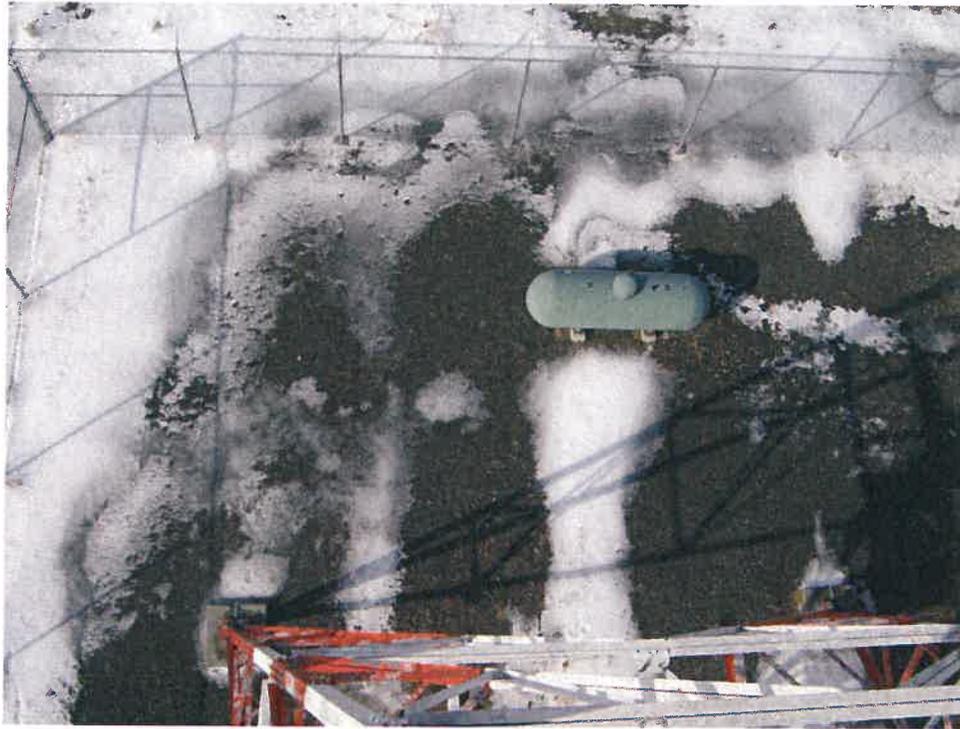
- The propane tank is un-protected from falling ice. See Appendix A, Photo #16.
- The winch and winch mounting bolts exhibits moderate surface corrosion. See Appendix A, Photo #25.

Photo #16: Un-Protected Propane Tanks

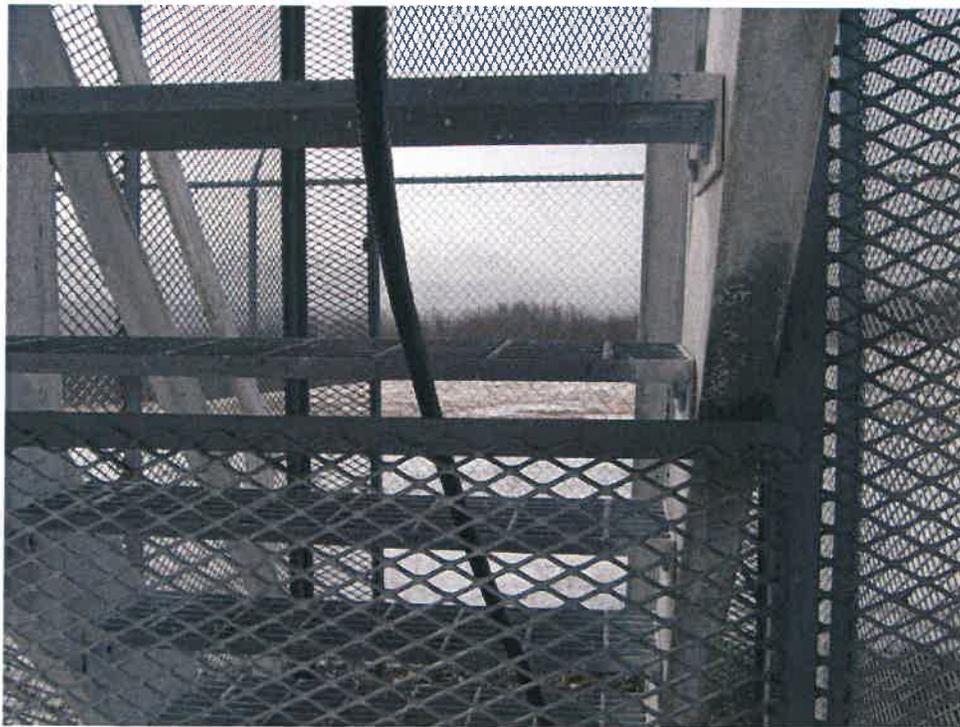
Photo #17: Loose Teck Cable

17	Install grounding from fence gates to fence posts.	C
18	Replace stainless steel bolts at 50 feet with galvanized A325 structural bolts of proper size and dimensions.	C
19	Wire brush and repaint winch and winch supports.	C
20	Install additional clips on teck cable on lower level stairs.	C
21	Remove disconnected steel on face 1-2 at 55 feet.	C

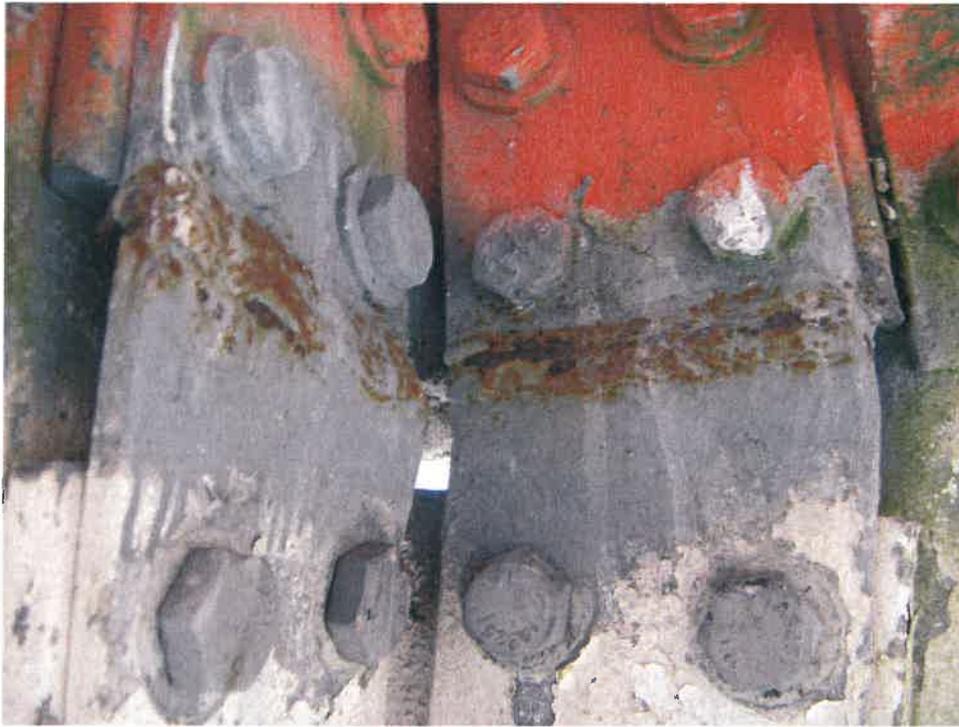
The welds on the plates connecting the tower to the building exhibits moderate surface corrosion. See Appendix A, Photo #18.

Photo #18: Surface Corrosion Typical 4 Locations

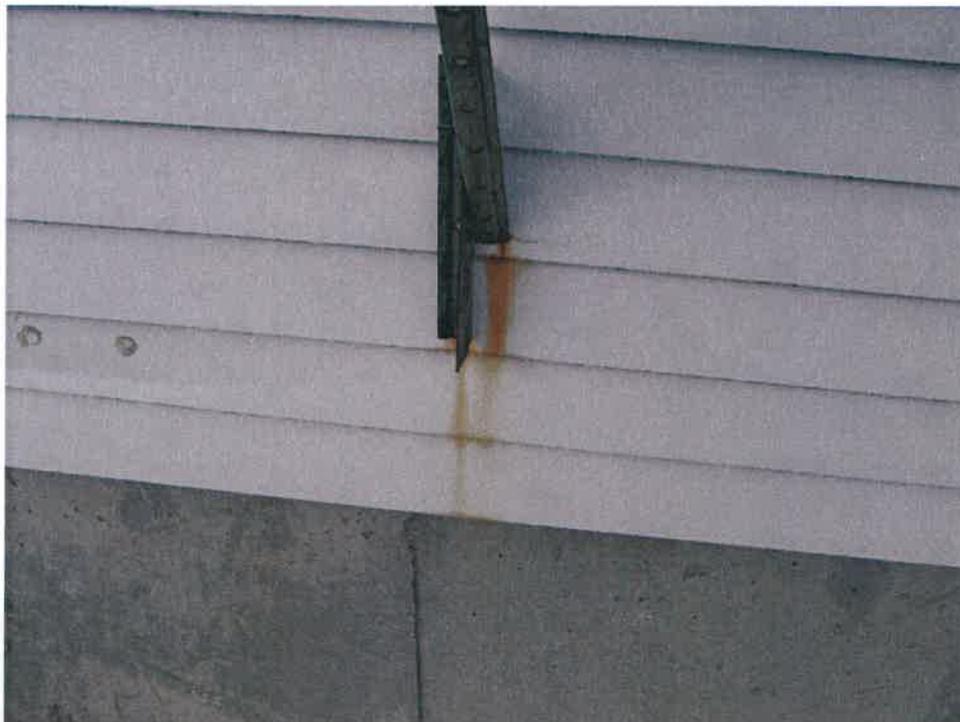
Photo #19: Air Conditioning Control Box Supports

The air conditioning control box support exhibits moderate surface corrosion. See Appendix A, Photo #19.

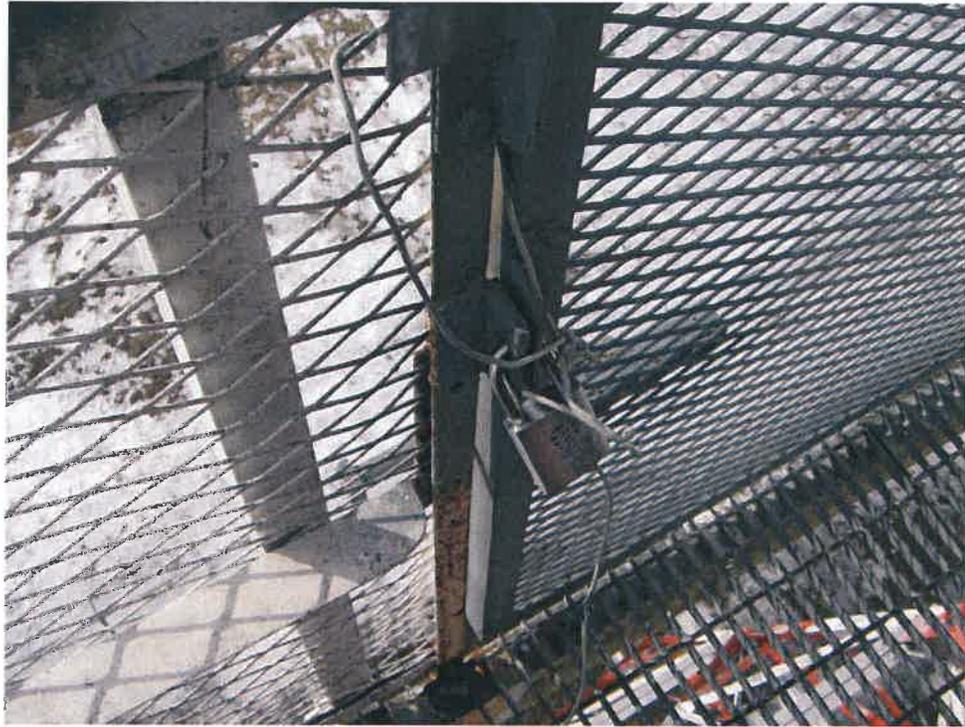
The safety rail exhibits minor to moderate surface corrosion at the top level and at various welds throughout the tower. See Appendix A, Photos #20 and #23.

Photo #20: Corroded Rail Connection

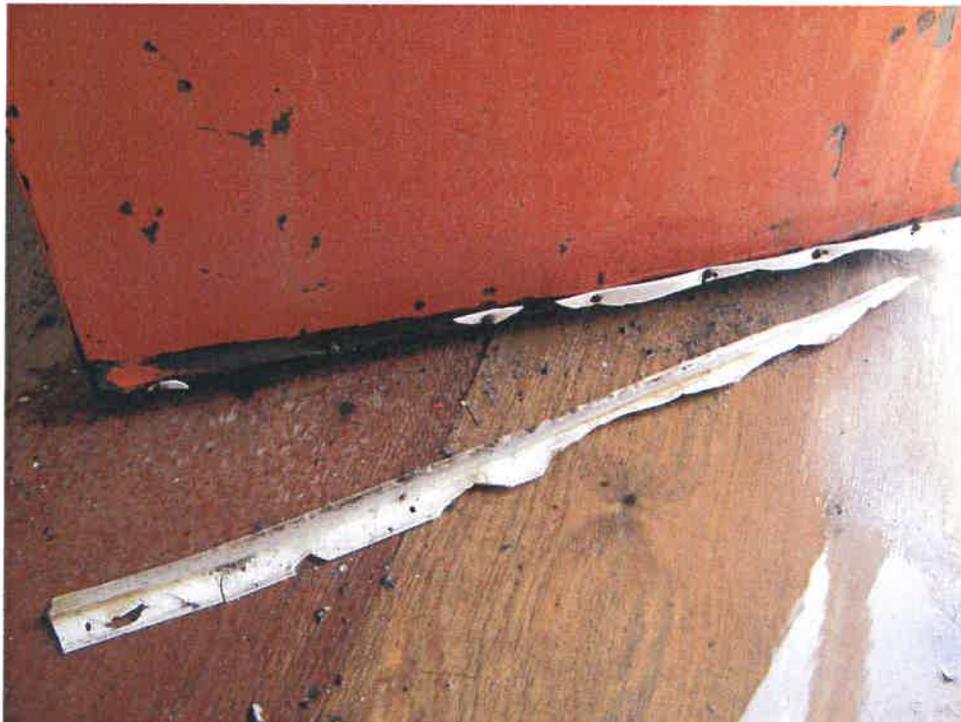
The sweep at the bottom of the door is broken. See Appendix A, Photo #21.

Photo #21: Damaged Door Sweep

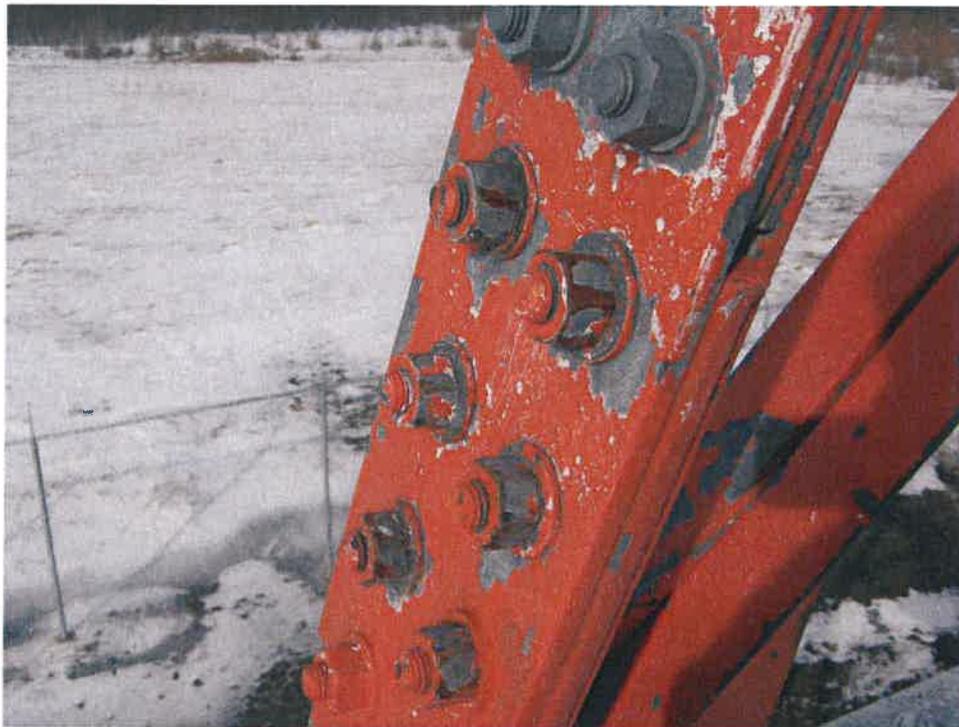
Bolts throughout the tower exhibit minor surface corrosion. See Appendix A, Photo #22.

Photo #22: Surface Corrosion on Bolts Typical

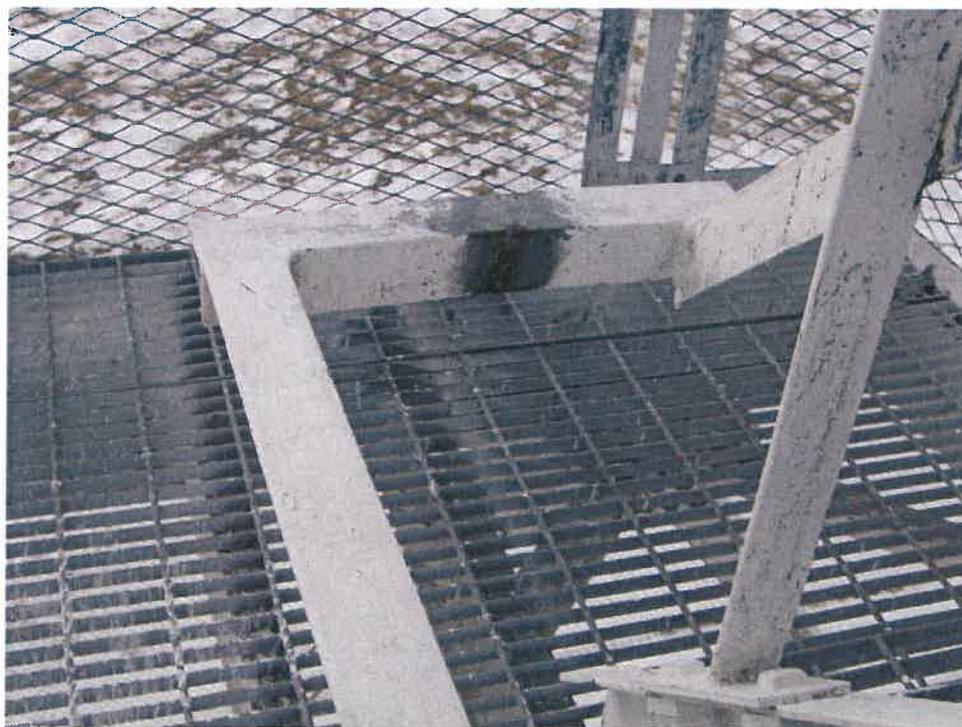
Photo #23: Surface Corrosion on Hand Rail

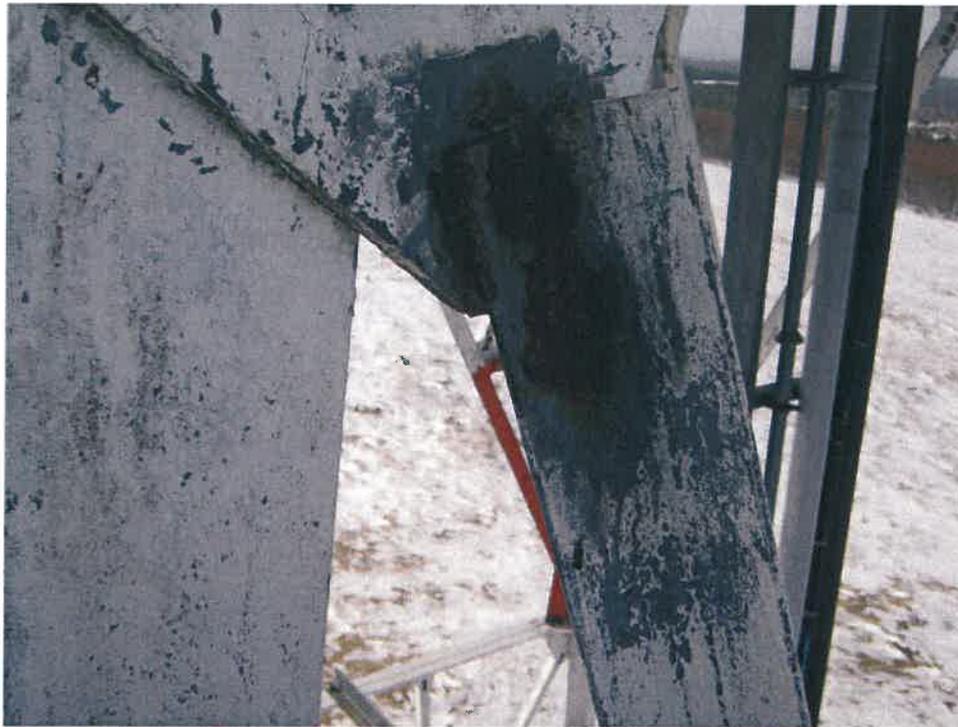
The diagonal welded to the leg plate on leg 4 at 60 feet exhibits moderate surface corrosion. See Appendix A, Photo #24.

Photo #24: Surface Corrosion on Welded Diagonal

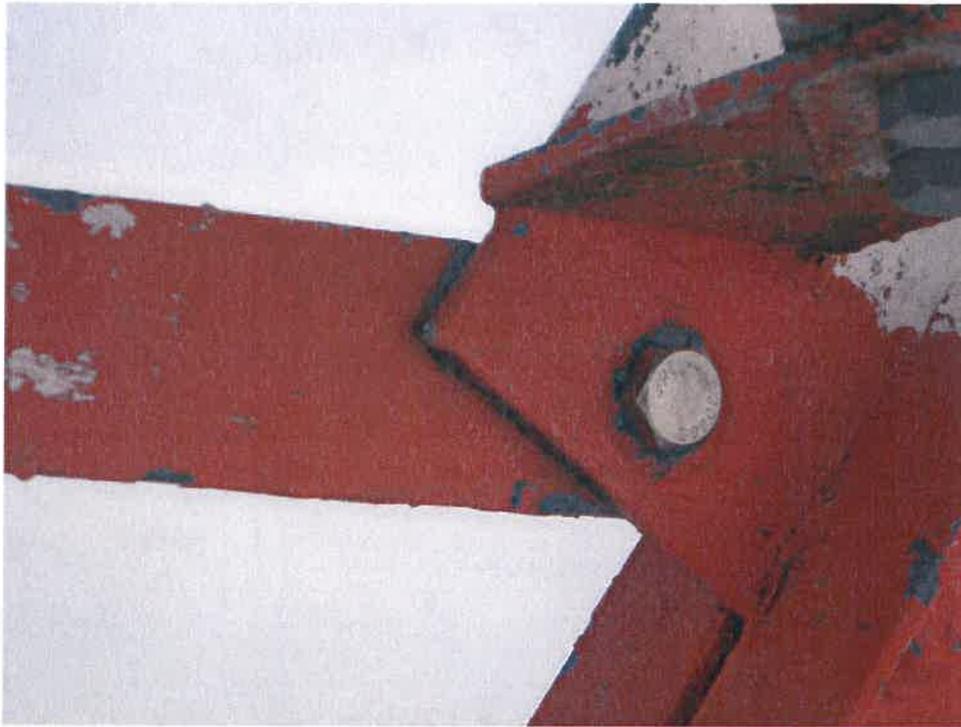
B. Connections: The splice connections appear satisfactory. The sub-horizontals at 50 feet off leg three have stainless steel bolts installed with galvanized nuts. See Appendix A, Photo #26.

Photo #26: Stainless Bolt Used 2 Locations

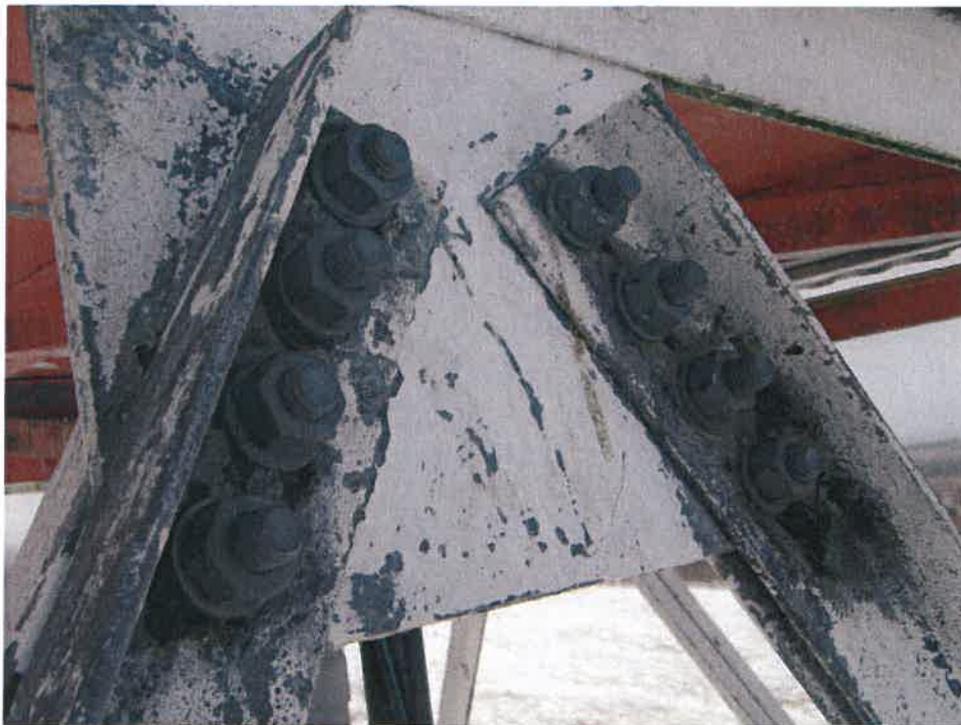
The connection plate for the diagonals to the horizontal on face 4-1 at top level had the holes burned through. This area exhibits moderate surface

corrosion. See Appendix A, Photo #27.

Photo #27: Burned Holes in Diagonals

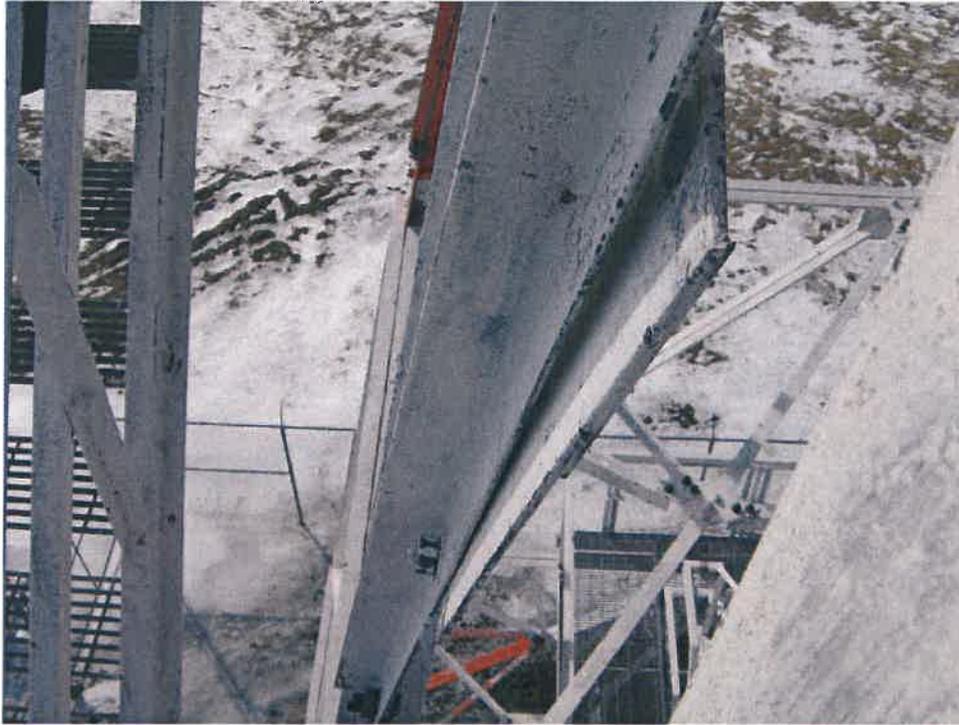
Sub-horizontal disconnected on one side at 55 feet on face 1-2. See Appendix A, Photo #28.

Photo #28: Disconnected Steel

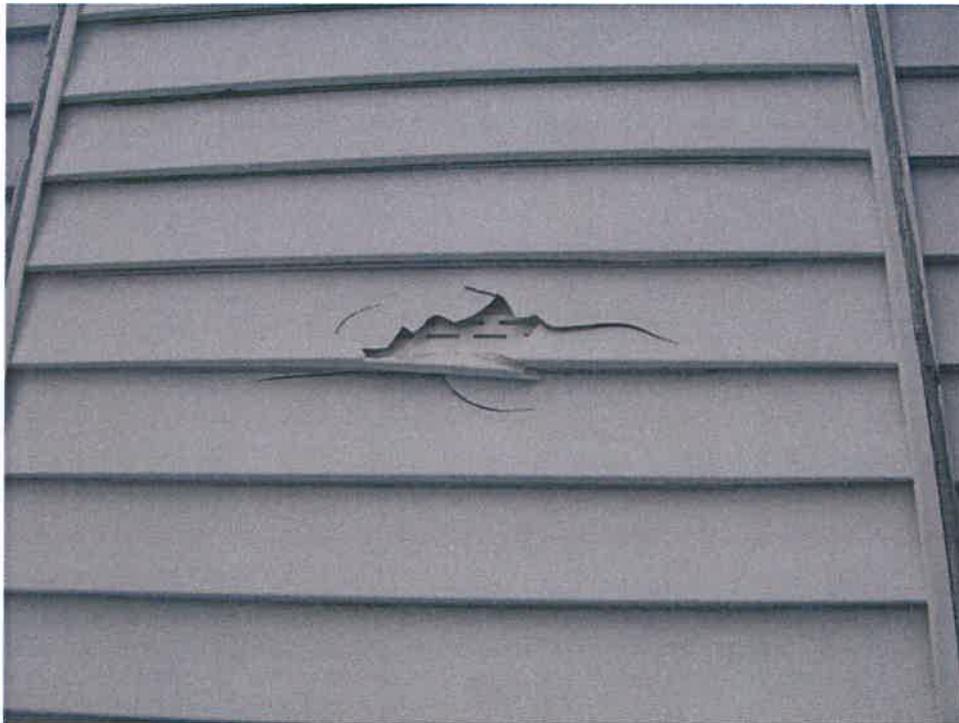
There is a damaged piece of siding on the East side of the building. See Appendix A, Photo #29.

Photo #29: Damaged Siding
