# ENVIRONMENT CANADA MAINTENANCE INSPECTION

## 27m (88.6 ft) KNOCK-DOWN SELF-SUPPORT TOWER

XDR Dryden, Ontario

Issue Date:	Status:	Project #:	Issued By:	Checked By:	Approved By:
March 14, 2008	R0-Issued to Client	2008 - 15	JP/KM	JW	JW

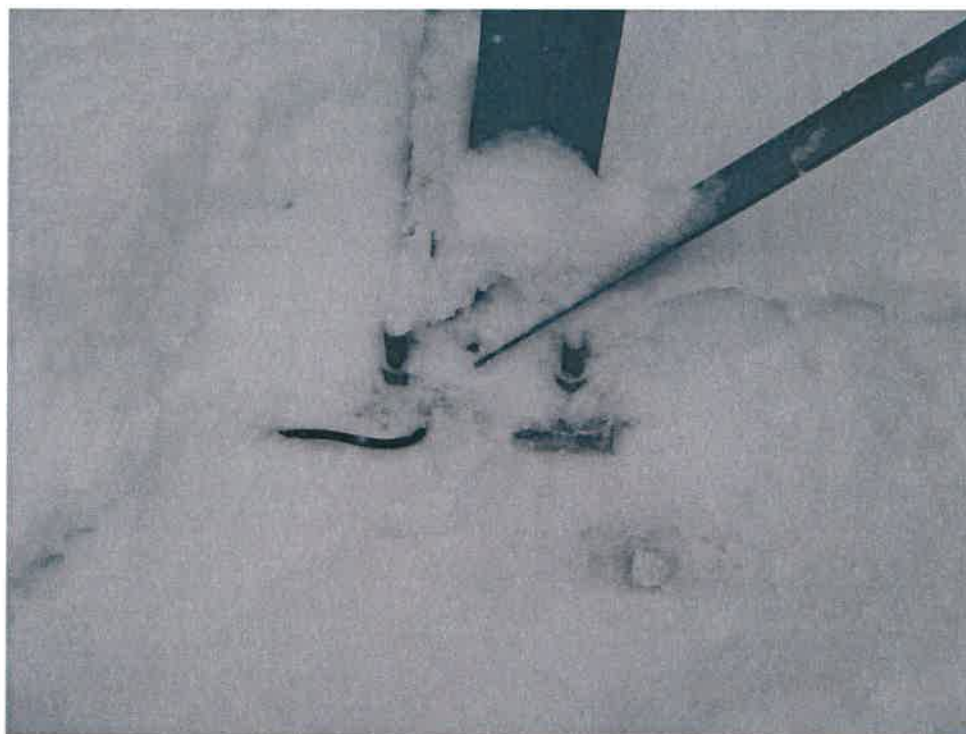
**Photo #2: Snow Covered Foundations**

- A. Tower Members:** Tower members appear satisfactory.
- B. Connections:** Tower connections appear satisfactory.
- C. Foundations:** The four foundations were snow covered at time of inspection. Visible portions appear satisfactory.

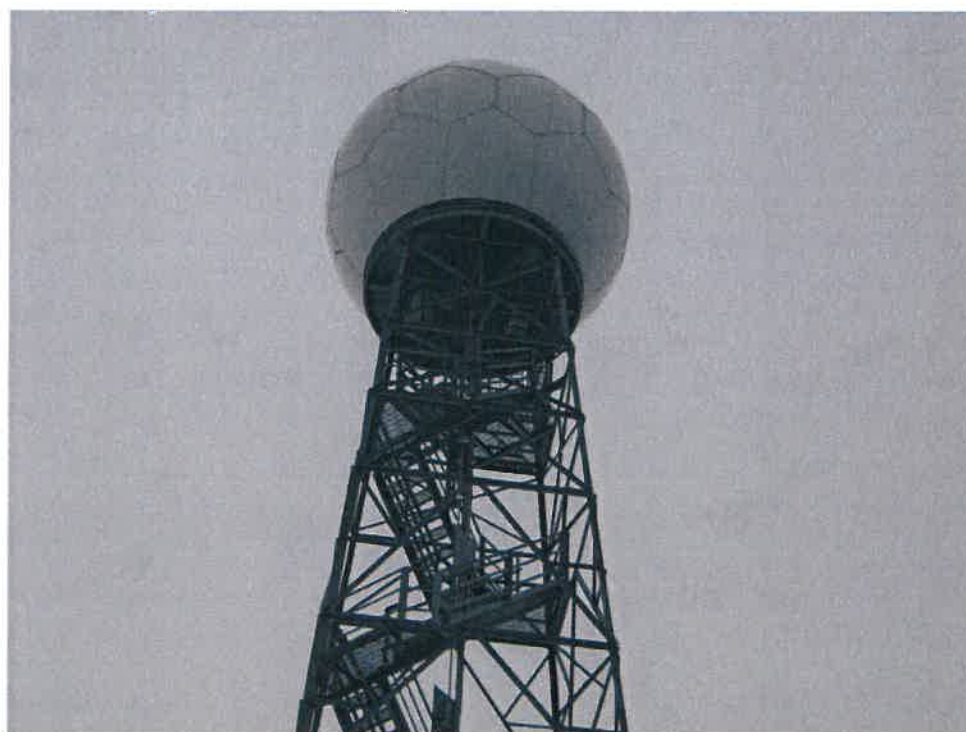
**Photo #3: Radome**

- A. Antennas:** The 5.5 meter radome appears satisfactory. See Appendix A, Photo #3.
- B. Transmission Line:** The existing hard line exhibits minor surface corrosion at 40 feet. See Appendix A, Photo #18.
- C. Antenna Building** This tower is not equipped with an antenna building.

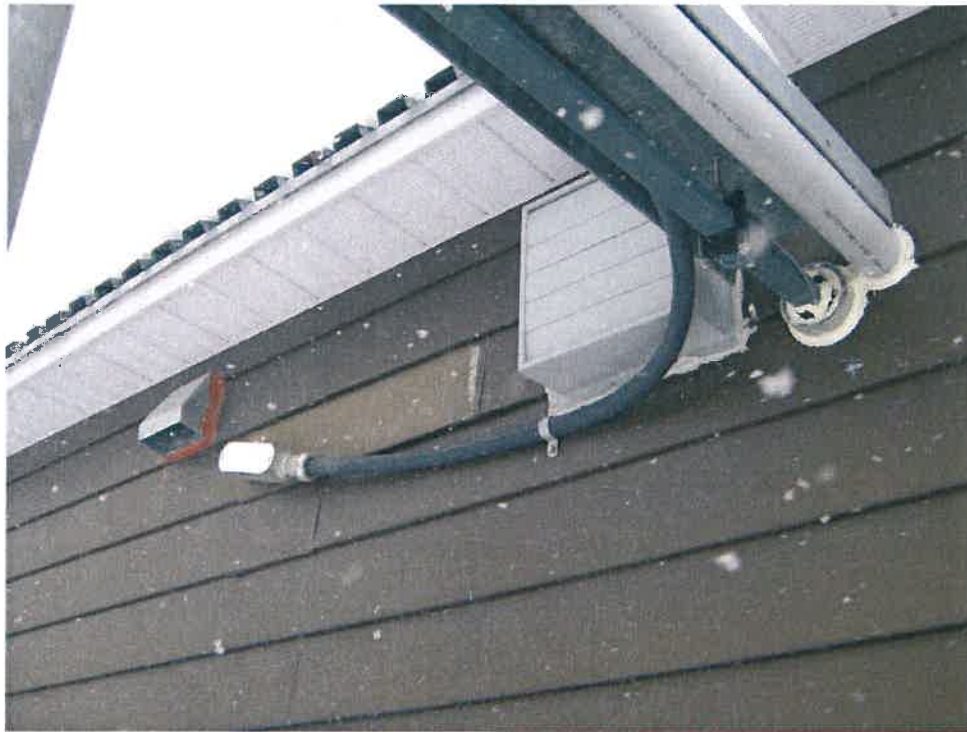
**Photo #4: Port Entry**

- A. Waveguide Bridge:** The waveguide bridge appears satisfactory. See Appendix A, Photo #6.
- B. Waveguide Port:** The waveguide port appears satisfactory. See Appendix A, Photo #4.

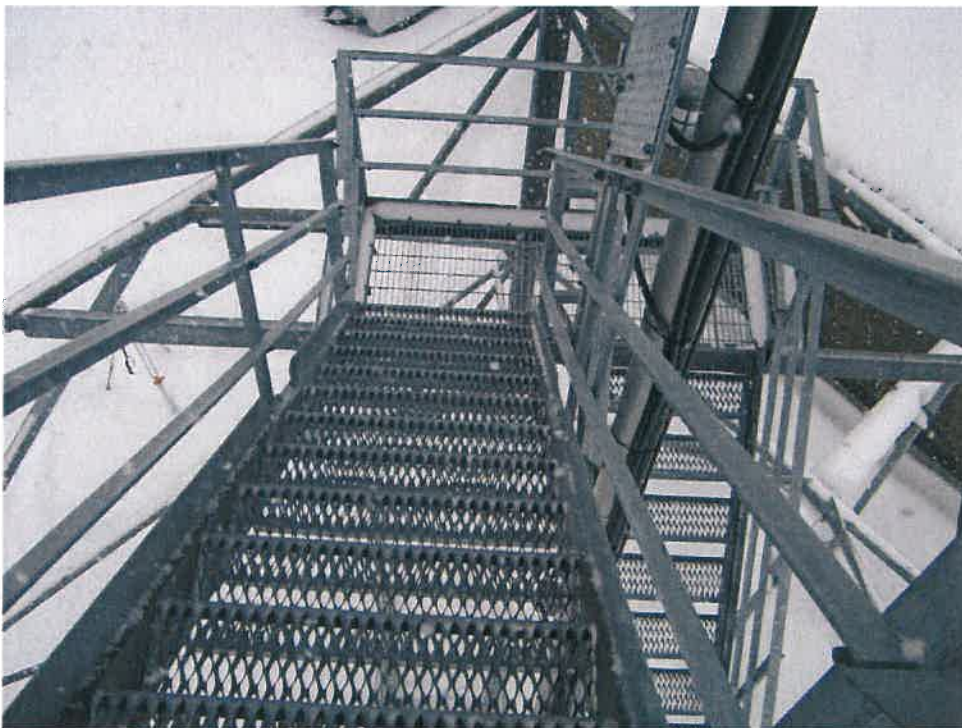
**Photo #5: Integral Stairs and Platforms**

- A. Stairs:** The top platform grating requires additional support. See Appendix A, Photo #20.
- B. Fall Arrest System:** The tower is not equipped with a fall arrest system. The stairs and platforms are equipped with a hand rail. See Appendix A, Photo #5.

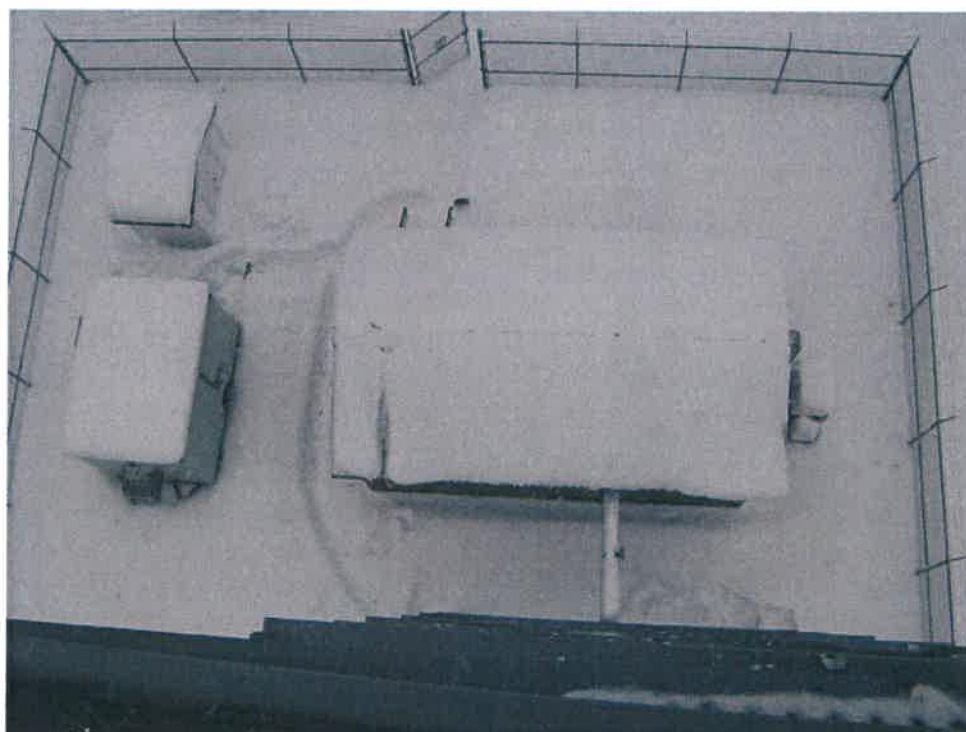
**Photo #7: Site Building**

- A. General:** The compound was snow covered but appeared clear of brush and debris. See Appendix A, Photo #7.
- B. Access:** The tower is located approximately 150 feet off the main road. Access lot was cleared of snow at time of inspection.
- C. Fencing:** The site fence appears satisfactory. See Appendix A, Photo #9.
- D. Security:** The compound fence has barbed wire installed and locked gates. There is a locked anti-climb at the base of the access stairs to the tower. The anti-climb was locked and appears satisfactory. See Appendix A, Photo #8.
- E. Due Diligence:** There is no warning signage installed on fence perimeter. Warning signs on building doors and anti-climb are satisfactory. See Appendix A, Photo #8.

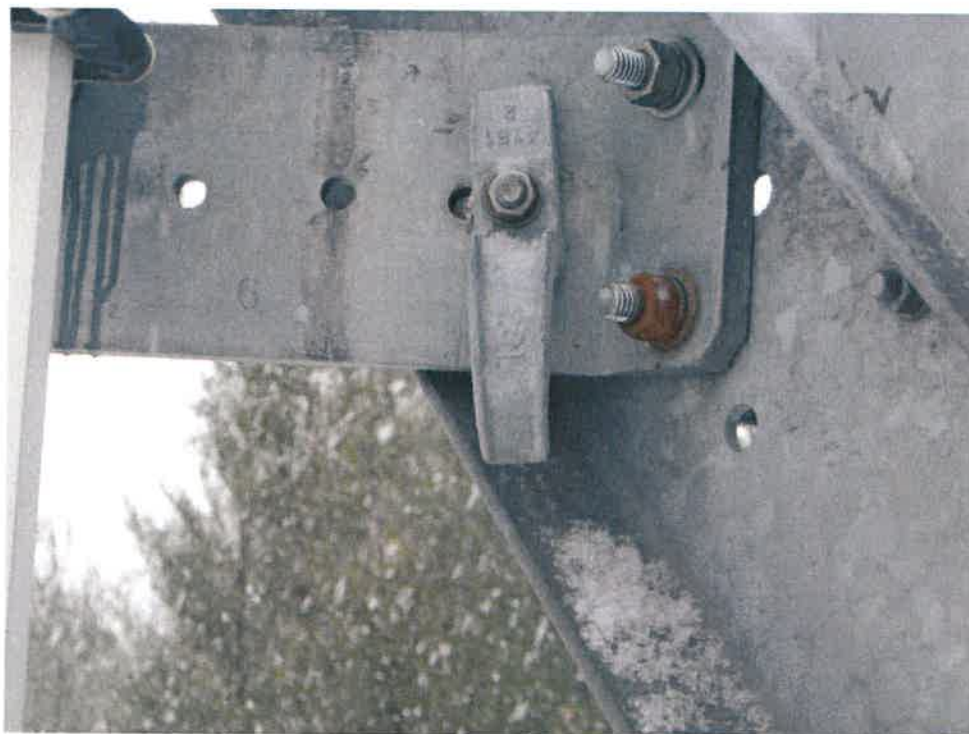
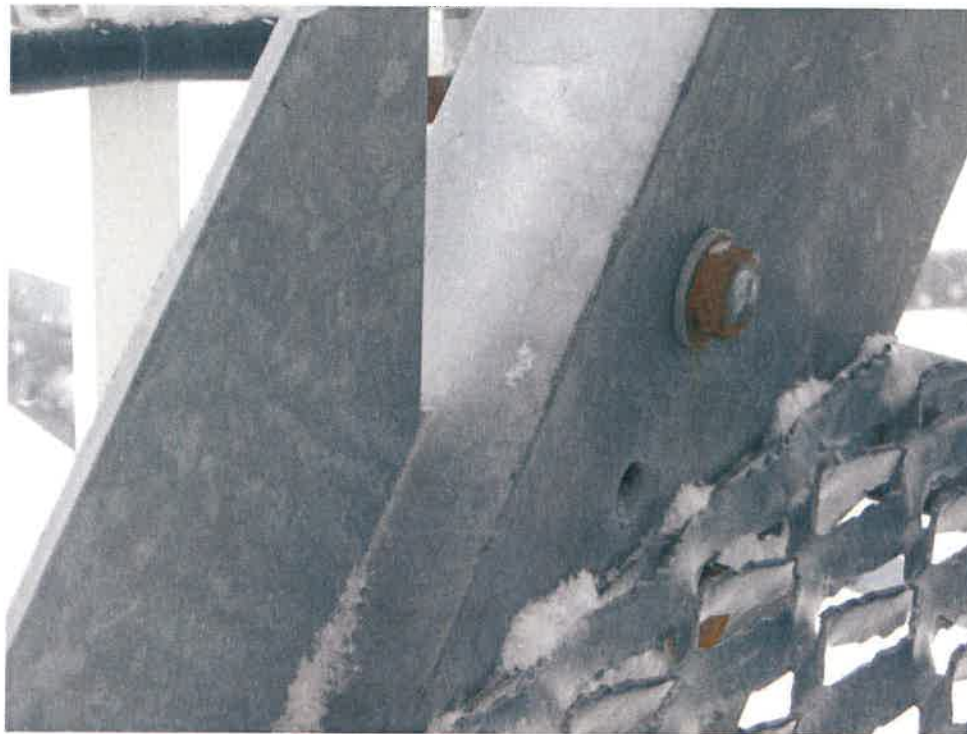
Various bolts in the stairs frame  
exhibits minor surface corrosion. See  
Appendix A, Photos #11 and #12.

**Photo #11: Corroded Nut**

**Photo #12: Corroded Bolt In Stairs**

Item	Description	Priority
1	Install site warning signage indicating falling ice and RF hazard on fence perimeter.	A
2	Install additional support for platform grating at top platform.	A
3	Install protection in front of propane tanks.	A
4	Install grounding to remaining two (2) waveguide posts.	B
5	Install additional heavy duty Ty-wraps on teck cable.	B
6	Clean corrosion on existing hard line at 40 feet.	C
7	Replace corroded bolts in tower access lighting fixtures.	C
8	Replace the two (2) corroded bolts in stair frame.	C
9	Replace corroded bolts in conduit protector on hand rail.	C

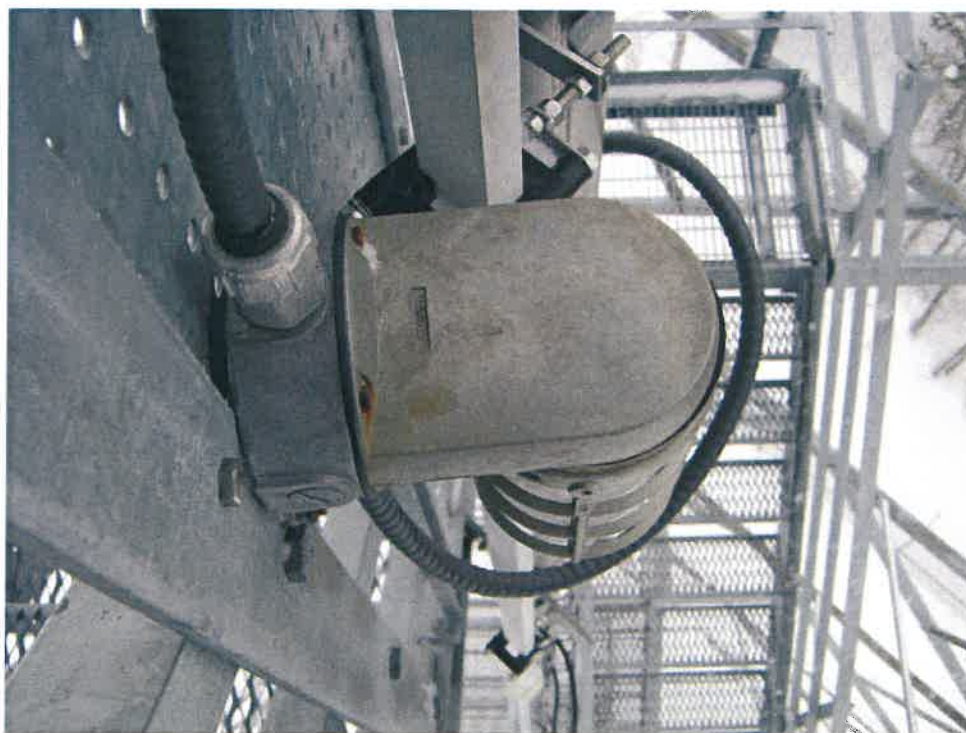
**Photo #15: Corroded Fixture Bolts**

The bolts in the tower access lighting  
fixtures exhibits minor surface  
corrosion.

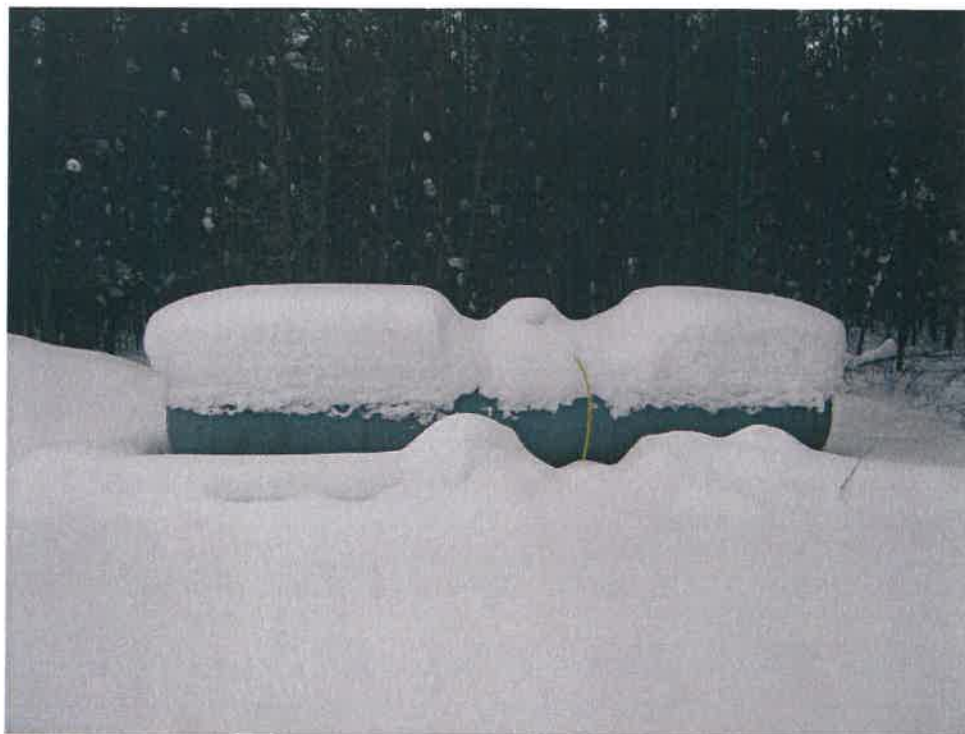
**Photo #16: Unprotected Propane Tanks**

- The propane tank has no protection from vehicles or snow clearing equipment. See Appendix A. Photo #16.

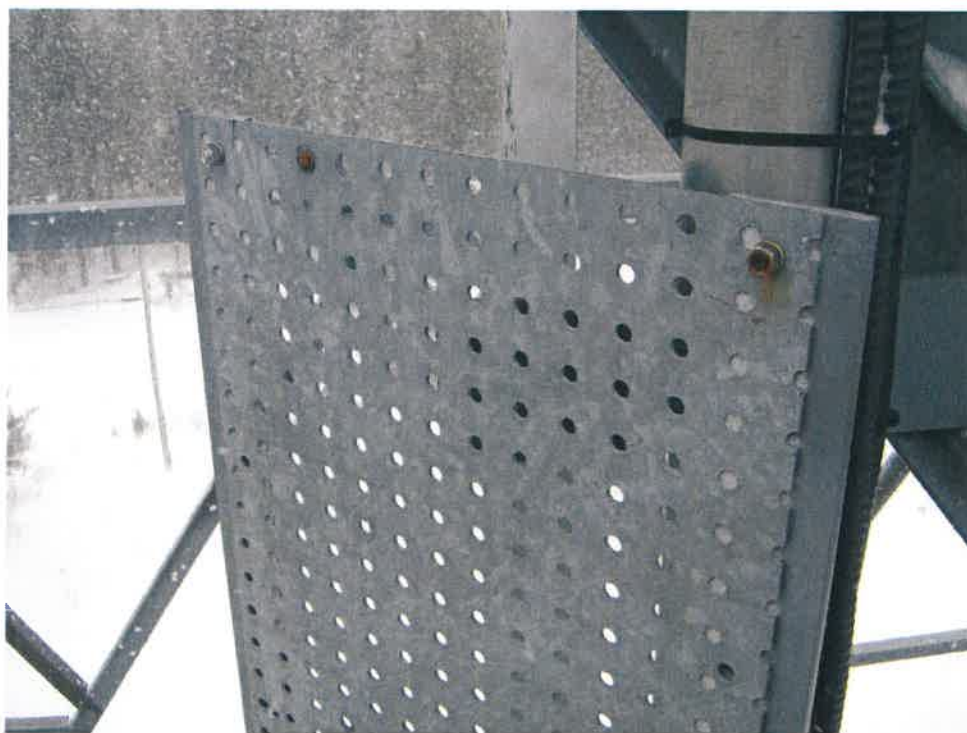
**Photo #17: Corroded Bolts**

Bolts in the conduit protector on the  
stair rail exhibits minor surface  
corrosion. See Appendix A. Photo #17.

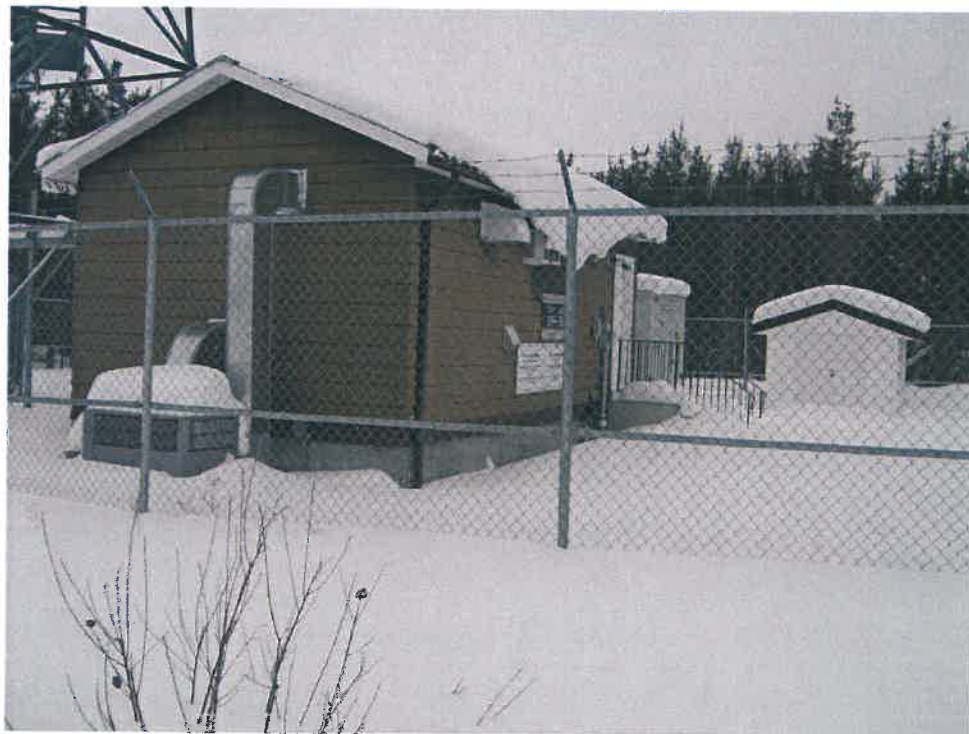
**Photo #19: Equipment Shelter**

The equipment shelters appeared  
satisfactory. See Appendix A, Photo  
#19.

- A. Condition:** The buildings on site appear satisfactory. See Appendix A. Photo #19.
- B. Electrical:** The buildings electrical components appear satisfactory.
