# Province House, Charlottetown PEI

## Masonry and Building Envelope Report (2013)

Presentation July 10, 2014

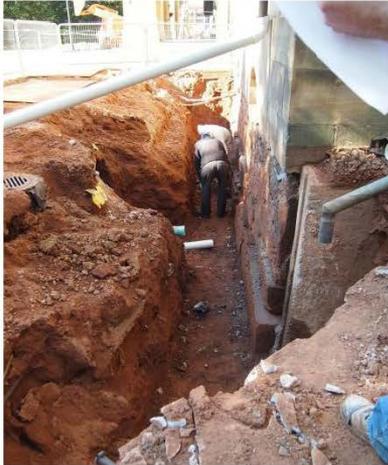
Figure 7.1.1

- ***VERY POOR***
- ***VERY UNSTABLE***

Deterioration ongoing and due to moisture entering through various sources:

- From below slab wicking up masonry walls
- From breeches in exterior wall
- Very poor surface drainage of roof and surface water away from the exterior wall
- Retained moisture between original sandstone foundation and new concrete bench wall along south elevation (full extent unknown)

- Underpin basement walls, pour new slab, drain, grout backfill, infill voids, new drainage courses, replace stone, deep point and point

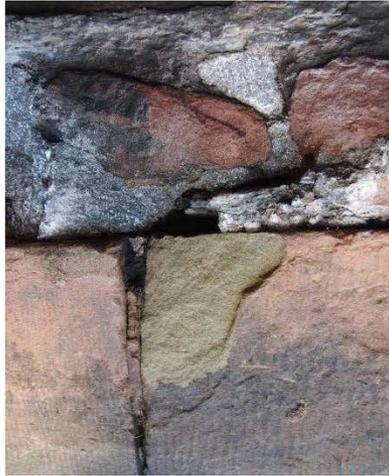
Figure 7.1. 16

- ***VERY POOR***
- ***VERY UNSTABLE***

Severe deterioration of masonry walls and heavy timber framing:

- Collapse is apparent in isolated walls and possible collapse in others
- Setting of walls related to portico piers
- Super-saturation of materials generates air-borne particulate and mould

- Abatement, remove meek/elect systems and redesign, fill gaps, rebuild walls, new stone, grouting, pointing, conservation of materials including historic finishes, conservation/reinforcement/rebuilding of timber structure

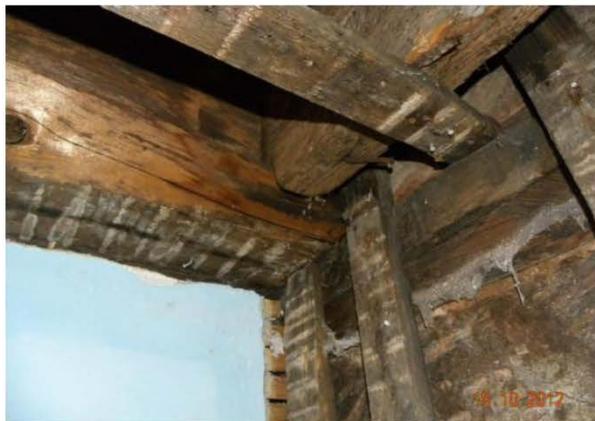
Figure 7.2. 1

- **VERY POOR**
- **VERY UNSTABLE**

Severe deterioration heavy timber framing when in contact with the exterior wall:

- Rot and dampness of bearing ends of heavy timber framing in Rm 214 where pocketed into wall
- These conditions can only be extrapolated across entire system until further investigations are completed
- Stone floor shows excessive wear and gaps have permitted wash and traffic supplied water to migrate into assembly below

- Removal of finishes, removal of flooring, removal of stone backup, conservation/reinforcement/rebuilding of timber structure

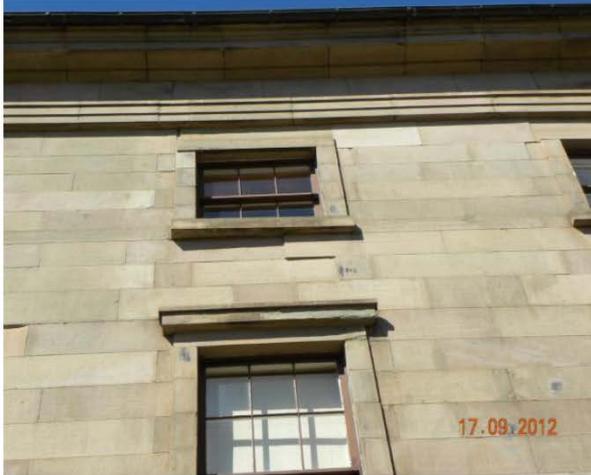
Figure 7.2. 39

- **VERY POOR**
- **VERY UNSTABLE**

Severe deterioration of the Pictou ashlar stone exterior wall face:

- Displaced, dislodged ashlar units throughout
- Wall planes bowed out (south elevation in several locations)
- Fractured and spalled stones and arises due to crushing
- Spalled stone face due to corrosion of metal cramp ties close to face
- Window jamb stones shifted, fractured and spalled
- Cornice blocks at top of the wall are displaced
- Saturated stone from failed gutters and roof drainage system
- Settlement of flat stone arch at main South entry
- Stone piers under stress
- Deteriorated pointing and voids of uncertain depth

- Complete exterior masonry restoration

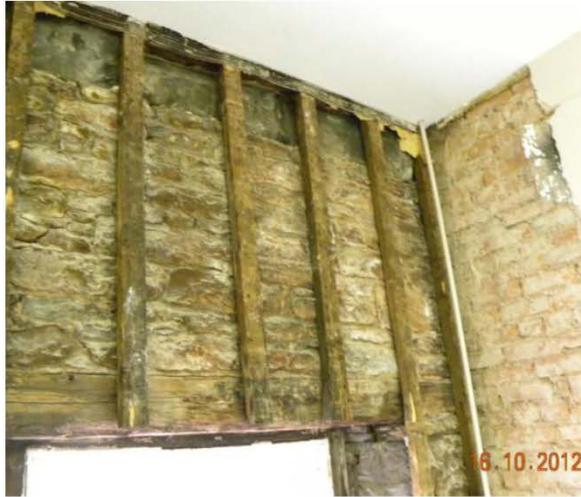
Figure 7.2. 123

- **VERY POOR**
- **VERY UNSTABLE**

Severe deterioration of the wall assembly found at 4 locations on 3rd floor:

- Original rubble wall assembly acted as a single solid mass in compression and tension
- Core of the wall assembly had become loose, free flowing sand and fines with grog interspersed
- Interior wythe of Island sand stone randomly coursed with sizes varying greatly
- Island stone units are deteriorated
- Free flowing water noted during 2012 site review and during PCA review in 2011
- Only bonding between Pictou facing and Island stone occurs at alternately coursed, full depth window jamb stones
- Bedding of exterior facing and interior wythe appears to be greatly reduced
- Rot of existing wood lintels at windows observed

- Complete exterior masonry restoration
