“Draft” Interim Report

**Cursory Structural Review of Province House
Charlottetown, PEI**

**Parks Canada
Historic Properties
1869 Upper Water Street
Halifax, NS
B3J 1S9**

**J.W. Cowie Engineering Limited
1046 Barrington Street, Suite#200
Halifax, Nova Scotia
B3H 2R1**

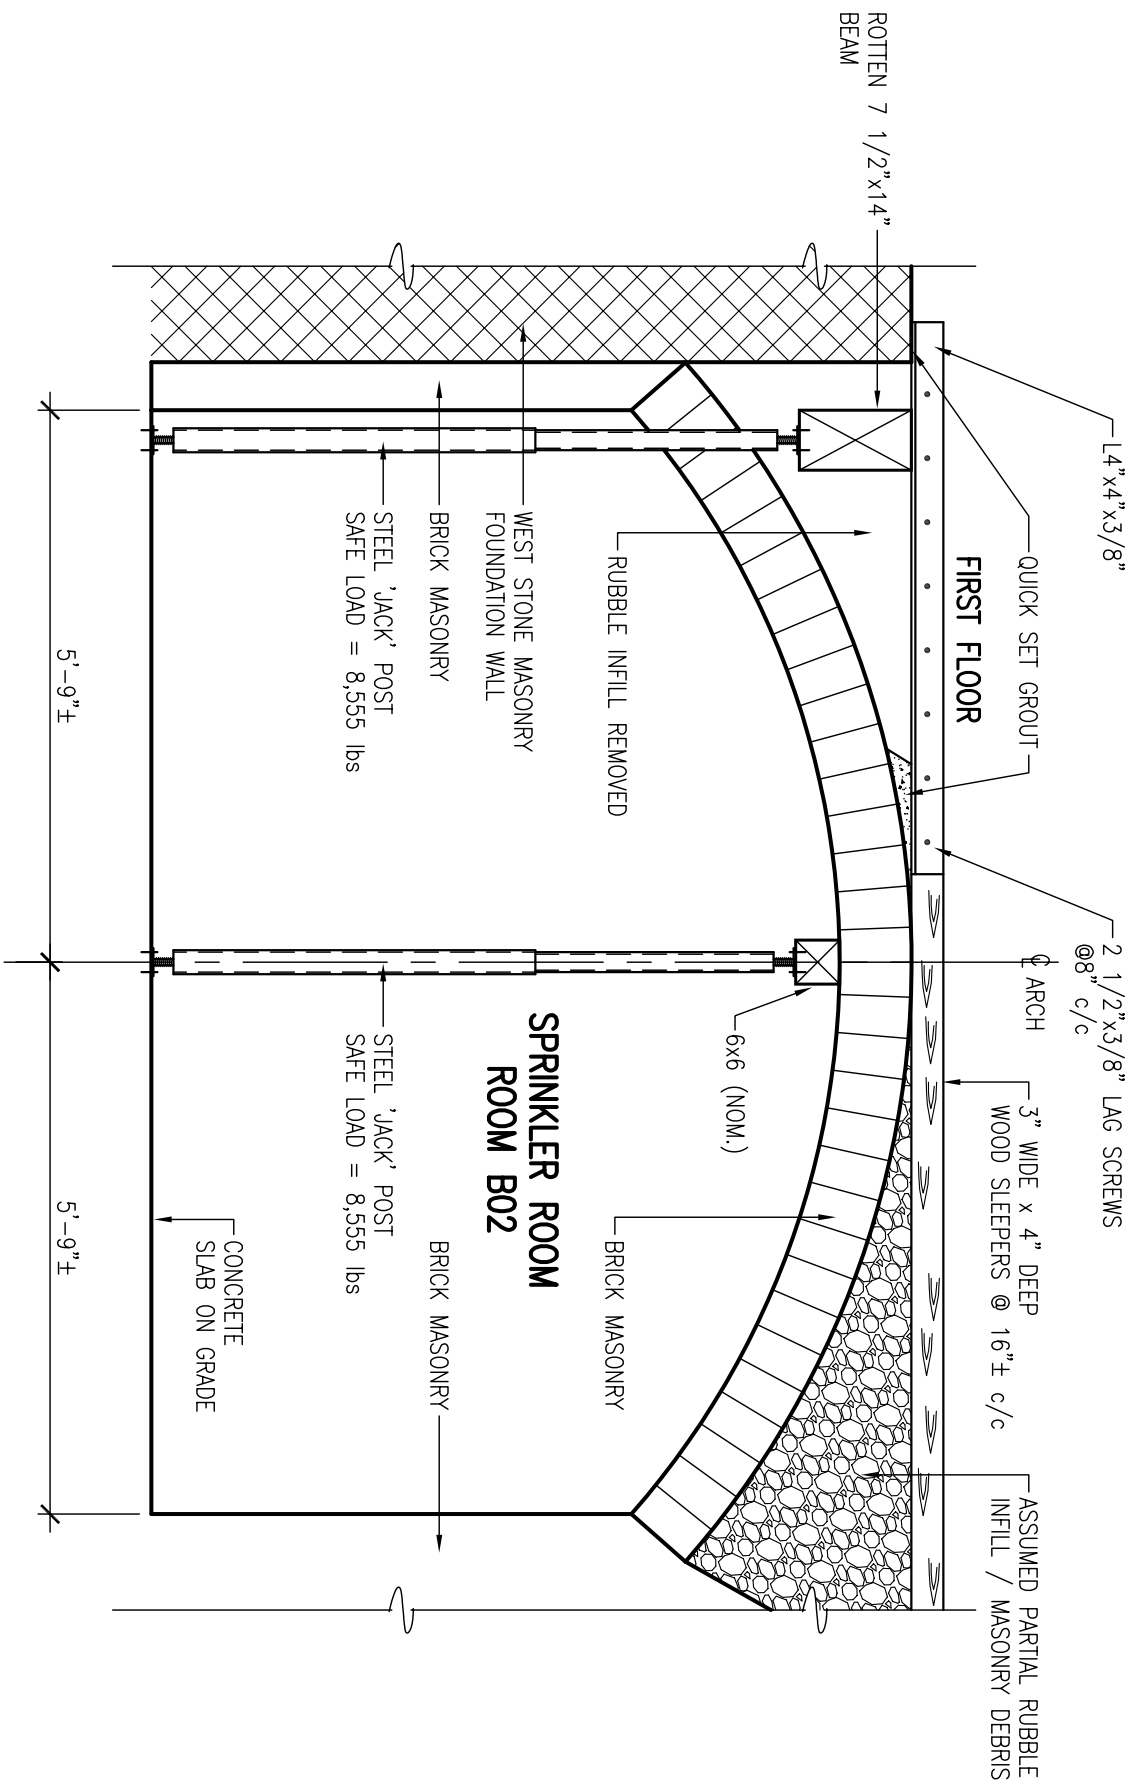
Figure 4
SECTION SHOWING STRENGTHENING OF TIMBER SLEEPERS AND SHORING OF ROTTEN TIMBER BEAM OF SPEAKER'S OFFICE FLOOR AND SHORING OF ARCH ROOF OF BRICK MASONRY VAULT BELOW (SPRINKLER ROOM)

A steel shore ("jack post") was placed under the deteriorated (rotten) 7 ½ in. x 14 in. North/South spanning timber beam. In addition, four of the East/West spanning "sleepers" were strengthened by anchorage of a 4 in. x 4 in. x 3/8 in. steel angle to the 4 in. vertical face of each "sleeper". At the East end of each angle, the horizontal leg bears on top of the brick masonry arch of the vault while at the West end, the horizontal leg of each angle bears on top of the sandstone exterior masonry wall. (Refer to Figure 3 "Plan – Temporary Structural Support of Speaker's Office Floor", Appendix "A", Volume I and Photographs RS-25 to RS-28, Appendix "B", Volume II).

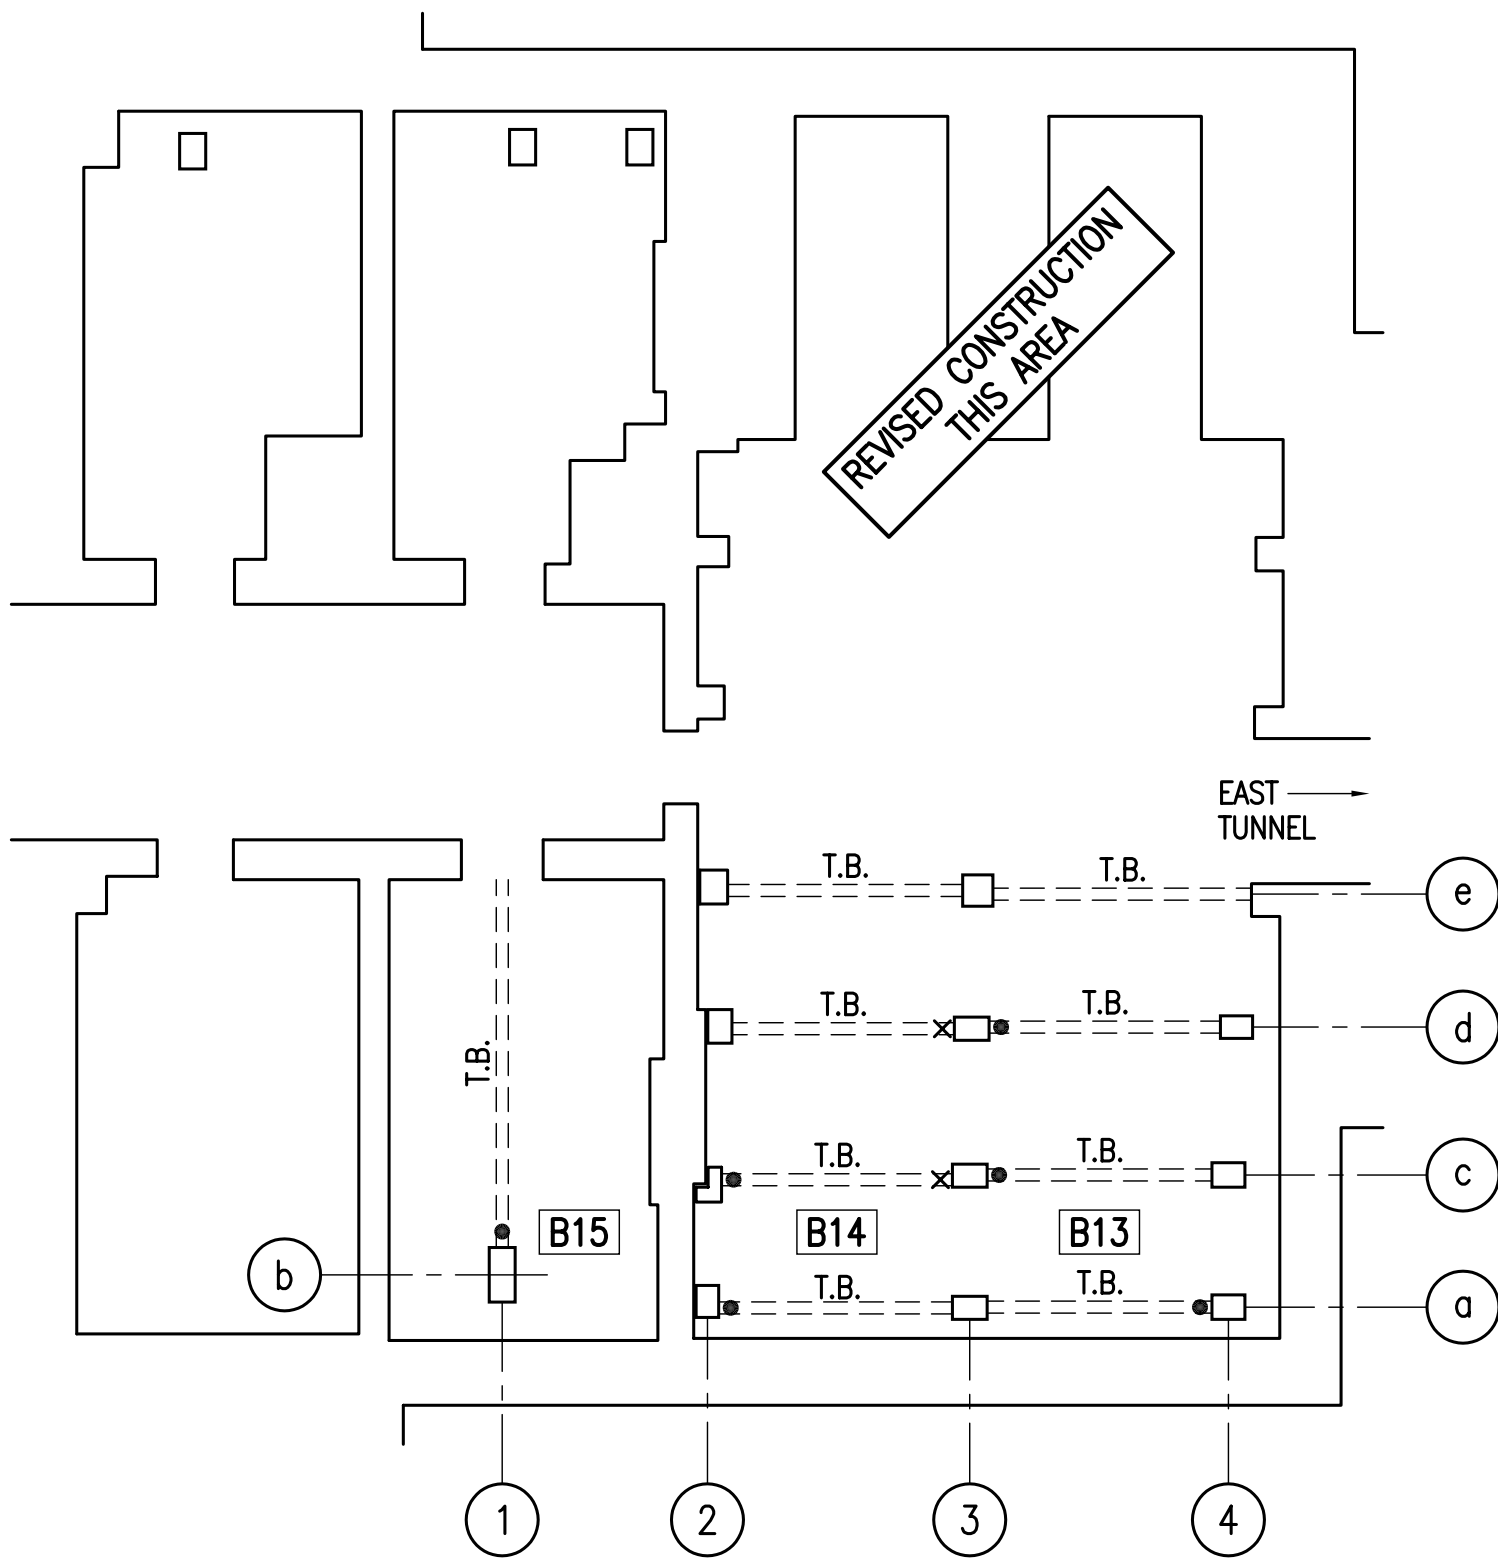
Figure 6
SOUTHEAST BASEMENT AREA
ROOMS B13, B14 & B15

The brick masonry Column 2c is located North of the brick masonry Column 2a found at the Southwest corner of the Basement Room B14. (Refer to Figure 6 "South Basement Area, Rooms; B13, B14 and B15", Appendix "A", Volume I. Also refer to Photographs; BSE-12 to BSE-15, Appendix "B", Volume II).

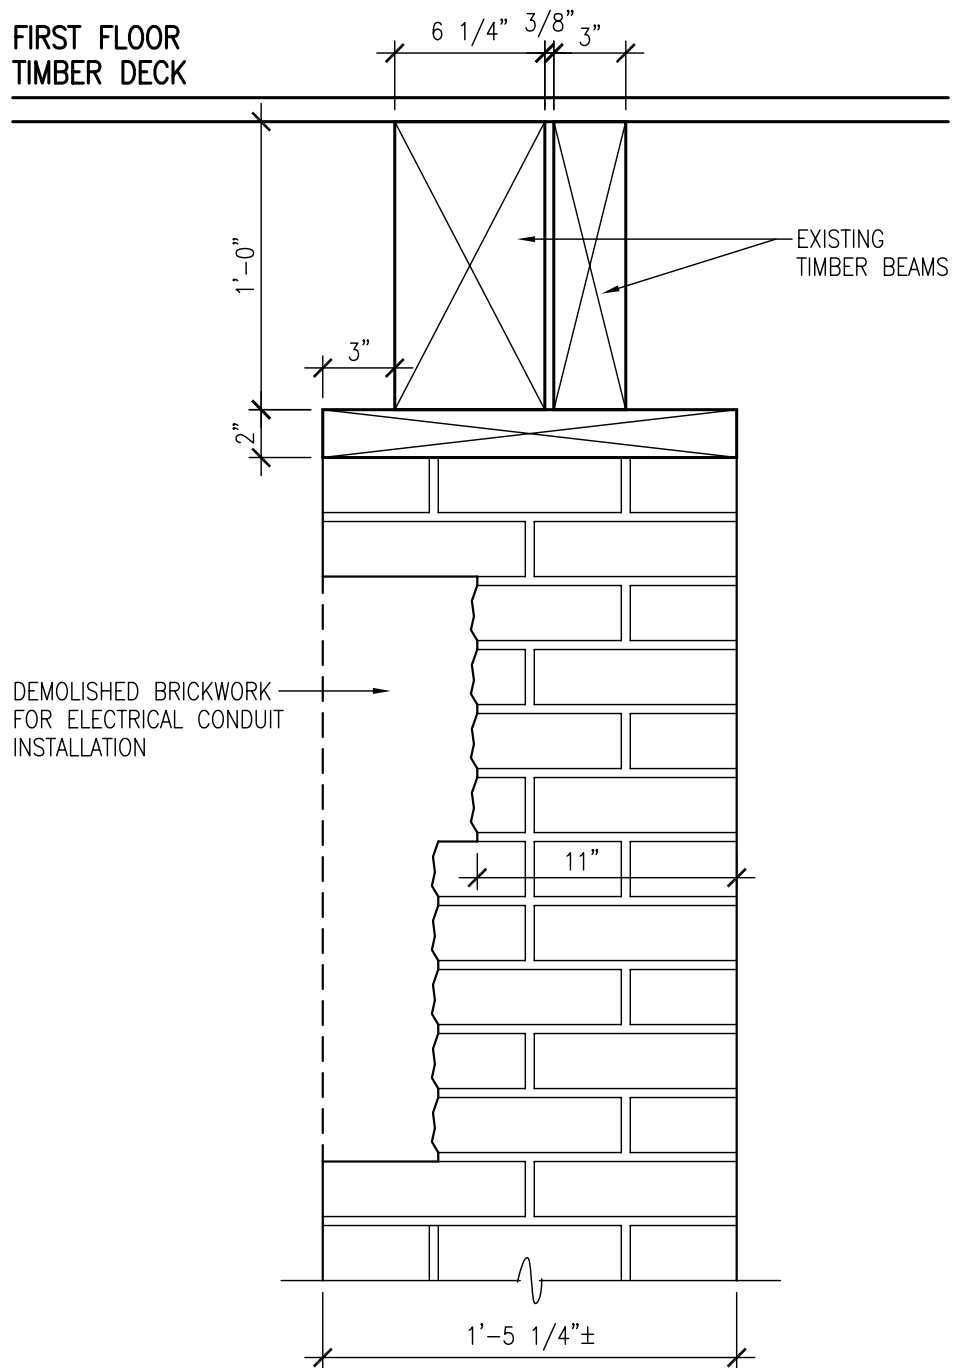
Figure 7
EAST ELEVATION
DAMAGED BRICK MASONRY COLUMN 2a,
SOUTHWEST CORNER OF BASEMENT ROOM B14

The South upper portion of the column has been demolished to enable the installation of electrical conduit. (Refer to Photographs; BSE-10, BSE-11, Appendix “B”, Volume II and Figure SK-7 “East Elevation of Damaged Brick Masonry Column 2a, Southwest Corner of Basement Room B14”, Appendix “A”, Volume I). Approximately 40% of the plan bearing area of the column has been demolished.

It is recommended the electrical conduit be relocated and the brick masonry construction be restored.

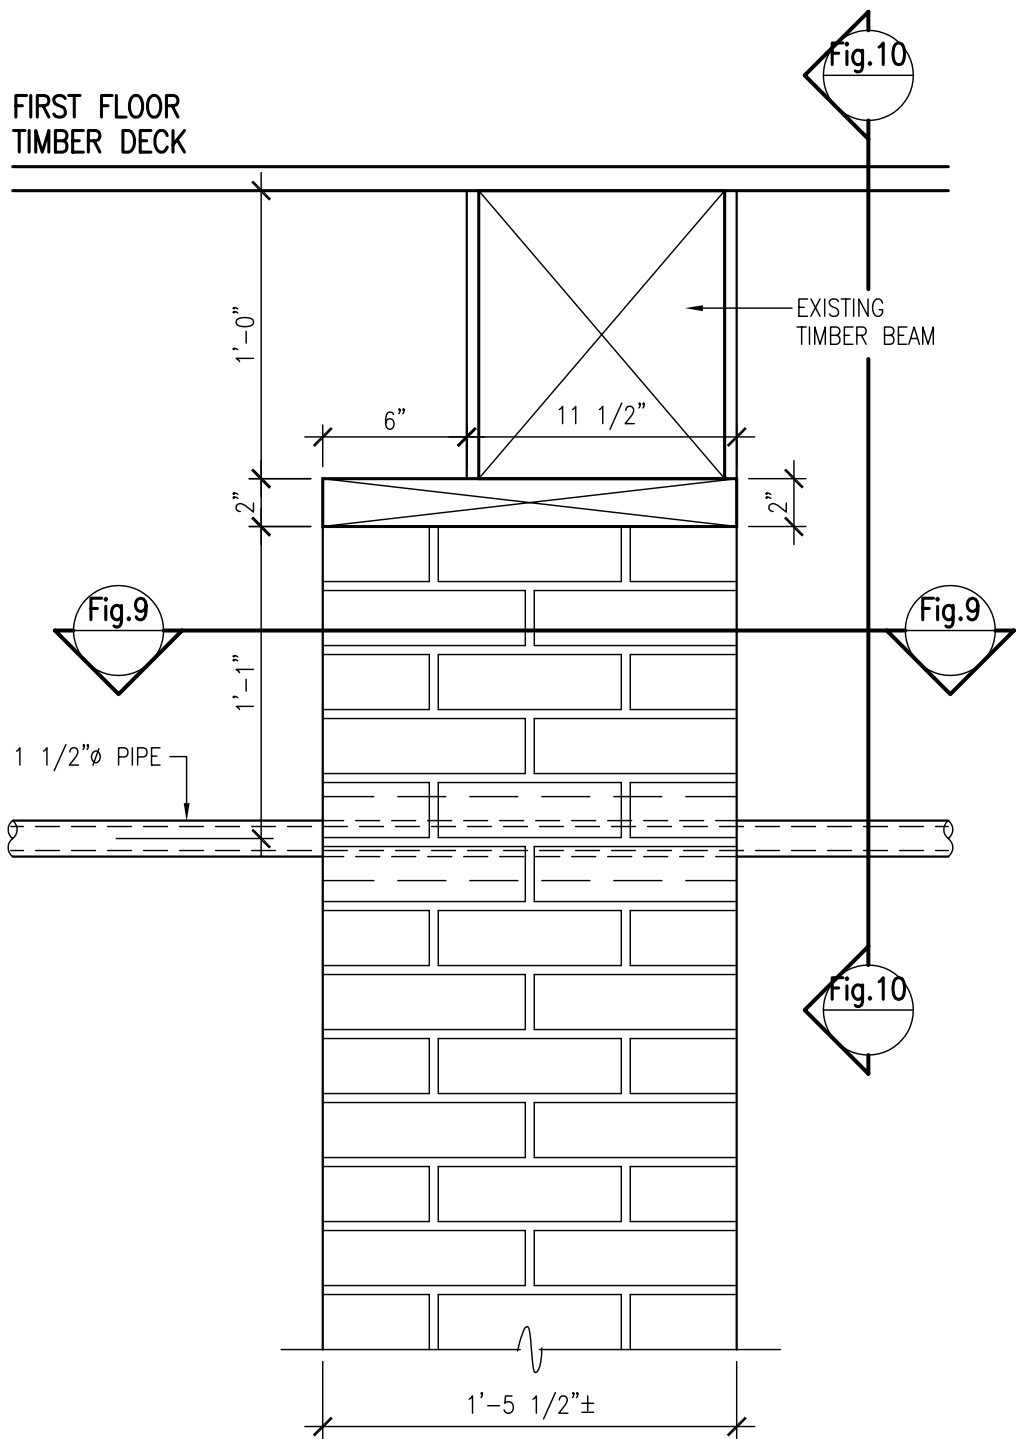
Figure 8
EAST ELEVATION
BRICK MASONRY COLUMN 2c,
BASEMENT ROOM B14

Recognizing the eccentric loading on the column and the damage to the column, a decision was made to install a steel shore ("jack post") to support the West end of the timber beam.

Further investigation is required to determine the reaction loads on the beam, the condition of the timber beam and the quality of the brickwork. The column could be restored by removal of the brickwork, disconnecting the pipe, installing a pipe sleeve around the pipe at the column location and rebuilding the brick masonry column. The bearing condition for the beam should be improved.

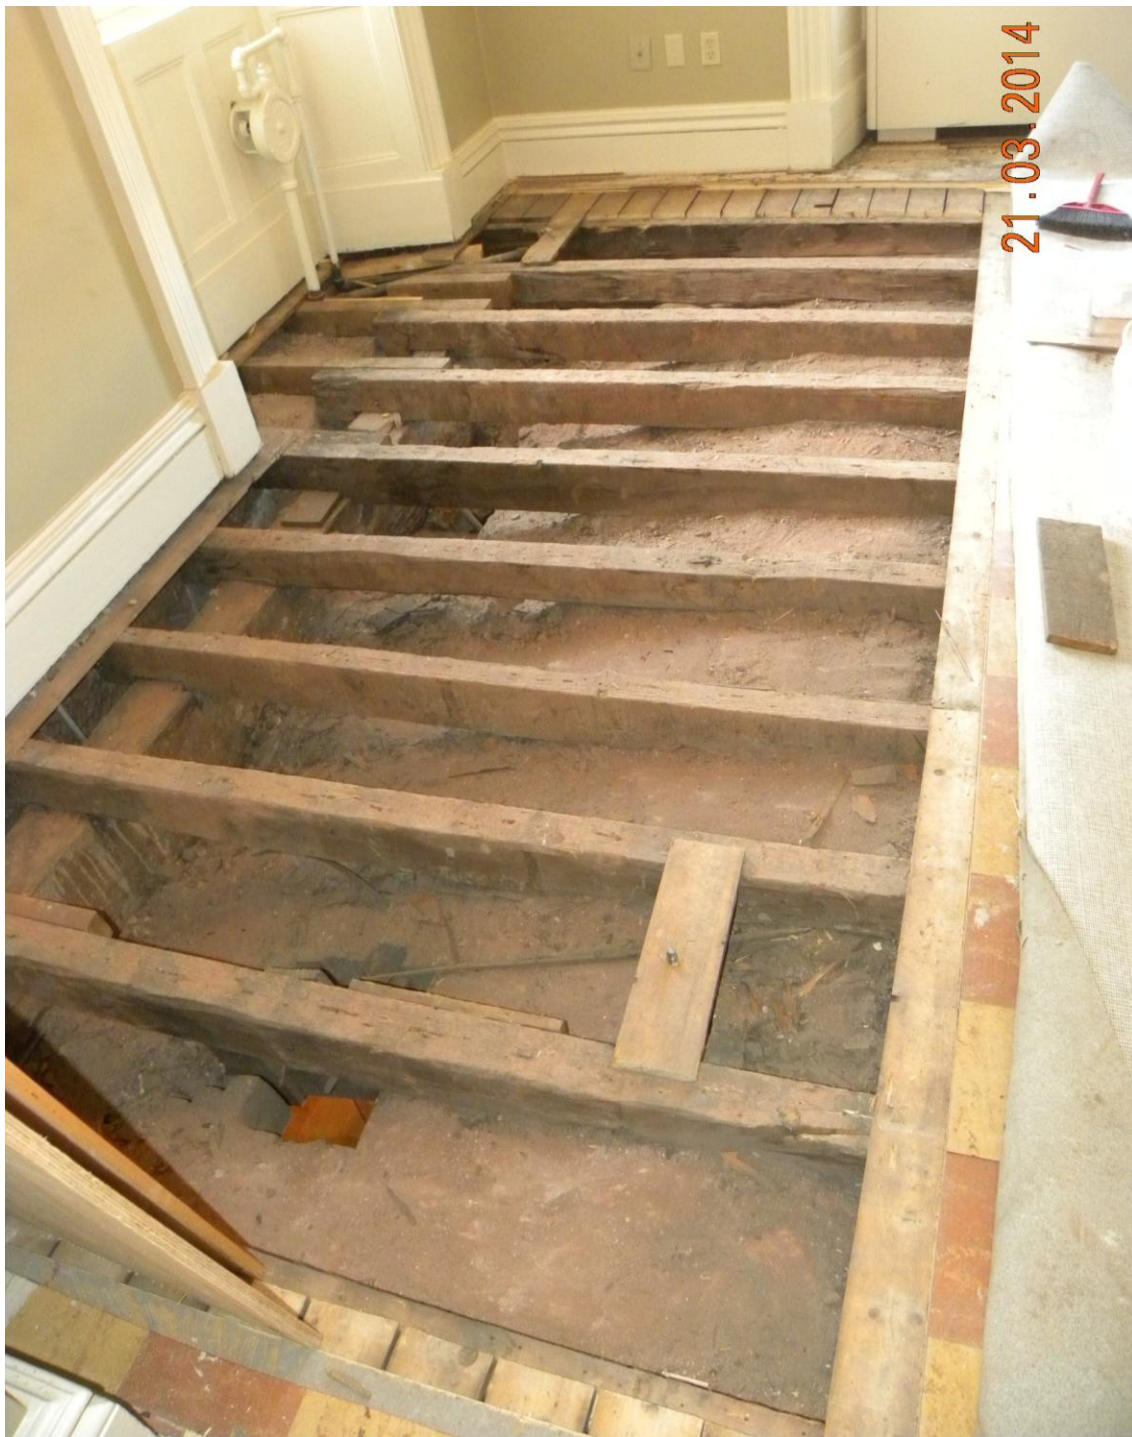
PHOTOGRAPH SR-2:

The debris (clay bricks, sections of stone and sand) was removed from the top of the brick masonry vault revealing numerous puncture holes within the West side of the roof of the clay brick masonry vault. Viewing Northwest. The size and locations of the holes within the masonry arch can be found in Figure 5 "Plan – Location of Puncture Holes in Brick Masonry Arch Supporting the Speaker's Office Floor", Appendix "A", Volume I.

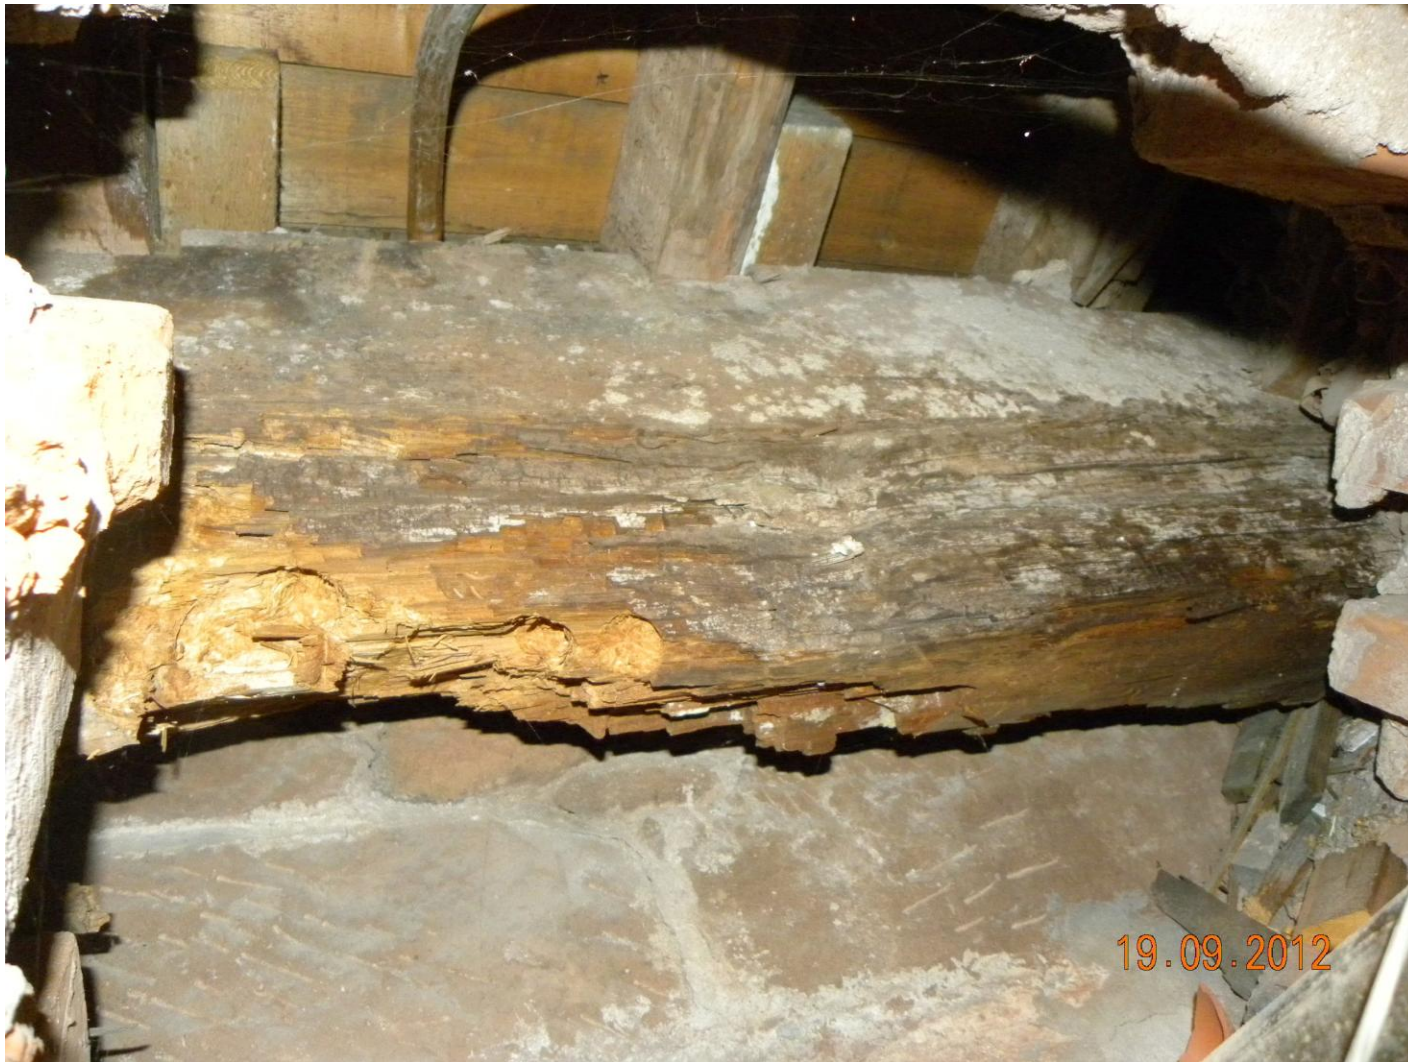
PHOTOGRAPH SR-15:

Approximately 50% of the depth of the timber beam **has** deteriorated from wood rot. (Refer to Photographs; RS-14 and RS-15, Appendix "B", Volume II). There however was no evidence of deterioration to the original timber "sleepers" nor any evidence of deterioration to the wood deck installed during the 1980's.

View of the deteriorated condition of the 7 ½ in. wide x 14 in. timber beam. The wood rot extends approximately 50% of the depth of the beam.

The existing rotten timber beam will have to be removed and replaced with a new pressure treated beam or new masonry wall construction.

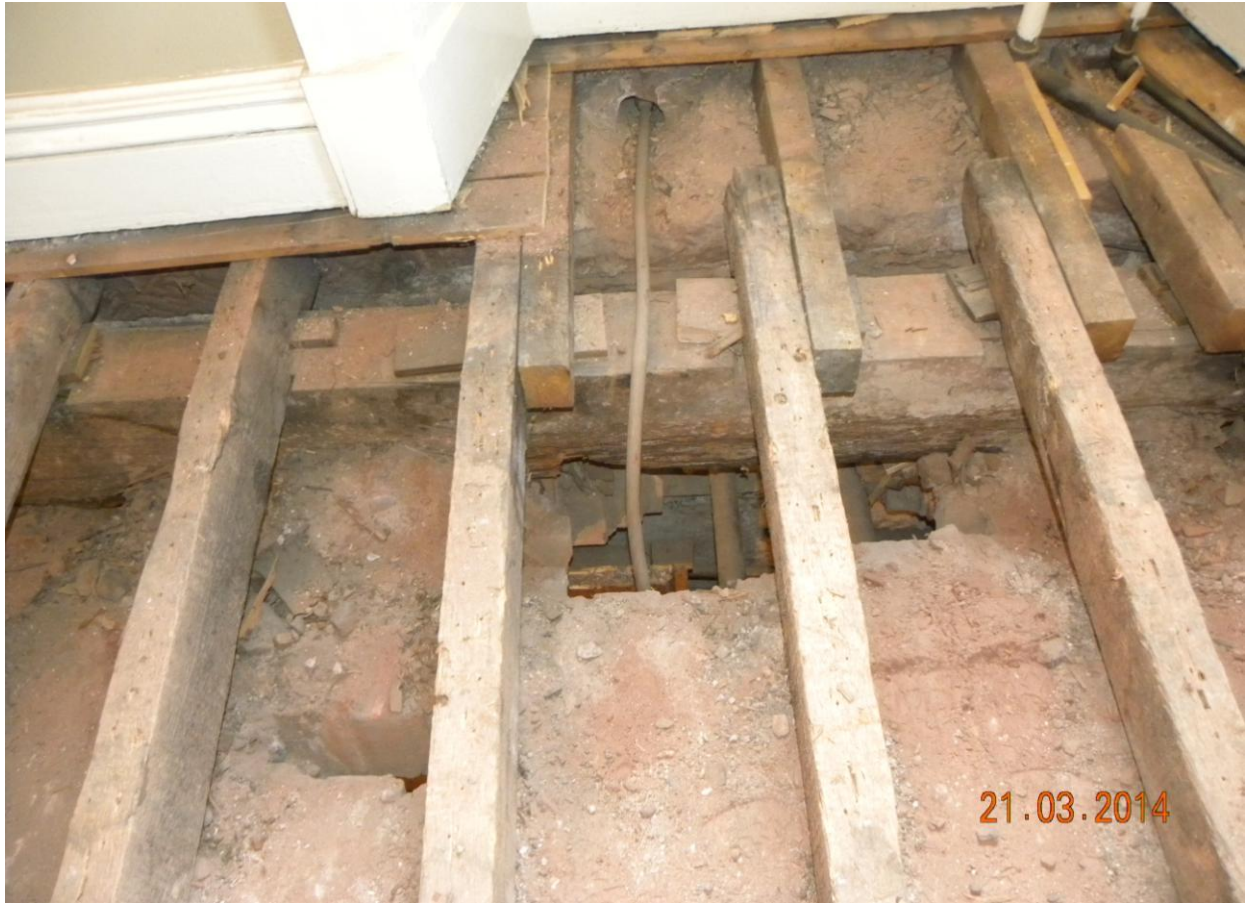
PHOTOGRAPH SR-16:

View of Holes; 3 and 4 within the brick masonry arch roof of the vault below. Shows the 3 in. wide x 4 in. deep timber “sleepers” bearing on top of the 7 ½ in. x 14 in. timber beam. Also shows the splice extensions to the wood “sleepers” bearing on top of the stone masonry wall below the window opening of the West wall. The “sleeper” extensions were loose.

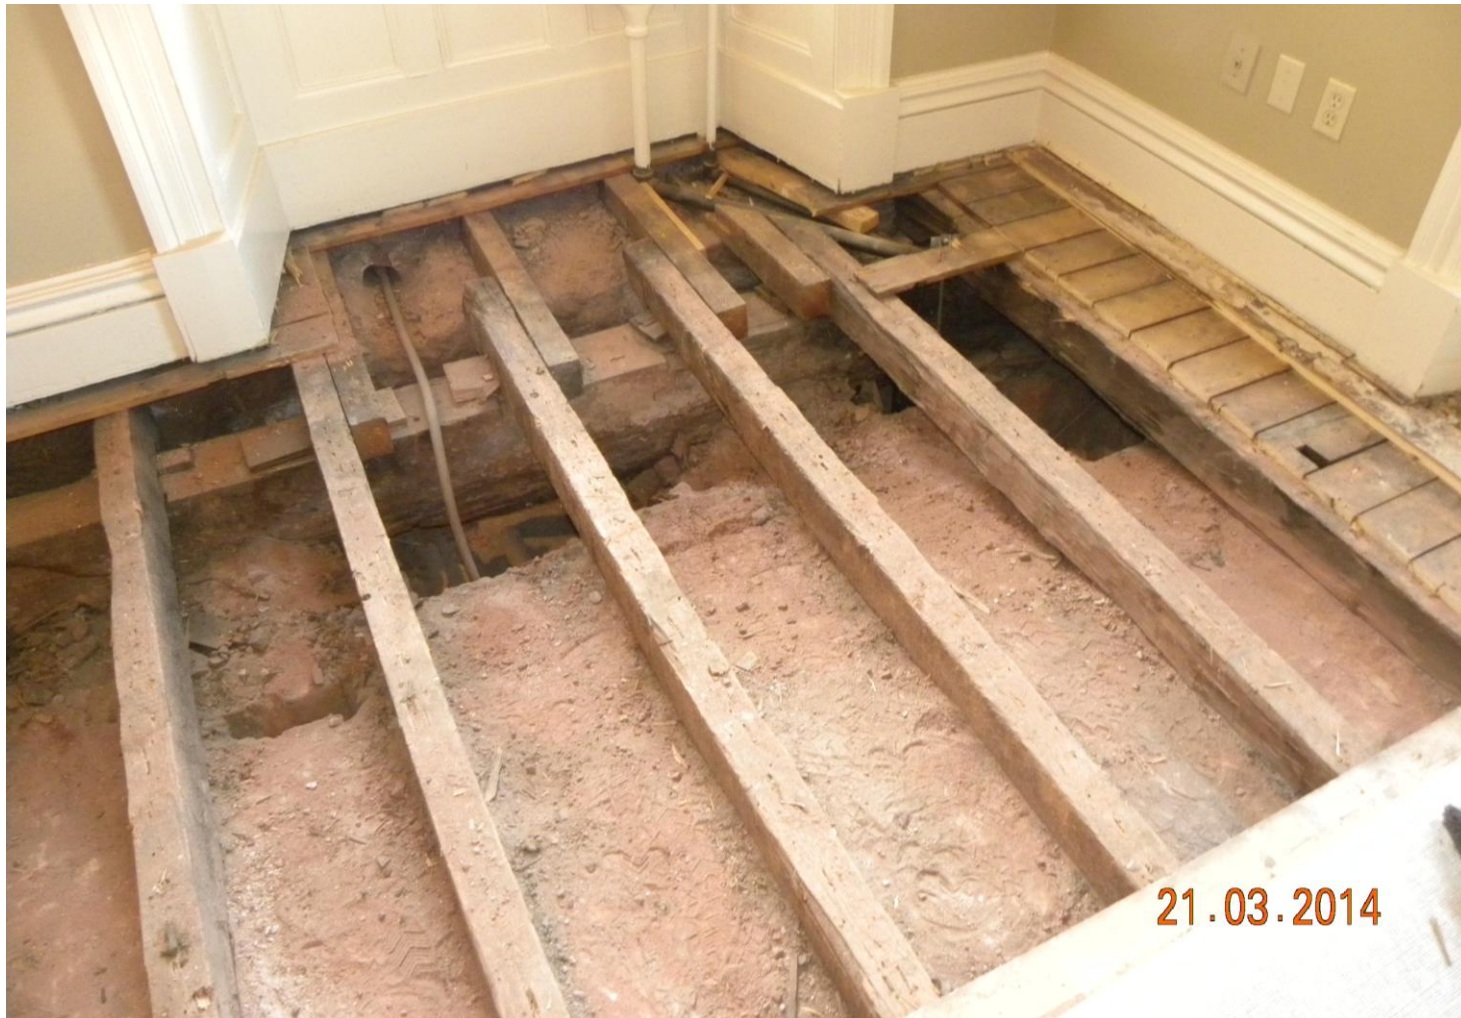
PHOTOGRAPH SR-21:

View of the existing structural support system, Northwest area of the Speaker's Office floor. A significant portion of the brick masonry arch is missing and the 7 ½ in. x 14 in. timber beam is rotten.

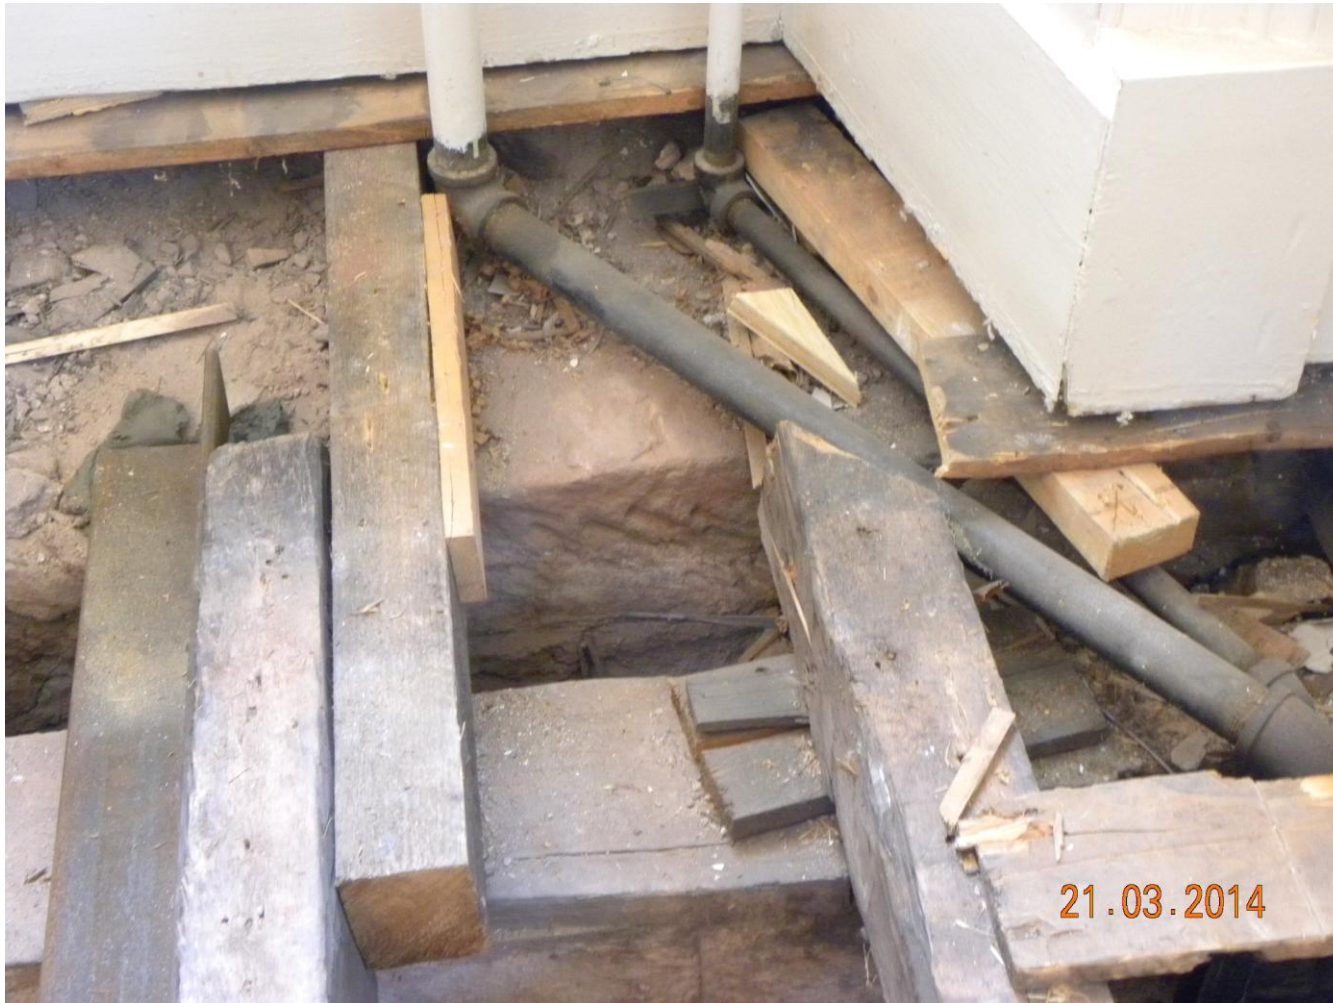
PHOTOGRAPH SR-22:

Shows a heating pipe passing diagonally through the end of the East/West spanning "sleeper". There is no bearing area for the "sleeper" on the stonework of the West foundation wall.

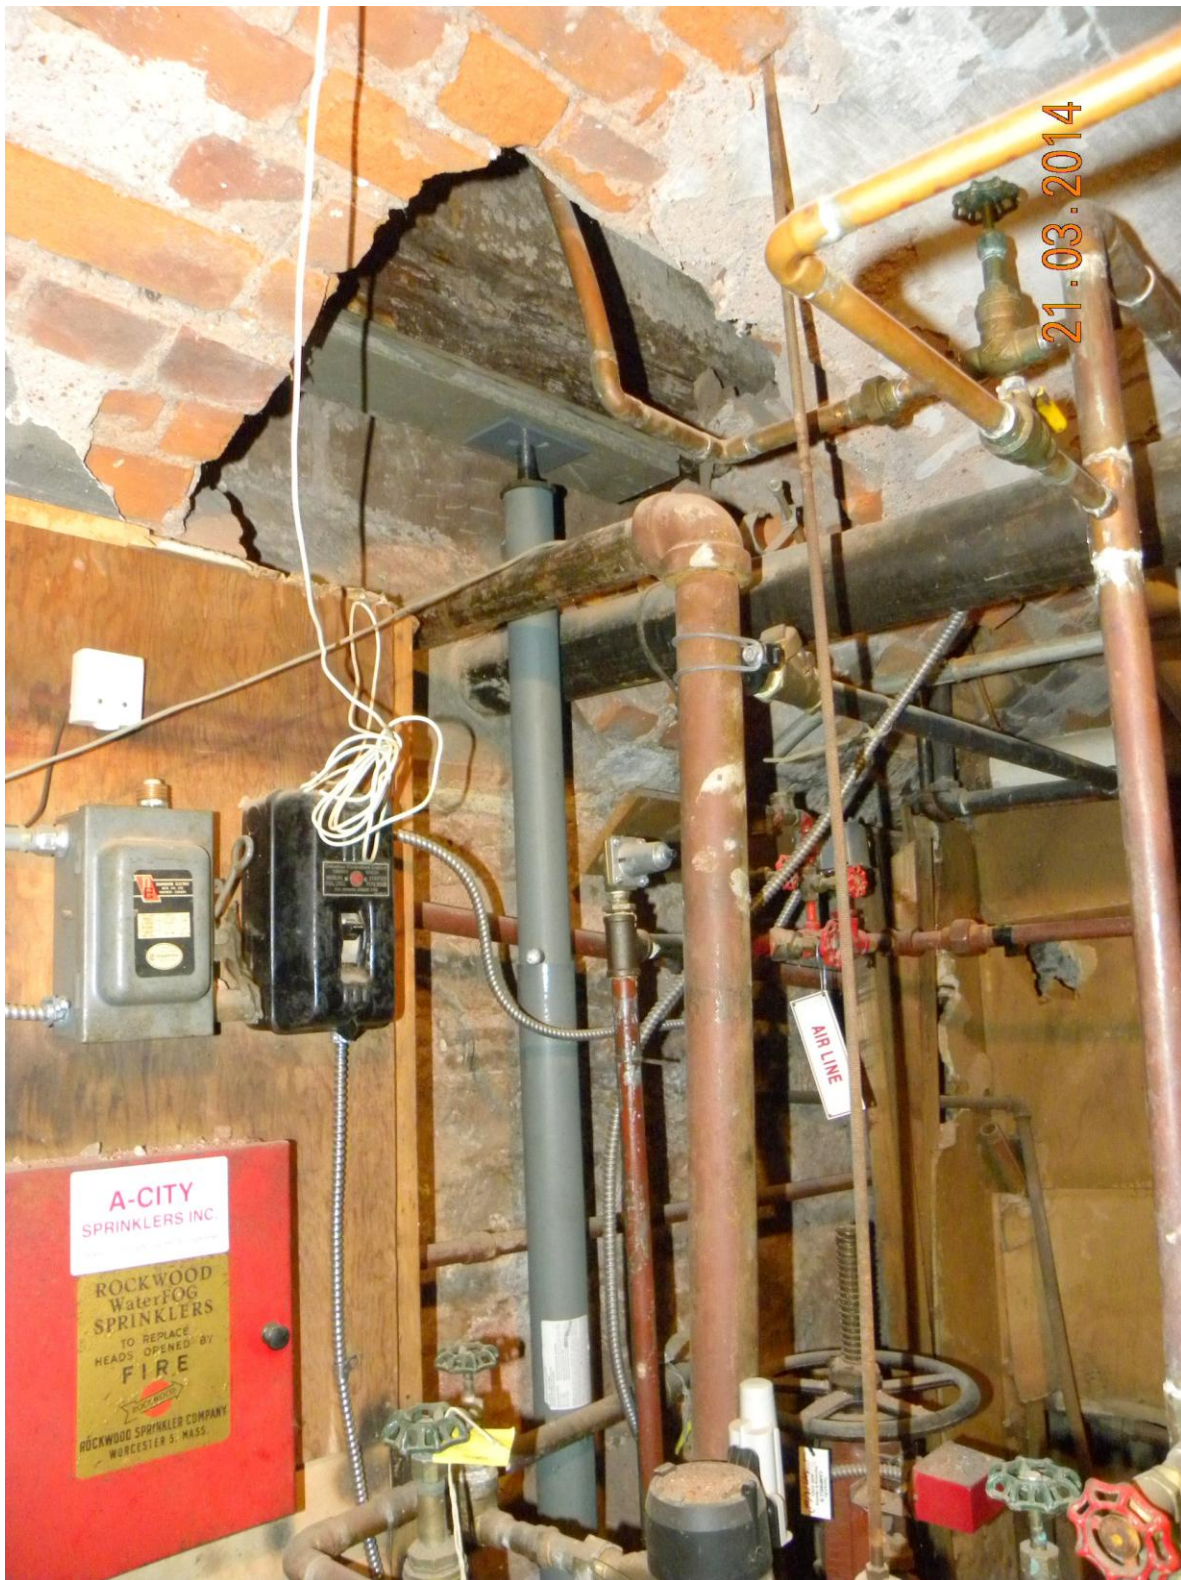
PHOTOGRAPH SR-23:

Shows the 21 March 2014 installation of a steel “jack post” through Hole 4 within the brick masonry arch ceiling of the vault for support of the deteriorated 7 ¼ in. x 14 in. timber beam above.

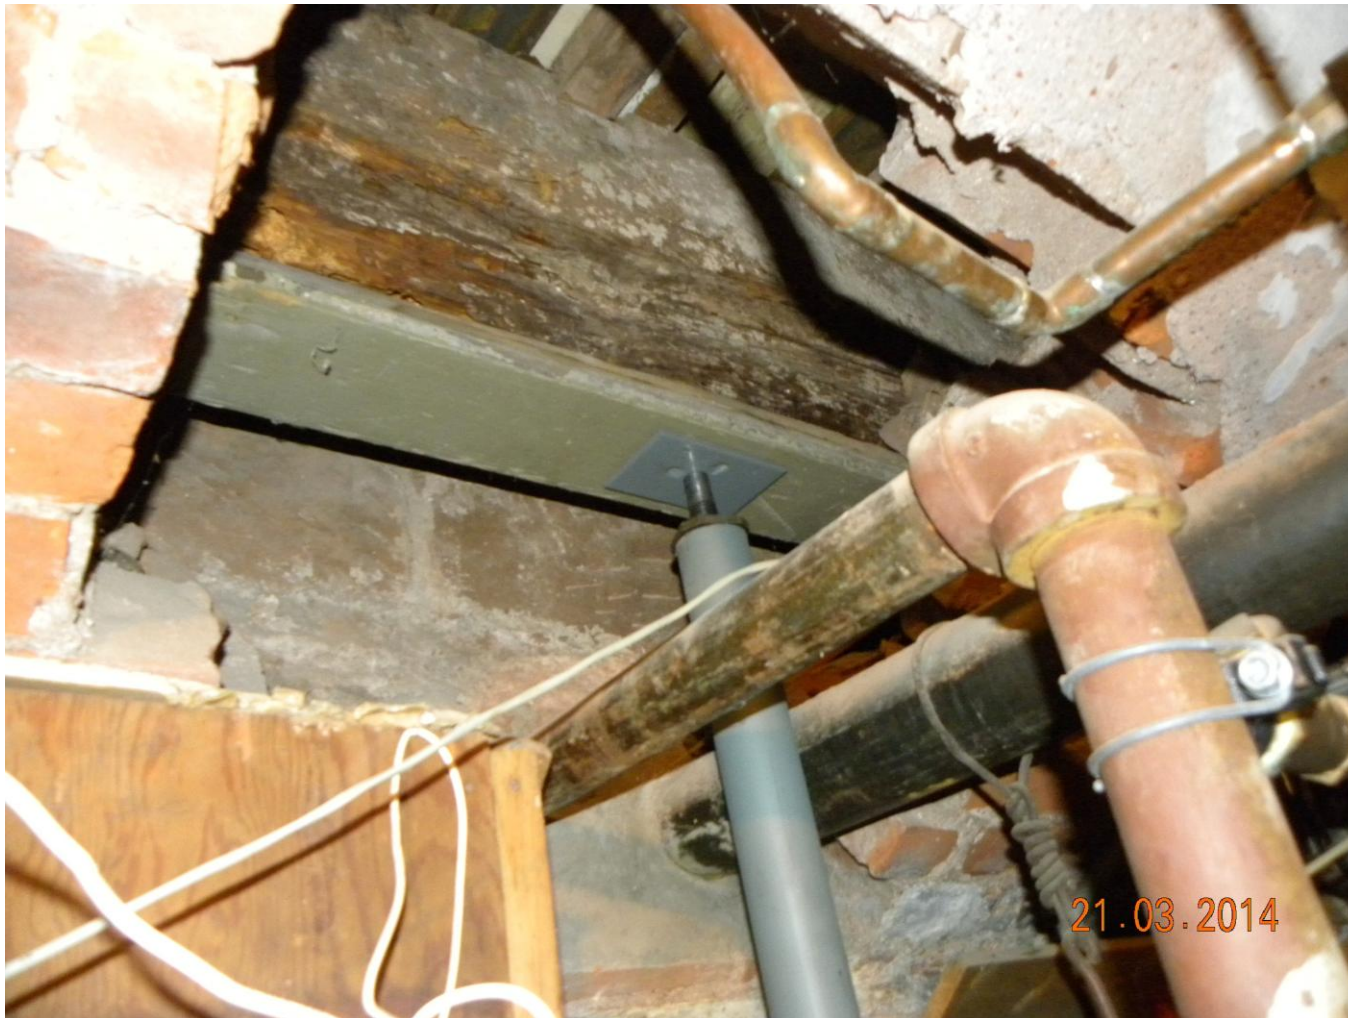
PHOTOGRAPH SR-24:

Close-up view of the top plate of the 21 March 2014 installed steel “jack post” bearing on the underside of the deteriorated North/South spanning timber beam of the Speaker’s Office floor construction.

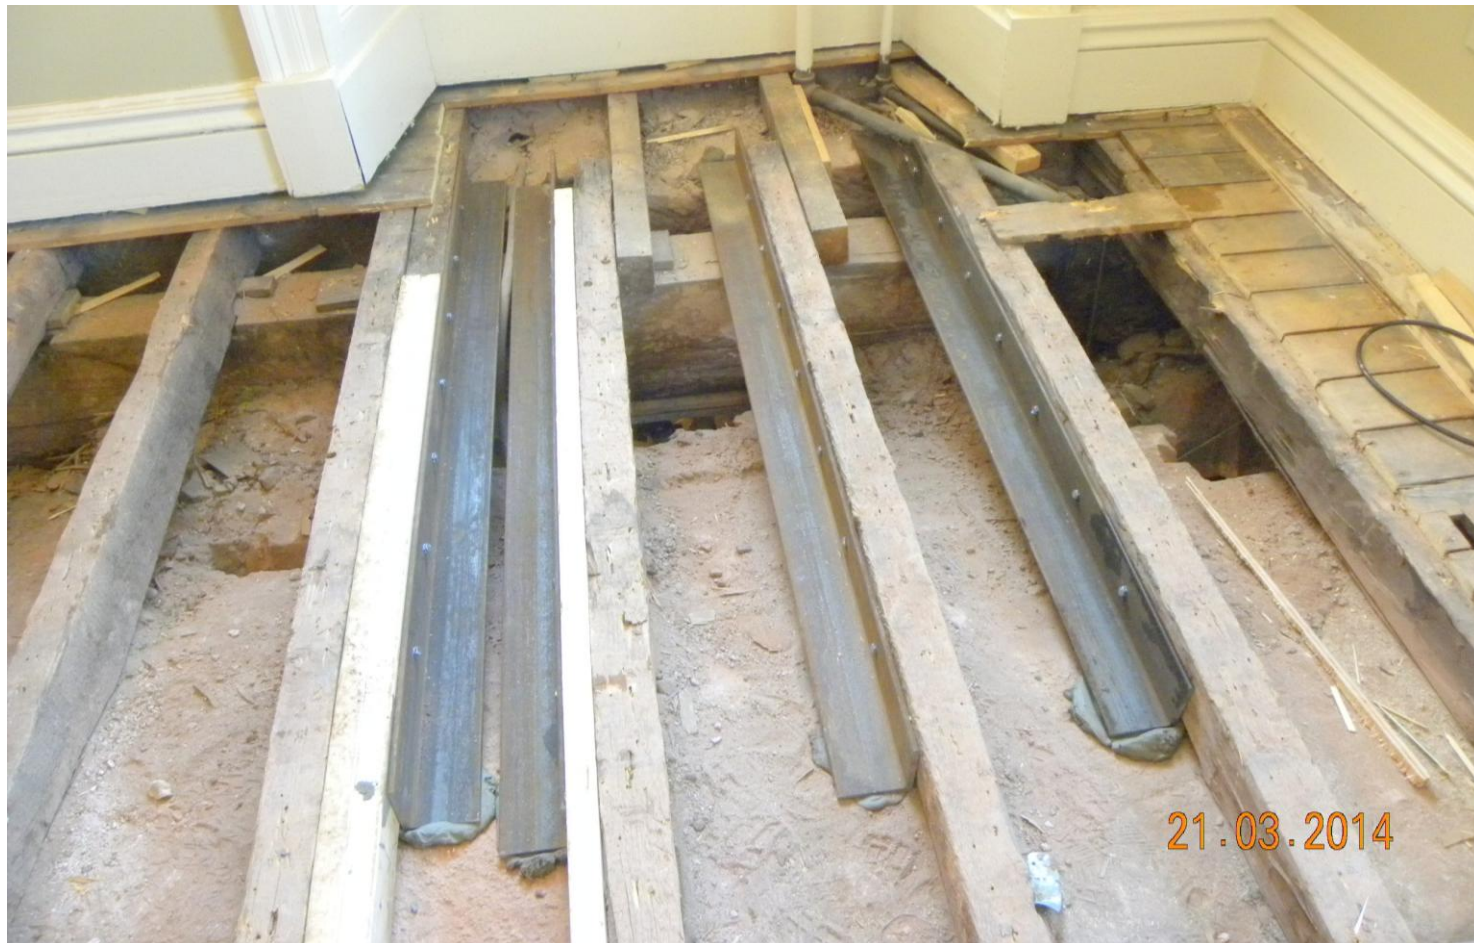
PHOTOGRAPH SR-25:

Strengthening of four 3 in. wide x 4 in. deep timber “sleepers” by the installation of 4 in. x 4 in. x 3/8 in. steel angles. The steel angles were connected to the sides of the “sleepers” by lag screws installed at 8 in. centre to centre. The East end of the steel angles bear on top of the brick masonry arch roof of the vault below. The West end of the steel angles bear on the top of the stone masonry exterior foundation wall. Viewing West.

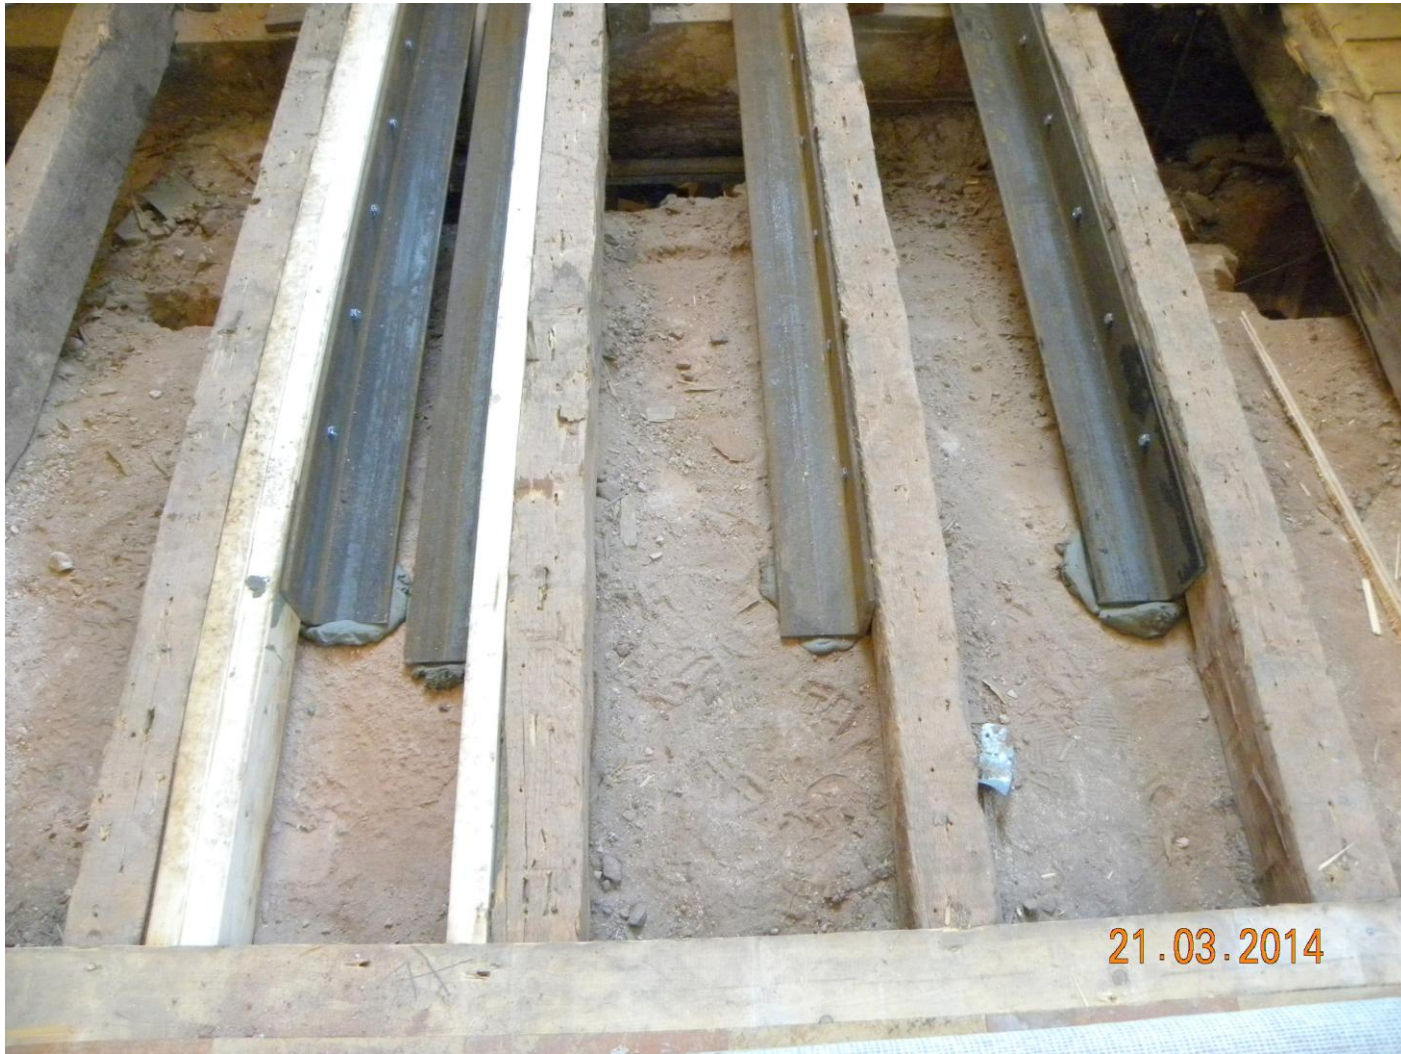
PHOTOGRAPH SR-26:

East bearing end of the steel angles. The horizontal 4 in. wide leg of the steel angles are bearing on a bed of "Quikrete", a quick setting cementitious grout.
