“Draft” Interim Report

**Cursory Structural Review of Province House
Charlottetown, PEI**

**Parks Canada
Historic Properties
1869 Upper Water Street
Halifax, NS
B3J 1S9**

**J.W. Cowie Engineering Limited
1046 Barrington Street, Suite#200
Halifax, Nova Scotia
B3H 2R1**

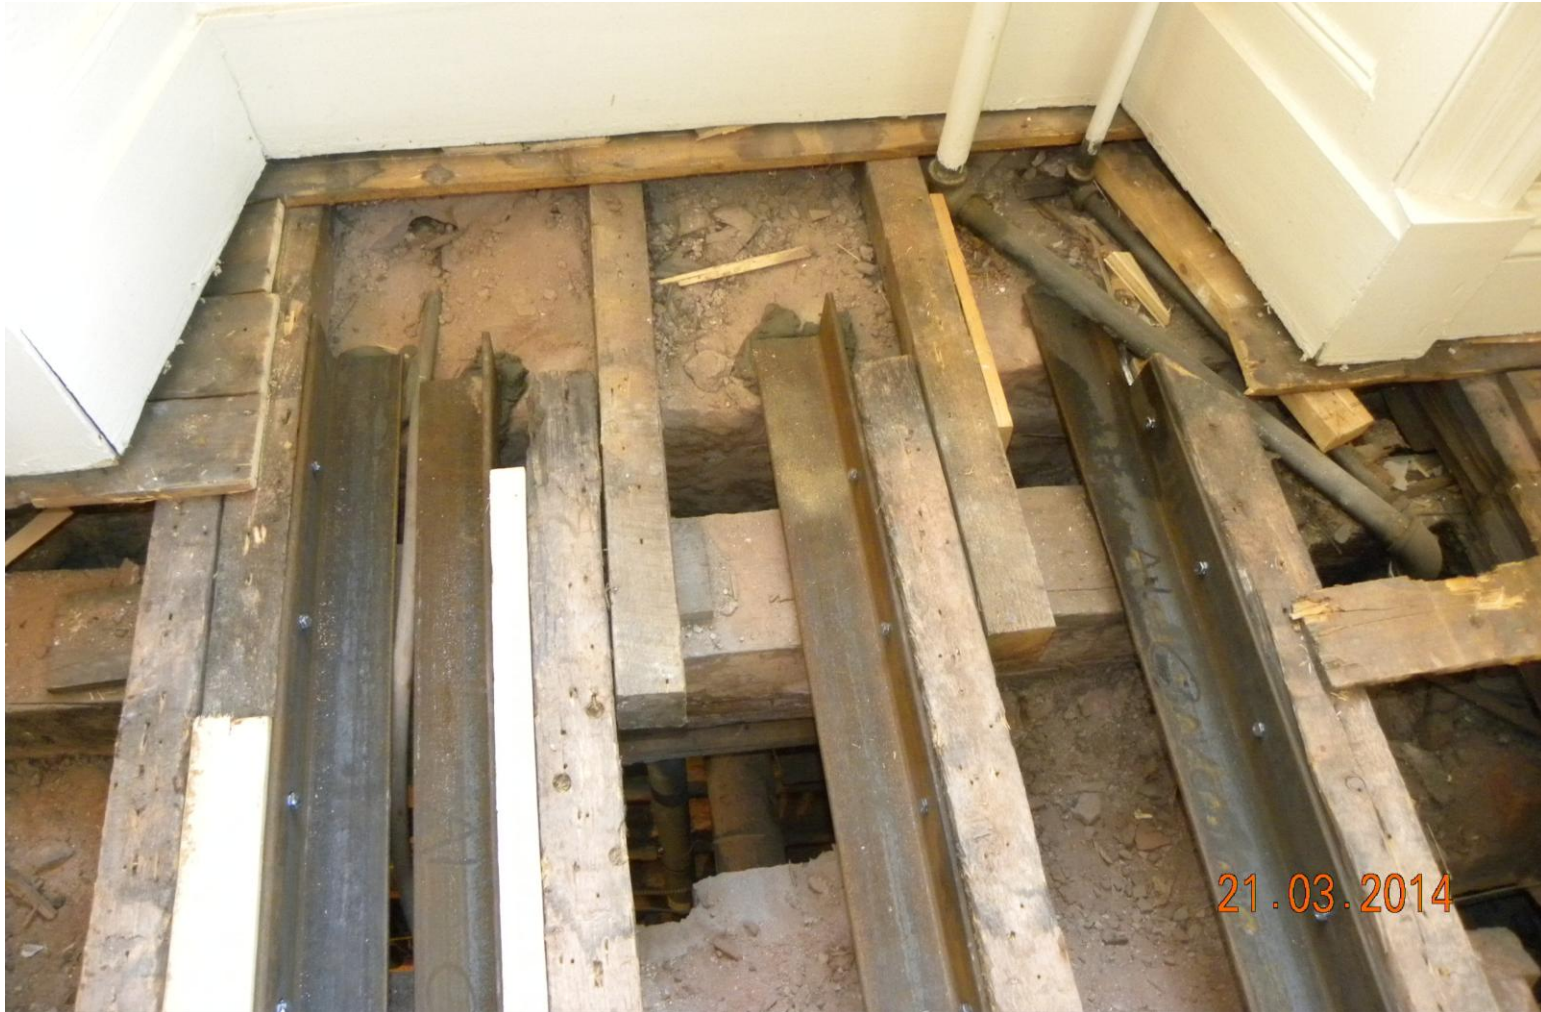
PHOTOGRAPH SR-27:

The West end of the steel angles are bearing on top of the West exterior stone masonry foundation wall of the building. The horizontal leg of the steel angles are bearing on a bed of "Quikrete", a quick setting cementitious grout.

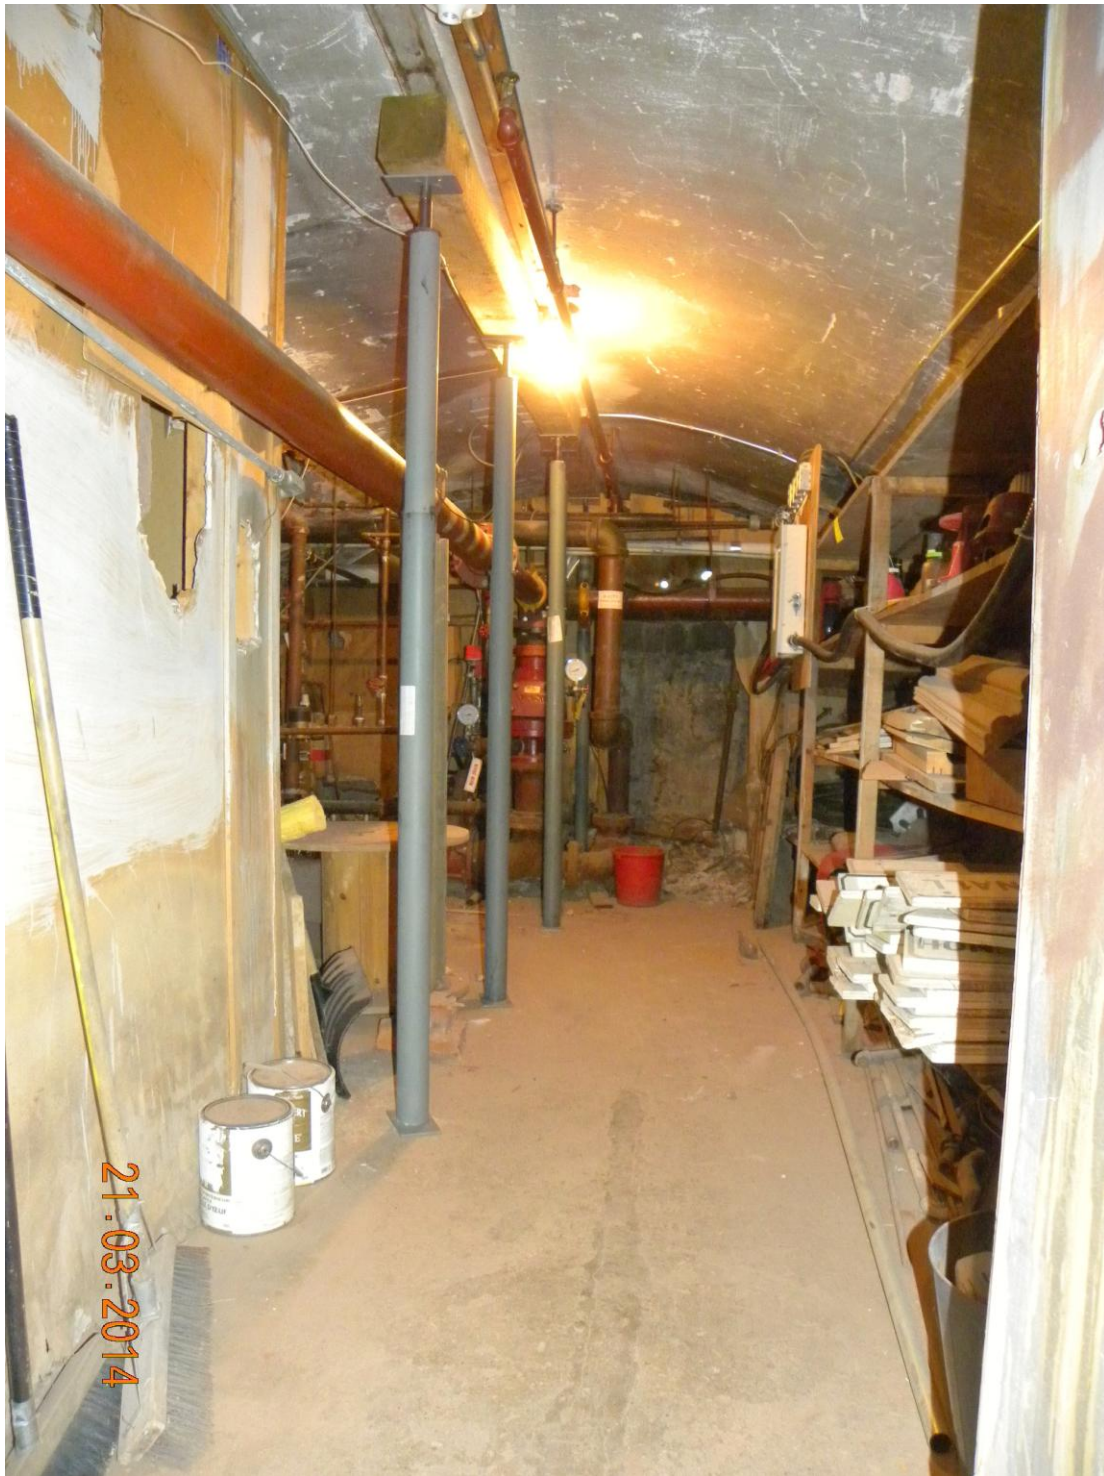
PHOTOGRAPH SR-31:

Installation of adjustable steel shores ("jack posts") with 6 in. x 6 in. (nominal) timber spreader beams spanning North/South for the temporary support of the brick masonry vault roof. The location of the "jack posts" can be found on Figure 5, Appendix "A", Volume I.

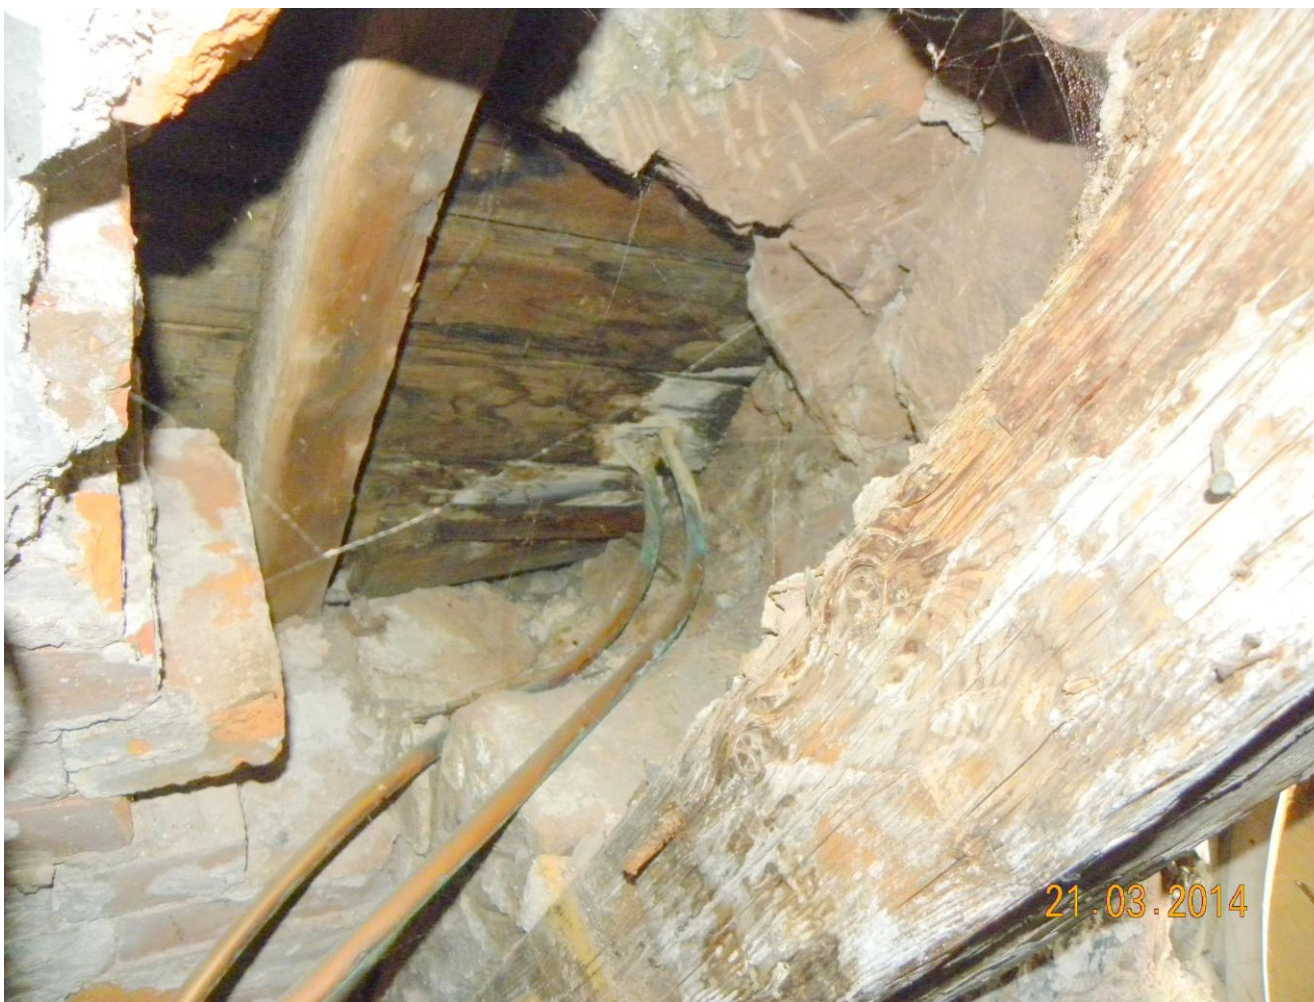
PHOTOGRAPH SR-37:

Hole opening 7 within the brick masonry arch. Evidence of water staining and wood rot within the floor boards below the hot water radiator located in front of window, North wall of the Speaker's Office.

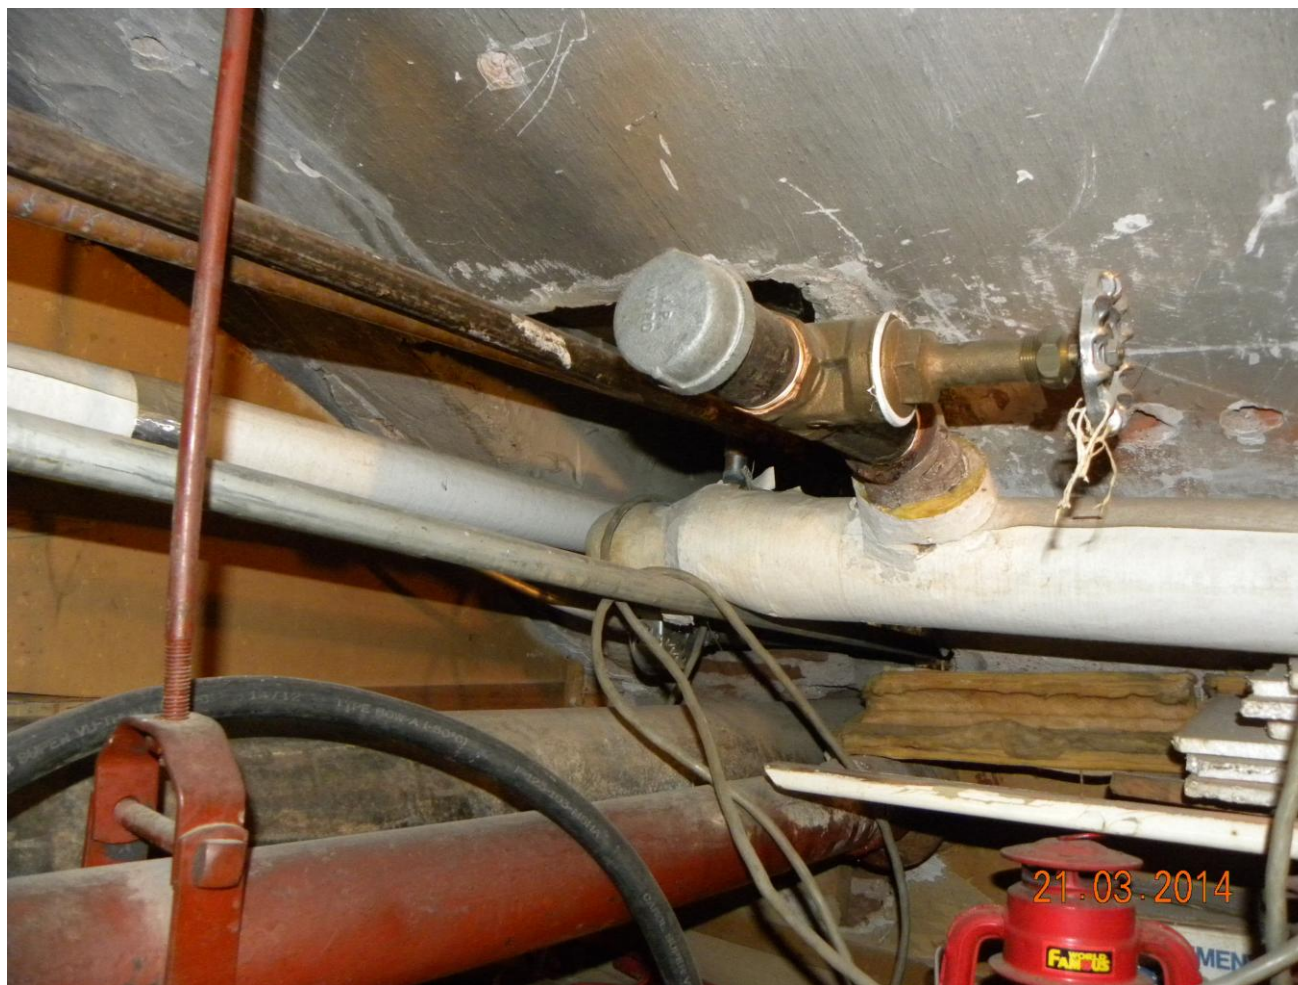
PHOTOGRAPH SR-38:

Horizontal pipe chase causing a reduction in the roof thickness of the Sprinkler Room vault as well as the roof of the adjacent vault (Room 104). (For reference purposes, horizontal pipe chase is noted as Hole 8, Figure 5, Appendix "A", Volume I).

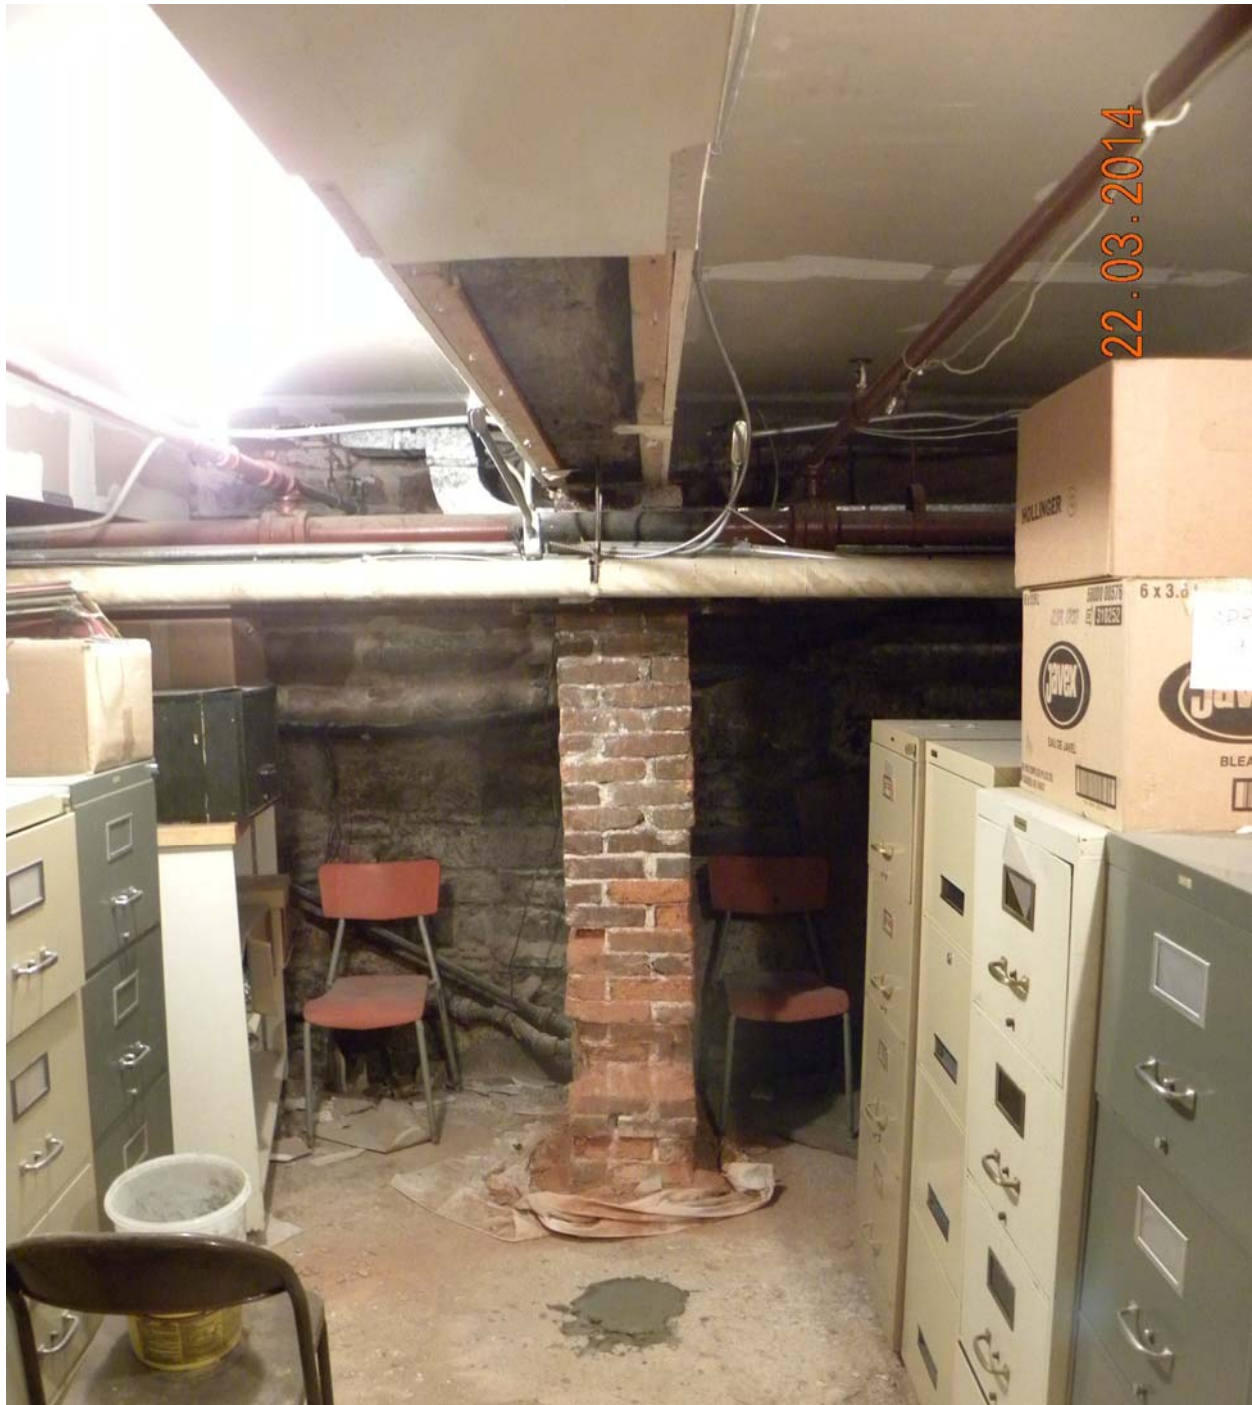
PHOTOGRAPH BSE-1:

The clay bricks within the bottom portion of the column (extending approximately 3 ft. above the concrete floor level) have deteriorated. (Refer to Photographs; BSE-1 to BSE-5, Appendix "B", Volume II).

As a consequence of the brick deterioration, the bottom portion of the column has lost approximately 47% of its original cross sectional area.

Clay brick masonry column located in Basement Room B15. The column is out of plumb and the brickwork within the bottom 2 ft. 10 in. has deteriorated. A North/South spanning timber beam is bearing on the top of the column. The timber beam is concealed with gypsum board. It appears, a 2 in. x 10 in. (nominal) timber joist is fastened to the East and West sides of the beam. Removal of a section of gypsum board from the underside of the beam revealed the beam had undergone extensive wood rot adjacent to the column. Viewing South within Room B15.

At the time of permanent restoration, it was recommended the deteriorated brick masonry column be replaced with a new brick masonry column and a detailed inspection be made of the 7 ¼ in. x 1 ft. 2 in. timber beam to determine the extent of required restoration.

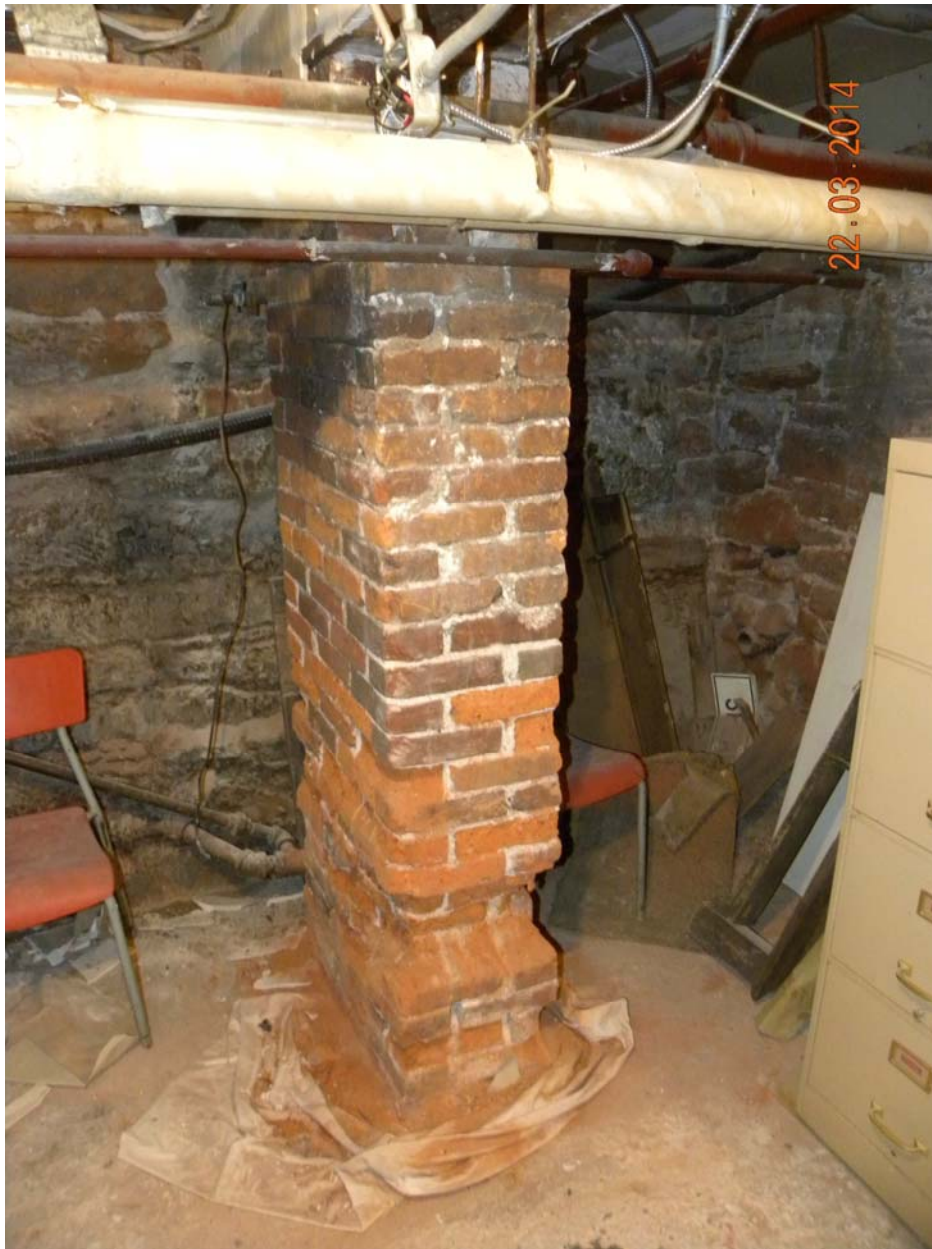
PHOTOGRAPH BSE-2:

East and North faces of brick masonry Column 1b. The plan dimensions of the undamaged top portion of the column measure 1 ft. 1 ¼ in. x 2 ft. 2 ½ in. representing a plan area of 351.12 in.². Without removing any of the deteriorated masonry within the bottom portion of the column the minimum dimensions of the column measure 8 ½ in. x 1 ft. 10 in. representing a cross sectional area of 187 in.². Deterioration of the bottom portion of the column has resulted in a cross sectional loss area of approximately 47%. The bottom bricks are very weak and with little effort, rubbing the face of the bricks would cause considerable loss of material. Viewing Southwest.

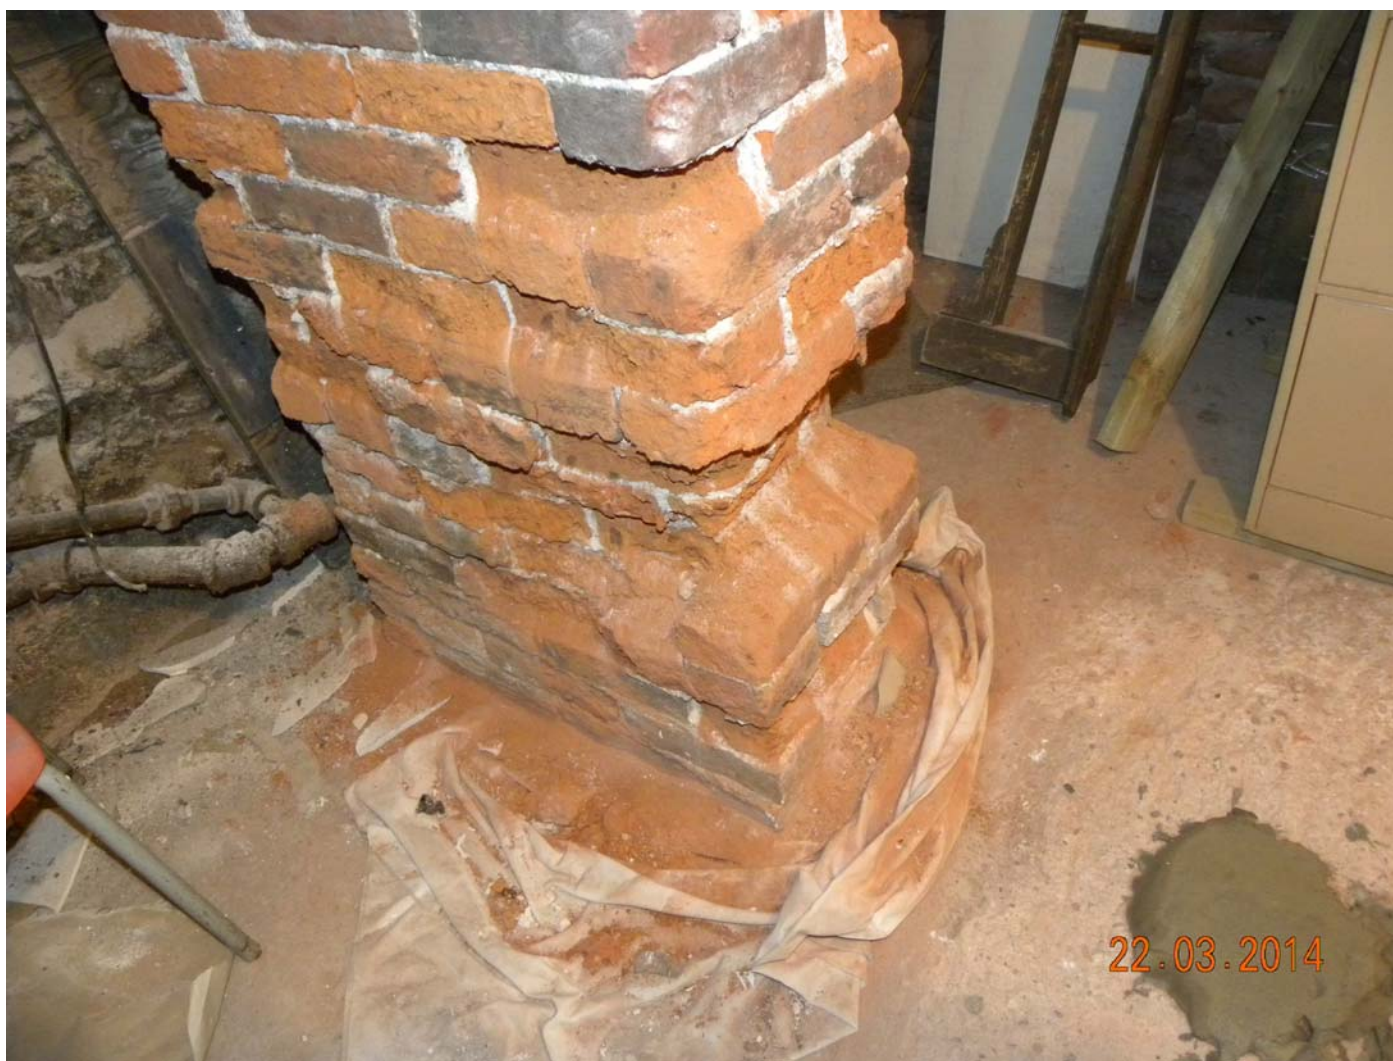
PHOTOGRAPH BSE-3:

The deteriorated bottom portion of the East and the North faces of masonry Column 1b, Room B15. Viewing Southwest.

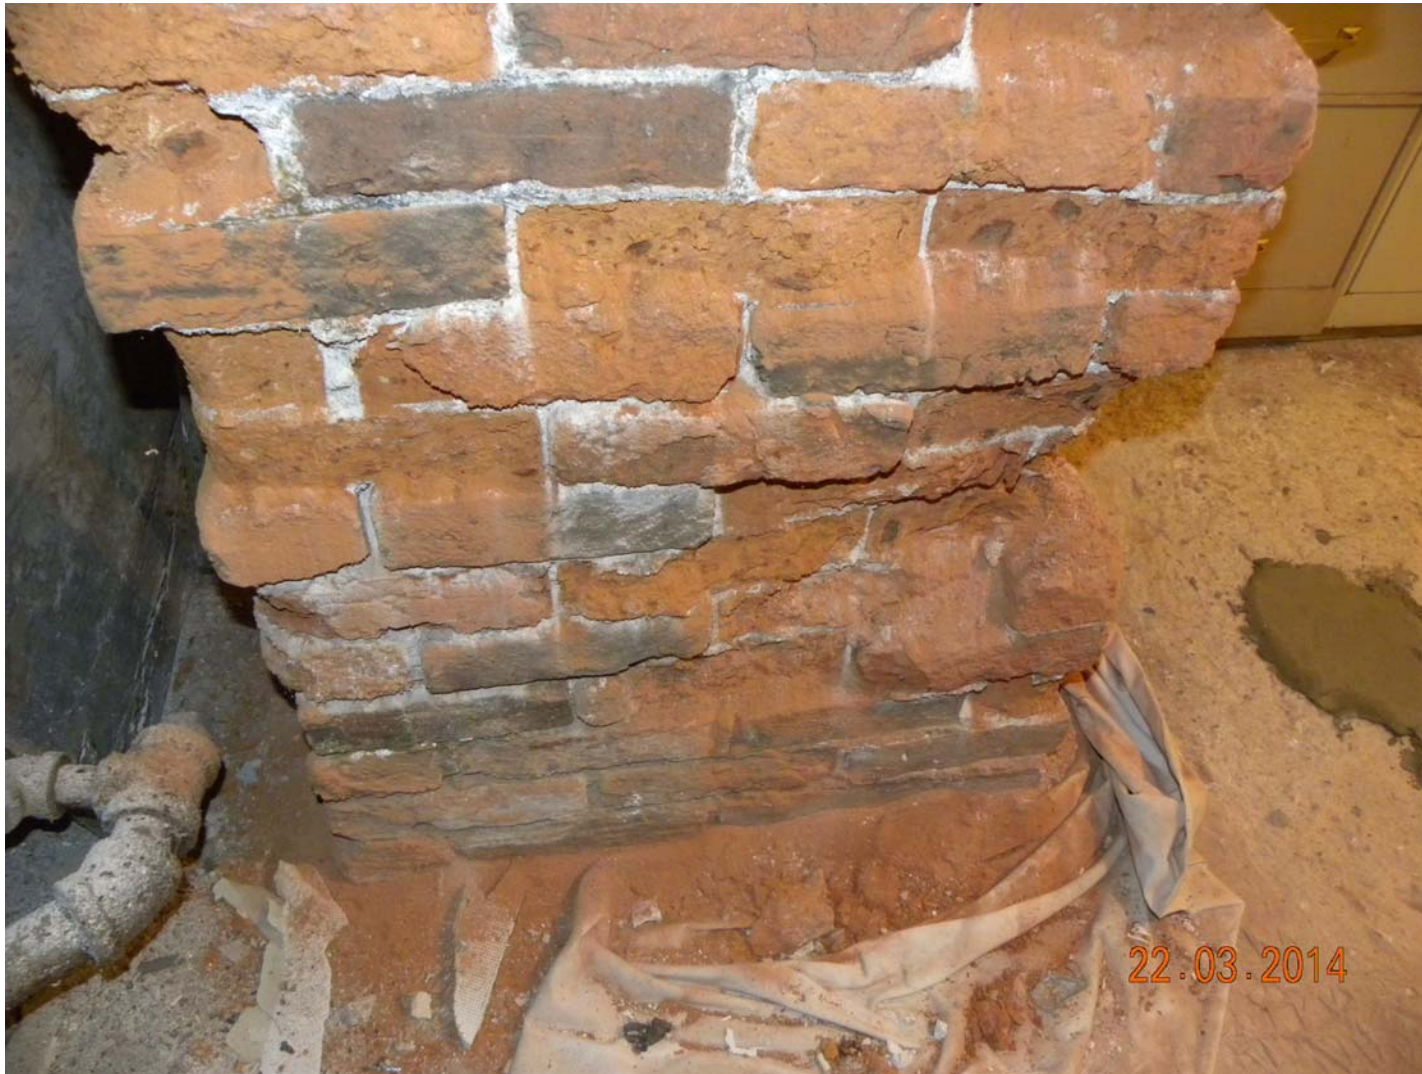
PHOTOGRAPH BSE-4:

Deteriorated bottom portion of East elevation Column 1b, Room B15. Viewing West.

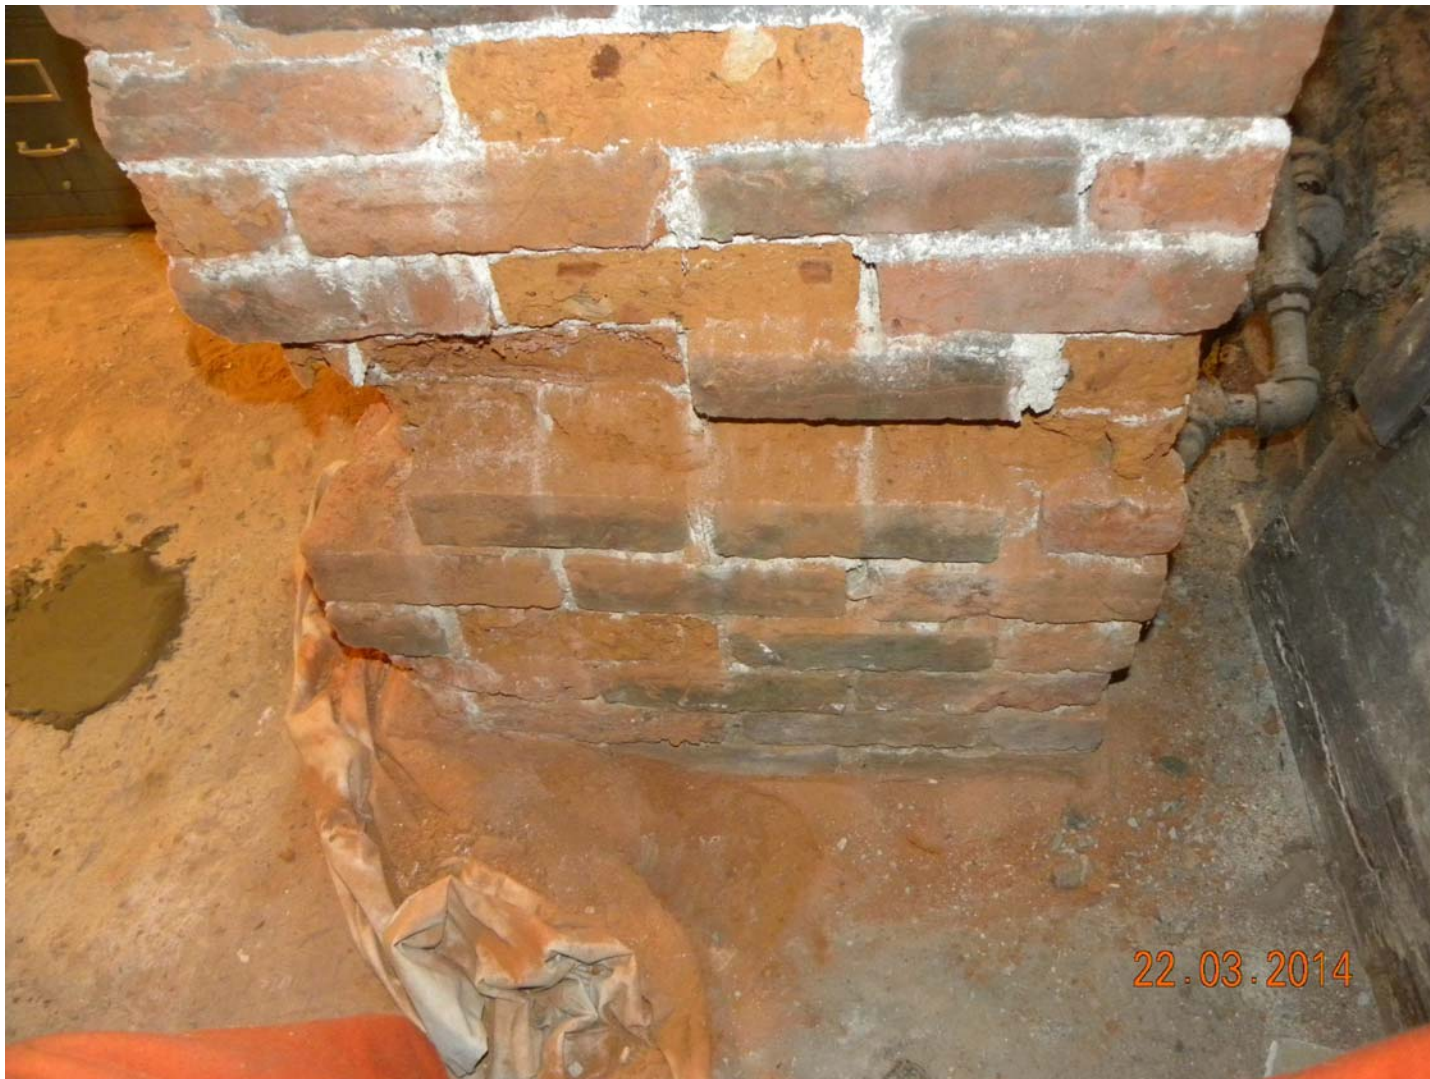
PHOTOGRAPH BSE-5:

Deteriorated bottom portion of West elevation of Column 1b, Room B15. Viewing East.

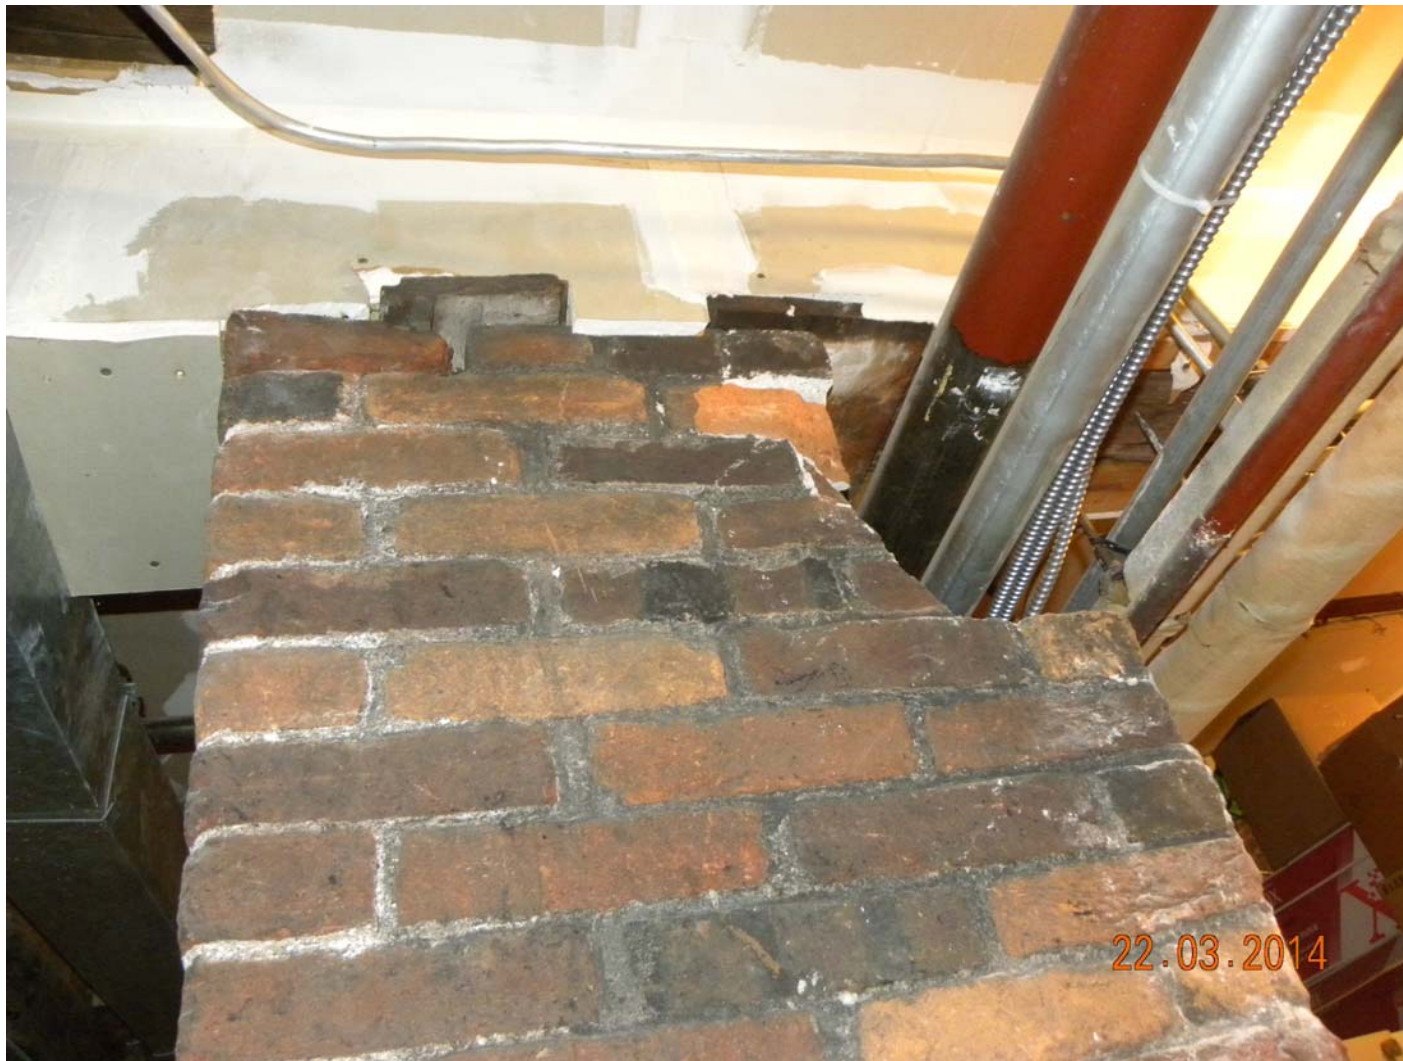
PHOTOGRAPH BSE-6:

The top East portion of Column 1b with 6 ½ in. x 12 ½ in. deep section of brickwork removed for the passage of East/West spanning pipes and electrical conduit.

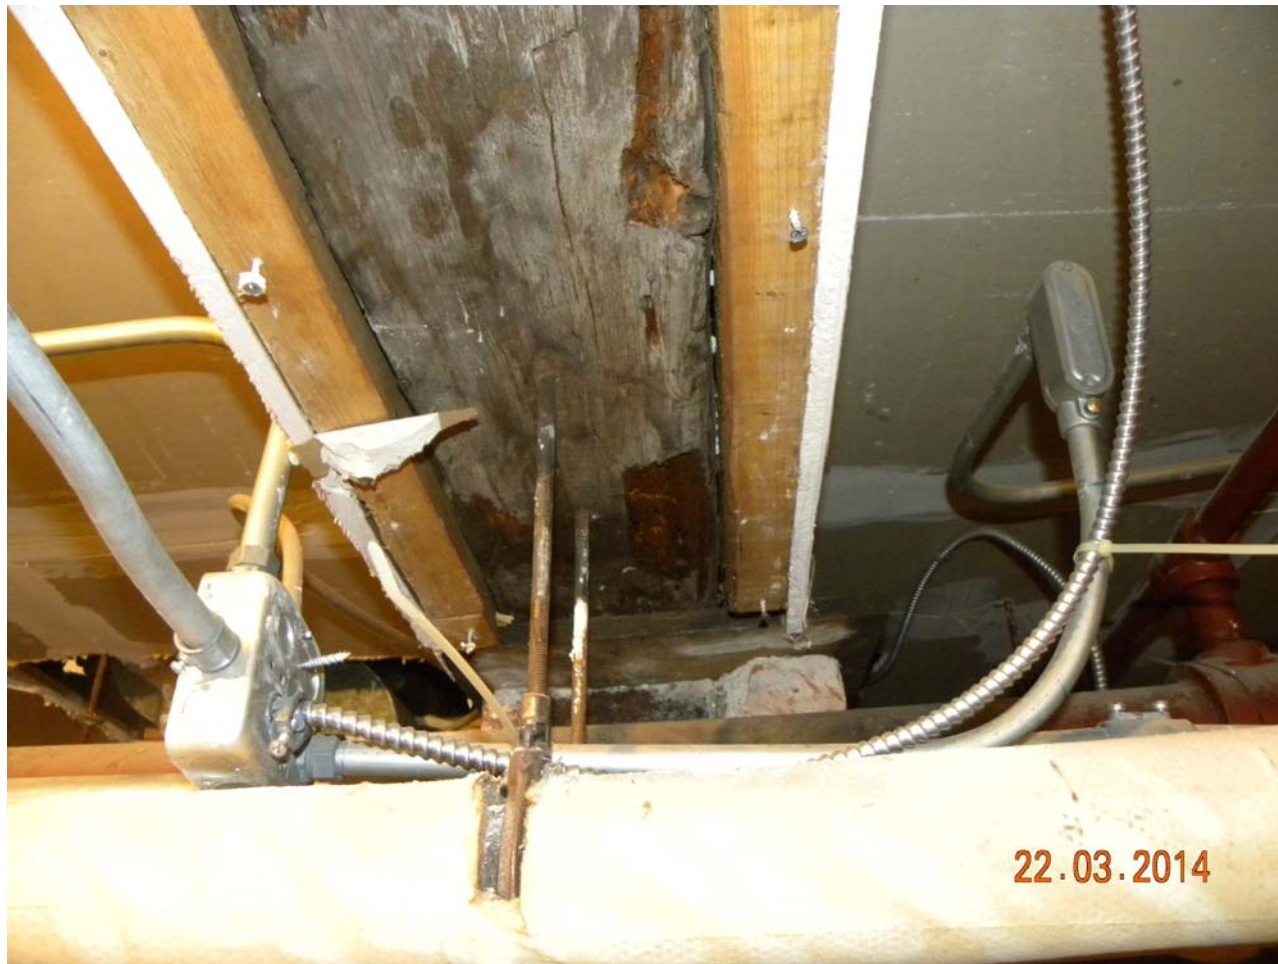
PHOTOGRAPH BSE-7:

adjacent to North face of the column revealed extensive wood rot near the Southern end of the beam. (Refer to Photographs; BSE-7 and BSE-8, Appendix “B”, Volume II).

View of the underside of the 7 ¼ in. wide x 1 ft. 2 in. deep timber beam with 2 in. x 10 in. (nominal) timber joists connected to the East and West sides of the timber beam. Considerable wood rot was detected on the underside of the 7 ¼ in. x 1 ft. 2 in. timber beam.

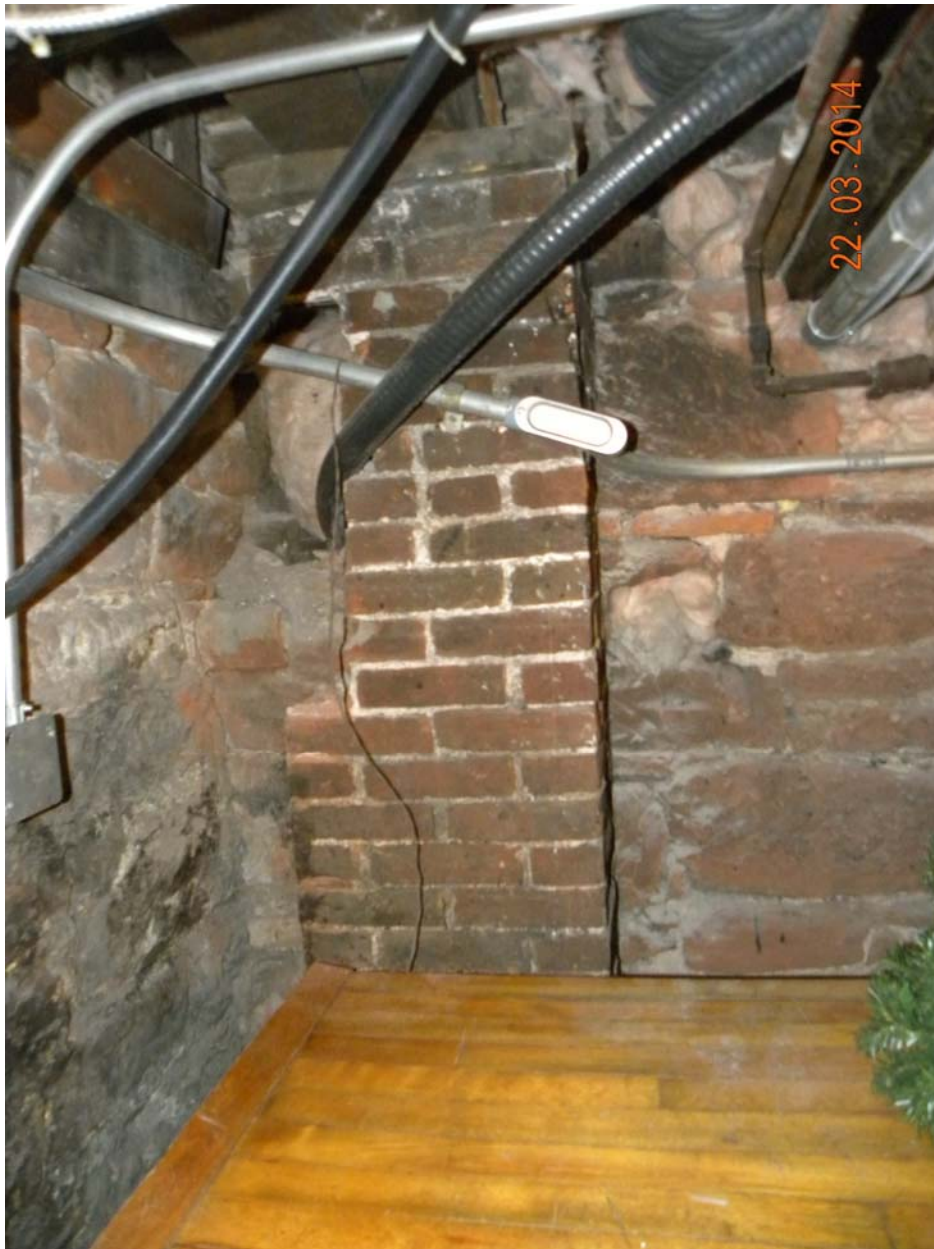
PHOTOGRAPH BSE-10:

Brick masonry Column 2a located at the Southwest corner of the Basement Room B14. (Refer to Figure 6 "Southeast Basement Area, Rooms B13, B14 and B15", Appendix "A", Volume I). A large section of the South top side of the brick masonry column has been removed from the column during the installation of the electrical conduit. (Refer to Figure 7 "East Elevation of Damaged Brick Masonry Column 2a, Southwest Corner of Basement Room B14", Appendix "A", Volume I). The plan dimensions of the column are 1 ft. 5 ¼ in. (North/ South) x 1 ft. ½ in. (East/West). Approximately 40% of the plan bearing area of the upper portion of the column has been demolished.

It is recommended the electrical conduit be relocated and the brick masonry construction be restored.

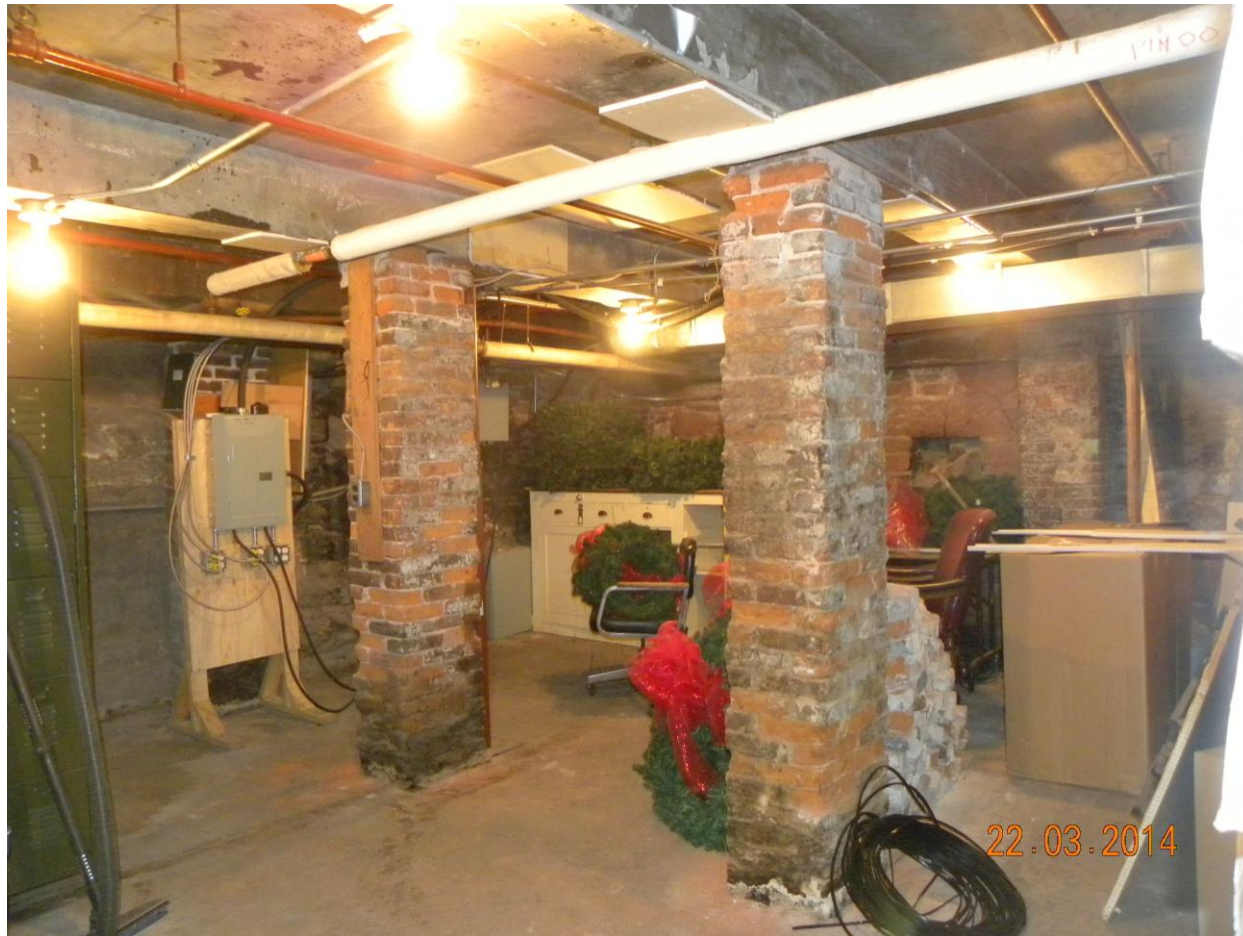
PHOTOGRAPH BSE-16:

Viewing Southwest at the entry to Basement Rooms; B13 and B14. (Refer to Figure 6, Appendix "A", Volume I). Column 3a is located left of centre of the photograph and adjacent to the South exterior foundation wall. Column 3c is located approximately at the centre of the photograph and Column 3d is located right of centre of the photograph.

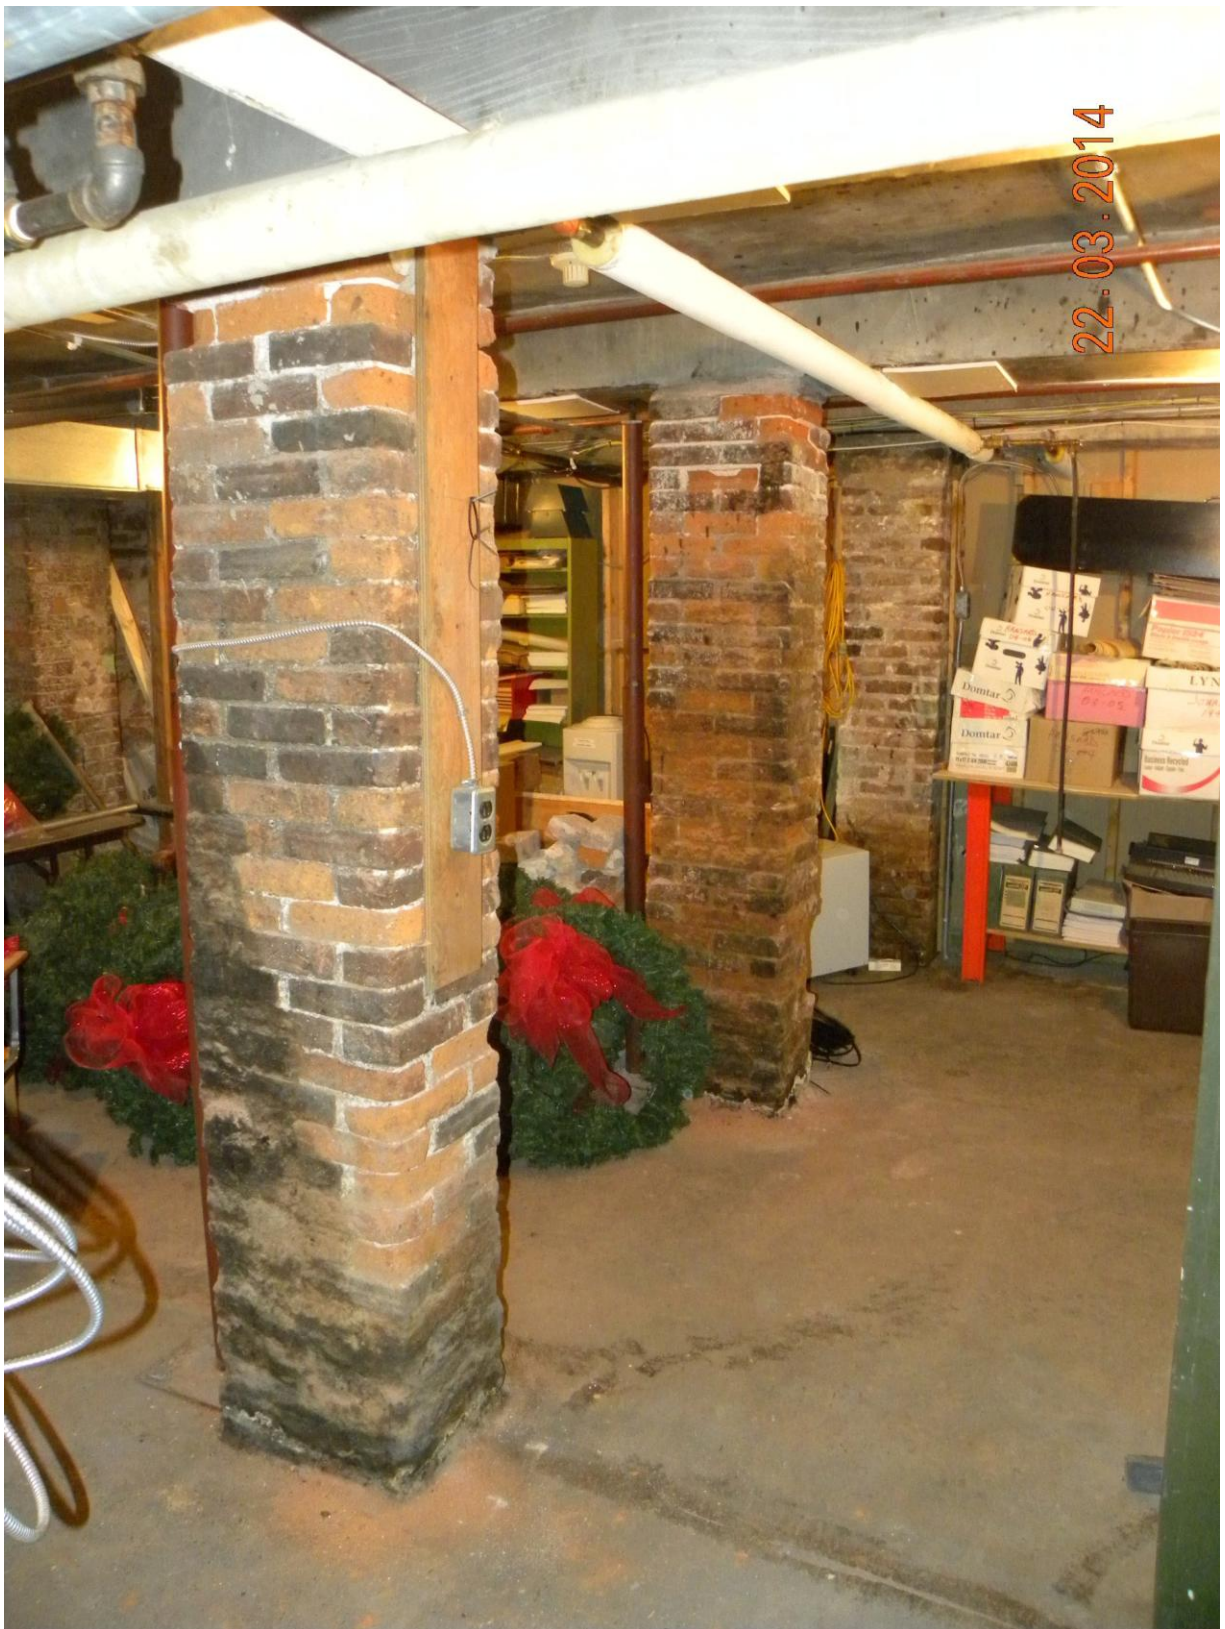
PHOTOGRAPH BSE-17:

South and East faces of brick masonry Column 3c. Viewing Northwest.

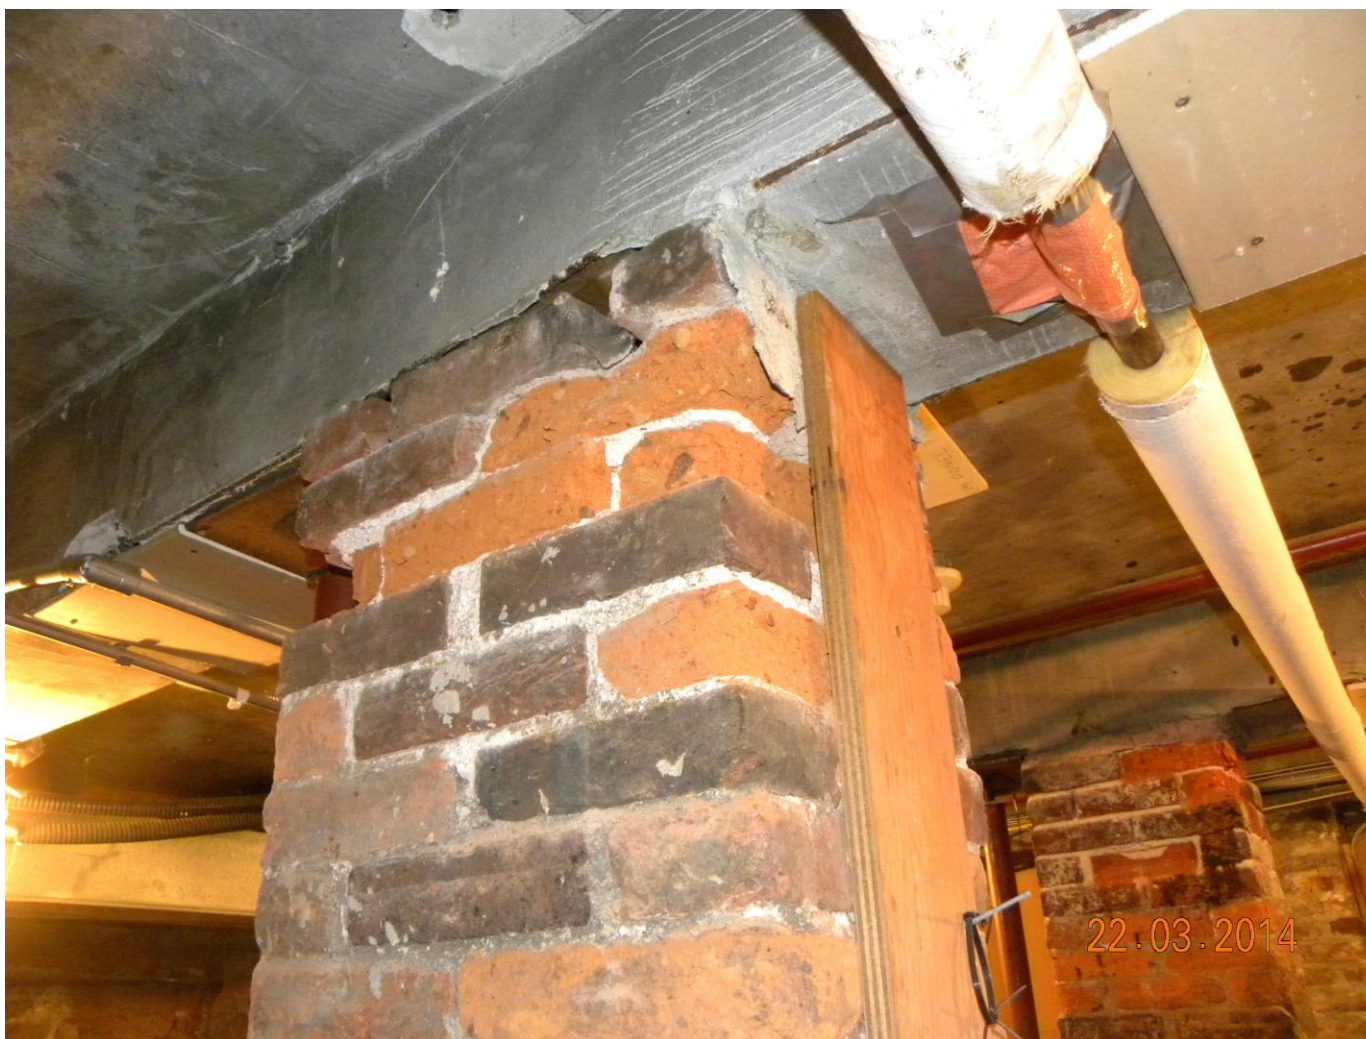
PHOTOGRAPH BSE-18

Clay brick deterioration at the top South and East faces of the brick masonry Column 3c. Viewing Northwest.
