“Draft” Interim Report

**Cursory Structural Review of Province House
Charlottetown, PEI**

**Parks Canada
Historic Properties
1869 Upper Water Street
Halifax, NS
B3J 1S9**

**J.W. Cowie Engineering Limited
1046 Barrington Street, Suite#200
Halifax, Nova Scotia
B3H 2R1**

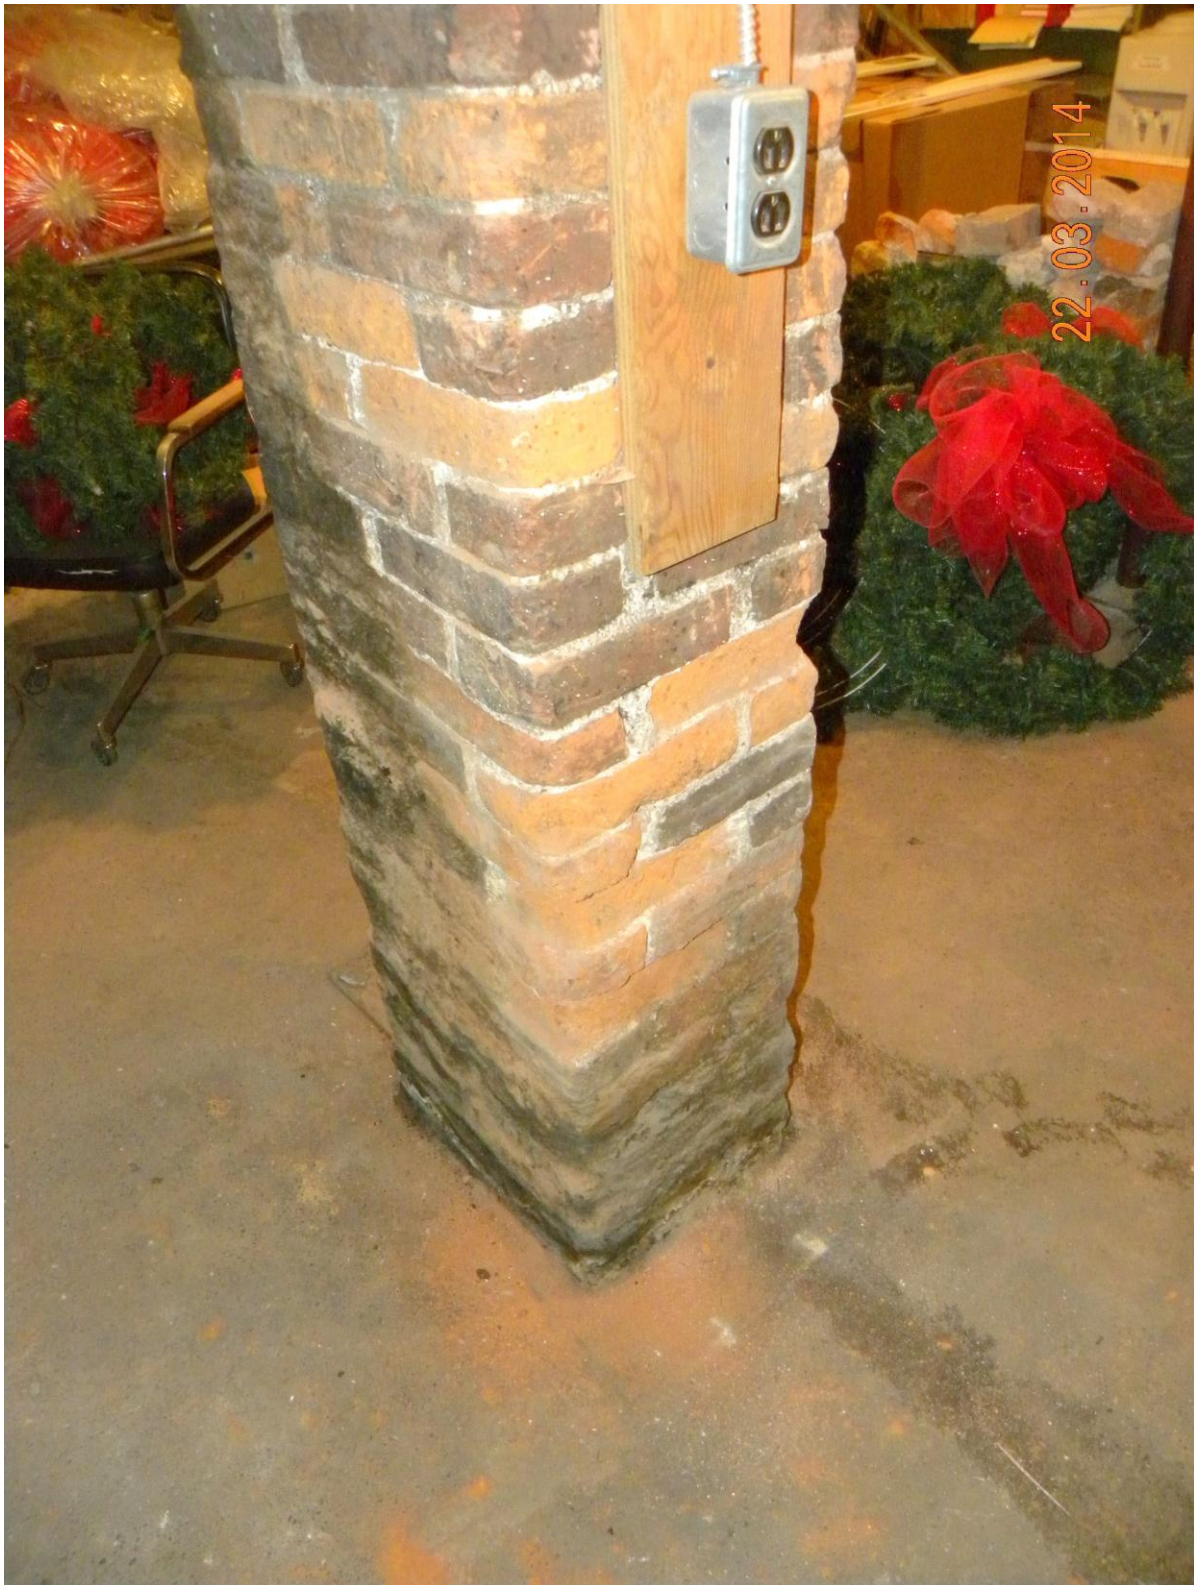
PHOTOGRAPH BSE-19:

Clay brick deteriorated at the bottom portion of the North and the East faces of the brick masonry Column 3c. Viewing Southwest.

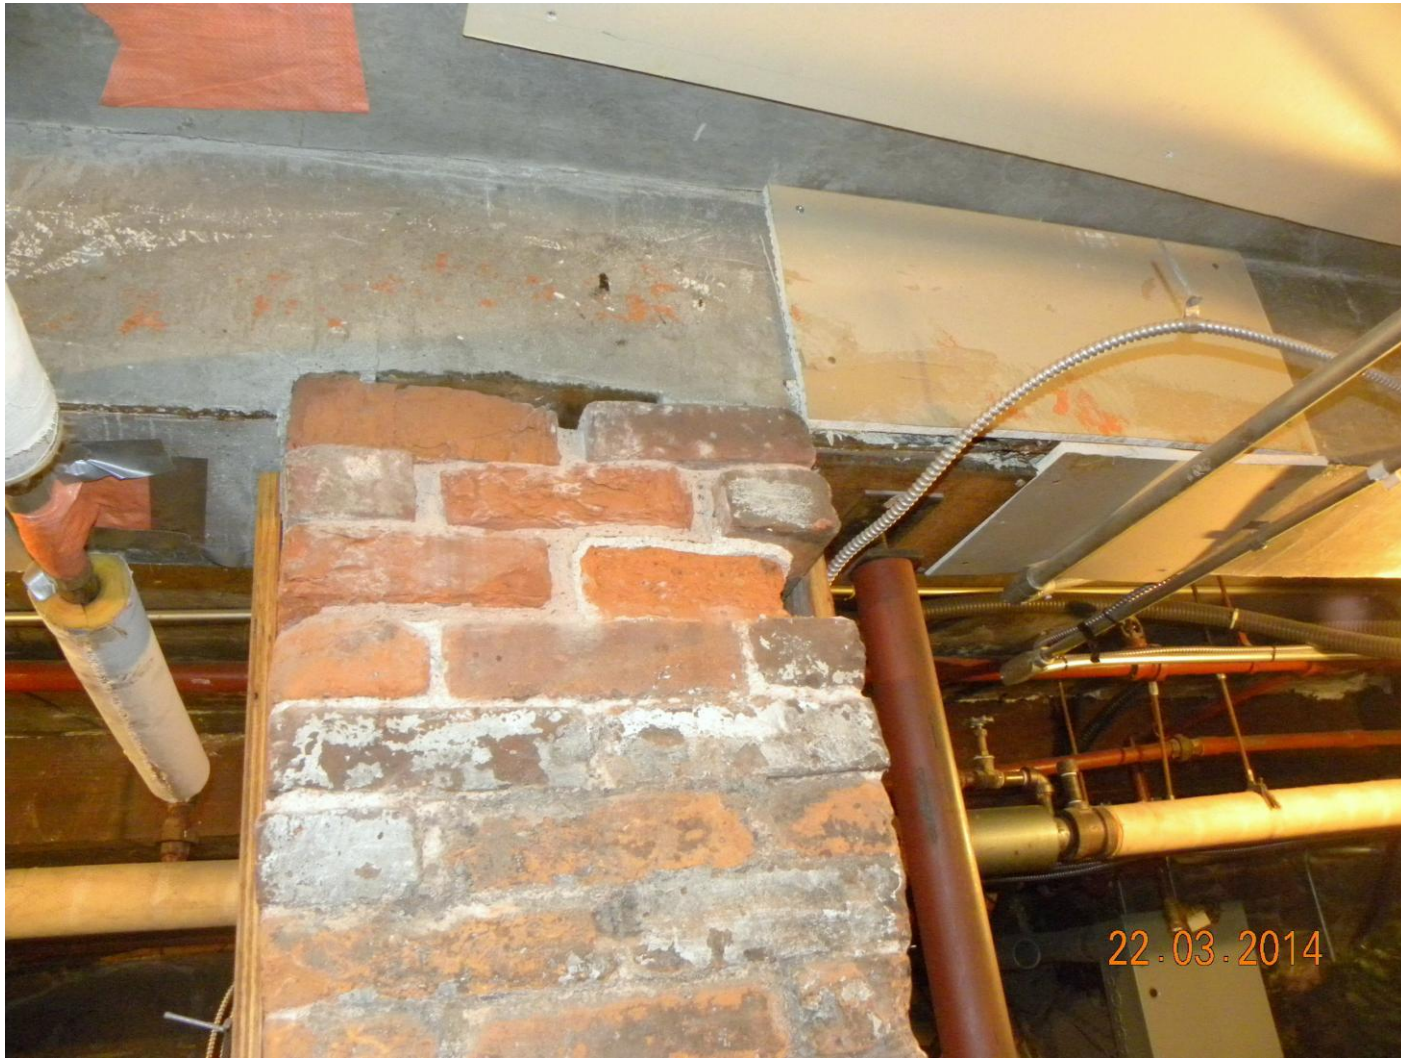
PHOTOGRAPH BSE-20:

Deteriorated clay bricks at the top North face of the masonry Column 3c. Viewing Southwest.

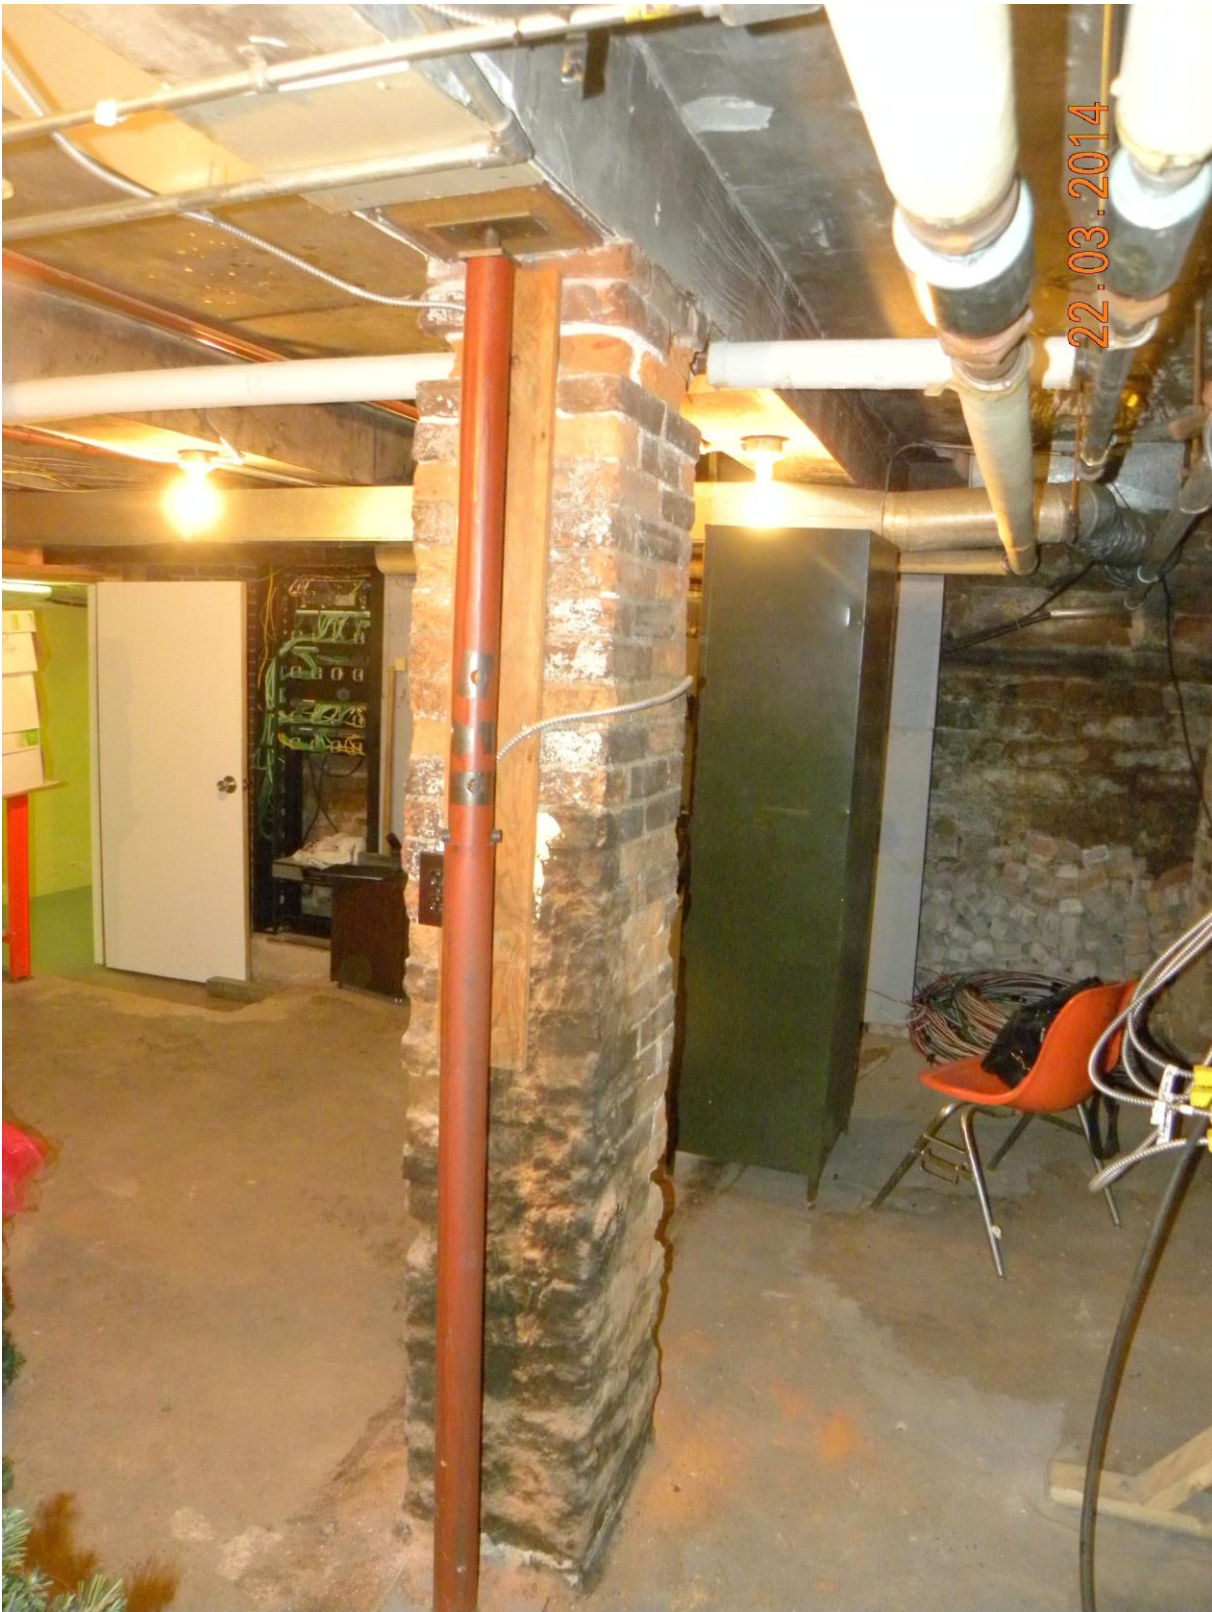
PHOTOGRAPH BSE-21:

Deteriorated clay bricks West and South faces of brick masonry Column 3c. Viewing Northeast.

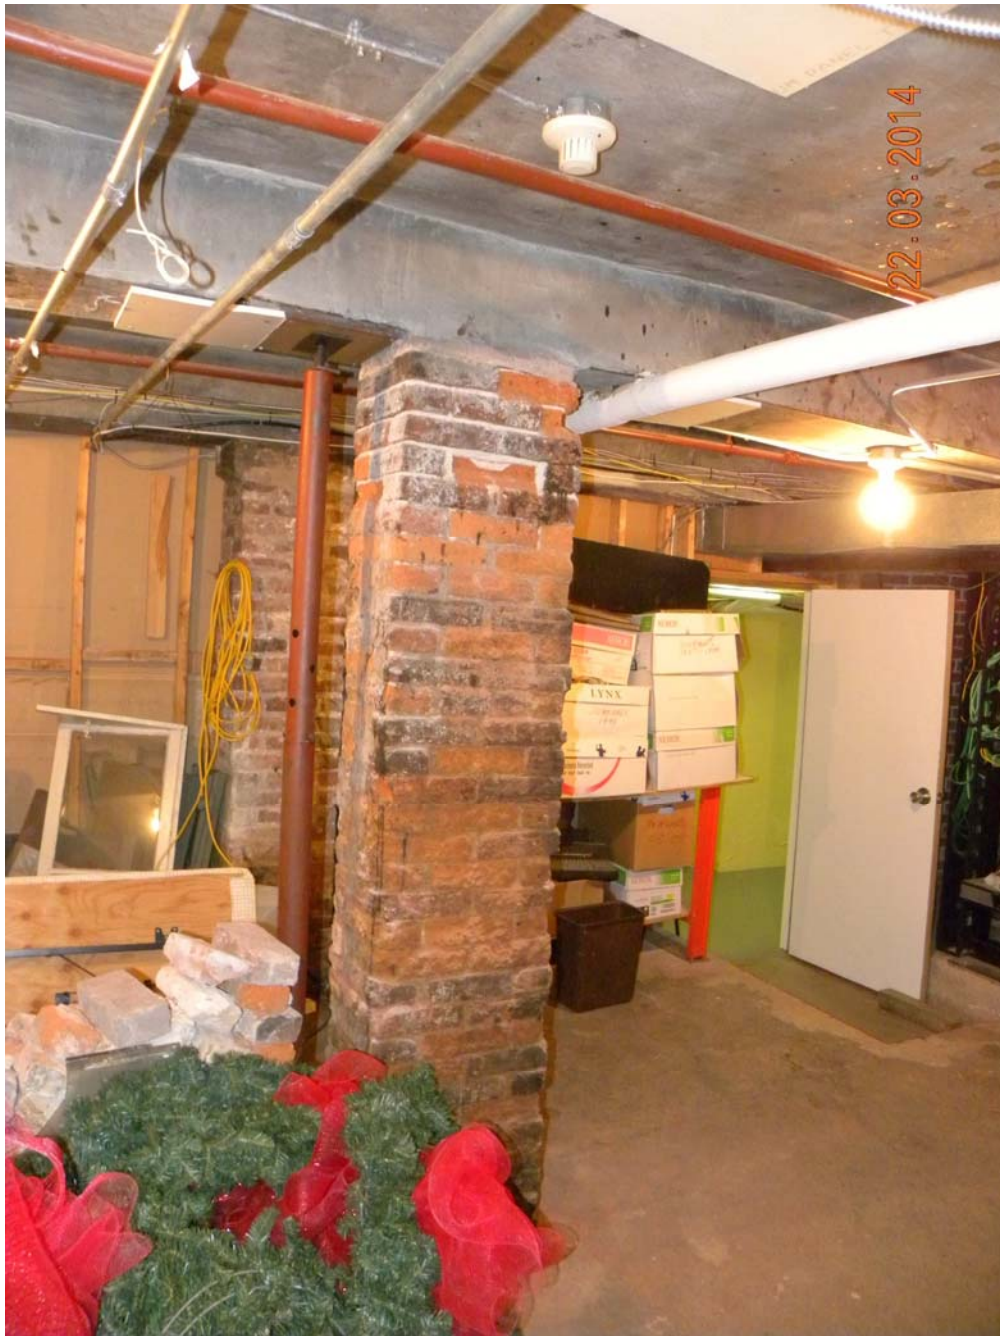
PHOTOGRAPH BSE-23:

South and West faces of brick masonry Column 3d. Viewing Northeast. Also shows the existing steel shore ("jack post") adjacent to the West face of the column. A decision was made to place an additional "jack post" adjacent to the East face of the column for support of the East/West spanning timber beam. This decision was made on the assumption that the timber beam is not a continuous beam but rather a simple beam that spans from Column 2c to 3c and from 3c to 4c. Deteriorated bricks can be seen on the South face. Viewing Southwest.

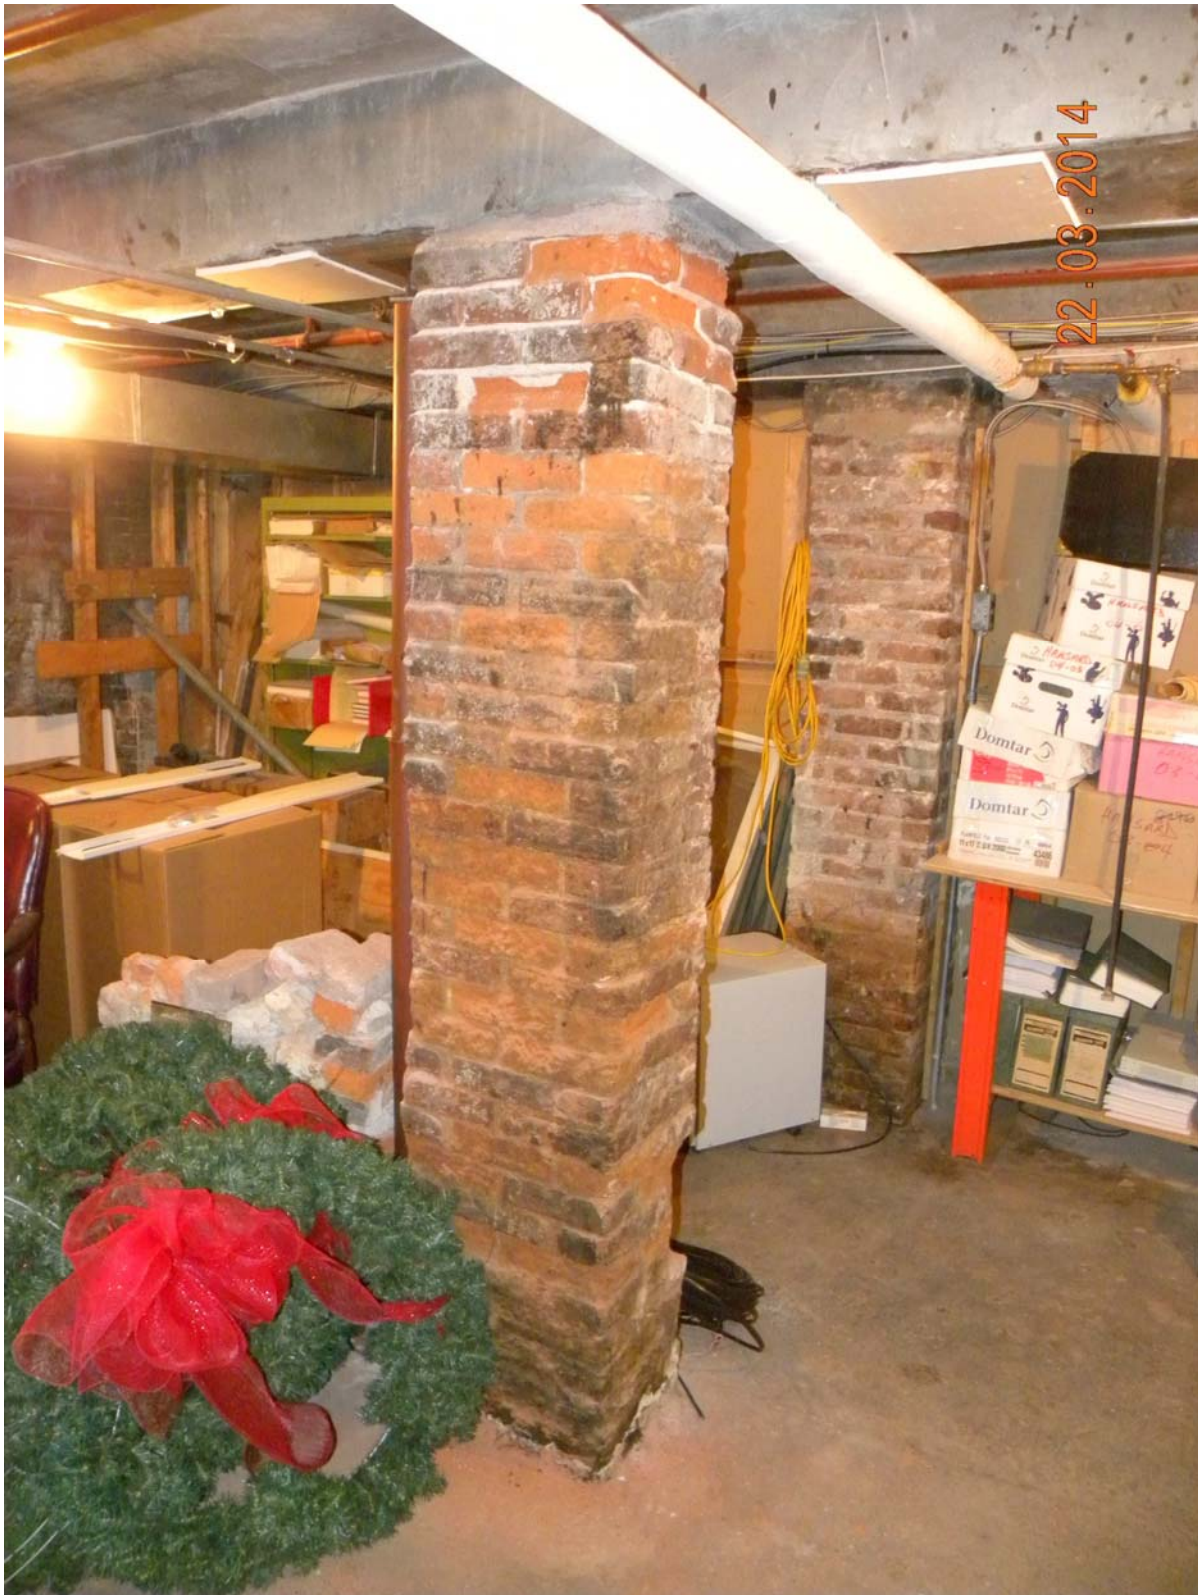
PHOTOGRAPH BSE-24:

South and East elevations of Column 3d. Viewing Southwest. Shows deterior-ated bricks on both faces.

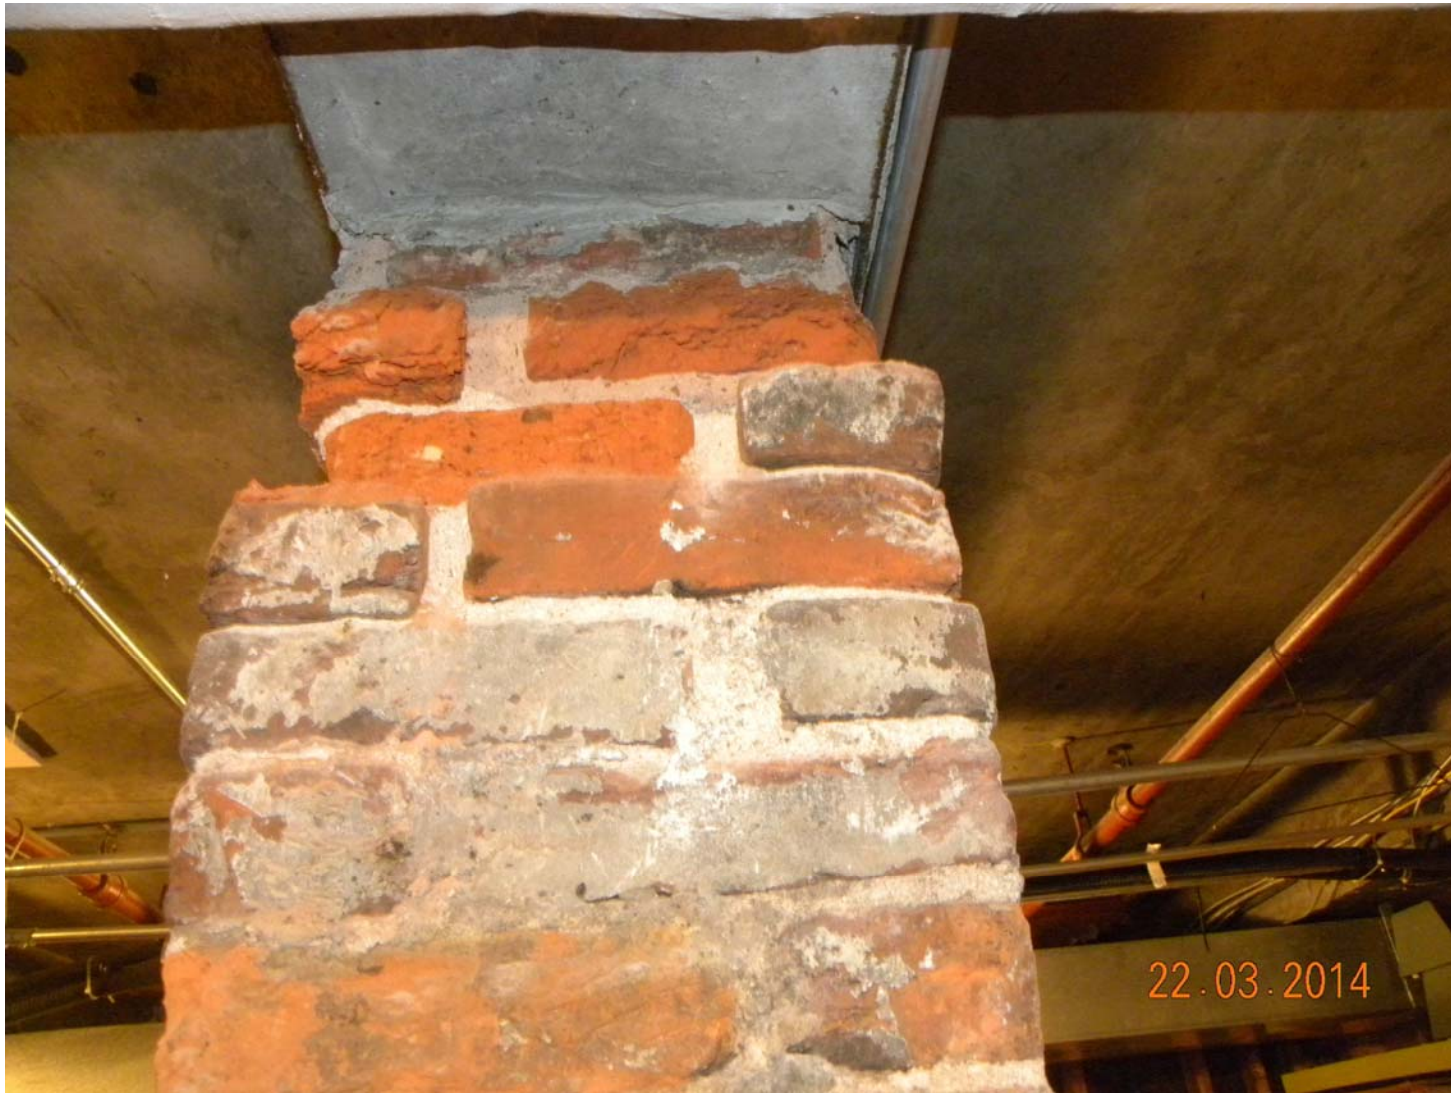
PHOTOGRAPH BSE-25:

Deteriorated bricks top of East face of Column 3d. Viewing West.

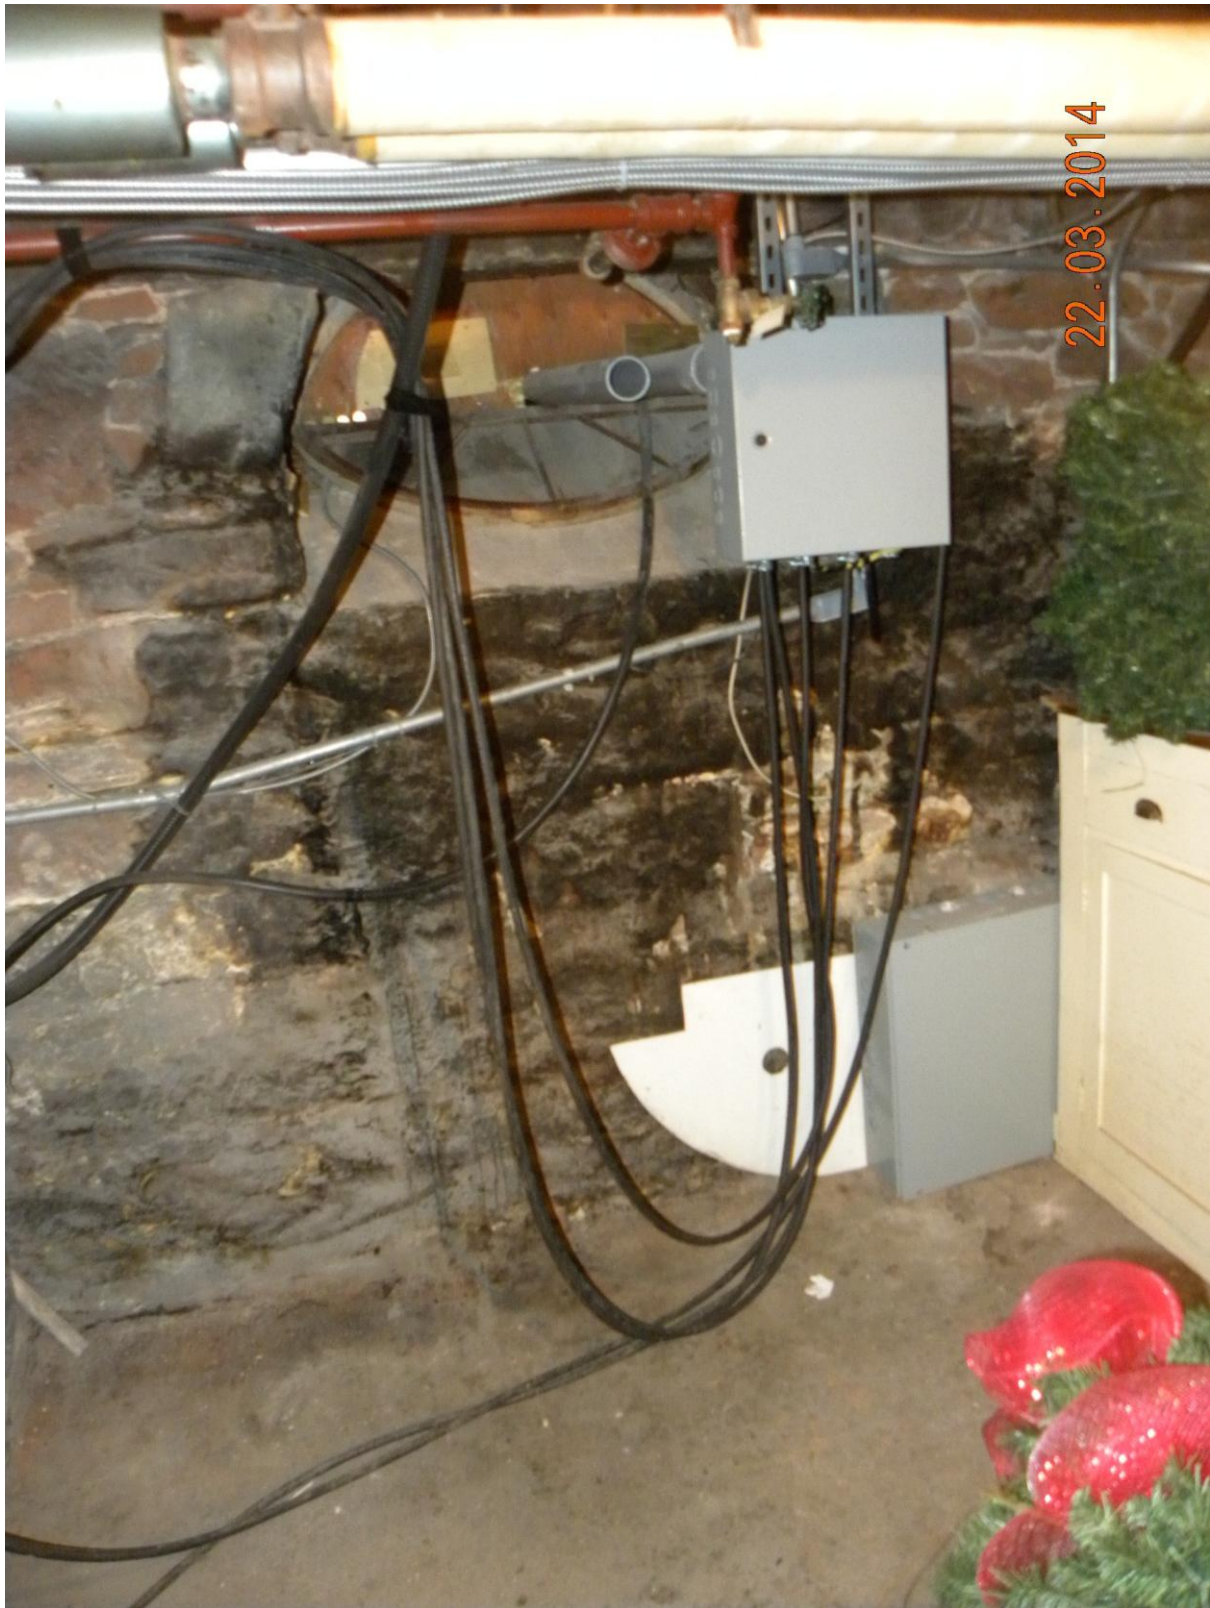
PHOTOGRAPH BSE-30:

The basement window of Room B14 located adjacent to the Southwest corner of Room B-14. Evidence of water leakage flowing through the window opening and down the face of the foundation wall.

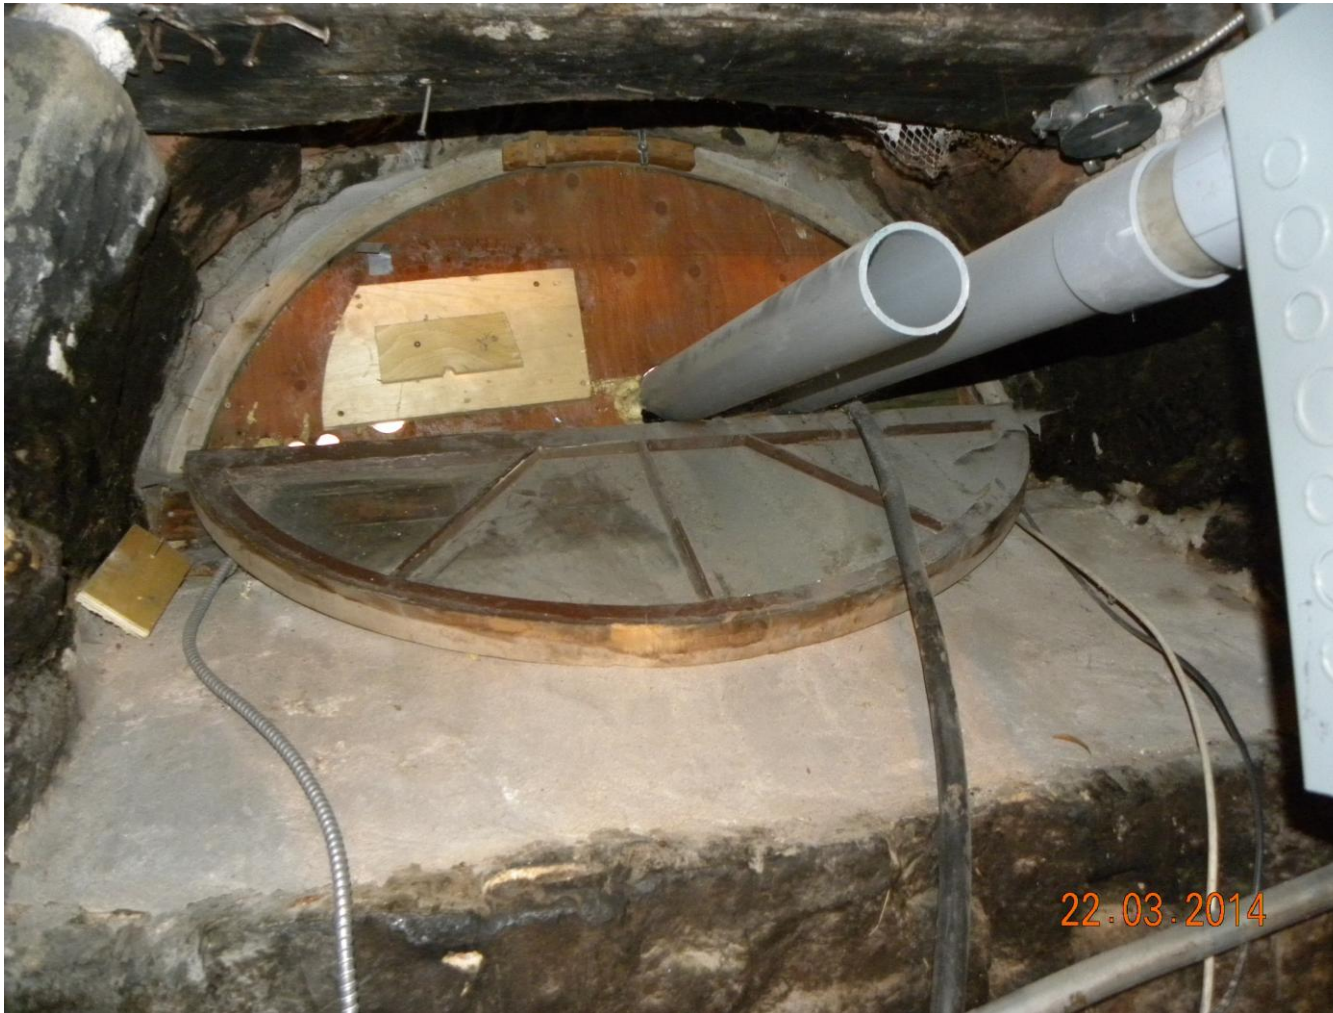
PHOTOGRAPH BSE-31:

The original basement window is lying on top of the foundation wall. The window opening is sealed with plywood sheathing. Two PVC conduits penetrate the plywood sheathing. Viewing South.

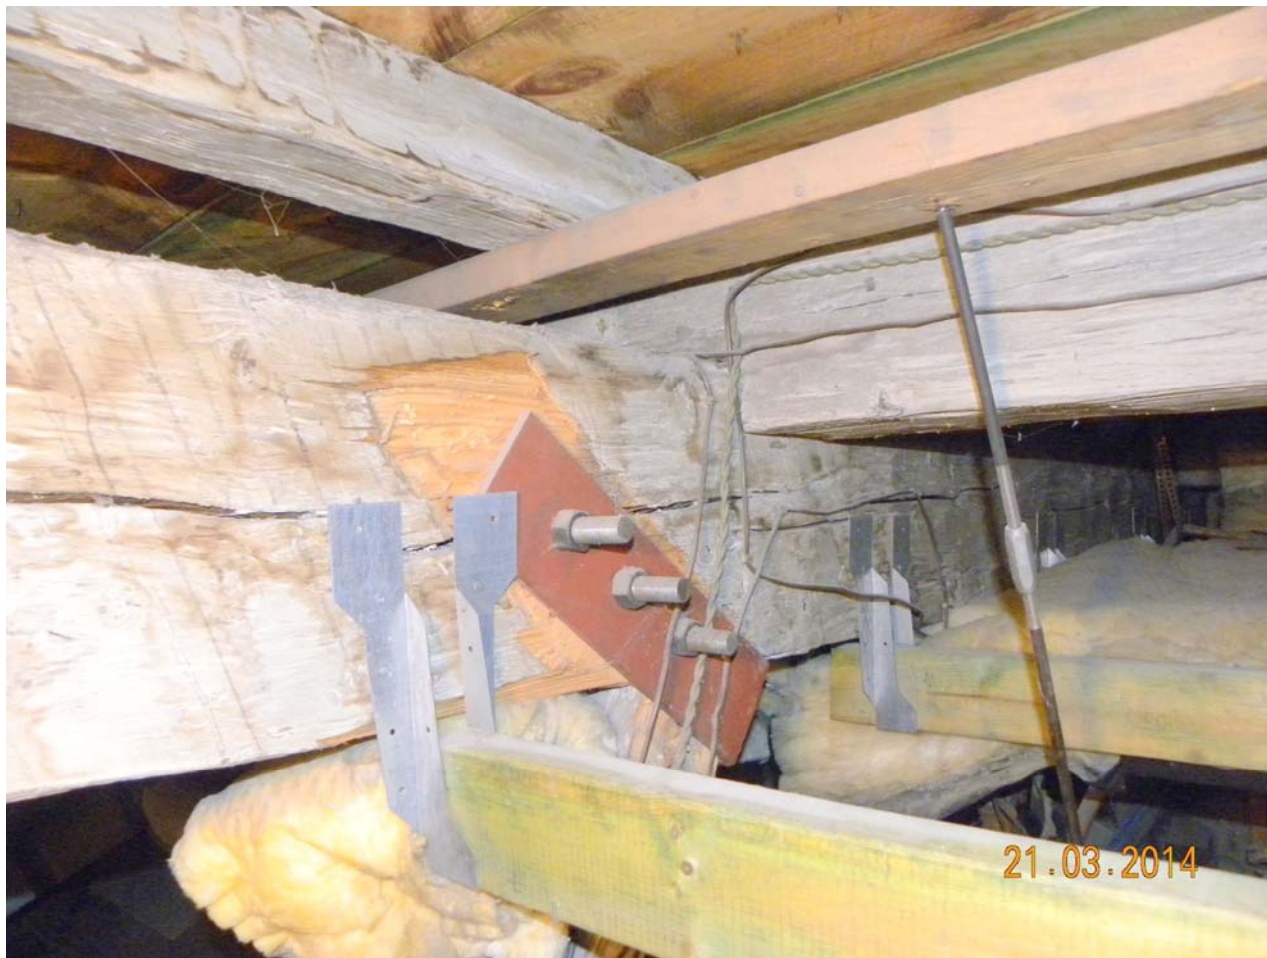
PHOTOGRAPH RF-2:

The top chord of the roof truss on Gridline 7. A continuous crack exists at approximately mid depth of the top chord of the roof truss. The top steel bolt of the steel plate connection is located at the centre of the wide crack in the top chord. The bottom bolt is located near the bottom of the top chord. Viewing Southeast.

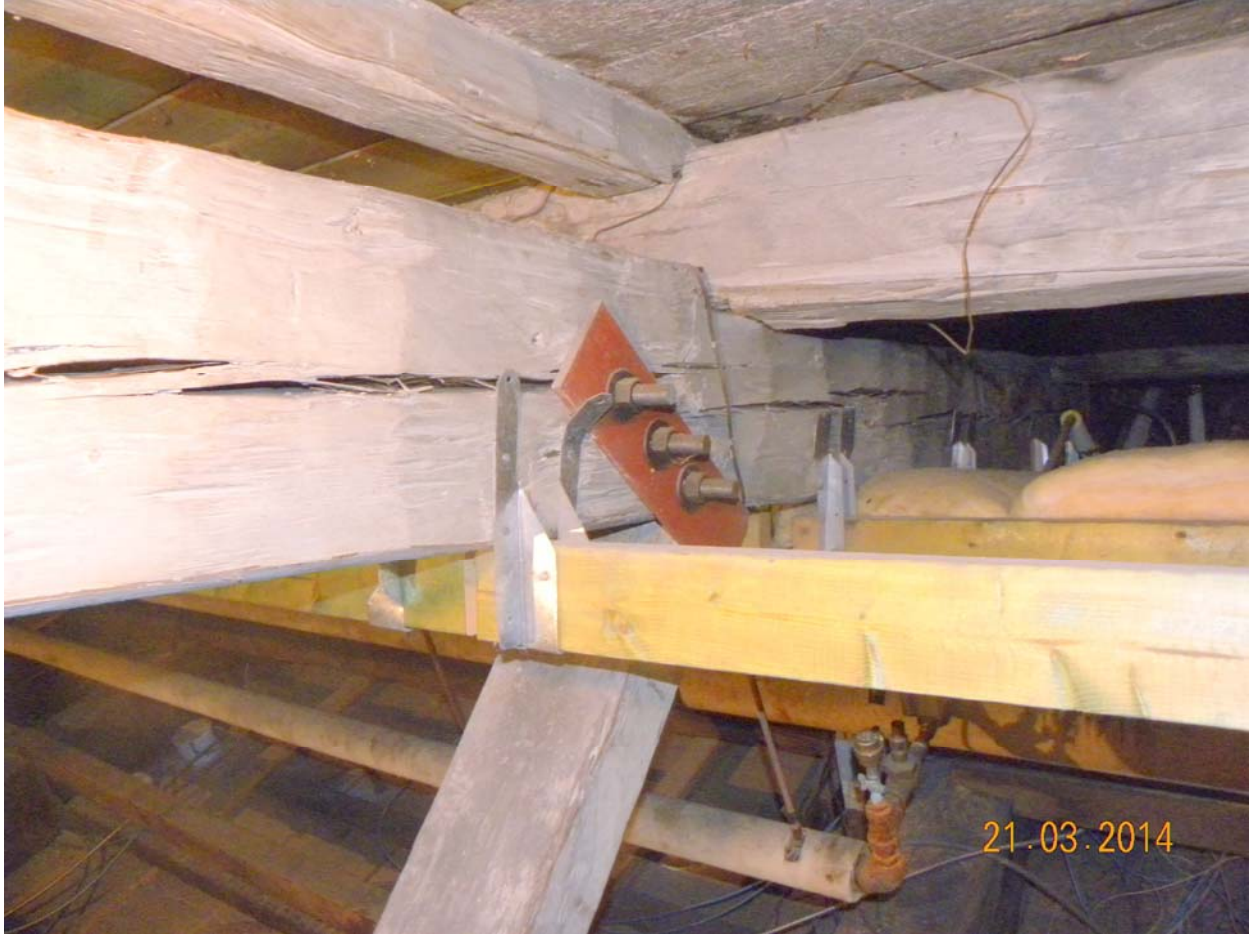
PHOTOGRAPH RF-3:

Top chord with steel bolted connection of roof truss on Gridline 3. Viewing Southeast. A wide continuous crack exists at mid height of the top chord. The top bolt passes through the crack. The bottom bolt is close to the bottom edge of the top chord. A structural analysis should be conducted on the truss including the connections as the connections may have inadequate strength because of bolting through the wide cracks and inadequate edge distance. Viewing Southeast.

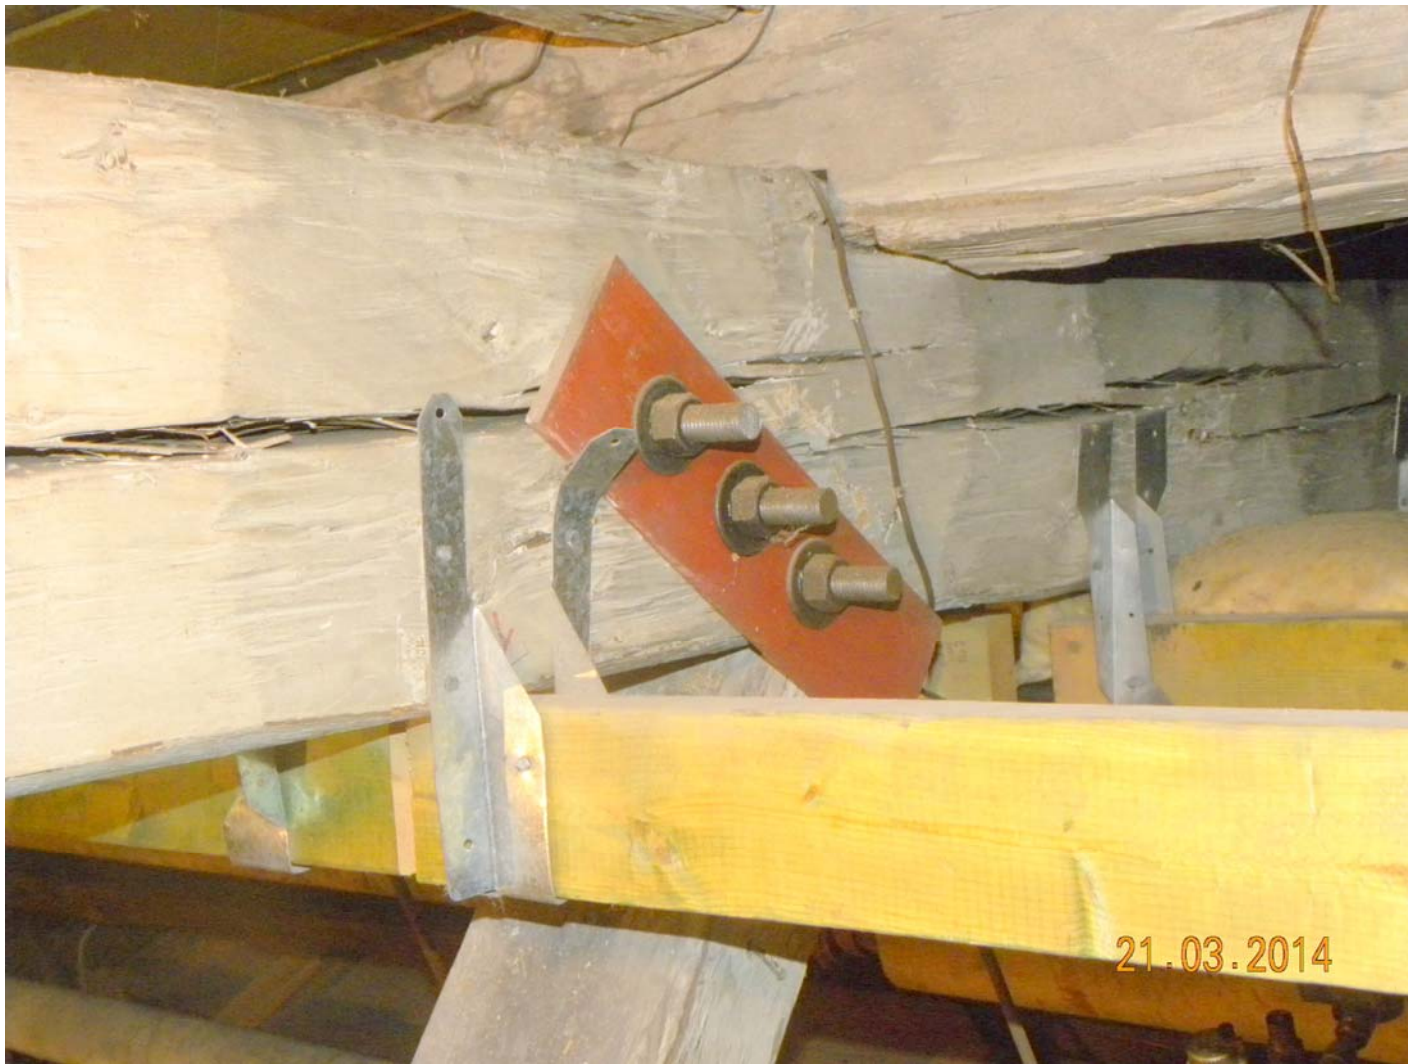
PHOTOGRAPH RF-4:

Close-up of the steel connection shown in Photograph RF-3. Shows the wide continuous crack located at mid height of the top chord of the truss. Viewing Southeast.

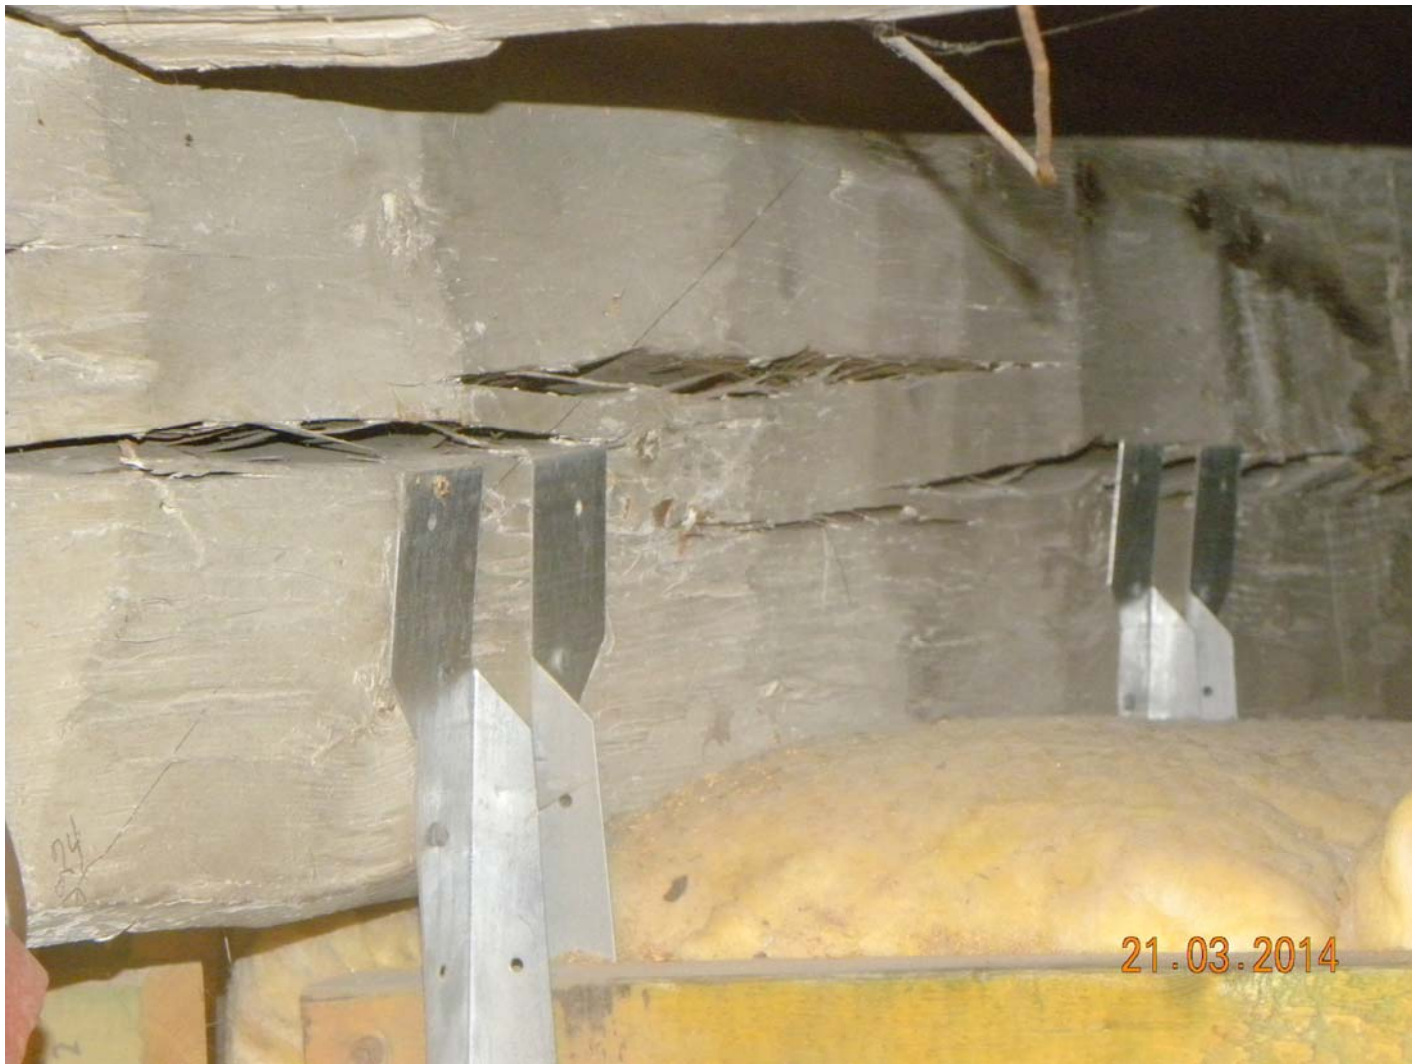
PHOTOGRAPH RF-5:

An example of continuous cracking at mid height along the top chord of Roof Truss 3. Viewing Southeast.

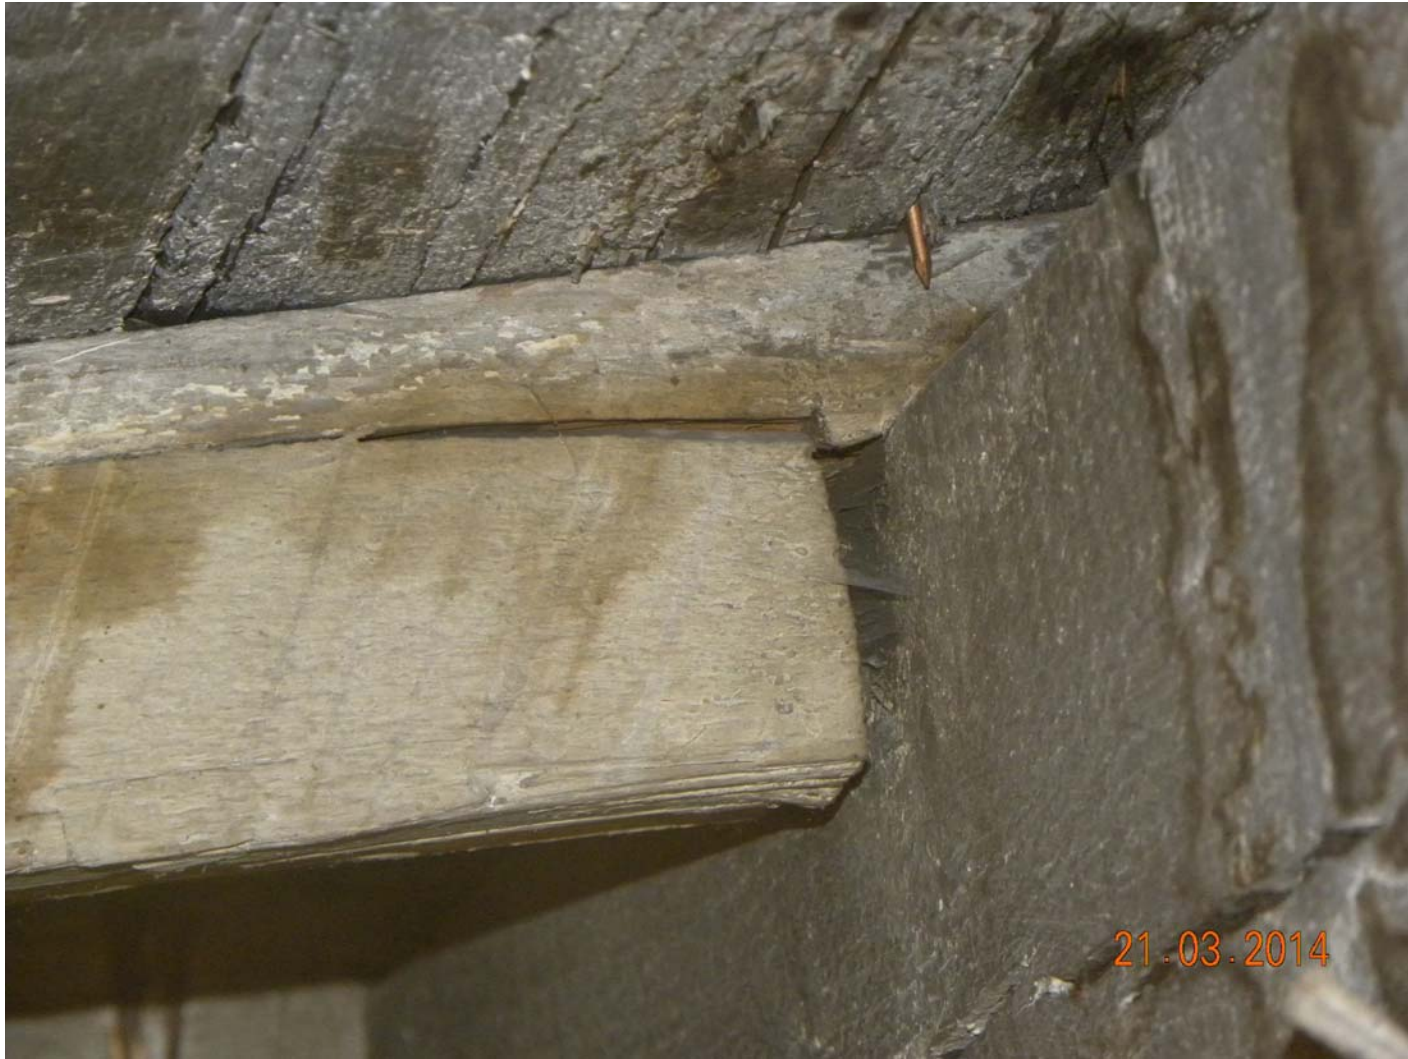
PHOTOGRAPH RF-10:

however, did observe instances where the roof framing is severely cracked and in one instance where **a** roof rafter is in imminent danger of shear failure and collapse.

Shows the failed notched end of the 3 ½ in. deep x 4 in. wide roof rafter. Viewing West. **Within time, collapse is imminent.**

If the defects observed by Cowie are representative of **the** timber framed construction throughout the roof, it is recommended the glass fibre batt insulation be removed from the underside of the roof framing, a detailed inspection and documentation be made of the roof framing. Where defects/damage is detected, temporary strengthening/shoring should be implemented. This work could be done without disturbing the occupants of the building.
