REPORT TO
CAMECO - A CANADIAN MINING & ENERGY CORPORATION

COMPLETION REPORT
BLUFFS STABILIZATION DEMONSTRATION
SECTIONS B5 AND B13
LAKE ONTARIO BLUFFS AREA
PORT GRANBY WASTE MANAGEMENT FACILITY
PORT GRANBY, ONTARIO

December, 1989

891-1529

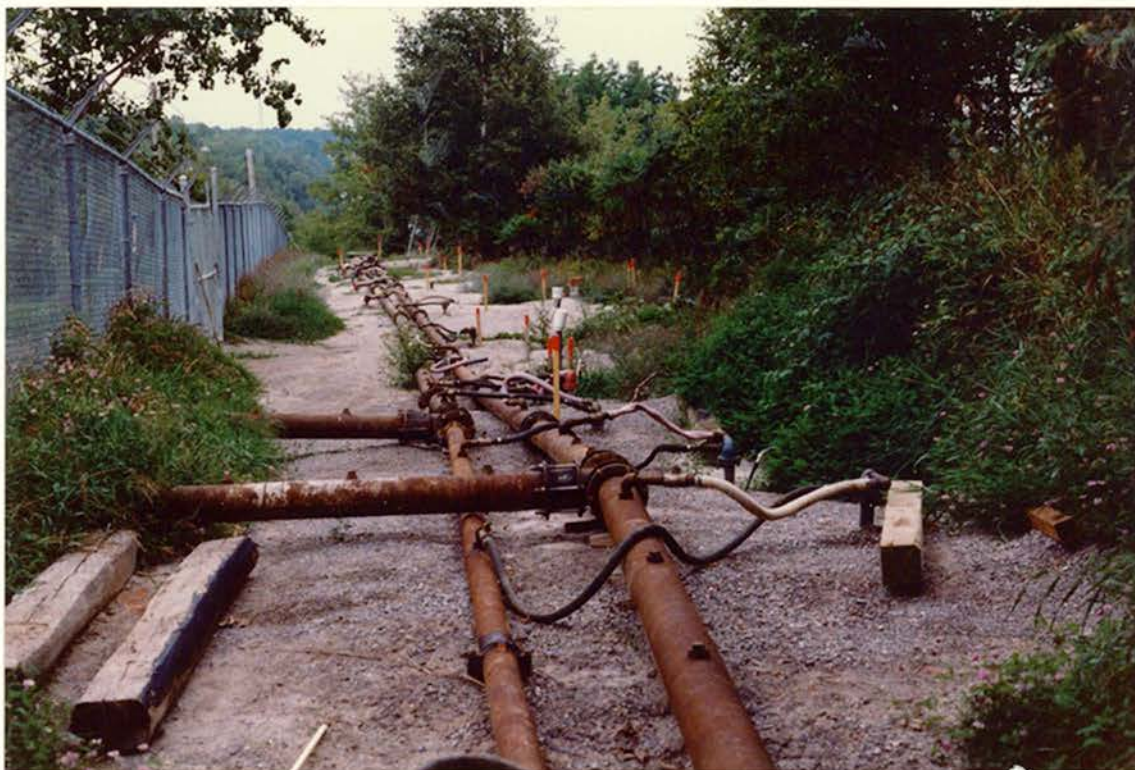
The locations of the 25 eductor wells used for the Section B5 and B13 Demonstration Project are shown on Figure 2. Twenty-four of these wells were installed during the 1989 construction. Well E6 was installed as part of the 1988 eductor trial (Reference 3) and was originally called 6P5. Photograph 1 is a perspective looking east along the wells from well E2.

PHOTO 1: Eductor Wells and Header Pipes, Looking East
 from Well E2.

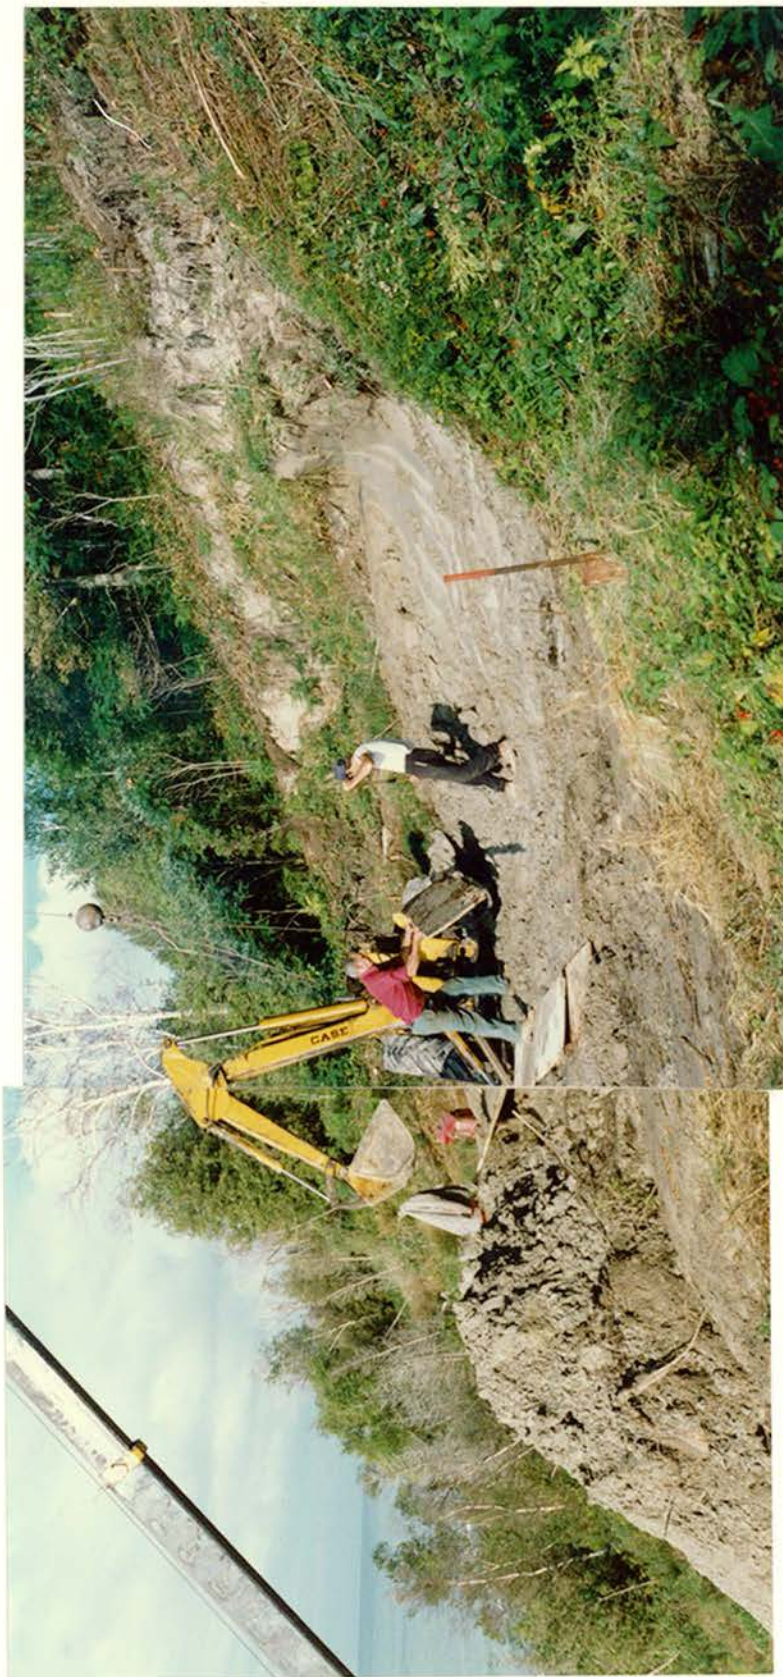
Once the trees had been removed from the eroded areas and the access roads were in place, the Case 580 was lifted in two pieces to the middle of the work area on the Middle Till. In places, the mudflow material was found to be sensitive to vibration and water (rain), it being necessary to support the backhoe on a platform of strips of plywood (see Photograph 2).

PHOTO 2: Initial Conditions, August 22, 1989.

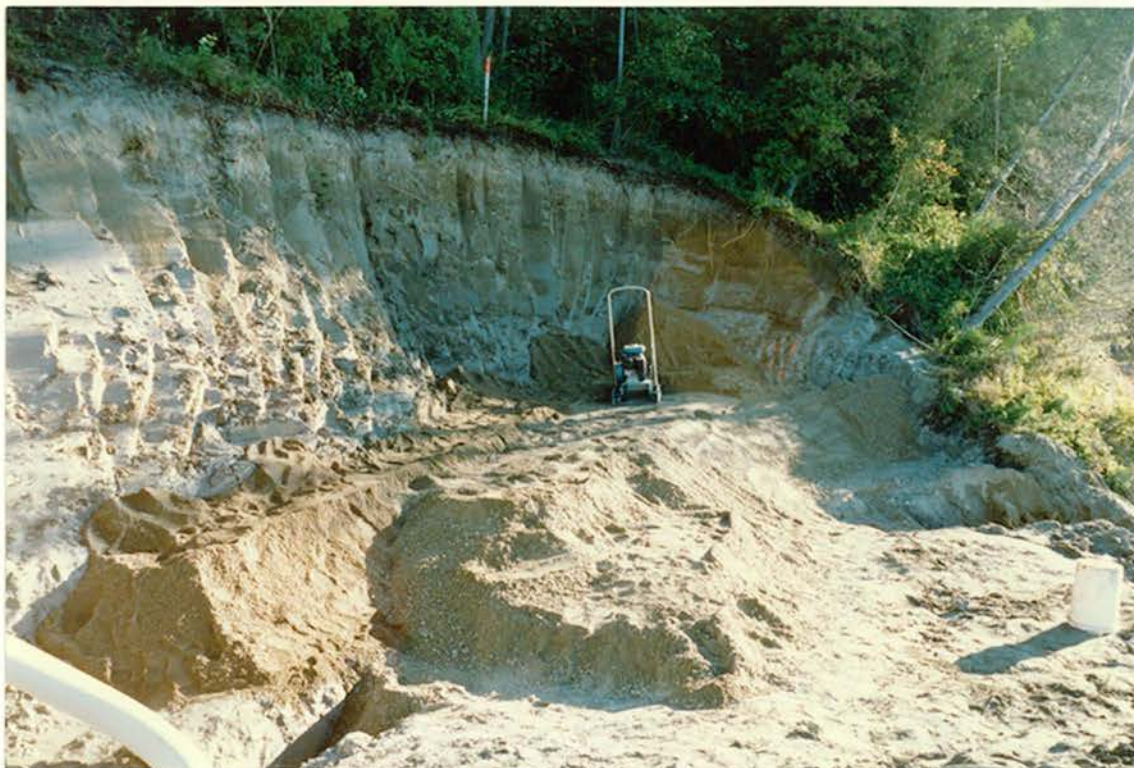
During excavation of the drainage trench, water was observed to seep from the silt between the till surface and about 0.5 m above the till surface in some locations. As the trench excavation progressed, layers and patches of loosened silt were removed and a blanket of concrete sand

was immediately placed over the silt, allowing the water to escape but preventing migration of the fine silt particles (see Photograph 3).

PHOTO 3: Initial Placement of Sand Filter and Granular "A" Material at East End. Note: part of this area was subsequently re-excavated to install the catch basin.

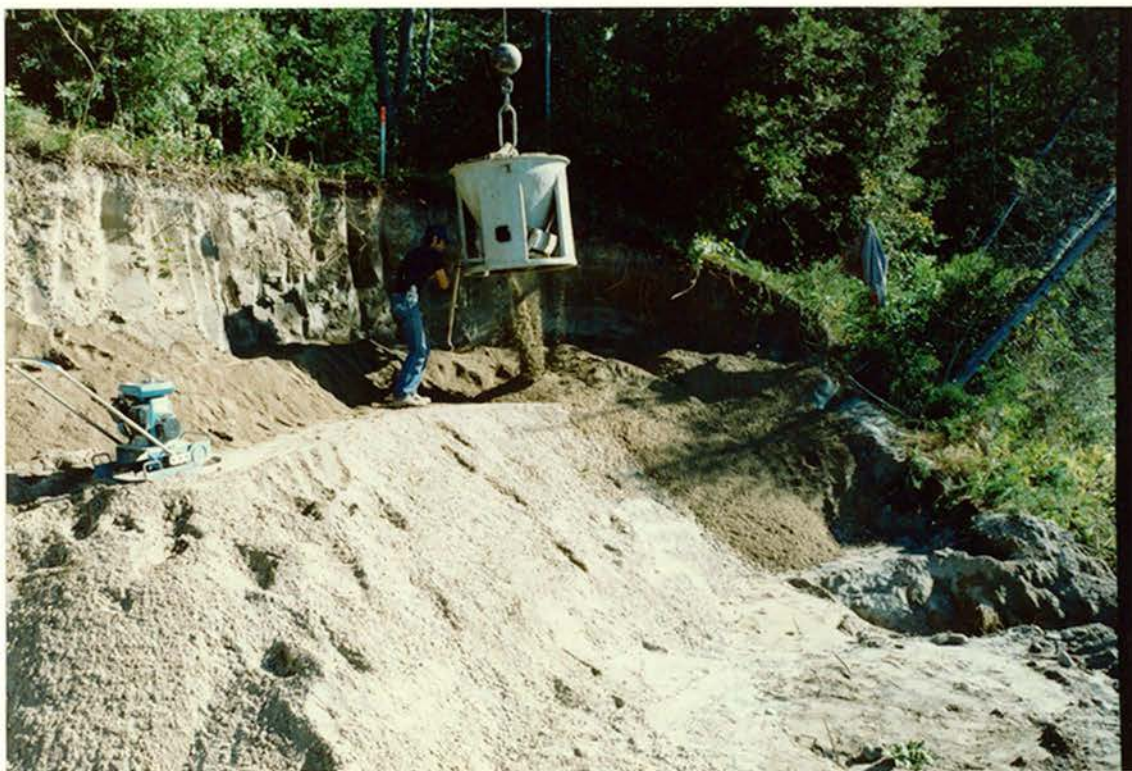
PHOTO 4: Initial Placement of Sand and Granular "A" Material at East End. Note: part of this area was subsequently re-excavated to install the catch basin.

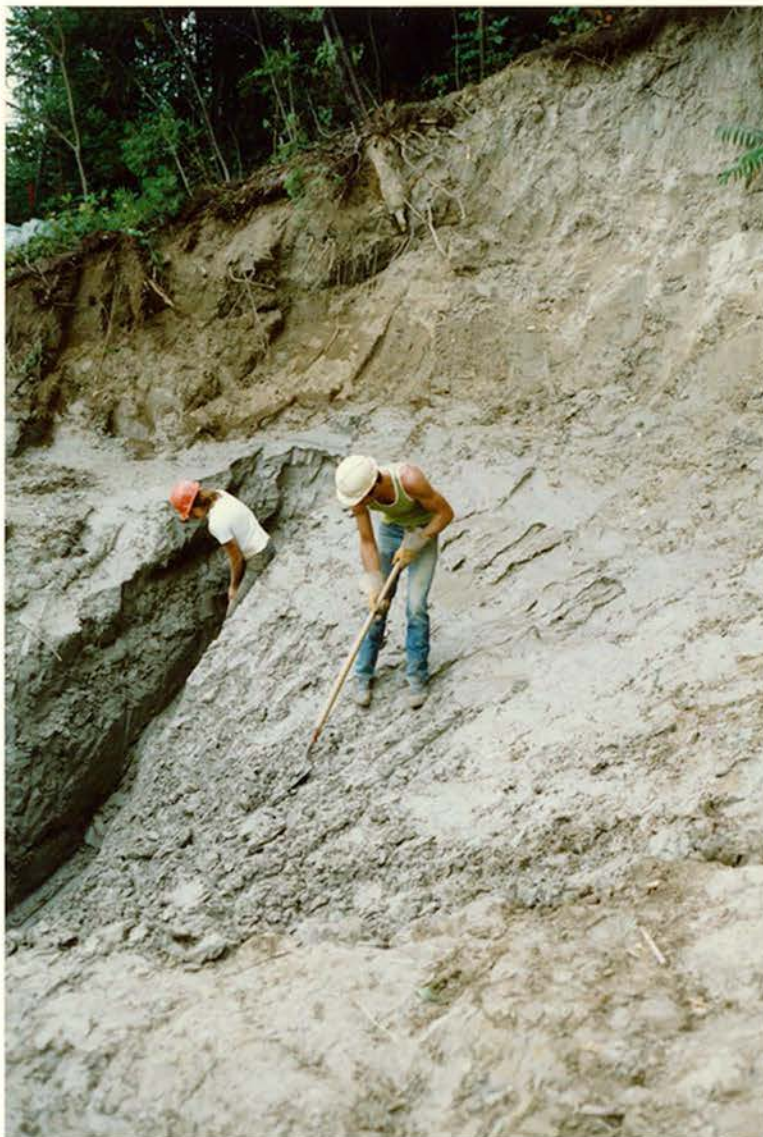
Photographs 5 and 6 illustrate this work at the west end of the site.

PHOTO 5: Excavation of Drainage Trench at West End of Site. Sloped Portion of Trench is in Lacustrine Silt.

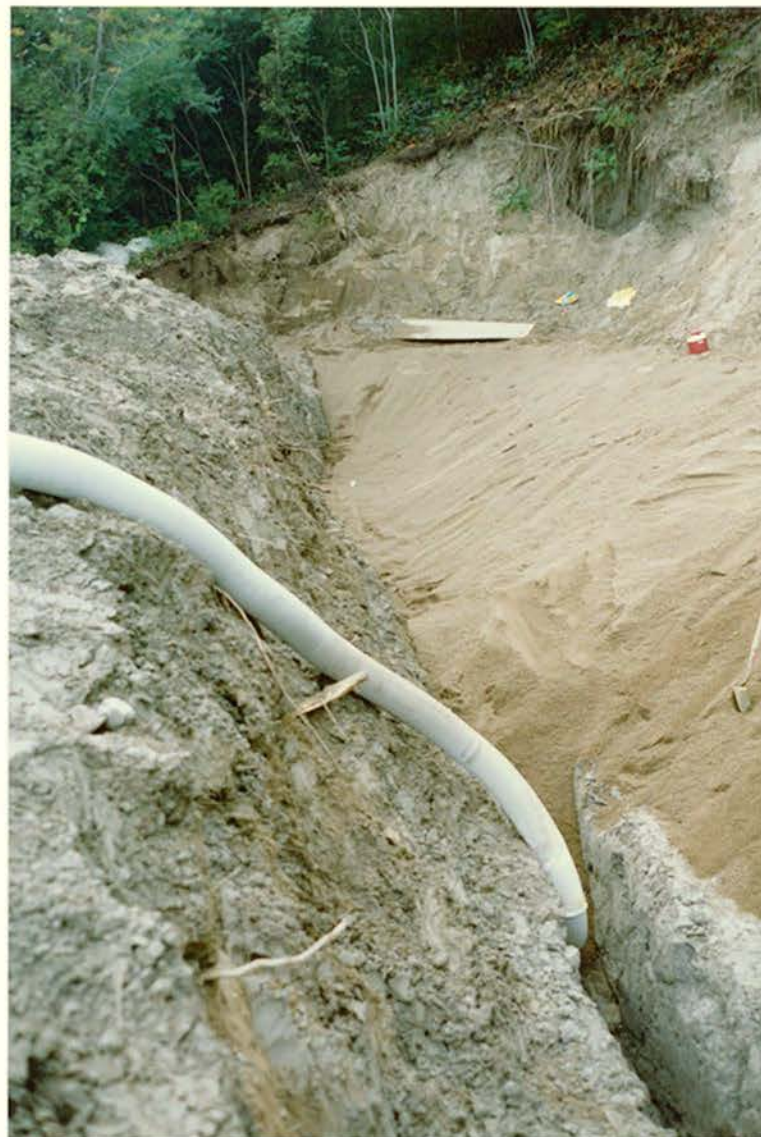
PHOTO 6: Drain Pipe and Initial Lift of Filter Sand in Place at West End of Site.

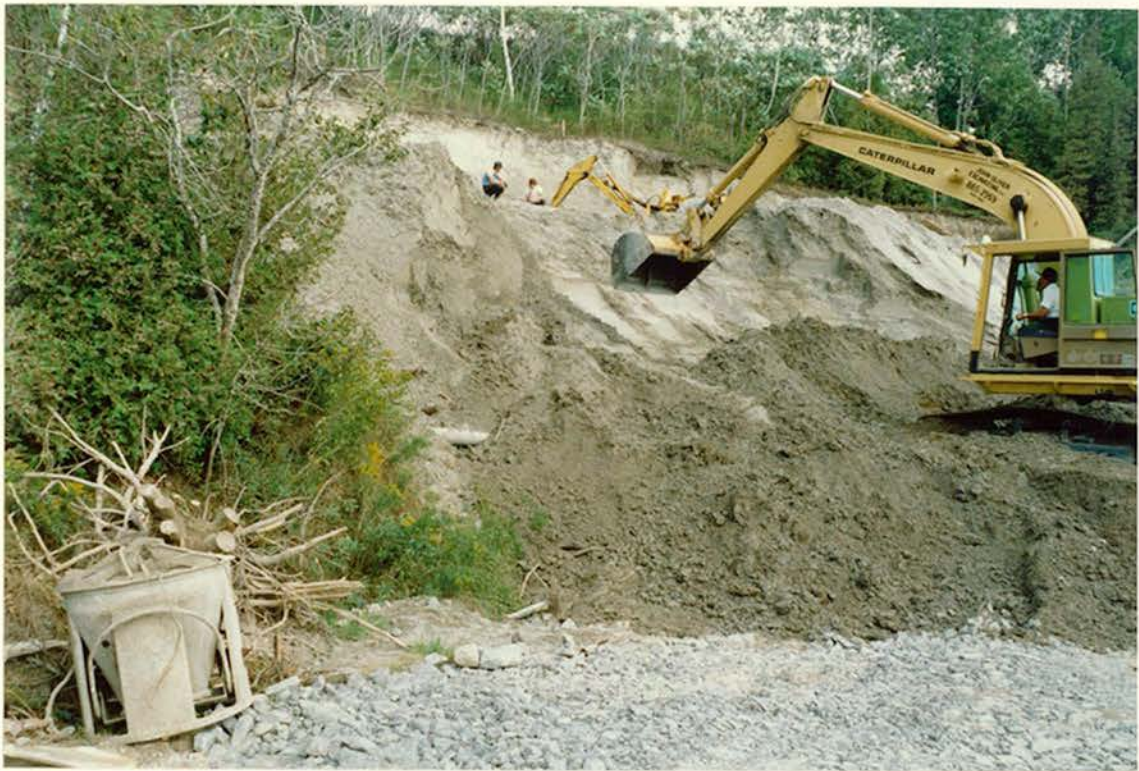
PHOTO 7: Cleaning and Grading Lower Slope.

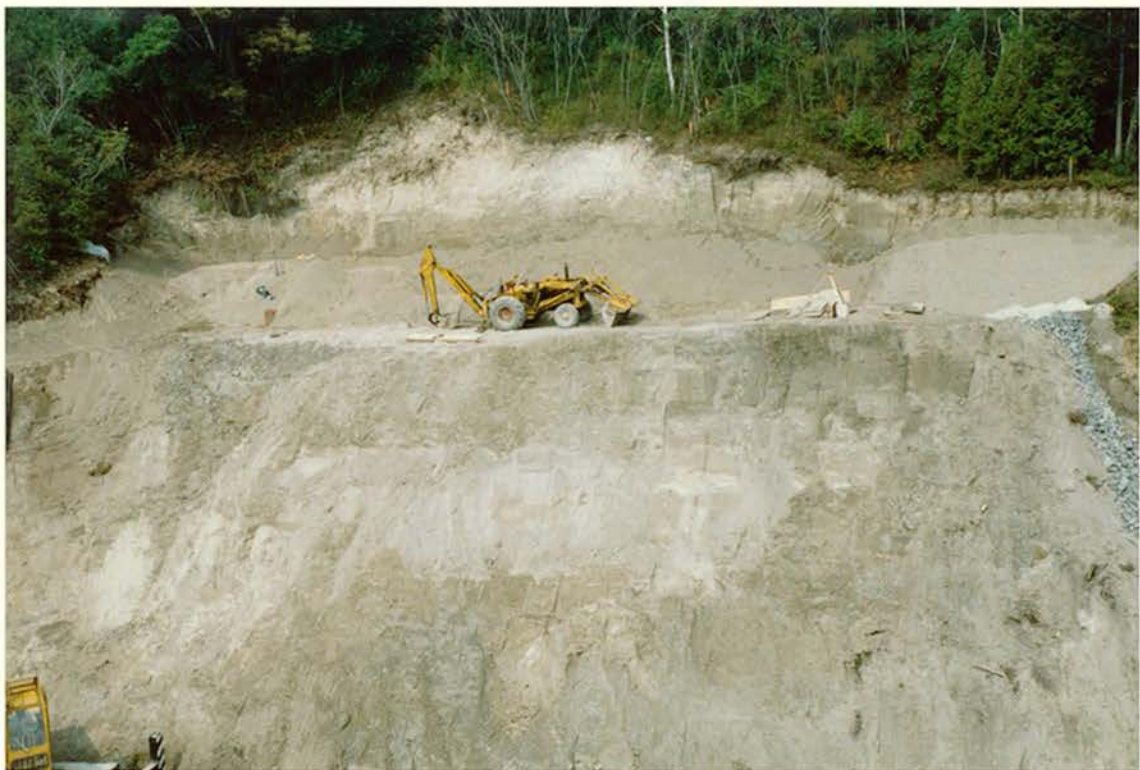
Excavation for the filter/drainage layer commenced on August 22, 1989 and was completed by August 31, 1989, with the exception of the excavation for the concrete catch basin installation which was carried out September 11, 1989. Total excavation from the upper bank was about 250 m³.

PHOTO 8: Excavation Complete (except for catch basin), August 31, 1989.

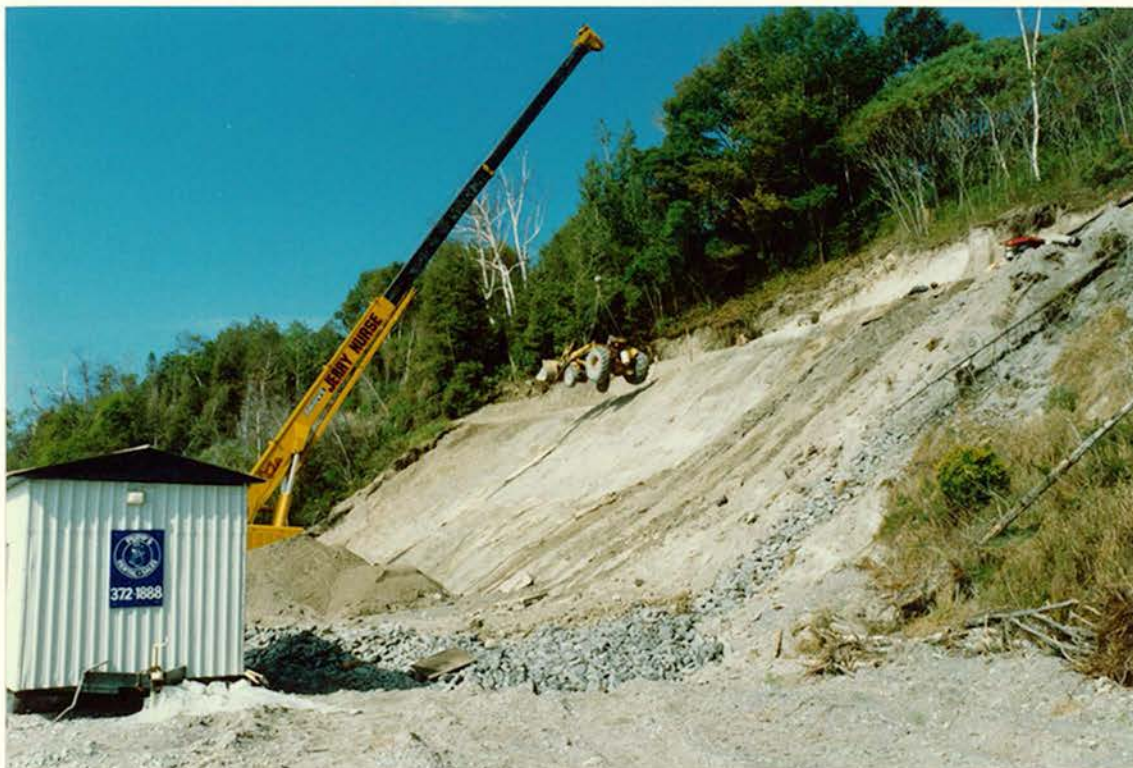
PHOTO 9: Demobilizing Case 580 Excavator (in two pieces).

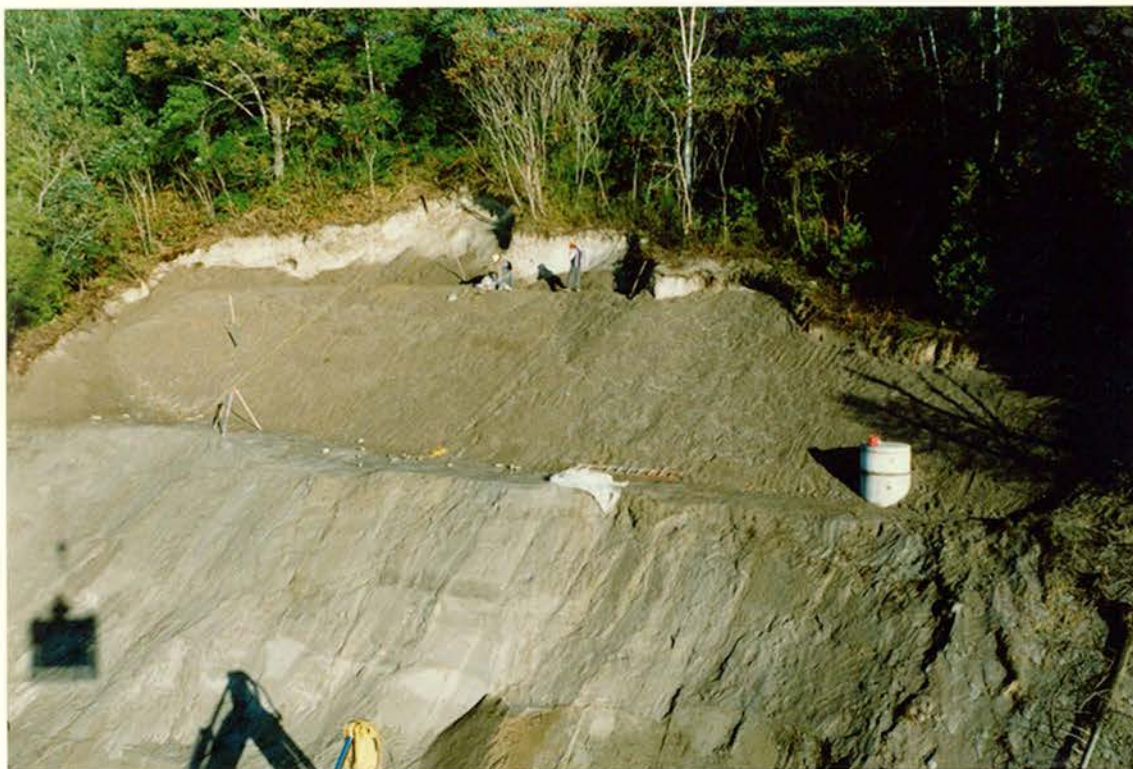
PHOTO 10: Nearing Completion of Sand Filter and Granular "A" Placement.

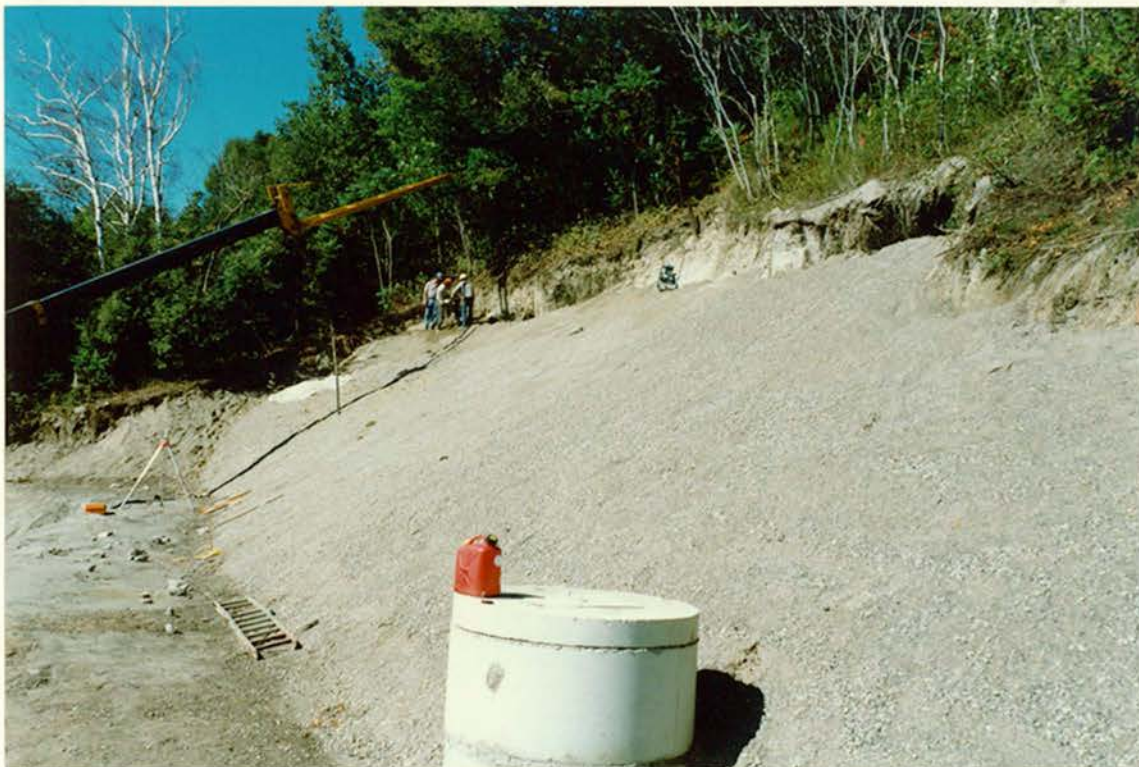
PHOTO 11: Crane Working at the Limit of its Reach.

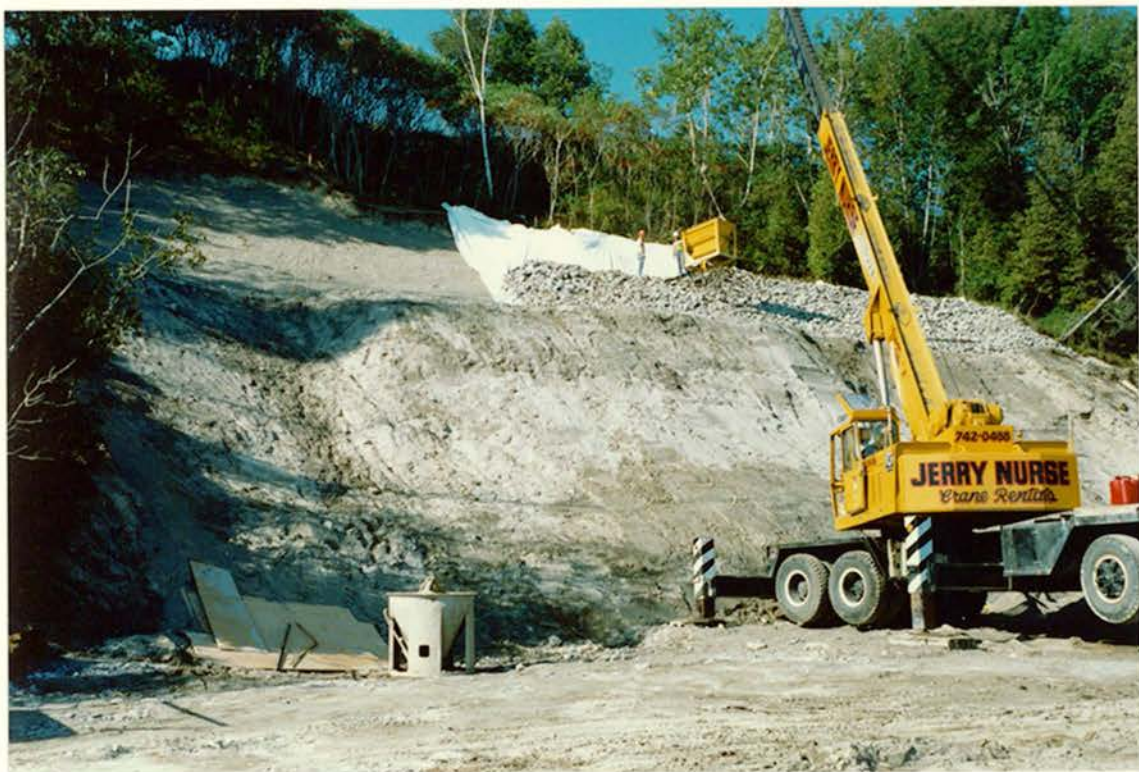
PHOTO 12: Rockfill Placement.

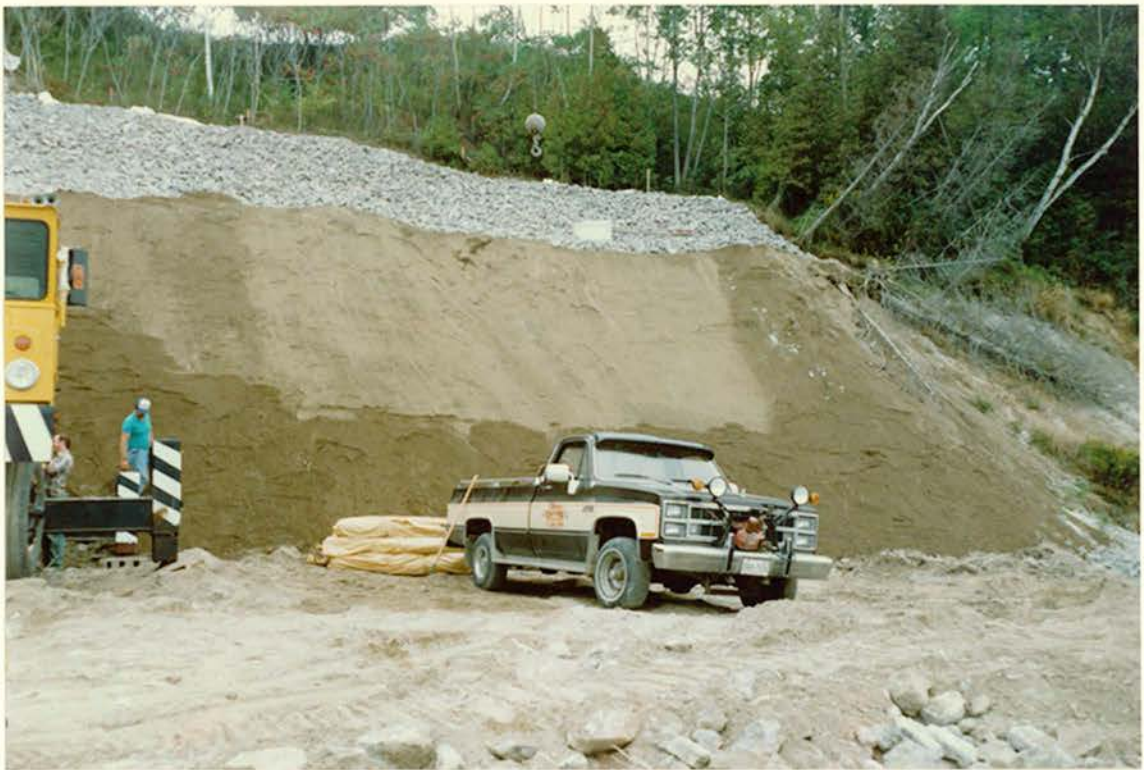
Grass had begun to grow by October 3, 1989. Once the vegetation is thoroughly established on the lower slope, Sections B5 and B13 should require minimal maintenance. However, in the interim, it may be necessary to replace topsoil and to reseed some areas.

PHOTO 13: Topsoil in Place on Lower Slope.

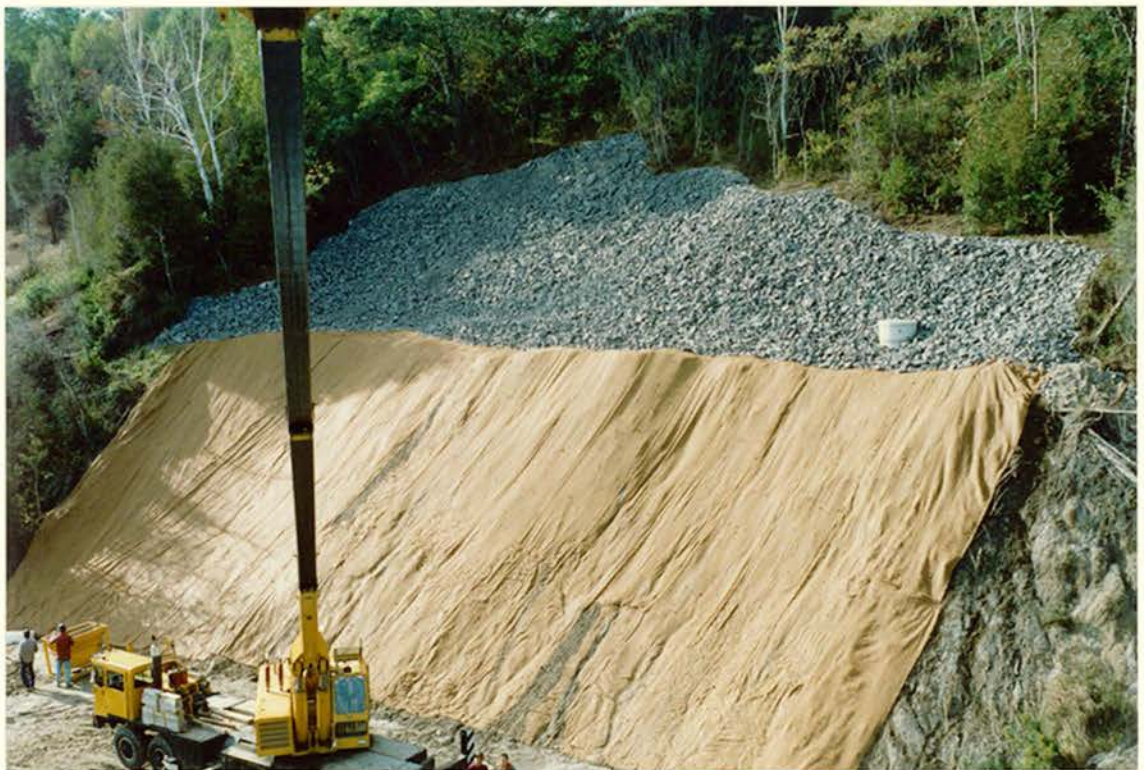
PHOTO 14: Reconstruction Work Complete (except for regrading at the toe of the slope).
