Report No. 6608-63-01
ASSESSMENT OF FOUNDATION WALLS
Québec City Armoury
East Building
Québec (Québec)
ARCOP/DFS/STGM
Consortium of Architects
File No. 6608-63
November 2014

Project Title:
Foundation Wall Assessment
Québec City Armoury
East Building
Québec (Québec)

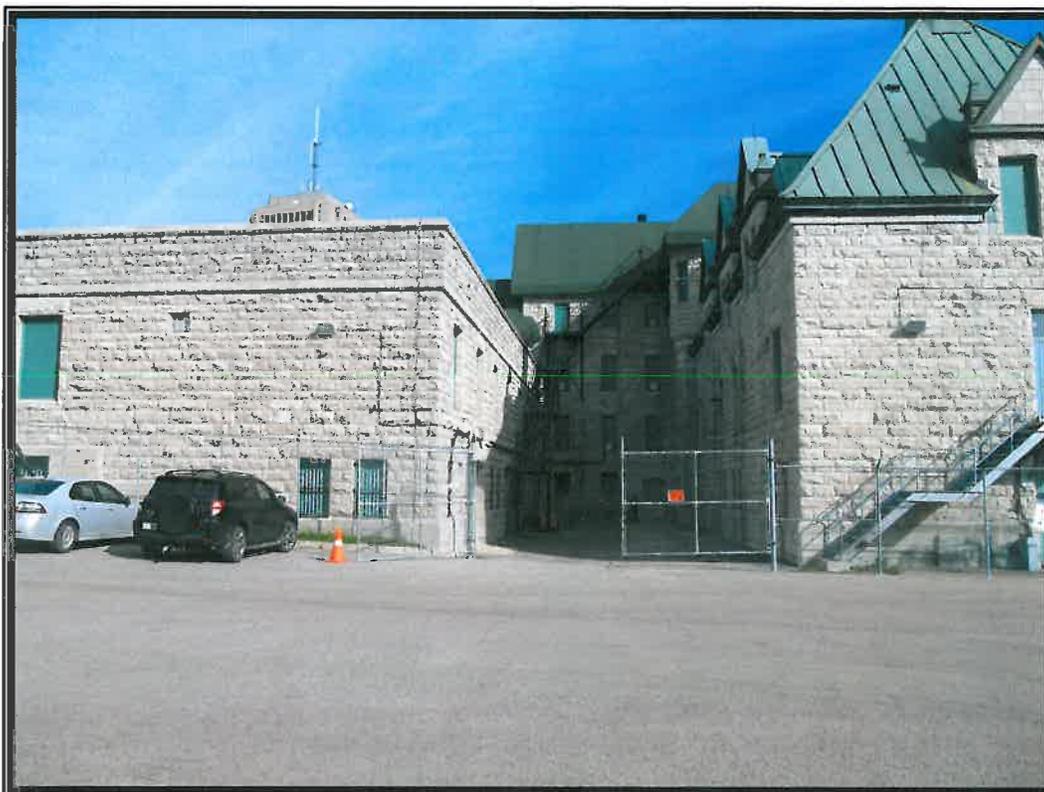
Picture 1 : View of the east building (right) of the Québec City Armoury. (2013-06-06)

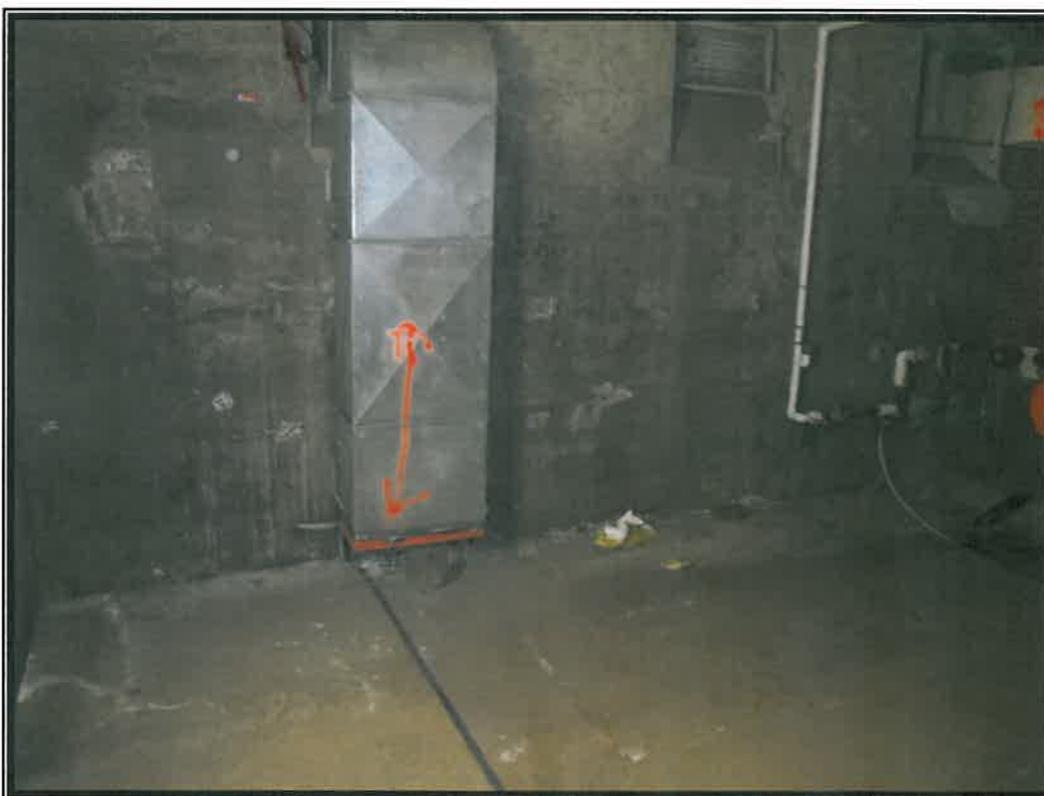
Picture 2 : View of the front wall of the east building. (2013-06-06)

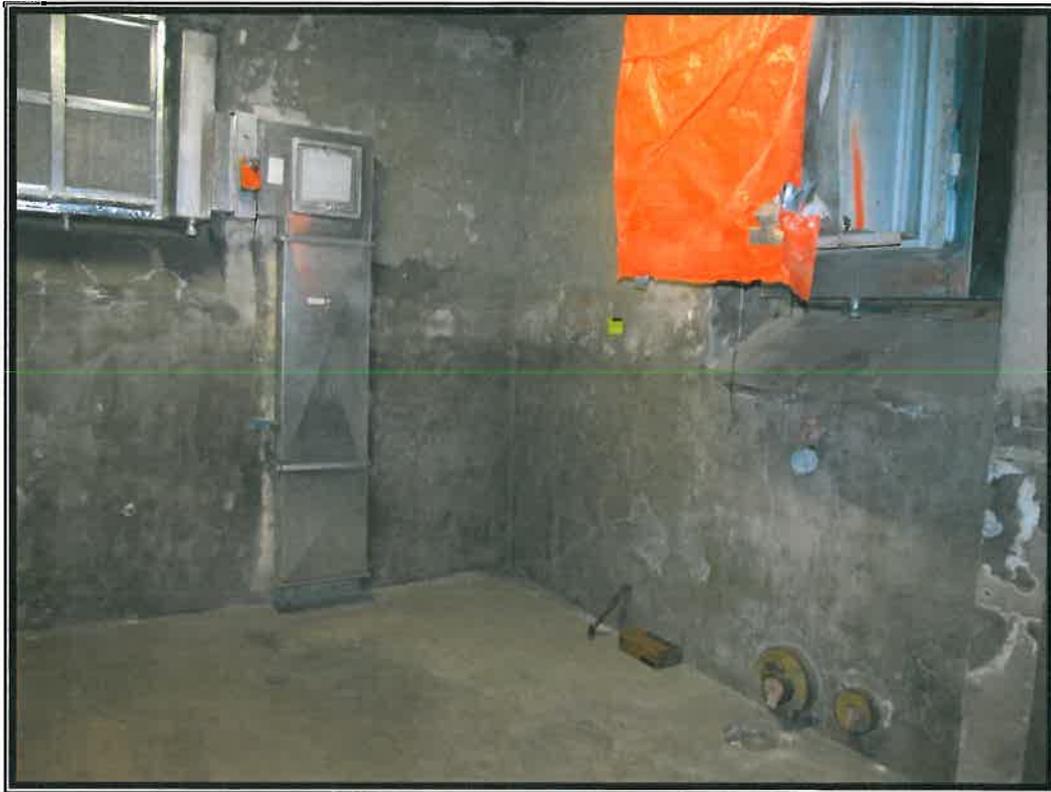
Picture 3 : View of the front and right walls of the east building. (2013-06-06)

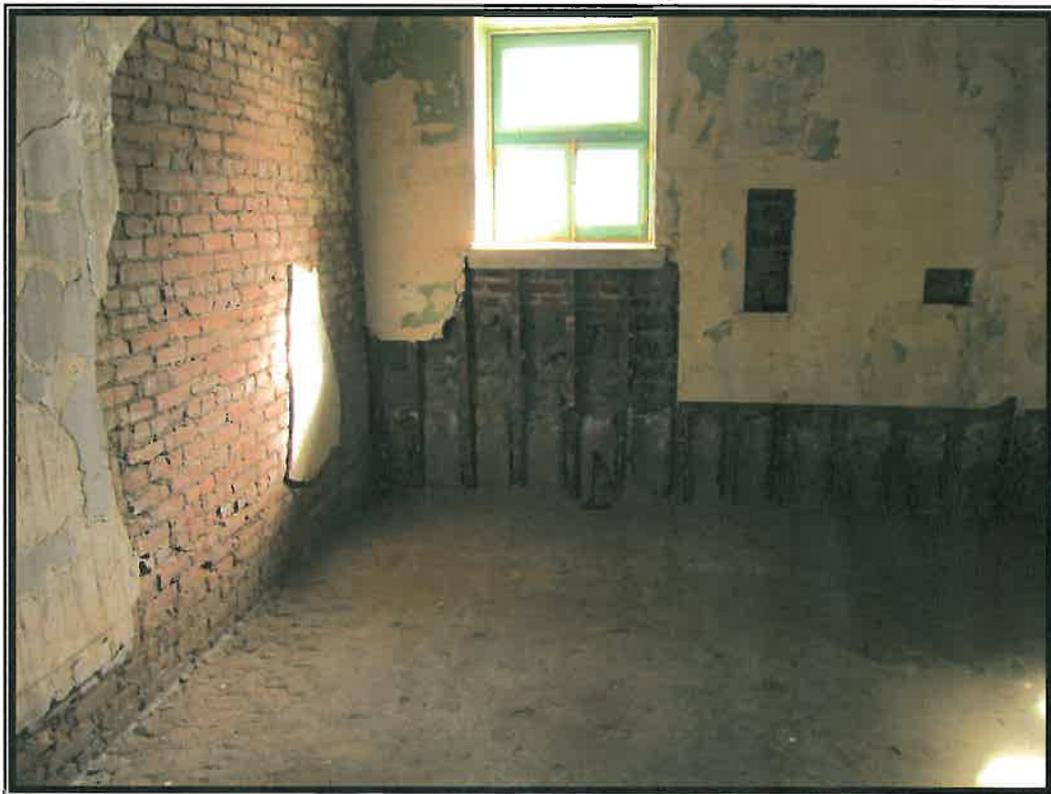
Picture 4 : View of the right wall of the east building. (2013-06-06)

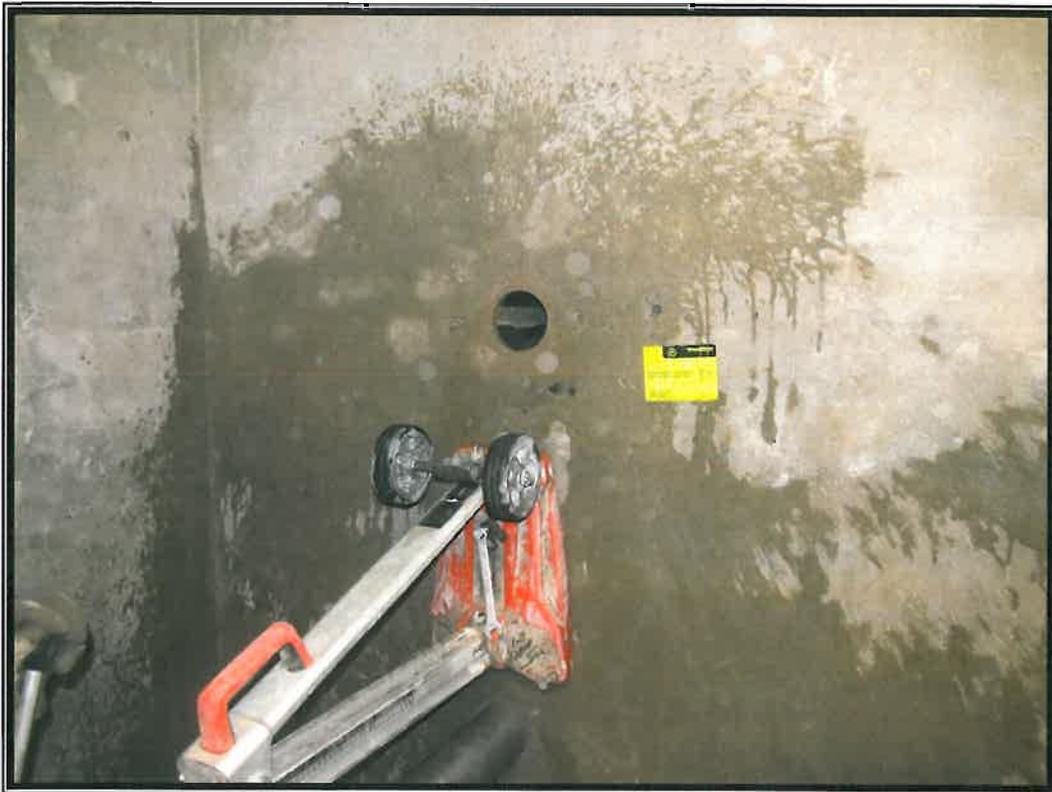
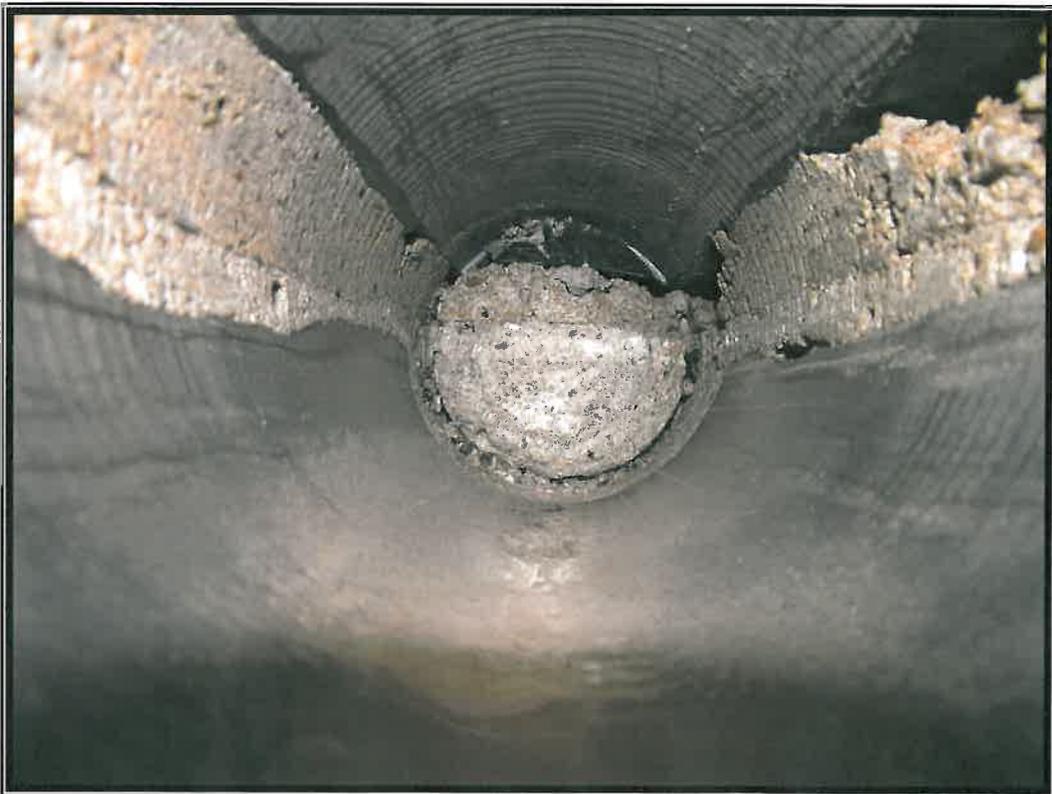
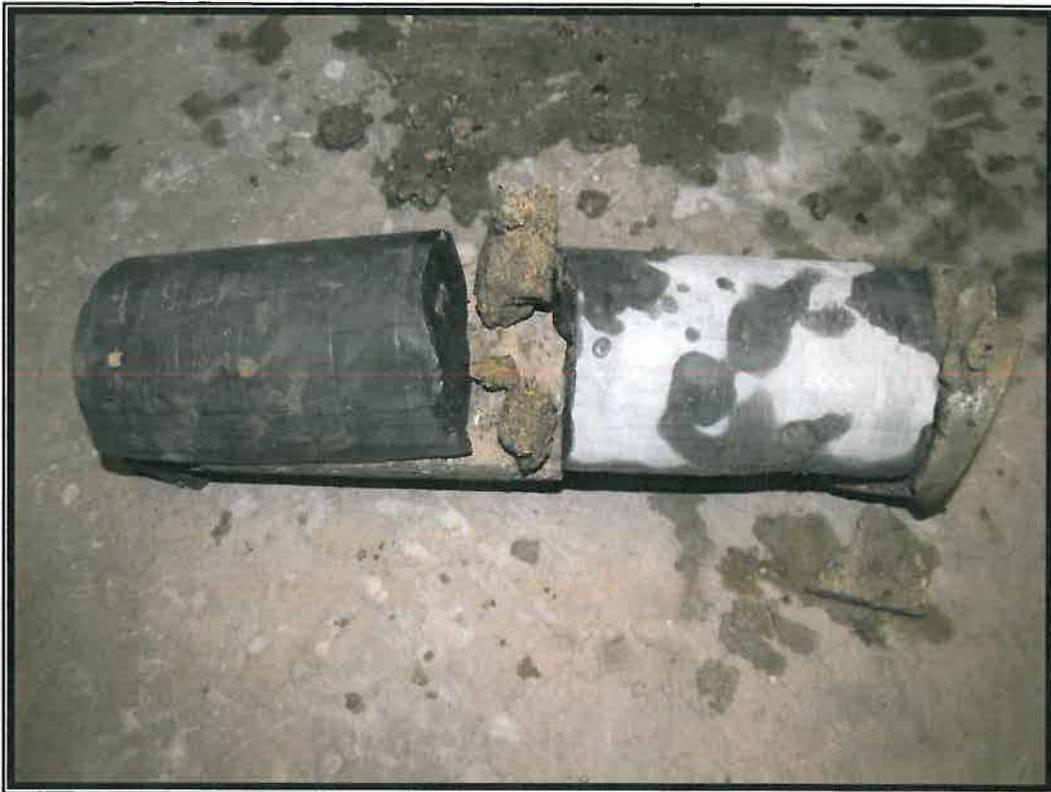
In addition, a core sample collected at a shallow depth has revealed that the interior part of the right-side foundation wall that corresponds to the exterior stone block wall is composed of a stone and mortar assembly (photographs 5 to 7). The stone used appears to be of the same type as the rock found in the various excavations that were part of the operations underway during the visit on June 6, 2013. The stones thus appear to have been made from clayey limestone.

Picture 5 : **Drilling of the exterior stone facing of the right wall of the east building
(2013-06-06)**

Picture 6 : **Inside view of the core through the right wall of the east building
(2013-06-06)**

Picture 7 : Sample from the right wall from the exterior stone facing of the east building. (2013-06-06)

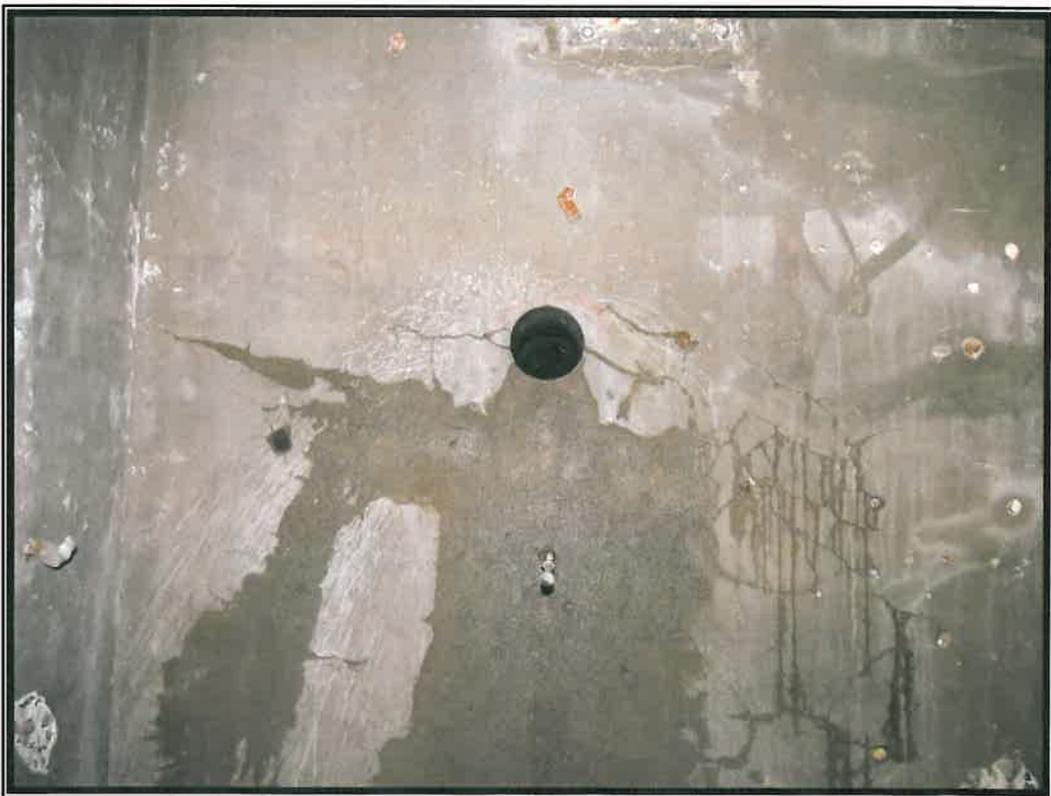
Picture 8 : Sample (C-1) from the front wall of the east building, below grade. (2013-06-06)

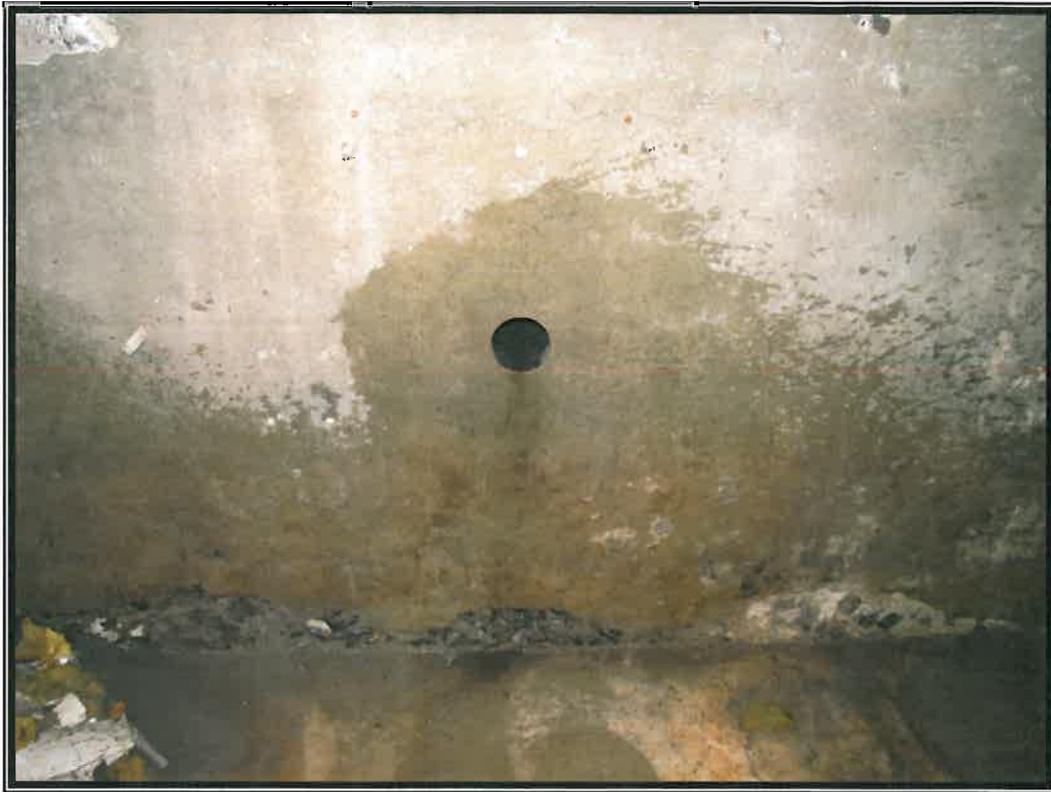
Picture 9 : Sample (C-2) of the front wall of the east building, below grade.
(2013-06-06)

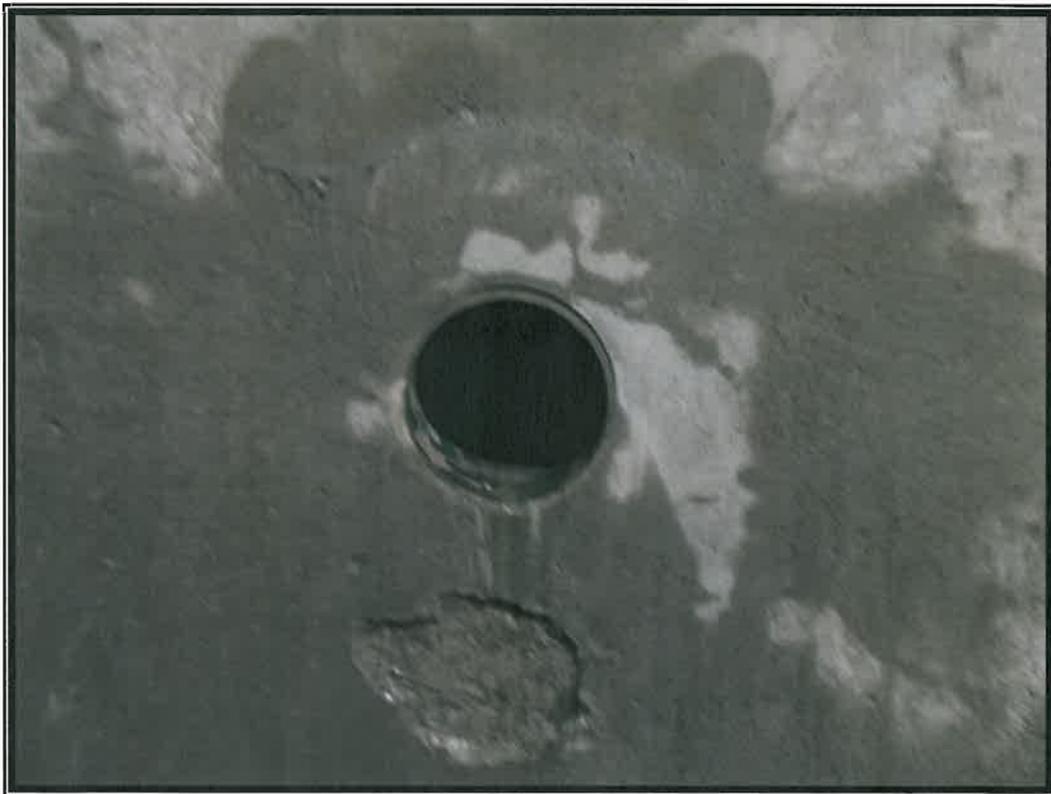
Picture 10 : Sample (C-3) of the right wall of the east building, below grade.
(2013-06-06)

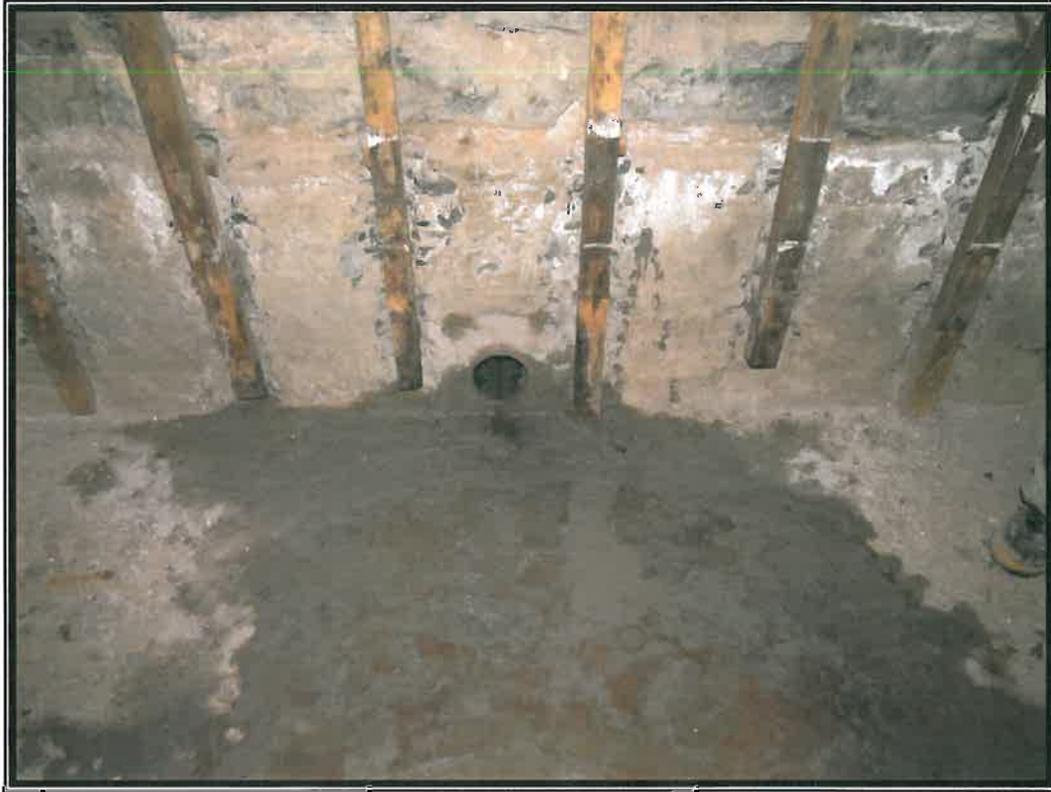
Picture 11 : Sample (C-4) from the right wall of the east building, below grade.
(2013-06-06)

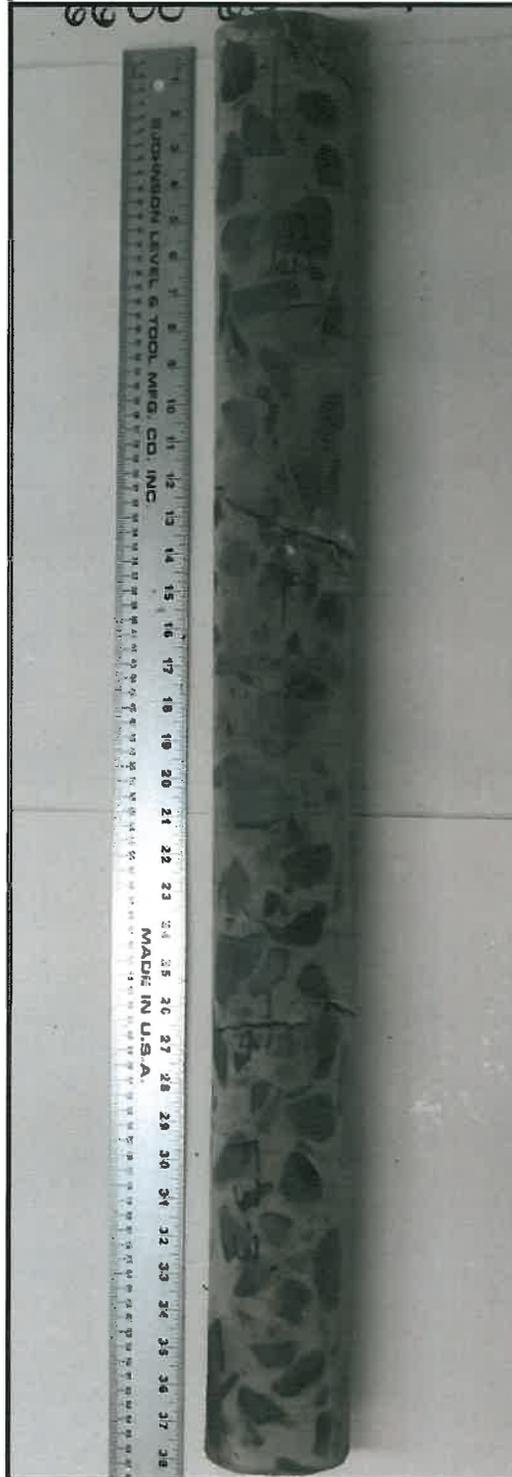
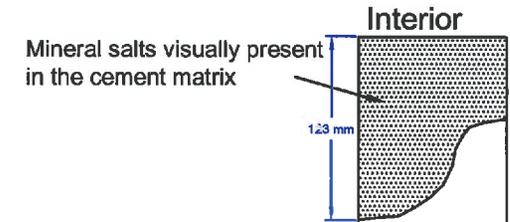
Location:	Québec City Armoury Québec (Québec)
Sample Location:	See drawing No. 6608-63-01
Drilling Angle:	Perpendicular to the surface
Core Diameter:	100 mm
Cored by:	Groupe Diamantex
Date Received:	2013-06-06
Core No.:	C-4
Sample No.:	6608-63-004

- Aggregate is partially and/or uncoated;
- Presence of wood fragments;
- Mixture is visibly heterogeneous;
- Crumbly surface;
- Granular discontinuity in the large aggregate;
- Consolidation defects are present.

Concrete	
Thickness:	812 à 816 mm
Cracking:	None
Compressive strength:	26.4 MPa
Notes:

Aggregate	
Large:	Clayey limestone
Diameter:	± 50 mm max.
Small:	Natural sand
Signs of ASR:	Slight

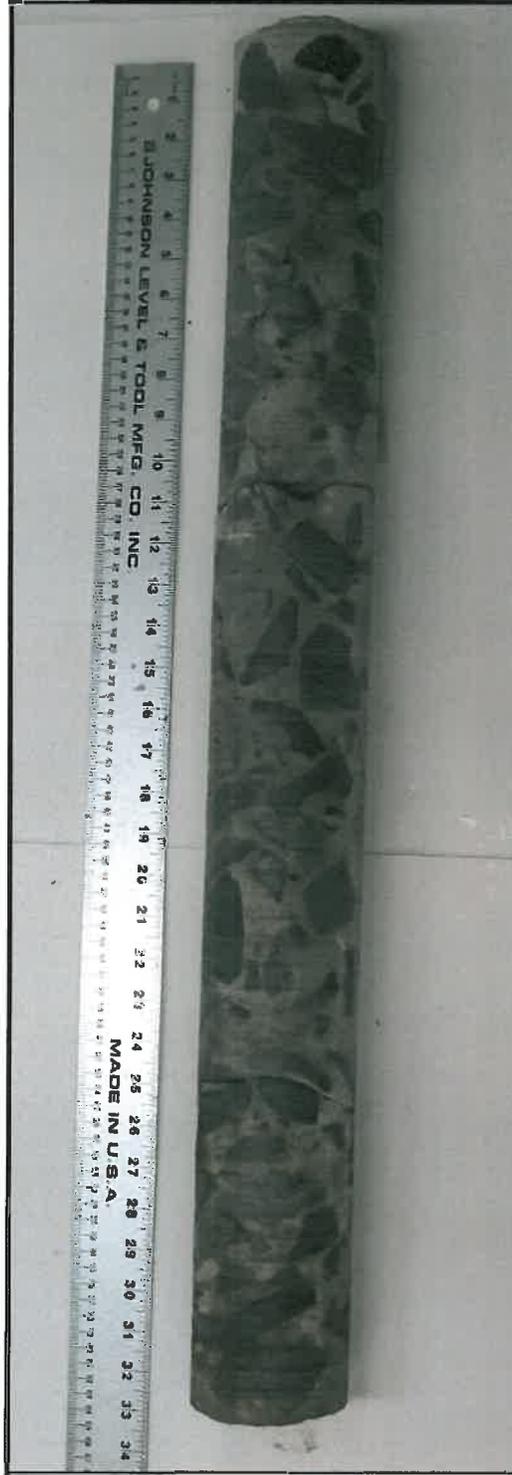
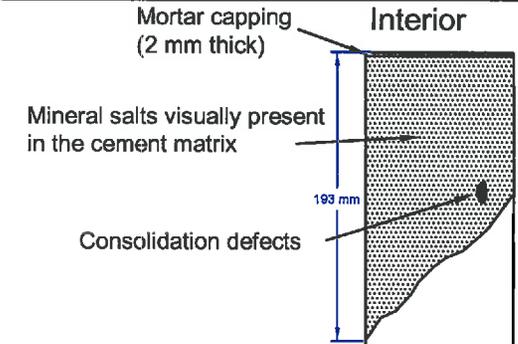
Location:	Québec City Armoury Québec (Québec)
Sample Location:	See drawing No. 6608-63-01
Drilling Angle:	Perpendicular to the surface
Core Diameter:	100 mm
Cored by:	Groupe Diamantex
Date Received:	2013-06-06
Core No.:	C-3
Sample No.:	6608-63-003

- Aggregate is partially and/or uncoated;
- Presence of wood fragments;
- Mixture is visibly heterogeneous;
- Crumbly surface;
- Granular discontinuity in the large aggregate.

Concrete	
Thickness:	927 à 931 mm
Cracking:	None
Compressive strength:	18.7 MPa
Notes:

Aggregate	
Large:	Clayey limestone
Diameter:	± 53 mm max.
Small:	Natural sand
Signs of ASR:	Slight

Consolidation defects

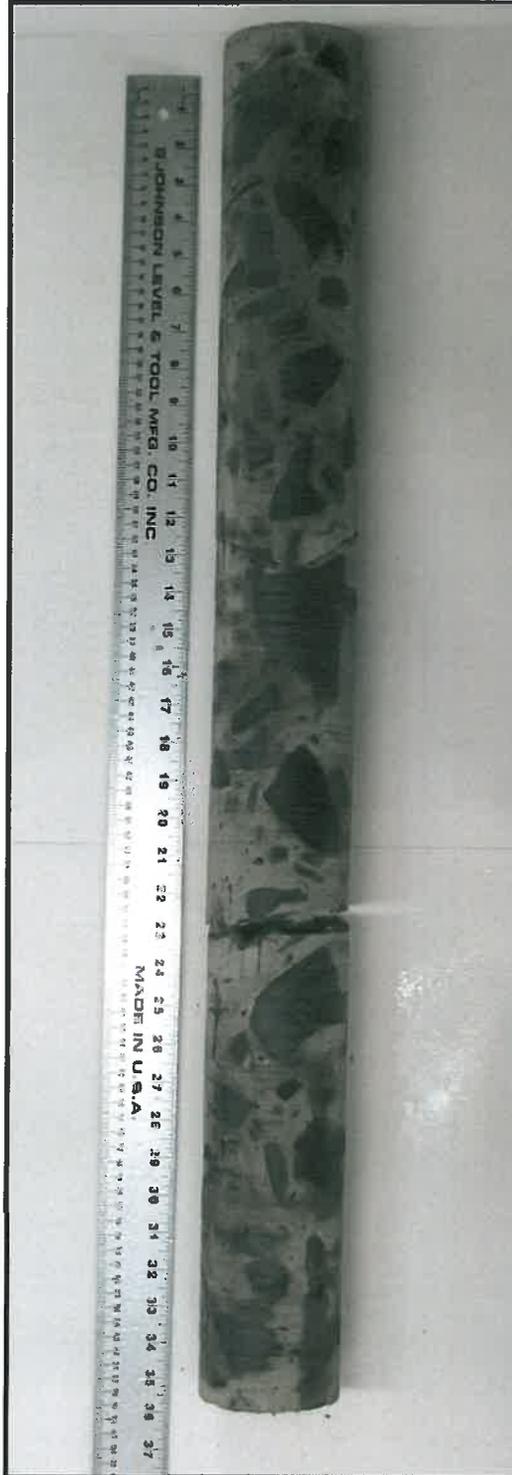
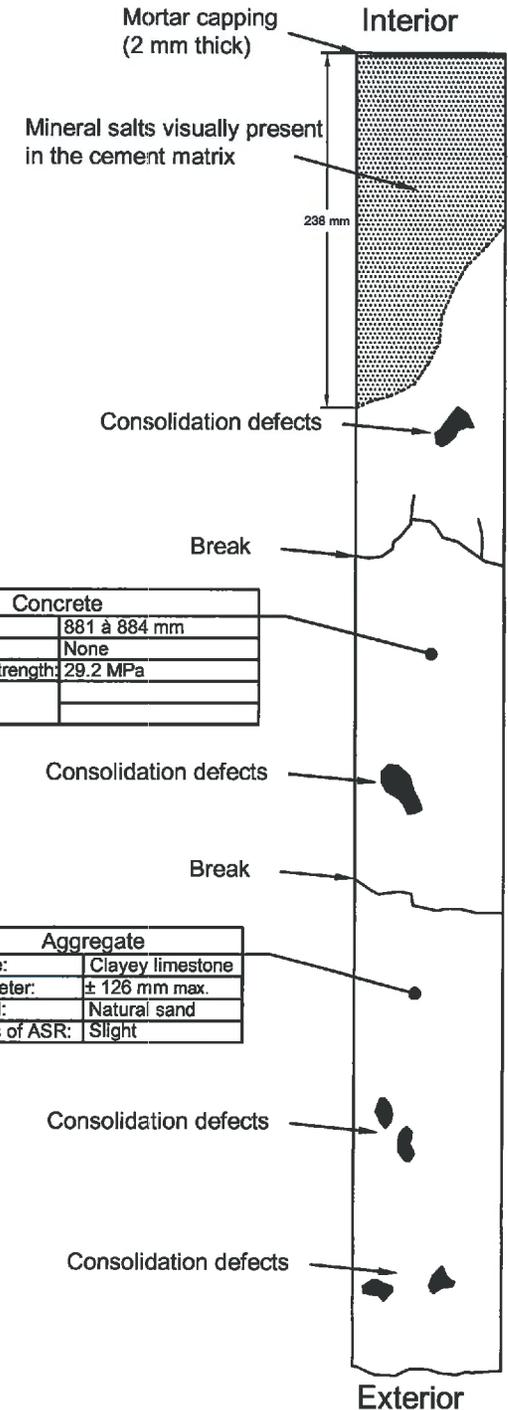
Location:	Québec City Armoury Québec (Québec)
Sample Location:	See drawing No. 6608-63-01
Drilling Angle:	Perpendicular to the surface
Core Diameter:	100 mm
Cored by:	Groupe Diamantex
Date Received:	2013-06-06
Core No.:	C-2
Sample No.:	6608-63-002

- Aggregate is partially and/or uncoated;
- Presence of wood fragments;
- Mixture is visibly heterogeneous;
- Crumbly surface;
- Granular discontinuity in the large aggregate.

Concrete	
Thickness:	881 à 884 mm
Cracking:	None
Compressive strength:	29.2 MPa
Notes:

Aggregate	
Large:	Clayey limestone
Diameter:	± 126 mm max.
Small:	Natural sand
Signs of ASR:	Slight

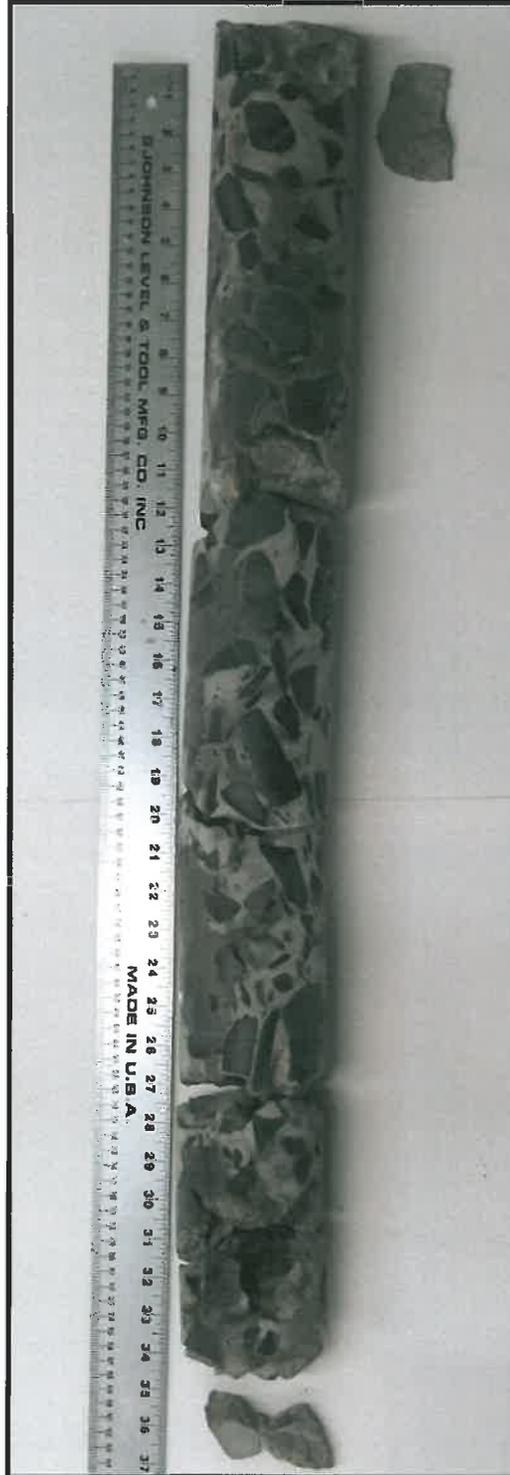
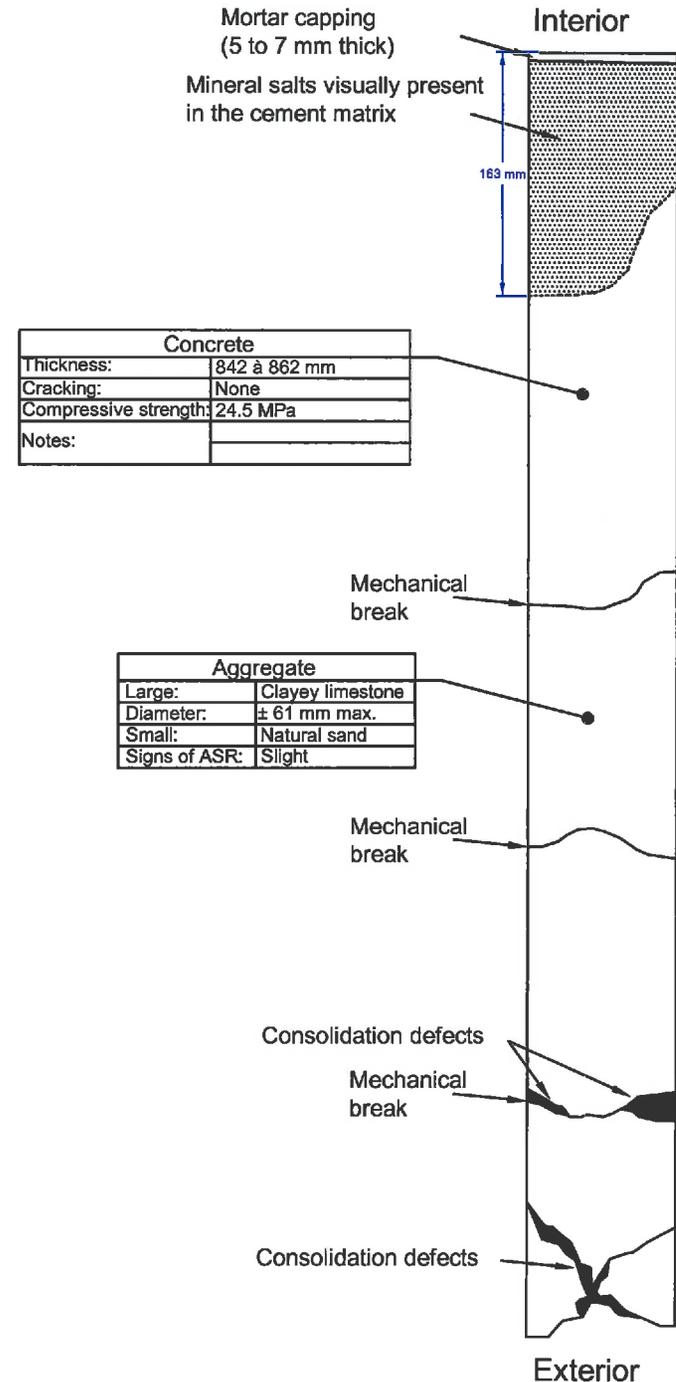
Location:	Québec City Armoury Québec (Québec)
Sample Location:	See drawing No. 6608-63-01
Drilling Angle:	Perpendicular to the surface
Core Diameter:	100 mm
Cored by:	Groupe Diamantex
Date Received:	2013-06-06
Core No.:	C-1
Sample No.:	6608-63-001

- Aggregate is partially and/or uncoated;
- Presence of wood fragments;
- Mixture is visibly heterogeneous;
- Crumbly surface;
- Granular discontinuity in the large aggregate.
