**Addendum / Addenda**

| Project Description / Description de projet<br><br>M23a Nanolab Renovations | | |

## DESIGNATED SUBSTANCES SURVEY

### BUILDING M-23A OTTAWA, ON

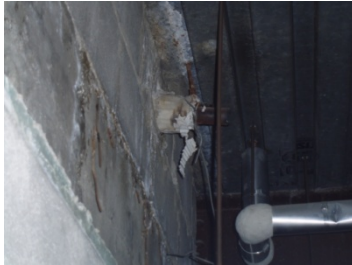
| <b>Photo #</b> | <b>Functional Space #</b> | <b>Location</b> | <b>Comments</b> | <b>Photograph</b> |
|---|---|---|---|---|
| A01 | B009 | 59 - Office | HWH: 1 damaged section of Aircell pipe insulation requires 1 removal (0.1LM) | |

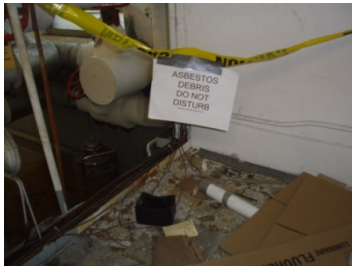
| <b>Photo #</b> | <b>Functional Space #</b> | <b>Location</b> | <b>Comments</b> | <b>Photograph</b> |
|---|---|---|---|---|
| A02 | B010 | 54/56/58 - Mechanical | ACM debris on top of HVAC unit (with caution tape and sign) requires 1 removal (1m <sup>2</sup> ) | |

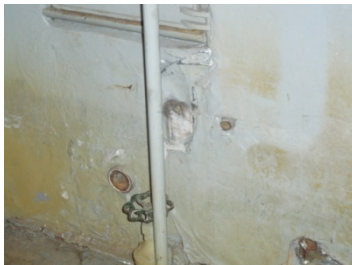
| <b>Photo #</b> | <b>Functional Space #</b> | <b>Location</b> | <b>Comments</b> | <b>Photograph</b> |
|---|---|---|---|---|
| A03 | B010 | 54/56/58 - Mechanical | Damaged FG with mud on the HVAC unit requires 1 encapsulation (0.5m <sup>2</sup> ) | |

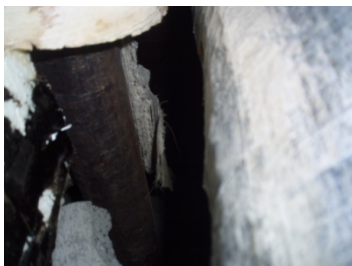
| <b>Photo #</b> | <b>Functional Space #</b> | <b>Location</b> | <b>Comments</b> | <b>Photograph</b> |
|---|---|---|---|---|
| A04 | B014 | 44 - Storage | Steam: 1 severely damaged section of Aircell pipe insulation requires 1 removal (0.5LM) | |

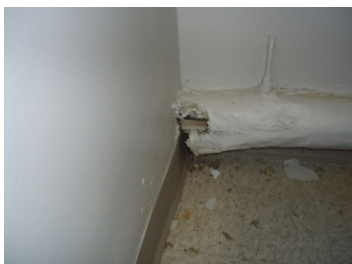
| <b>Photo #</b> | <b>Functional Space #</b> | <b>Location</b> | <b>Comments</b> | <b>Photograph</b> |
|---|---|---|---|---|
| A05 | B014 | 44 - Storage | Steam: 1 damaged section of Aircell pipe insulation requires 1 removal (0.5LM) | |

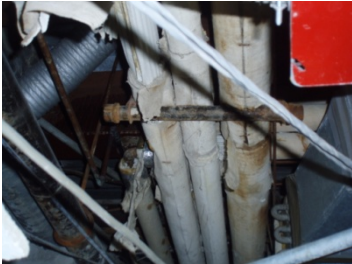
| A06 | B014 | 44 - Storage | <p>Steam: residual MJC fitting insulation requires 1 removal (1 unit)</p> <p>DHW: 1 badly damaged section of Aircell pipe insulation requires 1 removal (0.5LM)</p> <p>ACM debris sitting on pipes requires 1 removal</p> | |

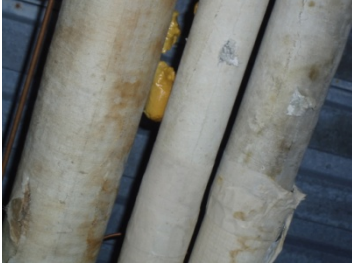
| A07 | B014 | 44 - Storage | <p>DHW: 2 damaged sections of Aircell pipe insulation require 2 encapsulations (0.5LM)</p> <p>DCW: 1 damaged section of Sweatwrap pipe insulation requires 1 encapsulation (0.3LM)</p> | |

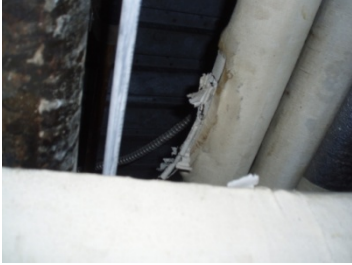
| A08 | B014 | 44 - Storage | <p>DHW: 1 damaged section of Aircell pipe insulation requires 1 removal (0.5LM)</p> | |

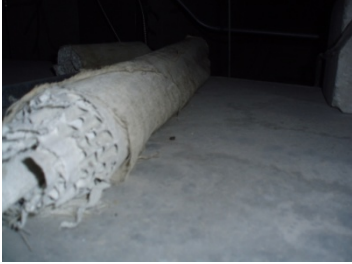
| A09 | B017 | 48 - Corridor | <p>ACM debris on top of duct above ceiling requires 1 removal (1m<sup>2</sup>)</p> | |

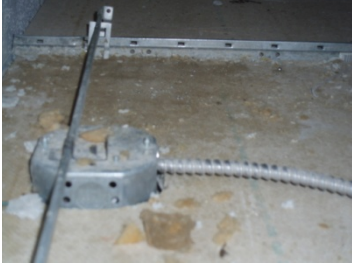
| A10 | B017 | 48 - Corridor | <p>ACM debris on top of ceiling tiles requires 1 removal (1m<sup>2</sup>)</p> | |

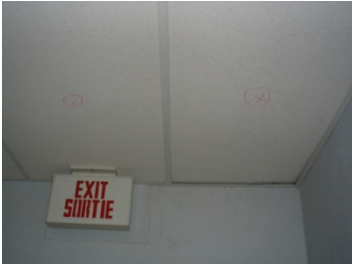
| A11 | B017 | 48 - Corridor | Photo showing ceiling tiles marked with pink X's indicating location of debris in photo A10 | |

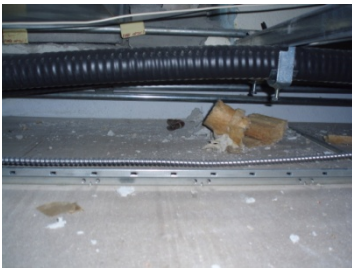
| A12 | B017 | 48 - Corridor | ACM debris on top of ceiling tiles requires 1 removal (3m <sup>2</sup> ) | |

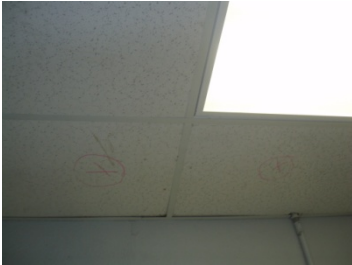
| A14 | B017 | 48 - Corridor | Photo showing ceiling tiles marked with pink X's indicating location of debris in photos A12 & A13 | |

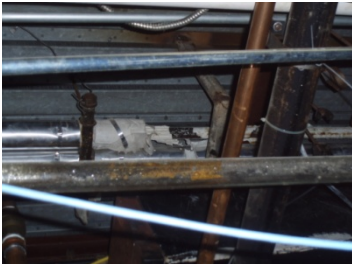
| A16 | B017 | 48 - Corridor | DHW: 1 badly damaged section of Aircell pipe insulation requires 1 removal (3LM) | |

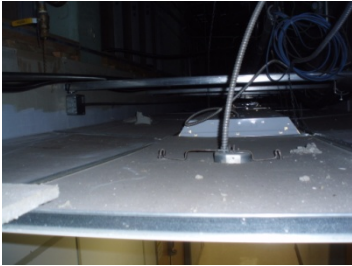
| A17 | B017 | 48 - Corridor | ACM debris on top of ceiling tiles requires 1 removal (1m <sup>2</sup> ) | |

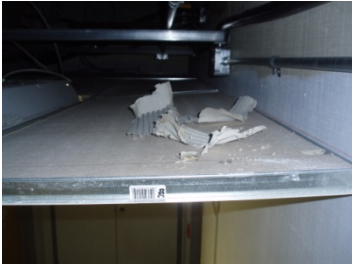
| A18 | B017 | 48 - Corridor | ACM debris on top of ceiling tiles requires 1 removal (1m <sup>2</sup> ) | |

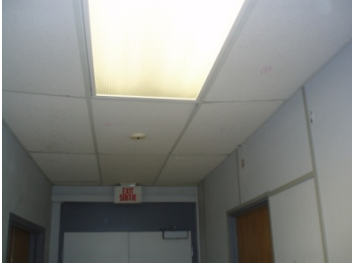
| A19 | B017 | 48 - Corridor | Photo showing ceiling tiles marked with pink X's indicating location of debris in photos A17 & A18 | |

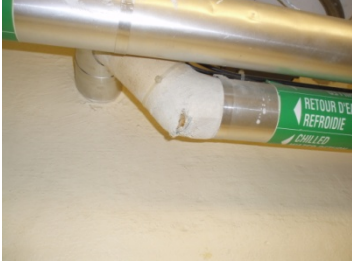
| A20 | B026 | 31 - Storage | Chiller: 1 damaged mud joint compound fitting requires 1 encapsulation (1 unit) | |

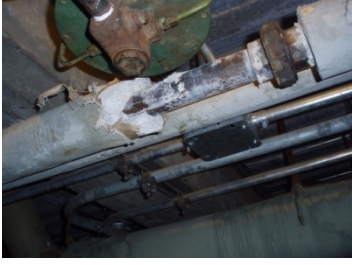
| A21 | B027 | 10/27/27A - Crawlspace | Steam: 1 damaged section of MagBlock pipe insulation requires 1 encapsulation (0.5LM) | |

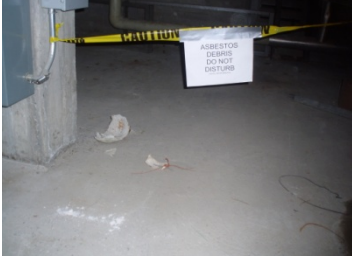
| A22 | B027 | 10/27/27A - Crawlspace | ACM debris on floor requires 1 removal (5m <sup>2</sup> ) | |

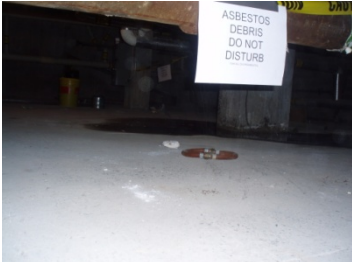
| A23 | B027 | 10/27/27A - Crawlspace | ACM debris on floor requires 1 removal (5m <sup>2</sup> ) | |

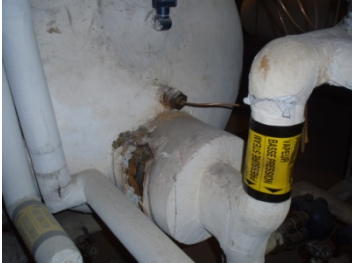
| A24 | B027 | 10/27/27A - Crawlspace | <p>Steam: 1 damaged mud joint compound fitting requires 1 encapsulation (1 unit)</p> <p>Hot water tank: 1 damaged section of grey tank insulation requires 1 encapsulation (0.3m<sup>2</sup>)</p> | |

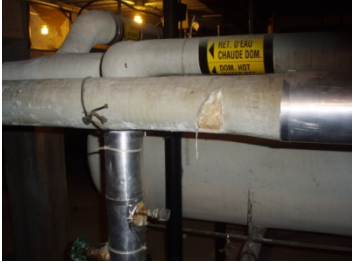
| A25 | B027 | 10/27/27A - Crawlspace | DCW: 1 damaged section of Sweatwrap pipe insulation requires 1 encapsulation (0.5LM) | |

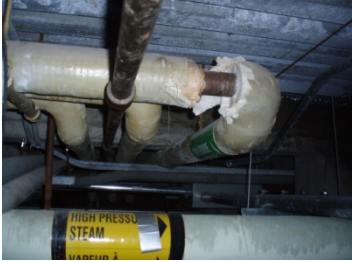
| A26 | B027 | 10/27/27A - Crawlspace | DCW: 1 damaged mud joint compound fitting requires 1 removal (1 unit) | |

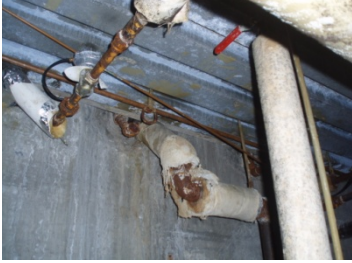
| A27 | B027 | 10/27/27A - Crawlspace | Steam (disconnected): 1 damaged mud joint compound fitting requires 1 removal (1 unit) | |

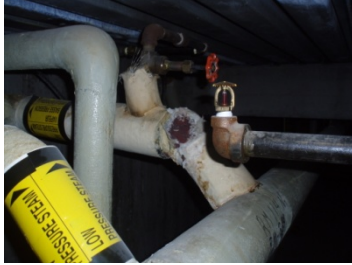
| A28 | B027 | 10/27/27A - Crawlspace | Steam: 1 damaged mud joint compound fitting requires 1 encapsulation (1 unit) | |

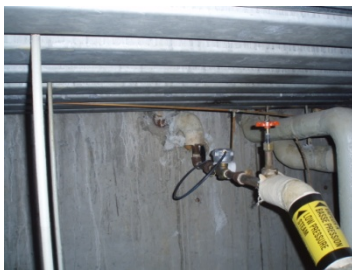
| A29 | B027 | 10/27/27A - Crawlspace | Steam: 1 damaged mud joint compound fitting requires 1 removal (1 unit) | |

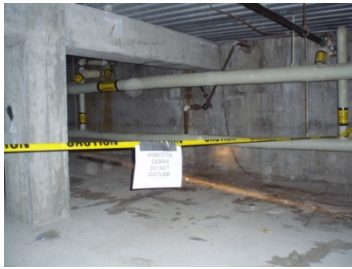
| A30 | B027 | 10/27/27A - Crawlspace | ACM debris on floor requires 1 removal (5m <sup>2</sup> )<br>Condensate: 2 residual mud joint compound fittings require 2 removals (2 units) | |

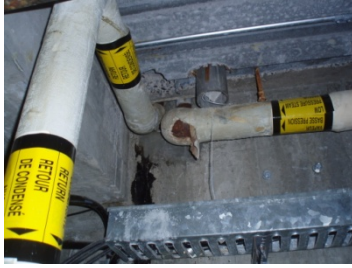
| A31 | B027 | 10/27/27A - Crawlspace | Steam: 1 damaged mud joint compound fitting requires 1 removal (1 unit) | |

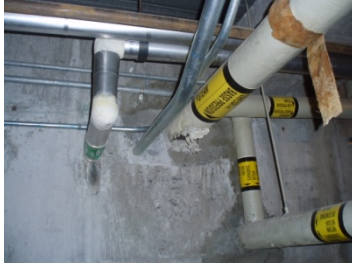
| A32 | B027 | 10/27/27A - Crawlspace | Steam: 1 damaged section of Aircell pipe insulation requires 1 removal (0.5LM) | |

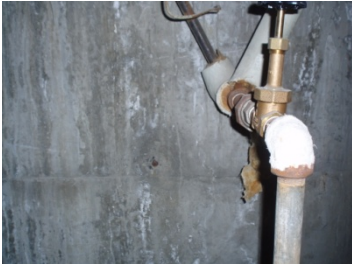
| A33 | B027 | 10/27/27A - Crawlspace | Condensate: residual mud joint compound fitting requires 1 removal (1 unit) | |

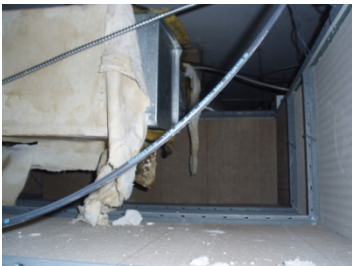
| A34 | 1003 | 121 - Storage | HVAC: 1 badly damaged section of FG w/mud HVAC insulation requires 1 removal (1m <sup>2</sup> )<br>ACM debris on ceiling tile requires 1 removal (1m <sup>2</sup> ) | |

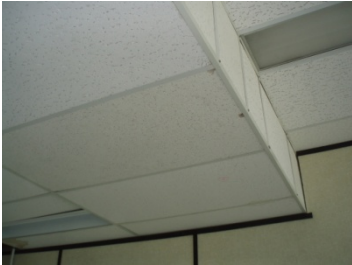
| A35 | 1003 | 121 - Storage | Photo showing ceiling tile marked with pink X indicating location of debris in photo A34 | |

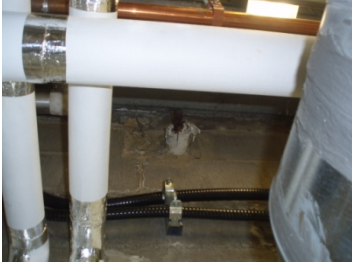
| A36 | B002 | 61/63/65/69 - Lab | HWH: 1 damaged section of Aircell pipe insulation requires 1 removal (0.2LM) | |

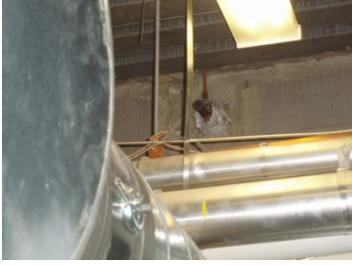
| A37 | B002 | 61/63/65/69 - Lab | HWH: 1 damaged section of Aircell pipe insulation requires 1 removal (0.2LM) | |

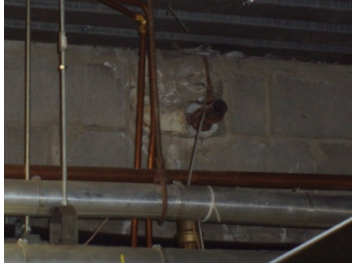
| A38 | B002 | 61/63/65/69 - Lab | HWH: 1 damaged section of Aircell pipe insulation requires 1 removal (0.2LM) | |

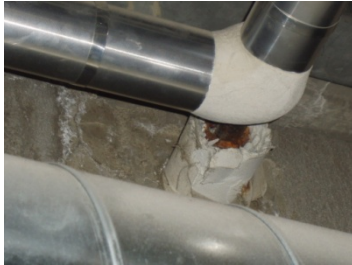
| A39 | B002 | 61/63/65/69 - Lab | HWH: 1 damaged section of Aircell pipe insulation requires 1 removal (0.2LM) | |

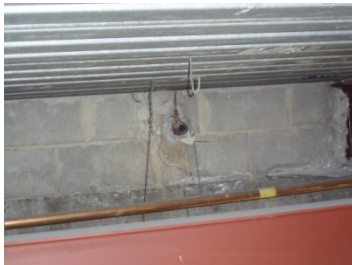
| A40 | B002 | 61/63/65/69 - Lab | HWH: 1 damaged section of Aircell pipe insulation requires 1 removal (0.2LM) | |

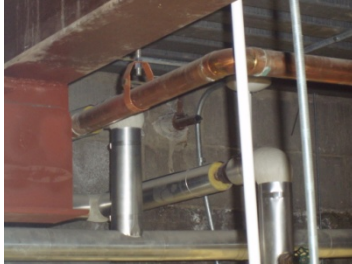
| A41 | B002 | 61/63/65/69 - Lab | HWH: 1 damaged section of Aircell pipe insulation requires 1 removal (0.2LM) | |

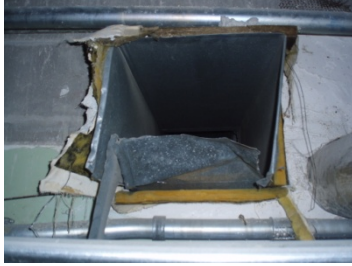
| A42 | 1044 | 1st floor corridor | Duct: 1 damaged section of FG w/mud duct insulation requires 1 removal (0.5m <sup>2</sup> ) | |

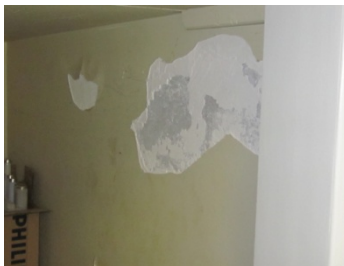
| A43 | B018 | 041B | ACM plaster:1 damaged section of wall plaster requires 1 encapsulation (1m2) | |

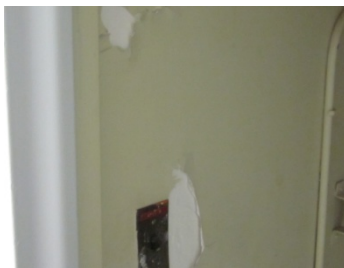
| A44 | B018 | 041B | ACM plaster:1 damaged section of wall plaster requires 1 encapsulation (1m2) | |

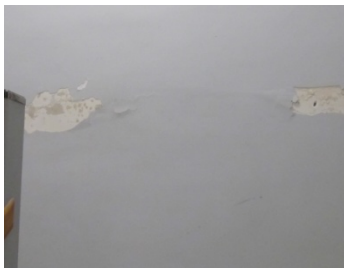
| A45 | B025 | Hallway | ACM plaster:1 damaged section of wall plaster requires 1 encapsulation (1m2) | |

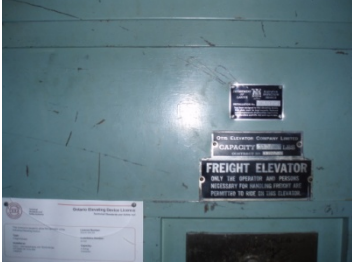
| Issue | Comments | Recommendations |
|---|--|---|
| Lead | <p>One paint sample was submitted for lead analysis. The green paint was found to contain significant levels of lead (i.e., equal to or greater than 5000 ppm).</p> <p>Lead may be present in the solder used on copper domestic water lines, as caulking in bell fittings, cast iron drainage pipes, in glazing on the ceramic tiles and in electrical equipment, wiring or fixtures.</p> | <p>The draft Proposed Lead Regulation on Construction Projects, May 5, 1995, (enforced by the Ministry of Labour) does not require removal of lead paint or lead-based materials, unless work on these materials is likely to produce lead fumes or dust, for example during welding, torch cutting, grinding, sanding or sandblasting.</p> <p>In the event that such work is conducted at this facility, ensure that lead fumes or dust do not exceed the maximum allowable Time Weighted Average Exposure Value (TWAEV) of 0.05 mg/m<sup>3</sup> as prescribed by the OHSA.</p> |

| <b>Photo #</b> | <b>Functional Space #</b> | <b>Location</b> | <b>Comments</b> | <b>Photograph</b> |
|---|---|---|---|---|
| L01 | EL01 | Cargo elevator | Green lead paint. | A photograph showing a close-up of a green-painted wall. The wall has several signs and notices. A prominent sign reads "FREIGHT ELEVATOR" with an arrow pointing to the right. Above it, there is a smaller sign that says "This elevator cannot be used for passenger transport". Below the "FREIGHT ELEVATOR" sign, there is another sign that reads "ONLY BE OPERATED AND MAINTAINED BY QUALIFIED PERSONNEL AND TRAINED TO USE THE LOAD CAPACITY". To the left of the signs, there is a white notice or document pinned to the wall. The wall shows some signs of wear and discoloration. |

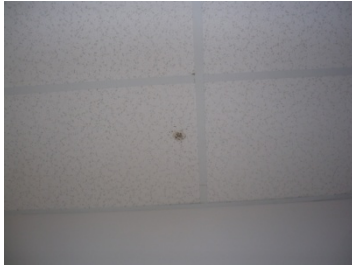
| Issue | Comments | Recommendations |
|---|--|--|
| | Suspect mould was observed in three locations on the ceiling tile. | Bulk fungal analysis should be performed to the species level. Once the hazard is qualified, the mould should be removed and the source of the moisture should be mitigated. |

| <b>Photo #</b> | <b>Functional Space #</b> | <b>Location</b> | <b>Comments</b> | <b>Photograph</b> |
|---|---|---|---|---|
| M01 | 2001 | 2nd floor | Suspect mould on ceiling tile | |

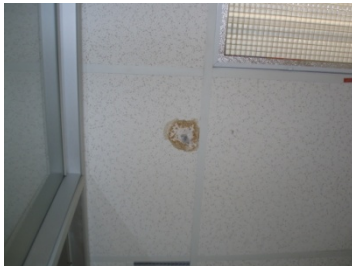
| <b>Photo #</b> | <b>Functional Space #</b> | <b>Location</b> | <b>Comments</b> | <b>Photograph</b> |
|---|---|---|---|---|
| M02 | 2001 | 2nd floor | Suspect mould on ceiling tile | |

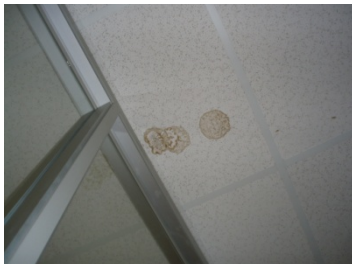
| <b>Photo #</b> | <b>Functional Space #</b> | <b>Location</b> | <b>Comments</b> | <b>Photograph</b> |
|---|---|---|---|---|
| M03 | 2001 | 2nd floor | Suspect mould on ceiling tile | |
