Designated Substances Hazardous Materials Survey

Canada Coast Guard Base Prescott, Ontario

PWGSC Project R.066414.001

Re: Report for the Designated Substances and Hazardous Materials Survey (DSHMS) for the Refurbishment of Canada's Coast Guard Base in Prescott, ON

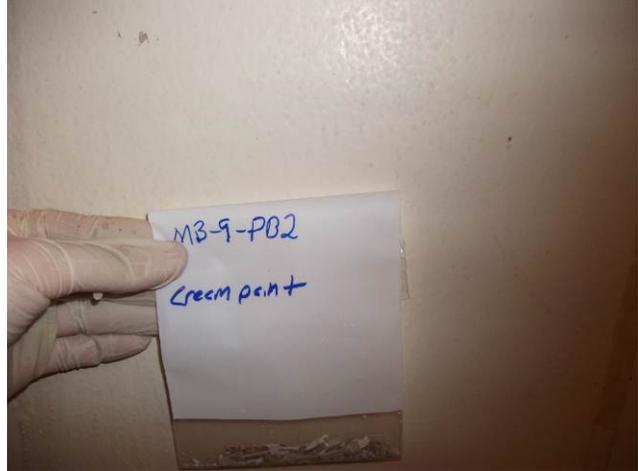
Building	Material	Location	Description	Assessment ¹	Action ²
Main Building	Cream Paint	Primary Undercoat Throughout Entire Building	Cream colour paint on most walls throughout building	- Sample ID: MB-Pb2 - Concentration: 160 ppm - Condition: Good	Institute routine surveillance of the paint. It is recommended that areas of lead-containing paints observed to be in fair condition (minor cracking/chipping/flaking), be encapsulated with a fresh coat of paint in order to reduce the likelihood of inhalation,
	Beige Paint	Primary Undercoat Throughout Entire Building	Beige colour paint on most walls throughout building	- Sample ID: MB-Pb3 - Concentration: 130 ppm - Condition: Good	
	Yellow Paint	Exterior Bollards Throughout Site	Yellow Bollard Paint	- Sample ID: MB-Pb7 - Concentration: 42,000 ppm - Condition: Poor	
	Brown Paint	Exterior Paint	Exterior of building	- Sample ID: MB-Pb8 - Concentration: 100 ppm - Condition: Fair

Photograph 2: Main Building- PB2 – Lead-Based Cream Paint Undercoat Throughout Main Building

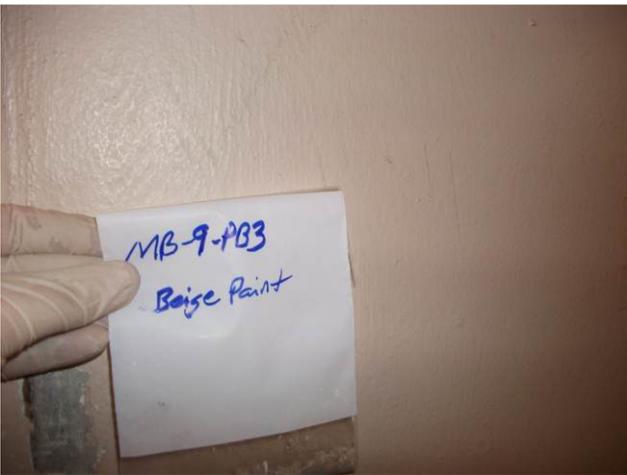
Photograph 3: Main Building- PB3 – Lead-Based Beige Paint Undercoat Throughout Main Building

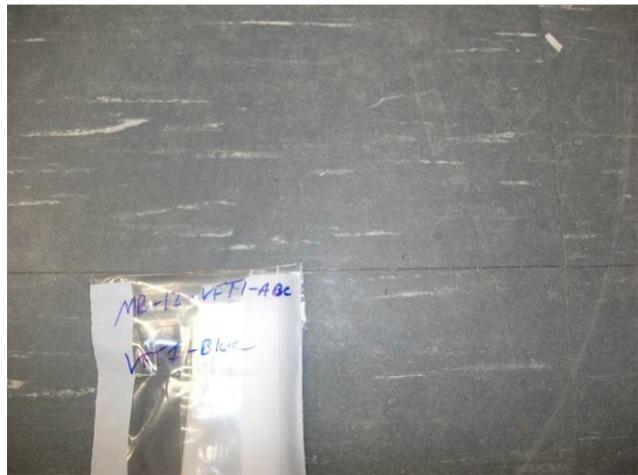
Photograph 4: Main Building – ACM (VFT1) Blue With White Streak 12" X 12" Vinyl Floor Tile

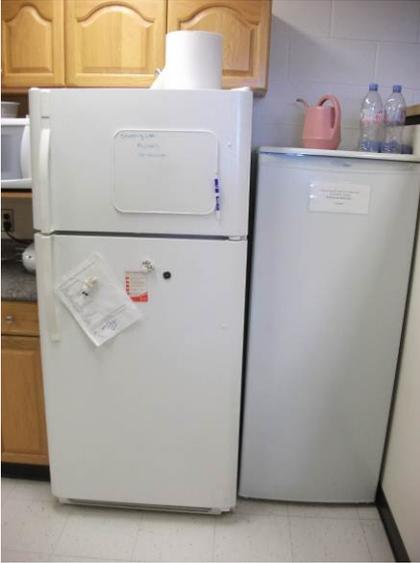
Fire extinguishers, refrigerators, freezers, and air conditioning units were observed throughout the facility. These pieces of equipment have the potential to contain ozone-depleting substances. Decommissioning and/or removal and disposal of any equipment suspected or confirmed to contain ODS must comply with Federal (FHR 2003), Provincial (O. Reg. 189/94) and Waste Management Regulations (R.R.O. 1990, Regulation 347).

Photograph 5: Typical Refrigerator Unit Observed in Buildings as CCGB Prescott

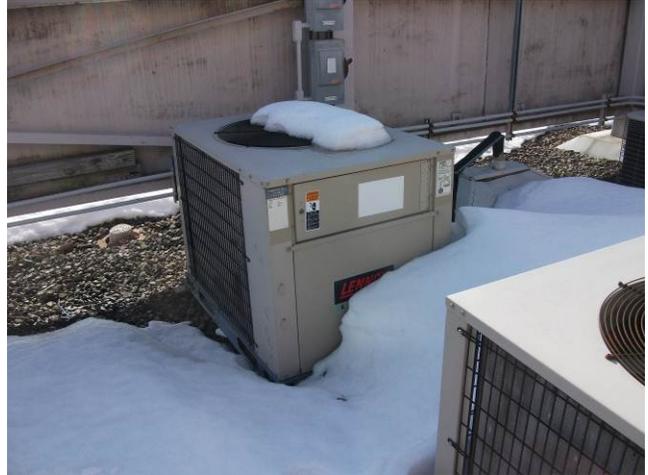
Photograph 6: Main Building – Roof Mounted Air Conditioning Unit

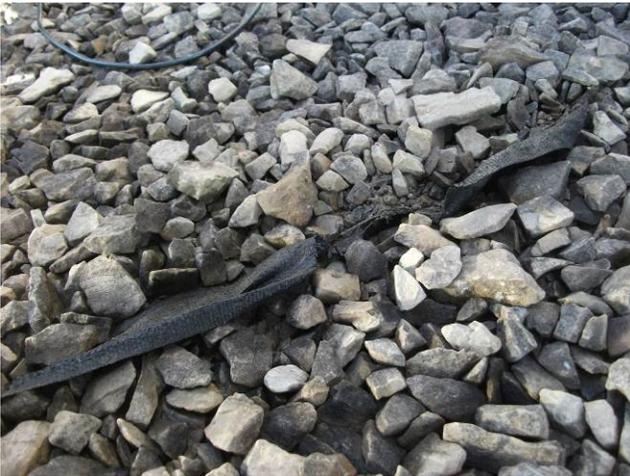
Roof sampling was limited strictly to non-destructive investigation, i.e., the collection of surface roofing materials which would not damage the weather/water-proofing integrity of the roof, including roof ballast filter fabric/cloth and caulking on roof-top HVAC equipment (refer section 3.2 for details). Based on the date of the original building construction there is the potential for some of the roofing materials to contain asbestos. Although no sampled materials returned asbestos containing results, WSP cannot confirm the absence of asbestos in all the roofing materials as no roof-core samples were able to be collected as part of this survey. It is recommended that roof cores (full depth roof membrane samples) be collected and analyzed for asbestos immediately prior to the timing of the roof replacement.

Photograph 7: Roof Ballast Filter Fabric/Cloth on the Roof of the Main Building at CCGB Prescott

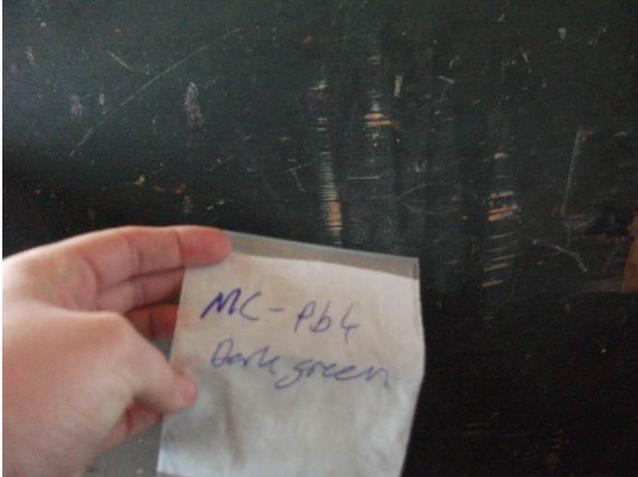
Photograph 9: Metal Clad Storage Building – Lead-Based Dark Green Wall Paint

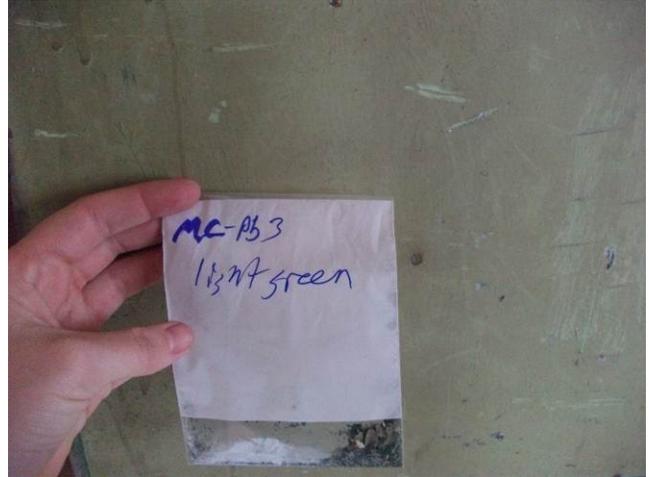
Photograph 10: Metal Clad Storage Building – Lead-Based Light Green Wall Paint

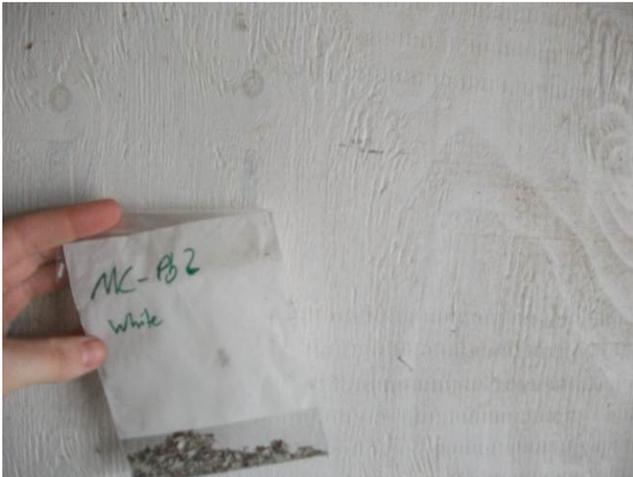
Building	Material	Location	Description	Assessment ¹	Action ²
	White Paint	Interior	Office Walls and Ceiling	- Sample ID: MC-Pb2 - Concentration: 1,100 ppm - Condition: Fair	
	Light Green Paint	Interior	Bay Walls	- Sample ID: MC-Pb3 - Concentration: 5,800 ppm - Condition: Fair	
	Dark Green Paint	Interior	Bay Walls	- Sample ID: MC-Pb4 - Concentration: 38,000 ppm - Condition: Fair	
	Grey Paint	Interior	Bay Walls	- Sample ID: MC-Pb5 - Concentration: 190 ppm - Condition: Fair

Photograph 11: Metal Clad Storage Building – Lead-Based White Wall Paint

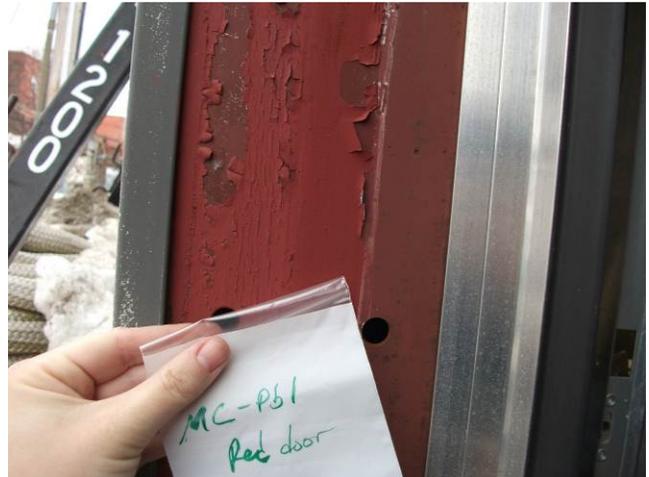
Photograph 12: Metal Clad Storage Building – Lead-Based Red Door Paint

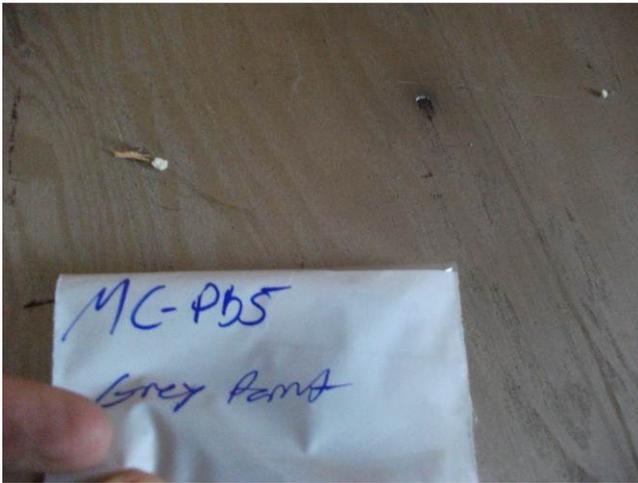
Photograph 13: Metal Clad Storage Building – Lead-Based Grey Wall Paint

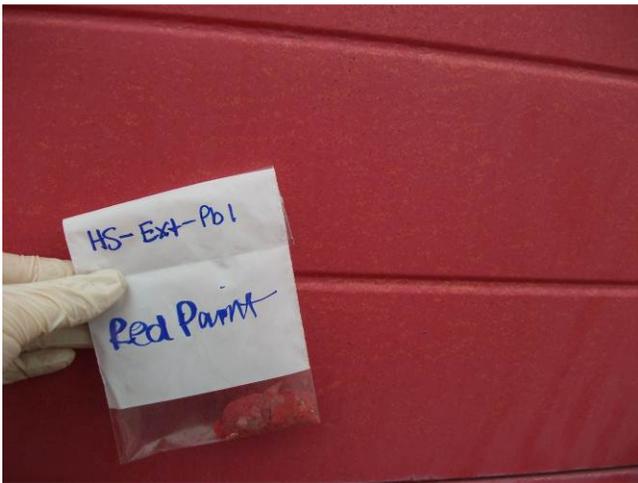
Heated Storage Building	Red Paint	Exterior	Exterior Doors and Windows	- Sample ID: HS-EXT-Pb1 - Concentration: 32,000 ppm - Condition: Good	
	Blue Paint	Interior	Ceiling, Walls, and Pillars	- Sample ID: HS-Pb2 - Concentration: 2,100 ppm - Condition: Good	
	Brown Paint	Interior	Doors and Windows	- Sample ID: HS-Pb3 - Concentration: 2,000 ppm - Condition: Good	
	White Paint	Interior	Office Walls and Ceilings	- Sample ID: HS-Pb4 - Concentration: 600 ppm - Condition: Good	
Metal-clad Storage Building	Red Paint	Exterior	Doors	- Sample ID: MC-Pb1 - Concentration: 3,100 ppm - Condition: Fair

Photograph 15: Heated Storage Building – Lead-Based Red Door Paint

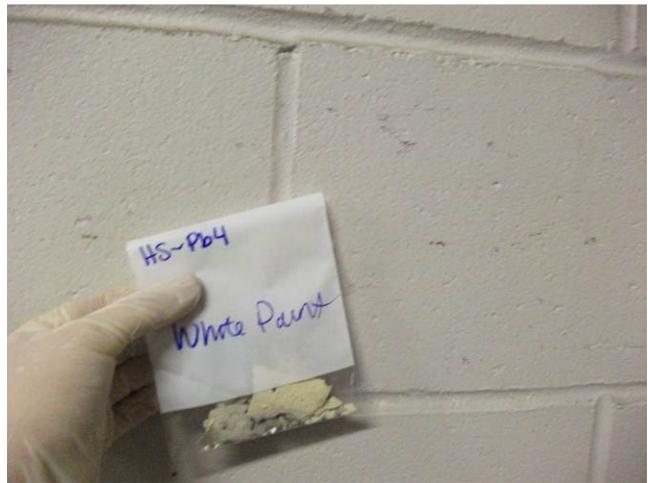
Photograph 16: Heated Storage Building – Lead-Based White Wall Paint

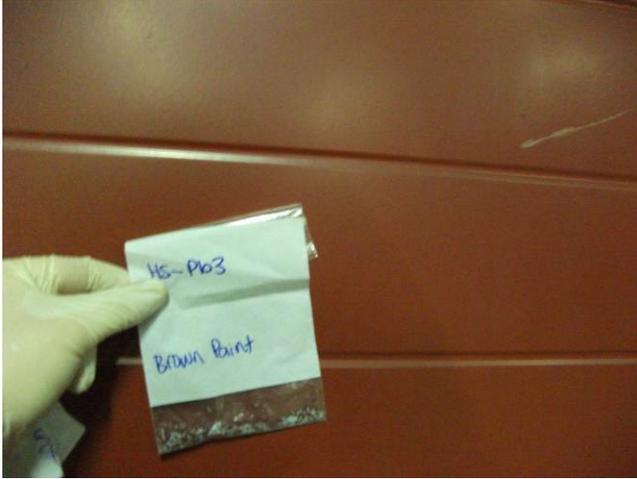
Photograph 17: Heated Storage Building – Lead-Based Brown Door Paint

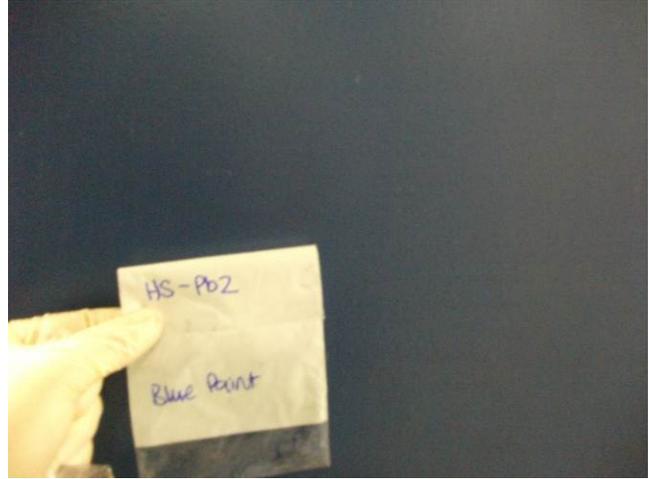
Photograph 18: Heated Storage Building – Lead-Based Blue Wall Paint

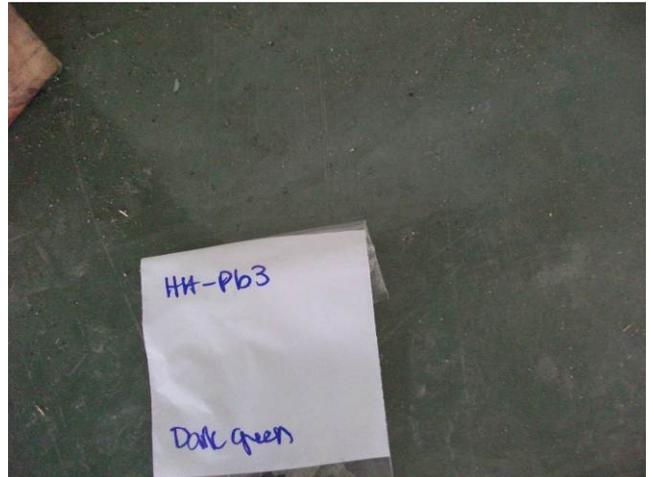
Photograph 20: Helicopter Hangar Building – Lead-Based Dark Green Floor Paint

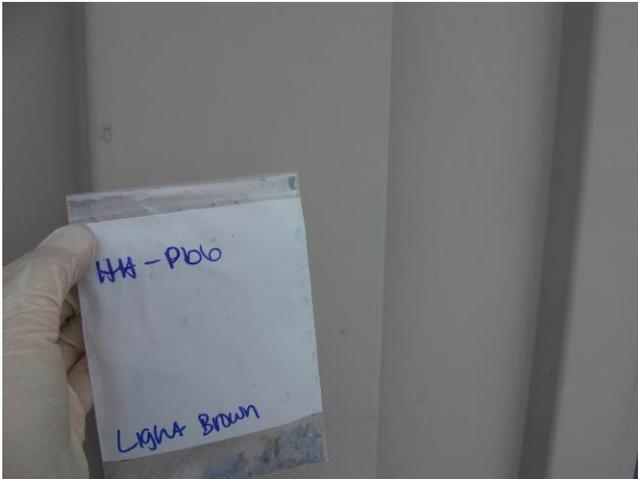
Photograph 21: Helicopter Hangar Building – Lead-Based Light Brown Exterior Wall Paint

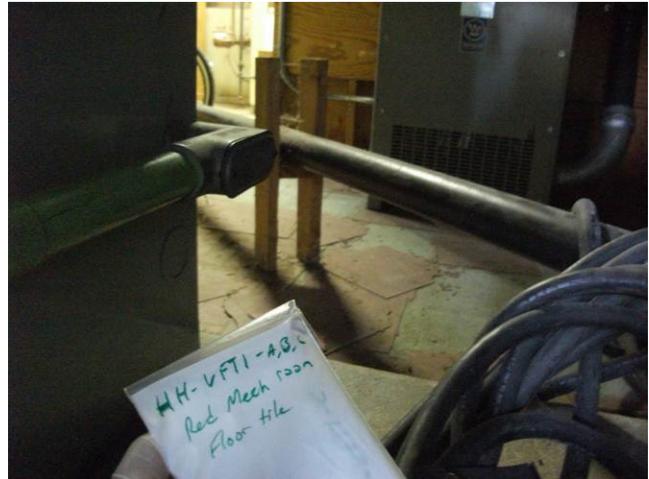
Material	Location ¹	Description	Assessment ¹	Action ²	Photo ³
Vinyl Floor Tile (VFT-1) (including mastic)	Mechanical Area on West Side of Building	Approximately 200 square feet (19 square metres) of VFT-1 (12"x12"; red) and underlying mastic	<ul style="list-style-type: none"> - Sample ID: HH-VFT1-A to C - Concentration: 29.3% Chrysotile - Material: Non-Friable - Accessibility: A (Areas of the building within reach, from ground level, of all building users. Activities of the building users may result in disturbance of ACM.) - Condition: Poor 	<p style="text-align: center;">Action 3 ACM removal required for compliance.</p> <p>Prior to demolition/construction activities, remove these materials following Type 1 abatement procedures – if the material is wetted and the work is done using non-powered hand tools and the mastic is removed using an appropriate solvent.</p> <p>Follow Type 3 abatement procedures – if mastic is removed via sanding or grinding with power tools.</p>	22

Photograph 22: Helicopter Hangar Building – ACM (VFT1) 12" X 12" Red Vinyl Floor Tile

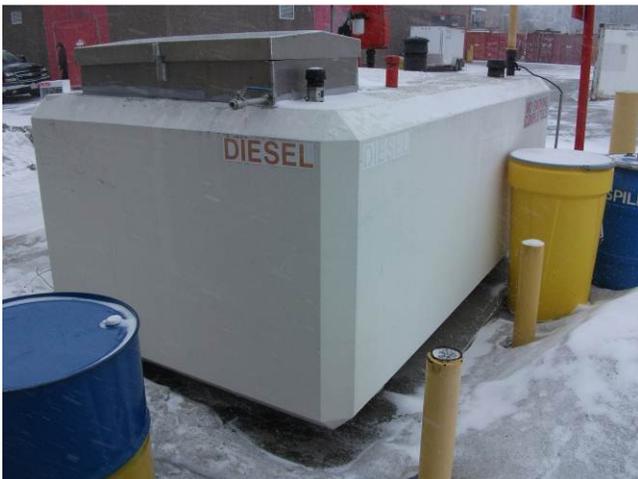
Material	Description	Action
Benzene	Benzene is likely a component in diesel, fuel, and oil in tanks, drums, and storage containers observed at CCGB Prescott.	Storage containers, tanks and drums were observed to be in good condition with no visible signs of damage or leakage. It is recommended that these containers be routinely maintained and monitored for any evidence of possible release. Work that may result in exposure to Benzene should follow all applicable provincial and federal regulations and guidelines pertaining to Benzene including the requirements of <i>O. Reg. 490/09</i> .
Acrylonitrile	Acrylonitrile was not observed in the area of work during the time of the survey.	No action required.
Arsenic	Arsenic was not observed in the area of work during the time of the survey.	No action required.
Coke Oven Emissions	Coke oven emissions were not observed in the area of work during the time of the survey.	No action required.

Photograph 23: Helicopter Hangar Building – Diesel Fuel Storage Tank

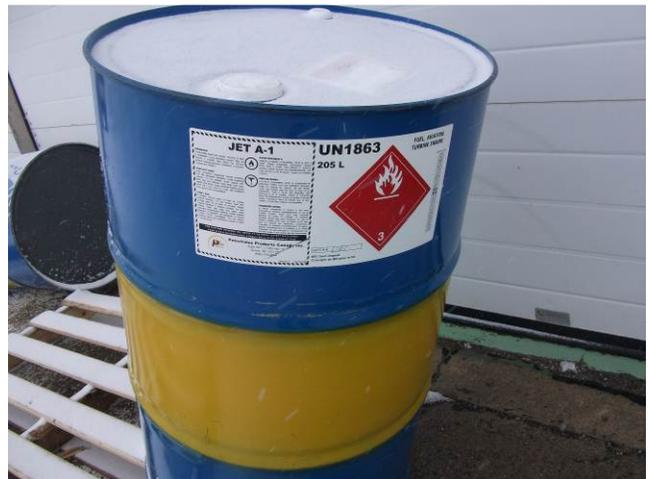
Photograph 24: Helicopter Hangar Building – Jet Fuel A-1 Fuel Storage Barrel

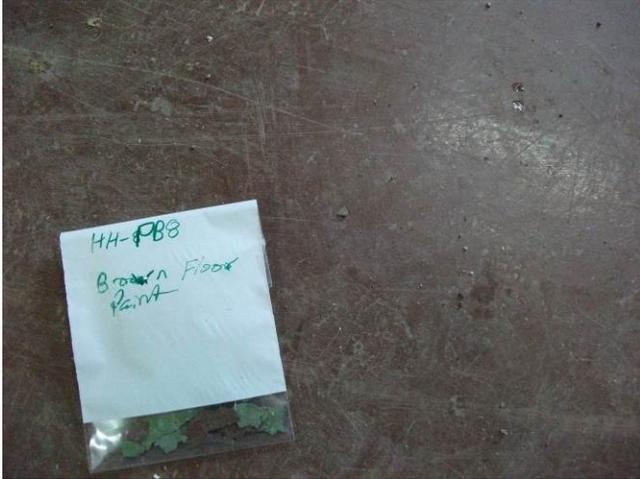
Photograph 25: Helicopter Hangar Building – Lead-Based Brown Floor Paint

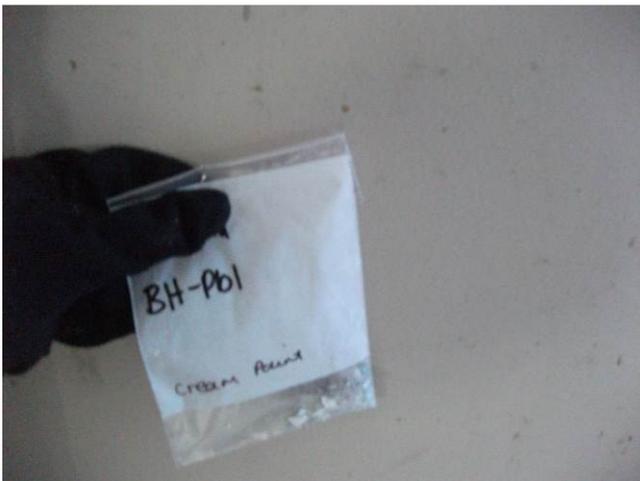
Building	Material	Location	Description	Assessment ¹	Action ²
Boat House	Cream Paint	Interior Paint	Interior Walls of Main Floor	- Sample ID: BH-Pb1 - Concentration: 100 ppm - Condition: Fair	<p>ingestion, and dermal absorption of lead.</p> <p>It is recommended that areas of lead-containing paints observed to be in poor condition (severe cracking/chipping/flaking and debris), be removed by a professional environmental contractor.</p> <p>In general, the following procedures are recommended when removing lead-containing materials, coatings and paint applications:</p> <ul style="list-style-type: none"> - Follow Type 1 – if the coating is to be removed with a chemical gel or paste; - Follow Type 2a – if the coating is to be removed by scraping or sanding using non-powered hand tools, or manual demolition of lead-painted building components by striking with sledgehammer or similar tool; - Follow Type 3a – if the coating is to be removed using power tools; or, - Follow Type 3b – if the coating is to be removed by abrasive blasting.

Photograph 27: Boat House Building – Lead-Based Cream Wall Paint

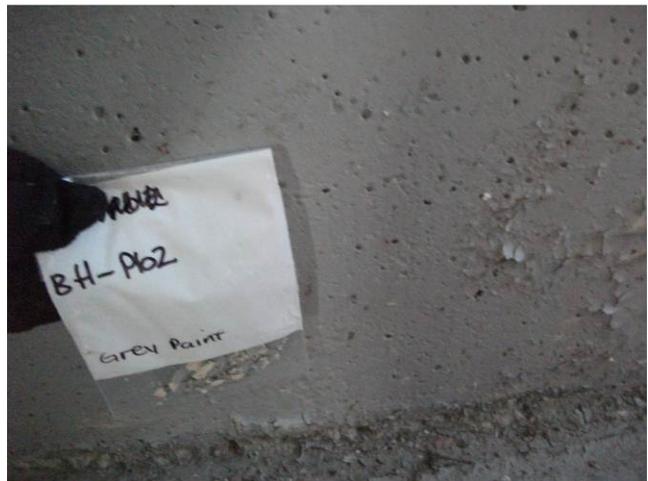
Photograph 28: – Boat House Building – Lead-Based Grey Floor Paint

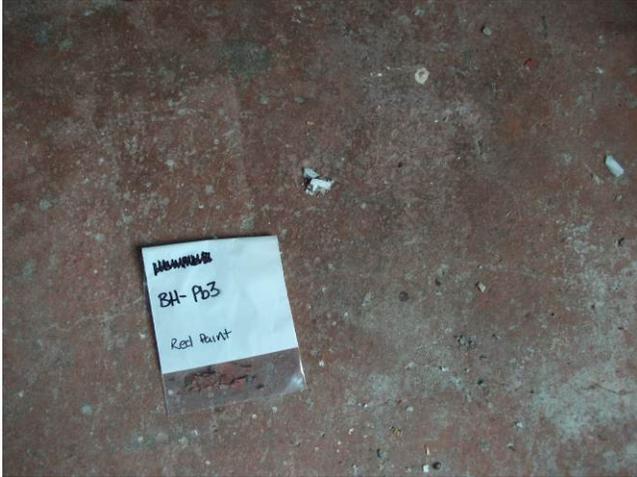
Photograph 29: Boat House Building – Lead-Based Red Floor Paint

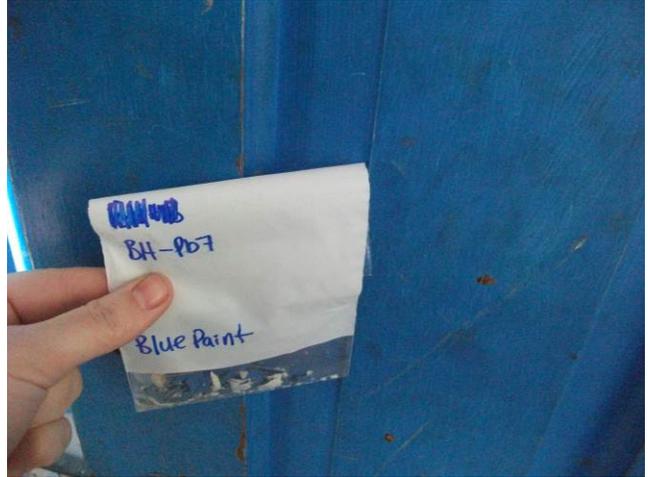
Photograph 30: Boat House Building – Lead-Based Blue Wall Paint

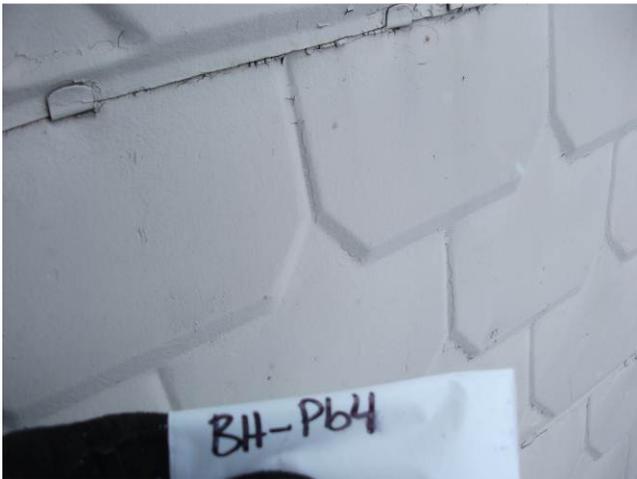
Photograph 31: Boat House Building – Lead-Based Beige Exterior Wall

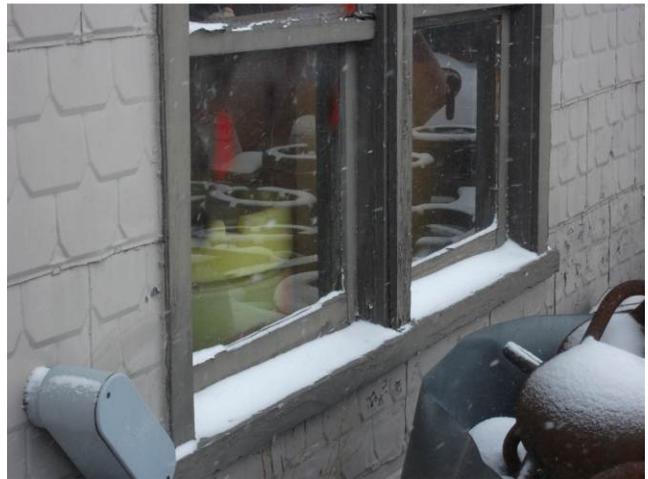
Photograph 32: Boat House Building – Lead-Based Green Exterior Window Paint

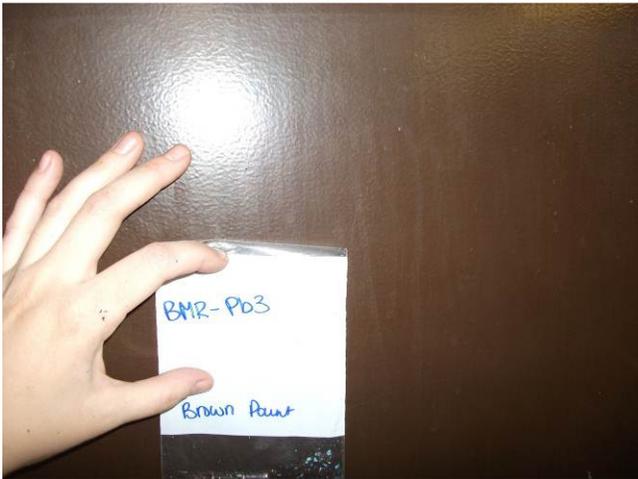
Buoy Maintenance Building	Cream Paint	Primary Undercoat Throughout Entire Building	Cream colour paint on most walls throughout building	- Sample ID: BMR-Pb1 - Concentration: 130 ppm - Condition: Fair	
	Brown Paint	Exterior Paint	Exterior of building	- Sample ID: MB-Pb3 - Concentration: 2600 ppm - Condition: Good

Photograph 35: Buoy Maintenance Building – Lead-Based Brown Exterior Paint

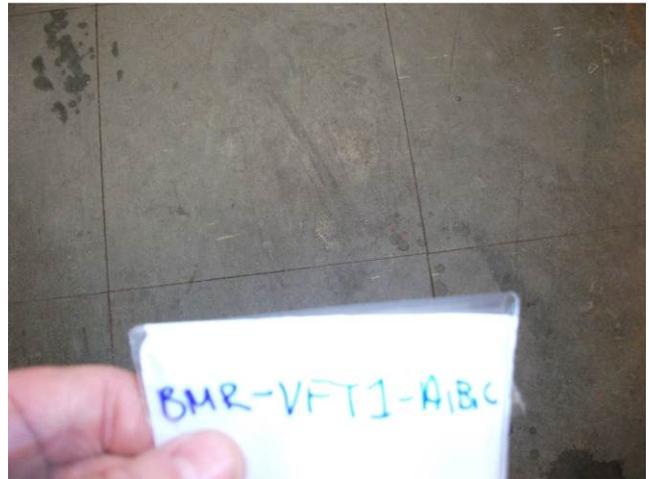
Material	Location	Description	Assessment ¹	Action ²	Photo ³
Vinyl Floor Tile (VFT-1) (including mastic)	Hall Between Shower and Work Area	Approximately 50 square feet (5 square metres) of VFT-1 (12"x12"; blue with white streak, covered by lots of dust/dirt) and underlying mastic	<ul style="list-style-type: none"> - Sample ID: BMR-VFT1-A to C - Concentration: 14.2% Chrysotile - Material: Non-Friable - Accessibility: A <i>(Areas of the building within reach, from ground level, of all building users. Activities of the building users may result in disturbance of ACM.)</i> - Condition: Good 	<p>Action 7 Routine surveillance of ACM in good condition.</p> <p>Prior to demolition/construction activities, remove these materials following Type 1 abatement procedures – if the material is wetted and the work is done using non-powered hand tools and the mastic is removed using an appropriate solvent.</p> <p>Follow Type 3 abatement procedures – if mastic is removed via sanding or grinding with power tools.</p>	36

Photograph 36: Buoy Maintenance Building – ACM (VFT1) Blue With White Streak 12" X 12" Vinyl Floor Tile

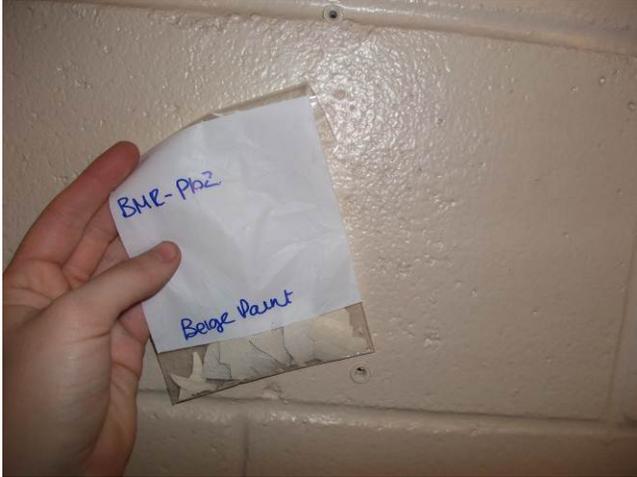
Photograph 37: Buoy Maintenance Building – Lead-Based Beige Undercoat Paint

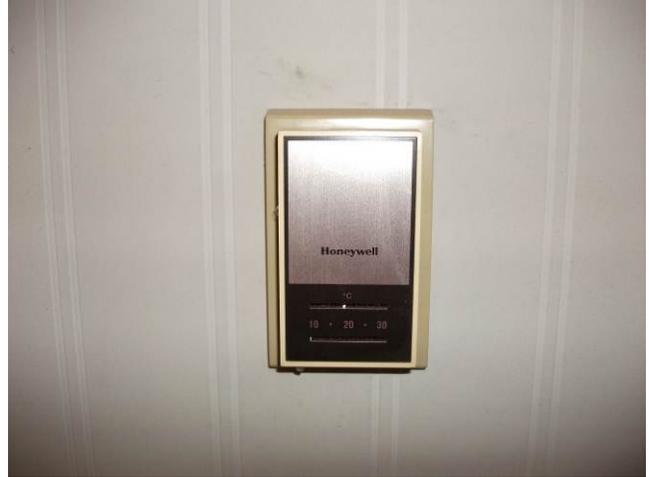
Material	Description	Action
Mercury	Mercury vapour may be present within fluorescent light tubes observed during the survey. Mercury-containing thermostats were confirmed to be present in the Main Building, Buoy Maintenance Building, Boat House, Helicopter Hangar, and Heated Storage Building.	Removal and disposal of mercury-containing equipment is required prior to demolition activities that may disturb the equipment. The handling, transport, and disposal of mercury containing equipment must follow all applicable provincial and federal regulations and guidelines pertaining to Mercury, including the requirements of O. Reg. 490/09 and the requirements of <i>Reg. 347 – General – Waste Management</i> .
PCBs	Fluorescent light fixtures were observed during the survey. The majority of the light ballasts were observed to be the T12 style and as such have the potential to contain PCB's.	When decommissioned, verify the PCB content of each fluorescent light ballast as per the <i>Environment Canada</i> publication "Identification of Lamp Ballasts Containing PCBs", 1991. Handle, store and dispose of PCB-containing ballasts in accordance with <i>Federal PCB Regulation SOR/92-507</i> and <i>R.R.O. 1990 – Reg. 347</i> .

Photograph 38: Typical Mercury Containing Thermostat Observed in Buildings at CCGB Prescott
