PRE-DESIGN REPORT

AAFC - Highfield Dam Rehabilitation

Report Number: 12-1345-0020

**FINAL REPORT – HIGHFIELD DAM SERVICES CONTRACT NO. 6:
PROJECT REHABILITATION PRE-DESIGN STUDY**

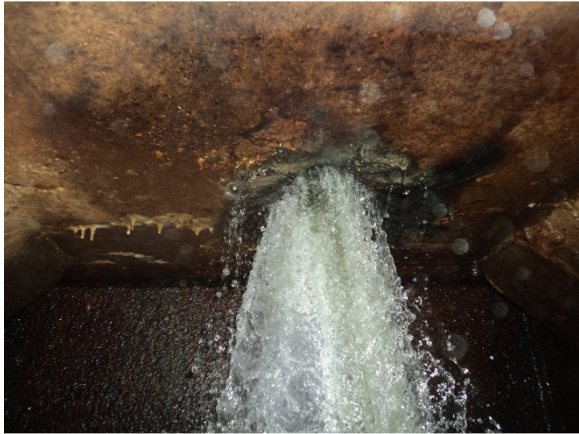
- The conduit vent pipe extends through the concrete structure but is fully exposed within the gate well riser in a submerged condition. The vent pipe was assumed broken within the gate well riser section as water flowed continuously into the outlet conduit for the duration of the inspection. A follow up inspection carried out by AAFC independent of Golder verified that the vent pipe is 'badly corroded' through inside the gate well riser and supplemented the observation by photograph received by e-mail October 24, 2012.

East LLO air vent leakage from gatewell riser at main control gate.

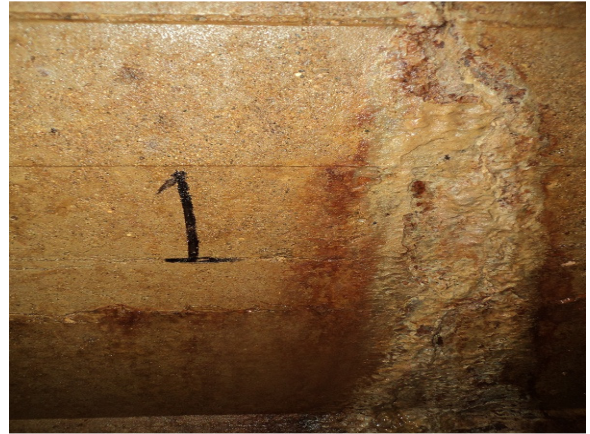
Efflorescence along vertical crack. Oxide stains, seepage

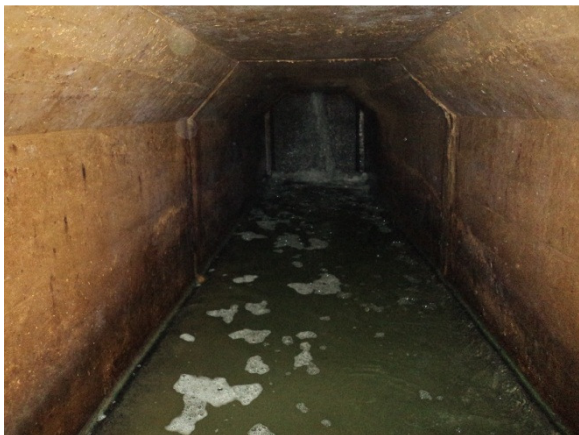
View towards main gate, air vent and gate leakage. Pour lines and oxide stains visible.

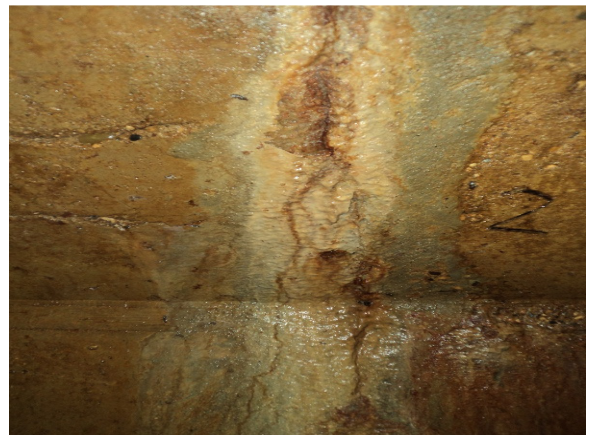
Cracking, seepage and efflorescence.

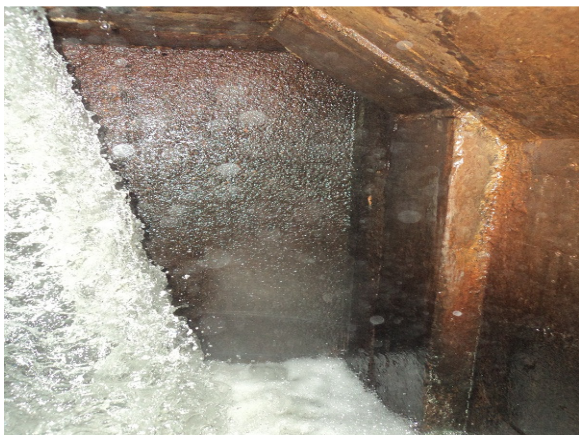
- The gate seated well with observed spray leakage from the four corners of the gate.
- The downstream face of the gate showed signs of corrosion with rust nodules present over 30% to 50% of the face. The gate appeared in overall fair condition.

Poor gate seat along invert. Gate skin shows rust nodules over entire surface.

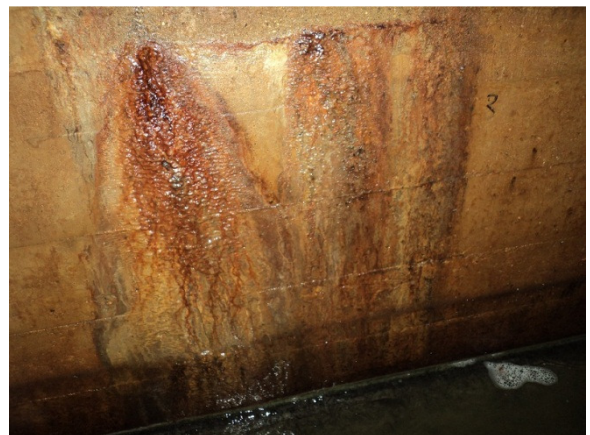
Seepage, oxide staining, and efflorescence along cracks and pour lines.

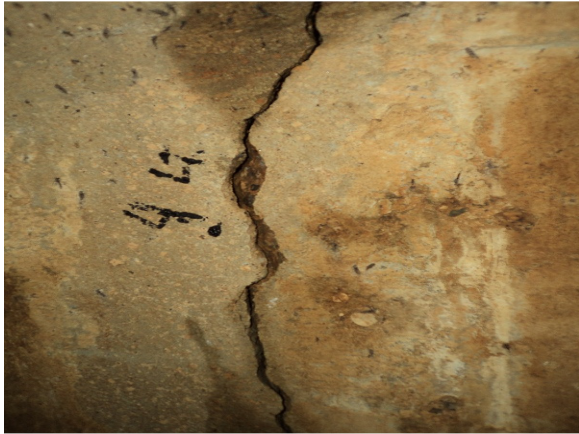
Existing crack with separation (left side looking downstream).

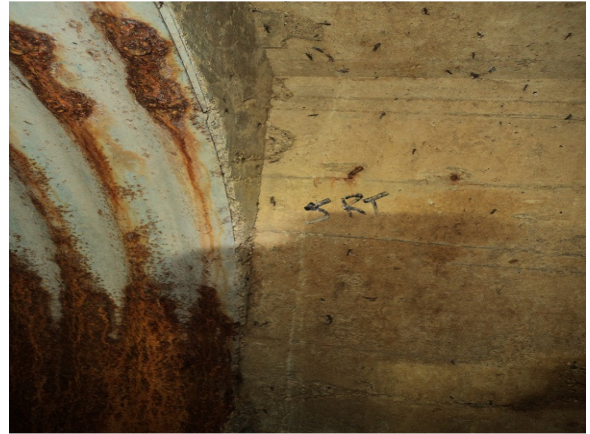
- The concrete transitions to the Corrugated Metal Pipe (CMP) area appeared in fair condition. The CMP showed advanced surface oxidation primarily along the haunch; between the spring line and invert of the pipe. A short section of (older) CMP was asphalt coated while the longer (newer) CMP was galvanized with advanced surface oxidation (rust) development. Horizontal and vertical measurements recorded indicated no significant deformation of the CMP. One puncture of the CMP was found on the crown of the pipe at about 5.4 m up the pipe measured from the end of the CMP at the 'waterface of the new headwall' (refer to PFRA drawing C116714) at the upstream side of the outlet works stilling basin. The puncture is suspected to have occurred during construction.

Concrete to CMP transition. Galvanized CMP w/advanced surface oxidation (rust).

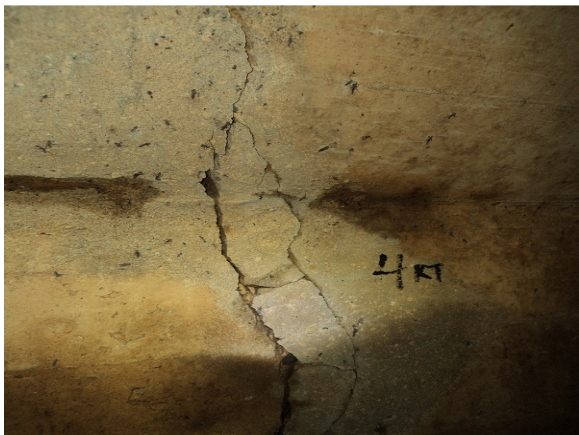
Wall Crack with separation (right side looking downstream).

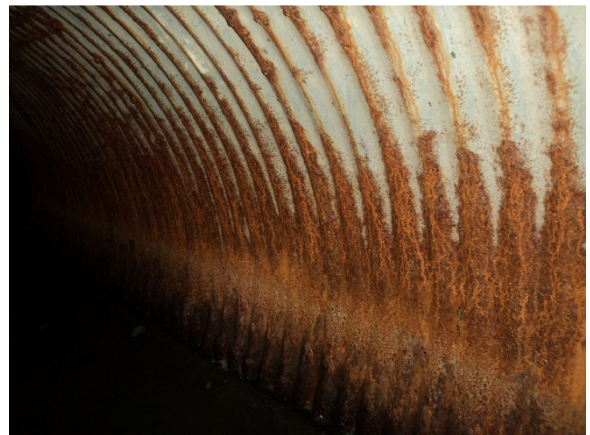
Rust over 60 % of the surface, primarily along invert.

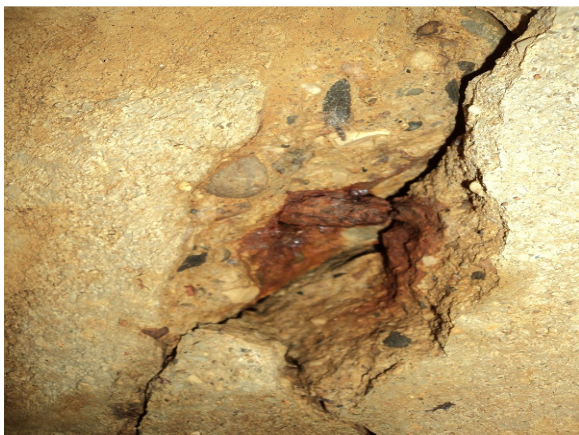
- Previous crack repair areas appeared in fair shape with separation cracks forming between the original concrete and repair mortar. Spalls or pop-offs were noted with one area with exposed reinforcing steel.

Wall crack with rebar stub end showing (oxidized)

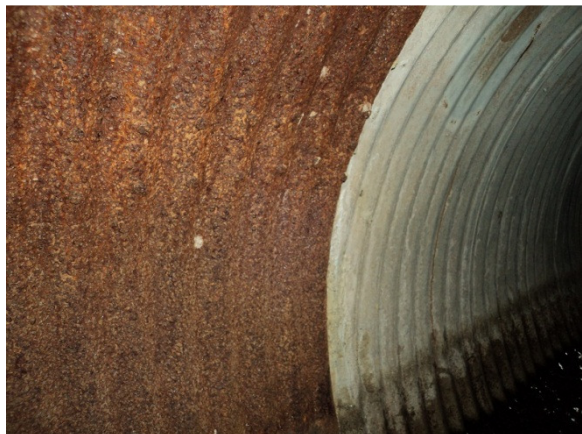
Extent of rusting between sections. Coating failure.

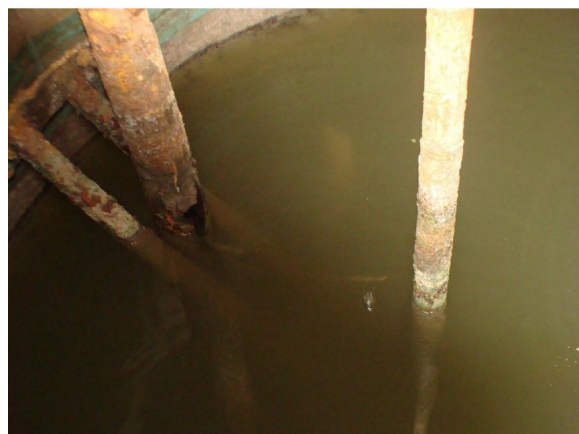
AAFC photo illustrates badly corroded air vent at waterline. Photo taken October 2012.

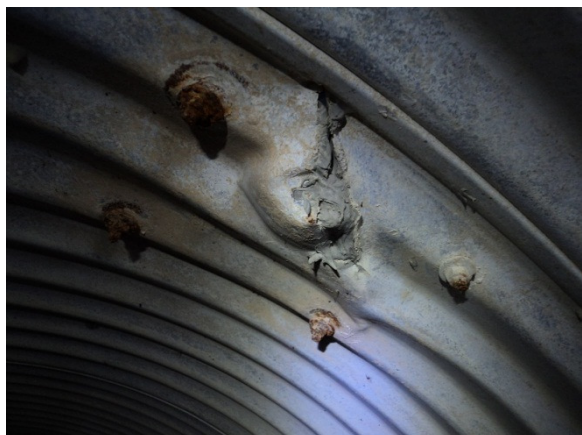
Puncture near crown of 1.6 m dia. CMP. Suspect occurred during construction.

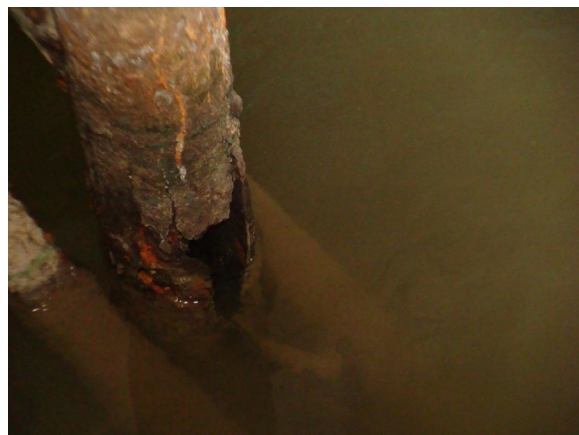
Close-up shows corrosion and break through rupture. Photo taken October 2012

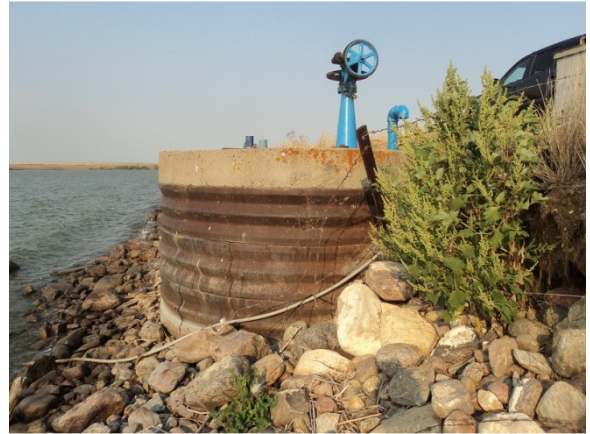
East LLO gatewell CMP riser and armor condition.

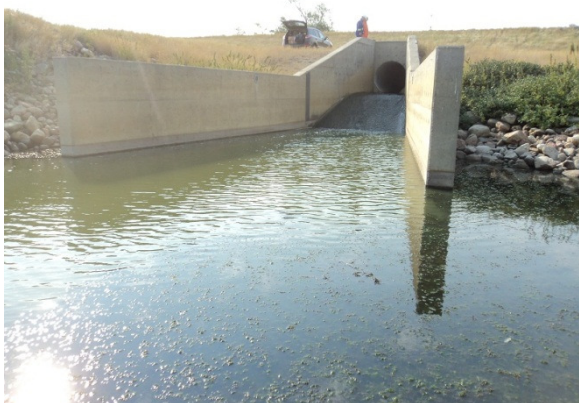
- The concrete outlet structure and stilling basin showed few signs of deterioration, deformation, displacement, or surface weathering and thus is in good condition. Minor scouring of the invert section was present and minor vertical cracking was observed in the basin walls. The stilling basin was submerged at the time of the inspection and was not inspected.

View looking upstream toward concrete outlet stilling basin. Note basin armor. Concrete in good condition.

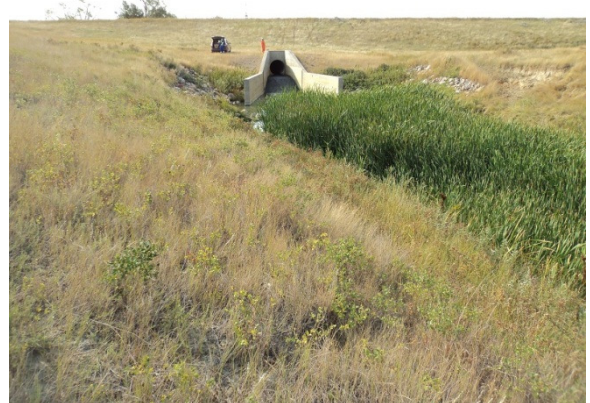
- The outlet channel was observed to be heavily vegetated with aquatic/wetland type plants (cattails). Armor protection provided to transition from the stilling basin to the original Rush Lake Creek channel appeared to be in good condition.

View of vegetation inside Rush Lake Creek at East LLO outlet.

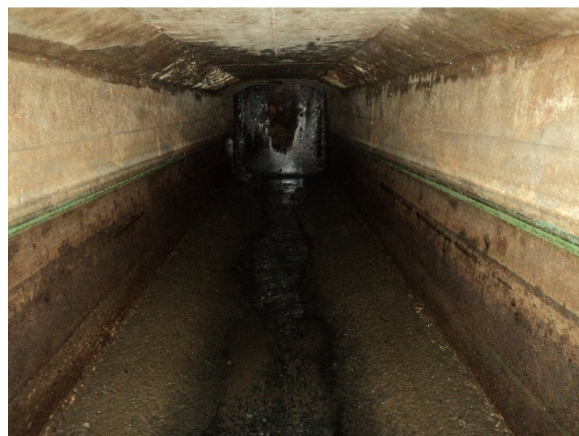
Overall view towards gate shows waterline staining, overall box condition, invert wear.

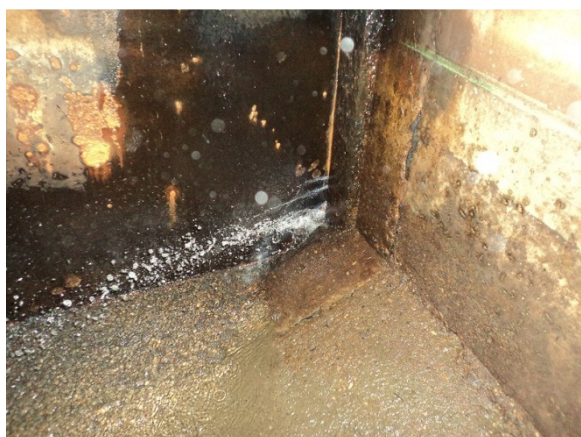
- The outlet conduit contained pooled water.
- The conduit vent pipe was dry and showed no signs of leakage.
- The gate appeared to be well seated with little leakage observed between the concrete and the gate.

Good gate seating with minor leakage at right and left bottom corners of gate.

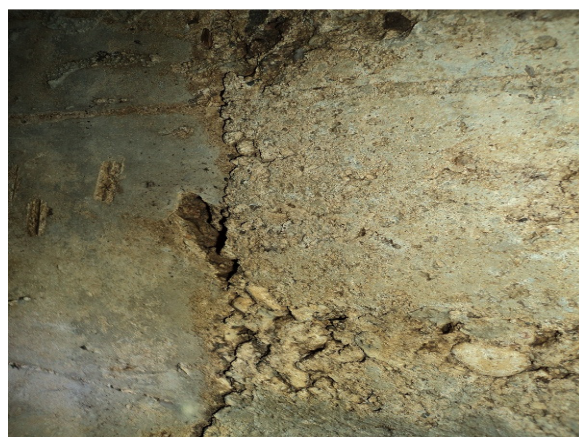
Honeycombing and crack formation..

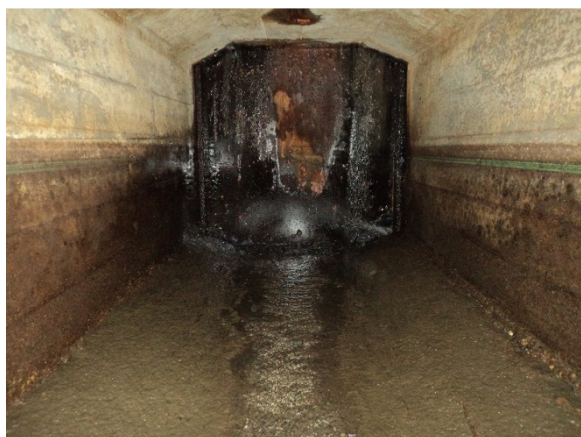
- The downstream face of the gate showed signs of corrosion with rust nodules and staining vertically over approximately 30% of the gate shell surface. The overall condition of the gate appeared to be good.

Overall condition of gate appears good with oxidization of centre. Roof vent dry.

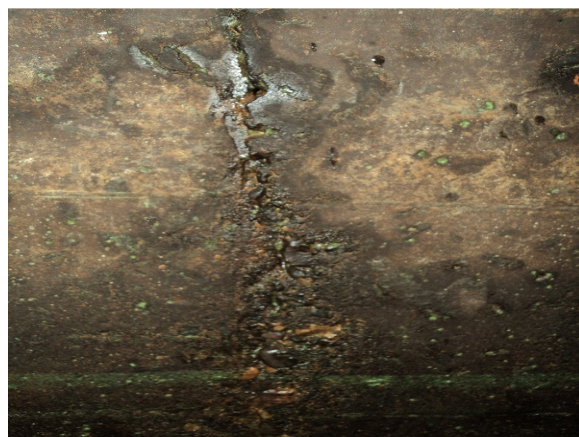
Crack and spall with minor seepage and efflorescence staining.

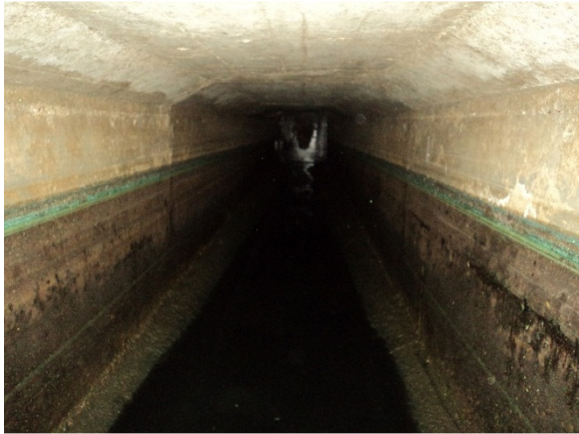
- The concrete conduit presented a lower degree of deterioration compared to structures having the same age. Visible cracks, pour lines, surface flaking revealing aggregate, and occasional spalls were observed along the outlet conduit. Concrete joints showed no signs of separation or displacement and there was no observed leakage. The water line in the conduit was well defined and was observed to be at the spring line (half the depth) of the conduit. Iron oxide (rust color) stains, and minor soluble salt deposition (efflorescence) was observed.

Overall view back toward gate to illustrate general condition of West LLO conduit

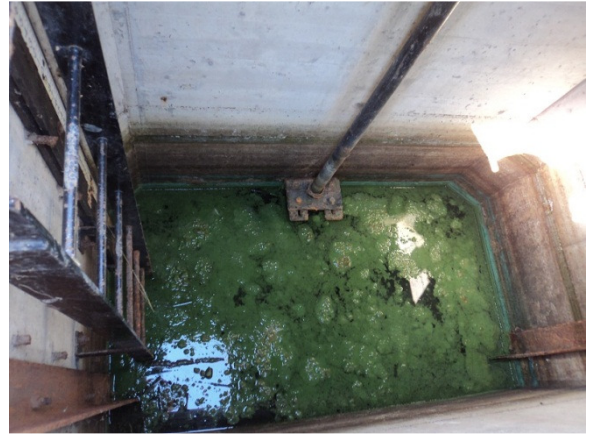
West LLO gatewell view from top of gatewell. Algae growth may produce oxygen deficient atmosphere.

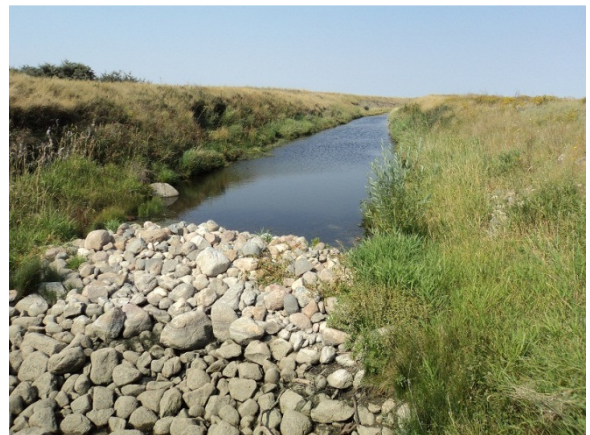
- Armor rock was observed to be piled beyond the concrete structure inside Herbert Canal. The purpose of the rock pile was surmised to provide energy dissipation at the transition point to the canal.

- The downstream canal banks were observed to be well vegetated with visible infilling of the canal invert as a consequence of the canal bank erosion processes.

Rock pile at end of West LLO transition to the Herbert Canal. Note general condition of canal banks.

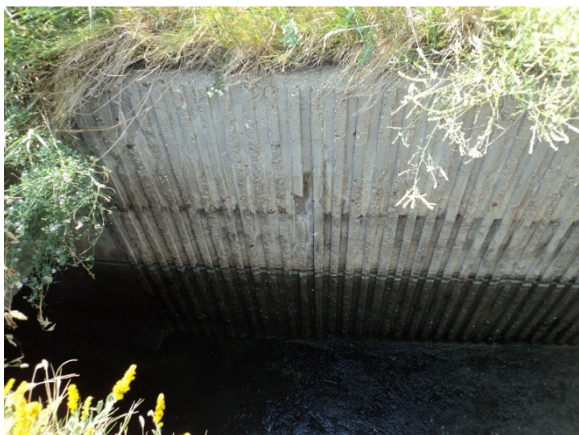
West LLO transition wall to stilling basin w/roughened wall for energy dissipation.
