**DRAFT Condition Assessment
Structures 302 and 304
Le Goulet Wharf
(Call Up EC015-121187)**

Le Goulet, New Brunswick
15 May 2012

Prepared for PWGSC
Project No. 5426.98-R01

File: 5426.98 – R01

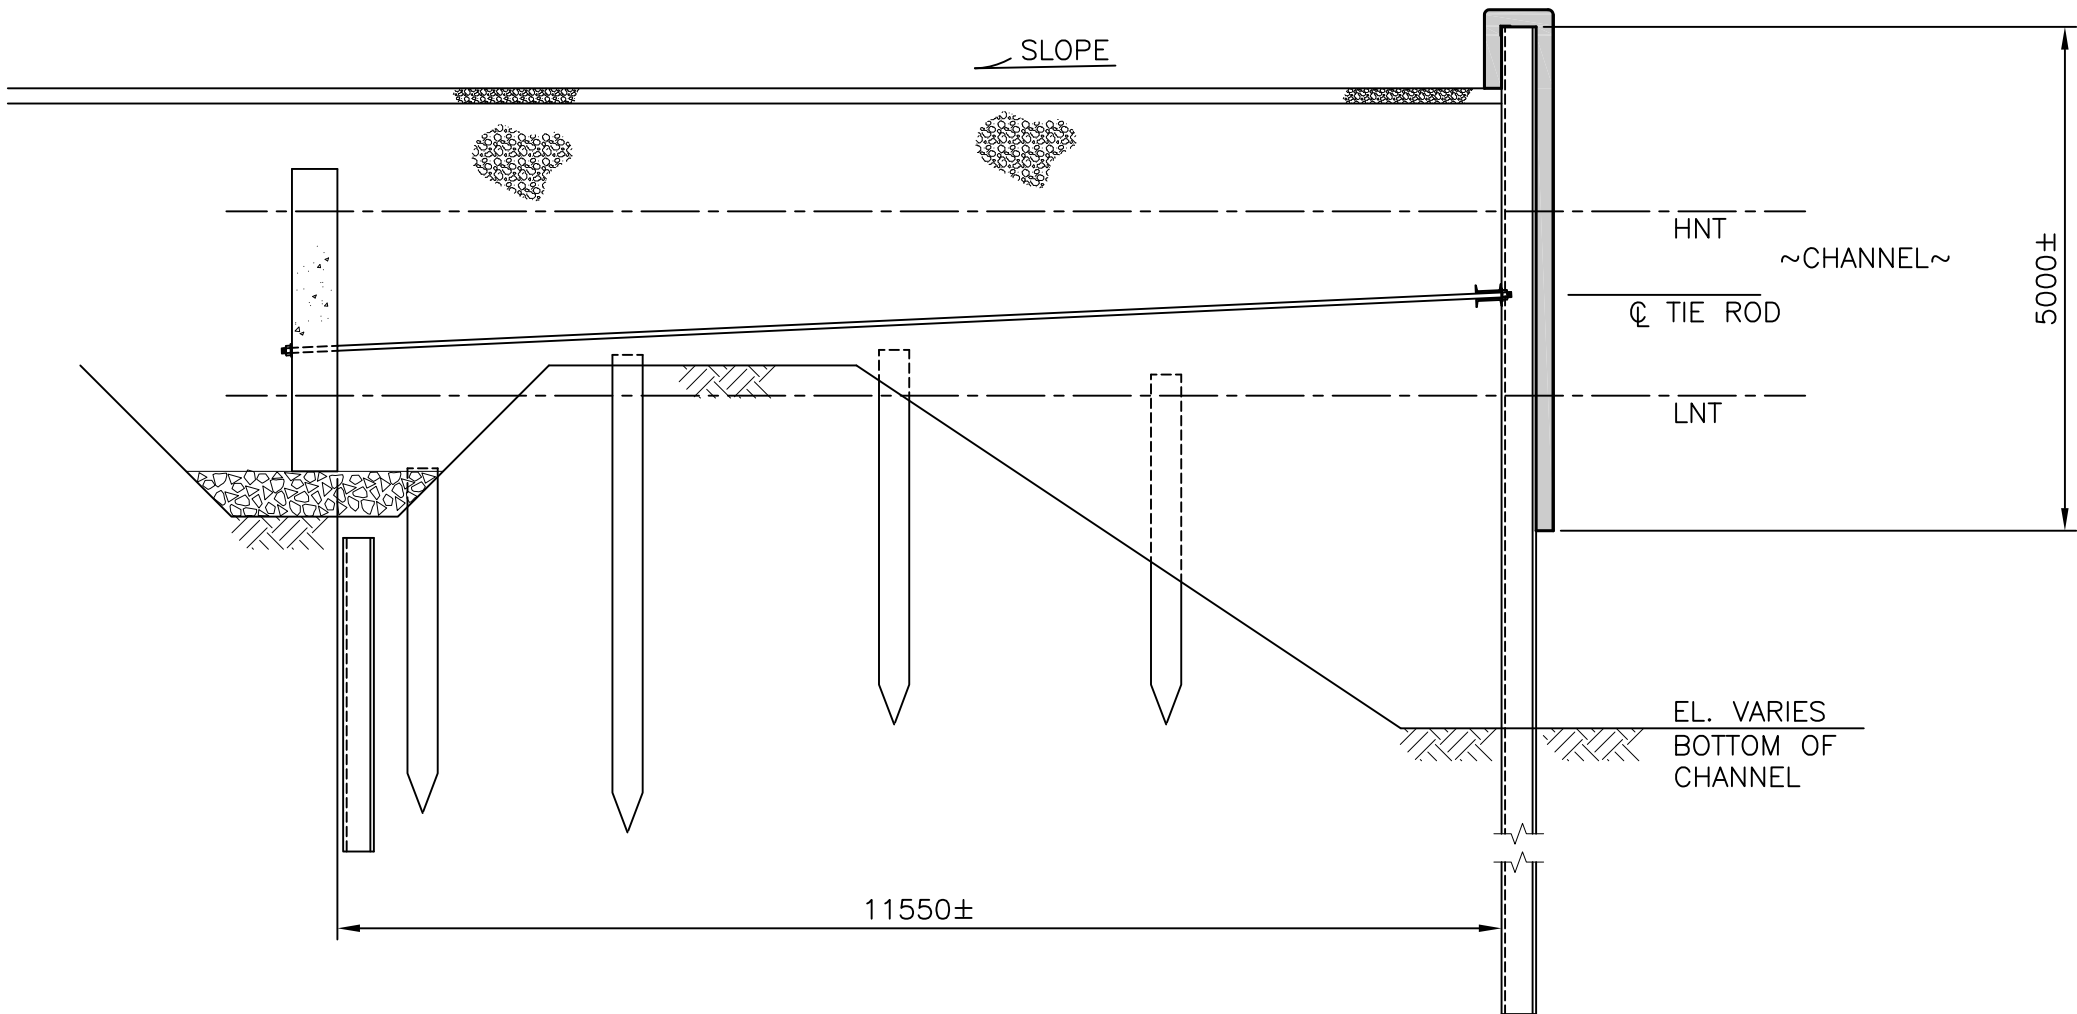
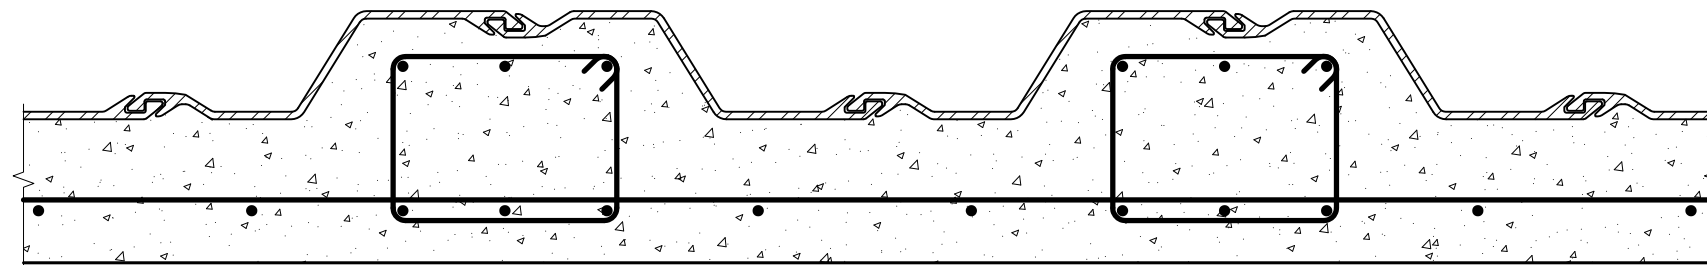
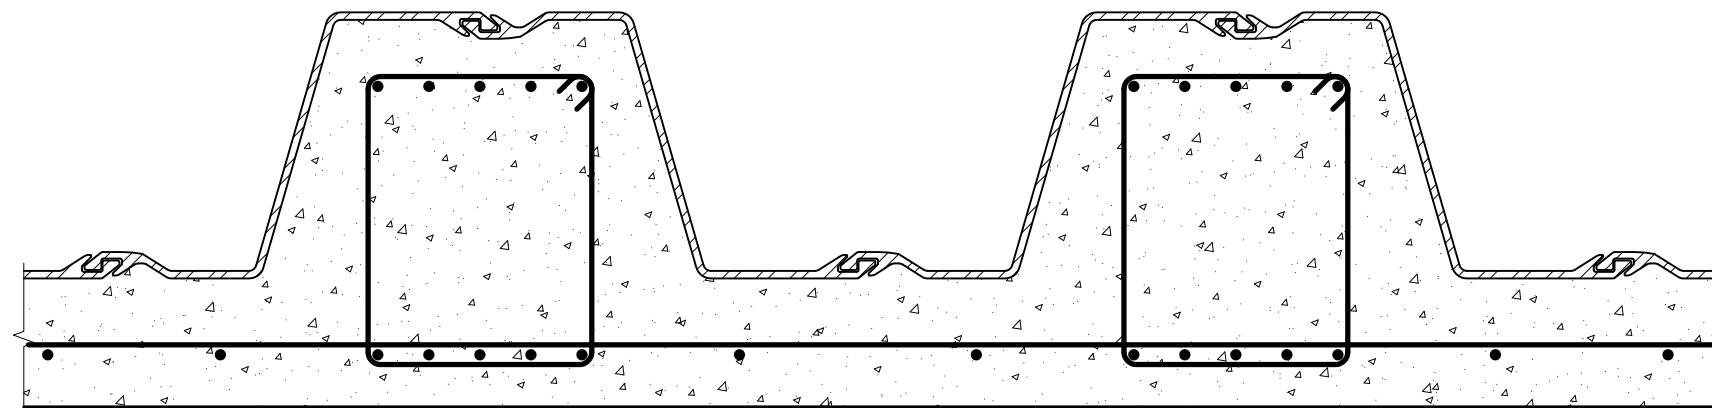
TYPICAL SECTIONS

The concept for the encasement of the wall section is shown on the sections and details provided in Figure S4, Appendix B. The encasement of the SSP on Structure 302 will be thicker and more heavily reinforced than that on Structure 304 due to the relatively shallow depth of the SSP profile. The encasement would extend down to varying depths along the channel face due to the differences in SSP section and location of competent material below areas of major deterioration.

The encasement must extend down to below the zone of major corrosion a sufficient depth to allow the transfer of loads from the remaining competent steel section to the reinforced concrete section.

It is recommended that the top of the encasement extend up beyond the top of the SSP and incorporate a barrier / wheel guard. Ladders and mooring cleats can be incorporated into the concrete encasement along both the harbour and channel faces of the reconstructed structures.

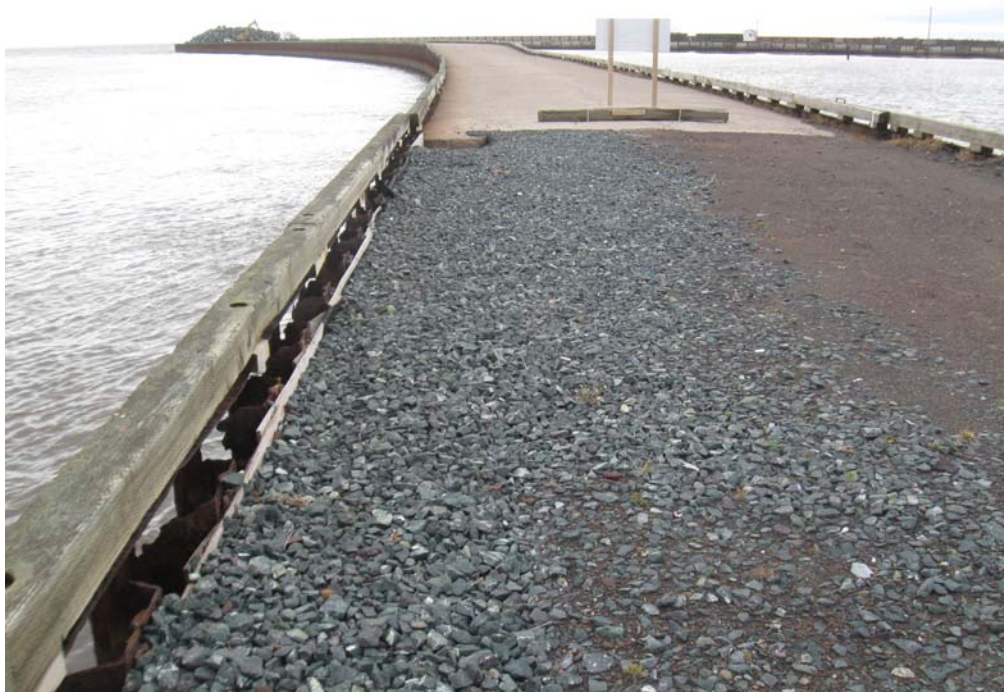
Photo No. 4: Gravel Fill where Material Loss Occurred Through SSP Face at South End of 1966 Section of Structure 302. (2011-11-29)

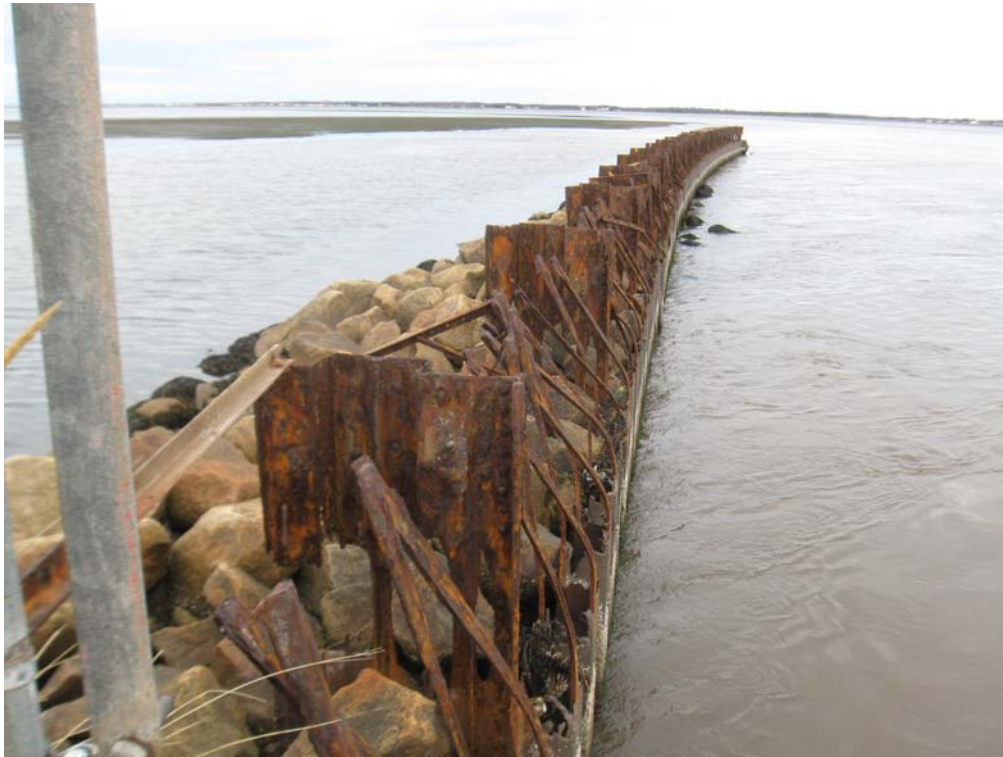
Photo No. 9: Deteriorated SSP Wall to North of Structure 302. (2011-11-29)

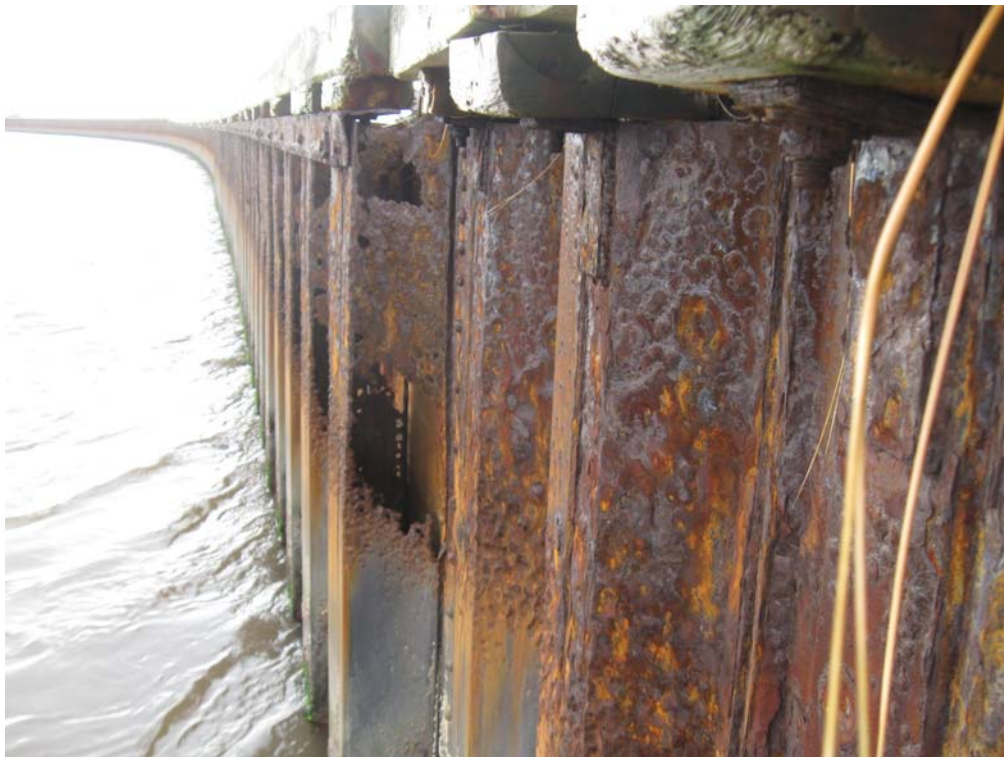
Photo No. 12: Perforations at Top of SSP Along Channel Face of Structure 302. (2011-11-29)

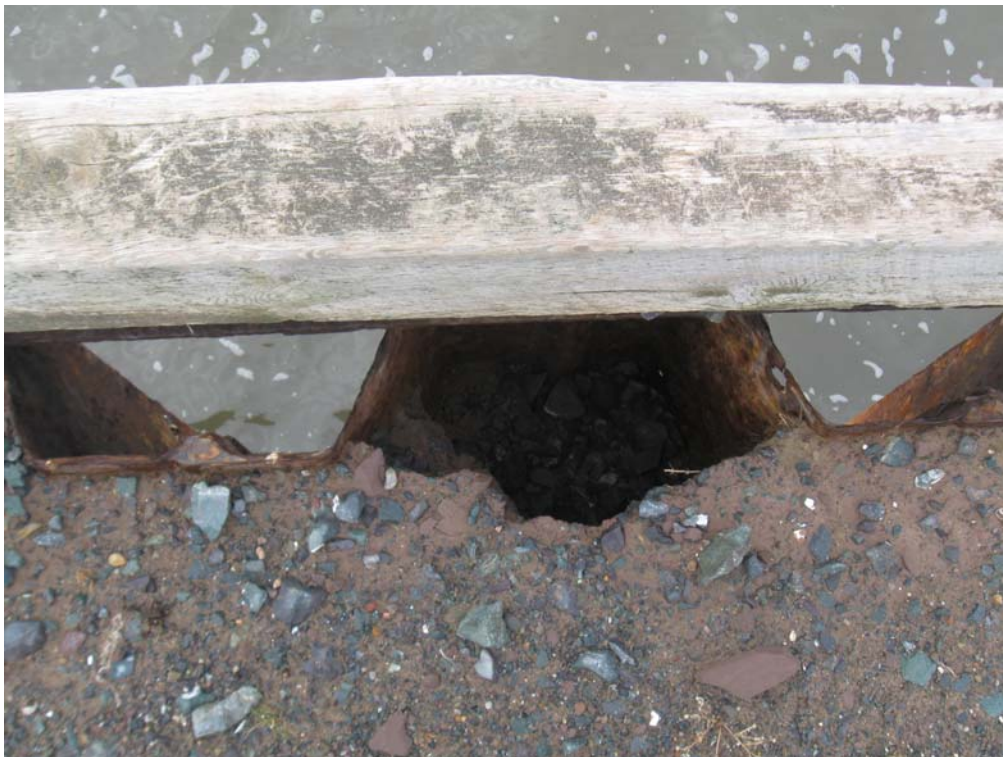
Photo No. 16: Voids In Fill at SSP Face at South End of Structure 302. (2011-11-29)

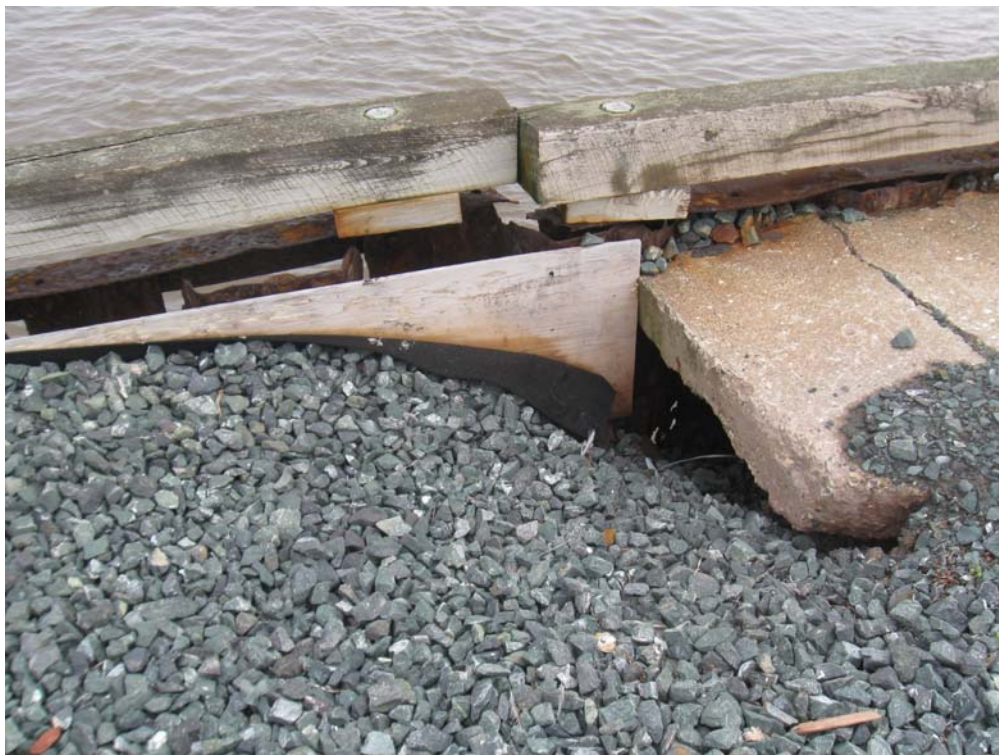
Photo No. 17: Loss of Material at Joint Between 1966 and 1968 Sections of Structure 302. (2011-11-29)

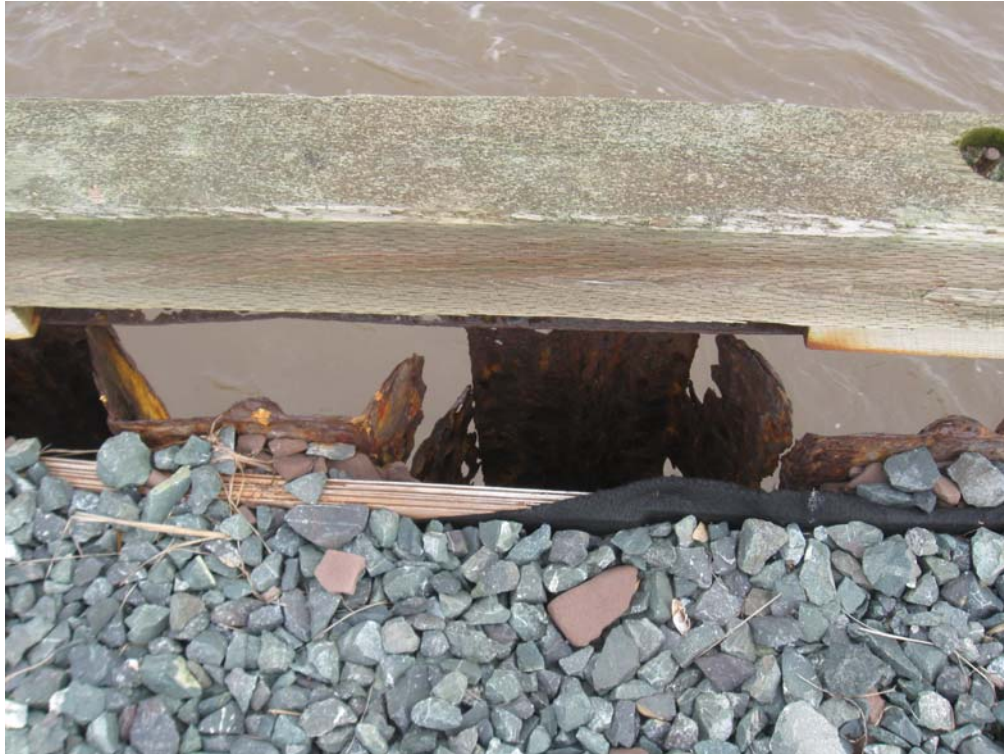
Photo No. 19: Deterioration at Top of SSP Channel Face at 1966 Section of Structure 302. (2011-11-29)

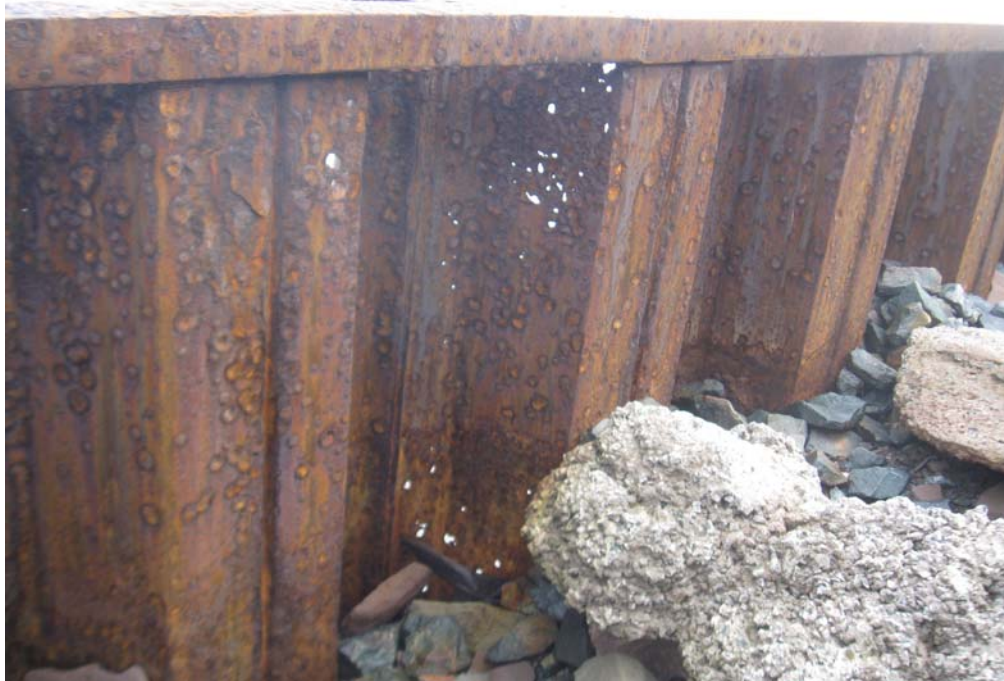
Photo No. 23: Severe Pitting on Back Face of SSP – East Wall of Structure 304. (2011-11-29)

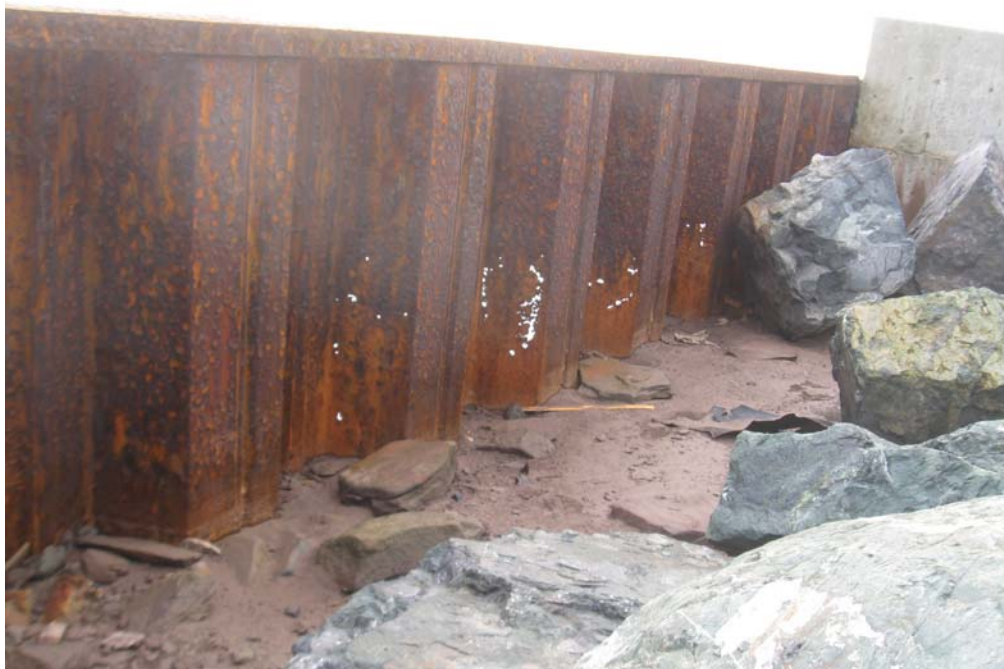
Photo No. 24: Perforations at South End of East Face – Structure 304. (2011-11-29)

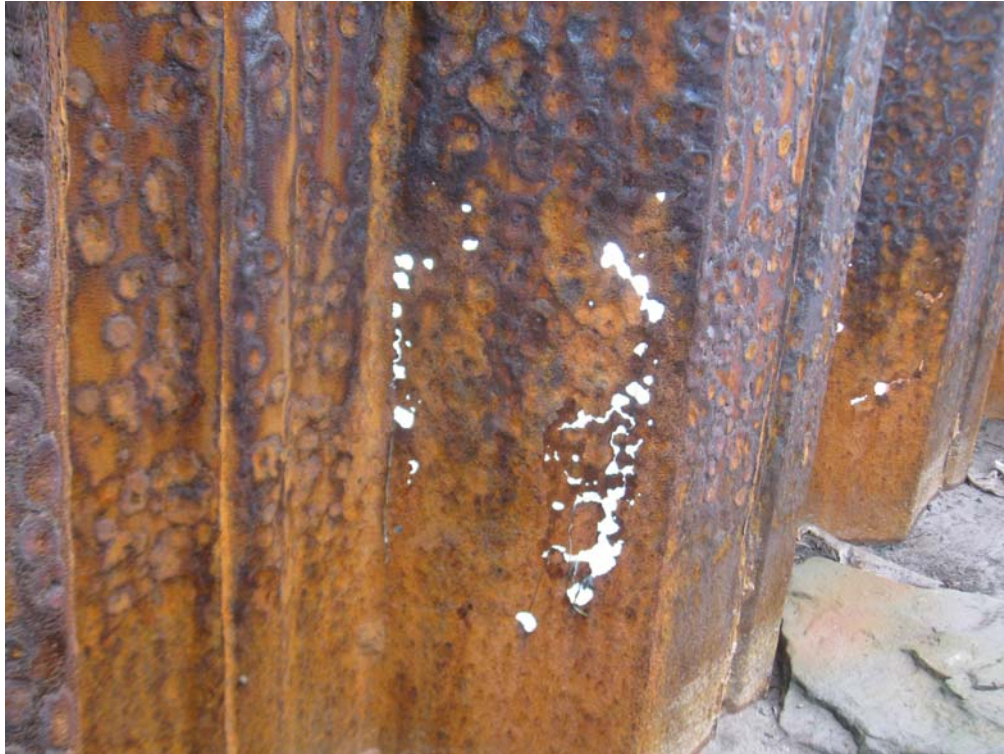
**Photo No. 25: Severe Pitting and Perforations in Back Side of SSP East Wall
- Structure 304. (2011-11-29)**

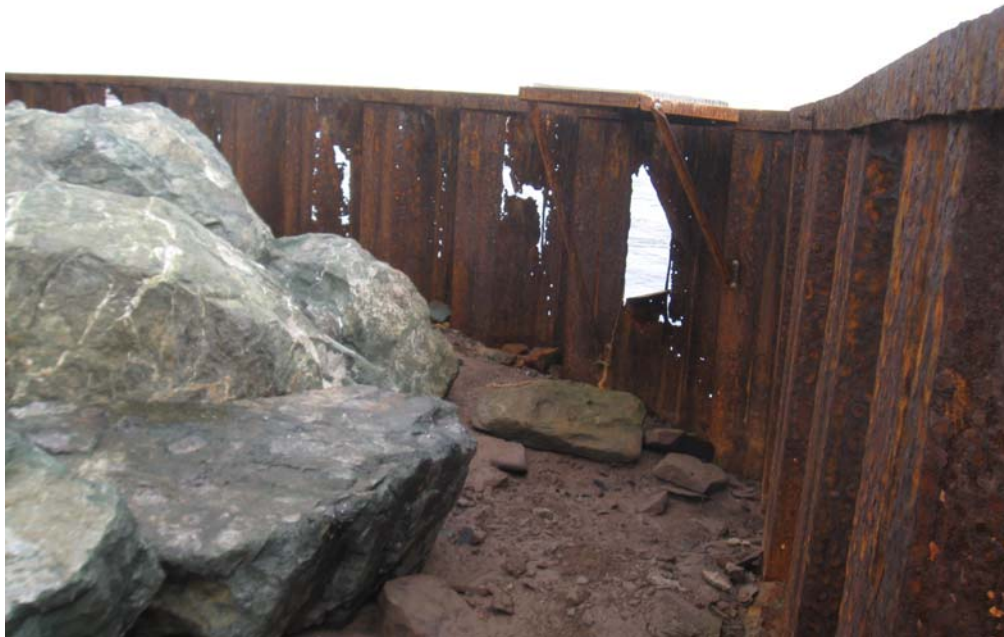
Photo No. 27: Back Face of Perforated SSP at South-East Corner of Structure 304. (2011-11-29)

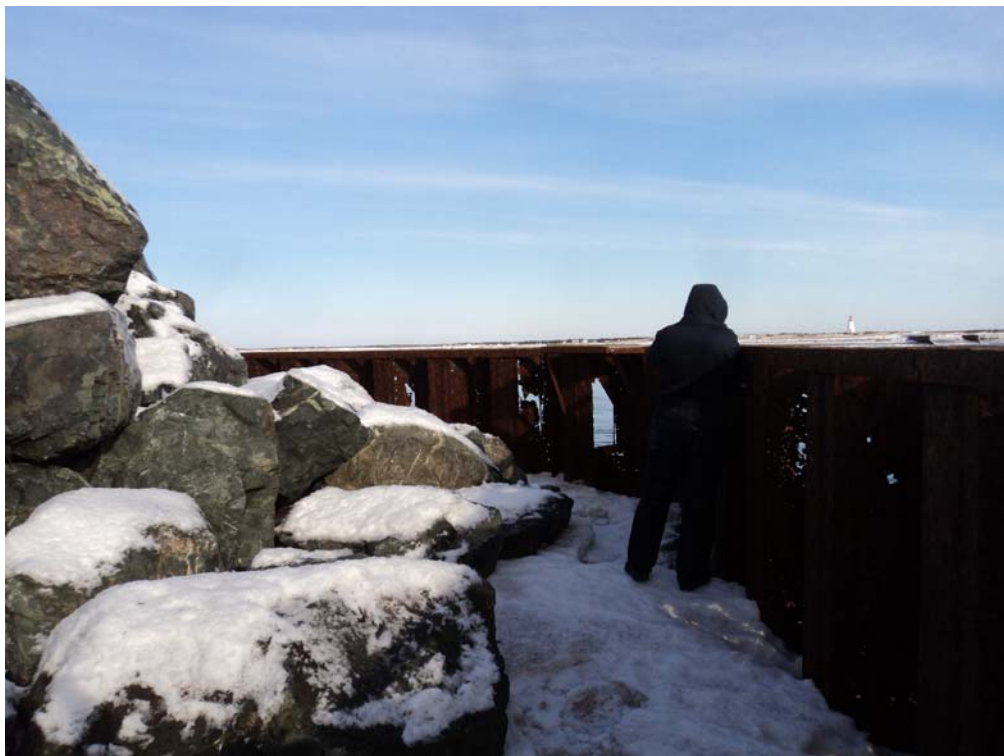
Photo No. 30: Perforations at South-east Corner of Structure 304.
(2012-02-08)

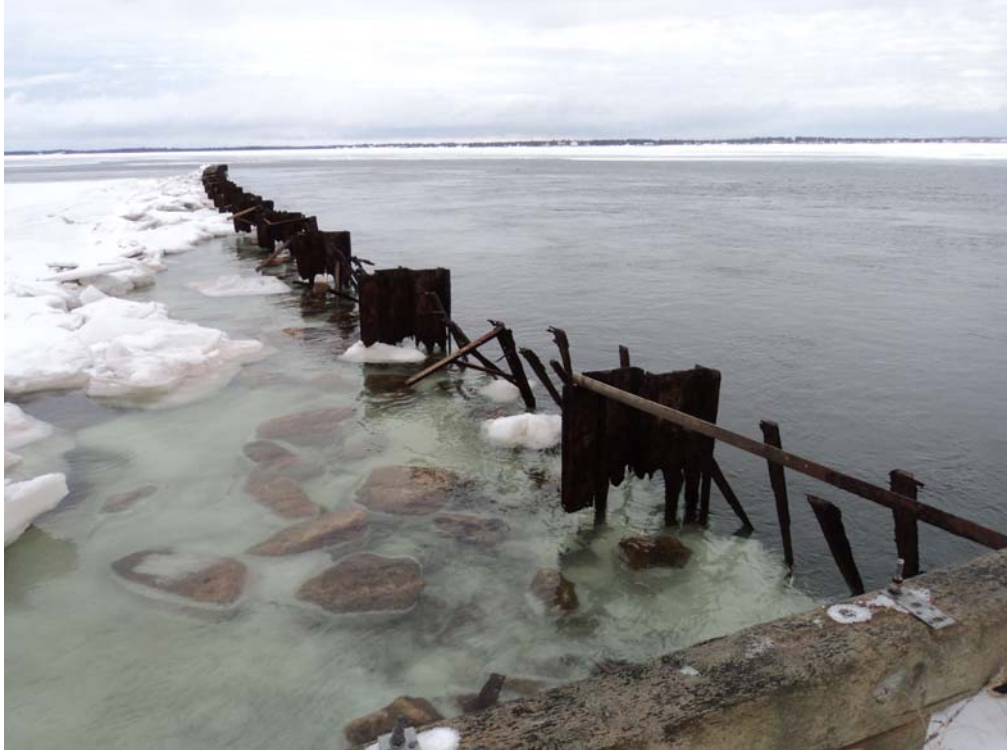
Photo No. 41: North of Structure 302. Remains of SSP Wall. (2012-02-08)

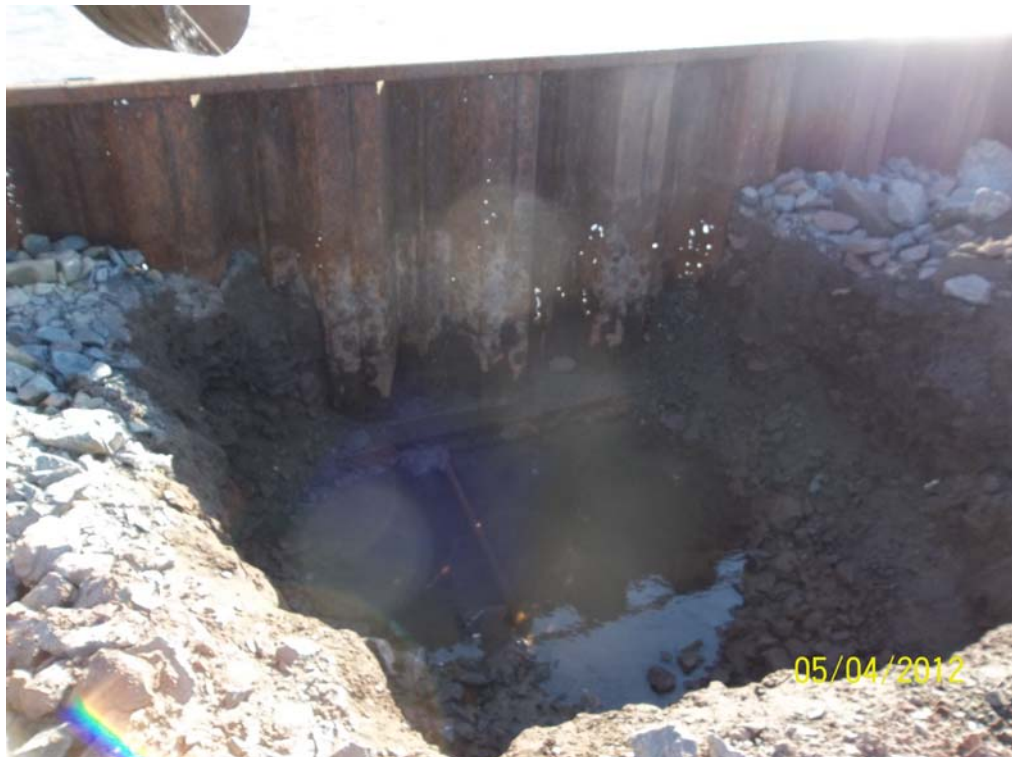
Test pit TP1 was excavated behind the SSP wall along the channel face of Structure 304. The tie-rods, walers, plates and bolts were determined to be in very good condition with negligible loss of section. Field measurement verified that members were as called up on the 'As-Built' drawings of Structure 304. Anchor rod spacing was not identified. Outer tie-rod ends are connected to the waler behind the SSP wall at this location. The tie-rod distance below the top of wall is 350 mm \pm higher than indicated on the 'As-Built' drawings. The fill behind the SSP wall was observed to be coarse sand with some gravel (i.e. beach sand fill).

Photo 42 - TP 1 – Tie-Rods exposed and perforations in upper portion of SSP visible.

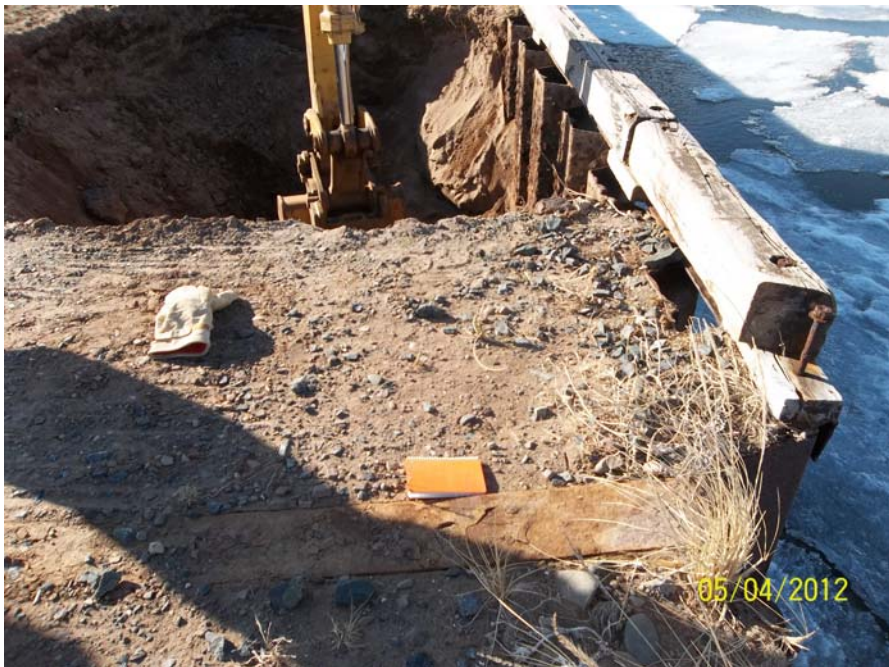
The spacing of the tie-rods in this location was found to be approximately 1000 mm on centre. This is closer than the 1800 \pm indicated on the plans. No significant section loss has occurred to any of these components; tie-rods, walers, or connection plates. Unlike the detail indicated

Photo 49 - TP 2 – Tie-rod spacing exposed.

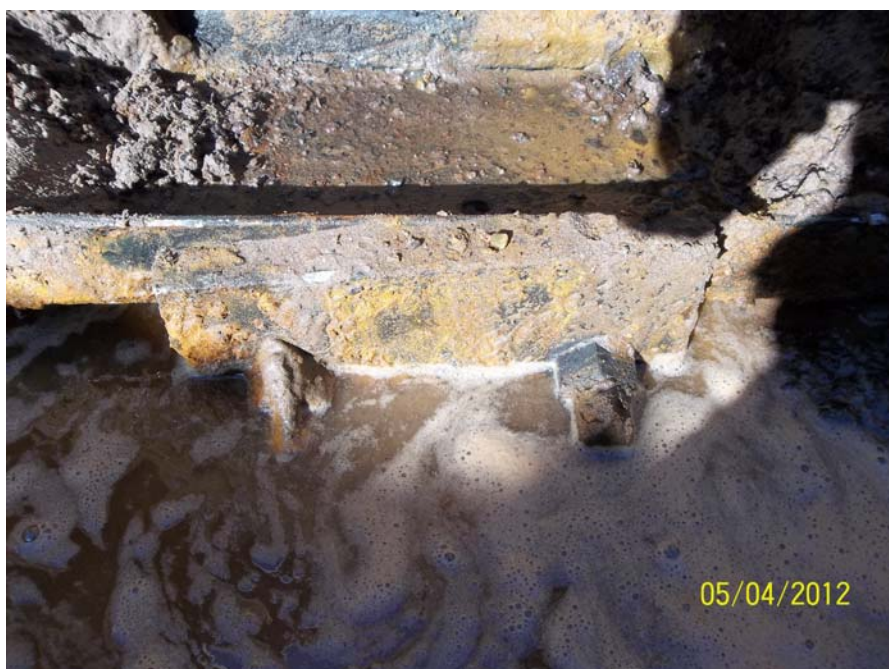
Photo 50 - TP 2 – Back plate and waler in good condition.

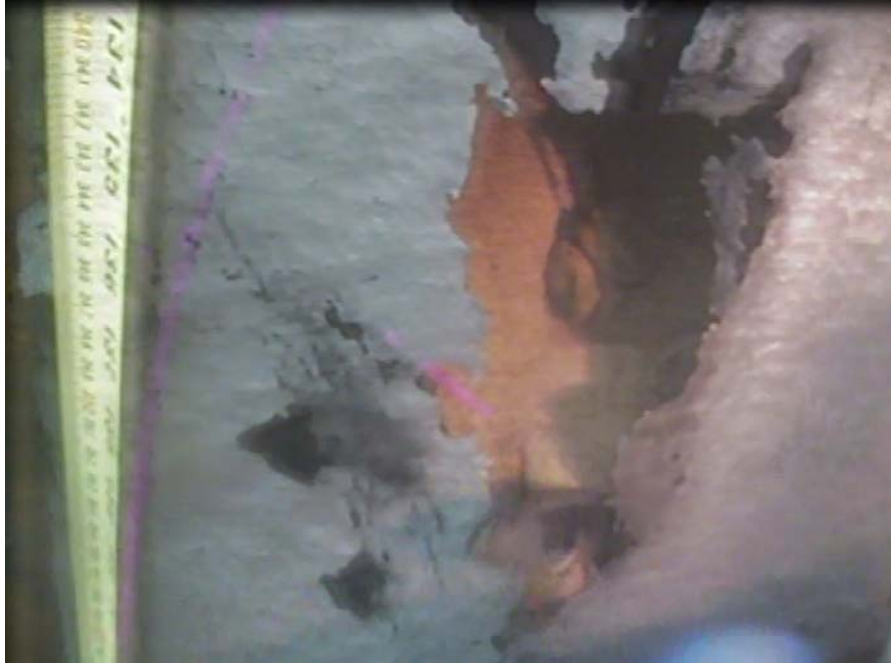
Similar loss of section as at the channel face was found at the low water zone. More perforations exist in this area with adjacent steel reduced to 4 to 6 mm in some test locations. The mud line is close to this zone due to a higher bottom elevation. The thickness of the SSP quickly returns to close to original just below the mud line.

Photo 59 – Perforation in SSP within tidal zone.
