Job No. 11320

**Regarding: Structural Investigation
Structures 302 and 304
Le Goulet Wharf, Le Goulet, NB**

STATUS REPORT

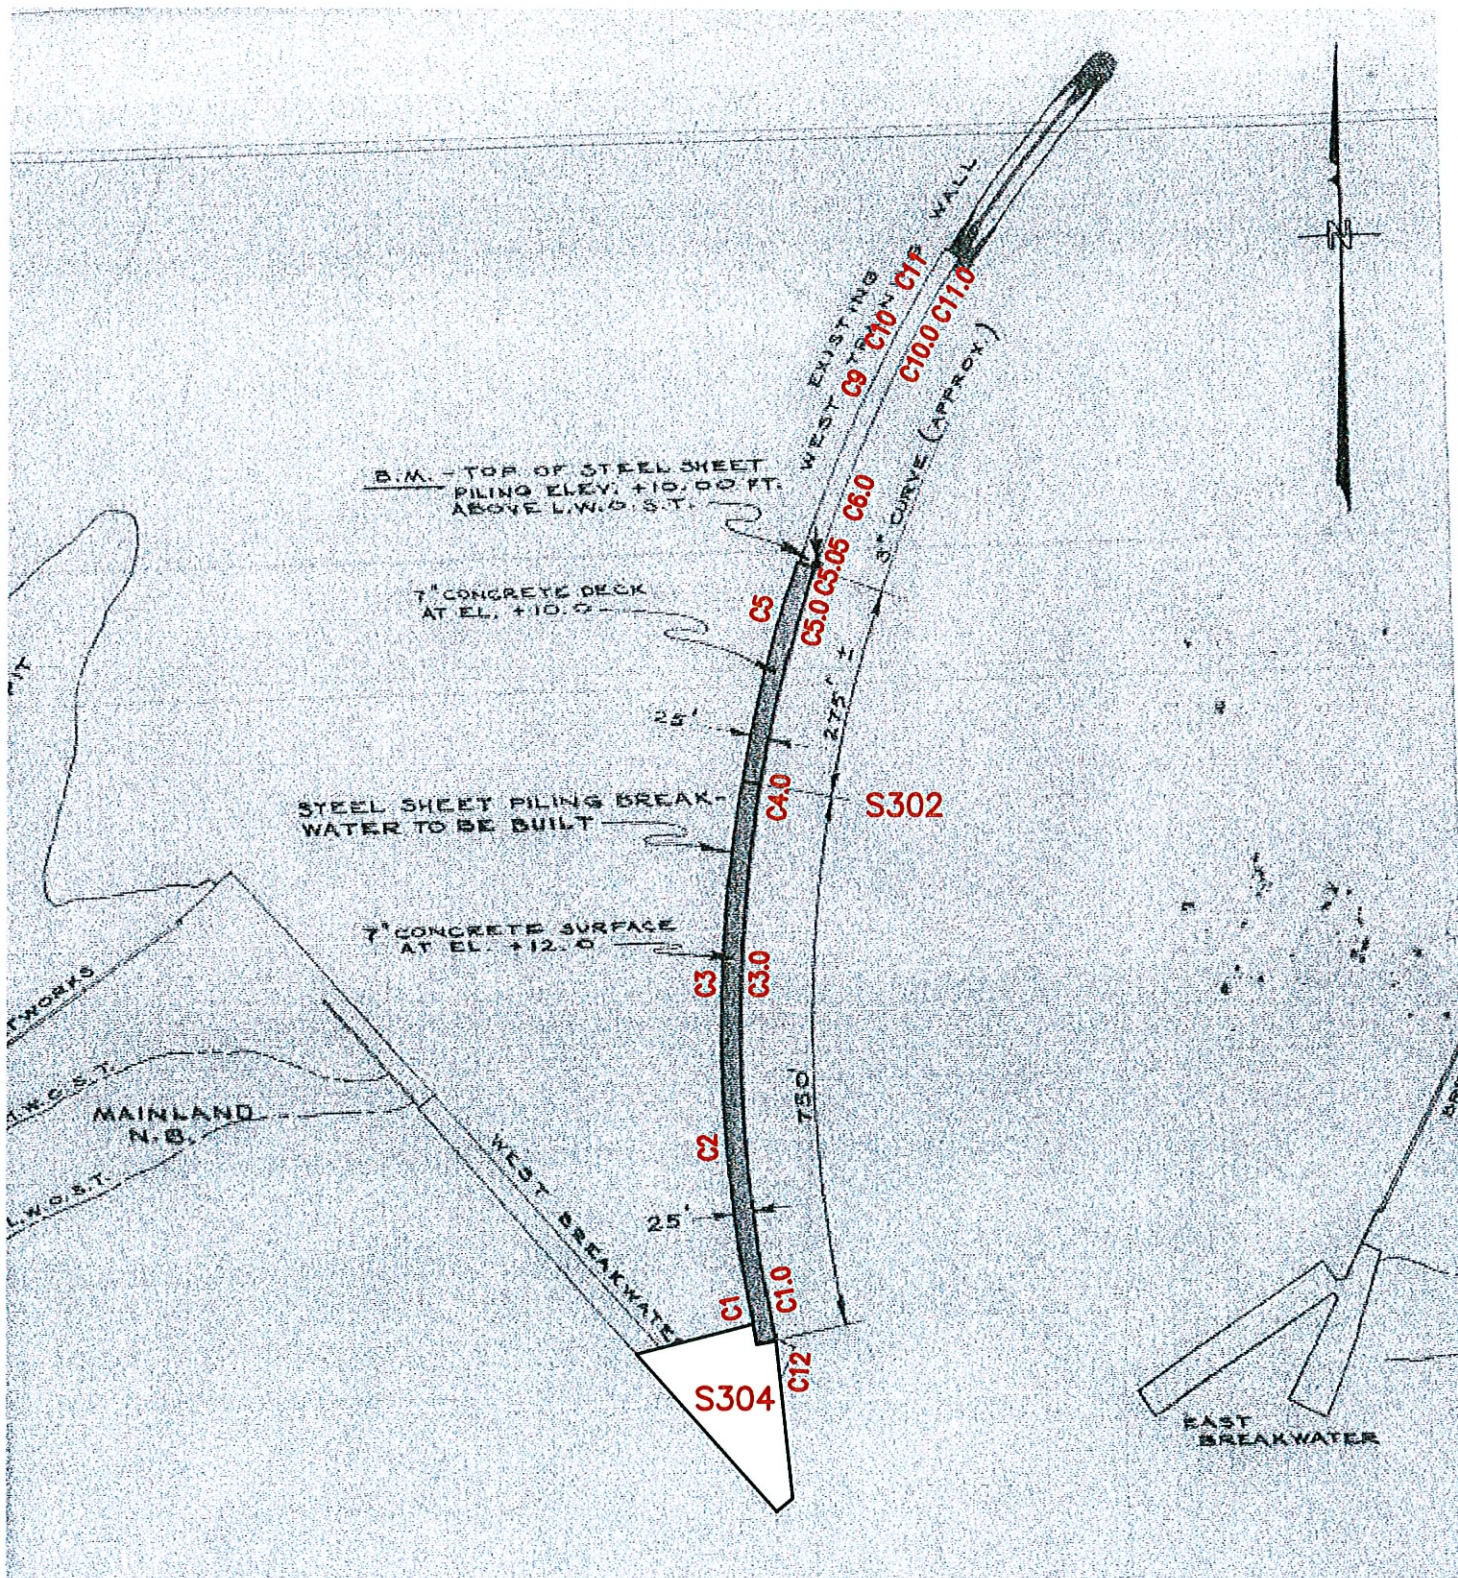
APPROXIMATE LOCATIONS – SSP THICKNESS MEASUREMENTS
 LE GOULET STRUCTURES 302 AND 304
 JANUARY 2012

Test locations were dispersed throughout the length of the structure and the corrosion pattern appears to be relatively consistent between profiles. (See attached Sketch S-1 showing test locations.)

Corrosion at the low water zone has reduced steel thickness to an average of about 6 mm from an original 11-12 mm. There are few, if any areas of perforations on this face at and below low water.

The top section is severely pitted in many areas. Steel thickness between pits is typically in excess of 10 mm. Localized sections of complete section loss, (at south end), appear to be restricted to above the low-tide zone.

Similar loss of section as at the channel face was found at the tidal zone. More perforations exist in this area with adjacent steel reduced to 4 to 6 mm in some test locations.

Severe perforations exist along the top 2 metres of the SSP at the south end. There is severe pitting at the north end with steel in the non-pitted areas having a 7-8 mm thickness. The SSP section is reduced to about 6 mm at the low tide zone. The section thickness returns to close to 10 mm at the mud line.

Based on the initial findings, it would appear that it will be feasible to repair the SSP faces using a concrete encasement similar to that used at Pigeon Hill.

The Pigeon Hill, (and Lameque 406), repair option is felt to be the more appropriate solution.
