**XCG File No. 1-336-183-01**

November 19, 2013

**DESIGNATED SUBSTANCES AND  
HAZARDOUS MATERIALS SURVEY  
2301 MIDLAND AVENUE  
TORONTO, ONTARIO**

**PUBLIC WORKS AND GOVERNMENT SERVICES CANADA**

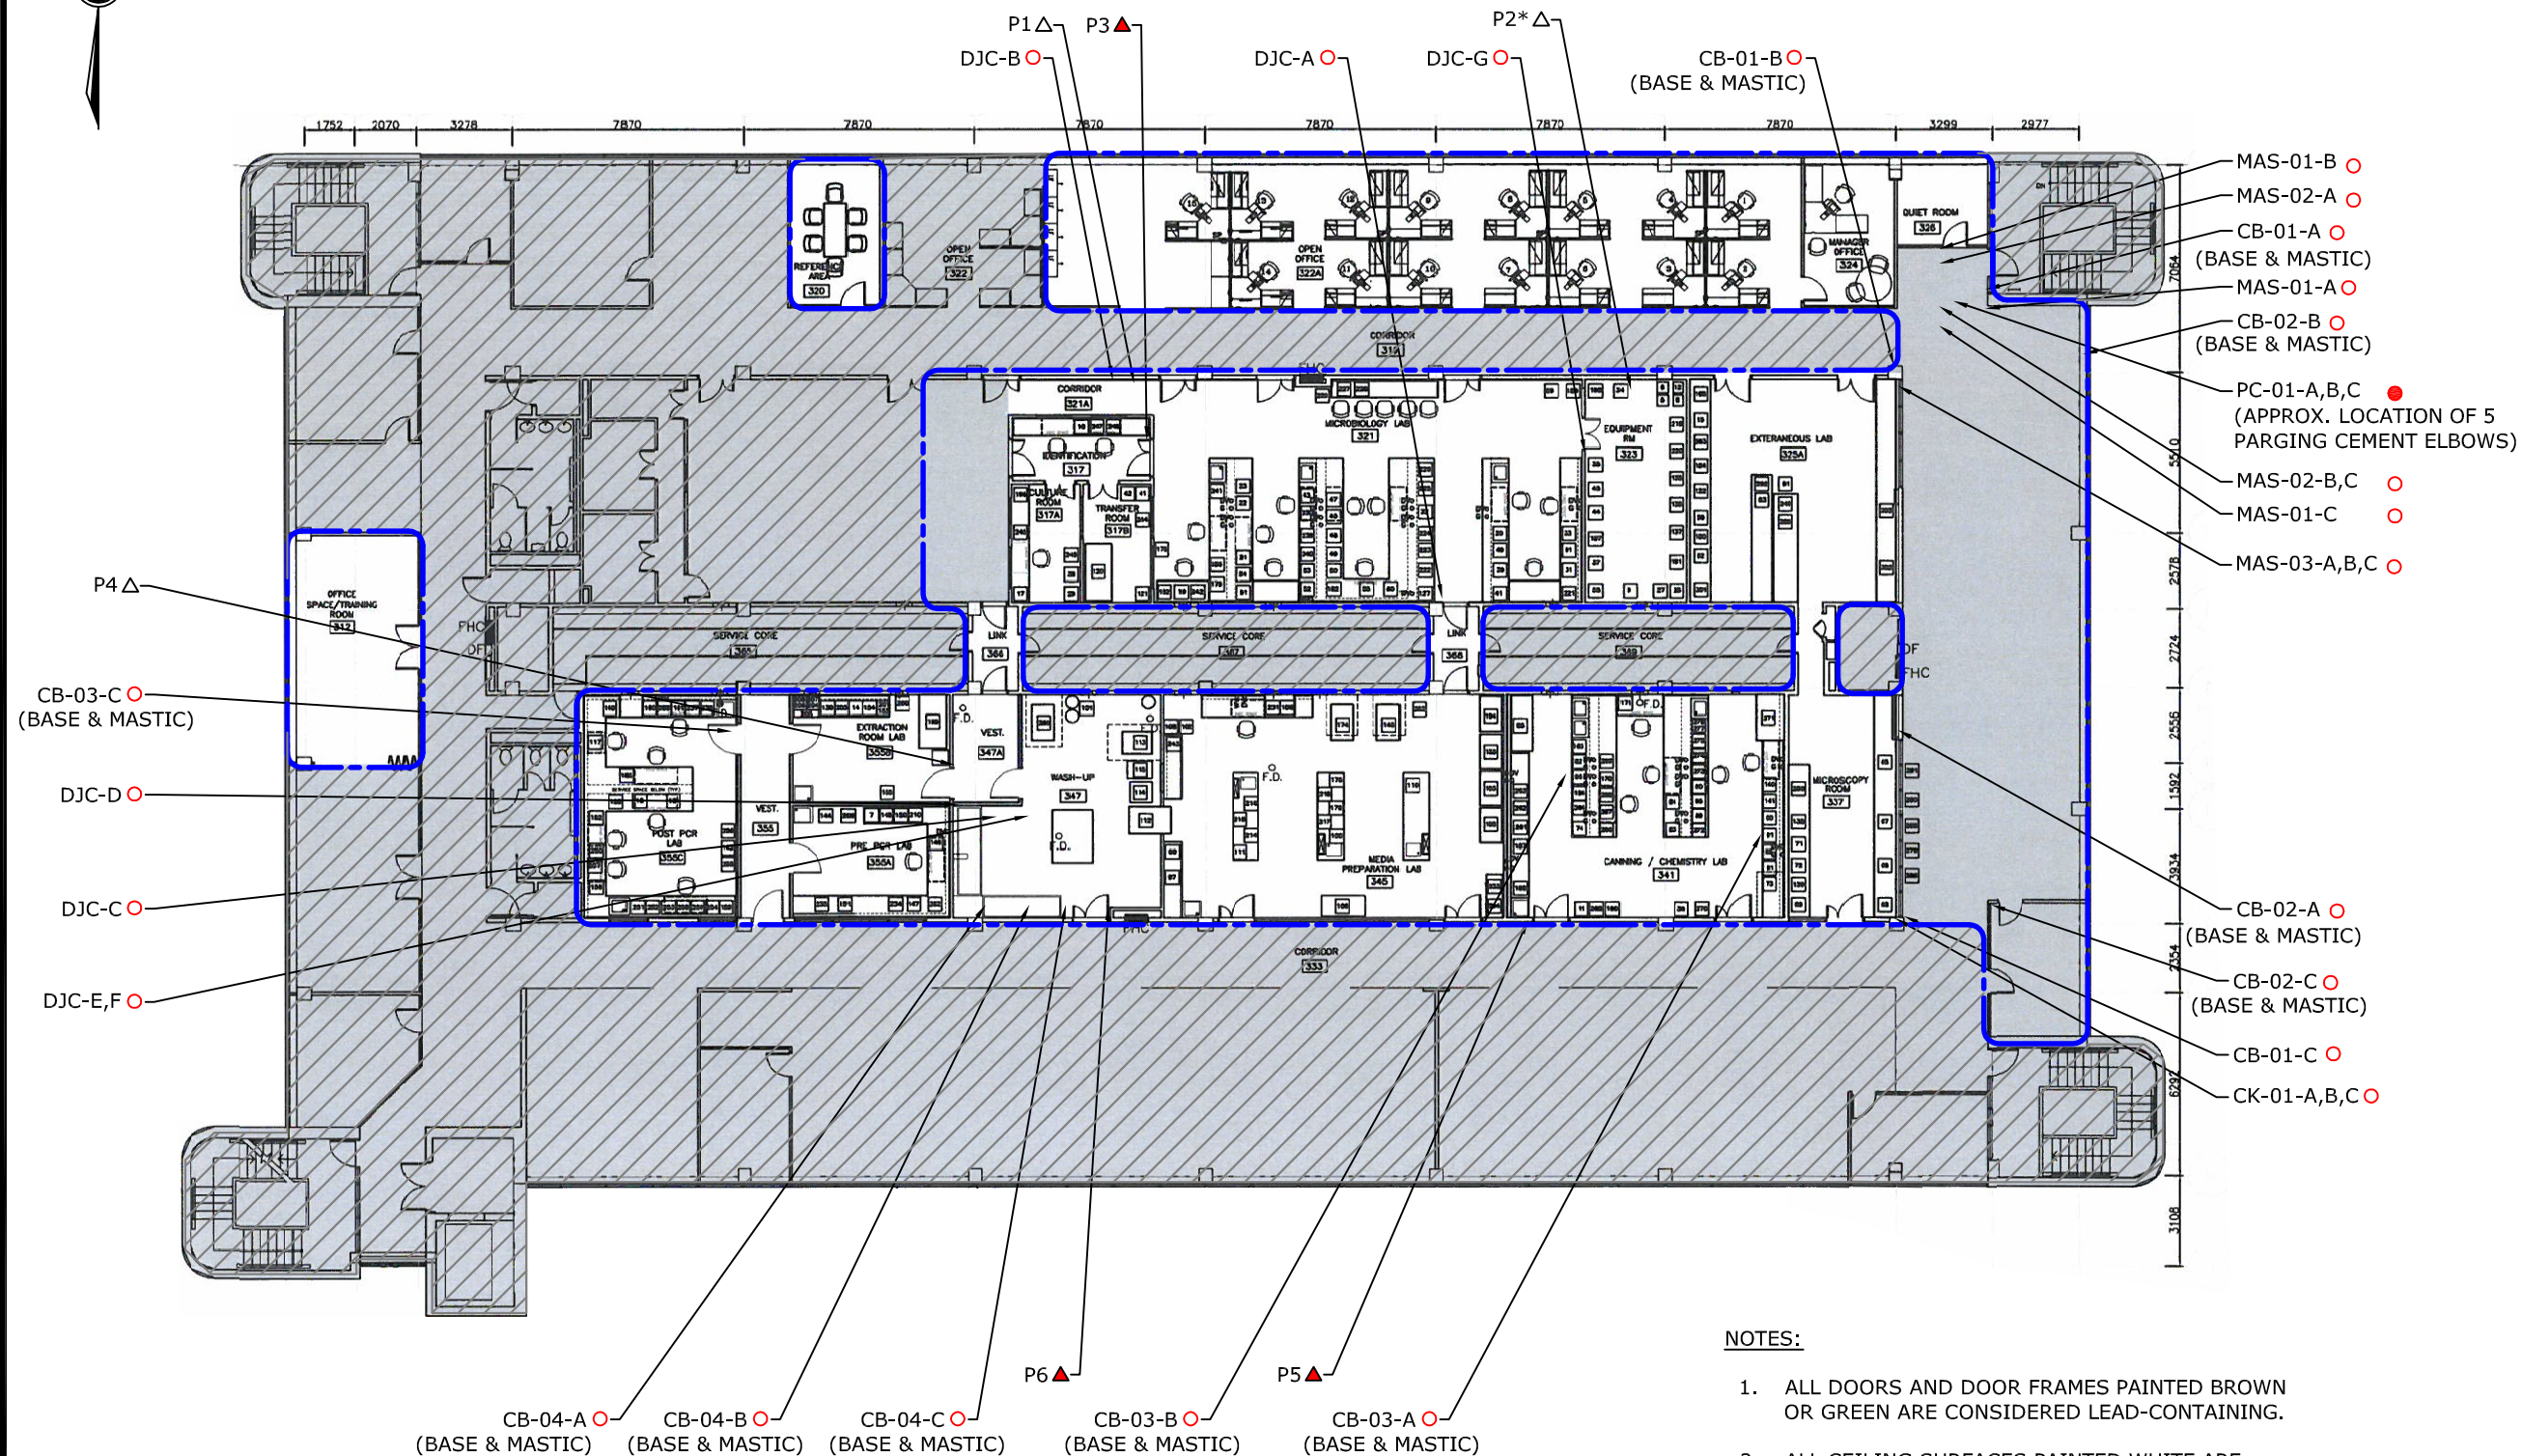
***FIGURE***

1. ALL DOORS AND DOOR FRAMES PAINTED BROWN OR GREEN ARE CONSIDERED LEAD-CONTAINING.
2. ALL CEILING SURFACES PAINTED WHITE ARE CONSIDERED LEAD-CONTAINING.
