**SHIPPAGAN HARBOUR  
CONDITION SURVEY  
AND ASSESSMENT  
WHARVES 401, 402, 403 & 404**

**Administration Portuaire de Shippagan Inc.  
83, 15<sup>ème</sup> Rue, Shippagan, NB**

2009-09-18

## CONDITION SURVEY AND ASSESSMENT

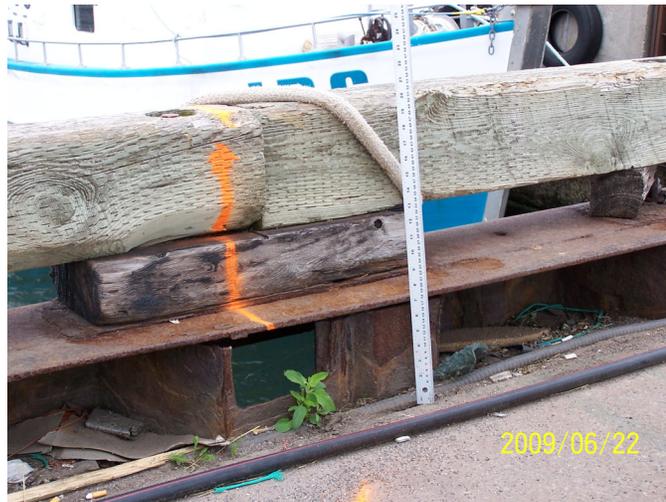
Subsidence of the deck surface behind the sheet pile face is evident throughout Wharf 401. Photo 1 shows the subsidence of the deck slab (190 mm±) at the back face of the steel sheet piling at Station 1. It is clear that the subsidence of the deck occurred some time ago and is not a recent event. At some point the sheet piling was deliberately cut at the in-pan for drainage purposes. It can be seen that additional subsidence of the deck surface has occurred (50 mm±), since the hole was initially cut. Photo 2 shows differential settlement between adjacent sections of the concrete deck slab behind the sheet pile at Station 5.5. The magnitude of the deck subsidence that has occurred throughout Wharf 401 indicates that significant amounts of fill materials are being lost.

Photo 1 - Wharf Deck Subsidence (Station 1)

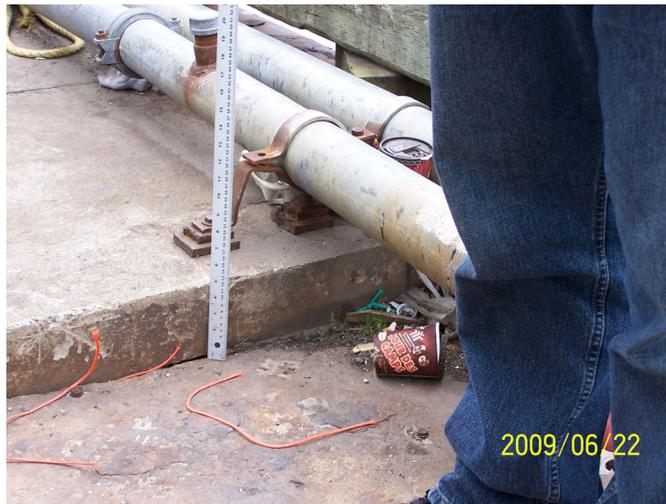
Photo 2 - Wharf Deck Subsidence (Station 5.5)

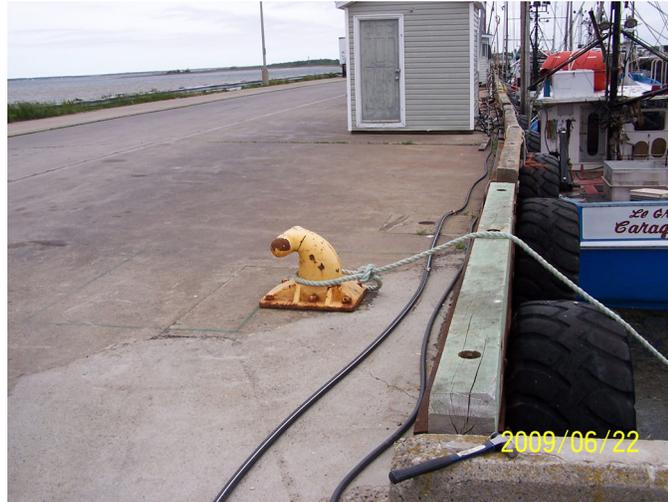
Photo 3 is a view of the top of the steel sheet piling wall taken from Station 0 looking eastward. The steel sheet pile wall is “bowed” at the top. Similarly Photo 4 shows outward bowing of the sheet pile wall between Stations 19 and 21 at the outer end of the “L” section of Wharf 401. Clearly at these locations, the top of the wall has moved outward. The outward movement of the wall also contributes to subsidence of the deck slab.

**Photo 3 - Outward Bowing SSP Wall (Station 1)**

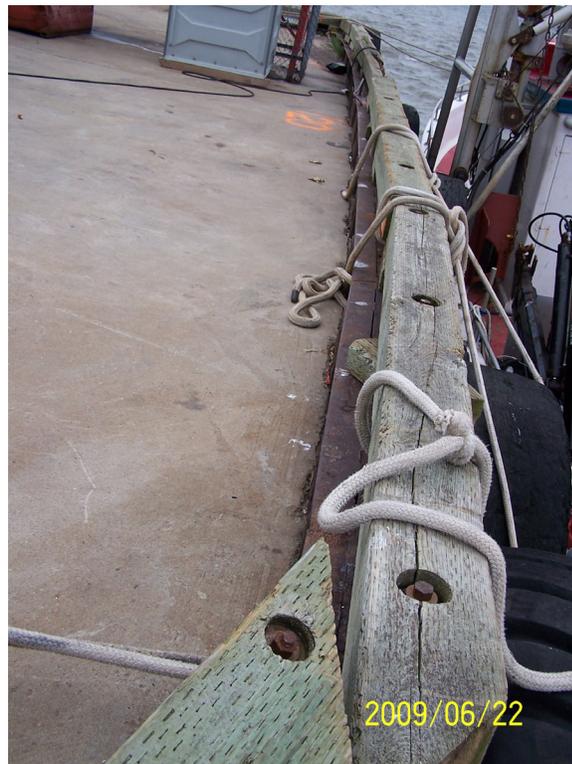
**Photo 4 - Outward Bowing of SSP Wall (Stations 19 to 21)**

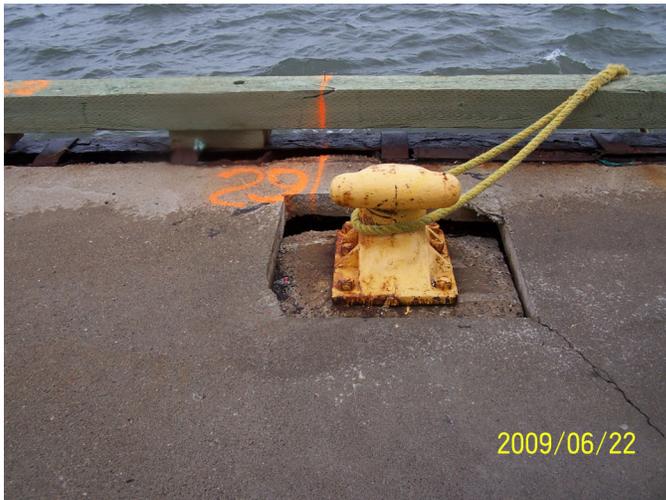
The most severely distressed section of the wharf deck occurs at the northeast corner of Wharf 401 between Stations 28 to 30. At this location a large cavity has been created beneath the deck slab. At the corner Station 29.3, the top of fill level is more than 1200 mm± below the underside of the deck slab. The cavity below the slab extends a considerable distance from the back face of the steel sheet piling. Photo 5 taken at Station 29 shows settlement of the bollard. At this location the top of fill level is approximately 200 mm below the underside of the deck slab. Photo 6 shows the wharf deck along Stations 29 to 30. The steel sheet piling has moved outward separating from the concrete deck slab. The deck slab is cracked.

**Photo 5 - Wharf Deck Subsidence  
(Station 29)**

The loss of fill materials at the northeast corner of Wharf 401 has created large cavities beneath the deck slab. The slab has to span across the cavities created by the loss of fill materials. As the deck slab was not intended to function as a “structural element”, it is only a matter of time until collapse of this section of the deck slab occurs.

Temporary repairs should be implemented in this localized area to prevent further loss of materials. The electrical building Photo 7 is located in the immediate vicinity and continued loss of fill materials could cause damages to the building and electrical services.

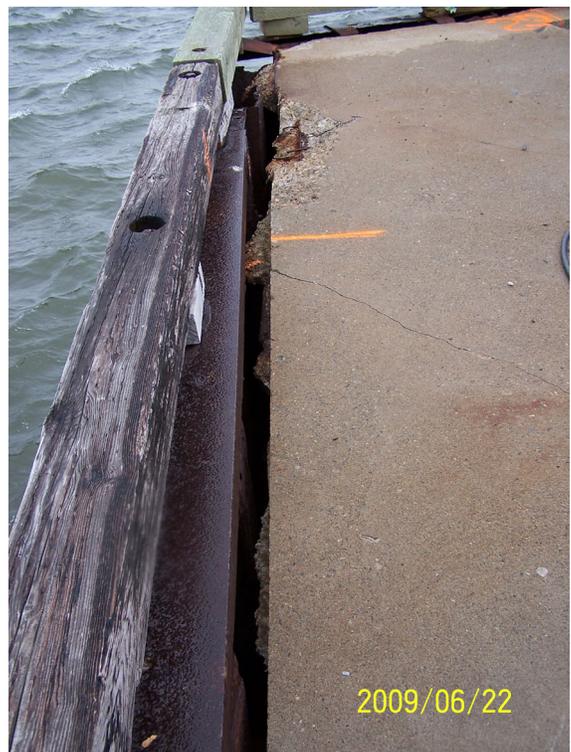
**Photo 6 - Wharf Deck (Stns 29 to 30)**

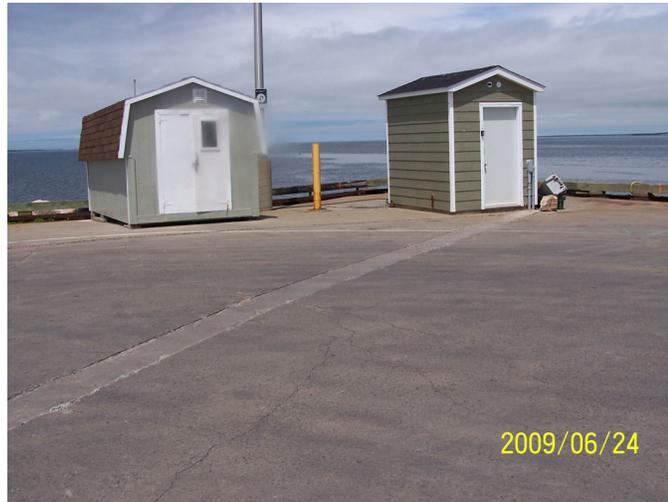
**Photo 7 - Electrical Control Building (Station 29)**

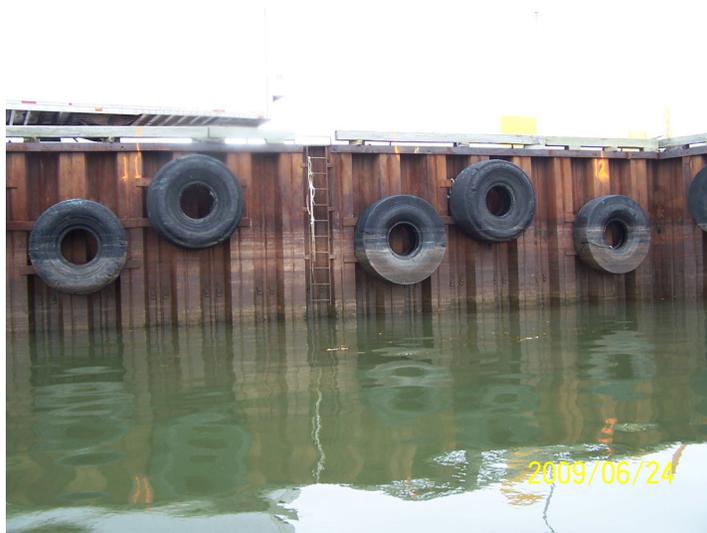
**Photo 8 - Steel Sheet Pile Wall  
(Stations 11 to 12)**

Above the high tide level the rust coating is heavier. There is some scaling and pitting throughout this zone. Photo 8 is a view of the wall between Stations 11 and 12 above water level and represents typical conditions along the wall from Stations 0 to 17.

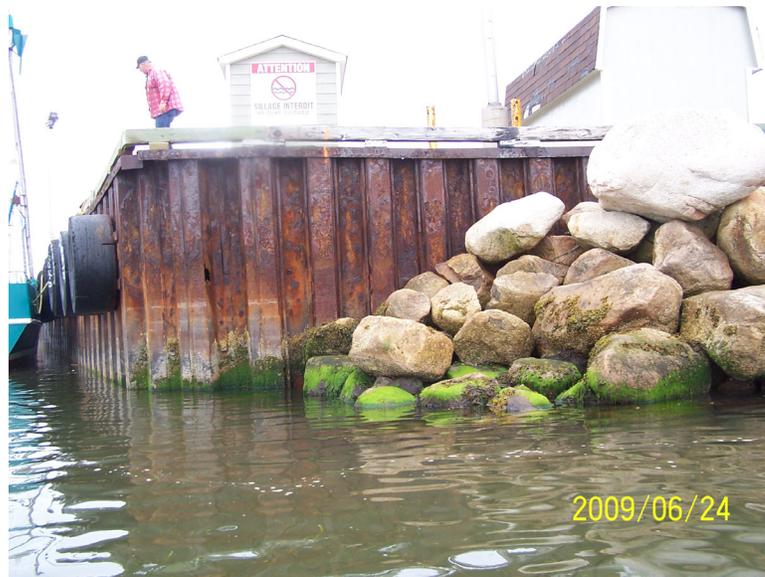
Pitting and scaling on the sheet pile surfaces is much more prominent along the walls of the seaward sides of the harbour basin. The upper 0.6 m± of the walls have a heavy rust coating but show less pitting and scaling. Photo 9 shows a section of the steel sheet pile wall at Station 29.5. This is the most severely corroded zone of the steel sheet pile walls in Wharf 401 that is visible above water level. This photo shows the perforation of the web at the corner steel sheet pile. It is also the area where a large cavity has formed beneath the concrete deck slab.

**Photo 9 - Steel Sheet Pile Wall (Station 29.5)**

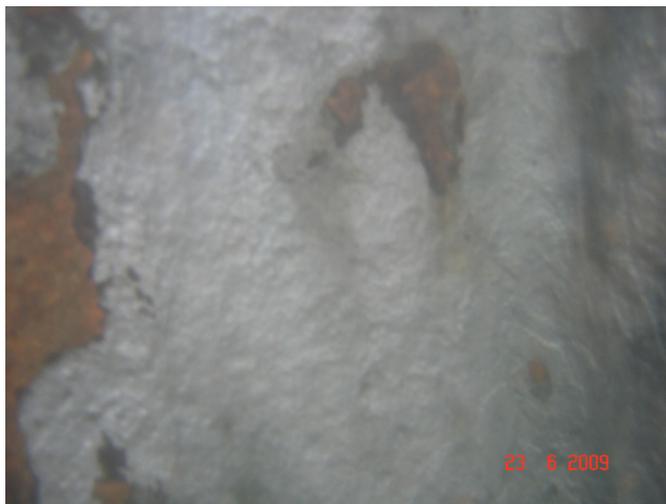
**Photo 11 - SSP Surface After MIC Has Been Cleaned**

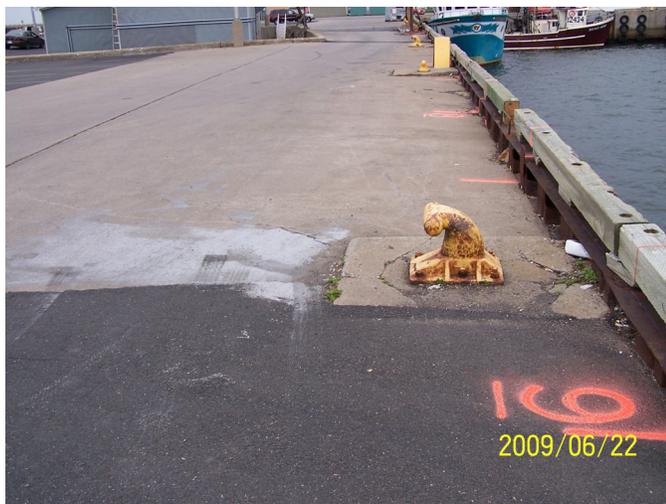
As is the case for Wharf 401, subsidence of the deck surface behind the face of the structure occurs throughout Wharf 403. Photo 12 is taken from Station 9 looking westward. Photo 13 is a close up view of the deck surface behind the wall at Station 8. The subsidence of the deck slab at this location is around 250 mm. As was observed along Wharf 401, it is clear that the subsidence of the deck occurred some time ago and is not a recent event. The steel sheet piling was deliberately cut at the in-pan for drainage purposes. Additional subsidence of the deck surface has occurred (125 mm±) since the hole was initially cut. The magnitude of the deck subsidence that has occurred throughout Wharf 403 indicates that significant amounts of fill materials are being lost.

Photo 12 - Wharf Deck Subsidence (403)

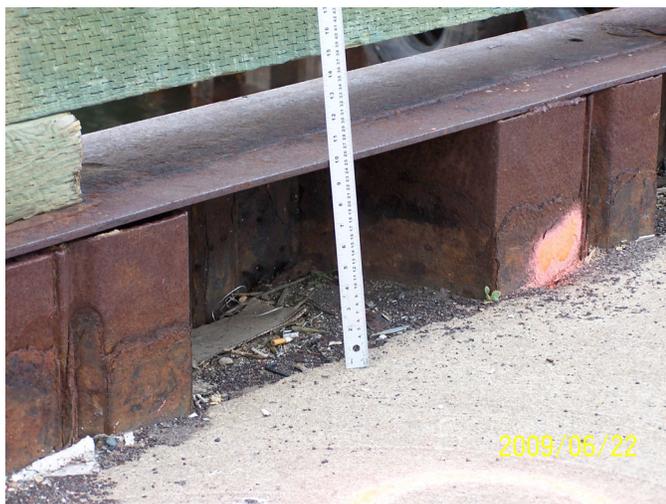
Photo 13 - Wharf Deck Subsidence (Station 8)

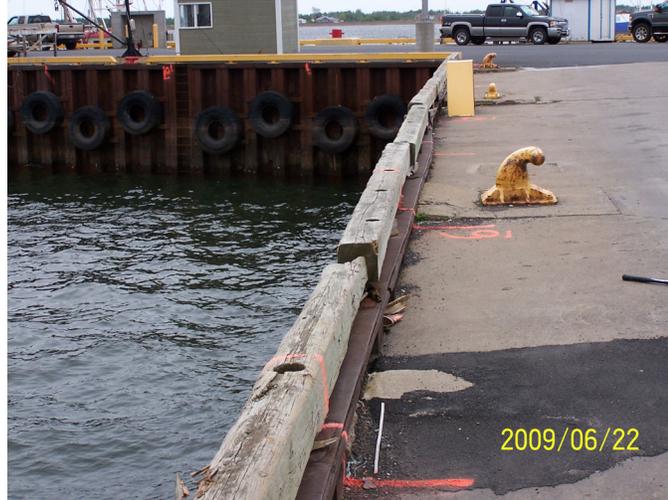
Photo 14 shows outward bowing of the sheet pile wall between Stations 6.5 and 7.5. Clearly at these locations, the top of the wall has moved outward. The outward movement of the wall also contributes to subsidence of the deck slab.

**Photo 14 - Outward Bowing SSP Wall (Stations 6.5 to 7.5)**

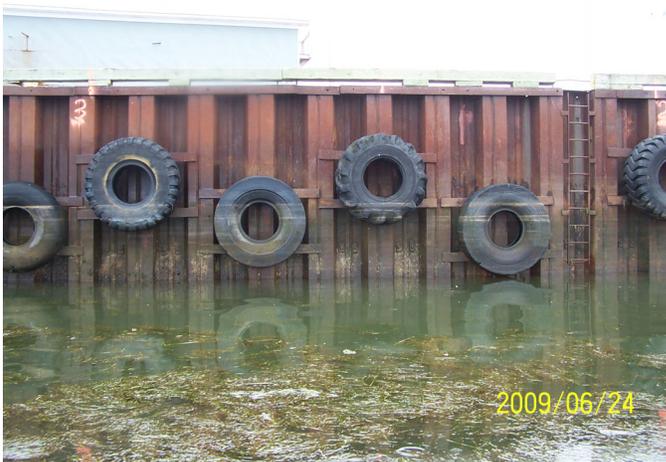
The condition of the wall above water level along Wharf 403 is similar to that described for Wharf 401. Above low water level the steel sheet piles generally remain in relatively good condition, i.e., relatively smooth with heavy rust coating from elevation 0.5 m to high tide level (elevation 2.0 m), heavier rust coating with some scaling and pitting above the high tide level. Photo 15 shows a section of the wall above water level between Stations 2 to 3.

**Photo 15 - Steel Sheet Pile Wall Wharf 403 (Stations 2 to 3)**

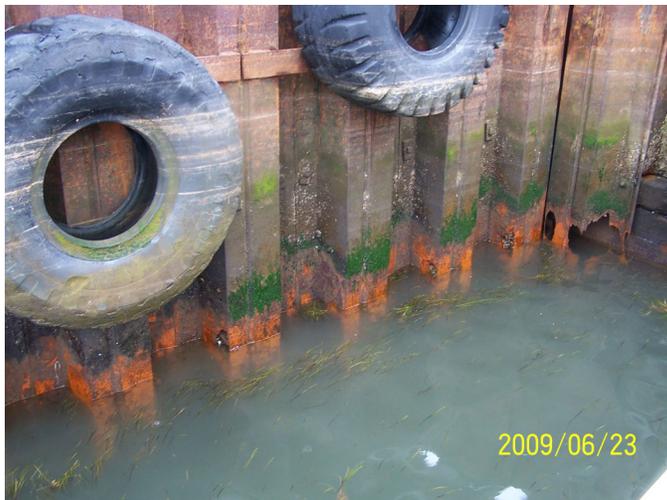
For safety reasons, the sheet pile wall between Stations 0 and 3.5 could not be observed by the divers as boats were using this section of the walls throughout the survey period. Two zones in this section of the wall were examined from the decks of boats moored there during a low water level. Photo 16 shows perforations of the steel sheet pile webs near Station 0. Photo 17 shows perforations of the sheet pile webs at Station 0.7. At least 6 perforations of the steel sheet pile webs are visible in this 7 m length of wall.

**Photo 16 - Wharf 403 Steel Sheet pile Wall (Stationn 0)**

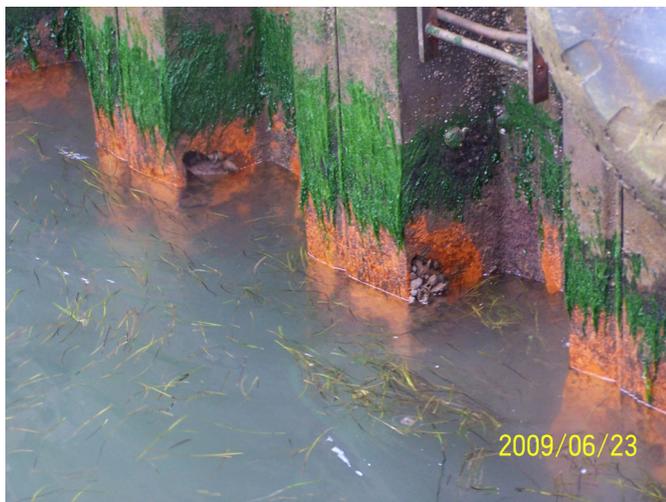
**Photo 17 - Wharf 403 Steel Sheet Pile Wall (Station 6)**

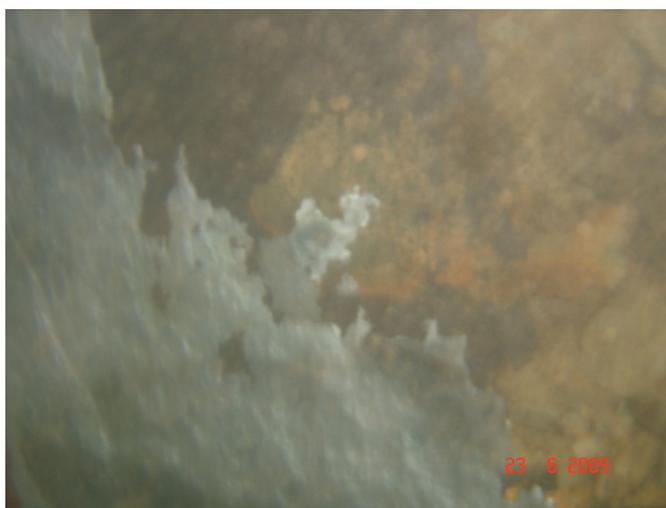
At locations where perforations were observed the thickness of the steel around the perforations were described by the divers as “paper thin”. The divers also remarked that in many cases where perforation had not yet occurred, the steel surface felt paper thin. At Station 6 the web of the steel sheet pile section was perforated while it was being cleaned with a pressure washer. Photo 18 shows the “paper” thin web adjacent to the perforated section of the pile at Station 6.

**Photo 18 - Wharf 403 Steel Sheet Pile Web (Station 6)**

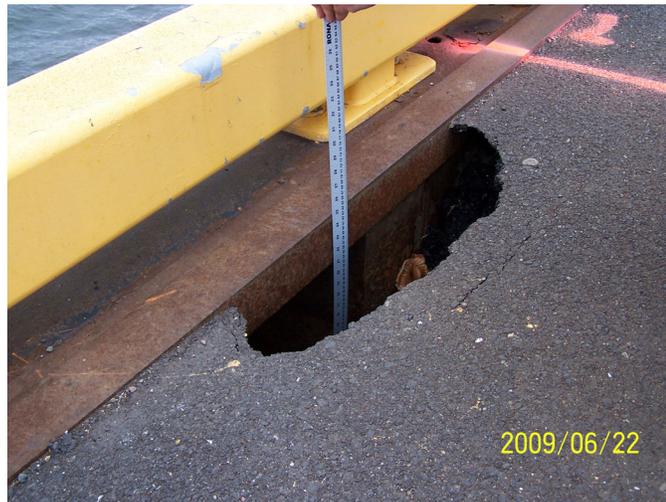
The deck surface behind the steel sheet pile walls along Wharf 404 was replaced as part of the Old North Wharf reconstruction (2003). There are at least two zones along Wharf 404 where subsidence of the new asphalt surface and loss of fill materials has already occurred. Photo 19 shows the hole in the asphalt surface at Station 9.5. The top of the fill materials in this location is about 750 mm below the deck level. The cavity below the surface is 400 mm in width and extends 1200 mm along the wall. Photo 20 shows the deck surface at Station 12.5. Granular materials have been used to fill the cavity formed at this location.

Photo 19 - Wharf 404 Loss of Fill Materials (Station 9.5)

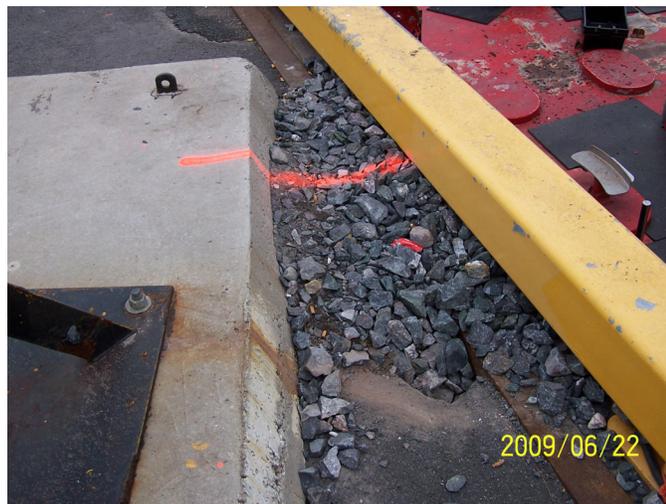
Photo 20 - Wharf 404 Loss of Fill Materials (Station 12.5)

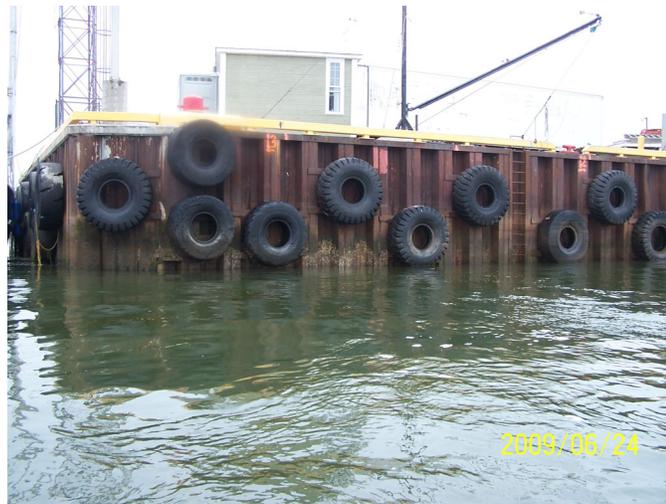
The steel sheet pile wall above low water level generally remains in relatively good condition: relatively smooth with heavy rust coating from elevation 0.5 m to high tide level (elevation 2.0 m); and heavier rust coating with some scaling and pitting above the high tide level. Photo 21 shows a section of the wall above water level between Stations 11.5 to 13.

**Photo 21 - Wharf 404 SSP Wall (Stations 11.5 to 13)**

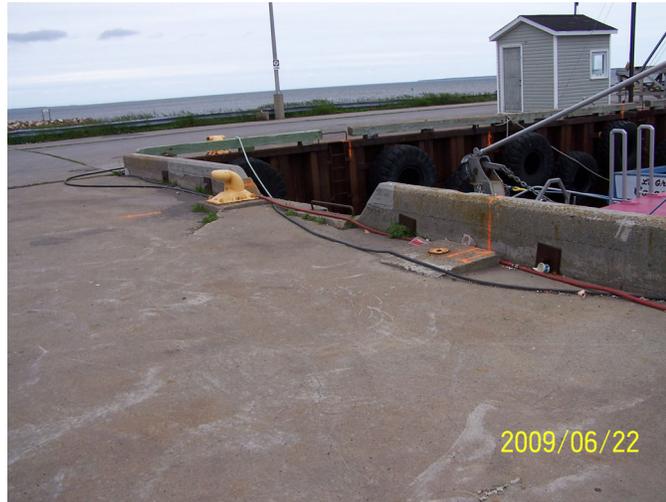
The curb along the top edge of the cope wall has been extended by 200 mm since the original construction. Some sections of the curb extension have been recently repaired. The section of the curb shown on Photo 22 is representative of the present condition of the curb along Wharf 402.

**Photo 22 - Wharf 402 Concrete Curb (Station 1)**

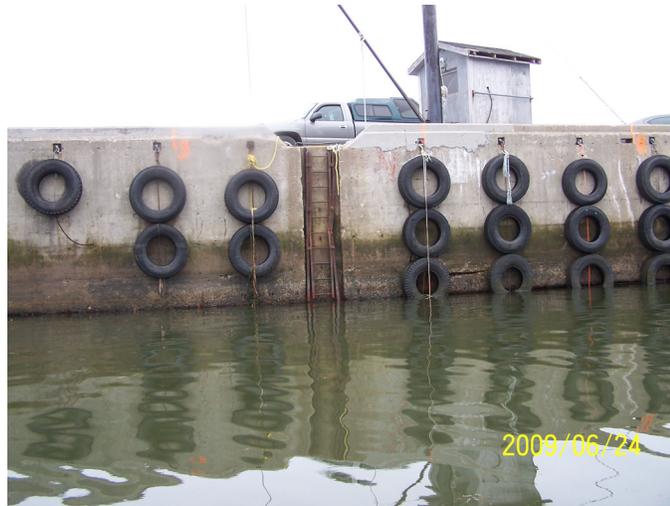
The cope wall face was examined from a boat operating in front of the wall. From the top of the cribwork level (elevation 0.91 m) to the top of high tide level (elevation 2.0 m±), the surface is covered by light marine growth and some molluscs adhering to the concrete surface. Above high tide level, the surface is clean and generally clear of marine growth or molluscs. The concrete surface is relatively smooth without evidence of severe abrasion or other forms of deterioration. Deterioration of the concrete was observed at some locations along the base/ stem interface of the cope wall structure. The base and stem were likely cast as separate pours. The deterioration occurs at the “cold joint” between the two wall elements. The amount of deterioration observed is considered as relatively minor in view of the service life. Photo 23 shows deteriorated section of the concrete at the cold joint between the base and stem of the cope wall.

**Photo 23 - Wharf 402 Concrete Deterioration at "Cold Joint" (Station 8.5)**

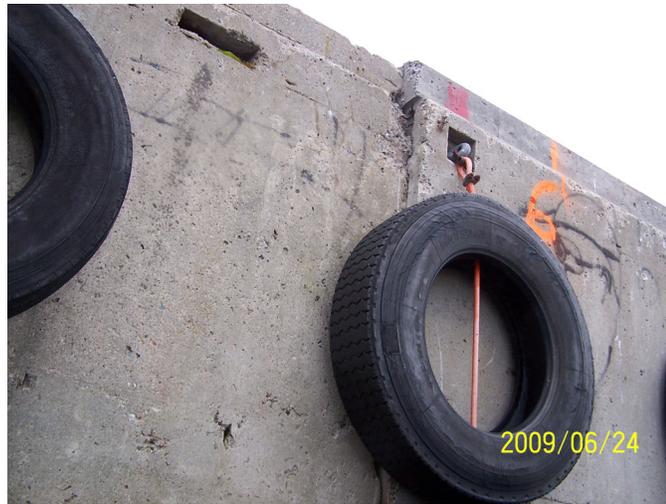
There is evidence that there has also been differential movement between adjacent wall sections. At Station 6.1 adjacent cope wall sections at a construction joint are misaligned by approximately 75 mm at the top of deck level (Photo 24).

**Photo 24 - Wharf 402 Cope Wall Misalignment (Station 6.1)**

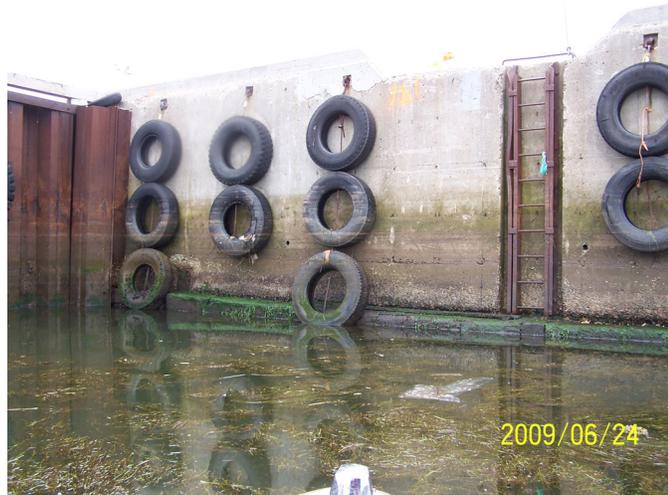
The face of the cope wall does not align perfectly with the face of the timber cribwork below. At the two ends of Wharf 402 the face of the cribwork projects out further than the face of the cope wall. At the northwest end of the structure, the cribwork projection is 50 mm at Station 0.0 increasing to a maximum of 200 mm at Station 2.0 and tapering back to become flush with the cope wall at Station 3.5. At the southeast end of Wharf 402, the cribwork is flush with the cope wall at Station 12.75 and tapers out to a maximum projection of 350 mm at the junction with Wharf 403. The misalignment of the cribwork and cope wall is probably due to construction issues. Photo 25 shows the projection of the cribwork face beyond the face of the cope wall at the southeast end of Wharf 402.

**Photo 25 - Wharf 402 Projection of Cribwork Beyond Cope Wall (Station 14)**

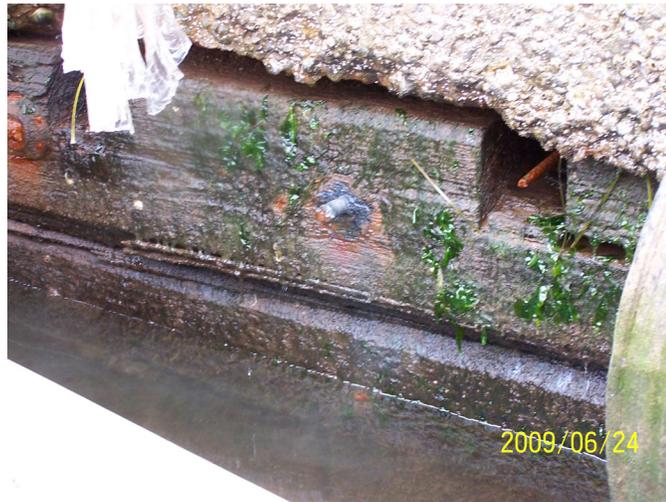
The timber elements from chart datum elevation to the underside of the concrete cope wall were examined from a boat operating in front of the structure. The timbers above chart datum level were also found to be sound without evidence of deterioration or damage. Photo 26 shows the horizontal cribwork timbers immediately below the concrete cope wall at Station 3.5.

**Photo 26 - Wharf 402 Timber Cribwork (Station 3.5)**

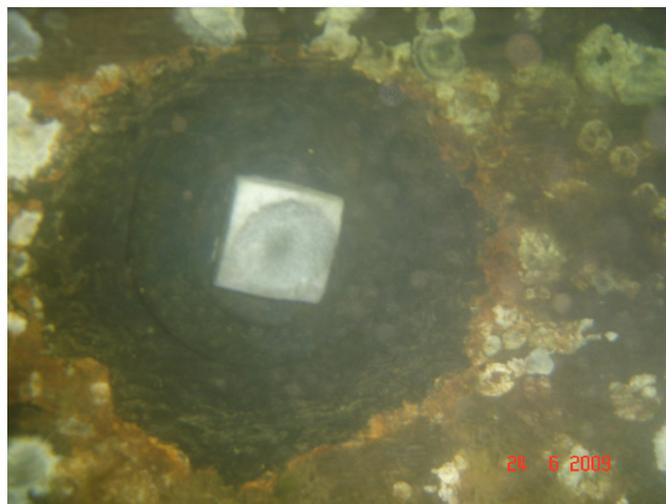
Damaged cribwork bolts were found all along the wharf in the upper 2 m section of the cribwork. The upper three to four bolts in the cribwork timbers have been sheared off. A damaged bolt can be seen in Photo 26. The bolts below the upper 2 m of the cribwork remain in good condition. Photo 27 shows the head of a bolt just below the sheared bolts at Station 5. The bolt remains in “like new” condition.

**Photo 27 - Wharf 402 Typical Undamaged Cribwork Bolts (Station 5)**

The cause of the damage is probably due to boats rubbing on the bolt heads as the rubber tire fenders do not keep the boat hulls away from the cribwork. For the most part, the cope wall and cribwork face are practically flush. In some areas the cribwork face actually projects beyond the cope wall face. Exacerbating the problem is the fact that the bolt heads and washers are not countersunk into the cribwork timbers and actually project from the cribwork face.

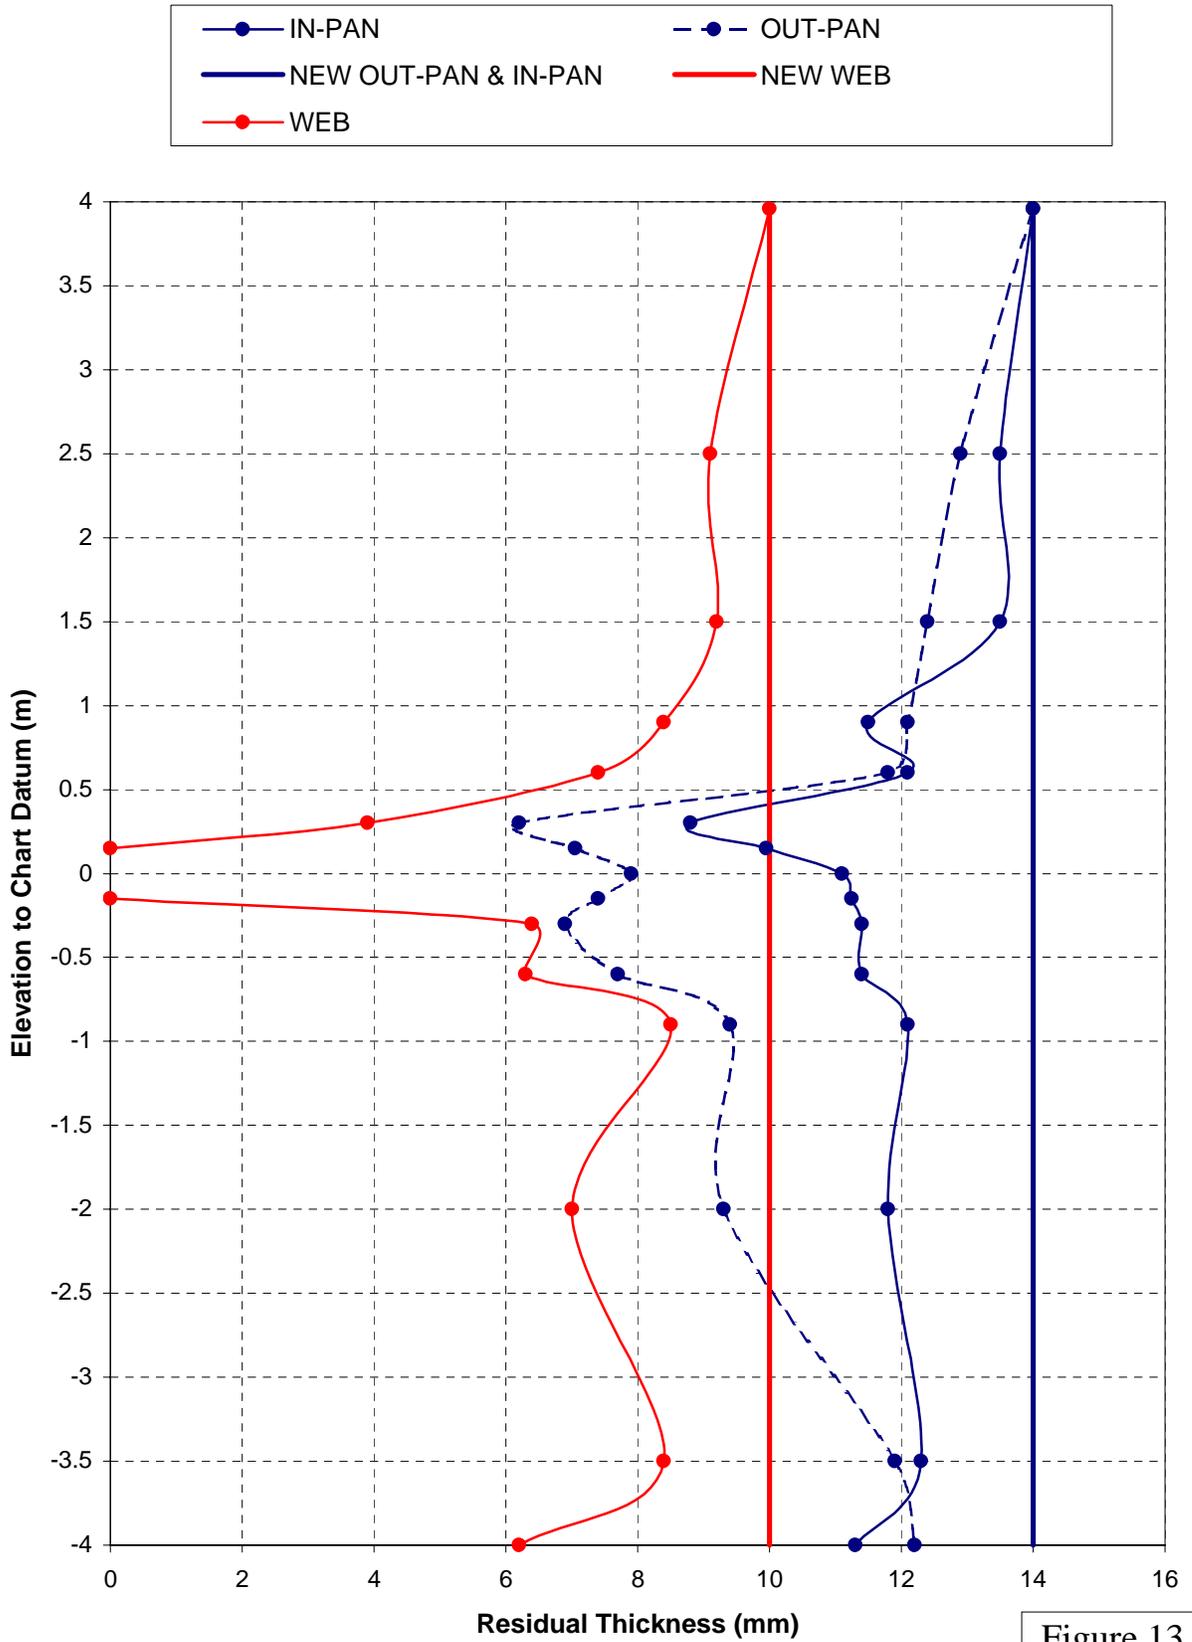
Figure 13 shows that at low water level the web has been perforated. The residual thickness of the out-pan flange is 6 mm±. Based on the thickness lost in the out-pan flange the average annual rate of corrosion at low water level is 0.22 mm/year. At elevation -3.5 m below chart datum the residual thickness of the web and out-pan flange is 8 mm± and 12 mm± respectively. The average rate of corrosion in the submerged section of the steel sheet piles is 0.06 mm/year. Both the rate for low water level corrosion and the rate for the submerged section of the steel sheet piling are in conformance with typical published rates contained in research literature.
