**Geotechnical Investigation
Supply & Services Canada
Superannuation Building Parking Lot**

Shediac, New Brunswick
19 January 2011

Prepared for Roy Consultants
Project No. 387.07

File: 387.07 – R01

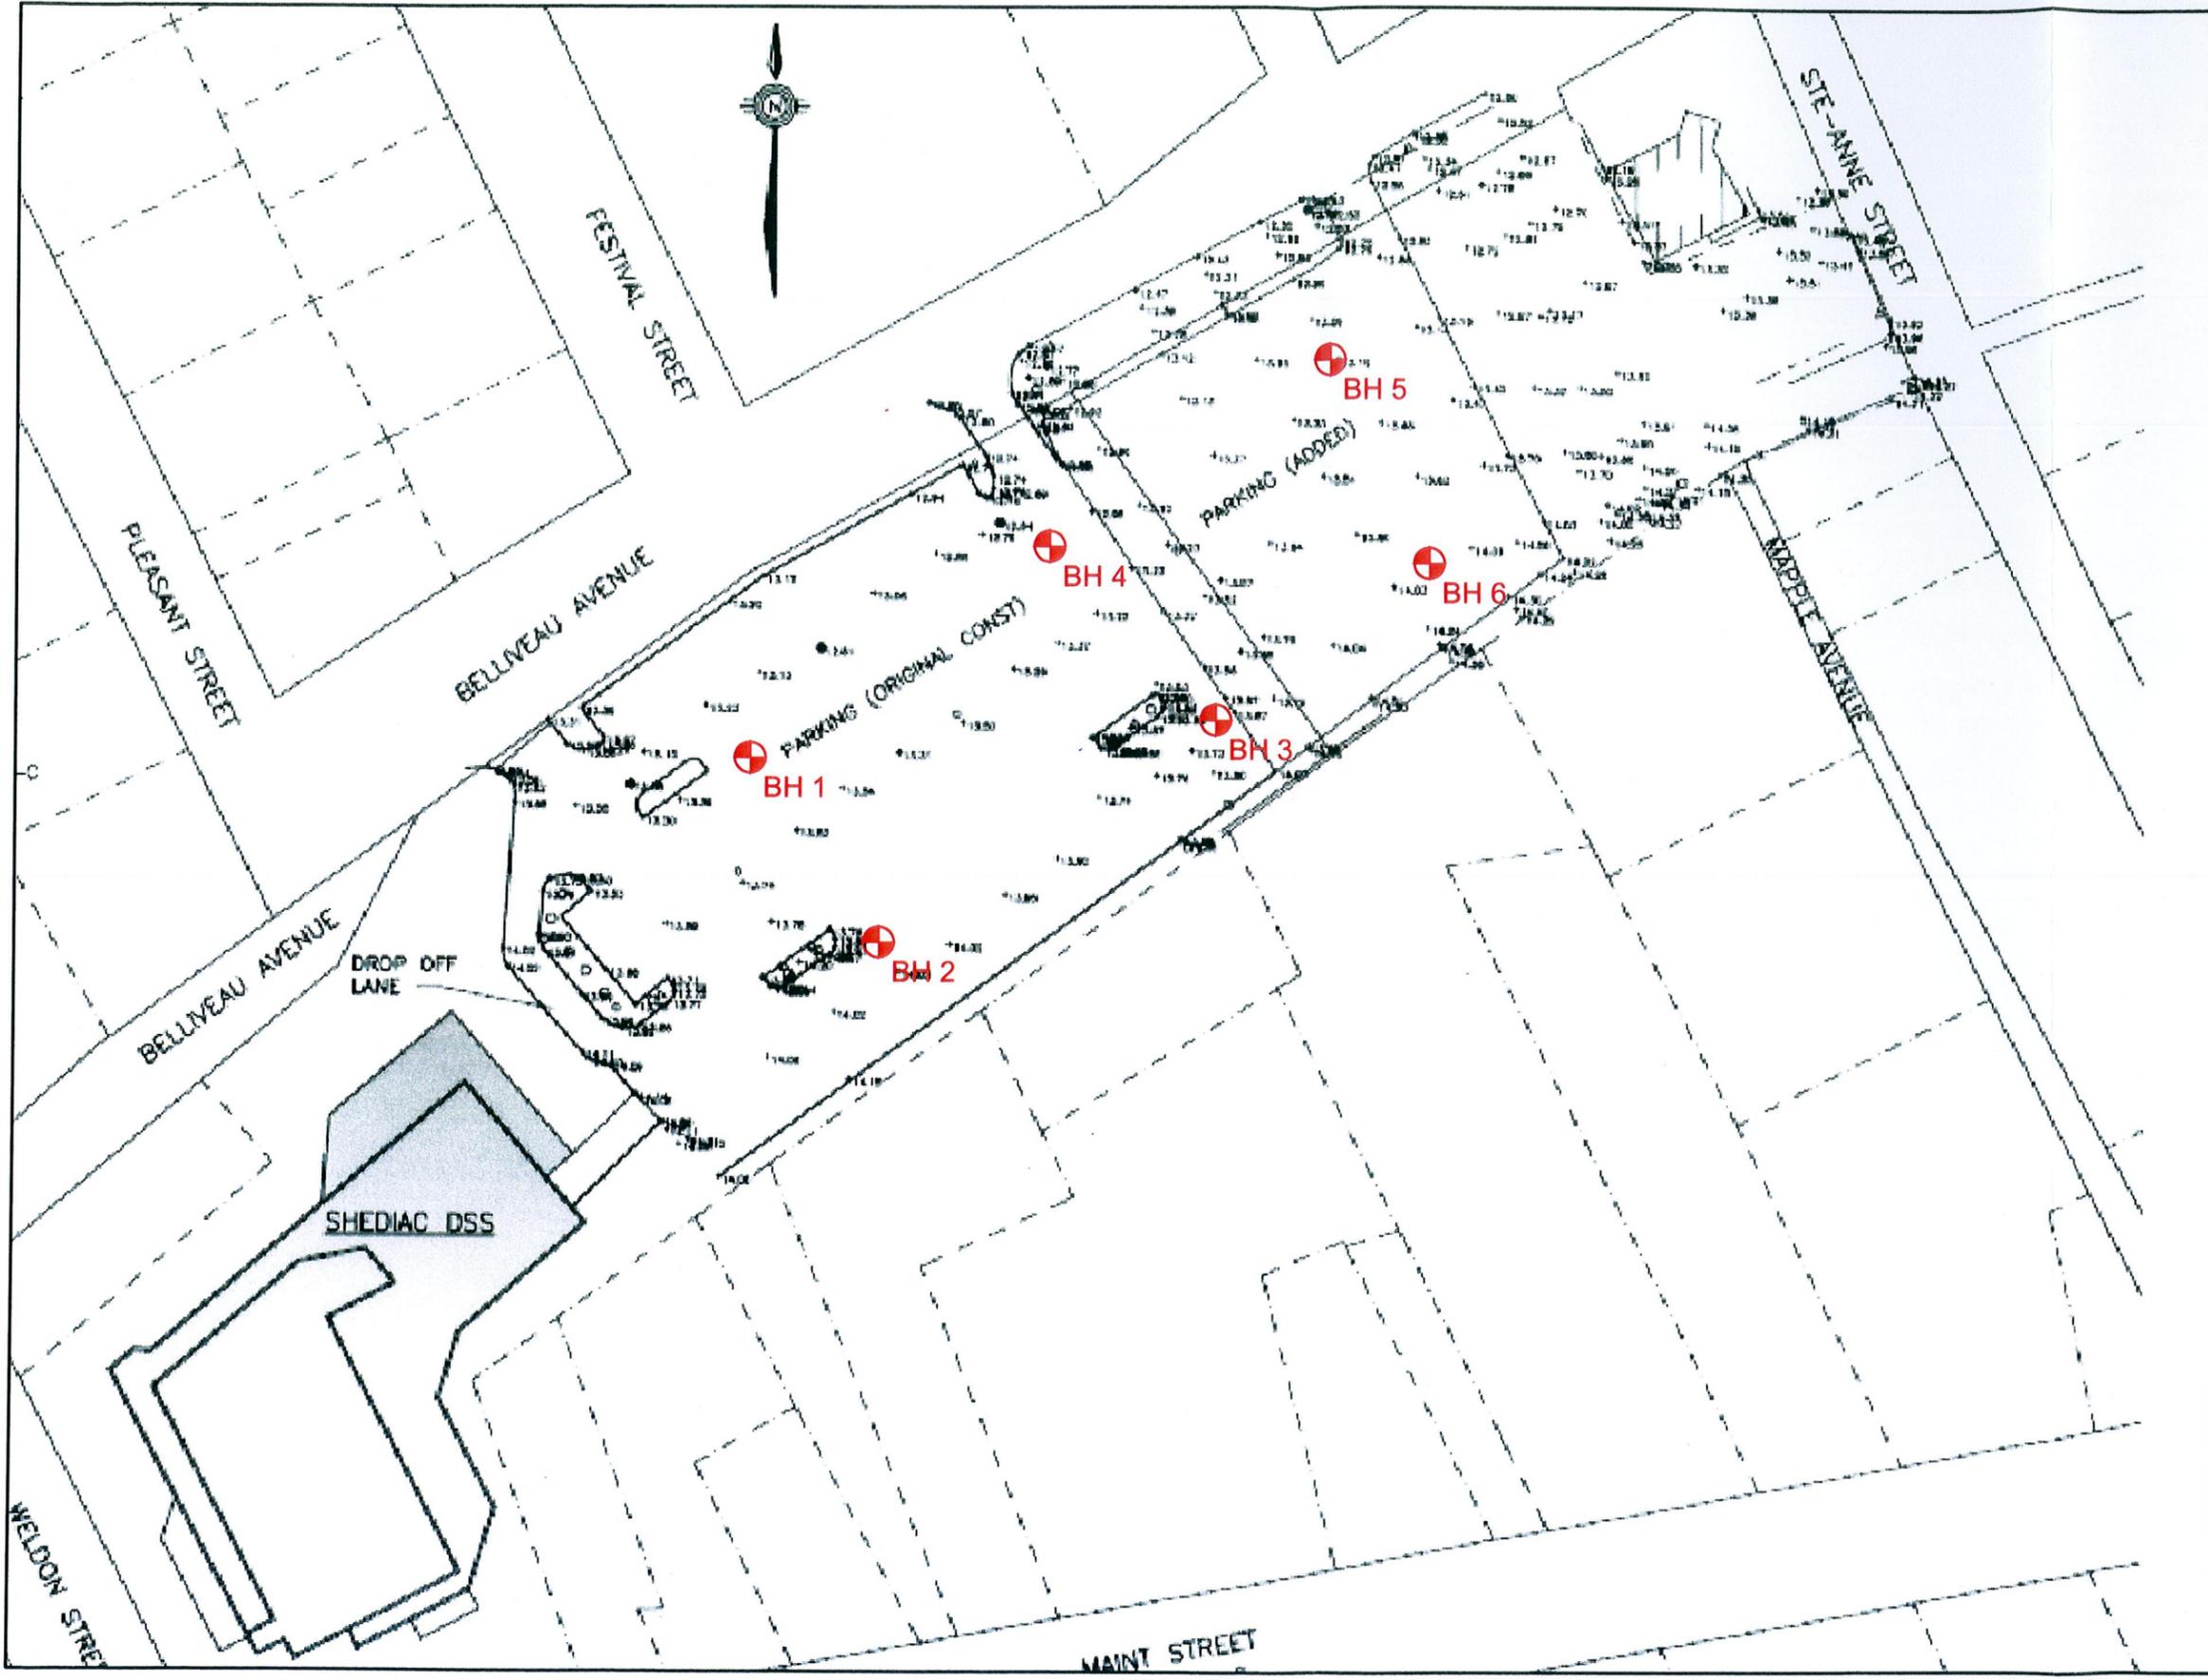
| File No. | 0387.07 | Drawing | FIGURE 1 |

The location of each borehole was established in the field by GEMTEC Limited personnel with the assistance of Bertrand Thibodeau of SNC Lavalin. A site plan with borehole locations is shown in Figure 1.

As shown in Figure 1, the site is located on Belliveau Street in Shediac, New Brunswick. At the time of our investigation, the site was covered with asphalt concrete.
