**Iqaluit, Nunavut
DFO Bunkhouse Building 1074,
Hazardous Material Abatement
Solicitation # E0208-151273/A**

ADDENDUM #2 February 19, 2015

DEMOLITION WASTE SURVEY

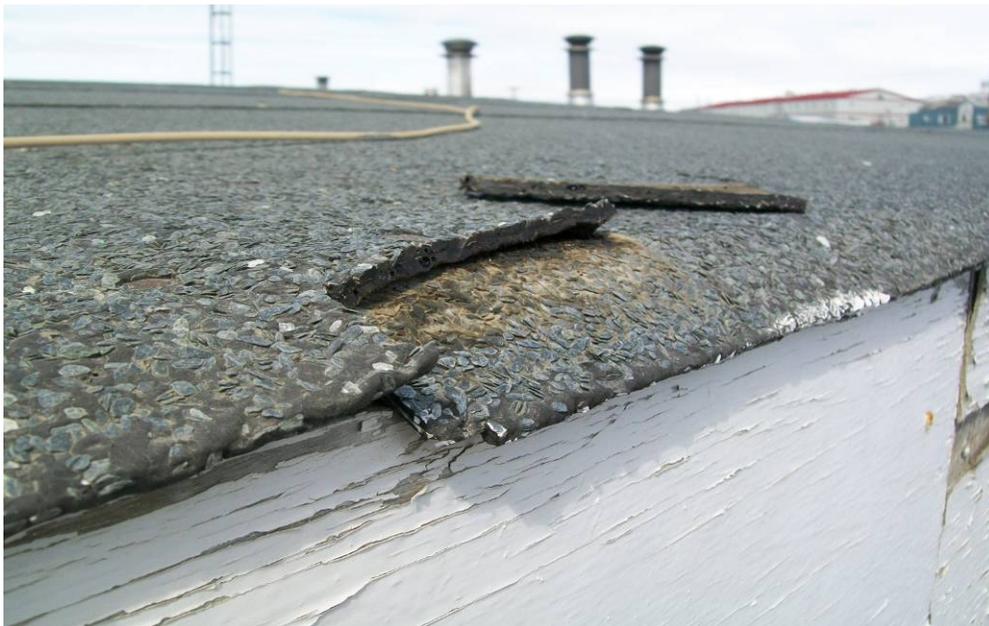
Photograph 2: View of asbestos-containing asphalt roof shingles on building. Sample (RF-01c) contained 3% Chrysotile asbestos.

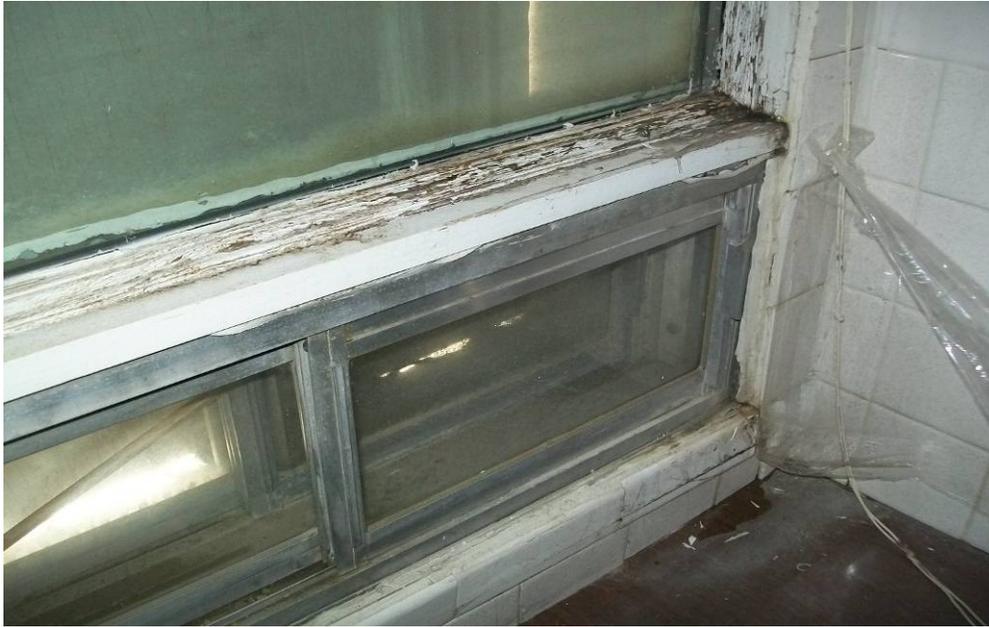
Photograph 3: View of asbestos-containing caulking along window sill of older window in west wing of building. Sample of caulking contained 4% Chrysotile asbestos.

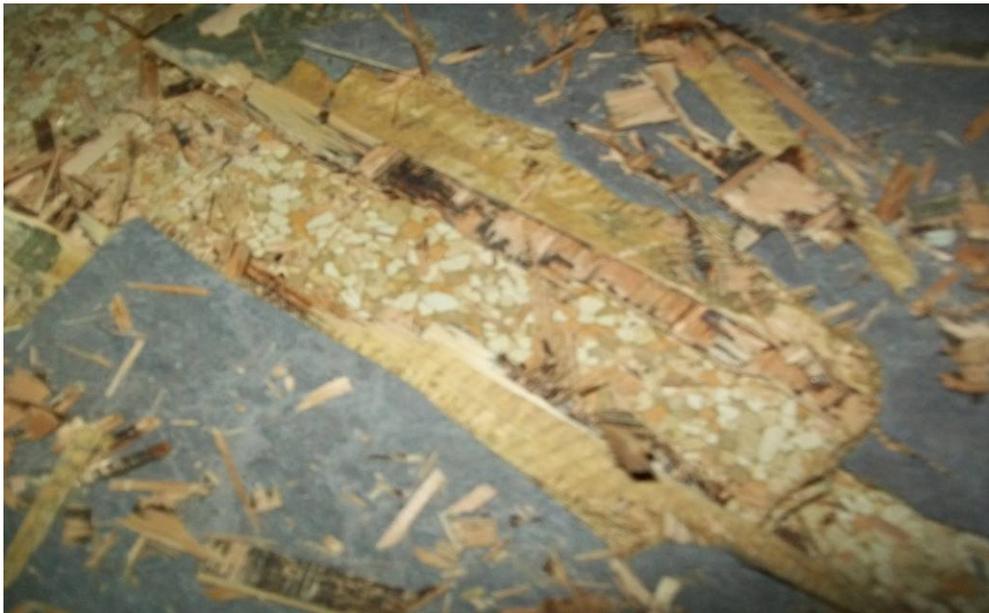
Photograph 4: View of asbestos-containing vinyl sheet flooring (VSF4) (white speckled) along floor of east wing of building. Sample (VSF4-01a) contained 20% Chrysotile asbestos.

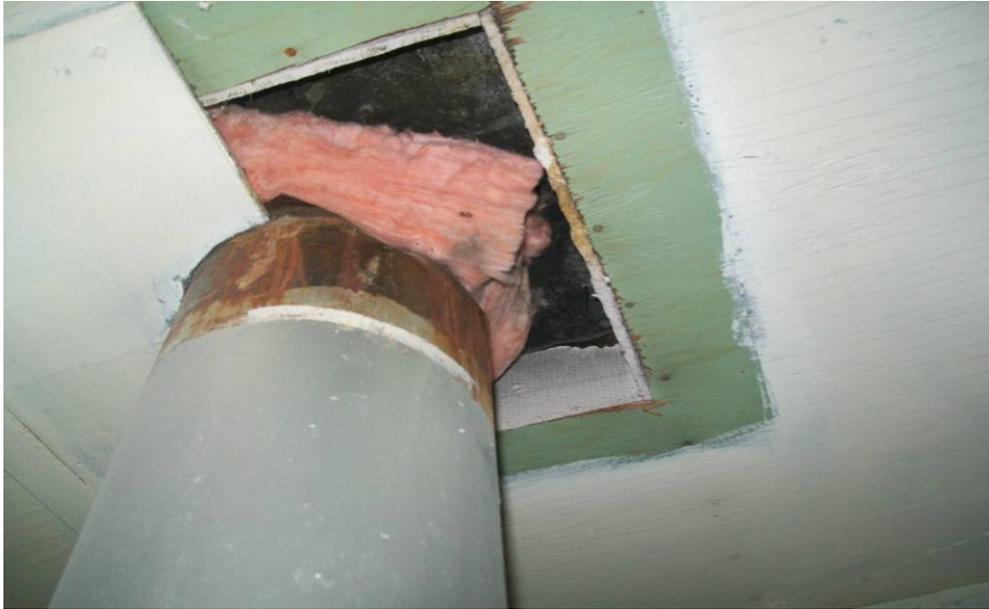
Photograph 5: View of asbestos-containing cement Transite panel along upper ceiling of in east wing of building. Sample of Transite contained 35% Chrysotile asbestos.

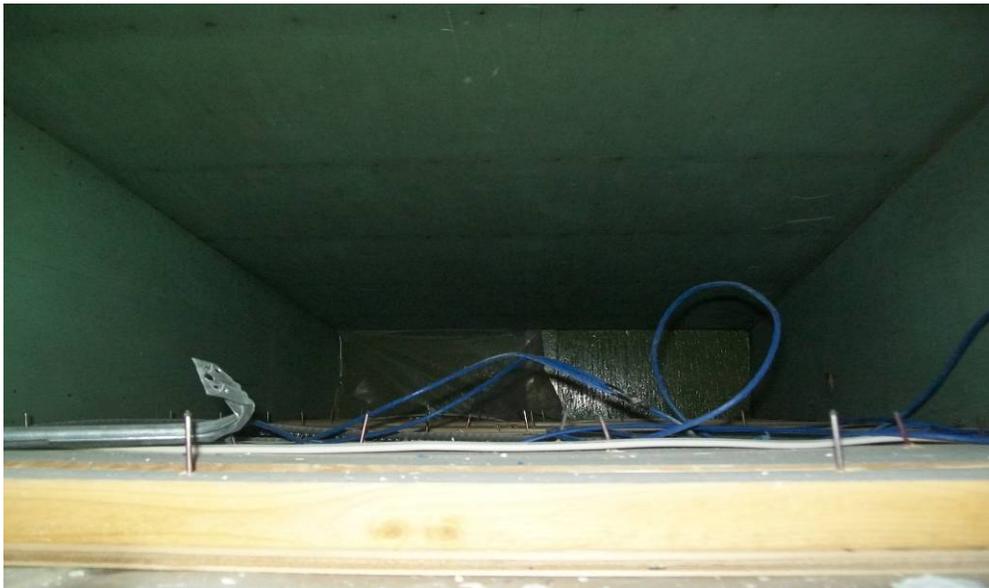
Photograph 6: View of older upper ceiling area of east wing of building. Paint samples collected from green paint of older ceiling contained 110,000 parts per million (ppm) of lead.

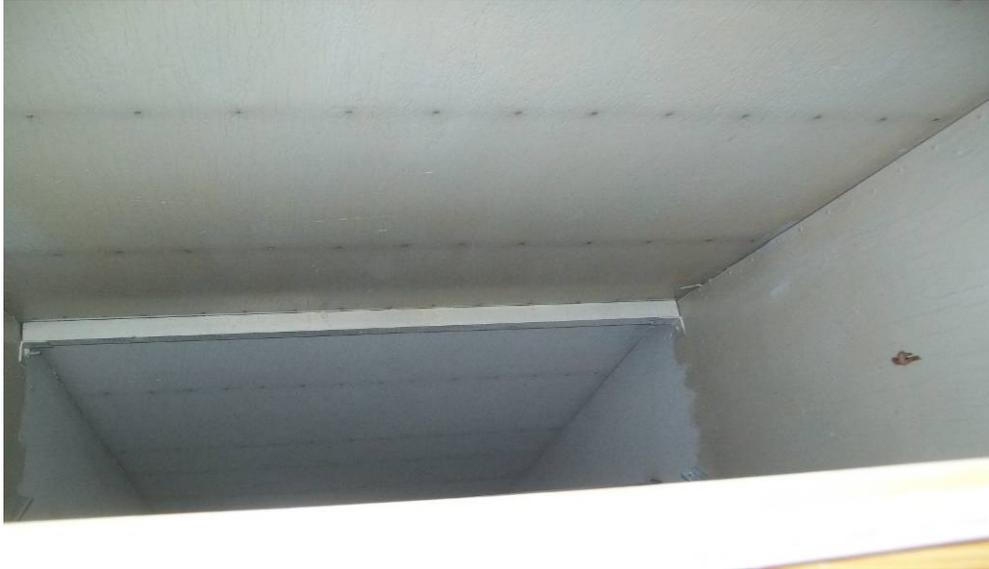
Photograph 7: View of older upper ceiling area of east wing of building. Paint samples collected from yellow paint of older ceiling contained between 7,800 – 64,000 ppm of lead.

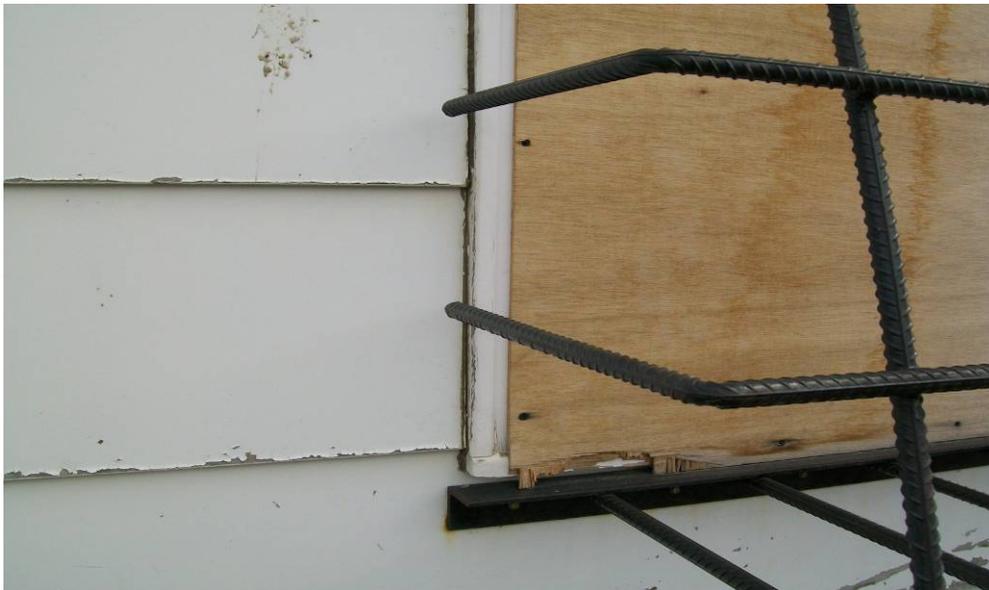
Photograph 8: View of white paint along the exterior window sill along the west side of the building. Paint sample collected contained 800 ppm of lead.

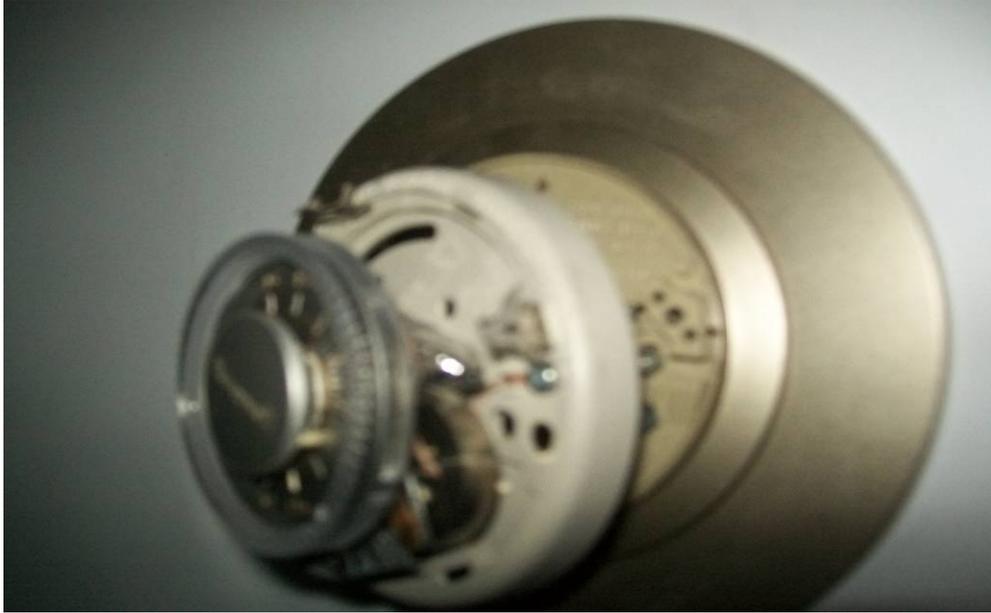
Photograph 9: View of wall mounted thermostat with mercury-containing ampoules along east wing.

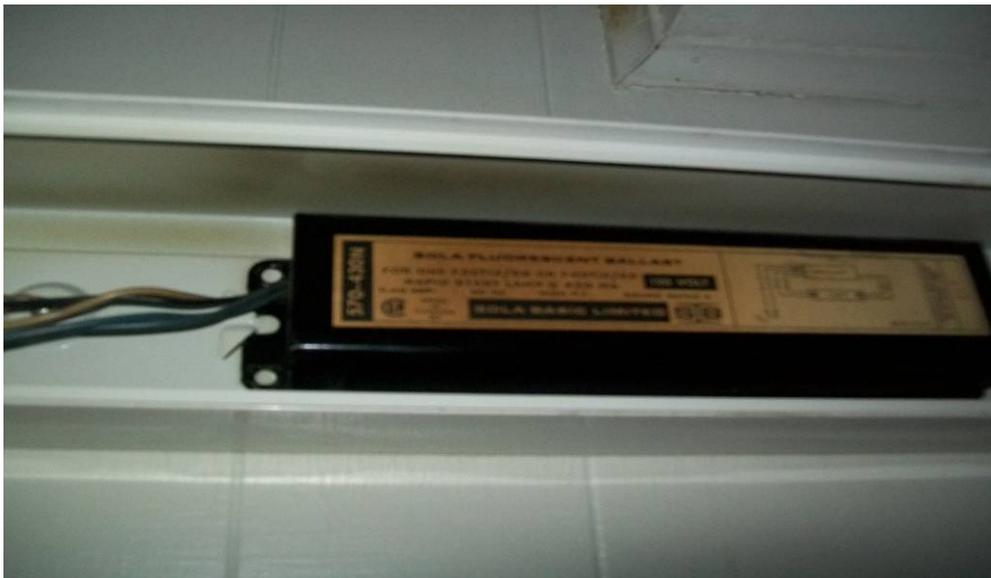
Photograph 10: View of assumed PCB-containing fluorescent lamp ballast along upper wall of washroom along west wing of building.

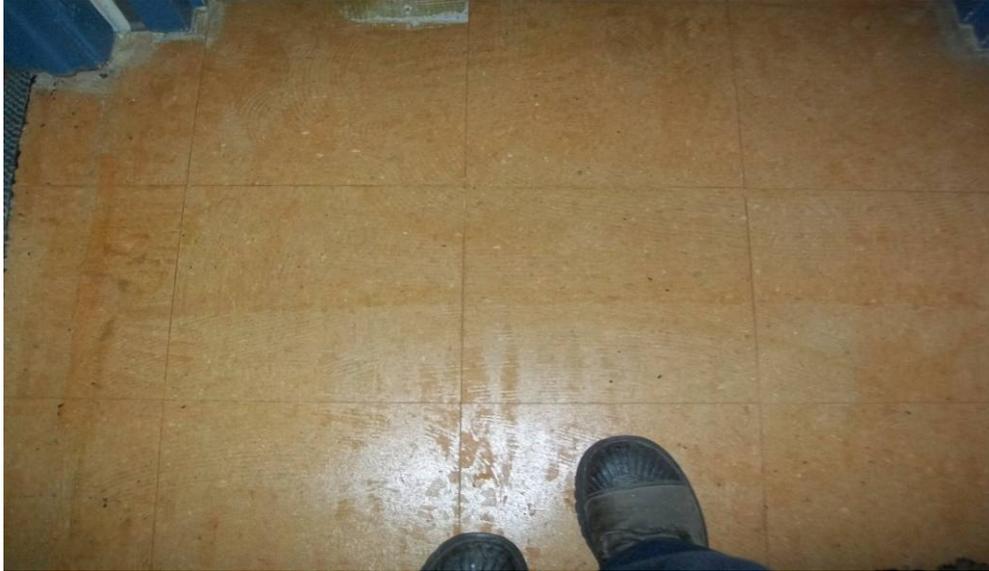
Photograph 11: View of typical assumed asbestos-containing vinyl floor tiles (“VFTs”) under carpeting along floor of west wing of building.

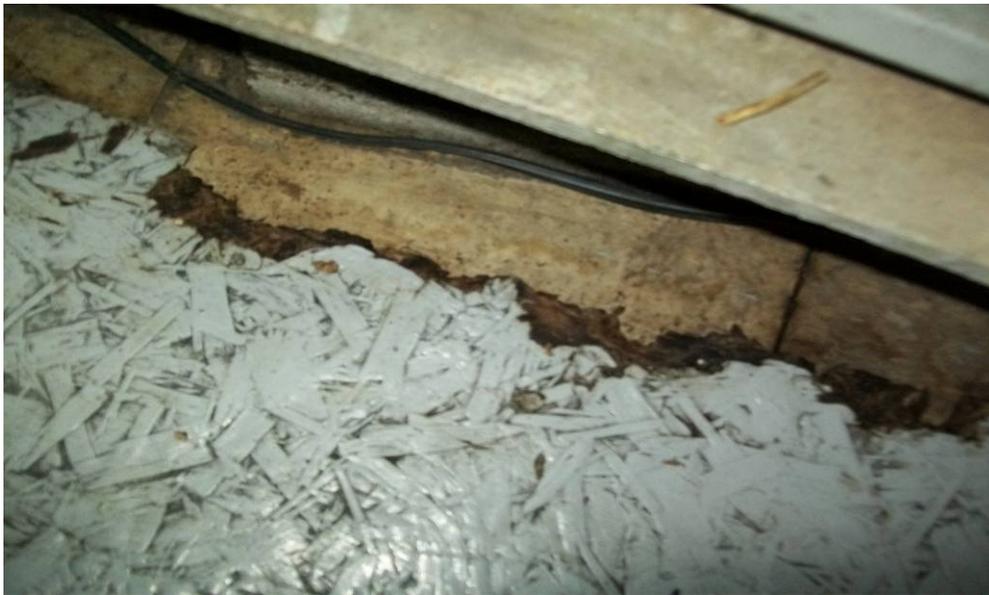
Photograph 12: View of additional typical assumed asbestos-containing VFTs under wood and other flooring material of building.

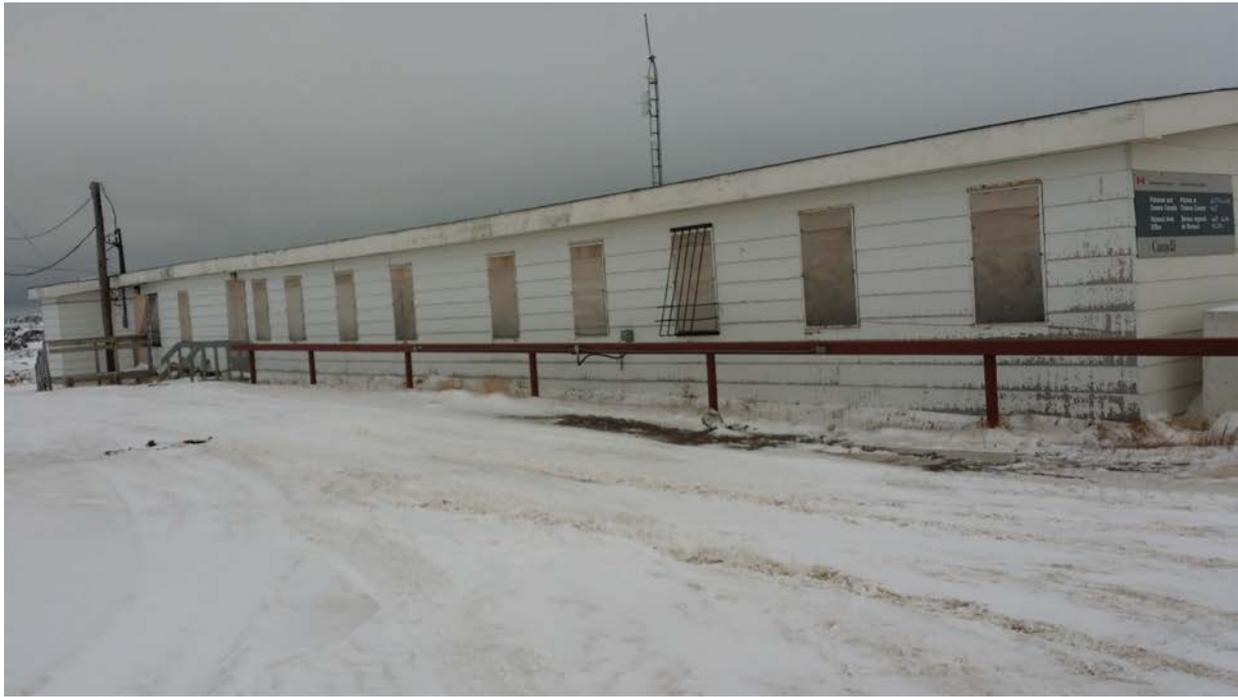
Photograph No. 1: View south along the east wing. Lead-containing paint (white) applied to the wall paneling, window frames, fascia and soffits.

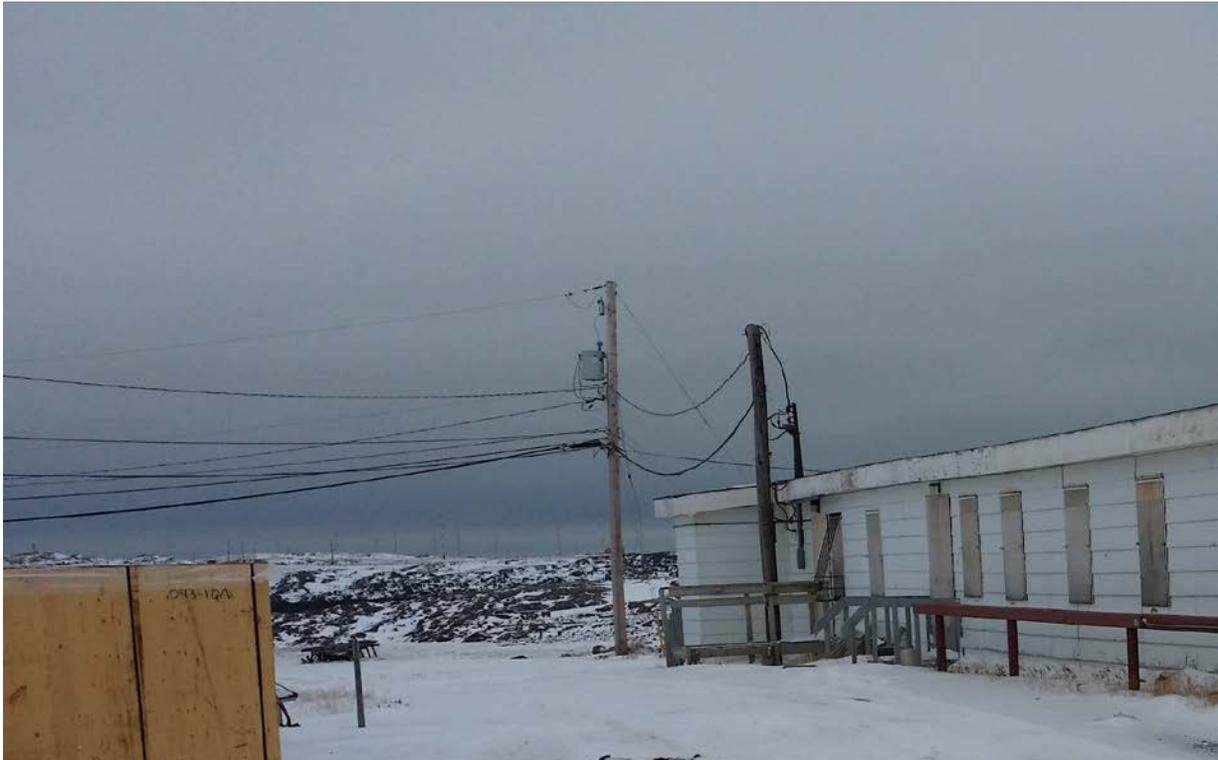
The electric power comes to the building from a pole located in the south east corner of the subject site. One pole mounted transformer was observed on the pole; however it is not associated with this building. No other PCB-containing equipment or materials were identified during the waste survey.

Photograph No. 2: View of the hydro-pole near the south east corner of the building. Note the pole mounted transformer.

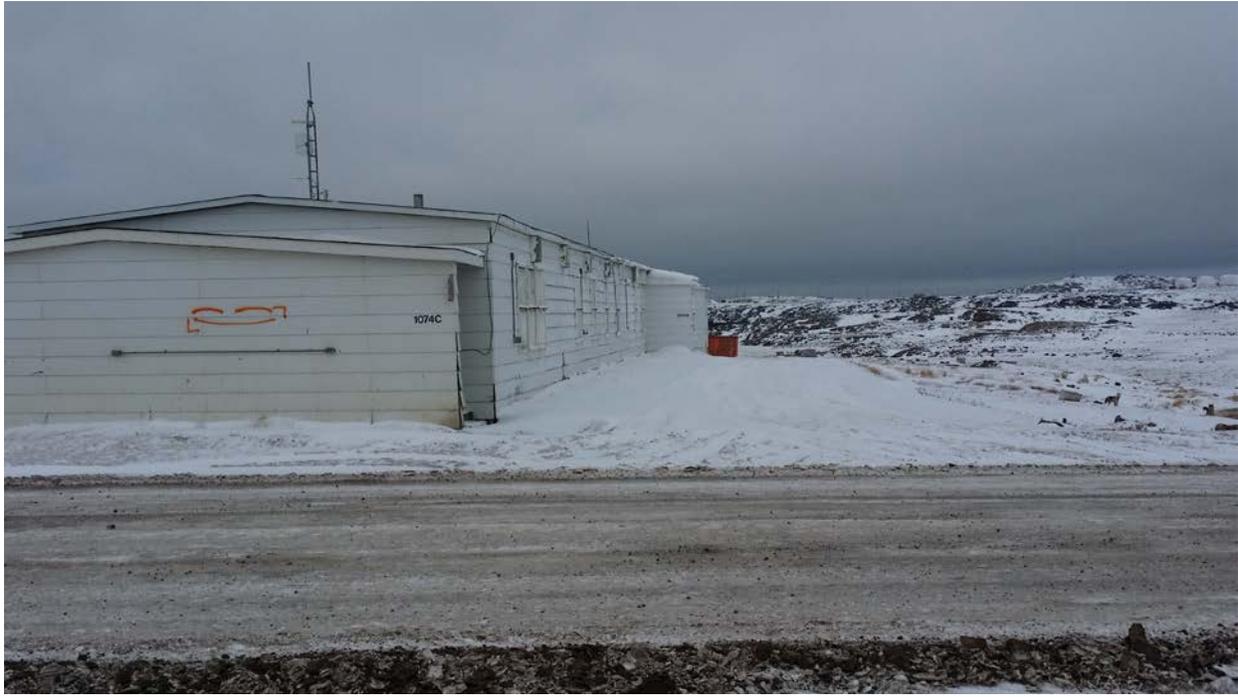
Photograph No. 4: View south along the west wing. Lead-containing paint (white) applied to the wall paneling, window frames, fascia and soffits.

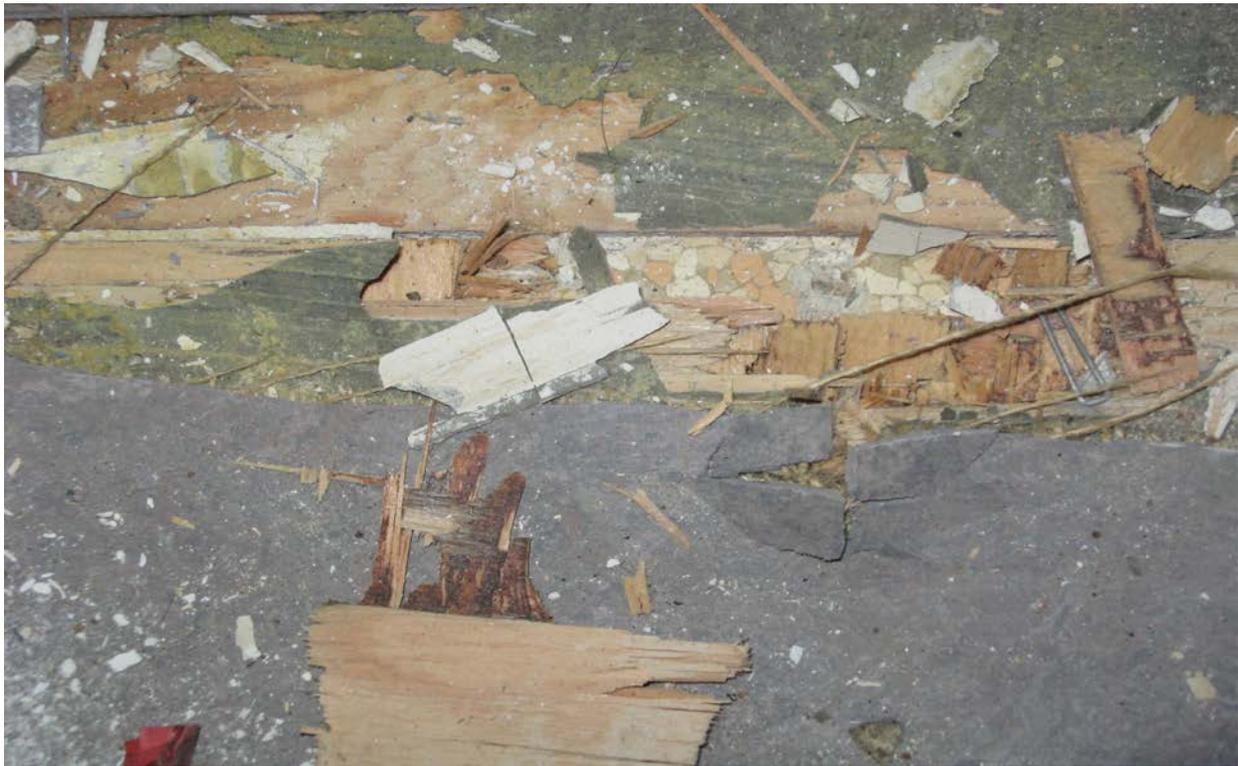
Photograph No. 5: Vinyl sheet floor flooring with asbestos-containing paper backing located under existing non-asbestos sheet flooring and plywood.

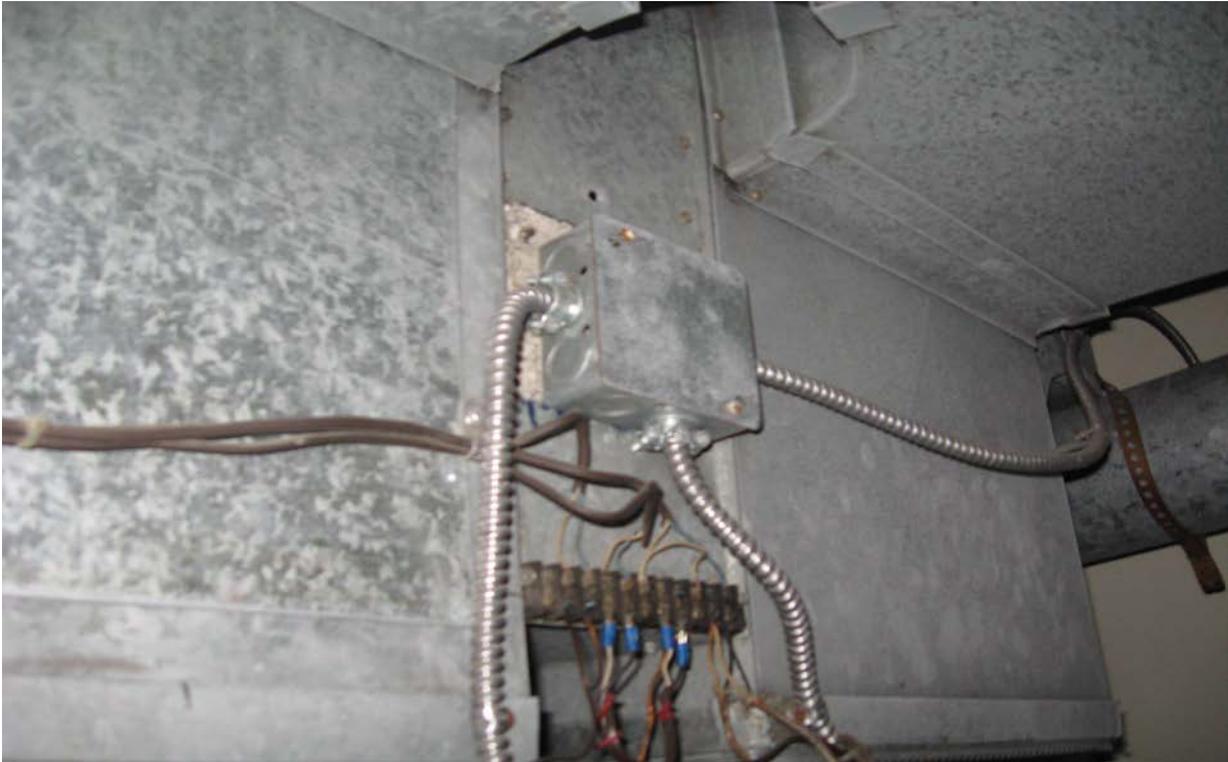
Photograph No. 6: Asbestos-containing gasket on forced-air furnace electrical junction box.

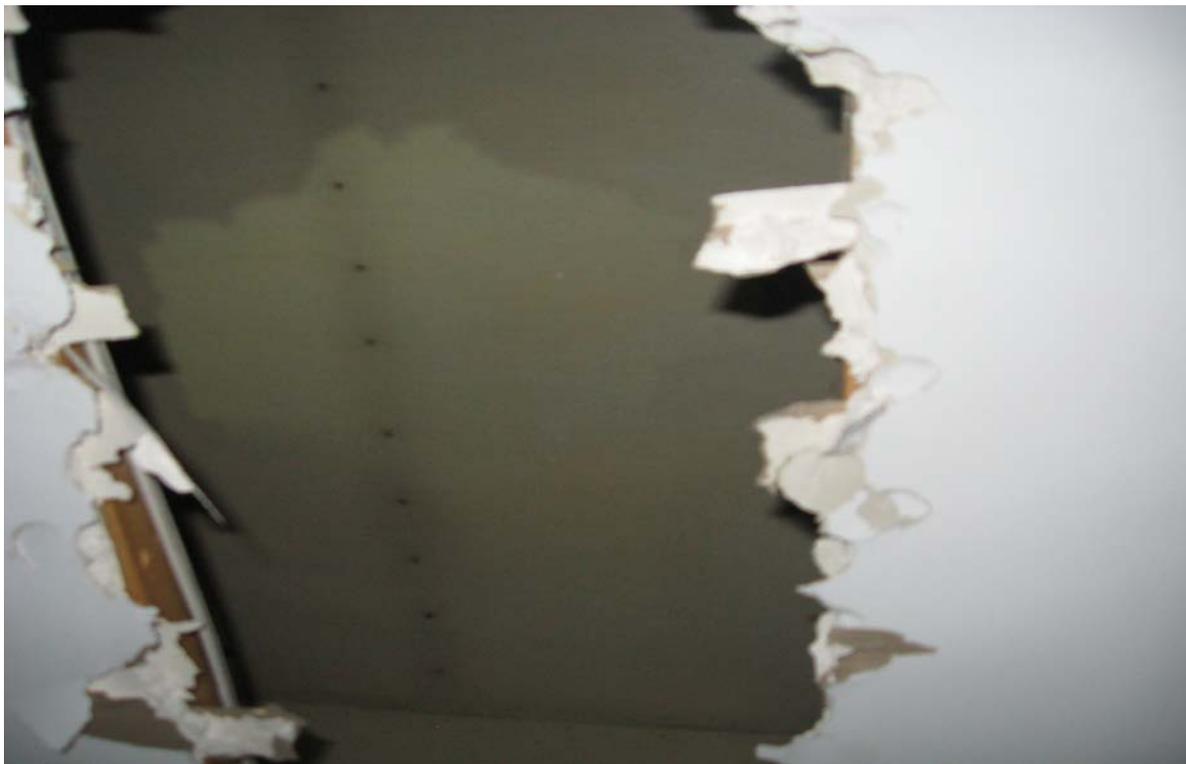
Photograph No. 7: Lead-containing paint (green) applied to underside of the roof sheeting.

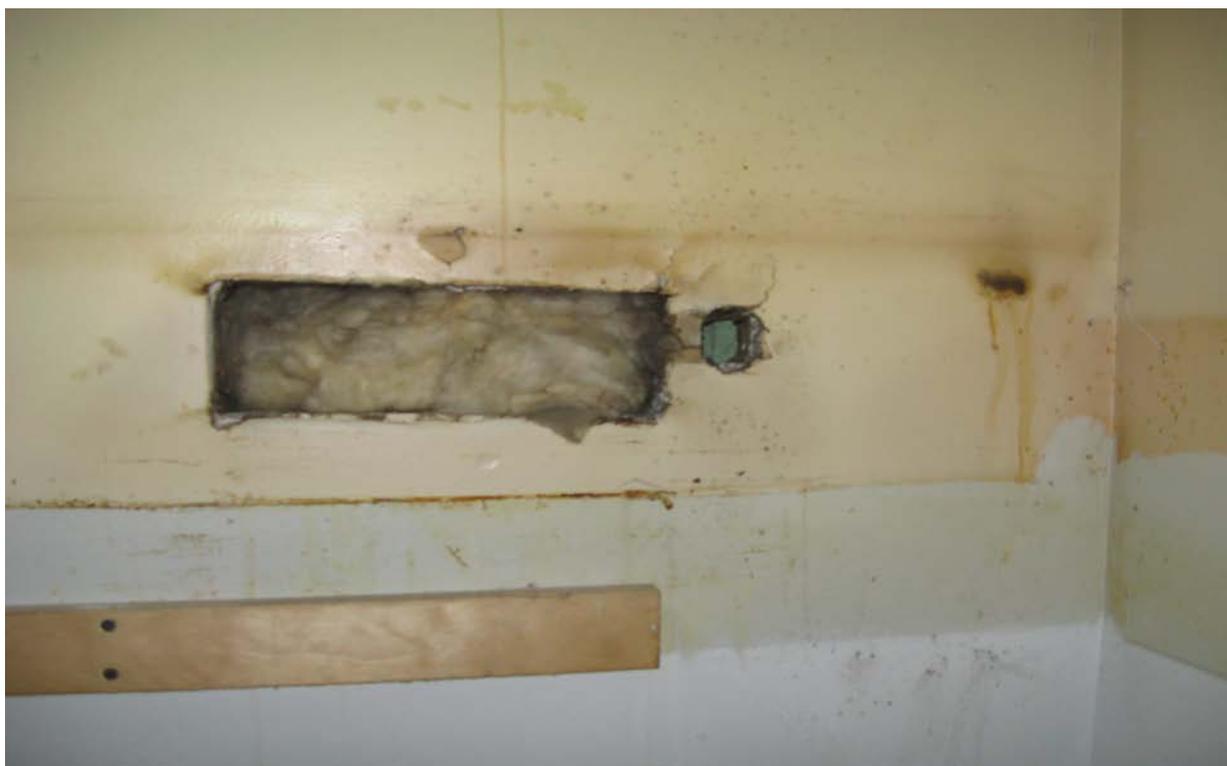
Photograph No. 8: Lead-containing paint (green) applied to the inside face of the exterior wood sheeting.
