## APPENDIX B

**GEOTECHNICAL INVESTIGATION REPORT  
PROPOSED BRIDGE REPLACEMENT  
HASTINGS SWING BRIDGE  
TRENT – SEVERN CANAL  
TORONTO, ONTARIO**

Project: 1842-910  
October 1, 2014

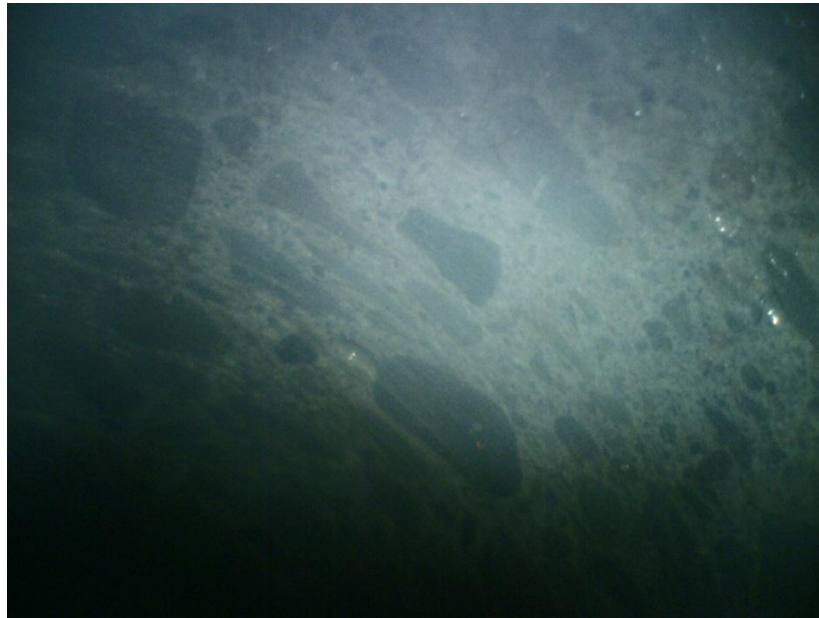
**Photograph 1: no cracking or fracture of the pier concrete noted inside the corehole**

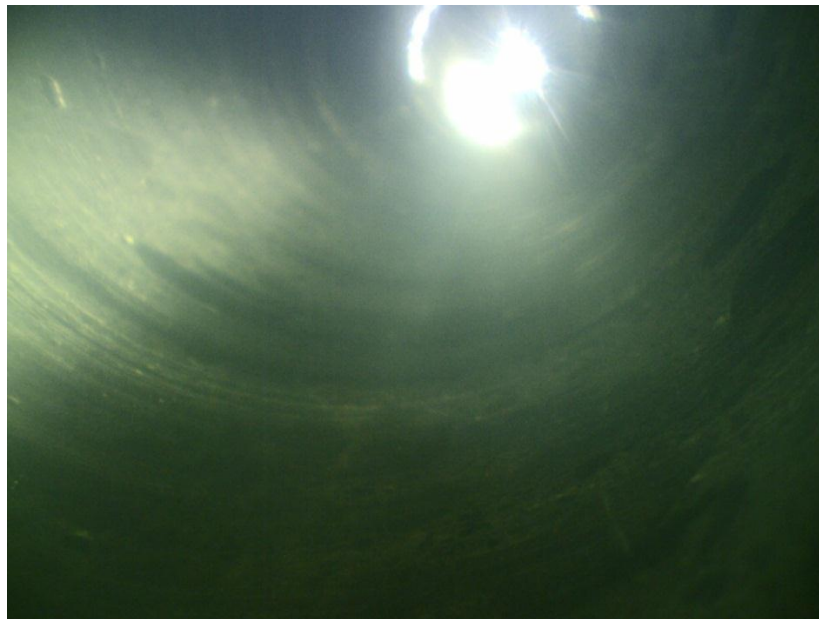
**Photograph 2: no cracking or fracture of the pier concrete noted inside the corehole**

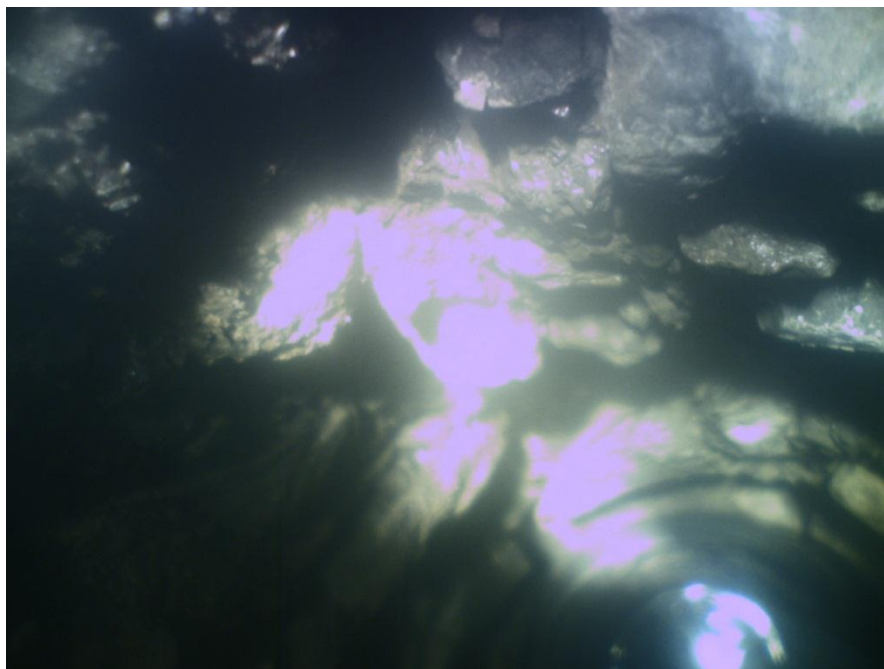
**Photograph 4: highly weathered rock below pier concrete; note the clayey silt soil within the voids between rock pieces**

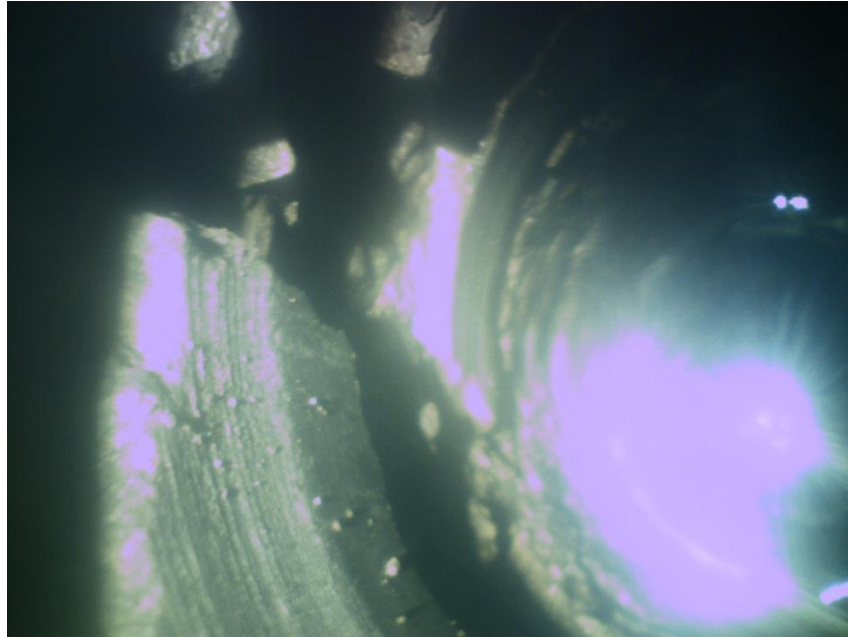
The voids in the weathered rock zones are considered to be obvious as shown in the photos taken inside the coreholes. However, it should be noted the voids observed inside of the coreholes were affected by the coring operation and may appear to be more severe. As noted above, the thickness of the weathered rock zones varied significantly between corehole locations. The weathered rock zone at the east portion of the existing concrete pier is very thin (i.e. approximately 0.3 m) while the weathered rock zone is up to a 1.0 m at the west portion of the existing pier. In consideration of the observed voids and potential ongoing erosion caused by the groundwater flow, the potential of excessive settlement of the existing pier should be considered as part of the bridge replacement design. Due to the variation of the weathered rock zone between the east portion and west portion of the concrete pier, the settlement could occur in a form of differential settlement. Therefore, it is recommended that measures such as grouting be considered for the existing pier to minimize/reduce the potential of further erosion of the existing founding materials.

**Photograph 5: void between pier concrete and bedrock and highly weathered rock pieces**

It should be noted that the purposes of the grouting should be only for filling/sealing the voids. High pressure grouting is not recommended at this site due to the potential concern of adverse impact to the existing wall of the canal and existing concrete pier. Low pressure close spacing grouting (such as polyurethane foam injection grouting or the equivalents) may be considered. Quick cure grouting should be considered in order to reduce the time of the bridge closure. Should it be practical, the grouting may be carried out prior to the bridge replacement to reduce the time of the bridge closure. In addition, consideration should be given to the following items for the grouting work:

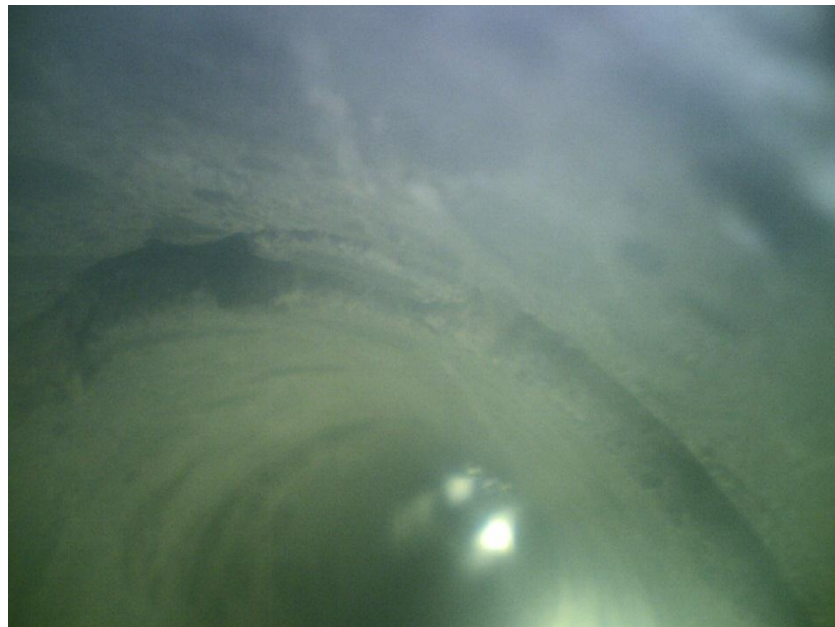
**Photograph 6: approximately 1 inch void between the pier concrete and bedrock**

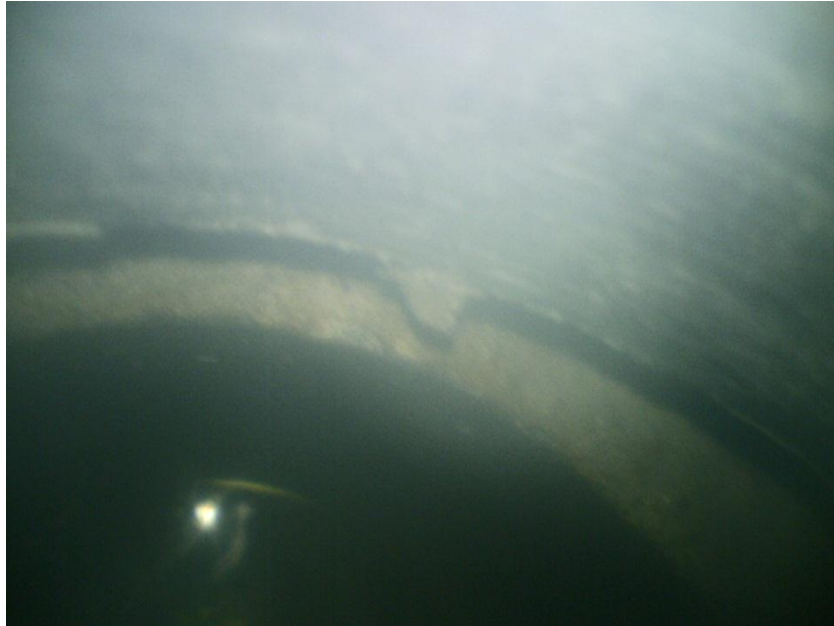
**Photograph 7: approximately 2 inches void between the pier concrete and bedrock**

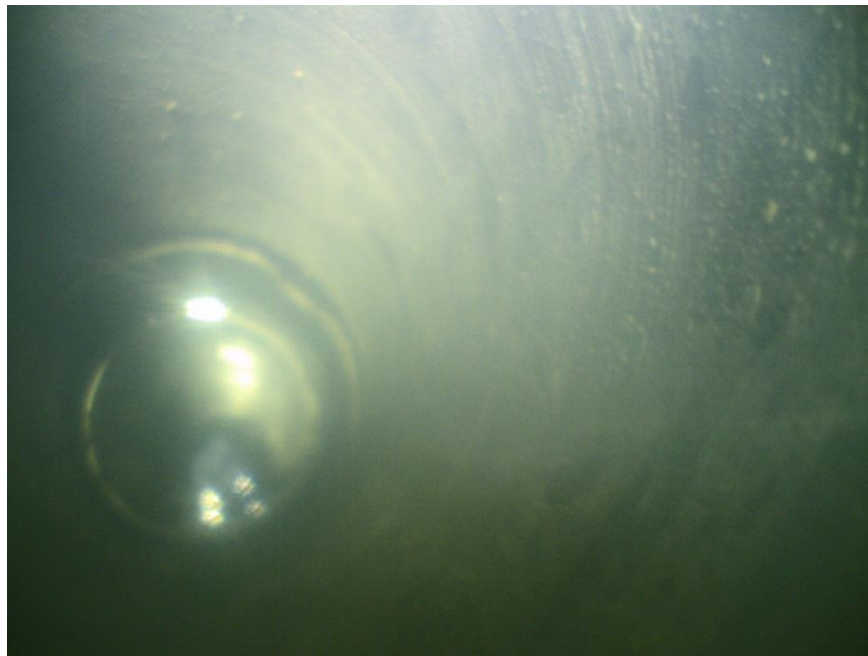
**Photograph 8: the void between the pier concrete and bedrock**

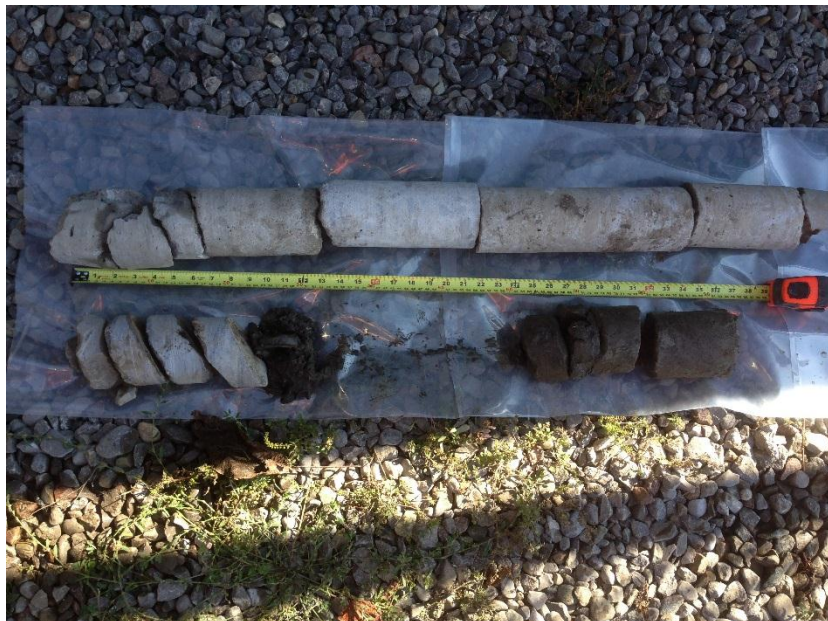
**Photograph 4: Corehole CH 13-2 Concrete Cores and zone of clayey silt within the limestone rock**

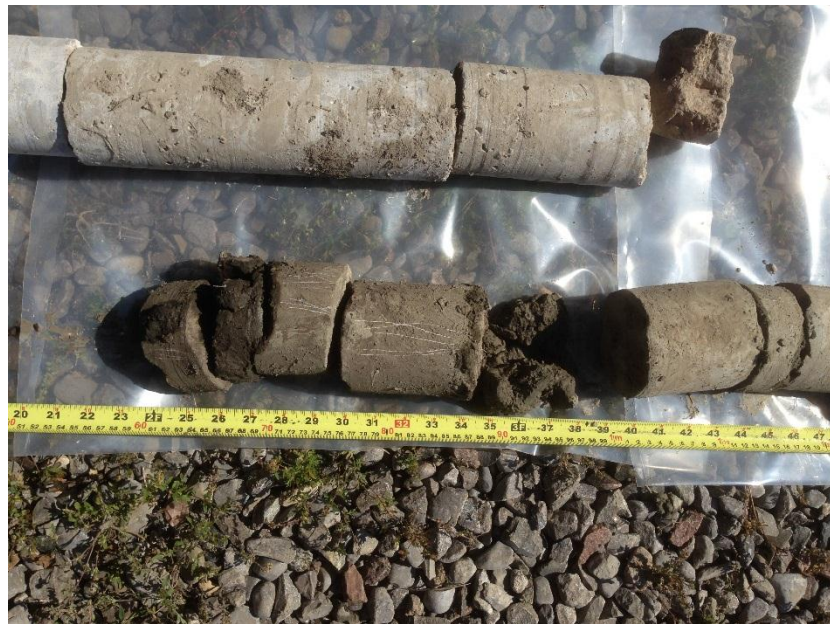
**Photograph 5: Corehole CH 13-2 Layers of clayey silt within the limestone rock**

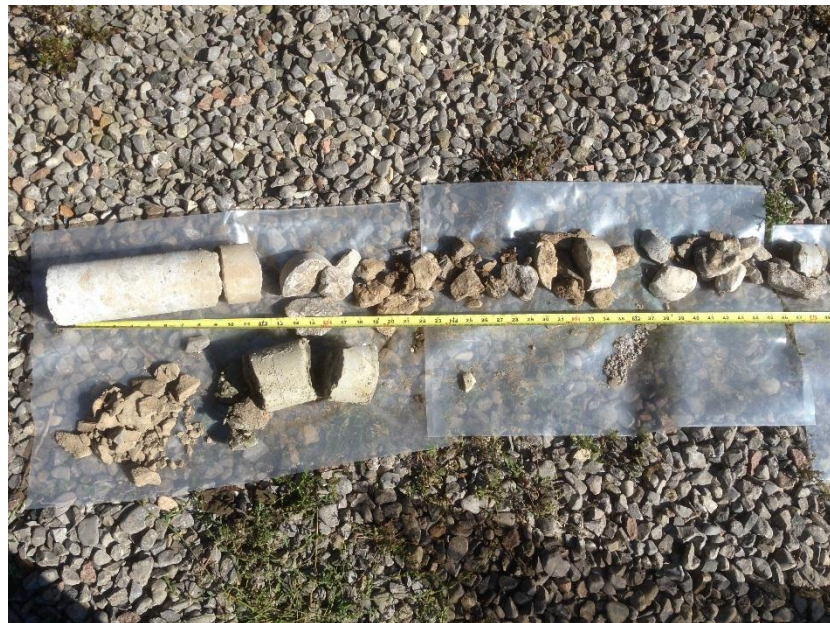
**Photograph 6: Corehole CH 13-3 Concrete Cores and Rock Fills or Highly Weathered Rock pieces**

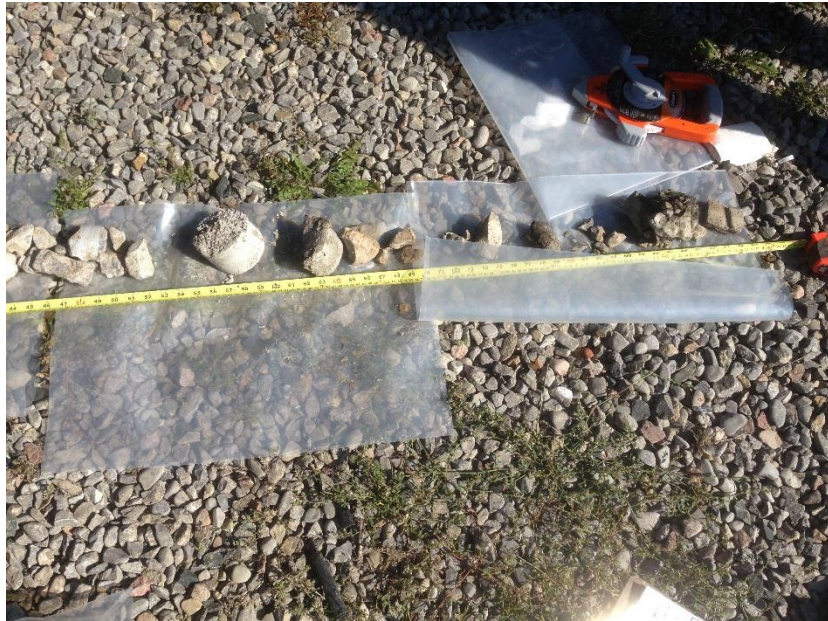
**Photograph 7: Corehole CH 13-3 Rock Fills or Highly Weathered Rock Pieces**

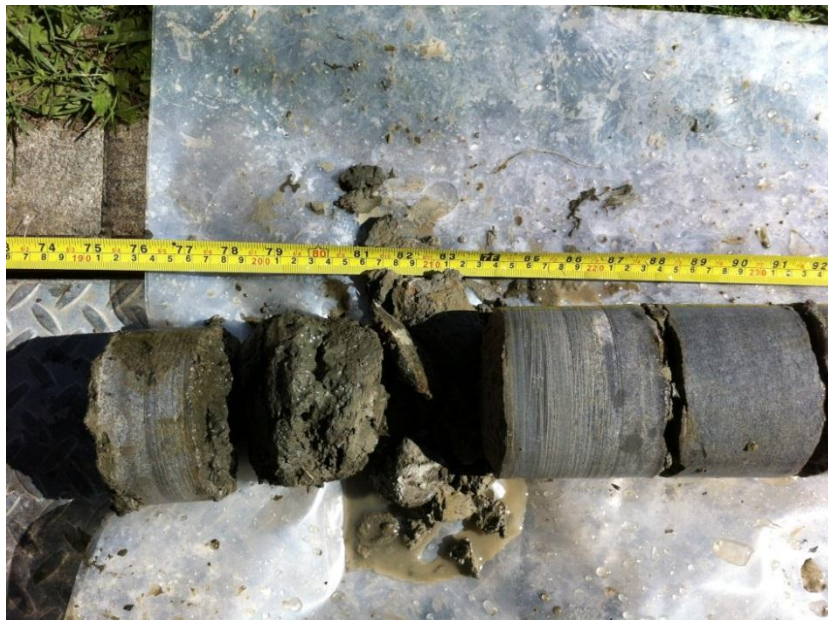
**Photograph 10: Layers of clayey silt within the limestone rock**

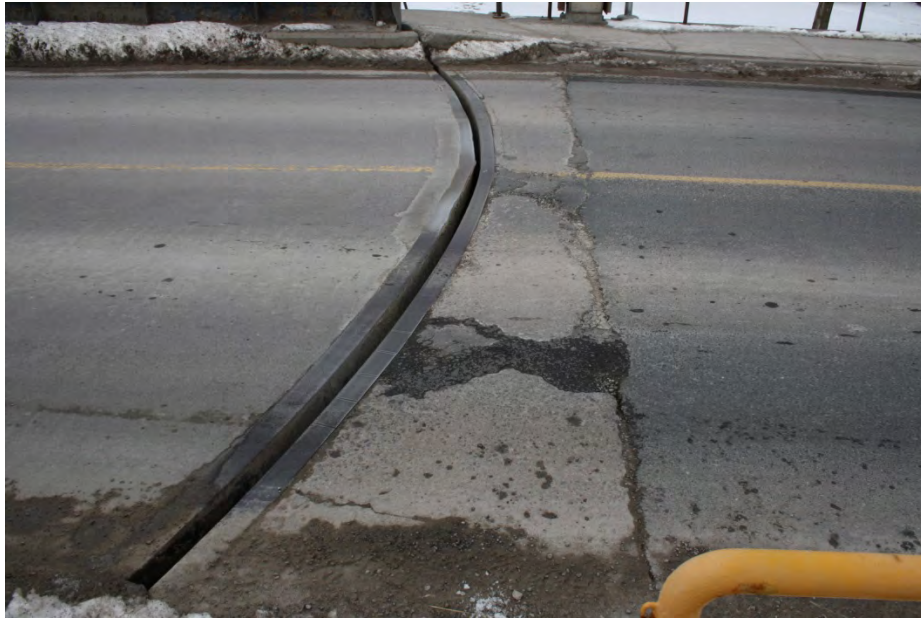
No.9: The north abutment wall and north nosing, looking west. Note the recent repair south of the steel nosing plate on the bridge deck; note the deterioration on top of the abutment wall and asphalt patch repair.

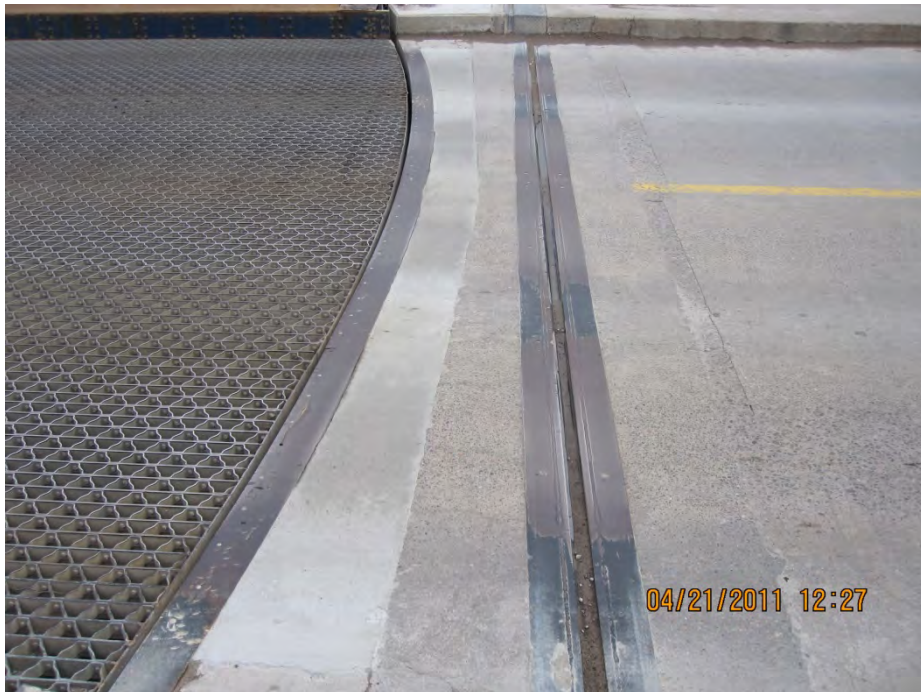
No.10: The south abutment wall and south nosing, looking west. Note the recent repair (lighter colour concrete) south of the steel plate on the abutment wall.

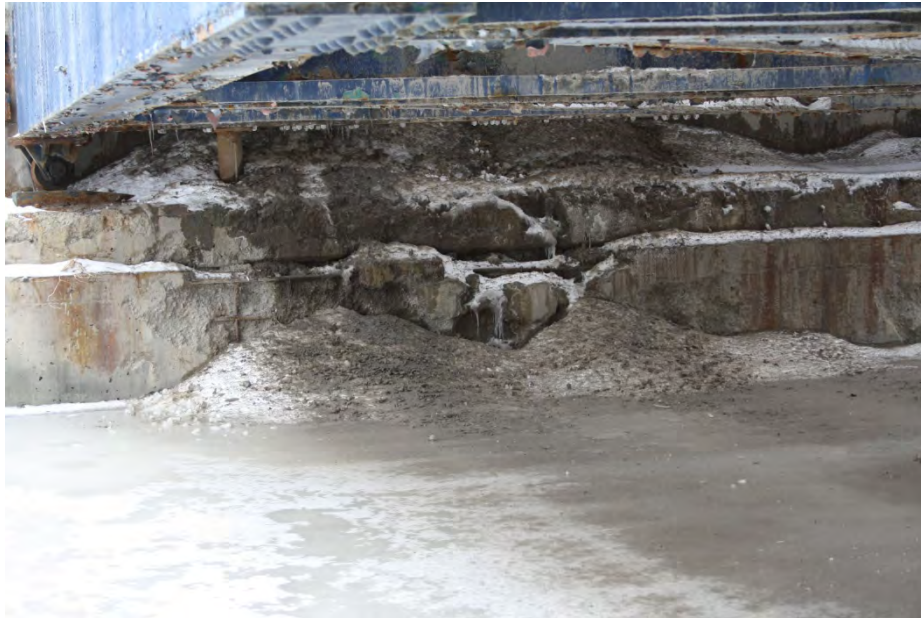
The geotechnical investigation and evaluation of the south abutment and canal walls are not within the scope of the work for this current assignment. However, from visual observations, the abutment footing and canal walls appear to be severely deteriorated and should be repaired as required.

No.11: The south abutment underneath the bridge deck, looking south; note the deterioration of the concrete, exposed steel rebar; note the snow, salt and sands or soils falling from the steel grate deck.

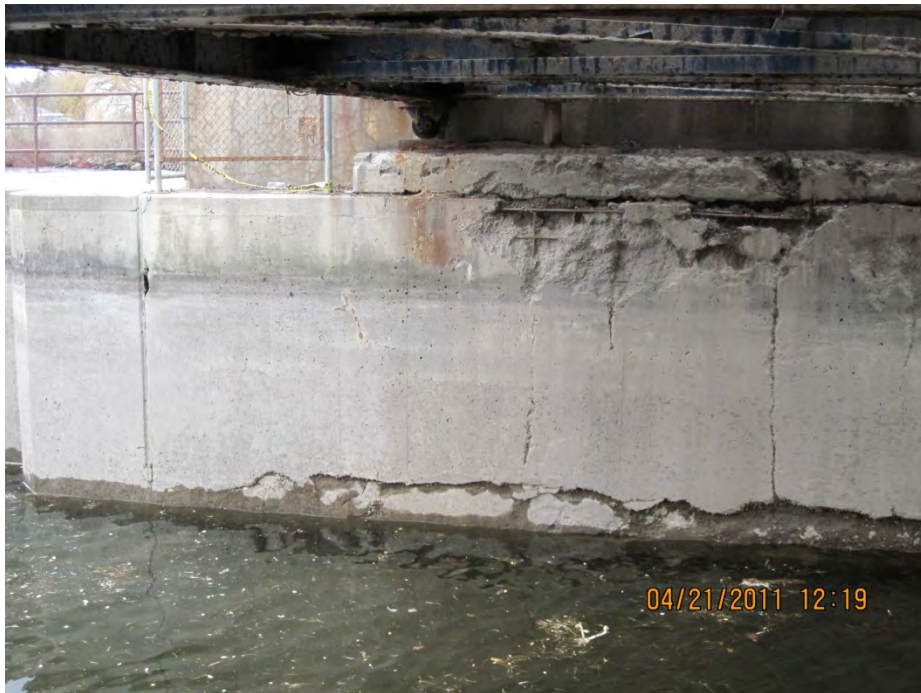
No.12: The south abutment underneath the bridge deck, looking south; note the deterioration of the concrete, exposed steel rebar at or immediate below the abutment slab; also note the nearly horizontal deterioration of the concrete at lower portion of the south canal wall.

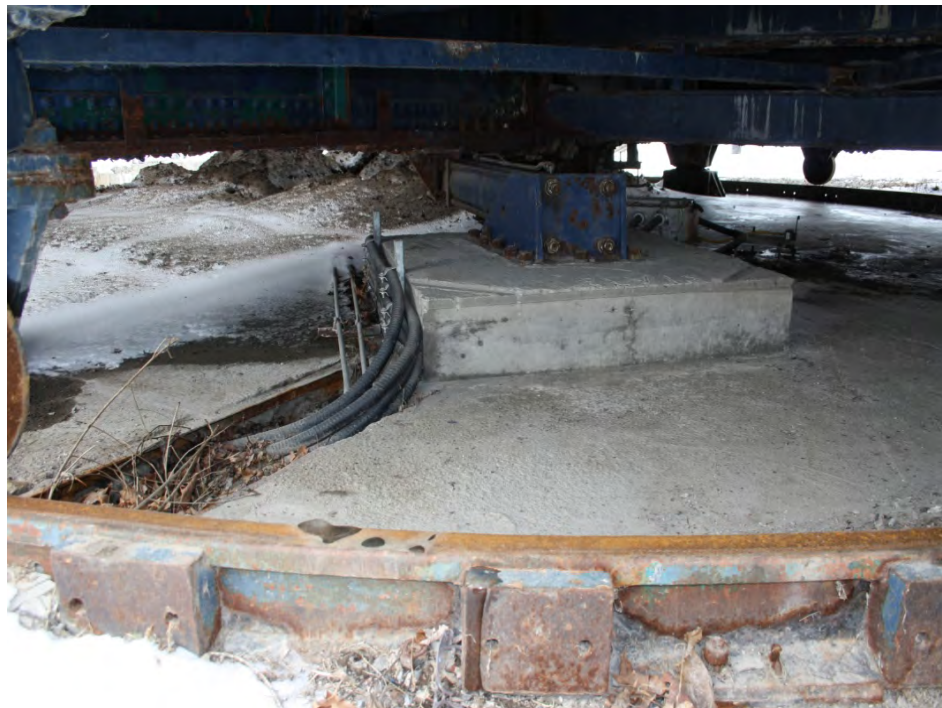
No.18: The central concrete pivot pier; note that the concrete at the surface of the pier appeared to be recently resurfaced; note the hydraulic system and the hydraulic jack used to swing the bridge.

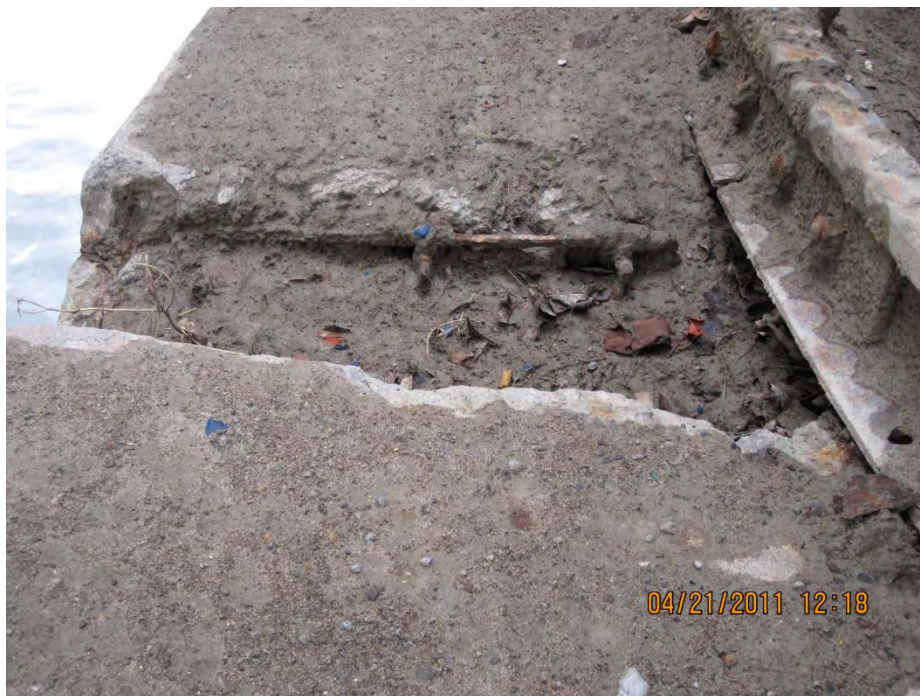
No.20: The north canal concrete wall; note the deterioration of concrete on the wall surface and exposed and eroded steel rebar and the void underneath the steel track on top of the central pier.

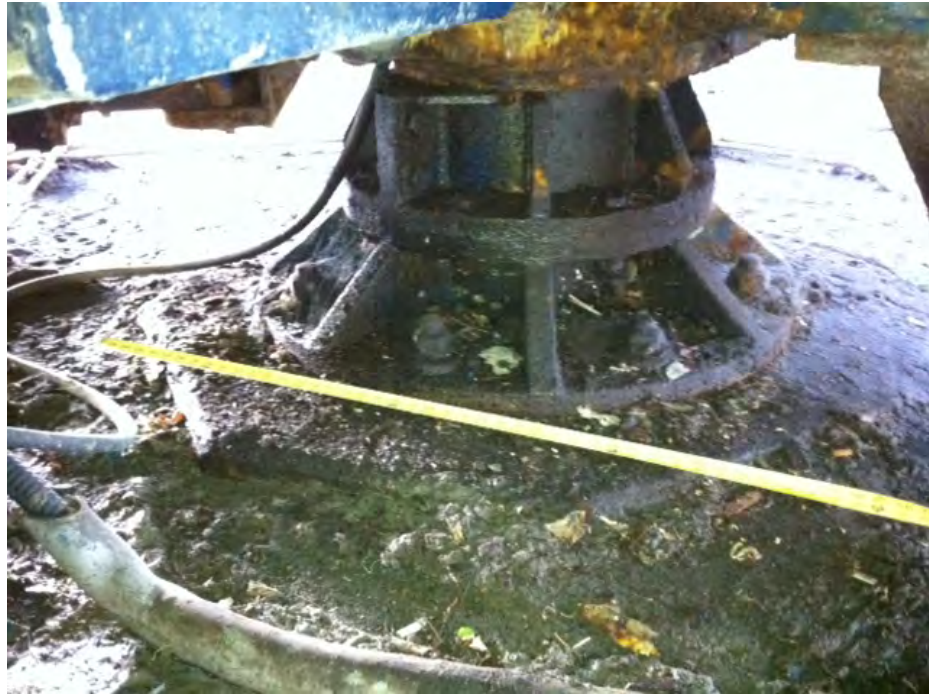
shape concrete platform which is slightly elevated above the concrete pier. No cracking was observed on the concrete surrounding the steel plate and in the hexagon shaped concrete platform. However, this concrete appeared to have been placed during relatively recent repair works and cracks that may be present in the original concrete would be obscured by this newer concrete.

No.21: Central pintle with a round steel plate (Approx. Dia. 0.8m) bolted on concrete platform slightly elevated above the pier concrete.

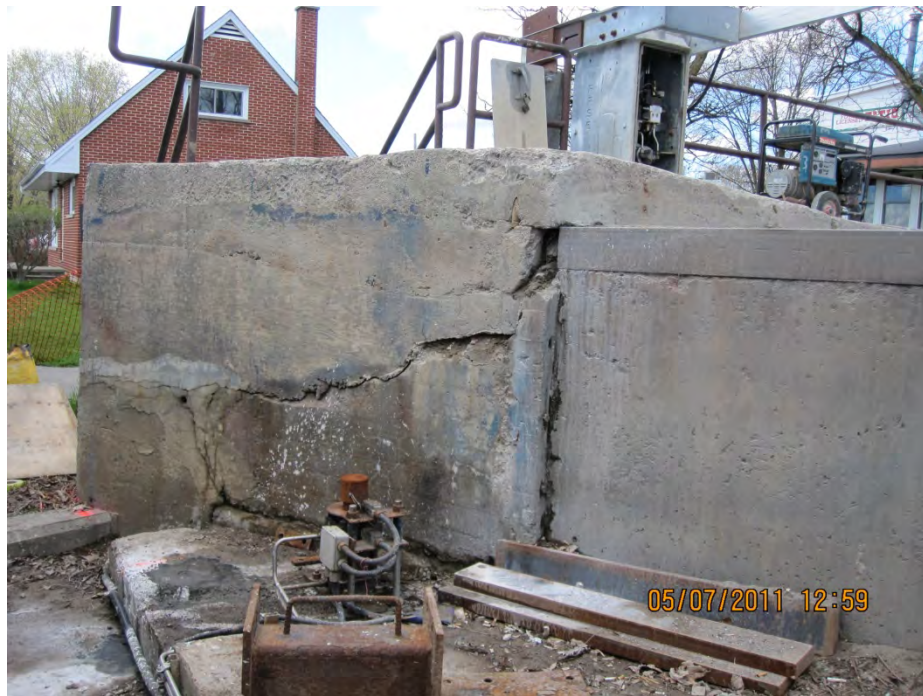
No.22: The west portion of the swing bridge abutment wall (the portion for the sidewalk and stairs). Note the concrete wall was poured in different years and the cracks between different pours.

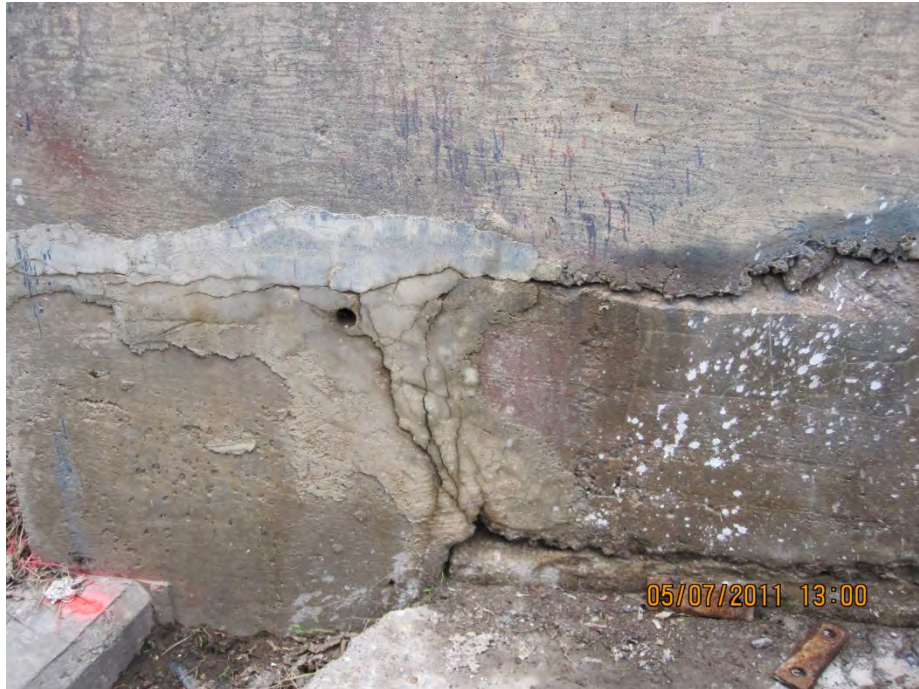
No.23: A close look of the west portion of the swing bridge abutment wall (the portion for the sidewalk and stairs). Note the concrete wall was poured in different years and the cracks between different pours; note the drainage hole on the wall.

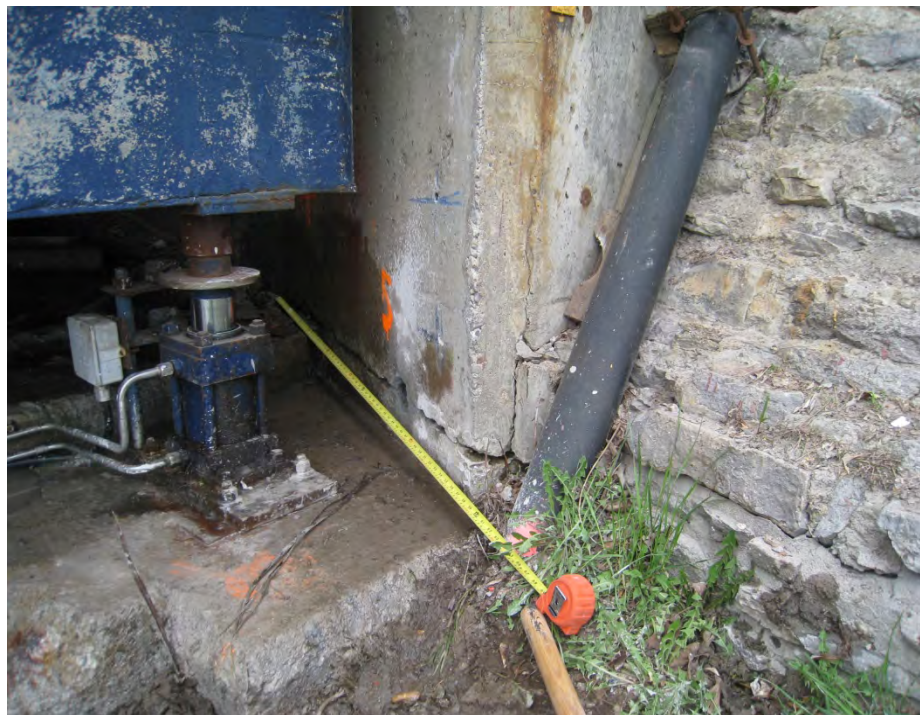
No.24: The northeast of the swing bridge; note the nearly-straight-line crack from the edge of the wing wall extending west to a distance of about 1.5 m.

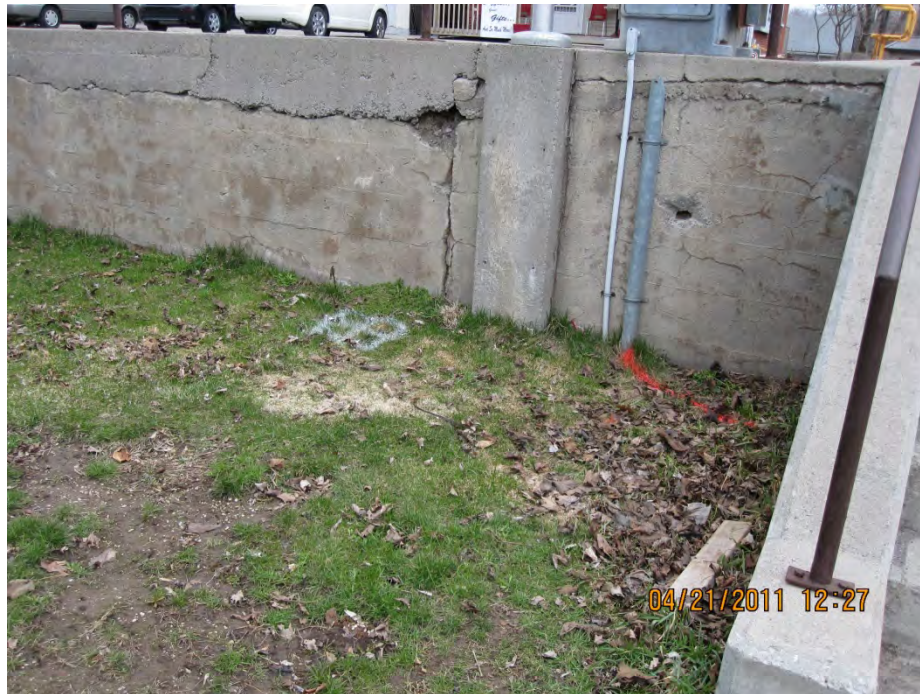
No.25: The retaining wall on the northwest side of the swing bridge; note the upper portion of the concrete was poured in different years and cracks between the different pours; note the deterioration of lower portion concrete.
