AMEC Geotechnical Report #TY1230281

**ADDITIONAL GEOTECHNICAL TEST HOLE INVESTIGATION
PROPOSED STRUCTURAL STABILIZATION OF STORES BUILDING
SAULT STE. MARIE, ONTARIO**

11 March 2014

AMEC Project No.: **TY1230281**

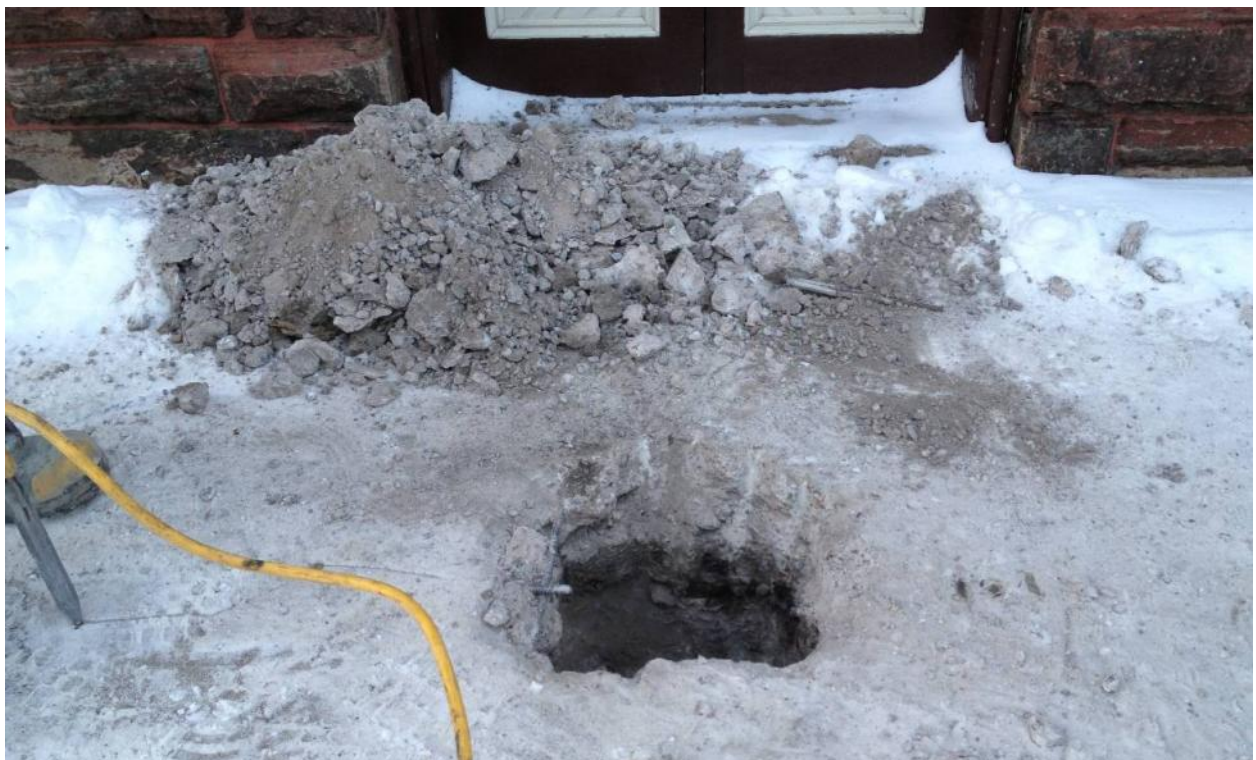
Photo 1: Jack hammered hole for pump well installation.

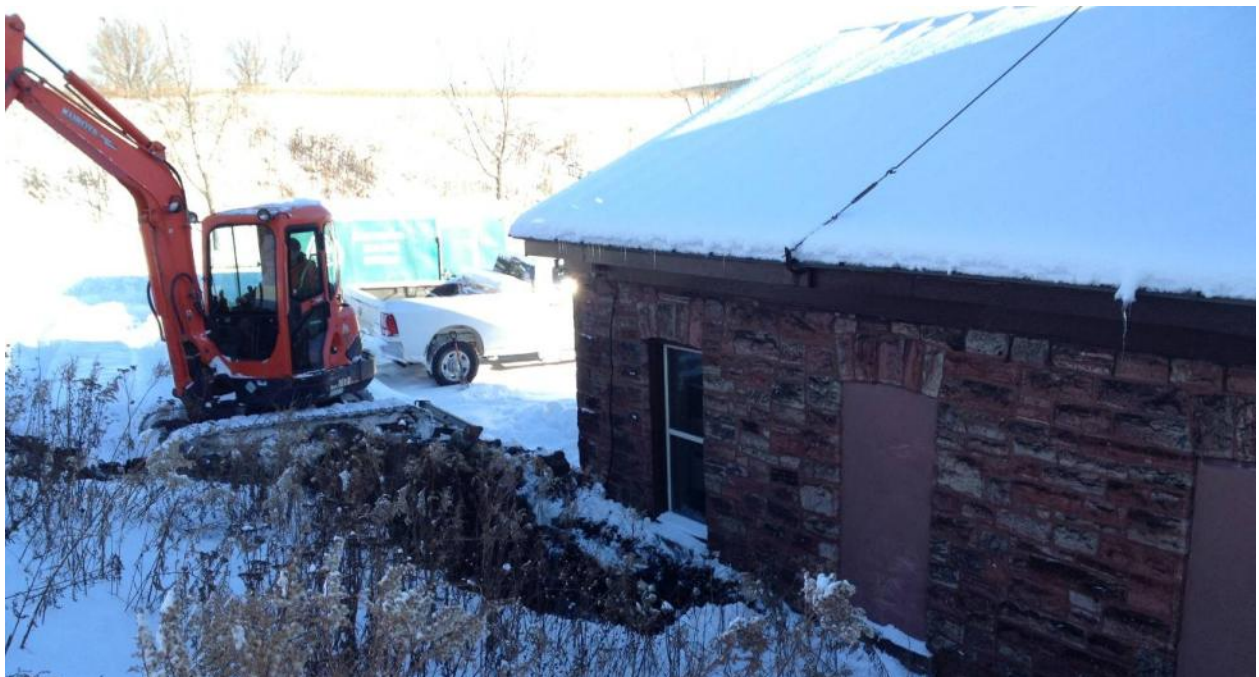
Photo 2: View of TP13-03 excavated at northwest corner of the building. The northern portion of the building does not appear to be moving, so this test pit was for comparative purposes.

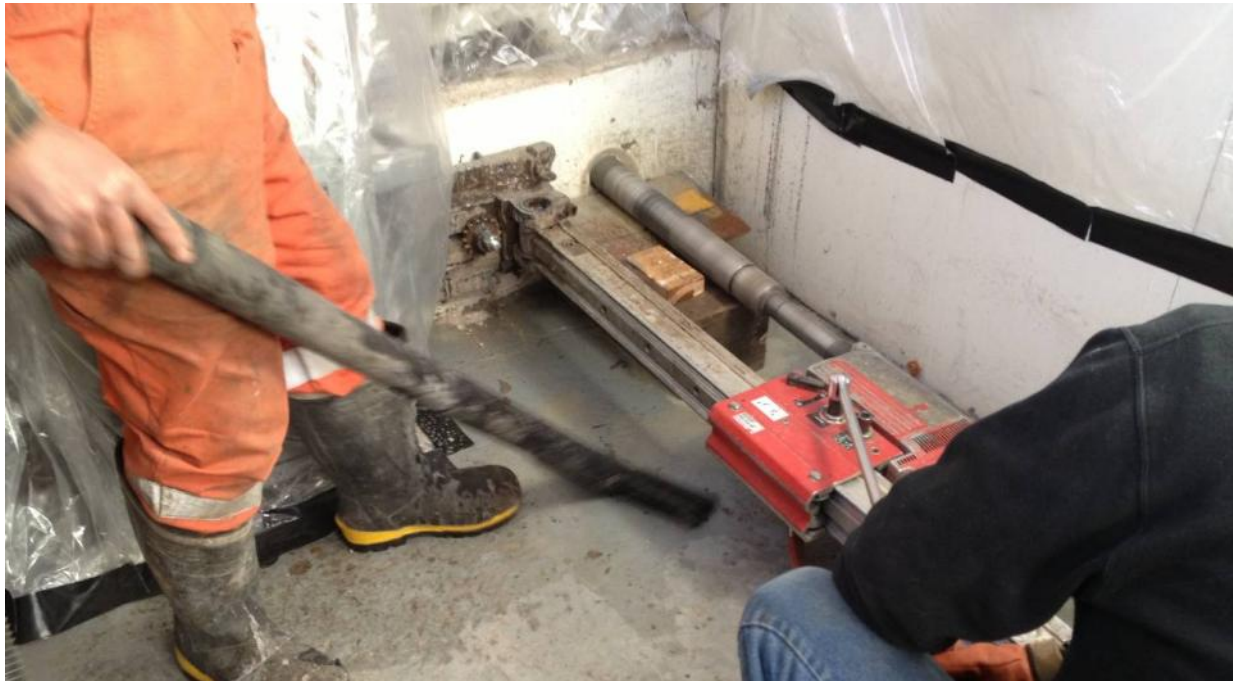
Photo 3: View of CH13-01 advanced through foundation wall.

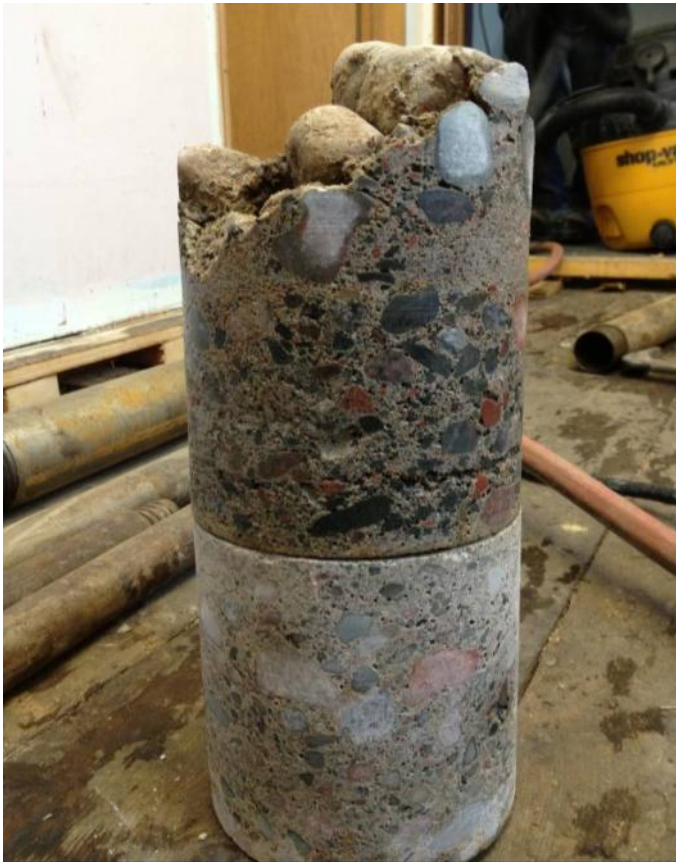
As indicated earlier, the floor slab and the foundation walls were cored. The basement slab concrete was intact and appears to be in good condition. Understandably, it is bonded to the underlying subsoil, which appear to be absent of fine soils, although they may have been washed away by the water used during coring. As can be seen in Photo 4, it is obvious a new slab has been poured over the original slab. The original slab (the top of the core in the photo) has coarser aggregate and indicative of older standards in concrete manufacturing. The upper, lighter in colour concrete has smaller, more uniform aggregate, typical of good quality concrete.

Photo 4: Core of floor slab.

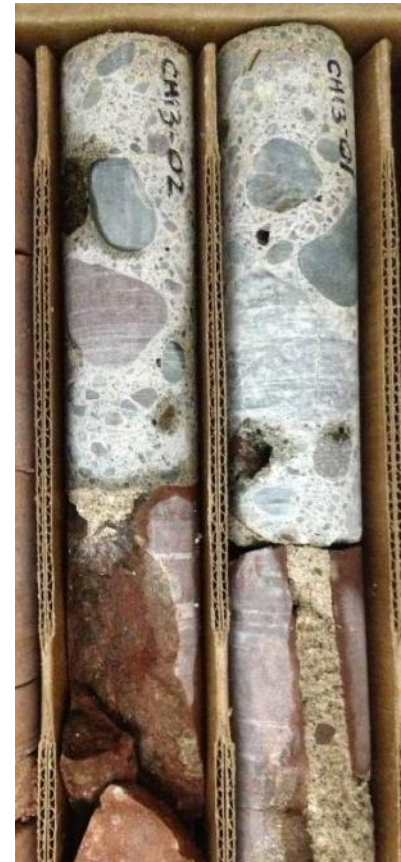
Photo 5: Core of interior concrete curb and foundation wall.

The cores taken of the foundation wall indicate the concrete curb inside the building is of good quality, but the large aggregate size would indicate it is of an older vintage. The cobbler foundation wall behind the concrete section is difficult to evaluate, however, it should be noted the mortar appeared to be deteriorated, although that may be in part due to the coring procedure and use of water for drilling.

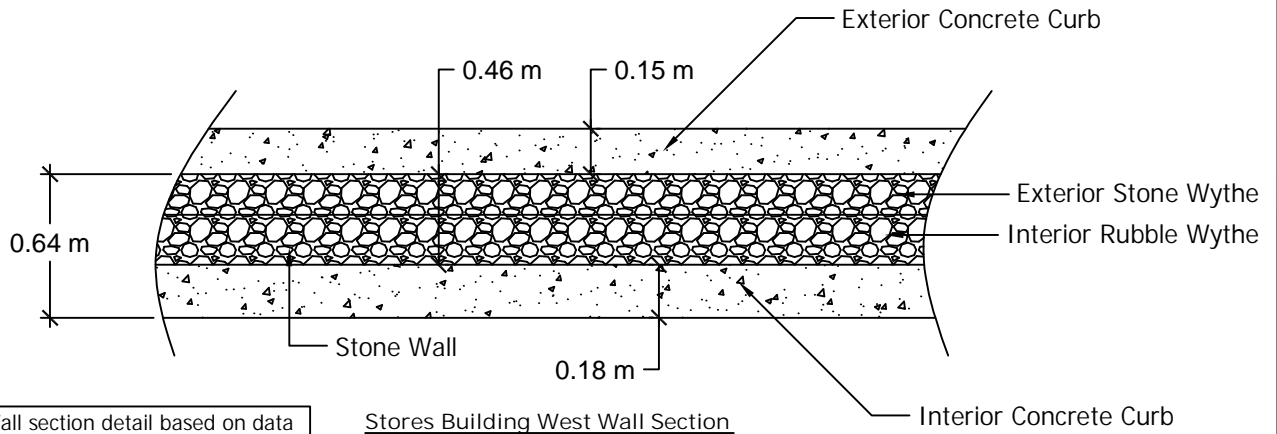
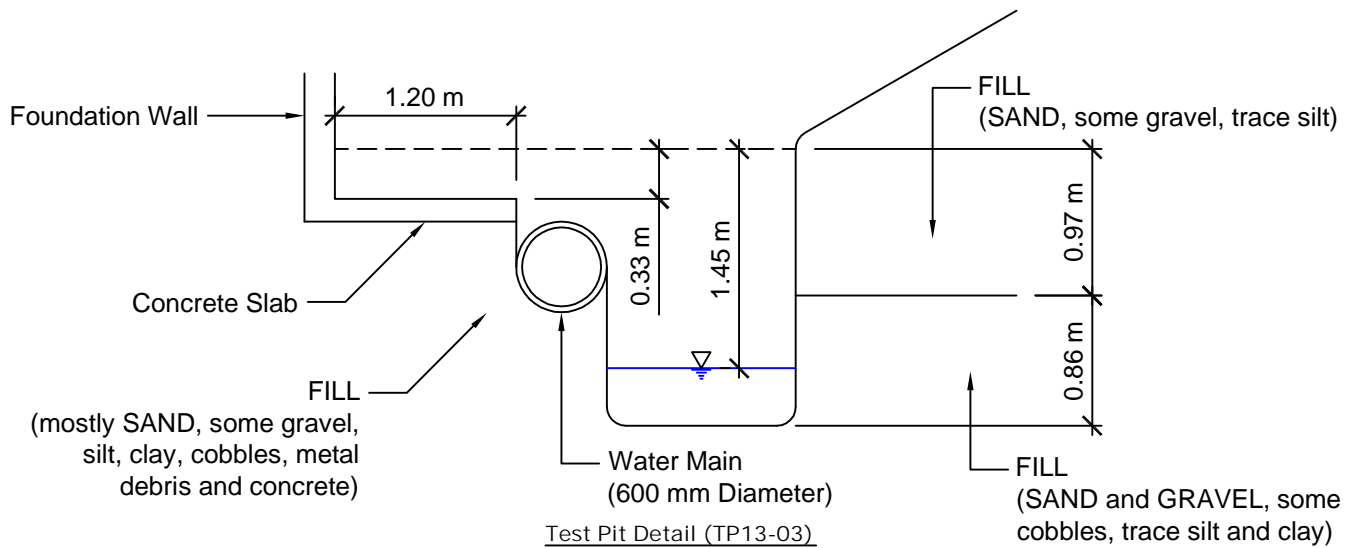
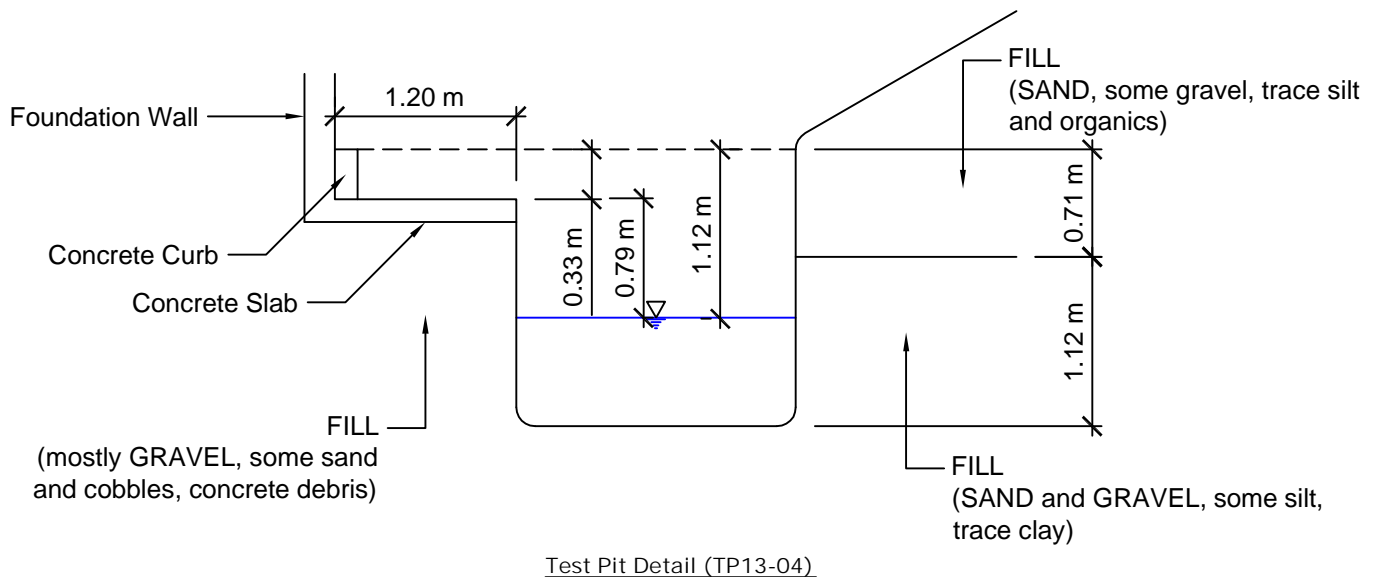
A cross-section of the foundation wall is depicted on Figure 3.

Note: Wall section detail based on data from coreholes CH13-01 & CH13-02.
