**ASBESTOS-CONTAINING MATERIALS
REASSESSMENT SURVEY 2015
CCGS HENRY LARSEN
ST. JOHN'S, NEWFOUNDLAND LABRADOR**

Prepared for:
Canadian Coast Guard, Atlantic North Region
Department of Fisheries and Oceans
St John's, Newfoundland Labrador
Canada

Prepared by:
Pinchin LeBlanc Environmental Limited

February 4, 2015

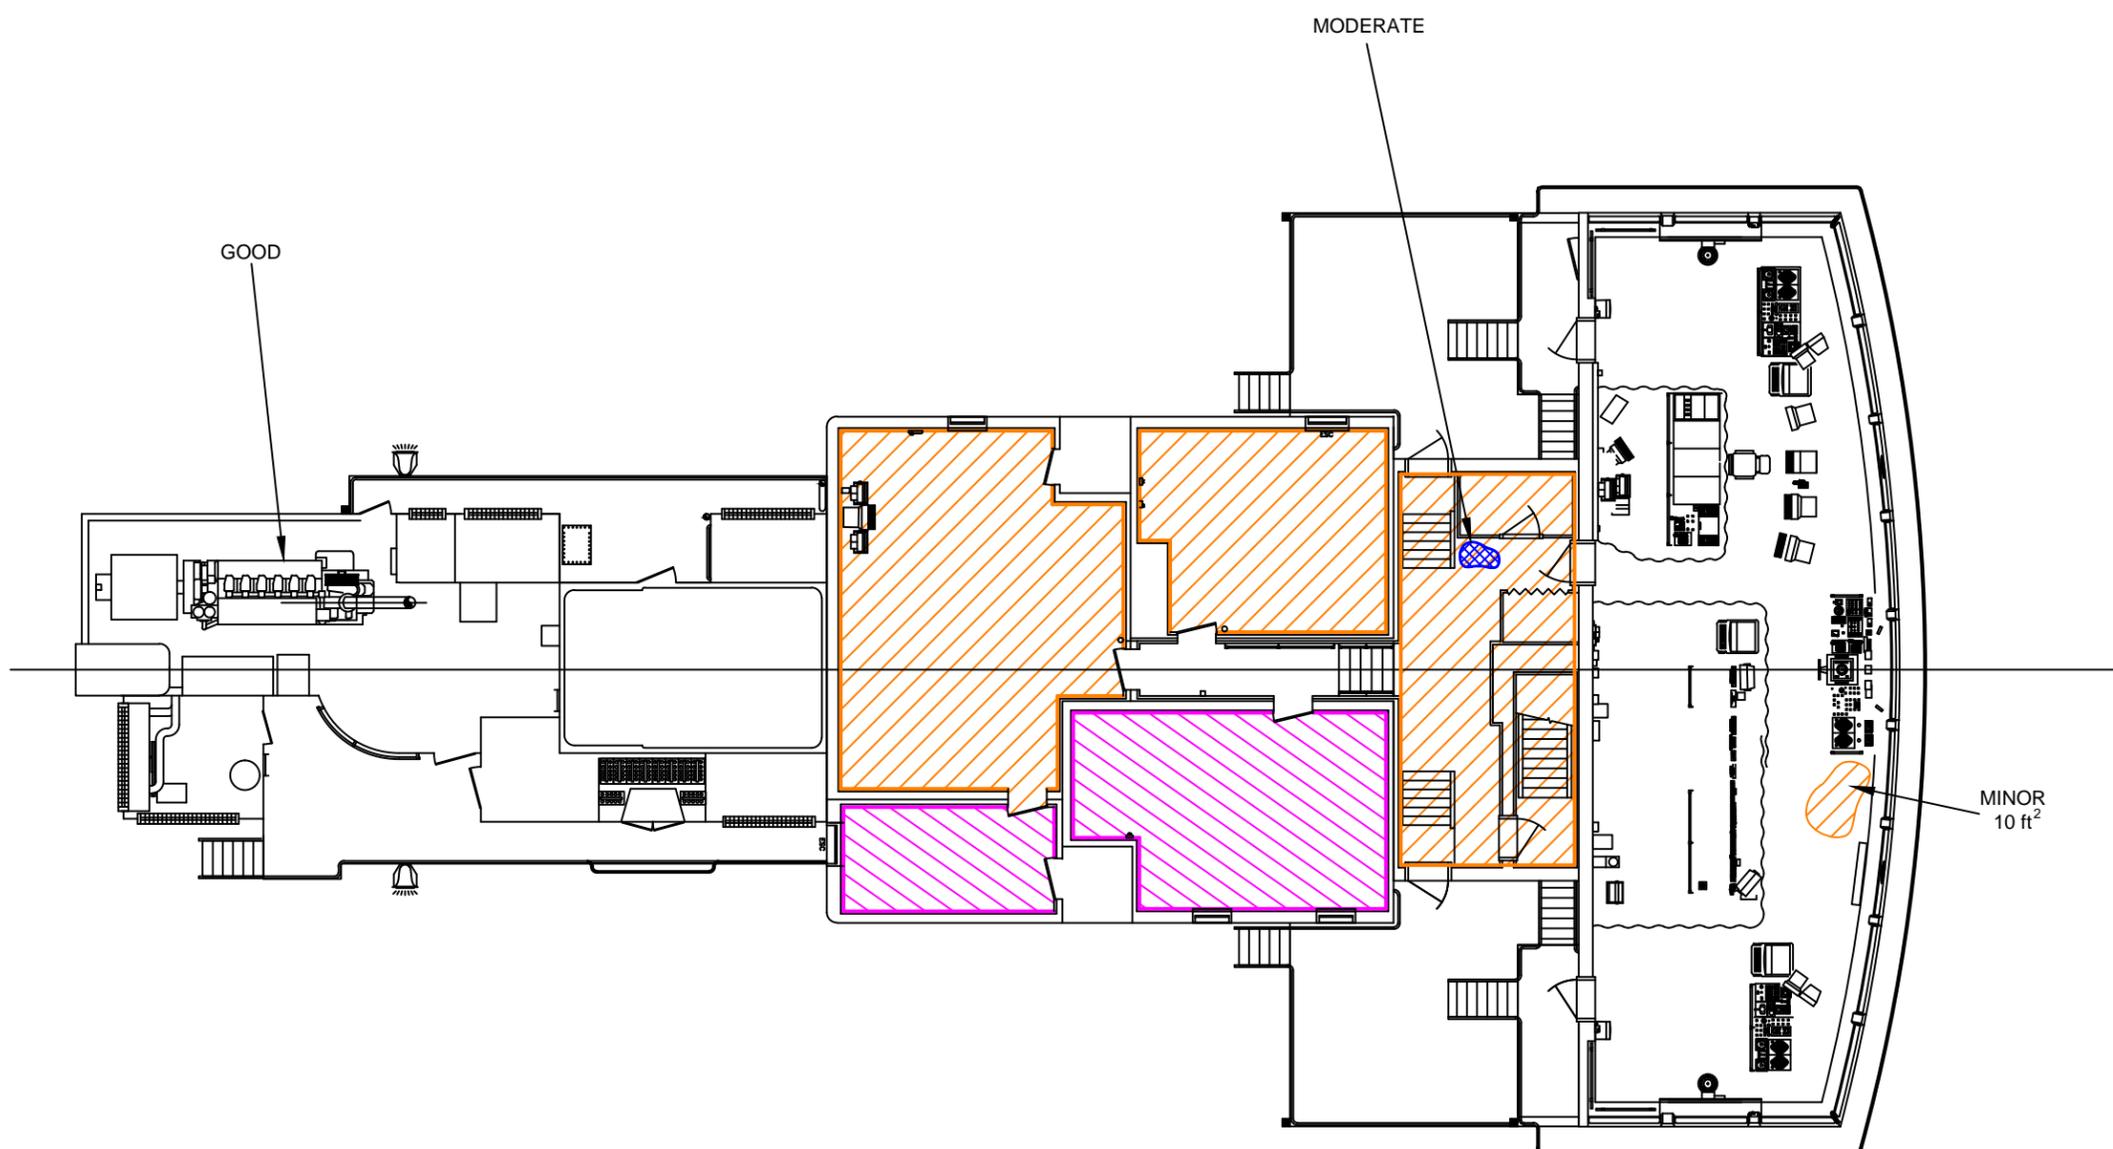
Fall-Out Conditions of Asbestos-Containing Weather Shield CCGS Henry Larsen, October 2013 & January 2015		
Cabin/Compartment and Deck Location	Condition October 2013	Condition January 2015
Navigation bridge Wheelhouse deck	Minor with patches of moderate	Minor on starboard side, good on port side
Lobby outside Navigation bridge including radar transceiver locker Wheelhouse deck	Mostly minor with isolated area moderate; partial delamination over EL102-P106, however noticeable moderate around structural beams	Mostly minor with isolated area moderate; partial delamination over EL102-P106, however noticeable moderate around structural beams
Ice observers room Wheelhouse deck	Good to minor	Good to minor
Electronics equipment room Wheelhouse deck	Good to minor	Good to minor
Special navigation chart room Wheelhouse deck 404	Minor, some pieces along forward bulkhead	Minor to moderate
AG #2 Generator Wheelhouse	Good	Good

1. Following Type II (moderate risk) asbestos abatement procedures clean areas identified in moderate and excessive condition as outlined by this reassessment. Please refer to the fallout condition table and updated condition drawings for specific locations referenced in this report.
2. Repair areas of perforated sheathing (expanded metal) on bulkheads and deck heads identified in excessive (poor) condition. Repairs to the metal may require the utilization of Type I (low risk) asbestos abatement procedures where metal may have damaged the underlying spray and Weather Shield.

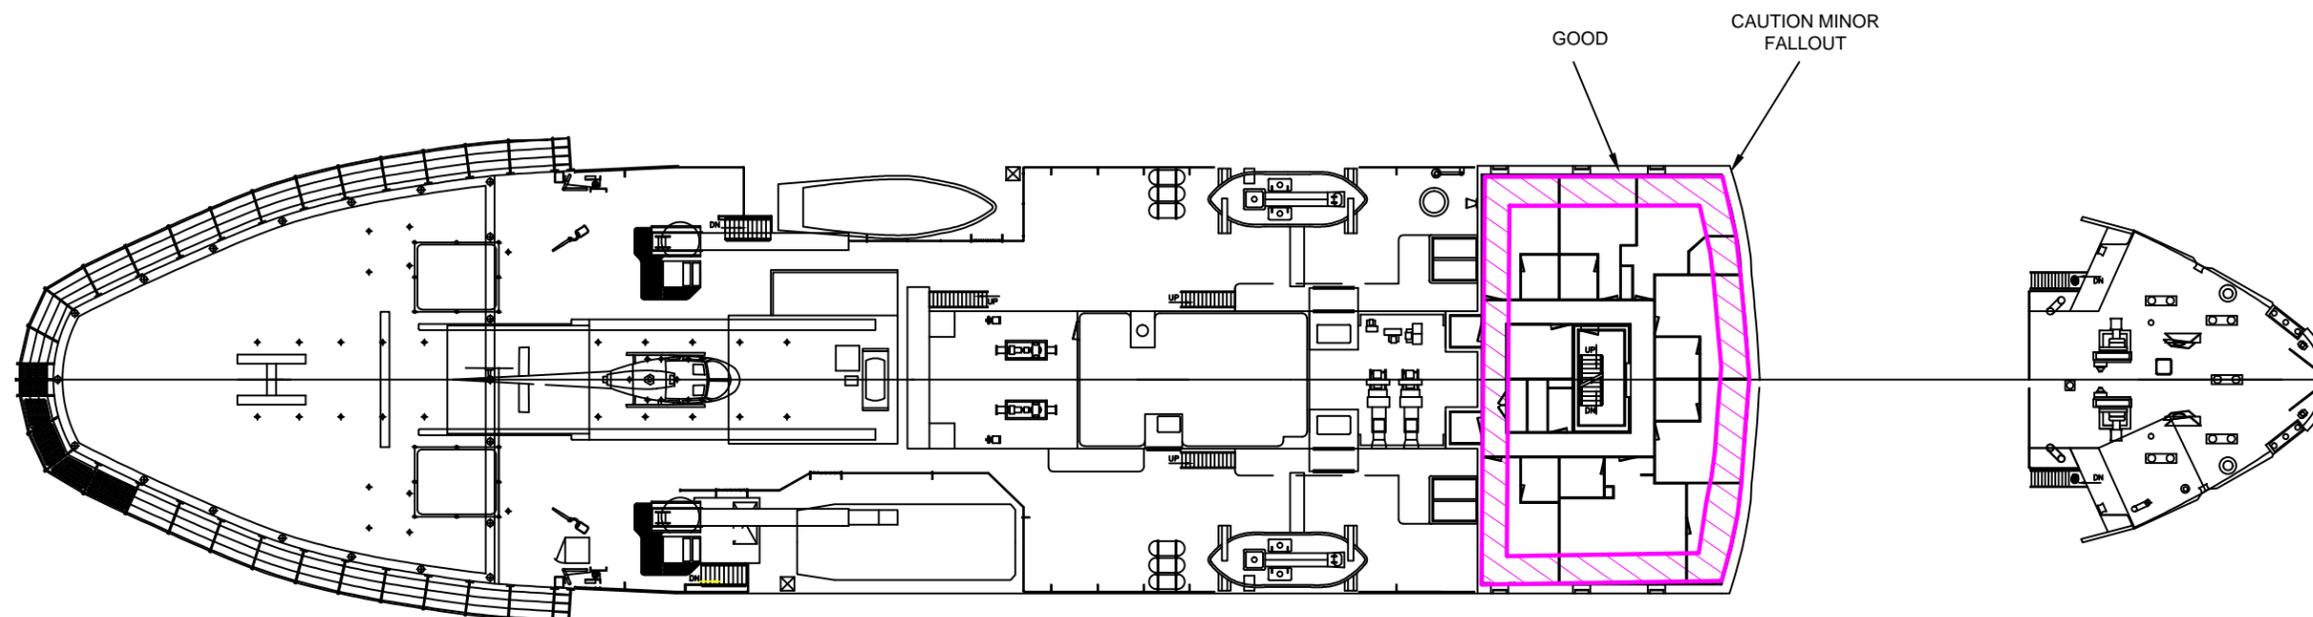
ASBESTOS CONDITIONS
FLIGHT AND BOAT DECK

Fall-Out Conditions of Asbestos-Containing Weather Shield CCGS Henry Larsen, October 2013 & January 2015		
Cabin/Compartment and Deck Location	Condition October 2013	Condition January 2015
Fan room AHU #1 Officers deck	Needs repair over duct	Needs repair over starboard side of duct
Static inverter room Officers deck	Good	Cut-outs around heater should be repaired
Starboard FM 200 Room Officers deck	Good	Caution: overspray on cable tray
Deck locker Officers deck	Repaired - Good	Good
Hallway near commanding officer cabin 389 Officers deck	Good with isolated areas of minor debris	Good with isolated areas of minor debris
Emergency Generator Room	Good	Good
Senior scientist cabin 383 Officers deck	Minor with pieces of fallout scattered throughout	Minor with pieces of fallout scattered throughout
First engineer cabin 339 Boat and flight deck	Good	Good
Helicopter engineer cabin 341 Boat and flight deck	Good	Good

Helicopter pilot cabin 343 Boat and flight deck	Good	Good
Official cabin 352 Boat and flight deck	Good	Good
Official cabin 350 Boat and flight deck	Good	Good
Chief engineer 347 Boat and flight deck	Good	Good
Second engineer 345 Boat and flight deck	Good	Good
Fan room AHU # 2 and # 4 Boat deck	Good	Repair metal lower Bulkhead near feed P507-13
AC chiller room Boat and flight deck	Good	Repair over light aft of chiller
Helicopter hanger Boat and flight deck	Fibreglass	Fibreglass
Paint storage on boat deck	Damage to expanded metal bottom of door	Damage to expanded metal bottom of door and around light
Engine casing at deck elevation Boat and flight deck	Good	Good
Officers lounge Upper deck	Minor to Moderate – with some large pieces	Good

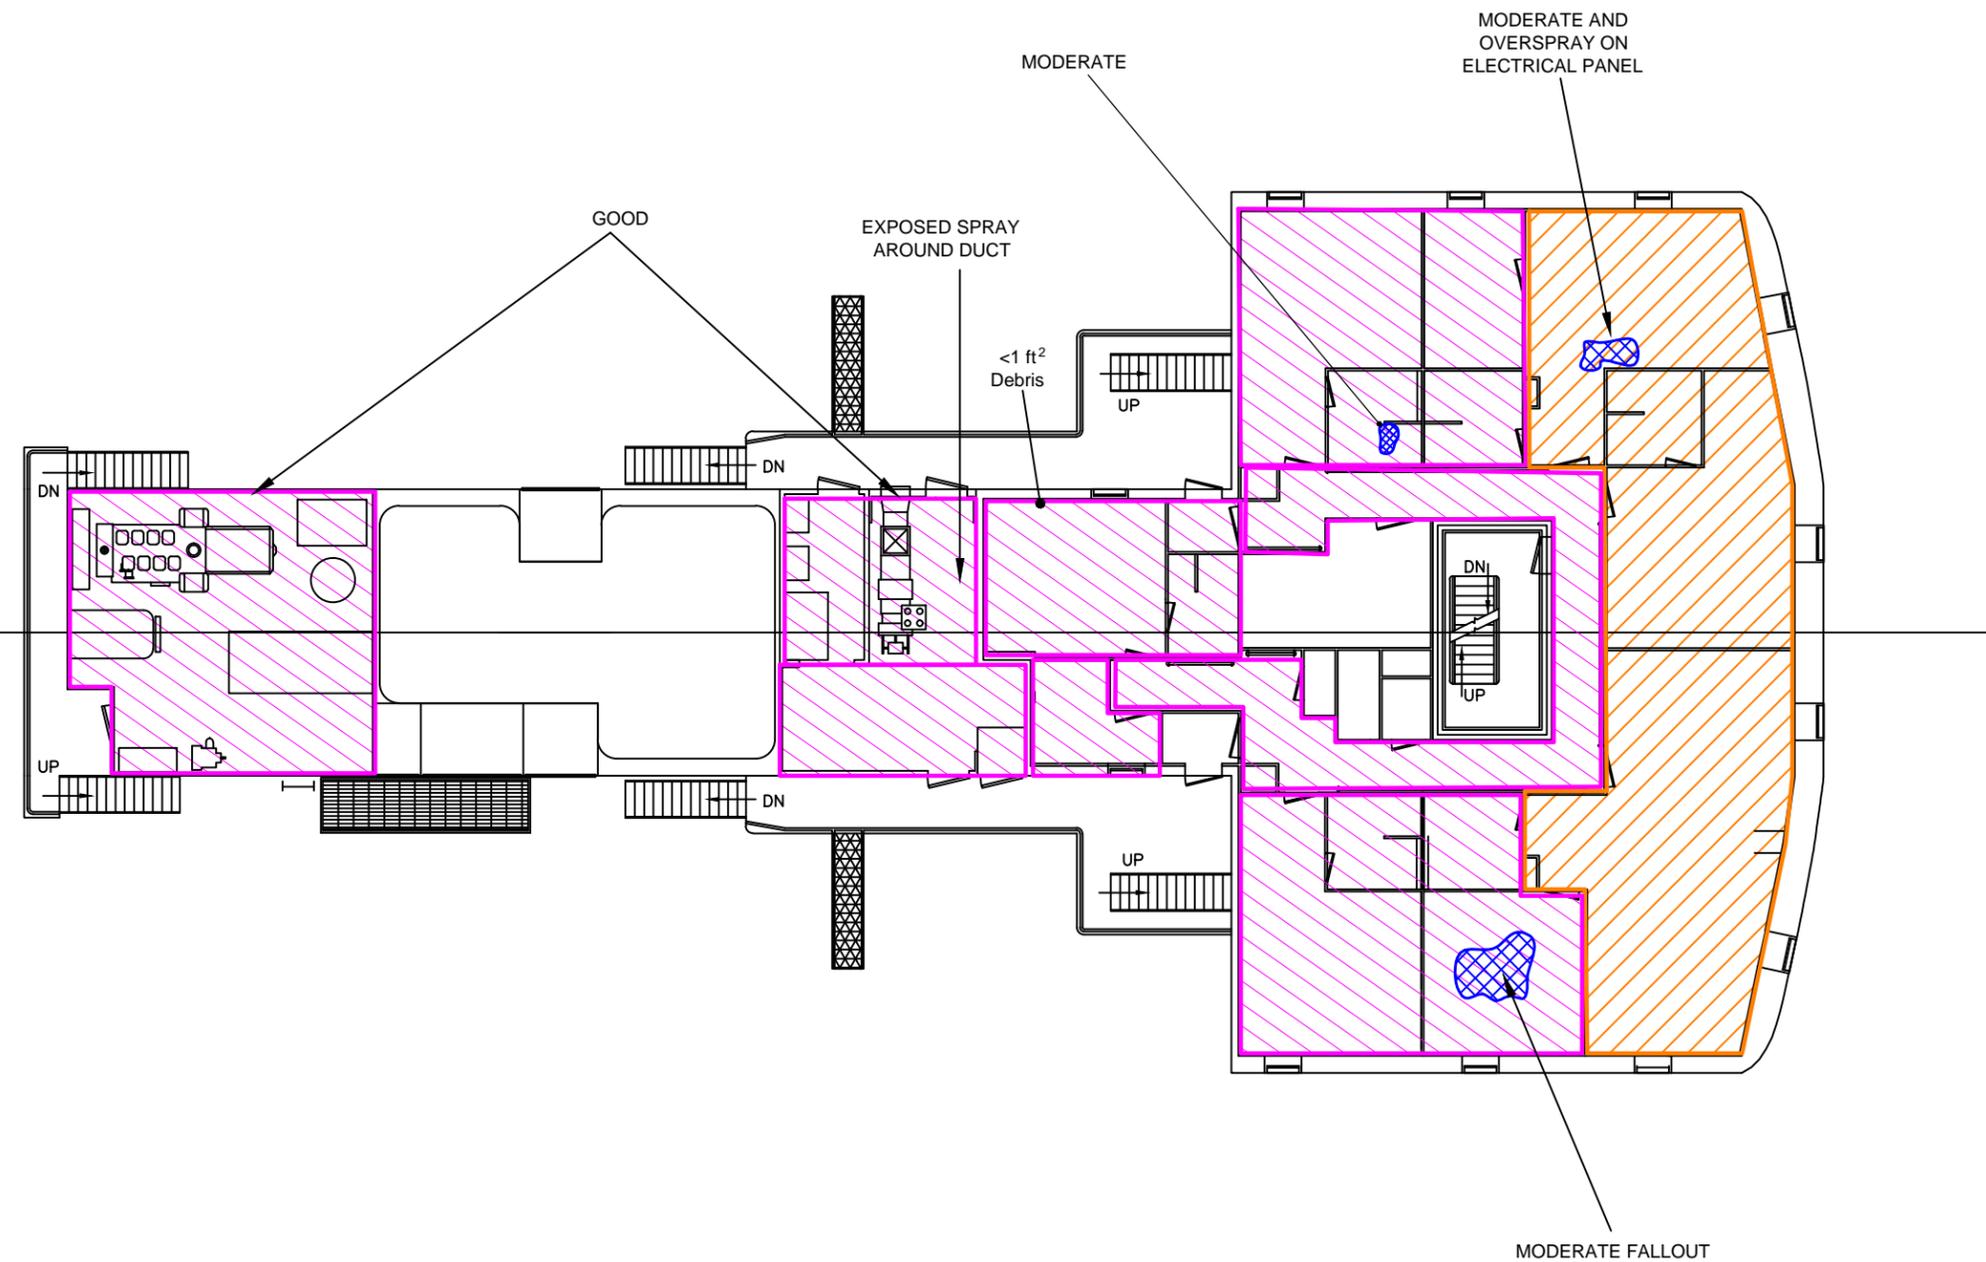
ASBESTOS CONDITIONS
OFFICERS DECK

ICS room Wheelhouse deck	Good	Minor
Void utility space under wheelhouse Raised deck	Removed 2008	Removed 2008
Commanding officers cabin 389 Officers deck	Minor with several small pieces of fallout on light, over spray on cable trays and fixtures	Minor with several small pieces of fallout on light, over spray on cable trays and fixtures, fallout over bedroom
Chief officers cabin 381 Officers deck	Minor with debris over foyer area, over spray on cable tray	Minor with debris over foyer area, over spray on cable tray, sporadic chunks of fallout
First officers cabin 378 Officers deck	Minor small debris over washroom.	Moderate
Second officers cabin 385 Officers deck	Good – minor with debris along aft BH	Good – minor with debris along aft BH – large chunk over clock area
Deck office 373 Officers deck	Minor	Minor – no spray
Laundry 365 Officers deck	Debris on light and ductwork	Good
Supernumerary officer cabin 367 Officers deck	Minor - <1ft ² debris	Minor - <1ft ² debris

Alleyway past linen locker 376 Officers Deck	Cable tray has excessive on wiring	Cable tray has excessive on wiring

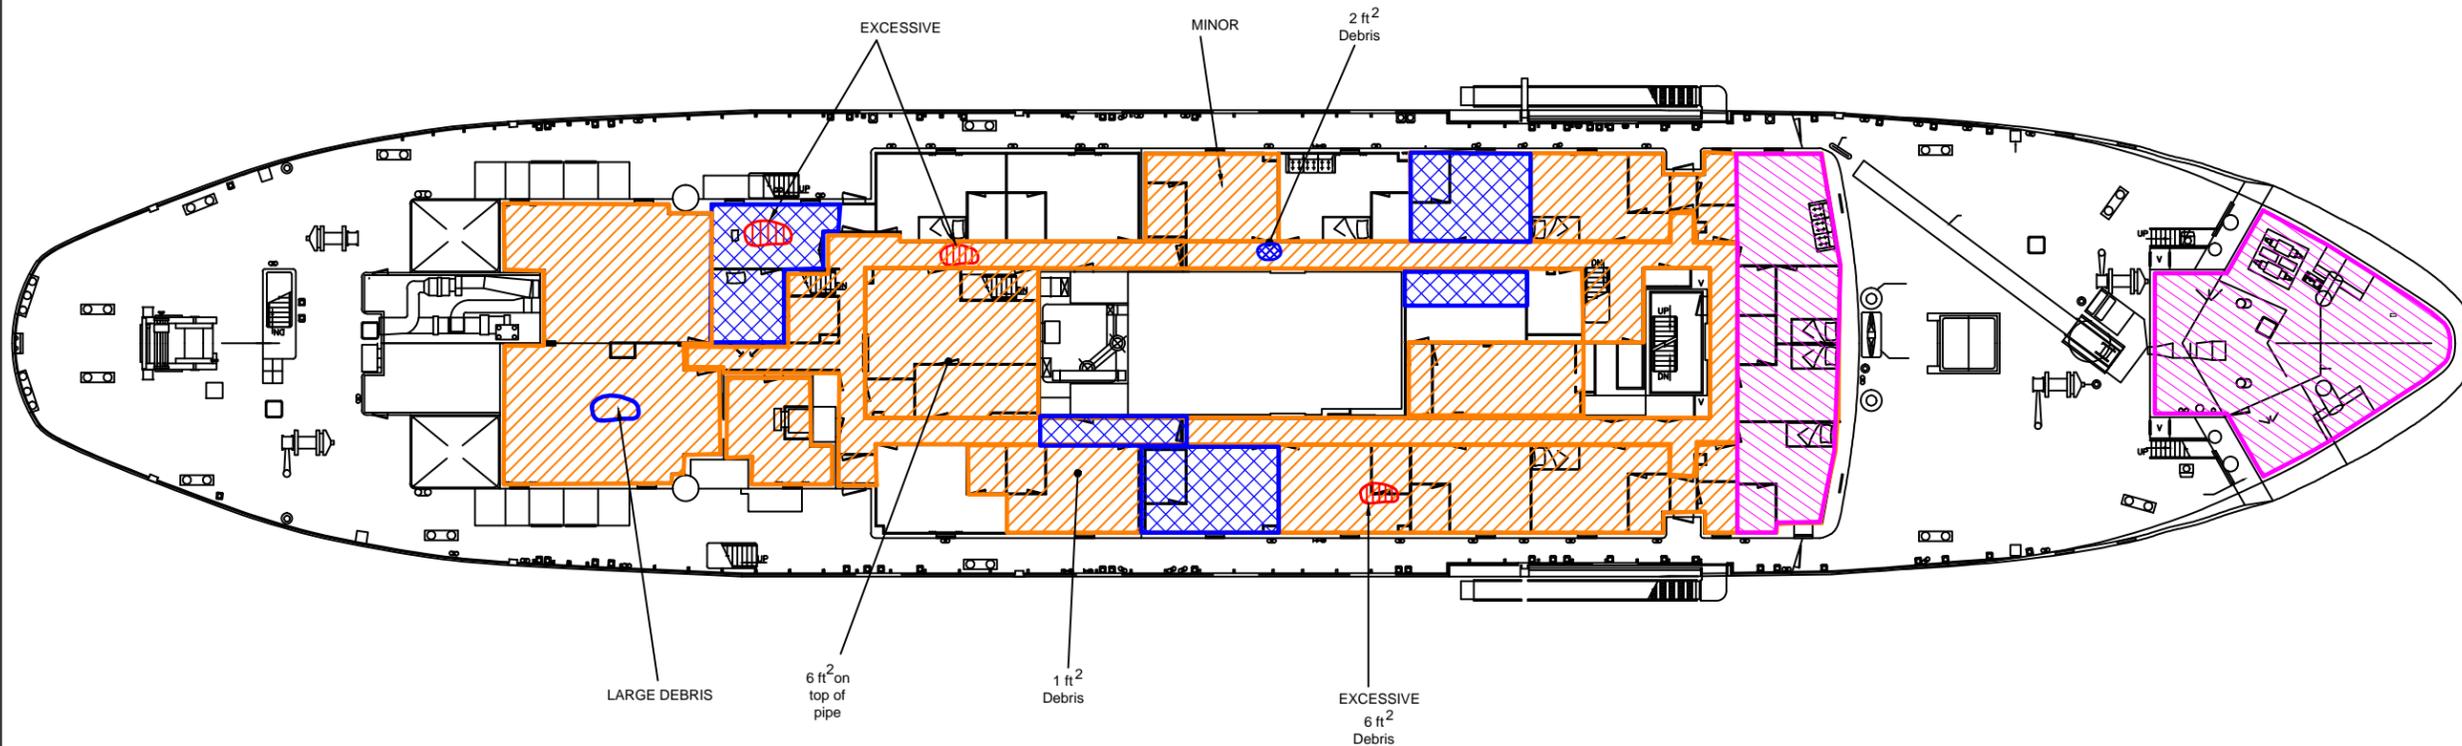
ASBESTOS CONDITIONS
UPPER DECK

Fall-Out Conditions of Asbestos-Containing Weather Shield CCGS Henry Larsen, October 2013 & January 2015		
Cabin/Compartment and Deck Location	Condition October 2013	Condition January 2015
Senior engineers cabin 274 Upper deck	Minor	Good
Spare cabin 293 Upper deck	Minor on bulkhead	Good
Electronics officer cabin 291 Upper deck	Minor along bulkhead	Good
Designated smoke room 270 Upper deck	Good	Good
Hallway from Cabin 270 past 274 to Cabin 287 Upper Deck	Minor some moderate	Minor some moderate, potential delineation
Logistics officers cabin 287 Upper deck	Minor	Minor
Boatswain's cabin 285 Upper deck	Minor to moderate	Minor
Cadets cabin 283 Upper deck	Minor	Minor
Cadets cabin 281 Upper deck	Minor; moderate over washroom	Moderate
Cadets cabin 279 Upper deck	Minor with large pieces	Minor with large pieces
Cadets cabin 277 Upper deck	Minor on perimeter, rest removed	Minor on perimeter, rest removed
Logistics officers office Upper deck	Moderate	Minor

Ships office Upper deck	Minor where accessed, overspray on ductwork and electrical	Where accessed, there is overspray on ductwork and electrical with fallout located on top of pipe
Alleyway from smoke room to cabin 266 Upper deck	Good	Minor some moderate
Engineers office Upper deck	Debris port side moderate	Good
Engineers change room Upper deck	Minor along Starboard Bulkhead	Minor along Starboard Bulkhead and debris on top of pipe
Alleyway port side of ships office	Excessive to moderate, near electrical officer's cabin Minor – all other	Excessive to moderate, near ships office
Supernumerary's cabin 268 Upper deck	Minor	Moderate
First electrical officer 266 Upper deck	Removed	Removed

Fall-Out Conditions of Asbestos-Containing Weather Shield CCGS Henry Larsen, October 2013 & January 2015		
Cabin/Compartment and Deck Location	Condition October 2013	Condition January 2015
Second electrical officer 264 Upper deck	Minor	Minor
Ice service specialist cabin 262 Upper deck	Removed	Removed
Medical officer cabin 260 Upper deck	Removed	Removed
Dispensary 228 and Ward 229 Upper deck	Moderate to excessive	Minor
Officers pantry 231 Upper deck	Minor	Minor
Officers dining room Upper deck	Moderate some large debris	Minor
Hallway outside cabin 244 Upper deck	Minor to moderate	Minor to moderate
Hallway outside cabin 279 Upper deck	Minor	Moderate
Hallway outside cabin 283 Upper deck	Moderate	Minor to moderate
Hallway outside cabin 287 Upper deck	Minor	Minor to moderate
Fan room #222 Upper deck	Good overall. Perforated metal along deck is damaged throughout	Good overall. Perforated metal along deck is damaged throughout

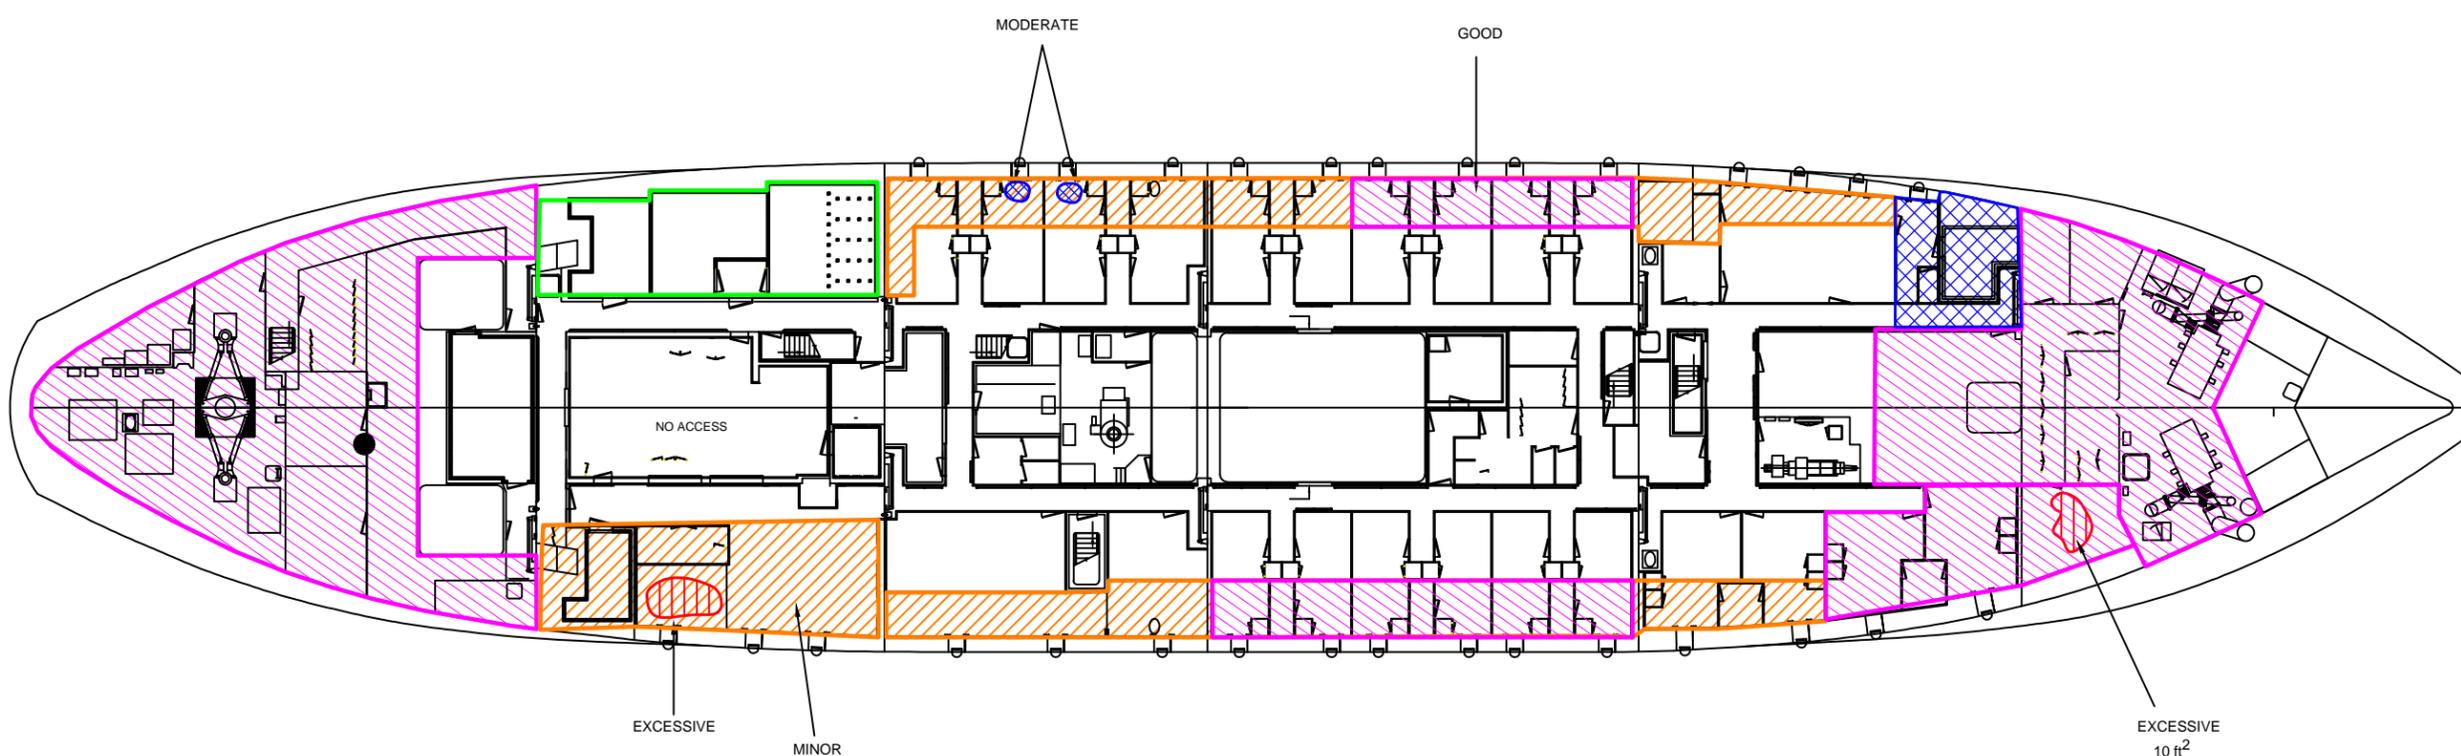
ASBESTOS CONDITIONS
MAIN DECK

Salvage/diving #221 Upper deck	Repaired Good	Good
Steering gear compartment and stores Main deck	Good	Good – suspect gasket material storage
Main Deck Cargo	Good	Good
Crew change room and adjacent stairwell Main deck	Good	Good
Refrigerated cargo room Main deck	No access above deck head	No access above deck head
Fruit and vegetable room Main deck	No access above deck head	No access above deck head
Cool dairy room Main deck	No access above deck head	No access above deck head
Cold room Main deck	No access above deck head	No access above deck head
Galley Main deck	Poor access during survey -Drawings indicate no spray present	Poor access during survey -Drawings indicate no spray present

Fall-Out Conditions of Asbestos-Containing Weather Shield CCGS Henry Larsen, October 2013 & January 2015		
Cabin/Compartment and Deck Location	Condition October 2013	Condition January 2015
Crews mess Main deck	Inboard side – minor Outboard – excessive aft of drink cooler	Inboard side – minor Outboard – excessive forward of drink cooler
Crews lounge 117 Main deck	Minor to moderate (isolated areas) especially along bulk head – Starboard side	Minor
Po's lounge 134 Main deck	Minor – several single chunks	Minor – several single chunks
Chief cook cabin 130 and second cook cabin 131 Main deck	Minor to little moderate on 131 side	Minor to little moderate on 130 side
Steward cabin 132 and 133 Main deck	Minor with 10 square feet of debris aft of washroom 132	Minor with 10 square feet of debris above washroom
Store keeper 157 and spare 158 Main deck	Good	Good
Leading seaman cabins 159 and 160 Main deck	Minor, excessive over washroom	Good

Leading seaman cabins 161 and 162 Main deck	Minor - moderate	Minor on piping
Canteen and canteen store Main deck	Good (No spray)	Good (No spray)
Gymnasium Main deck	Minor	Minor
Hallway from bubbler compartment to canteen Main deck	Minor	Minor to moderate
Bubbler compartment including lower compartment Main deck	Good	Good
Laundry Main deck	Access gained – Moderate to excessive still present	Moderate to excessive still present along bulkhead
Central stores Main deck	Good	Good
E/R technician cabins 193, 192, 191 and 190 Main deck	193 – Excessive 192 – Excessive 191 – Minor 190 – Minor – Moderate, over washroom	193 – Good 192 – Minor 191 – Minor 190 – Minor – Moderate, over washroom
Oiler cabins 167 and 168 Main deck	Minor with some moderate over the washroom.	Good
Seamen 165 and 166 Main deck	Minor	Good
Small carpenters work shop Main deck	Good	Good

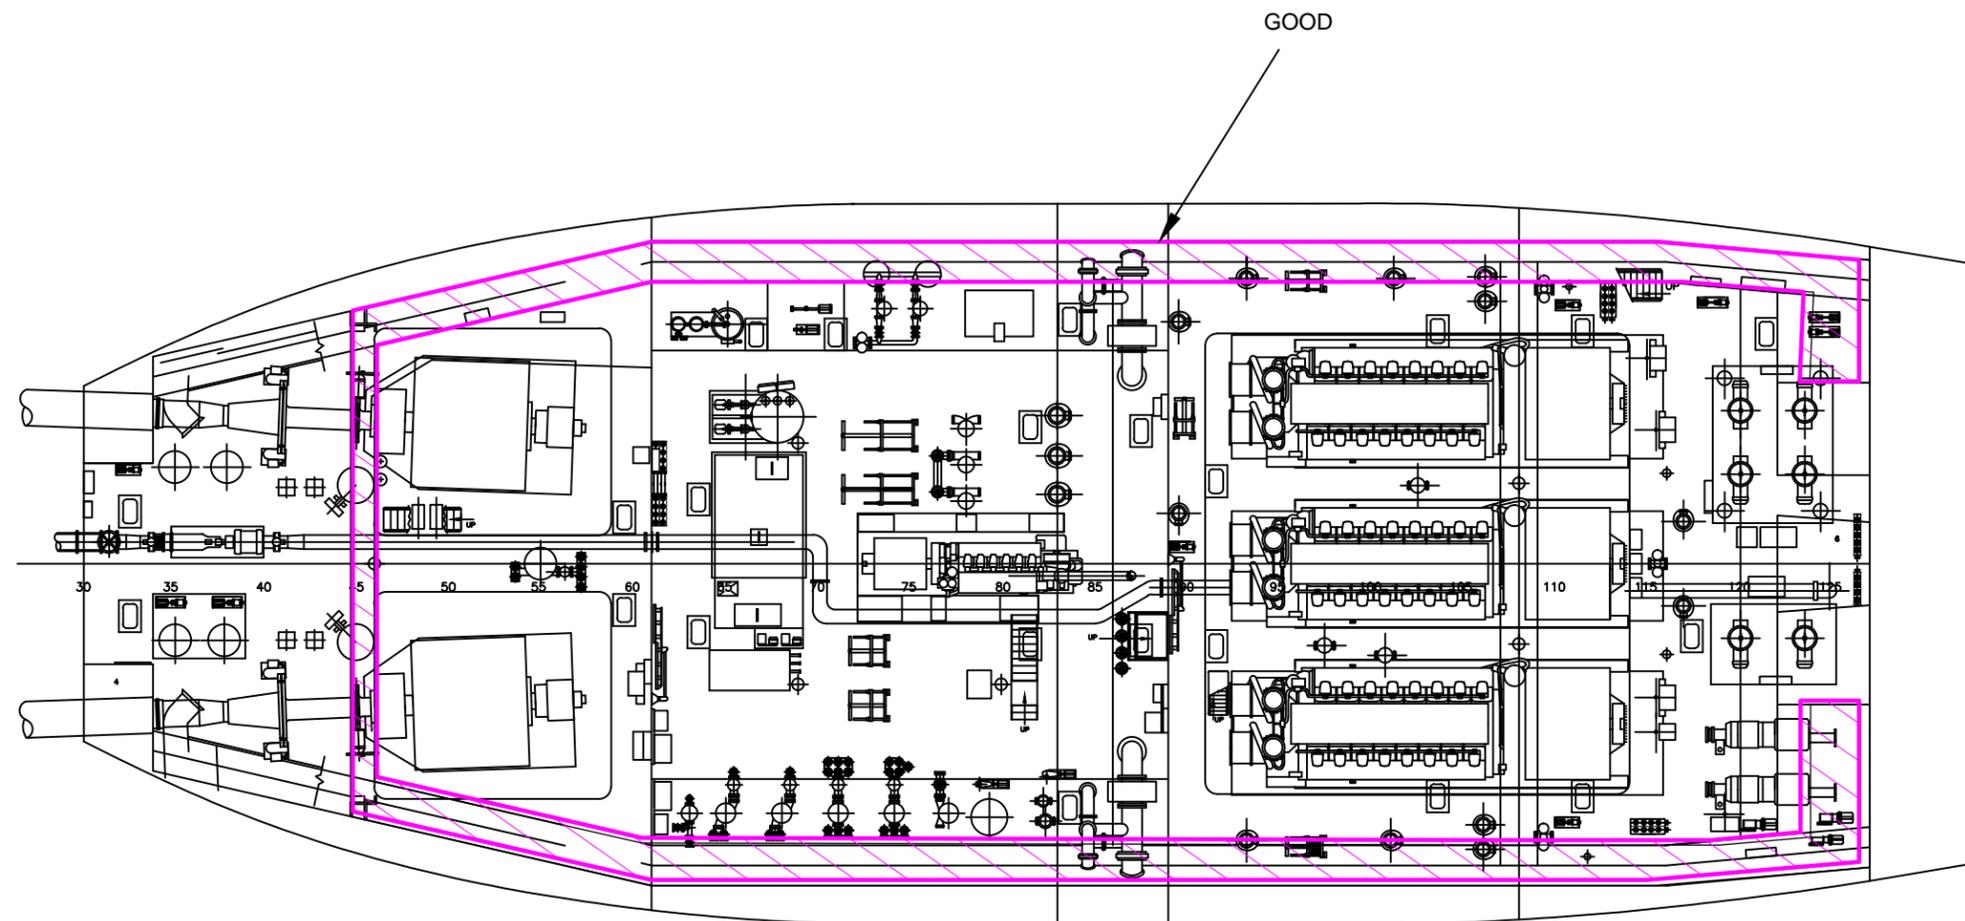
ASBESTOS CONDITIONS
LOWER DECK

Fall-Out Conditions of Asbestos-Containing Weather Shield CCGS Henry Larsen, October 2013 & January 2015		
Cabin/Compartment and Deck Location	Condition October 2013	Condition January 2015
Seamen 163 and 164 Main deck	Minor with excessive over Br 163	Good
Engine casing Main deck	No spray	No spray
Cargo hold Main deck	Good	Good
Beer/bonded stores Main deck	Good - no spray	Good - no spray
Propulsion Motor Room, Port and Starboard Sides, Aft corners near shafts. Tank Top	Good	Good – #1 void tank hatchway edges damaged, need repair
Motor Room Flat Escape Hatch	Good	Good
Auxiliary Room	Good	Good
Fore Peak	Repairs completed with duct tape are not adequate – consider expanded metal or other alternative.	Good -adequate repairs completed
Main Generator Room, Structural Steel at Deckhead elevation, forward of Main Generator #2 and starboard corner forward of Generator #1 over purifiers Tank Top	Good	Some exposed spray forward of #2 generator, but intact

202 – Clothing Storage	Good	Good
Upper propulsion room		Good
Engineers workshop		Good
Electrician workshop		Good – some repair required around door and aft wall
MCR		Good
