CCGS Henry Larsen

Status of Helicopter Hanger

**Submitted
September 2011**

Indal Technologies
Telescopic Aluminum Helicopter Hanger
Model 1256-001, Cont No 110-0009
Ident No 36334, Job No 40-6571
Serial No 001, for CCG Type 1200

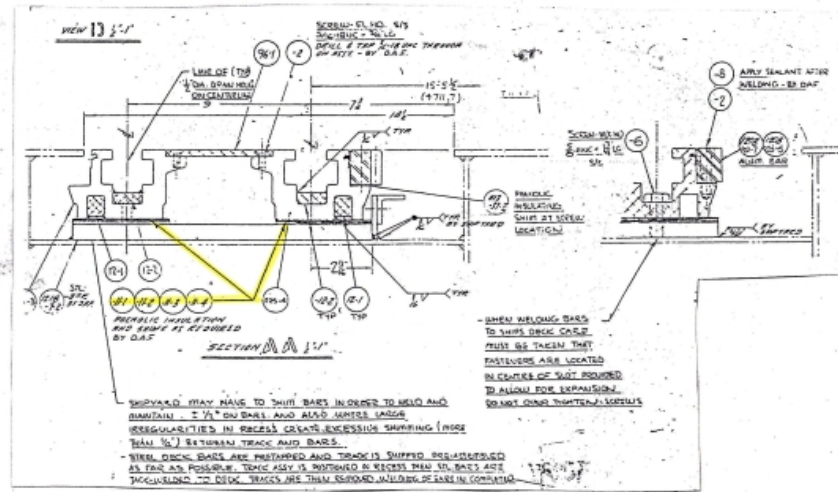
The area in way of where the aluminum track is fastened to the steel decking is showing signs of severe corrosion. Phenolic insulating material (highlighted in yellow above) is fitted to isolate the aluminum from the steel however it is seen to be failing and the aluminum track extrusion is corroding as per the images below.

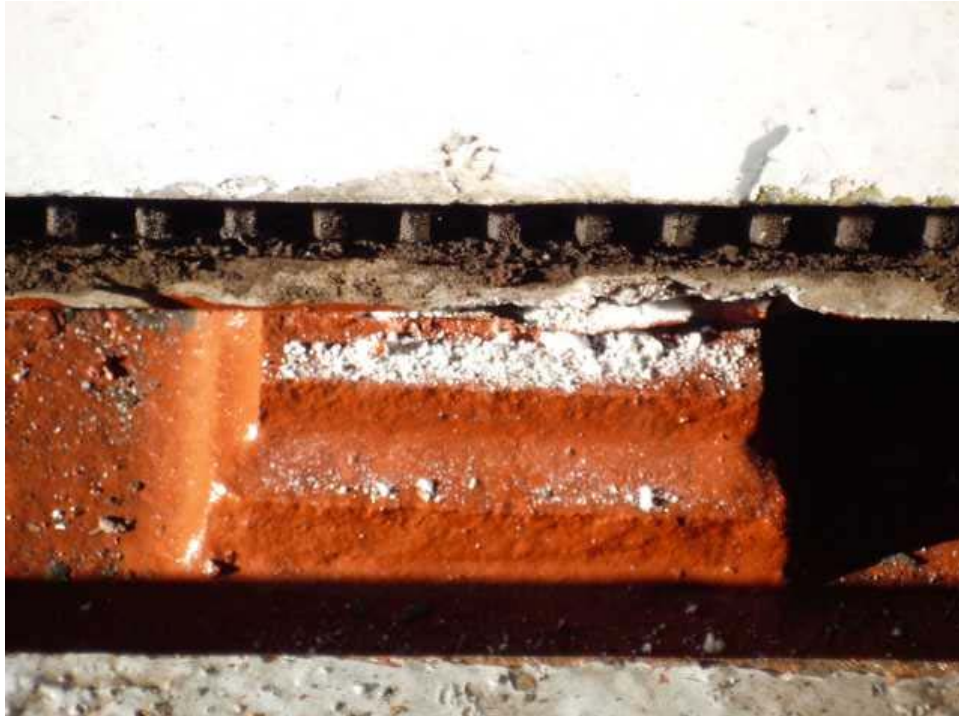
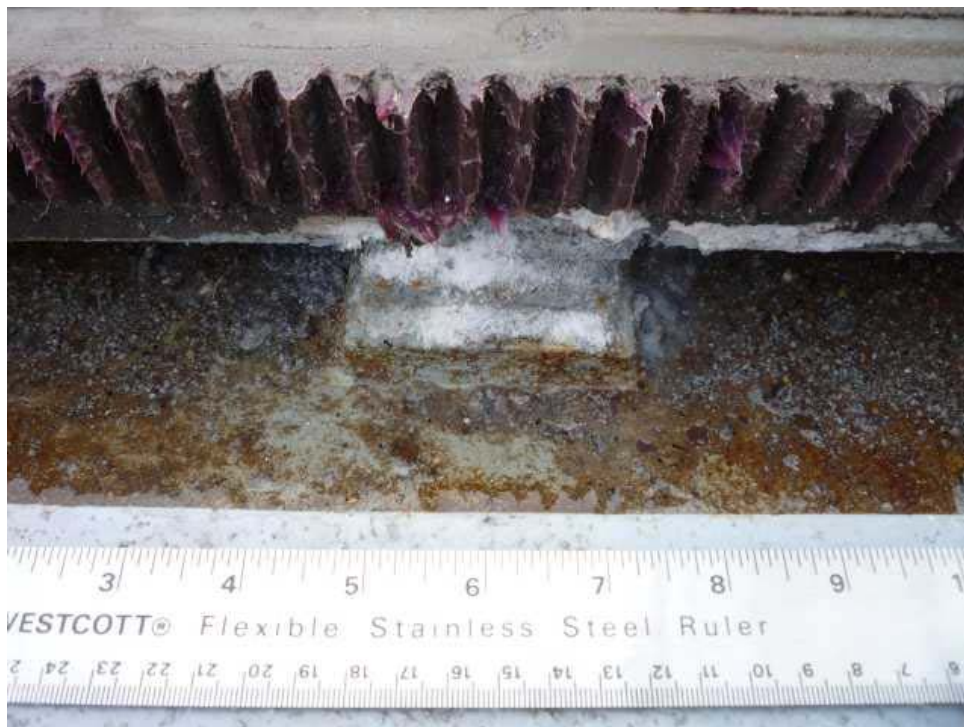
of the hanger to within $\pm 1/16''$. (Manual sect 8-8).'With the track support structure corroding as it is this alignment will soon be adversely affected if it is not already.

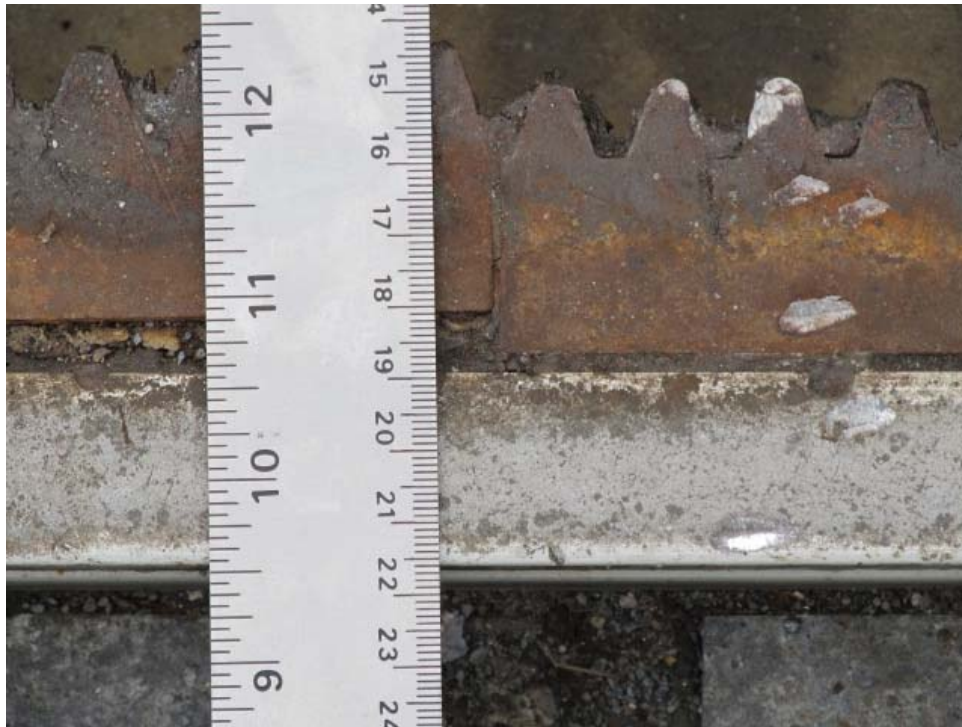
The image above shows a continuous rack gear section pushed out from the aluminum extrusion by corrosion occurring between them.

The corrosion occurring between the aluminum channel extrusions and steel flight deck and between the aluminum channel extrusions and rack gear segments likely accounts for the jumping or erratic traversing of the hanger sections. It also likely accounts for the traversing drive shaft shear pin and pinion gear failures.

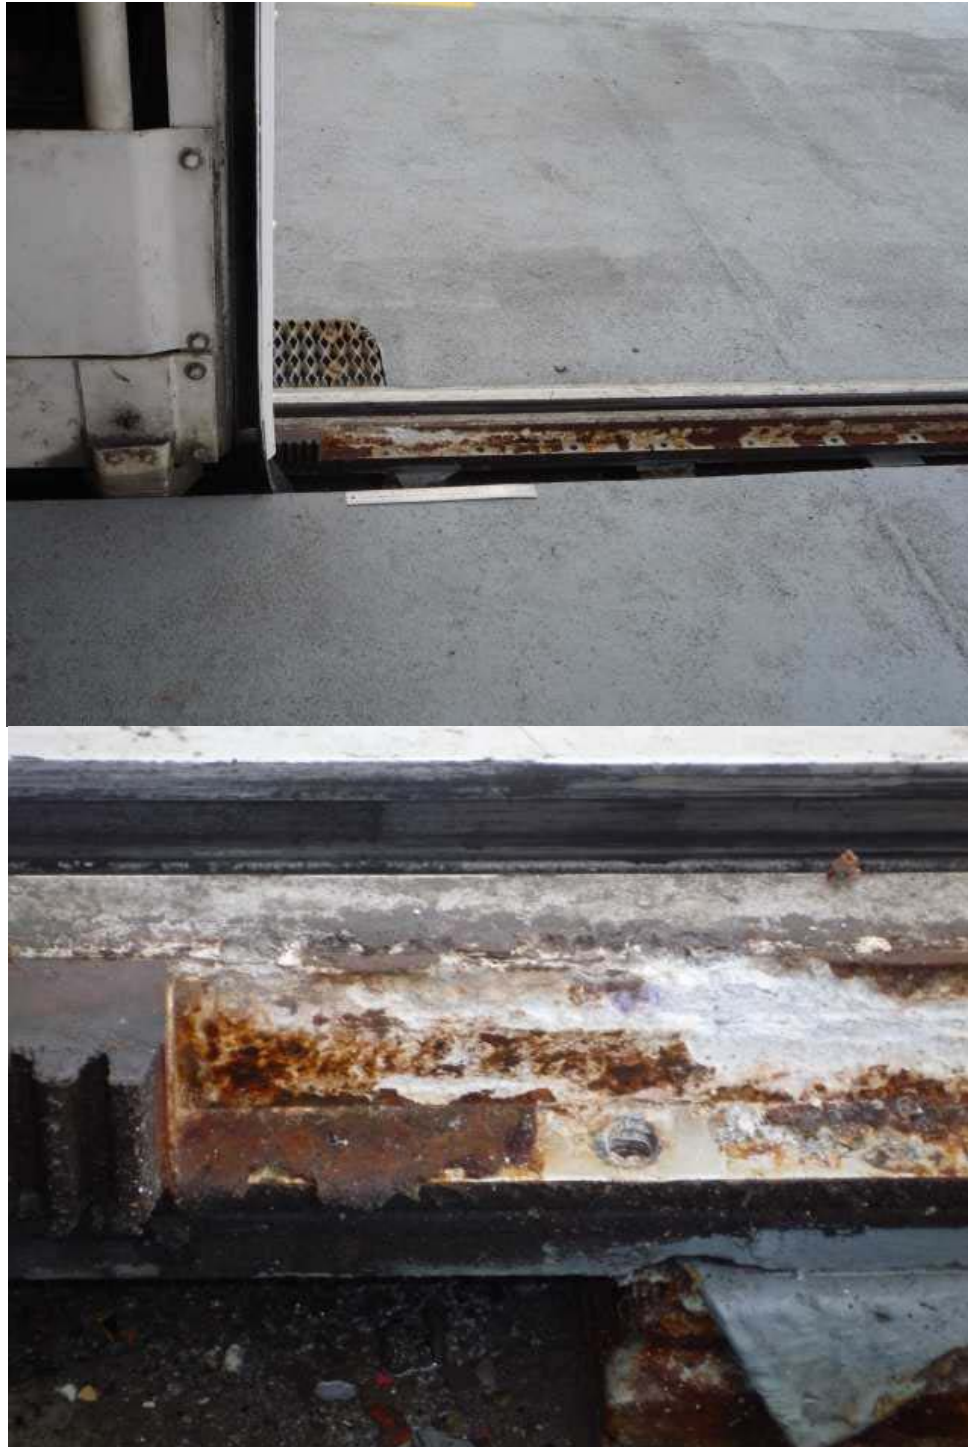
The above 2 images show the corrosion occurring between the continuous rack gear section and aluminum extrusion. This difference in pinion gear to track alignment puts

undue strain on the traversing shaft gear pinion and has resulted in pinion gear drive shaft universal and shear pin failures.

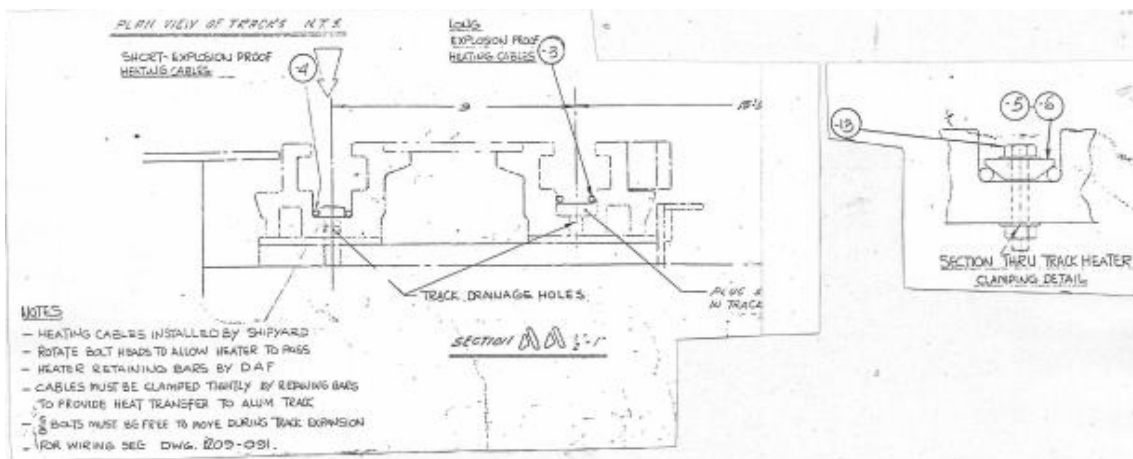
The hanger tracks are fitted with 24VAC heating cables as indicated on items 3 and 4 below..

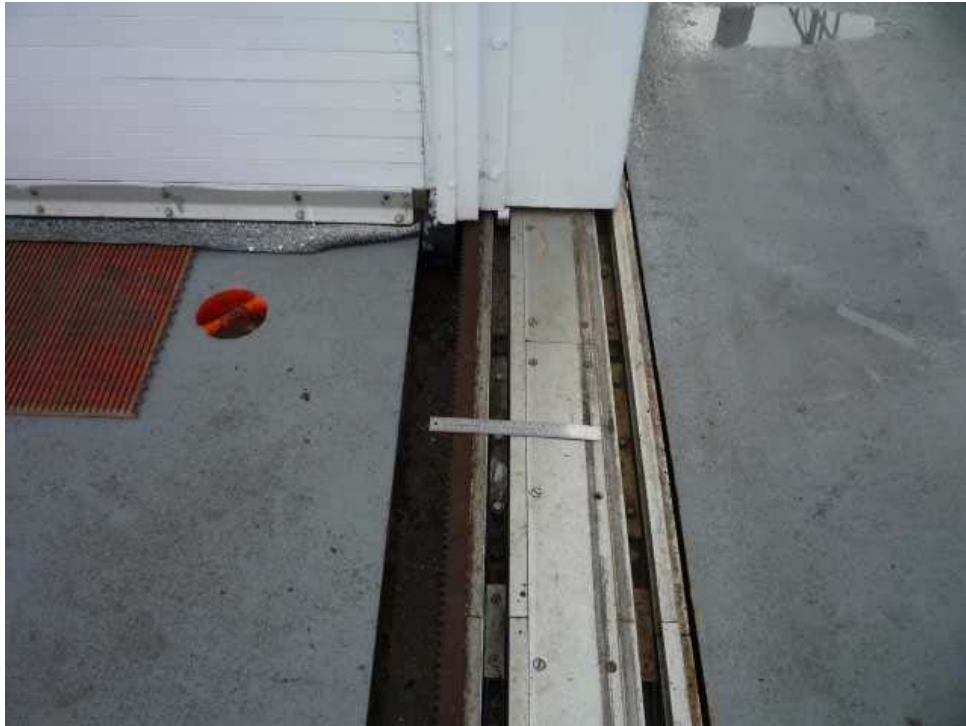
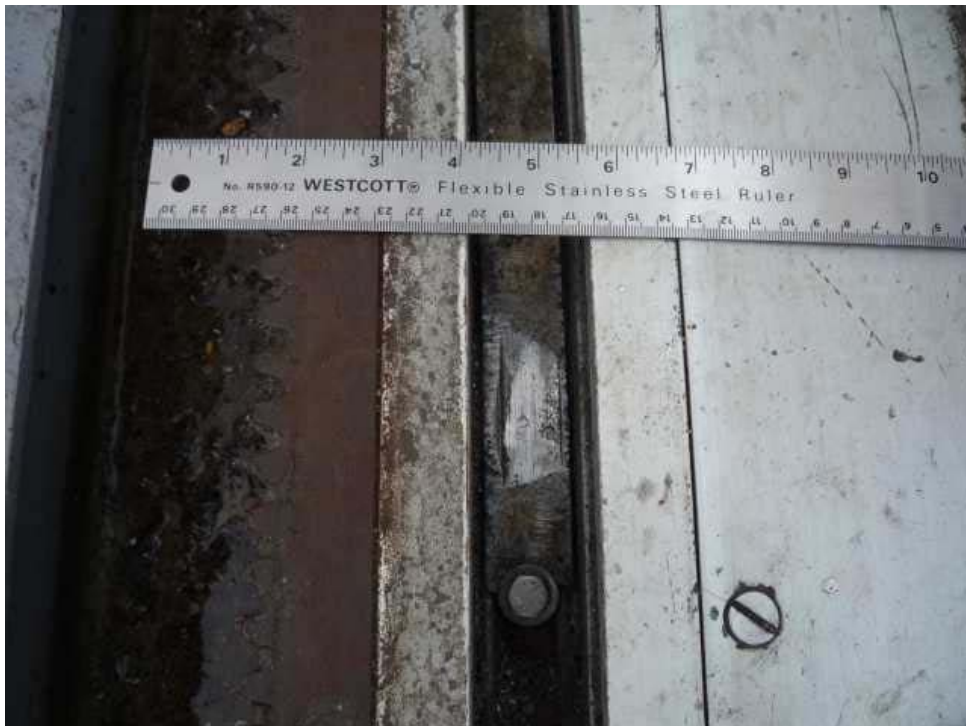
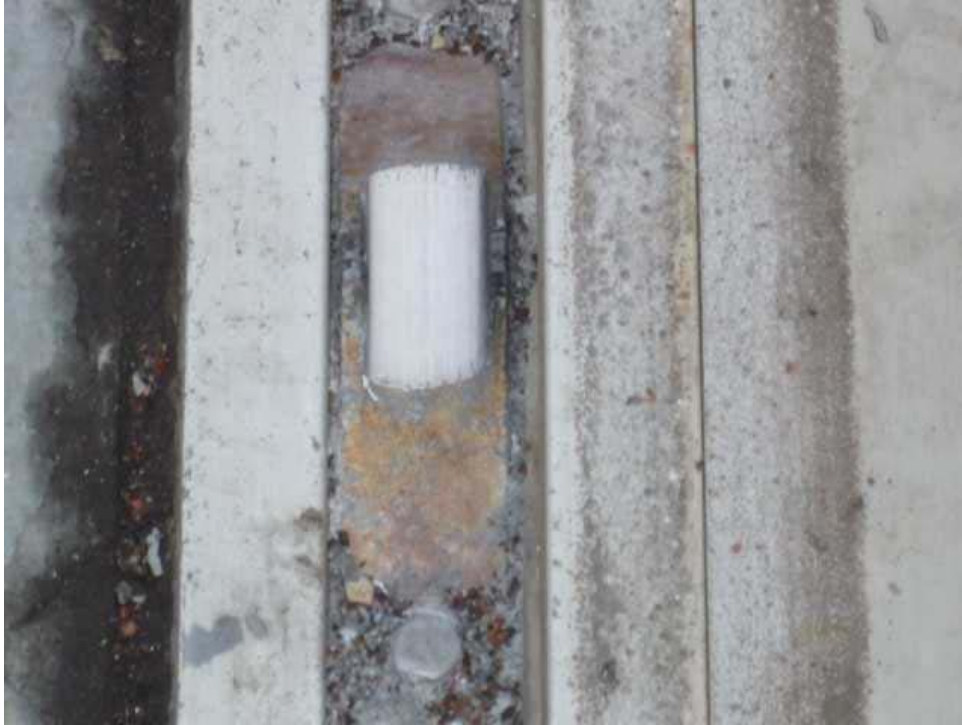
The images below show rubbing in way of the retaining bar (item 6 above) securing the heating cable in the hanger track. The retaining bar was pushed up by products of corrosion between it and the aluminum extrusion. It has been removed, straightened and replaced.

One of the four heating cable elements has failed and has been isolated leaving one section of the hanger track assembly with no protection from snow and/or ice build-up.

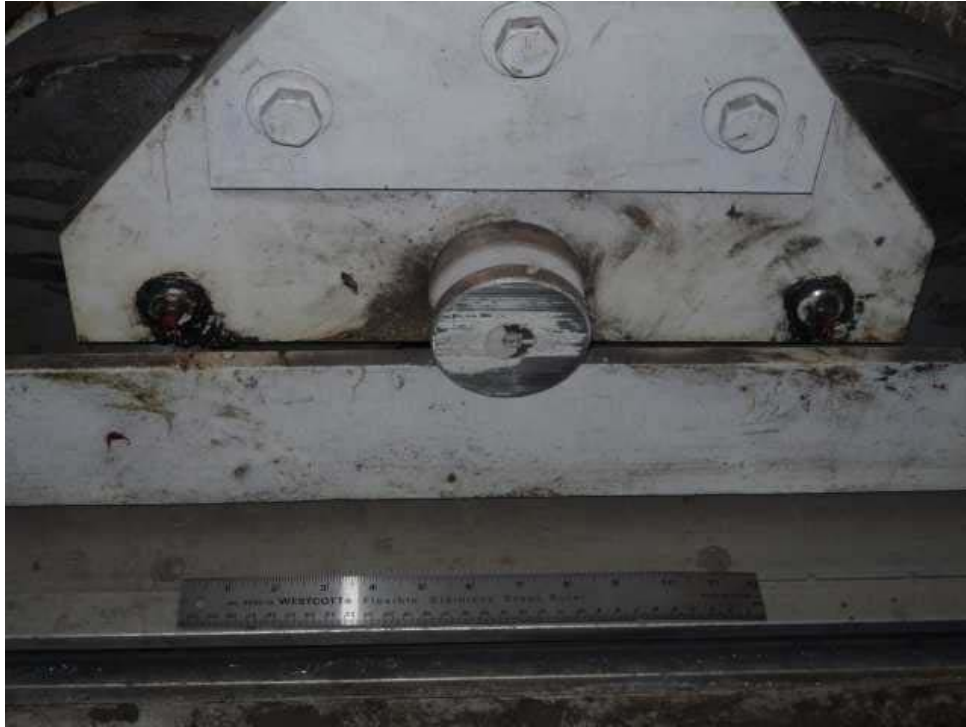
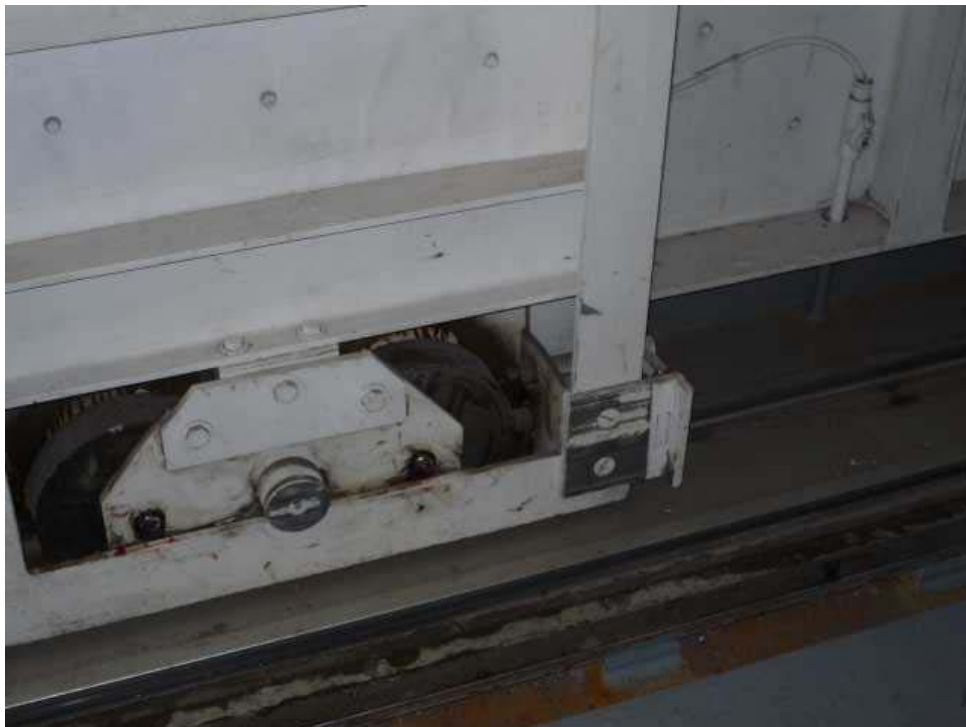
The images on the following page show rubbing on the wheel assemblies on the trailing hanger section and on the pick up pads. The pick up pads are located on the aft end of the trailing hanger section. When the hanger is being retracted the leading hanger section picks up the pads to pull the trailing hanger section with it. The rubbing marks would indicate either lateral movement of the hanger leading section or deformation of the leading hanger section.

We have disassembled and inspected the wheel assemblies and did not see any major wear or deformities that could account for the vibration and wear observed.

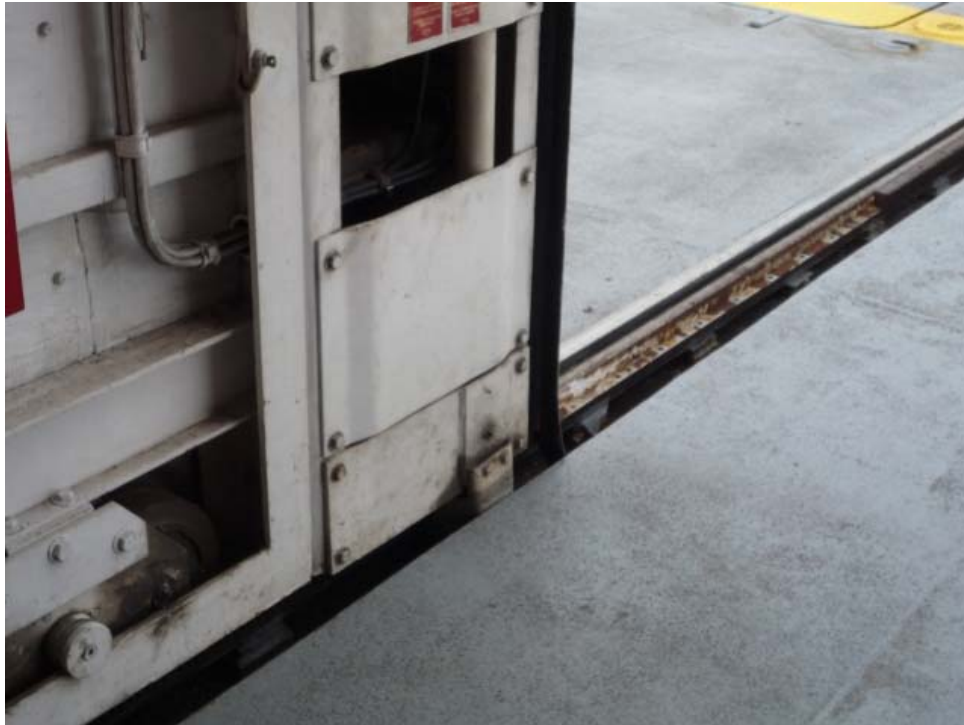
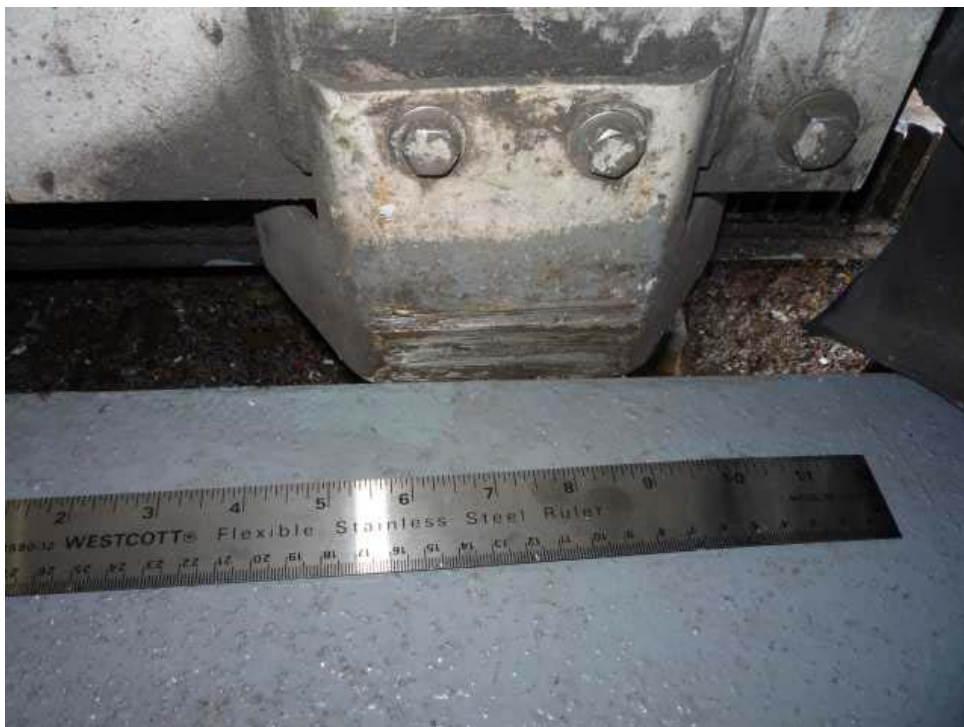
The images below show wear on the cover for the hanger curtain door assembly.

These wear marks indicate the leading and/or trailing hanger sections are not traversing true to the tracks and or may be moving laterally.

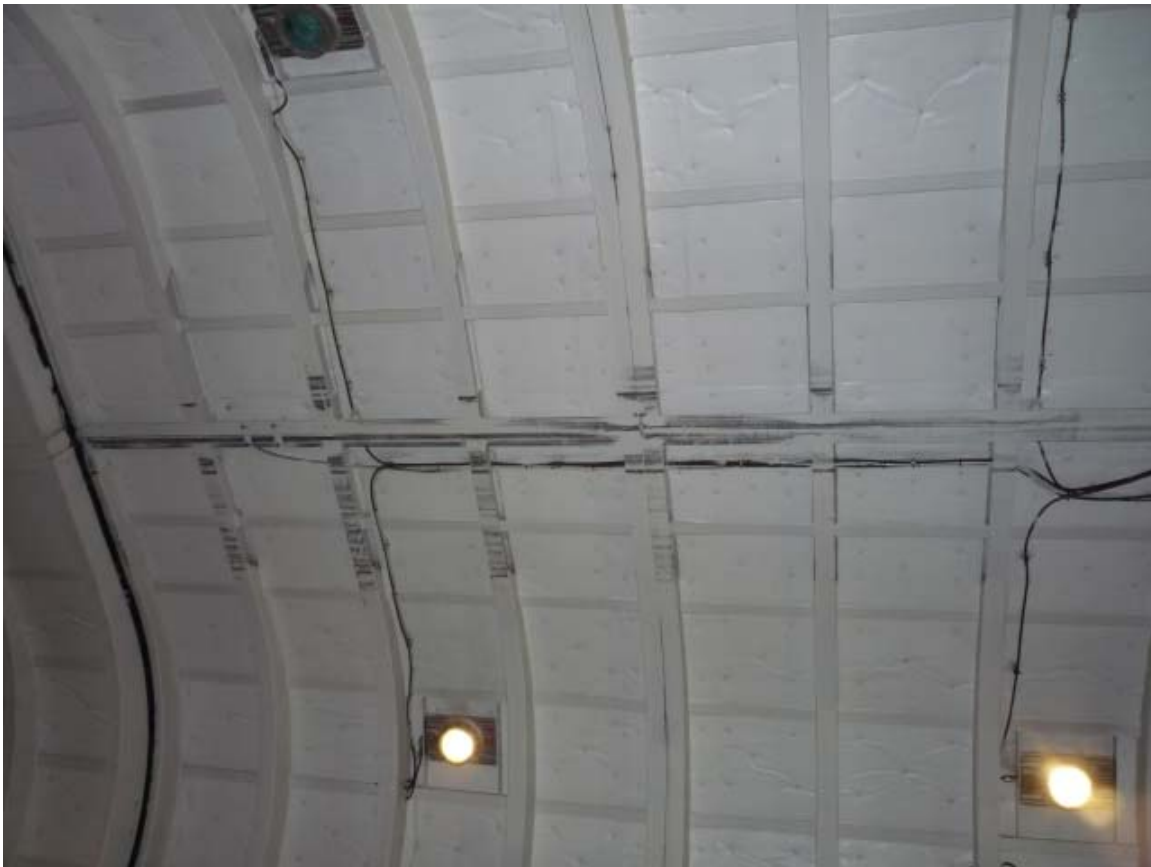
The image below shows rubbing along the top of the stationary section of the hanger caused by the weather seal on the trailing hanger section during traversing of the trailing section.

Both of the above and reports of precipitation leaking into the hanger would indicate problems with the weather seals.

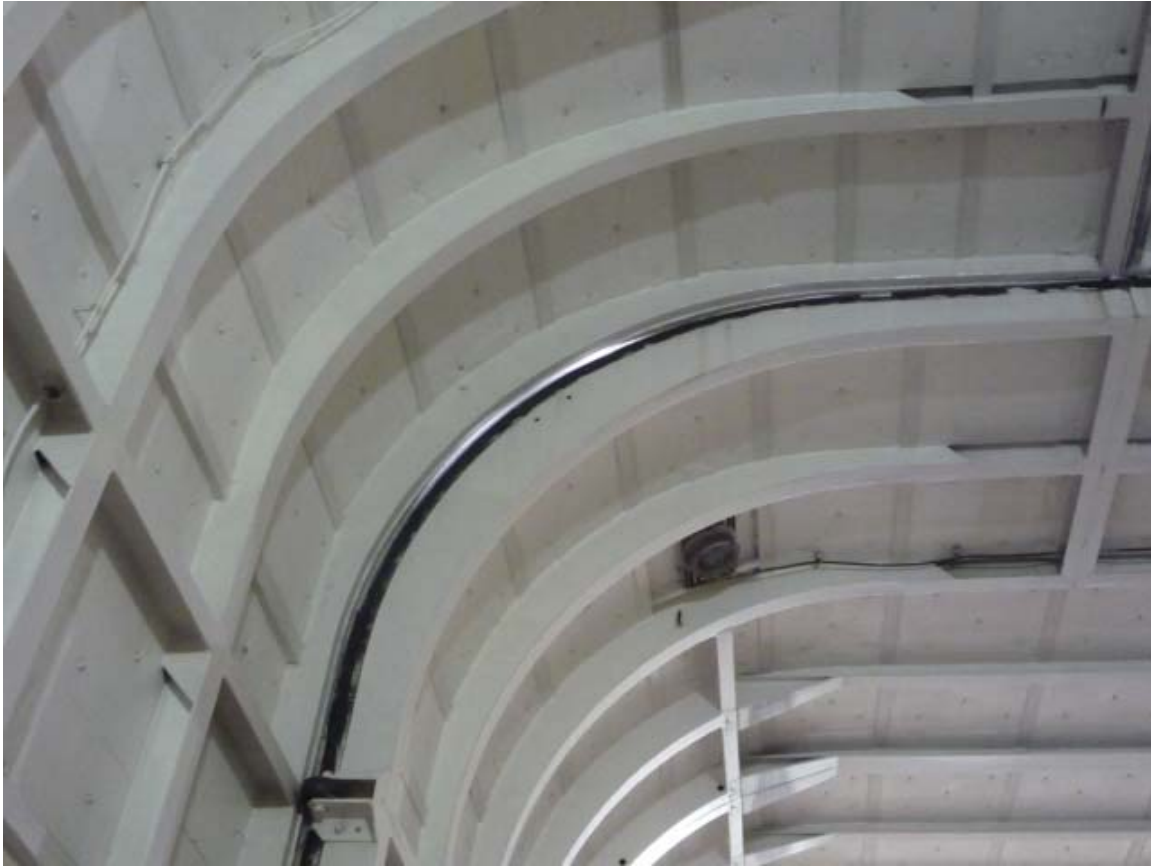
The image above shows day light between the stationary and trailing hanger sections with the hanger extended.

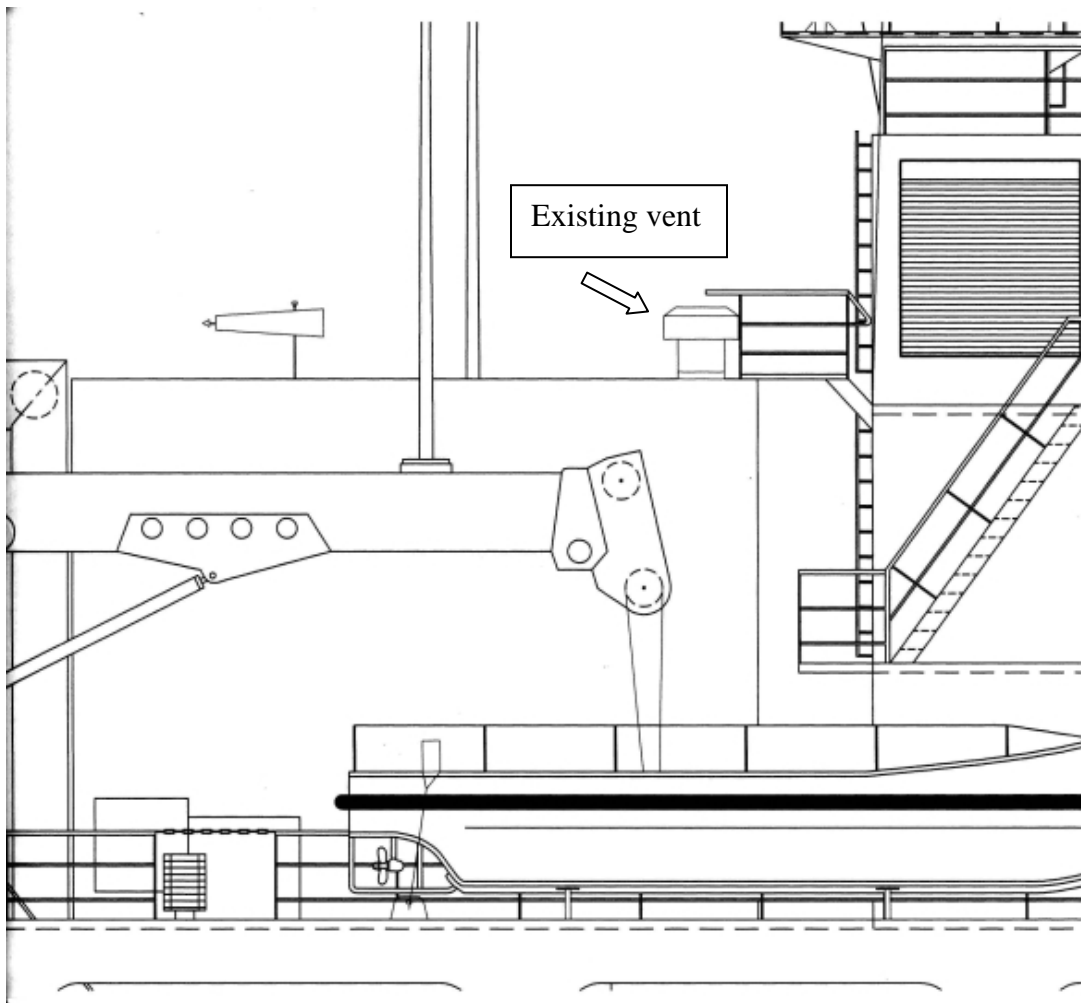
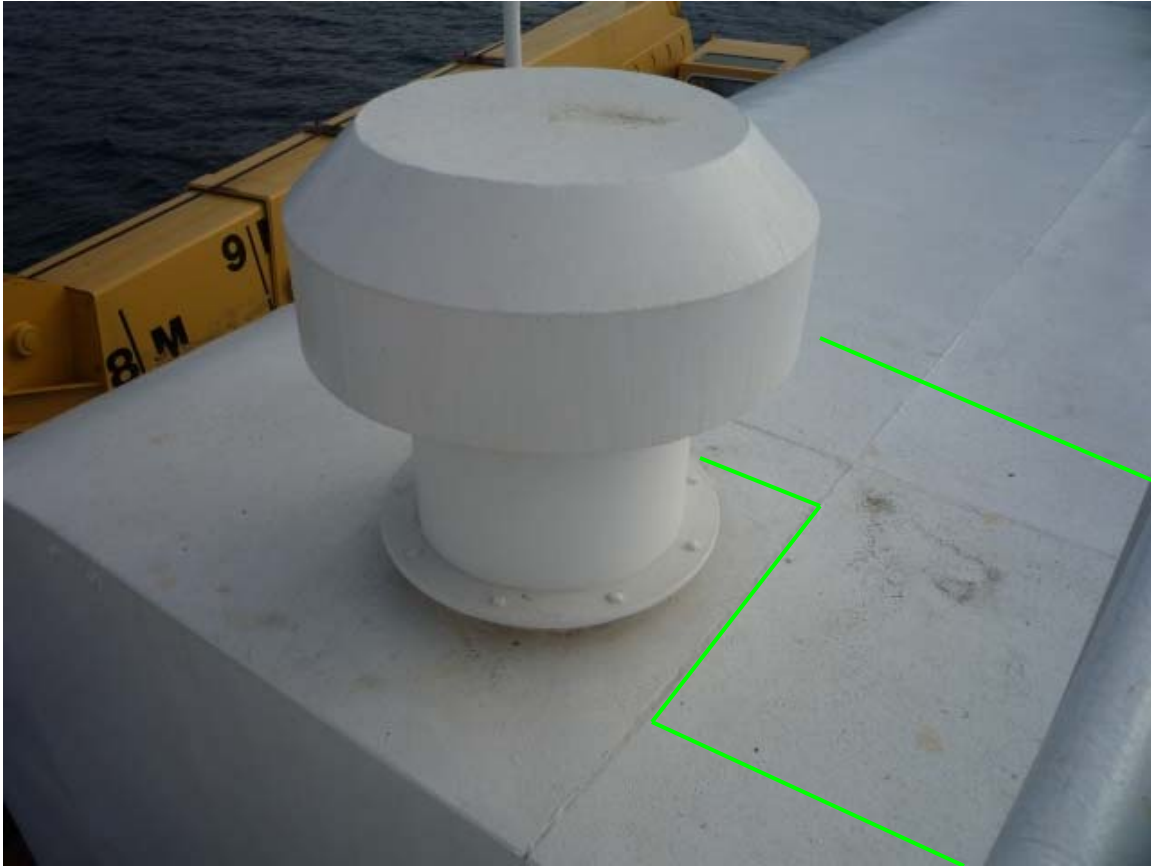
The existing helicopter hanger exhaust fan located on top of the fixed hanger section is not fitted with a fire damper or means of closing it off in the event of a fire in the hanger. While the top of the hanger is accessible from an existing ladder and platform, to reach

the external vent on the hanger top personnel must step on the hanger itself. The hanger top is smooth with no traction or handrail.

Area of proposed new deck grating outlined in green above.

It is proposed to fit a self closing fire damper in the trunking and attach an aluminum deck grating c/w handrail to the hanger top to allow safe access to the vent.
