## **Hazardous Building Materials Assessments**

Palace Grand Theatre  
Dawson City, YT

Project No.: 123220212

March 18, 2015

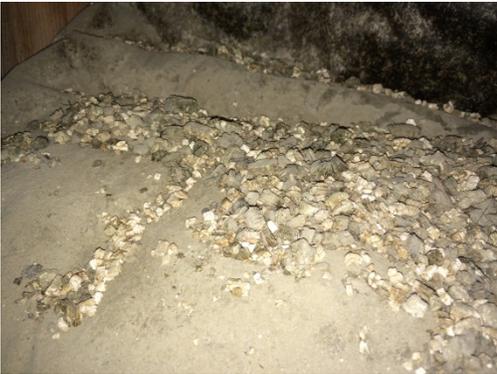
Identified ACM Description		Photo
Vermiculite insulation present between the floor joists throughout the ground floor.

Condition	Good where concealed within floor space. Vermiculite debris (poor condition) observed in joist spaces of perimeter walls in the crawlspace (joist spaces themselves are insulated with fiberglass batt) – expected to be releasing from the floor joist spaces.	
% Type	1-10% Actinolite (according to Maxxam Analytics record reviewed on-site)	
Friability	Friable

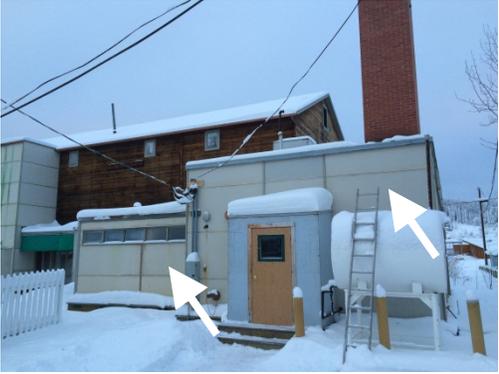
Identified ACM Description		Photo
Exterior cement panels present on the walls of the Mechanical Room and the emergency stairwells (east and west), and building paper behind those cement wall panels

Condition	Good	
% Type	15% Chrysotile in cement board; Trace (<0.25% Chrysotile) in building paper	
Friability	Non-friable	
White woven flex duct connectors found in the Mechanical Room between the main furnace units and primary furnace ducting (one on each of the four furnaces)

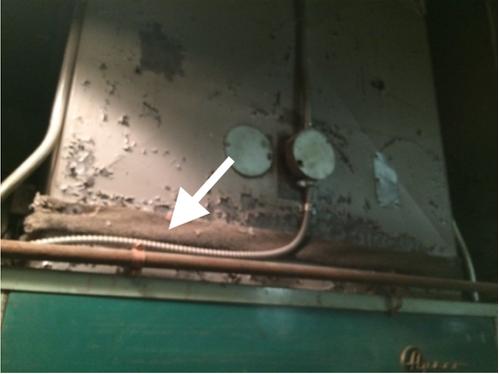
Condition	Good	
% Type	60% Chrysotile	
Friability	Non-friable	
White fibrous liner/gasket found in mechanical room on circular furnace hatches (one on each of the four furnaces)

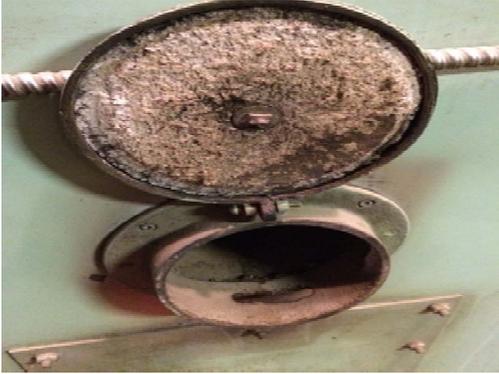
Condition	Good	
% Type	50% Chrysotile	
Friability	Friable	
White furnace gasket found in Mechanical Room between furnace and red burner box

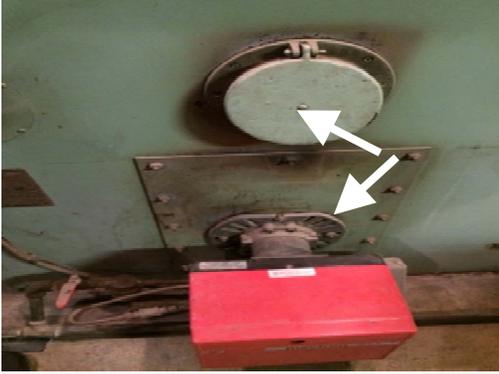
Condition	Good	
% Type	1.3% Chrysotile	
Friability	Non-Friable

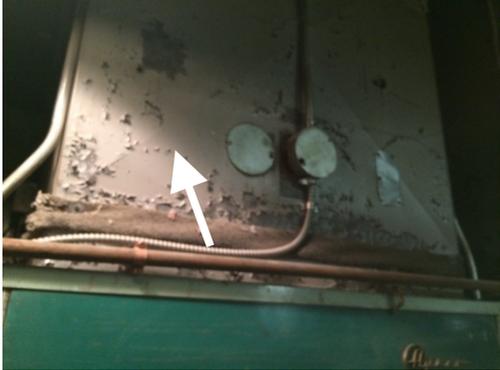
Lead-Containing Material Description	Photo
Grey paint on furnace ducts in the mechanical room This paint was observed to be in poor condition (flaking and peeling) in various locations.

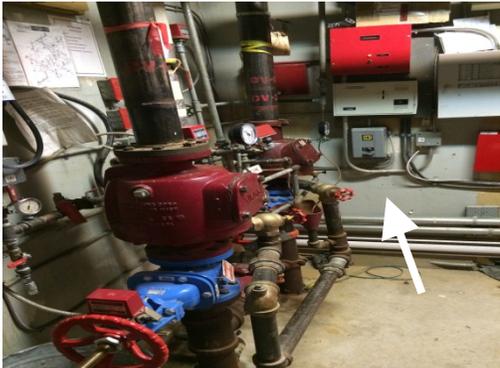
Grey paint on mechanical room walls and ceiling This paint was observed to be in good condition (minimal flaking, bubbling, and peeling)

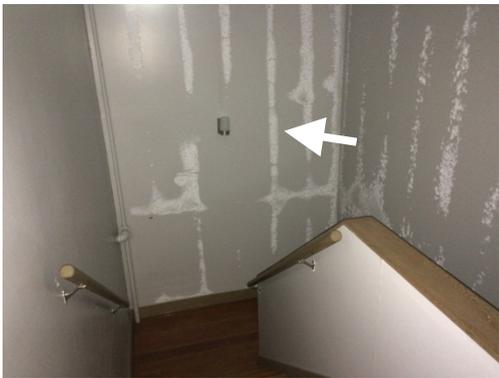
Suspect Mould and/or Moisture Impacted Building Material Observed	Photo
Frost and ice was observed on drywall walls and around window frames in various locations throughout the building. When this melts, the resulting moisture that will impact porous materials in the areas (e.g. paper facings of drywall) can create conditions conducive to mould growth.

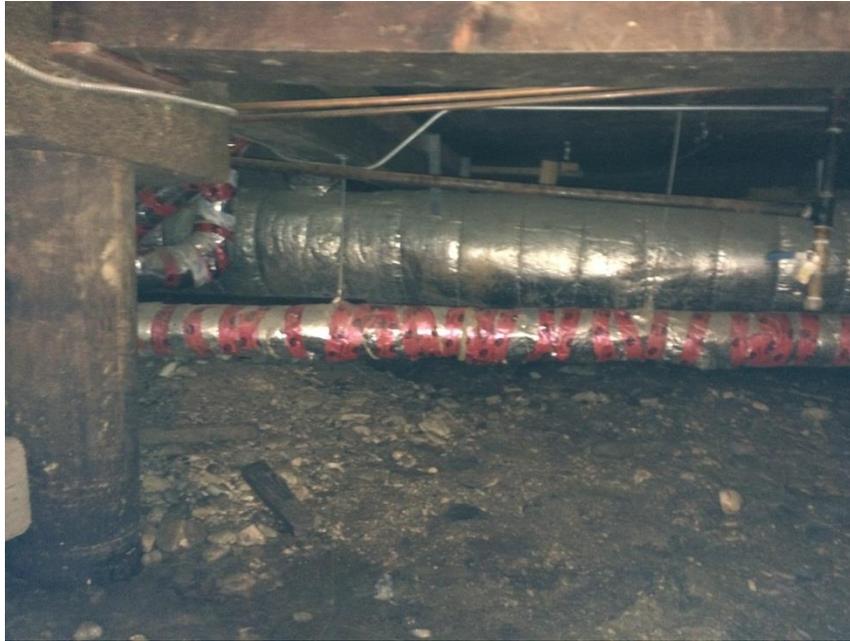
**Photo 3** Palace Grand Theater Crawlspace - Non-asbestos foil-wrapped fiberglass insulation to be removed from HVAC ducting in the crawlspace.

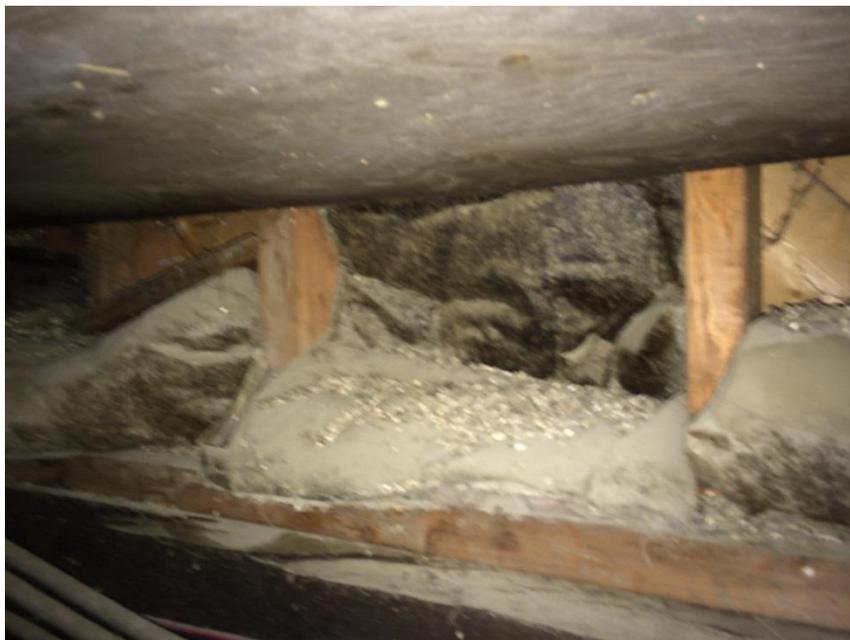
**Photo 4:** Palace Grand Theater Crawlspace - Asbestos-contaminated fiberglass insulation in the crawlspace at perimeter walls.

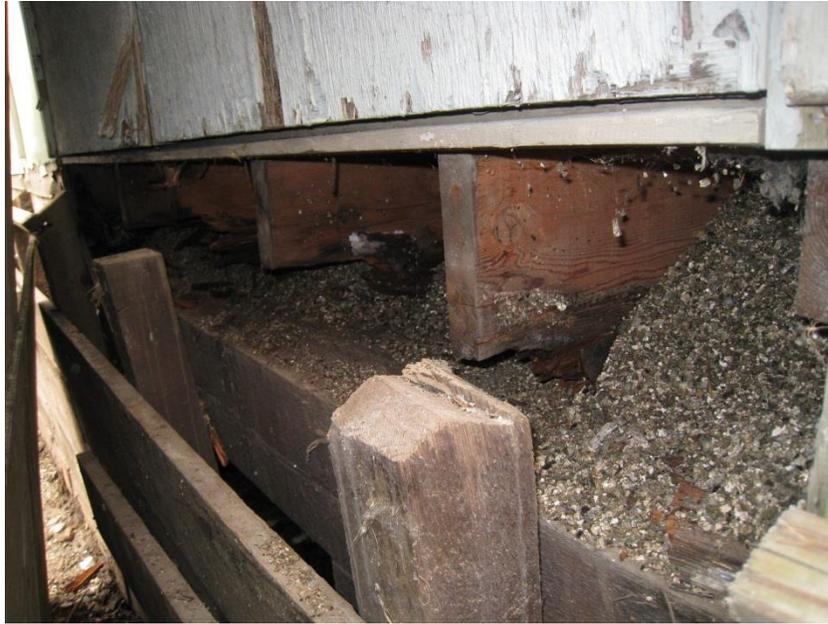
**Photo 5:** Palace Grand Theater Crawlspace - Asbestos-containing vermiculite insulation to be removed from the “ceiling” space of the crawlspace as seen from the exterior when skirting was removed.

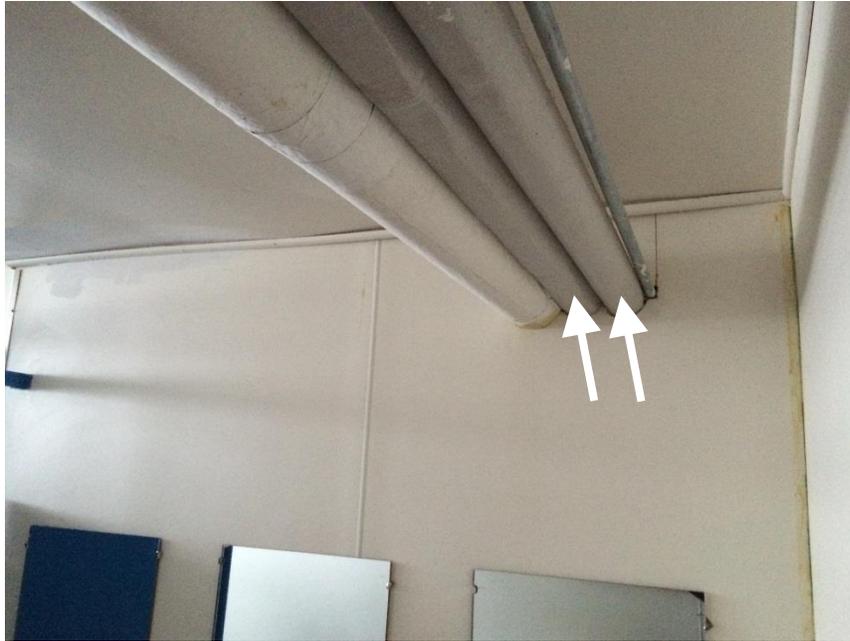
**Photo 15:** Palace Grand Theater - Asbestos-containing pipe wrap in Room 116 Women's Washroom.

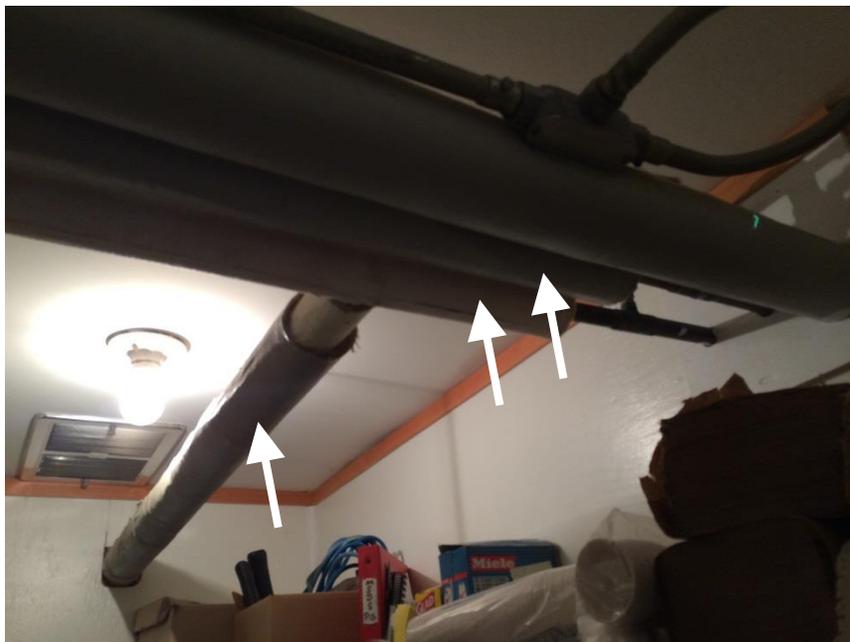
**Photo 16:** Palace Grand Theater - Asbestos-containing pipe wrap in Room 117 Janitor's Washroom.

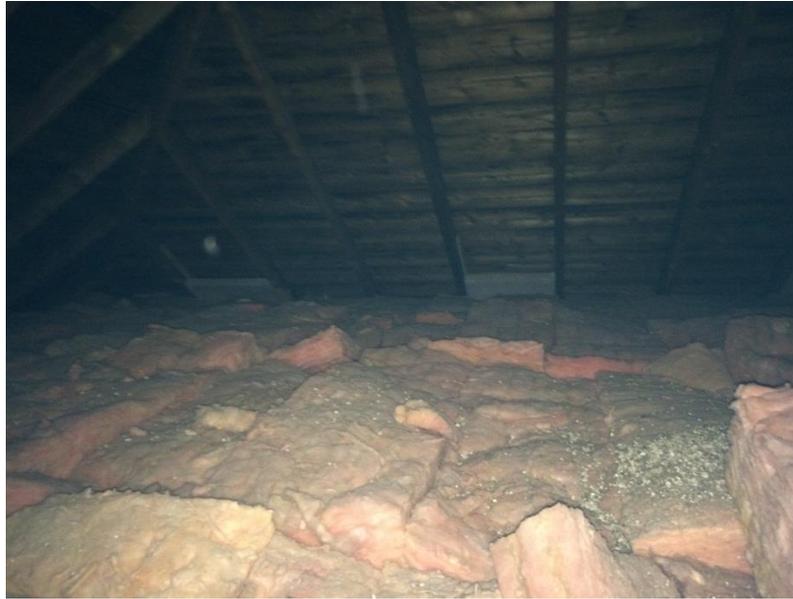
**Photo 19:** Commanding Officer's Quarters - Fibreglass batt insulation laid on top of asbestos-containing vermiculite insulation in the attic space.
