Addendum / Addenda

No./N^o
1

Project Description / Description de projet M-22 Aircraft Cabin Comfort and Environment Research Facility		
Solicitation No./ No de sollicitation 15-22004	Project No./N ^o de projet M-22 3788	W.O. No./N ^o d'ordre de travail
Departmental Representative / représentant ministériel Maurice Richard		Date June 24, 2015
<p>Notice: This addendum shall form part of the tender documents and all conditions shall apply and be read in conjunction with the original plans and specifications.</p>		<p>Nota: Cet addenda fait partie intégrale des dossiers d'appel d'offres; toutes les conditions énoncées doivent être lues et appliquées en conjonction avec les plans et les devis originaux.</p>

DESIGNATED SUBSTANCES SURVEY

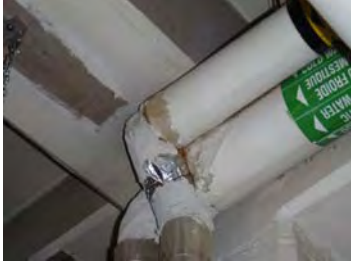
A29	B014	Room 9	Steam: Two damaged mud joint compound fittings requires two encapsulations (2 units).

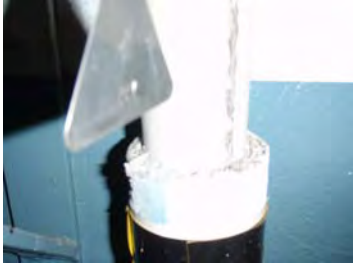
Photo #	Functional Space #	Location	Comments	Photograph
A40	B017	Wave Room	Cond.: One open end of aircell pipe insulation requires one encapsulation (0.2 LM).

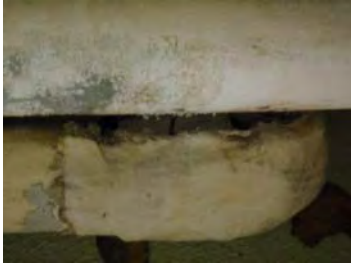
Photo #	Functional Space #	Location	Comments	Photograph
A59	1006	Room 103	Steam: One damaged mud joint compound fitting requires one encapsulation (1 unit).

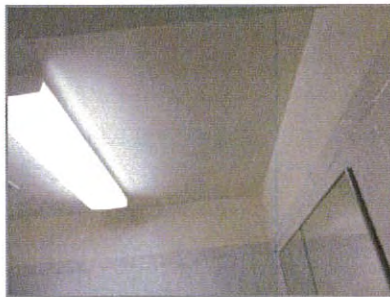
Plaster, containing chrysotile asbestos in the base layer, is present on walls and ceilings in the rooms assessed in B-36 (Samples 0001A-C, 0002A-C, 0003A-C, 0004A-C and 0005A-C). Plaster sampled in the closet on the second floor did not contain asbestos (Samples 0006A-C); however, based on the remaining samples results, should be treated as asbestos containing. Plaster is non-friable while in place, but generates friable dust upon removal. All plaster is painted and is in good condition.

Photo 1, B-100, plaster containing chrysotile asbestos in plaster base coat(sample 0003A-B)

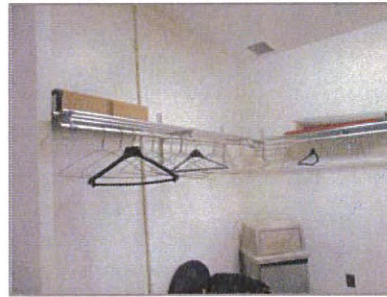
Photo 2, 2nd floor closet, plaster does not contain asbestos,(sample 0006A-C)

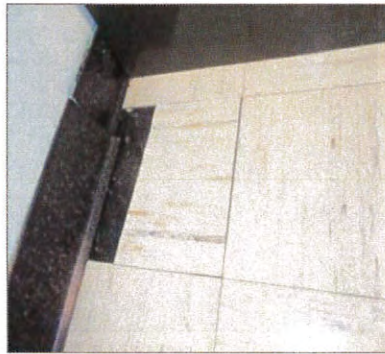
The vinyl floor tiles and mastic are non-friable and are in good condition.

Photo 3. Asbestos-containing 9"x 9" vinyl floor tile. Mastic does not contain asbestos. (sample 0007A-C)

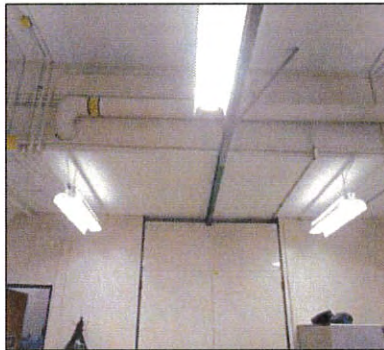
Photo 5 – Cementitious parge at ceiling, beginning of room 120
