# GEOTECHNICAL INVESTIGATION REPORT

January, 2015

Y/Ref. : R.064816.019

**Workshop Bathroom Renovation and Site Drainage Project  
Cap Tourmente National Wildlife Area  
Chemin de la Friponne, Saint-Joachim (Québec)**

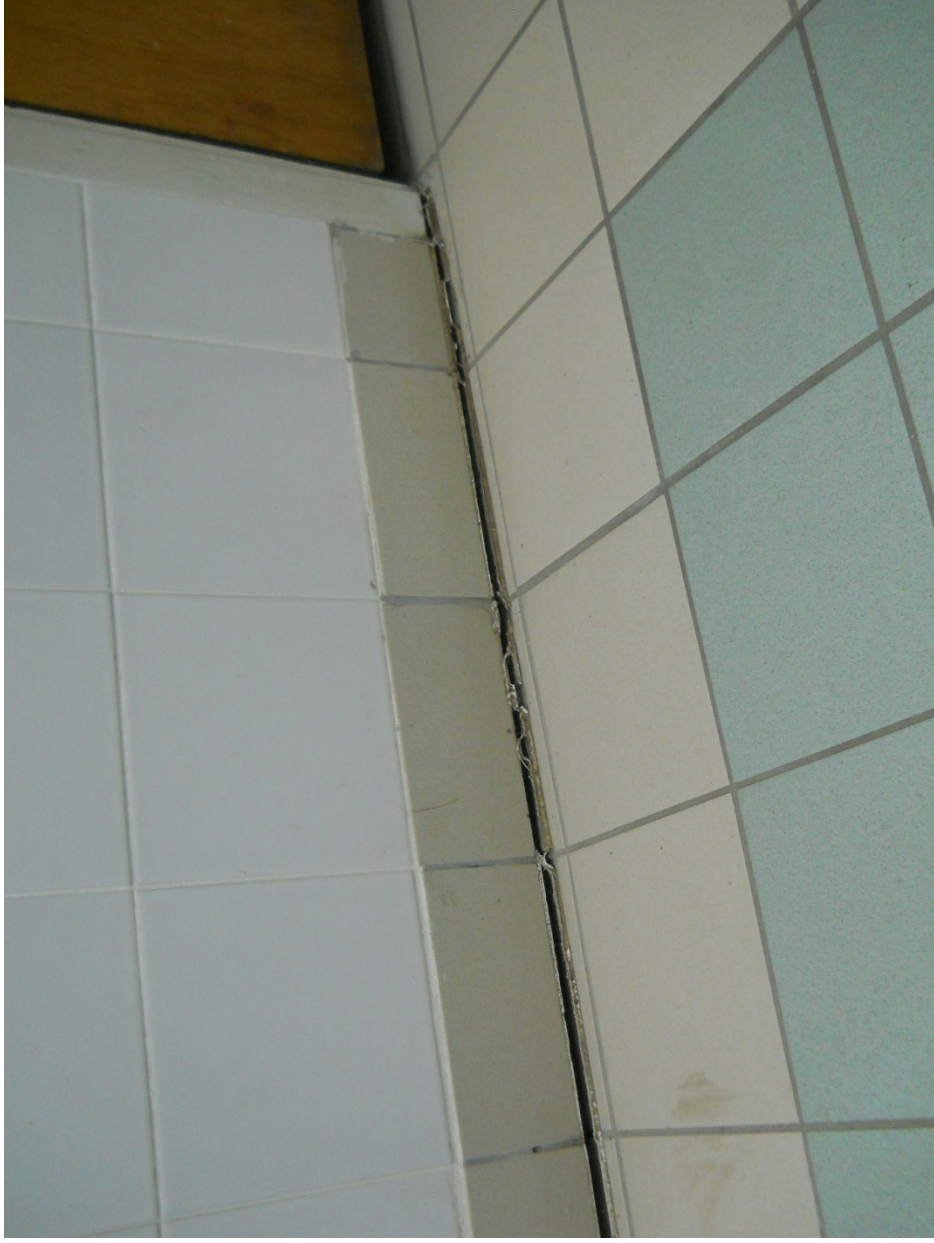
The ceramic tile and the concrete slab of the Workshop's bathroom show numerous cracks generally located along the walls and the floors. A separation between the interior bathroom walls and the concrete slab was observed and is shown on Photo #1 (Appendix IV). Significant cracks were also observed along the outside walls, specifically in the area of the bathroom's north wall near the location of TF-101-14 (Photo #2, Appendix IV). A 70 mm thick void was found directly under the concrete slab indicating that the slab is unsupported in the bathroom area.

The void found under the concrete slab may be explained by the presence of a 1.1 m thick layer of very loose organic soil. Such soils are very compressible and organic matter will break down over time.

Consequently, settlement progressively occurred with time within this layer of soil. Moreover, organic soils are susceptible to experience volume changes depending on the groundwater conditions they are subjected to. Finally, the displacement of soil particles within this material is made easy by its low compactness. It is also important to consider that a layer of fill containing voids and an important amount of brick and wood debris as well as cobbles was observed along the Workshop building in a previous investigation done by Labo S.M. (September 2014, ref : F1313256-006). This mediocre quality fill material is also subjected to settlement and particle displacement by water flow, especially considering the existence of voids within the fill.

**Photo 1 – Separation between the ground slab and the bathroom's interior wall.**

Given the aforementioned information, the reconstruction of the bathroom's concrete slab (total area of about 6 m x 10 m) will have to be completed. According to the results of our investigation, the required work should consist of the excavation of the organic soils and the construction of a new concrete ground slab installed on a properly prepared subgrade. Another option is the construction of a structural slab supported by pile foundations.

The reconstruction of the concrete ground slab on the organic soils found on site is not recommended. Excavations of a depth of 1.4 m or more are required to remove the organic soils before reconstructing the bathroom's concrete ground slab.

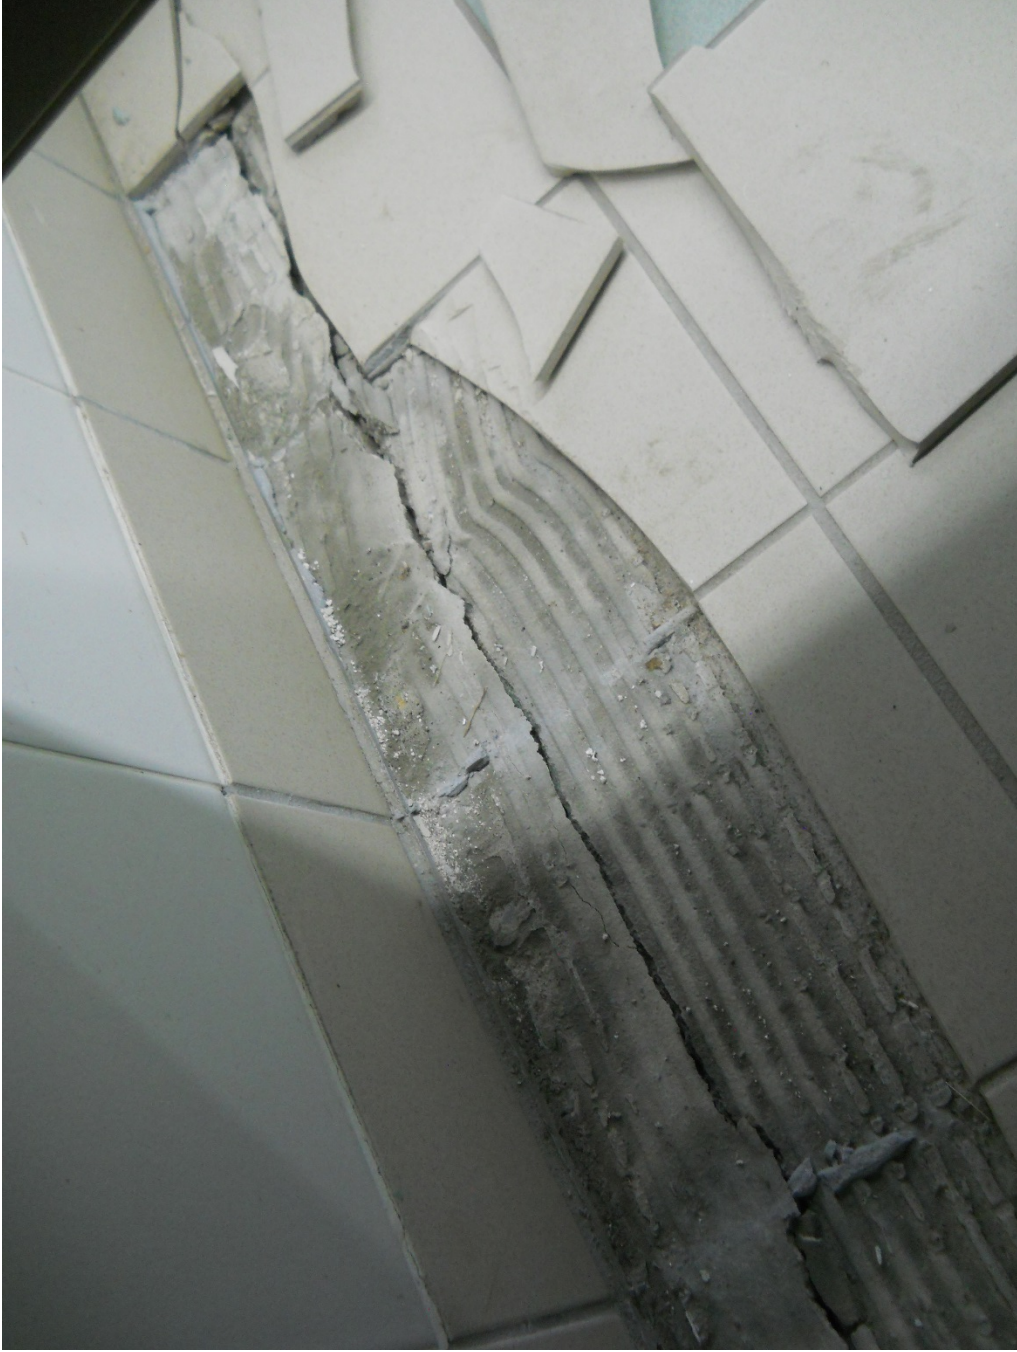
Photo 2 – Crack in the concrete ground slab along the bathroom's north wall.

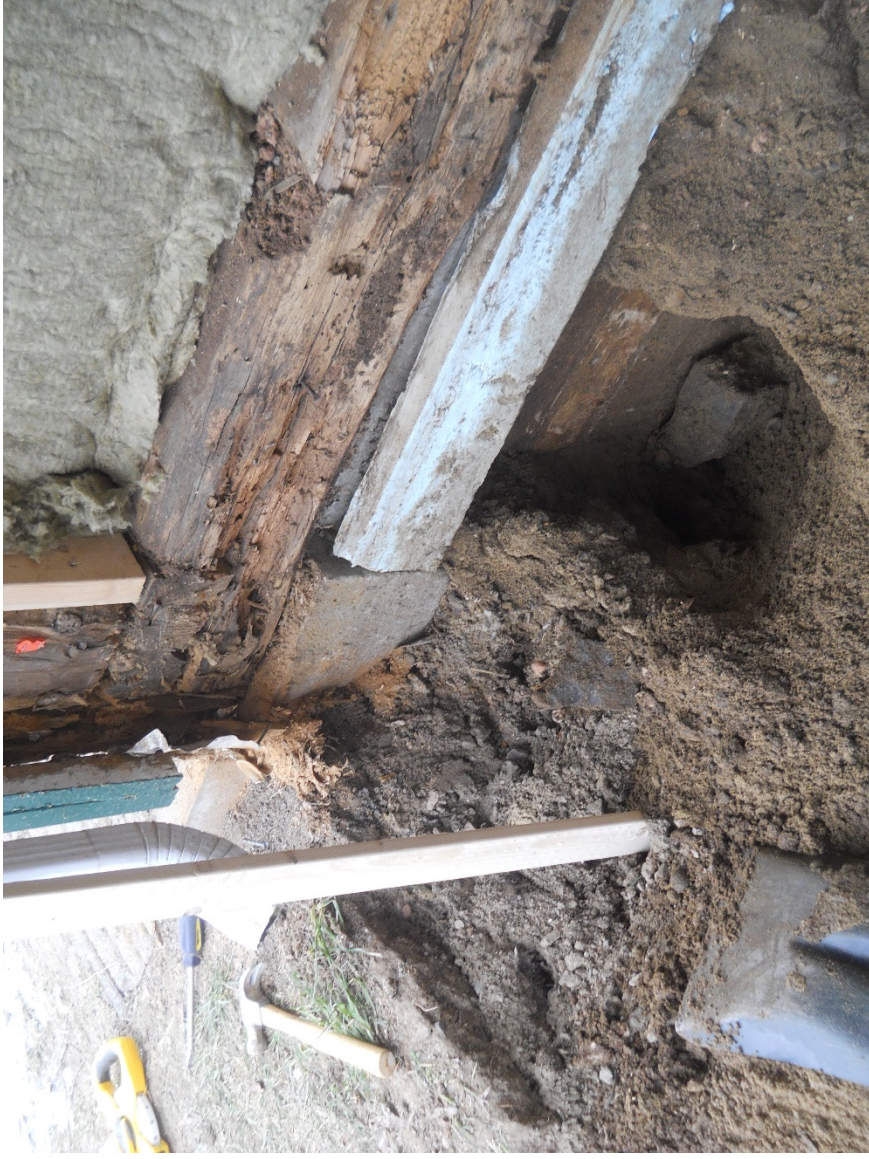
A site visit was done on December 16<sup>th</sup> 2014 during the site preparation for scheduled piling work of the building's foundations. At the time of the visit, an excavation of about 300 mm deep had been completed around the building's foundations. The open excavation allowed us to determine that the outside wall at the north end of the bathrooms (area omitted in the previous investigation) seems to be supported by a concrete beam or a strip footing about 600 mm in height (Photo #3, Appendix IV). Cracks observed along this specific wall section seem to be caused by the differential displacement between this foundation and the building's concrete slab. The interior concrete slab cracks on its perimeter because of the settlement of the supporting ground but the outside wall does not show obvious signs of displacement. Consequently, the separation between the inside wall and the interior concrete slab is explained by the fact that the inside wall is attached to the roof trusses which sit on the outside walls.

**Photo 3 – Northeast corner of the bathroom building (a section of the exposed foundations is shown)**

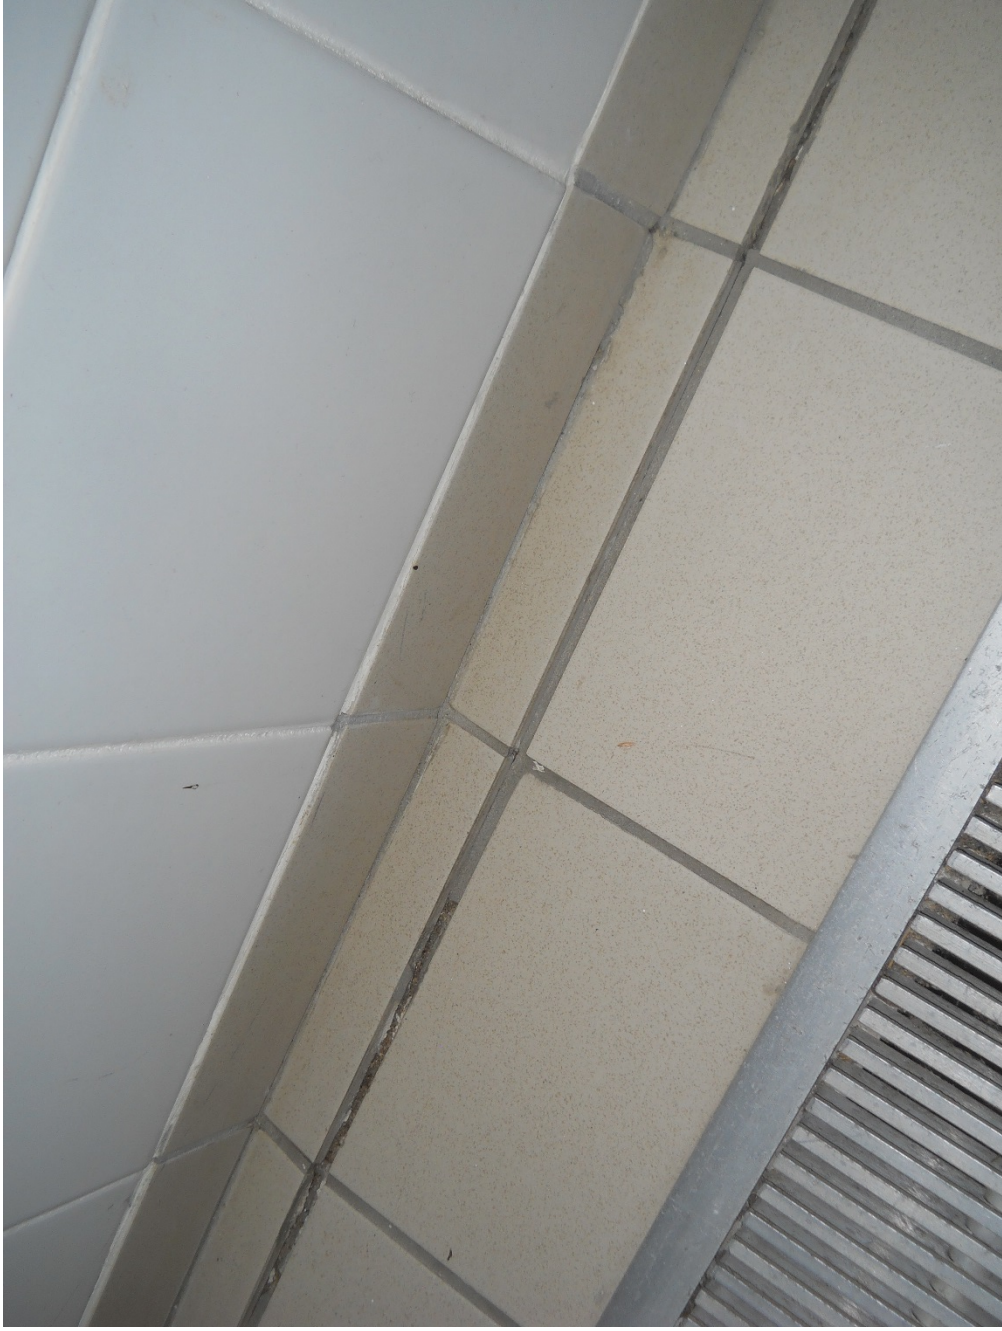
The cracking problematic is not as extensive on the building's south wall (Photo #4, Appendix IV). An increased concrete thickness was observed at the base of this wall but no foundation structure was seen, as found in the previous investigation. Also, the differential settlement issue seems to be less important in that portion of the building. Note that the bathroom's east wall appears to be sitting on a wooden beam which rests at its ends on concrete pillars.

**Photo 4 – Junction between the ground slab and the south bathroom wall**
