North Perimeter Wall Rehabilitation: Phase 3

Parliament Hill, Ottawa, ON,
Ottawa, ON

Final Design Development Report

October 6th, 2014

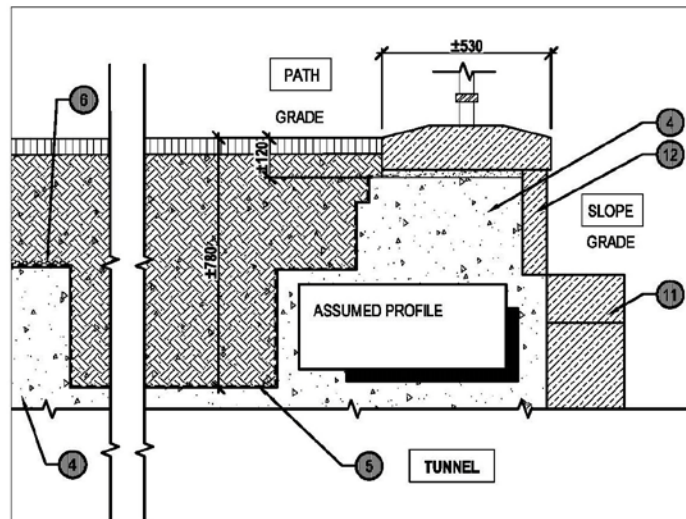
The Lookout will be raised by about 400mm to avoid conflict with the C3 tunnel (fig. 1).

Figure 1: Section at Lookout over Tunnel C3 - existing condition.

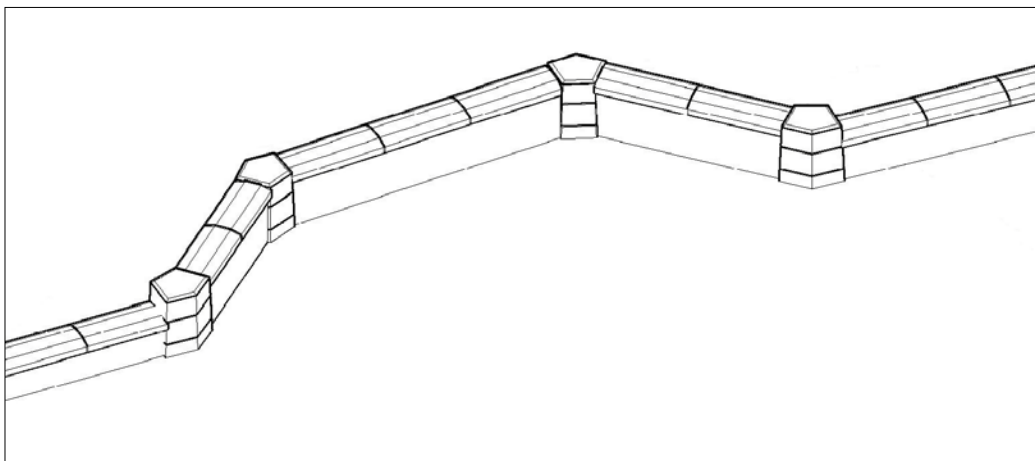
Figure 2 - Schematic axonometry of reworked Lookout - introducing pentagonal piers at the corners (fencing not shown).

A new pier is introduced at the western corner of the Lookout that allows the wall to be raised around the Lookout and eliminates the need to do excavation at the edge of the Lookout. This also helps define the Lookout as a space instead of a simple enlargement of the path. Pier 39 is relocated at the eastern corner of the lookout for symmetry. Additional piers are added at the inside corners of the Lookout to help better define the space. The new piers will all be pentagonal in shape, to match the orientation of the Lookout, while the capstones between them will all be at the same level, with changes in elevation stopping to either side of the Lookout (fig. 2).

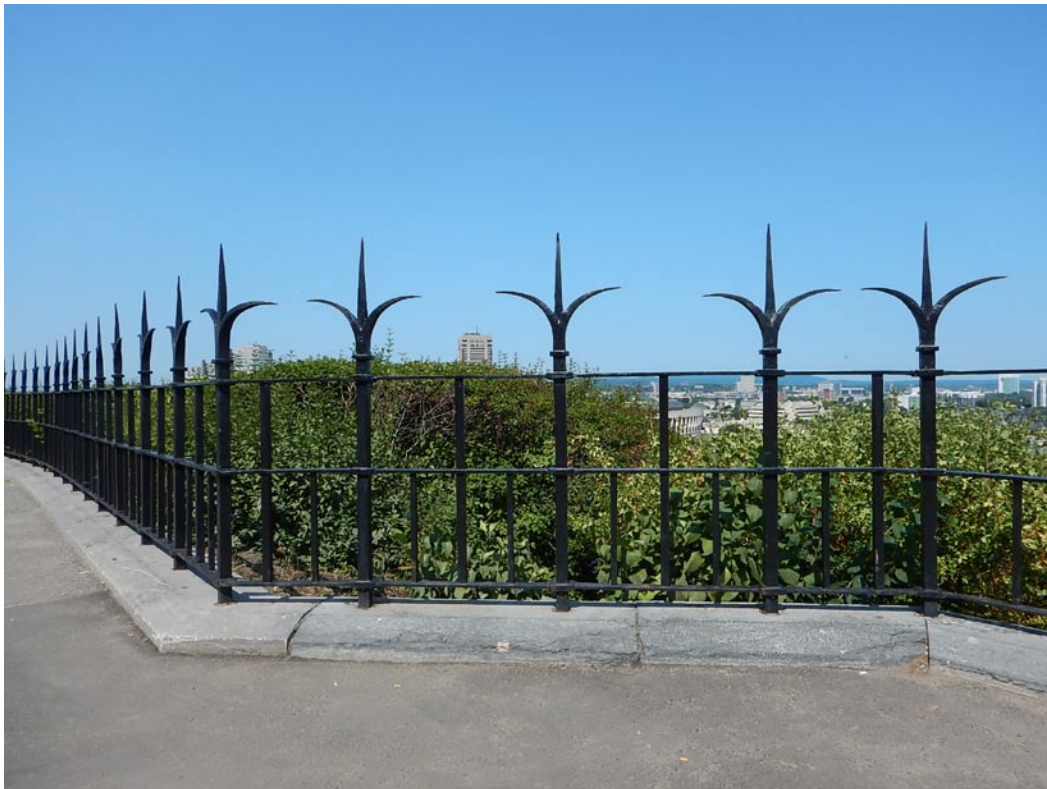
It is also proposed to adjust the iron panels and layout of the Lookout in order to create a more consistent approach and to address the previous poor quality modifications. The original wall consists of repetitive panels, with the panel sizes ranging from around 785 to 812mm O.C. post to post. It is proposed is to rebuild the Lookout using multiples of a dimension as close as possible to these. While the angle of the two sides of the Lookout will change slightly to allow for a more equal spacing of the iron panels, the overall skewed shape of the Lookout will not change. We believe the best solution would be to have the side walls equal, at about 3050mm long (4x762mm panels) and the long wall 5070mm long (6x845mm panels). This would mean the first posts that define the start and end of the Lookout would remain in their original locations and the longer stretch of the wall would be shifted slightly to the east, also resulting in a slight change in the angles of the inner corners. It should be noted that the Lookout currently has an irregular shape, of a skewed trapezoid, determined by the fact that the long side needs to remain parallel with the top of the tunnel portal, which is not parallel to the wall which is where the sides of Lookout spring from.

Figure 3 - Showing existing condition at the Lookout with capstones at grade level and uneven ironwork panels.

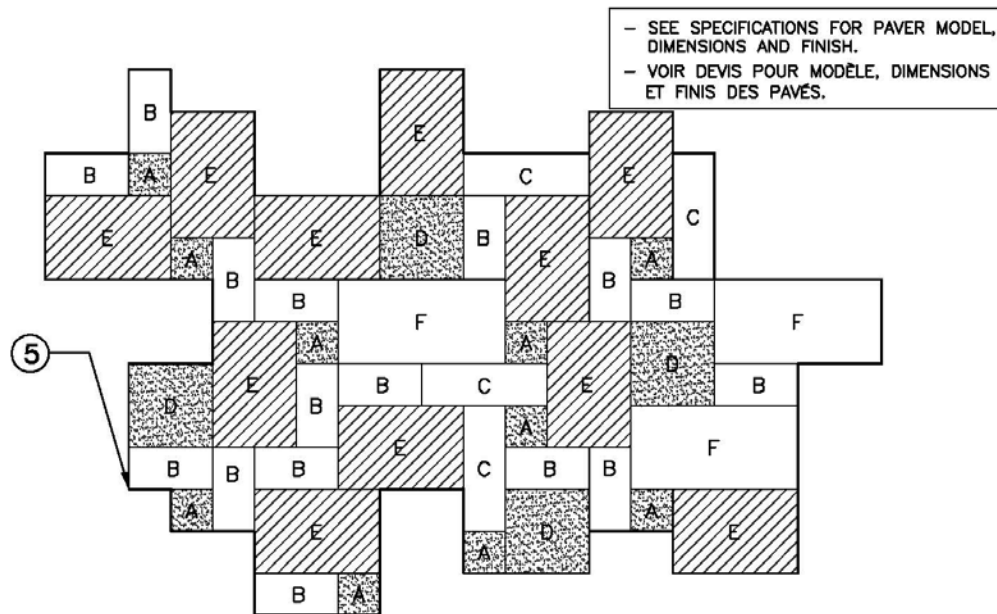
Figure 4 - Limestone pavers pattern layout

The pattern for both the path and the nodes was the same, but paver sizes are twice as large in the nodes, except for thickness. A special soldier course was introduced in front of each pier to help with pattern alignment. For this section of the wall, it might be necessary to include soldier courses between piers also, since there are major changes in pathway orientation between some piers, like between Piers 35 and 36.

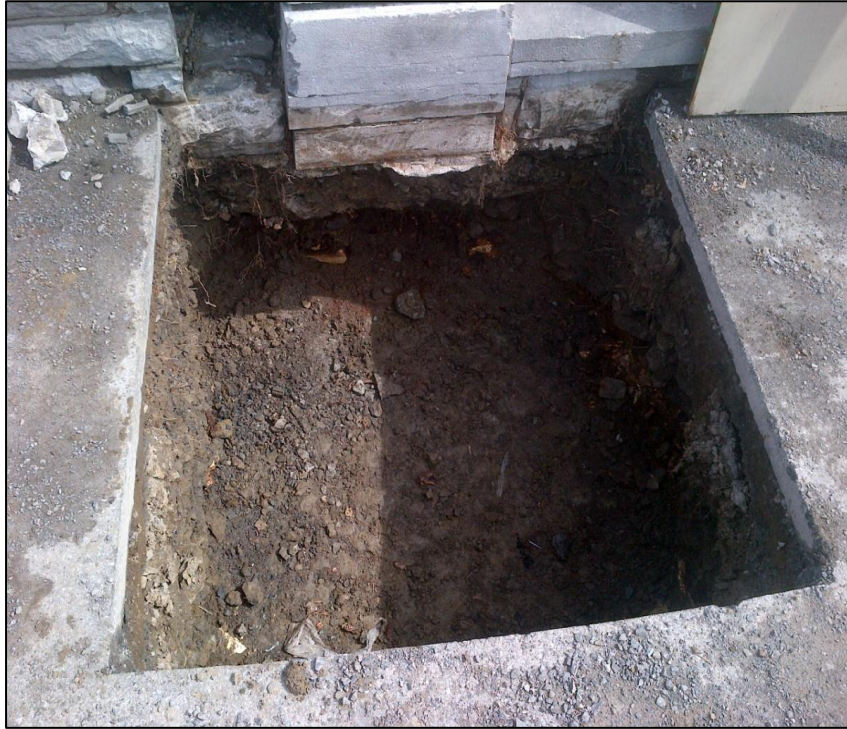
Photo 1 – Silty sand fill at base of test pit along with the existing perimeter wall foundation exposed at TP 1A.

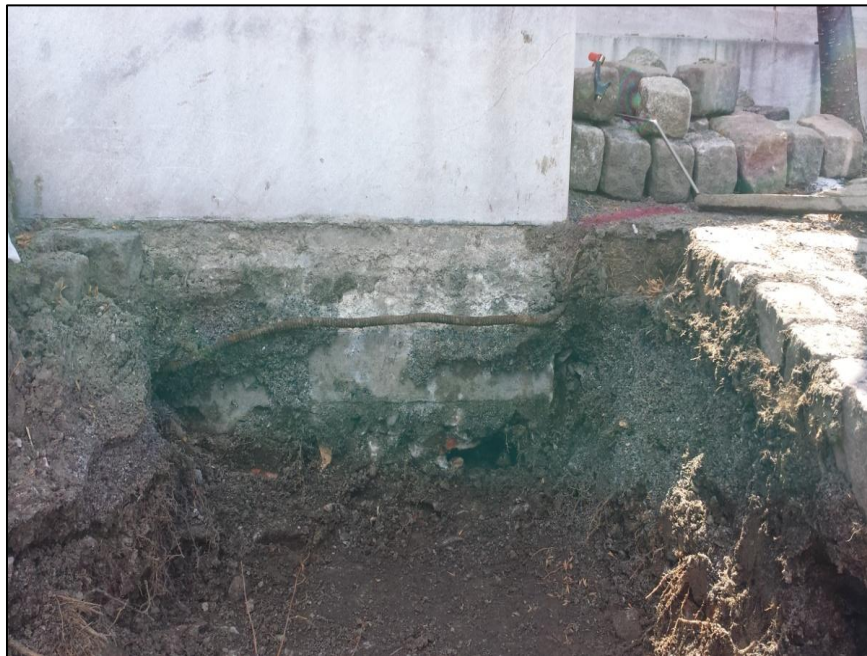
Photo 2 – Existing foundation of monument structure exposed along east side of test pit at TP 3B.

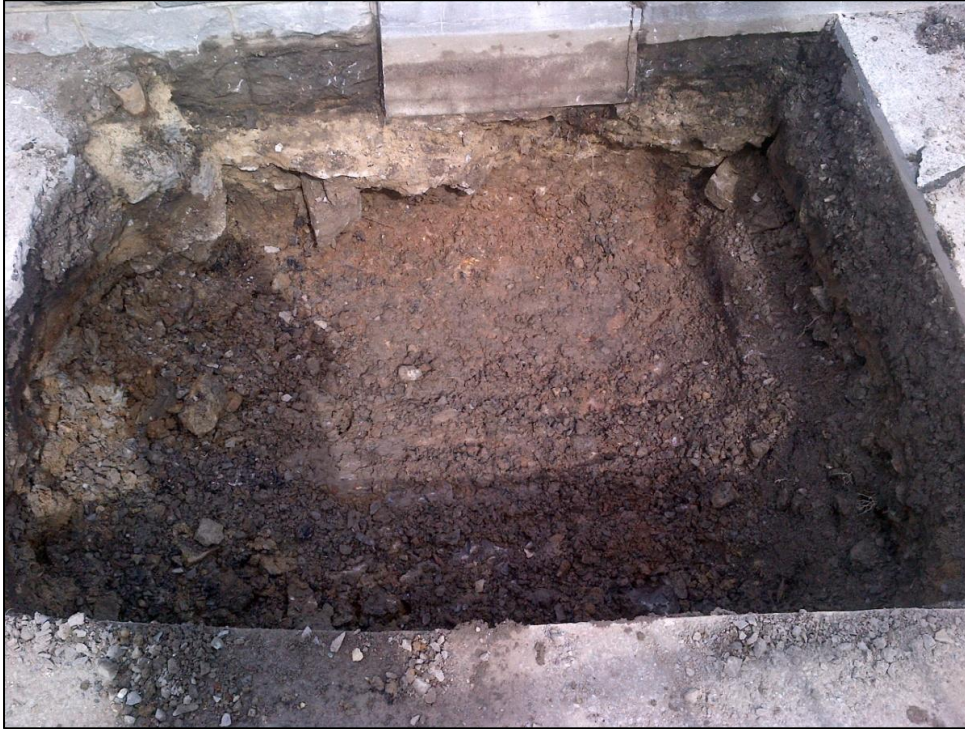
Photo 3 - Soil profile along north side of test pit and existing wall foundation exposed at TP 7A.

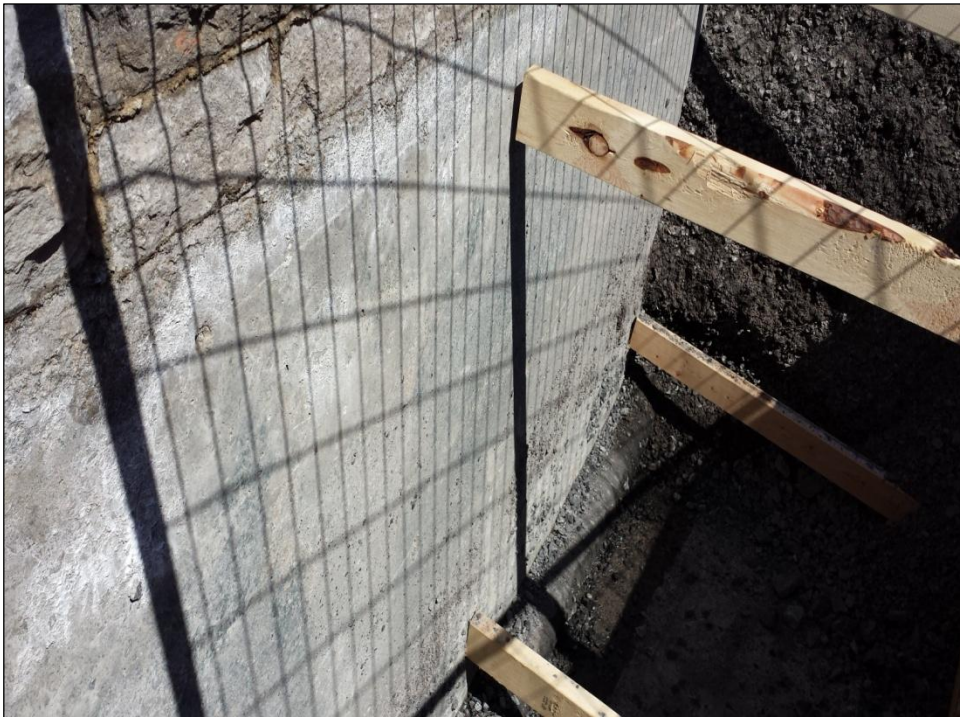
Photo 4 - Exposed foundation wall and top of tunnel at TP 9C.

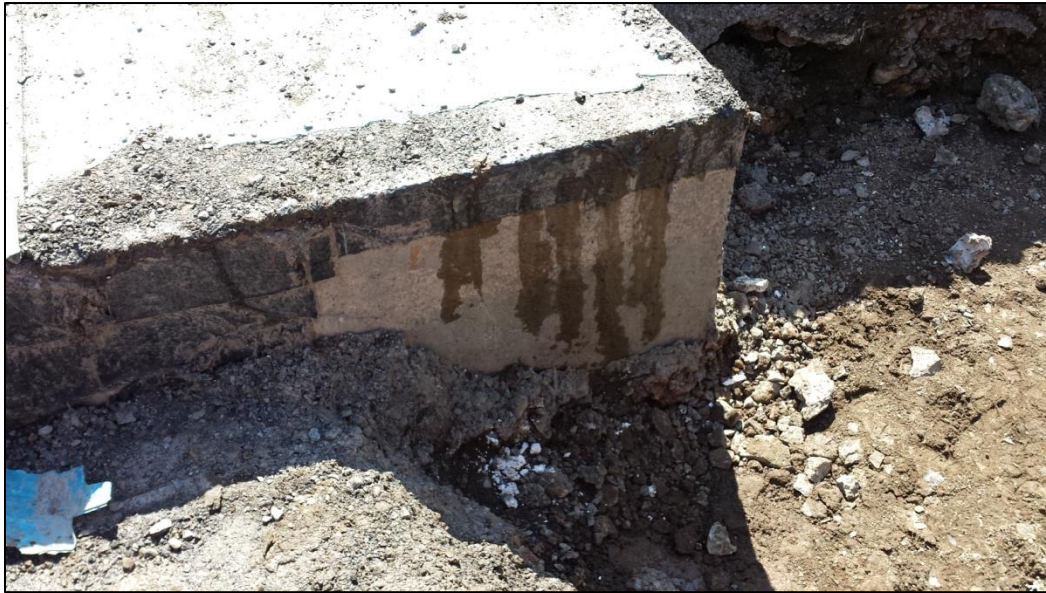
Photo 5 - Exposed corner of existing tunnel within east portion of TP 12D.

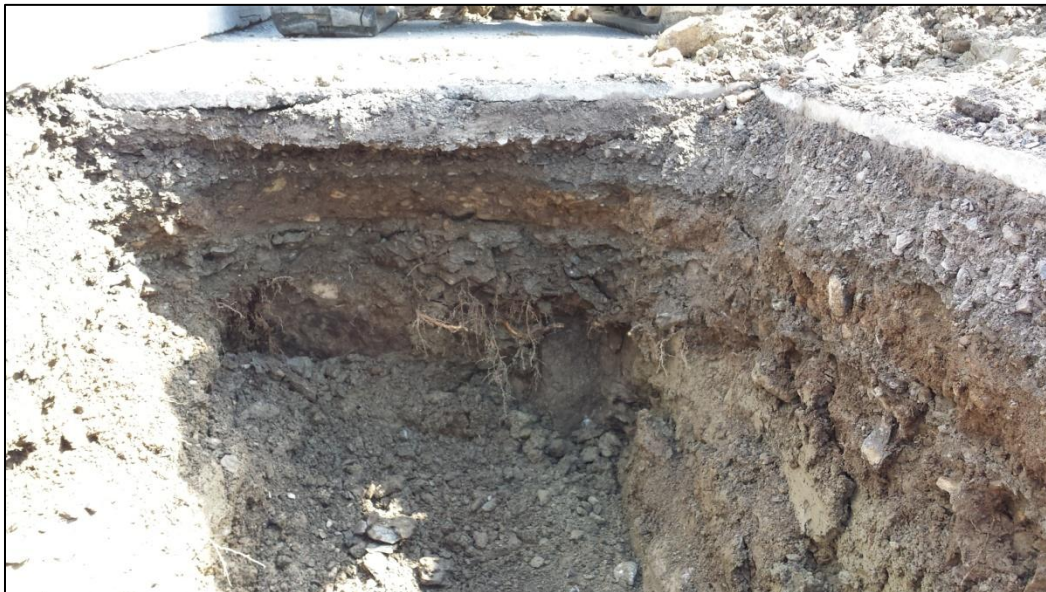
Photo 6 - Excavated sidewall at TP 14C.

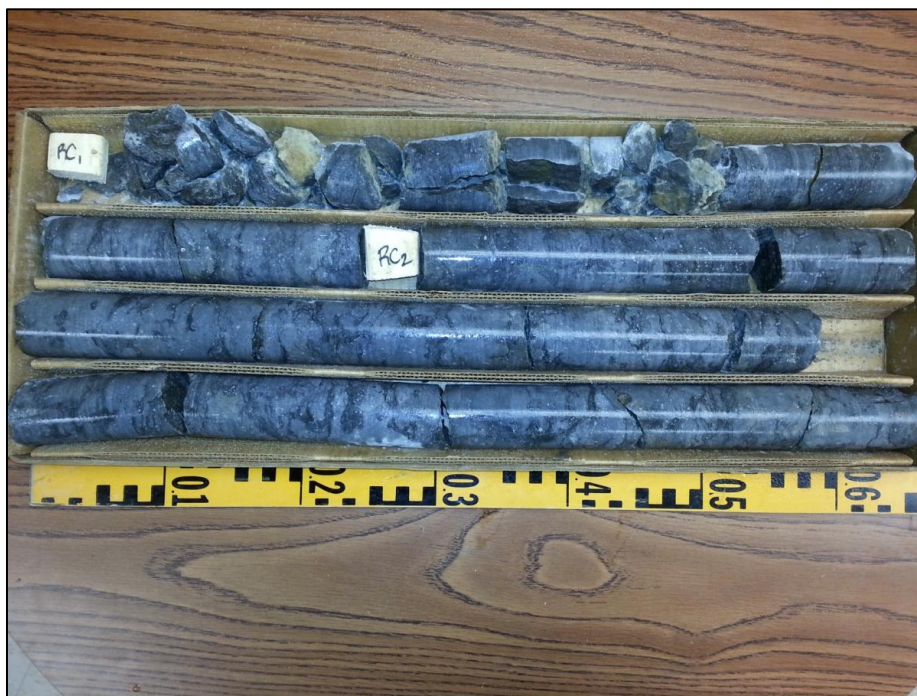
Photo 7 - Grey limestone bedrock cored between 0.6 to 2.9 m depth at BH 2.

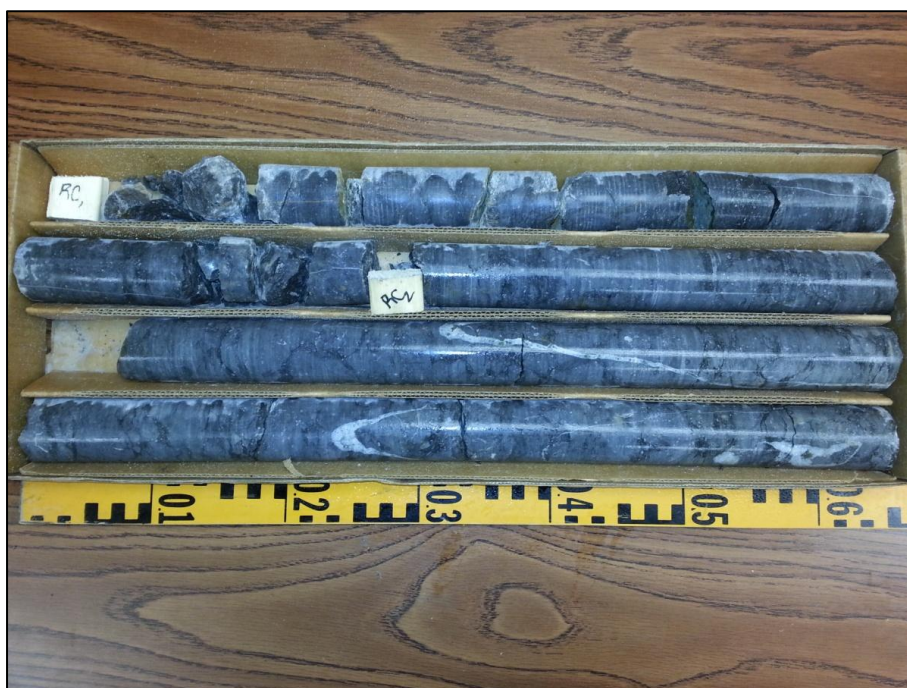
Photo 8 - Grey limestone bedrock cored between 0.8 to 3.1 m depth at BH 5.

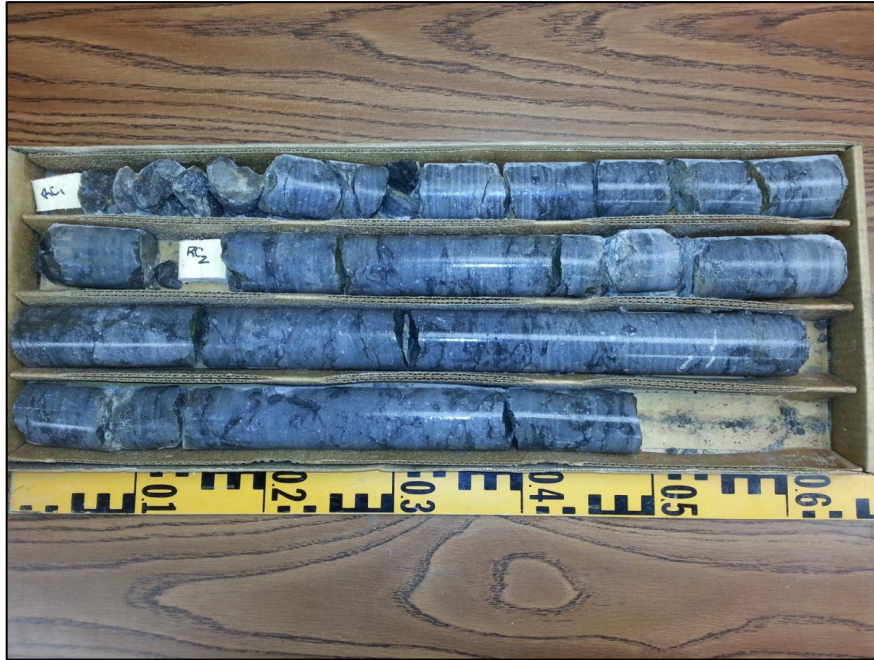
Photo 9 - Grey limestone bedrock cored between 0.9 to 3.1 m depth at BH 7.

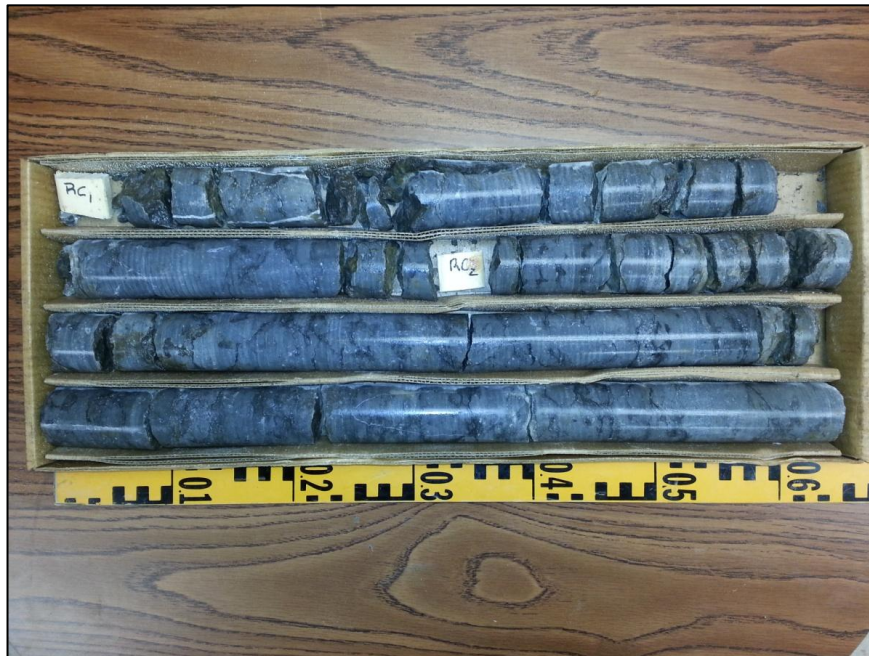
Photo 10 - Grey limestone bedrock cored between 0.6 to 3.0 m depth at BH 10.

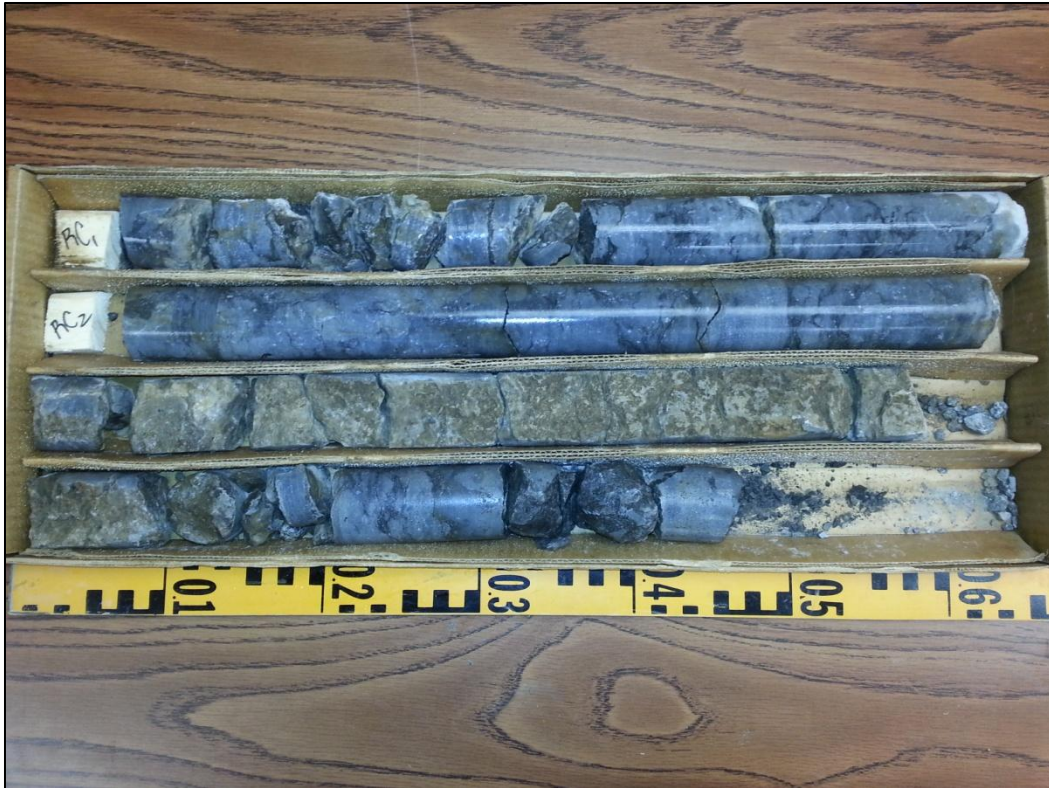
Photo 11 - Grey limestone bedrock cored between 1.1 to 3.2 m depth at BH 13.
