**REPORT ON  
PARLIAMENT HILL – CENTRE BLOCK  
NORTH ELEVATION  
MASONRY-STEEL GIRDER ASSEMBLY  
OTTAWA, ONTARIO**

April 2013

**PUBLIC WORKS AND GOVERNMENT SERVICES CANADA**  
Parliamentary Precinct Branch  
107 Sparks Street  
Ottawa, Ontario  
K1Z 7P2

**J.L. RICHARDS & ASSOCIATES LIMITED**  
Engineers • Architects • Planners  
864 Lady Ellen Place  
Ottawa, Ontario  
K1Z 5M2

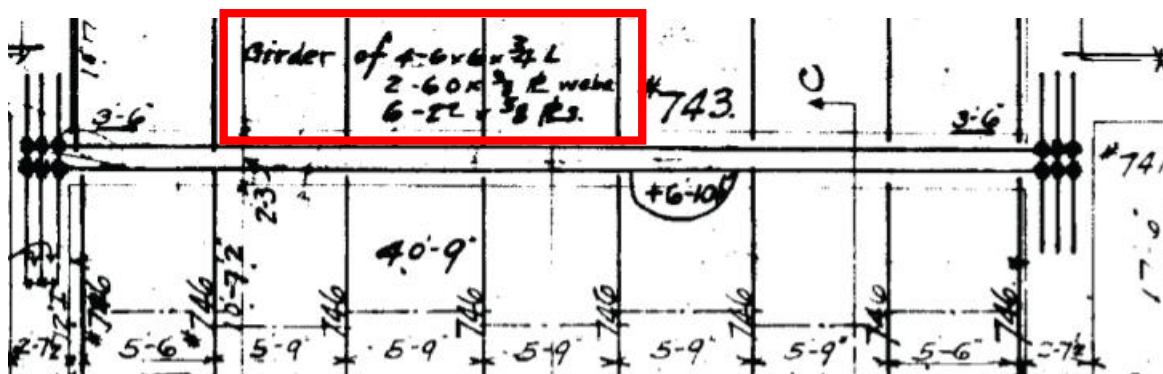
The steel girder construction is noted on the first floor framing plan drawing; the drawing indicates the construction as follows:

The PDF scans provided of the drawings do not have sufficient resolution to determine the construction of the girder; however, the assumed construction is as follows:

- (4) – 152x152x19 (6"x6"x3/4") Angles
- (2) – 1524x9.5 (60"x3/8") Web Plates
- (6) – 559x16 (22"x5/8") Flange Plates
