**REPORT ON  
PARLIAMENT HILL – CENTRE BLOCK  
NORTH ELEVATION  
MASONRY-STEEL GIRDER ASSEMBLY  
OTTAWA, ONTARIO**

April 2013

JLR No. 25829

This report presents the results of a structural condition assessment of an existing steel girder that supports an exterior load-bearing masonry wall on the north elevation of Parliament Hill – Centre Block, which is a “Classified” Federal Heritage Building and is also a part of the Parliament Hill National Historic Site of Canada.

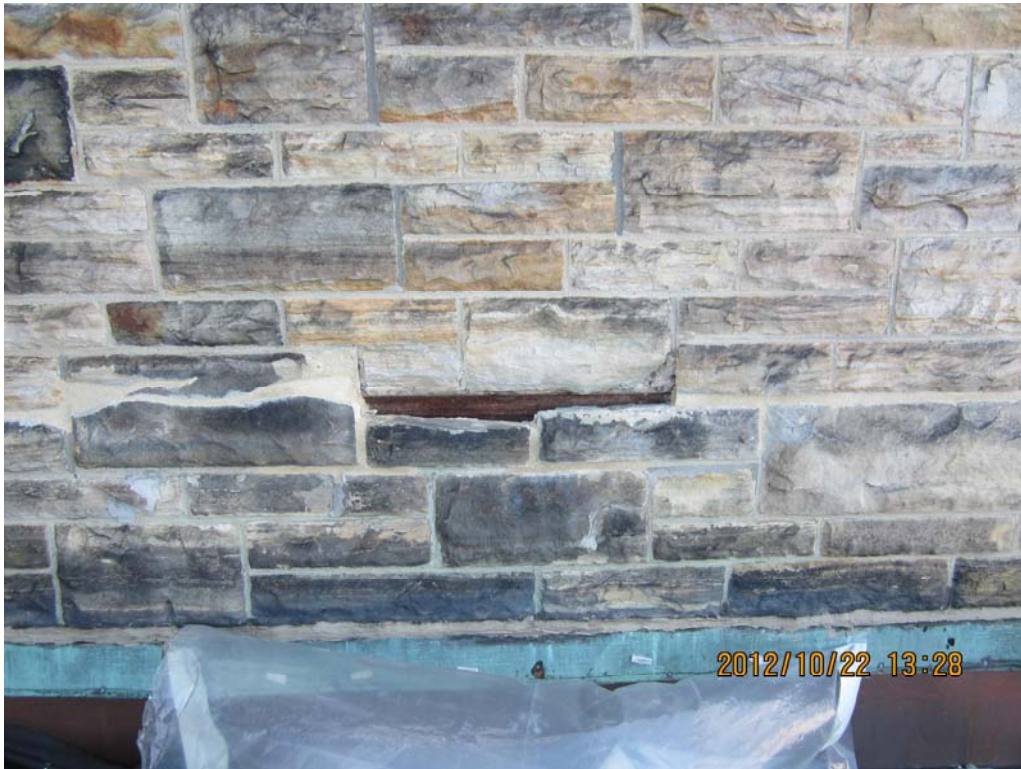
The steel girder is concealed by the exterior Nepean Sandstone stone facing, however, two areas of stone facing had been removed from the wall by masons engaged by PWGSC Plouffe Parks Heritage Mason (PPHM), exposing the built-up top flange of the steel girder. The first exposed area is approximately 750 mm (2'-6") long and is located at the east side of the North Gable (Photograph No. 1, Appendix 'A'). The second exposed area is approximately 1600 mm (5'-3") long and is located at the west side of the North Gable (Photograph No. 2, Appendix 'A'). Black soiling of the stone was noted on either side of the North Gable (Photograph No. 3, Appendix 'A').

**PHOTOGRAPH NO. 1** – Exposed steel girder top flange at the east side of the North Gable.

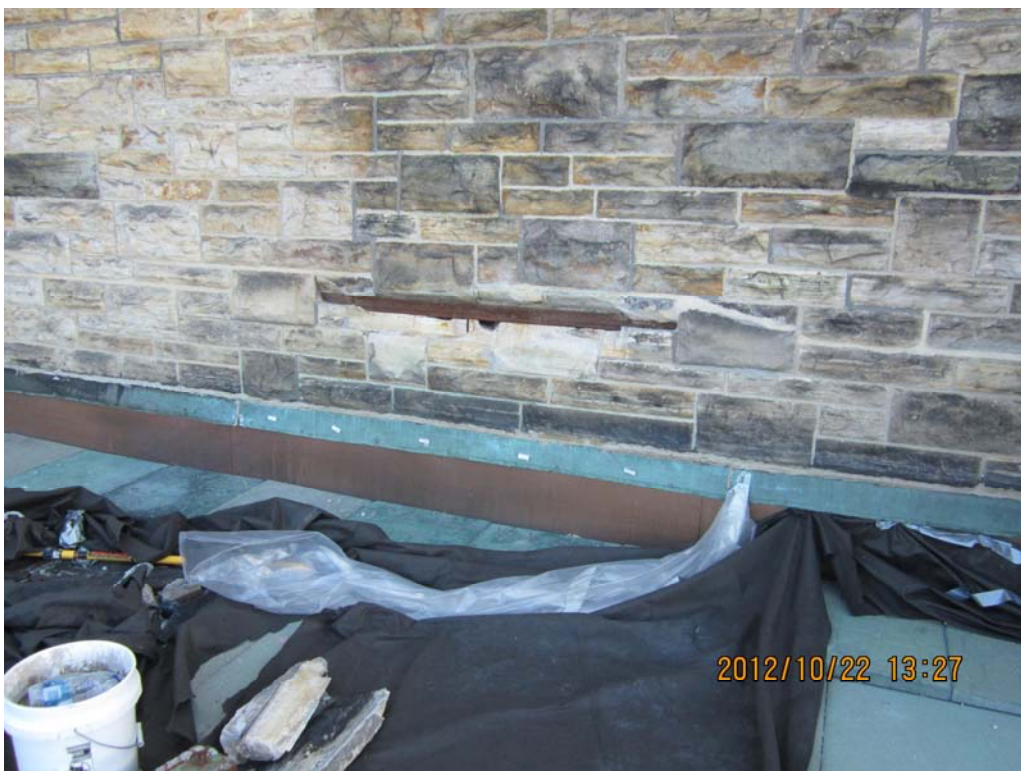
**PHOTOGRAPH NO. 2** – Exposed steel girder top flange at the west side of the North Gable.

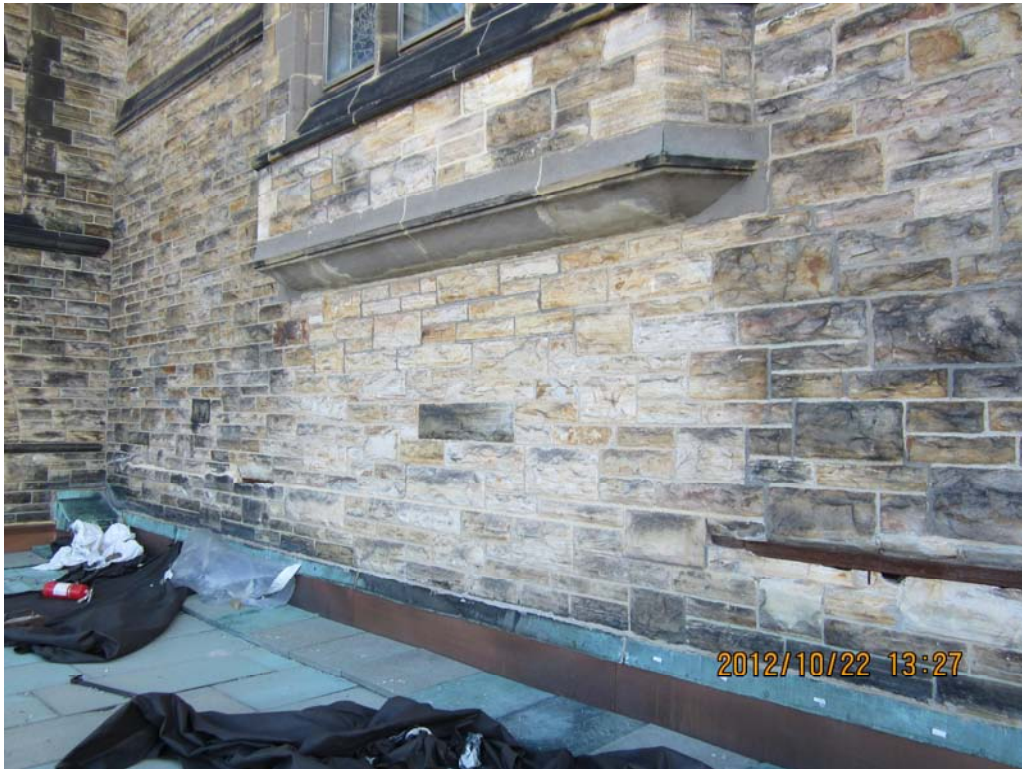
**PHOTOGRAPH NO. 3** – Black soiling of Nepean Sandstone on either side of the North Gable.

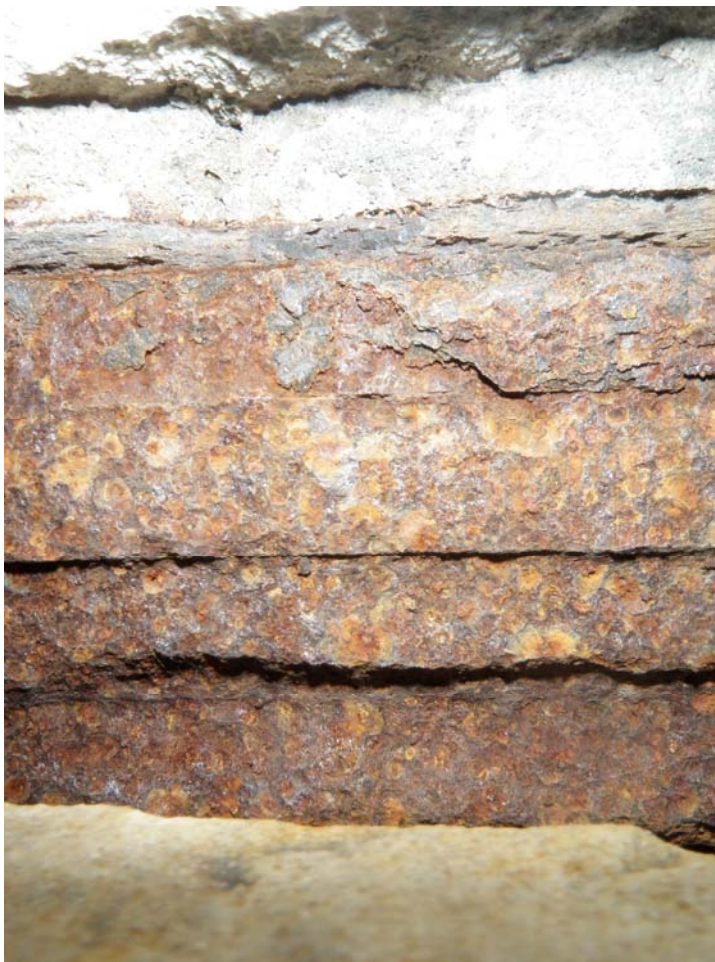
The sections of the steel girder top flange visible due to removed stone facing consisted of four steel sections riveted together. The four sections consisted of three top plates of similar thickness and a bottom section which was thicker (Photograph No. 4, Appendix 'A'). It is assumed that the bottom steel section is the 152x152x19 (6"x6"x3/4") angle noted on the structural drawings that connects the top flange plates to the web plate. Surface rust was noted on all exposed steel, and some structural flaking was noted at the edge of the girder top flange exposed on the east side of the North Gable (Photograph No. 5, Appendix 'A').

**PHOTOGRAPH NO. 4** – Exposed built-up top flange of steel girder.

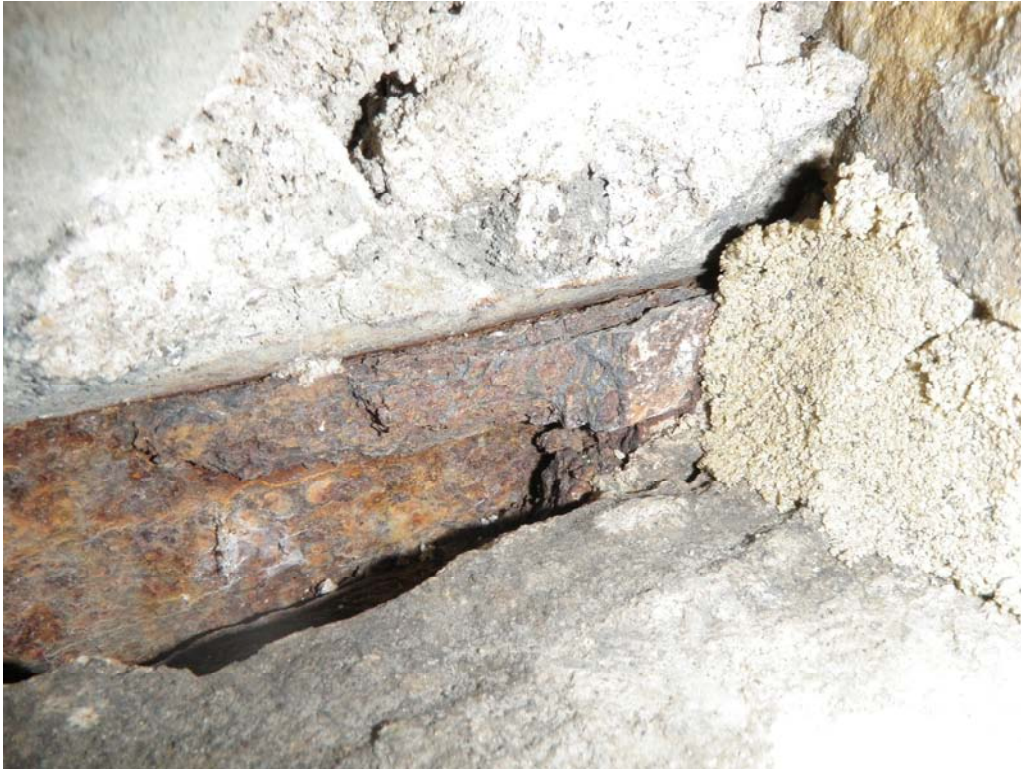
The broken stones noted at the top flange of the steel girder are likely caused by a combination of water penetration, freeze-thaw cycles, and steel expansion due to corrosion. Although the amount of structural flaking noted on the outside edge of the steel girder top flange, it is possible that corrosion may be a factor in the broken stones noted.

**PHOTOGRAPH NO. 5** – Evidence of structural flaking on the edge of the exposed built-up top flange of the steel girder.

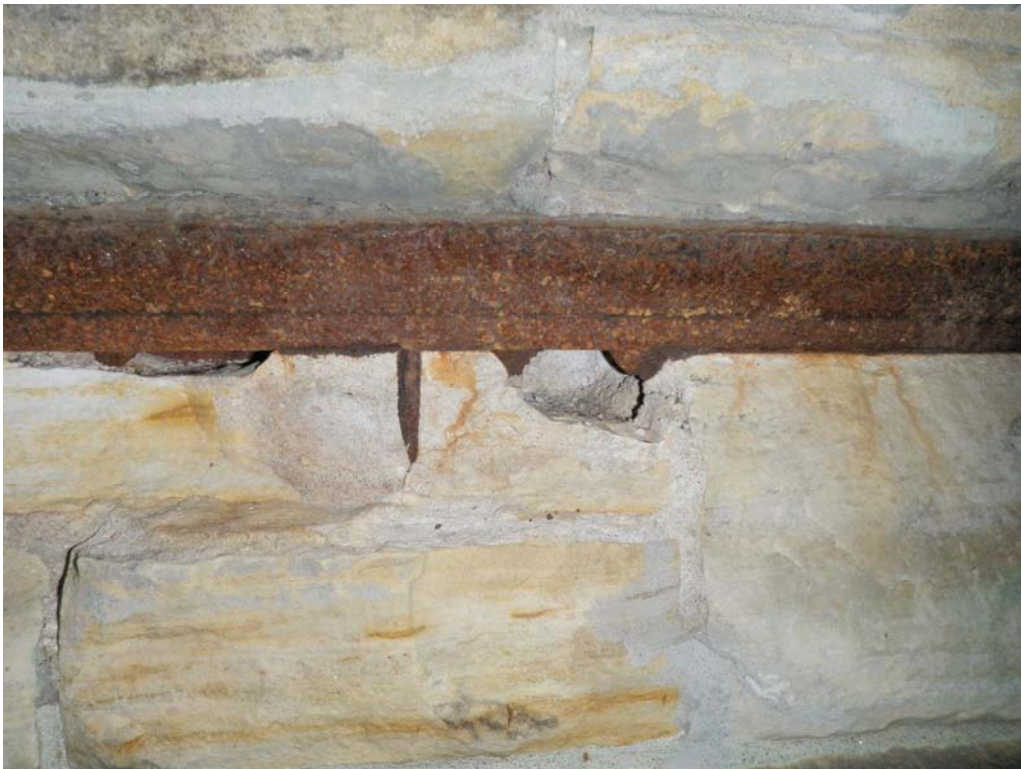
**PHOTOGRAPH NO. 6** – Exposed web stiffener of steel girder.

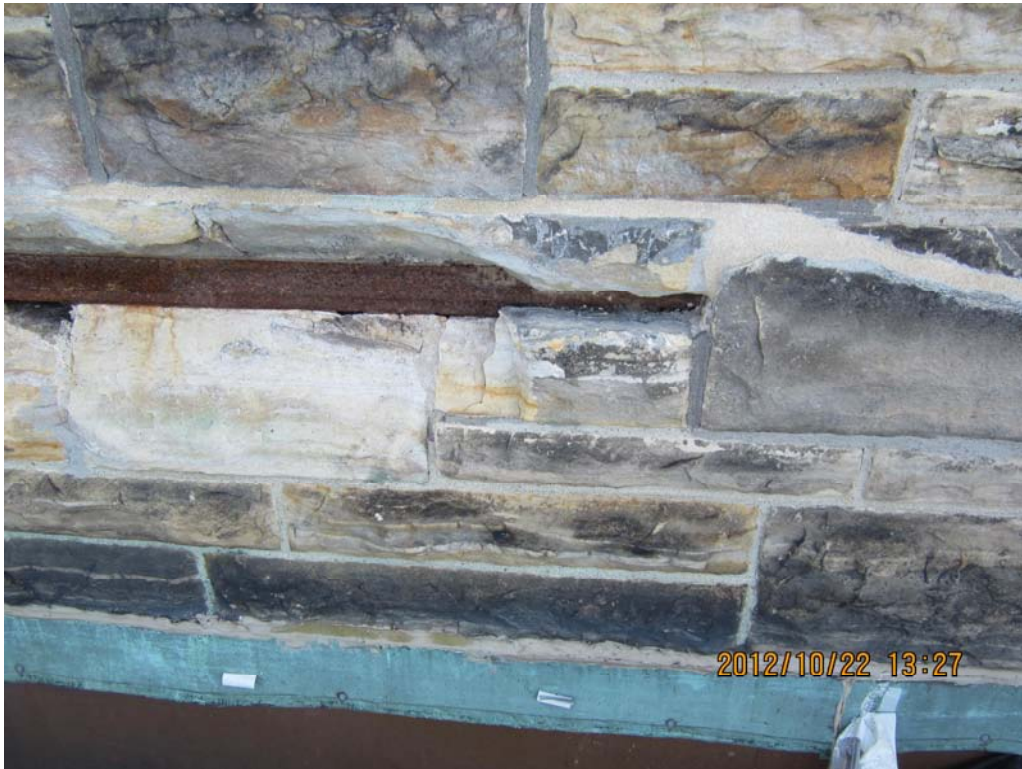
A number of mortar joints had been repointed, including the joints running parallel to the top flange of the steel girder, of which most had nearly been entirely repointed (Photograph No. 7, Appendix 'A'). A representative from HCD indicated that some of the repointing had been completed in August 2012 as part of work performed to temporarily close and prevent additional ingress of water into the cracks discovered during site review at the north dormer.

A number of stones had broken along the top flange of the steel girder; the cracks in the broken stones had been pointed with the same repair mortar used to repoint existing mortar joints.

Previous repointing work has been met with varying degrees of success due to the varying nature of the mortars used. As discussed in the referenced 1999 Condition Assessment report, hard cement-based mortars reduce breathability of the masonry wall assembly which may cause premature degradation of the masonry due to accelerated freeze-thaw action. This freeze-thaw action may cause the mortar or stone to crack or spall, allowing additional moisture into the wall assembly.

**PHOTOGRAPH NO. 7** – Exterior cracked stone repairs and repointed joints.

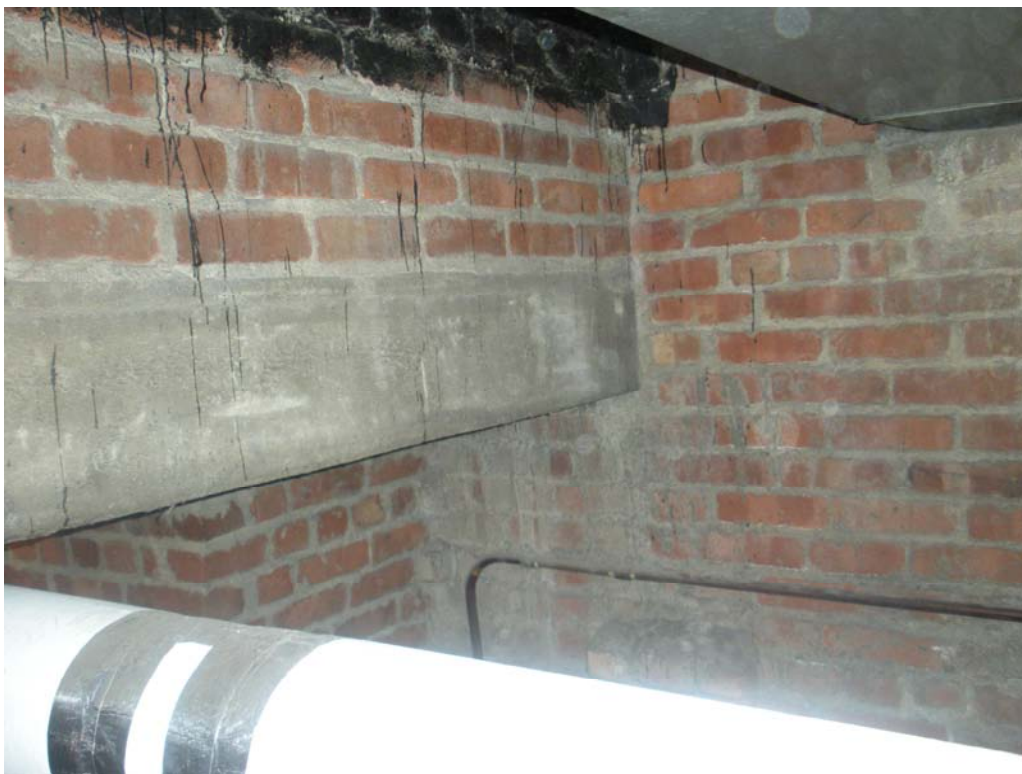
The steel girder is concealed by the interior brick masonry backing, except for the bottom flange, which is encased in concrete (Photograph No. 8, Appendix 'A'). No spalling of brick was noted. Hammer sounding was performed and hollow sounds were noted at the apparent top flange of the steel girder, indicating a possible void between the face of the top flange and the back of the brick.

**PHOTOGRAPH NO. 8** – Bottom flange of steel girder encased in concrete.

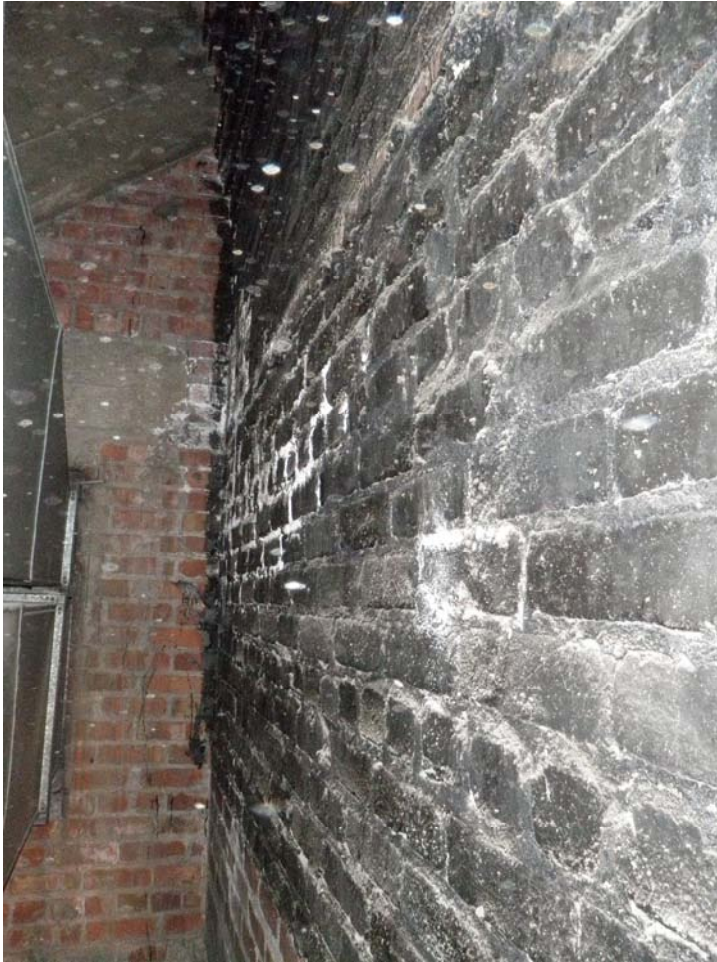
The efflorescence noted on the interior face of the masonry wall assembly could be an indication that moisture is travelling through the wall from the exterior to the interior. This type of moisture travel is opposite to that of traditional masonry wall assemblies, in which moisture typically travels from the warm, moist interior towards the colder exterior. One possible reason for the atypical efflorescence is that the area above Room 216N is under negative pressure, possibly due to stack effects caused by the adjacent Ventilation Tower and Water Tower.

**PHOTOGRAPH NO. 9** – Efflorescence of interior face of masonry wall.

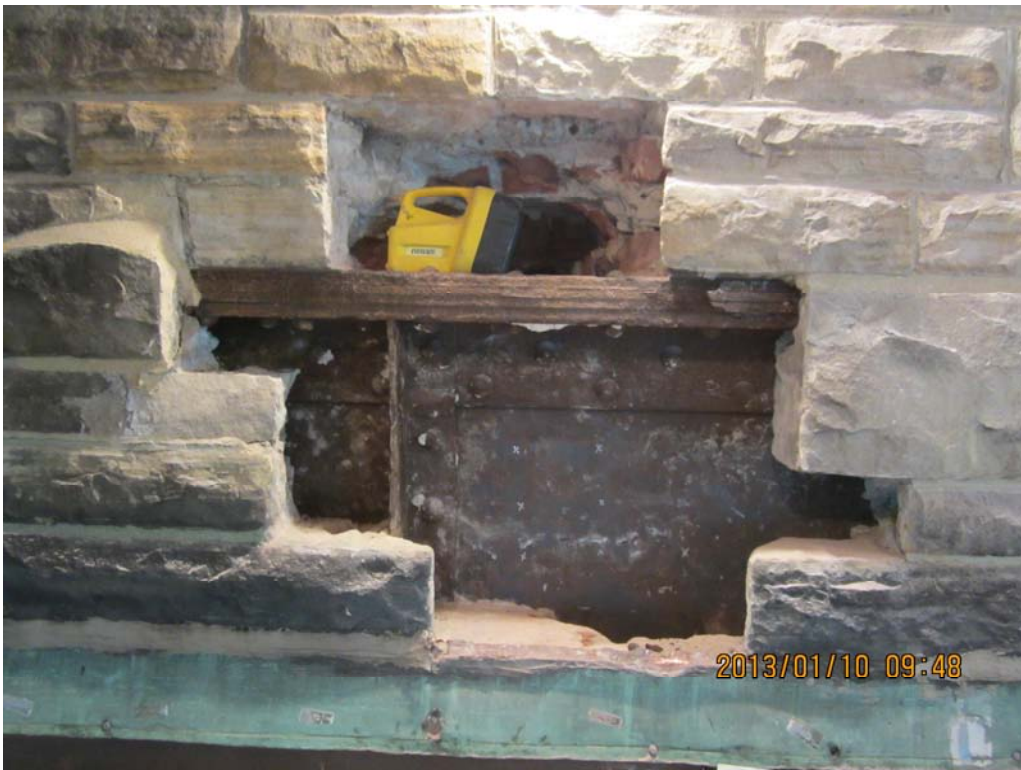
The two areas of exposed top flange noted in the preliminary visual inspection had been enlarged by selective dismantling of the exterior stone wall by masons engaged by PPHM. The two openings penetrated through the entire wall assembly and exposed the entire width of the top flange, a portion of the web plate and stiffener angles (Photograph Nos. 10 and 11, Appendix 'A').

**PHOTOGRAPH NO. 10** – Selective dismantling of masonry wall at the east side of the North Gable.

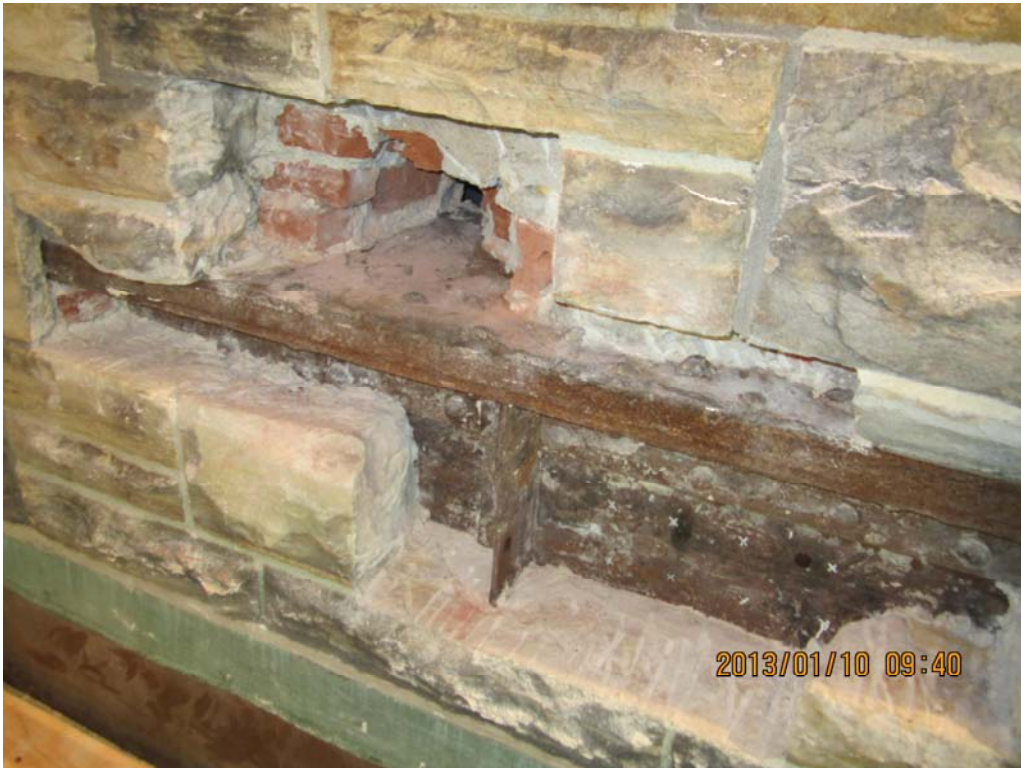
**PHOTOGRAPH NO. 11** – Selective dismantling of masonry wall at the west side of the North Gable.

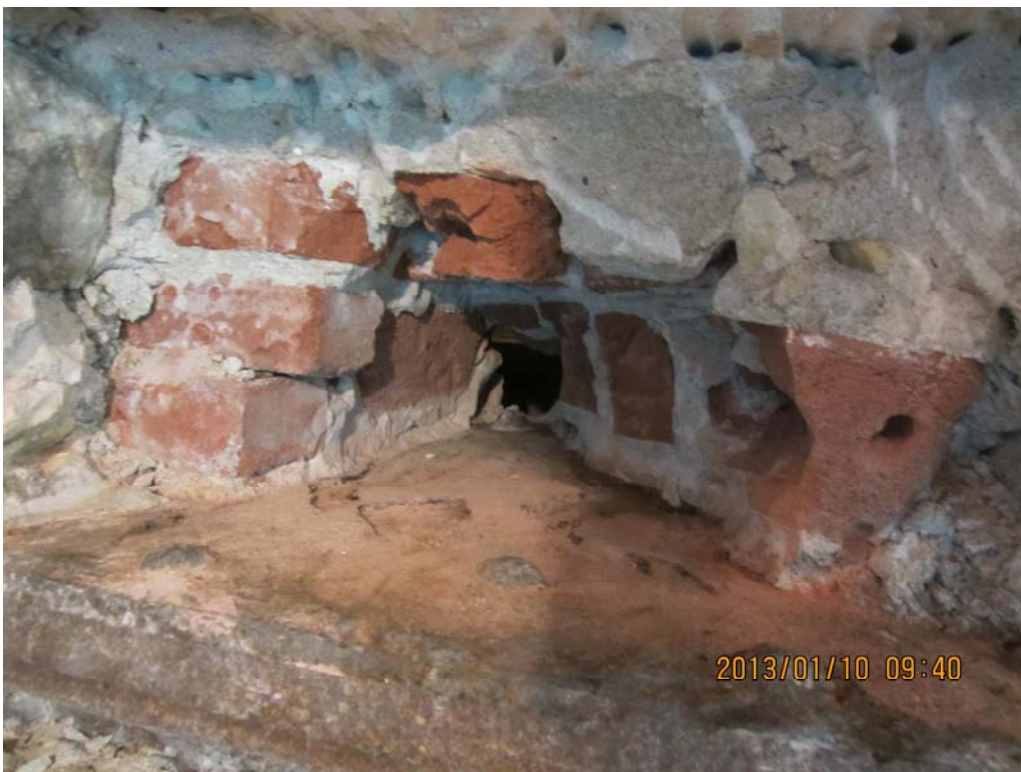
Surface rust was observed on both the top and exterior side of the exposed portions of the top flange (Photograph No. 12, Appendix 'A'). The surface rust was flakey and friable and was measured to be approximately 4 mm (5/32") thick, except for one area of the side flange at the east opening which had localized flaking over 6 mm (1/4") in thickness. Very little surface rust was noted on the underside of the top flange. The top flange width was measured to be 559 mm (22") wide, confirming the width noted on the structural drawings.

Some surface rusting of the top flange was noted during the site visits; however, this rust appears to be limited to the top plate of the three-plate built-up top flange and did not appear to show signs of significant loss of section. The areas of the web plates exposed by selective masonry removals did not show any signs of significant corrosion.

**PHOTOGRAPH NO. 12** – Surface rust on built-up top flange of steel girder.

In order to ensure that the existing steel girder maintains its current condition and to extend its service life, it is recommended that PWGSC consider three options for the installation of a protective coating to the top flange of the girder:

- Install coating on an “as needed” basis as any future damaged masonry is discovered.
- Install coating to the entire length of the steel girder.

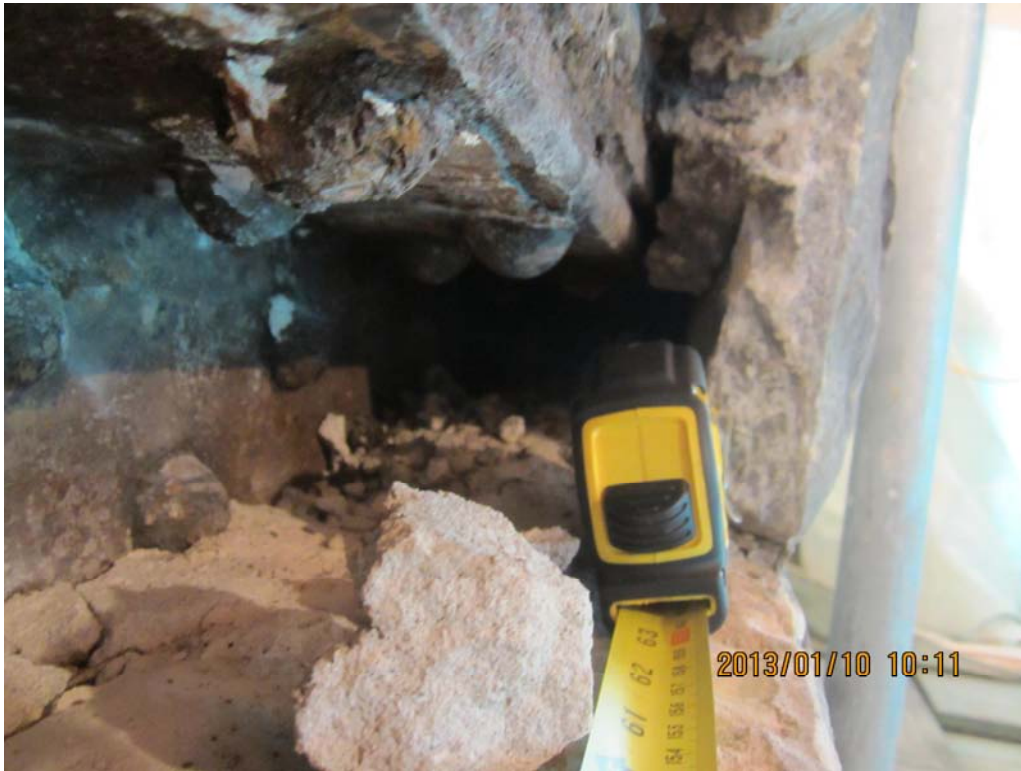
It was noted that the stone immediately to the west of the west opening had no backing brick or stone between the stone face and the steel girder web face (Photograph No. 13, Appendix 'A'). Voids were also noted between the exterior face of the top flange and the back face of the exterior stone.

**PHOTOGRAPH NO. 13** – Void between exterior stone and steel girder web at west side of North Gable.

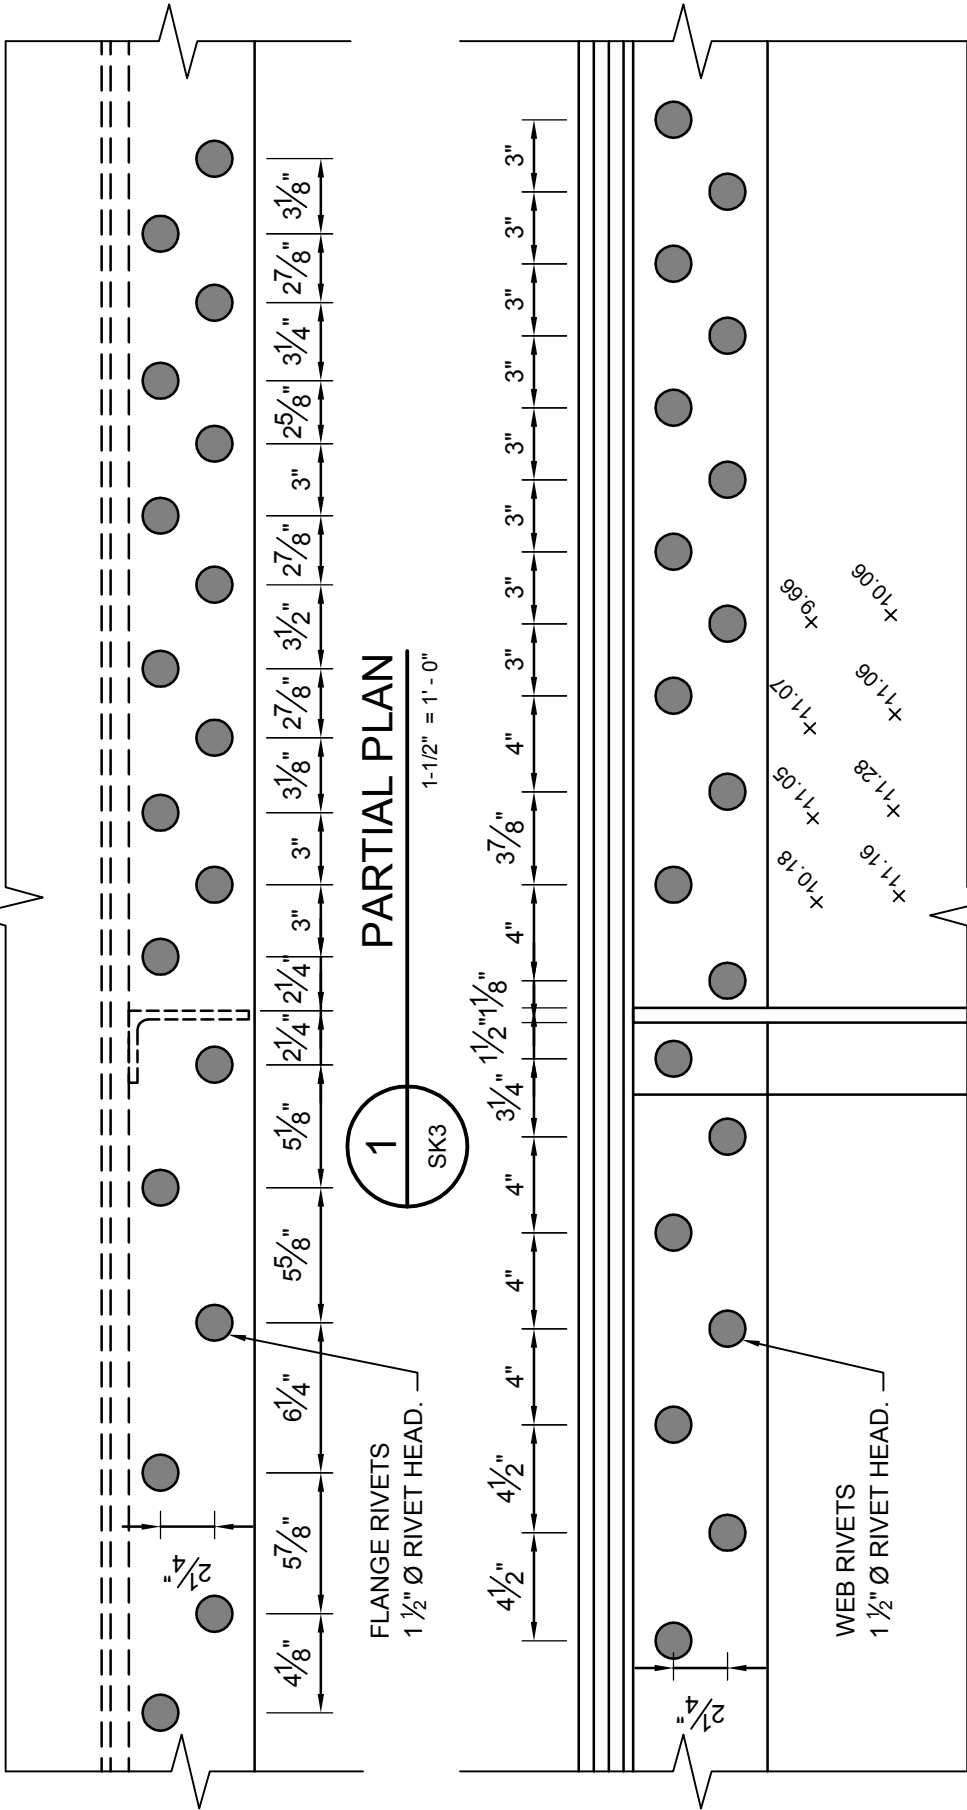
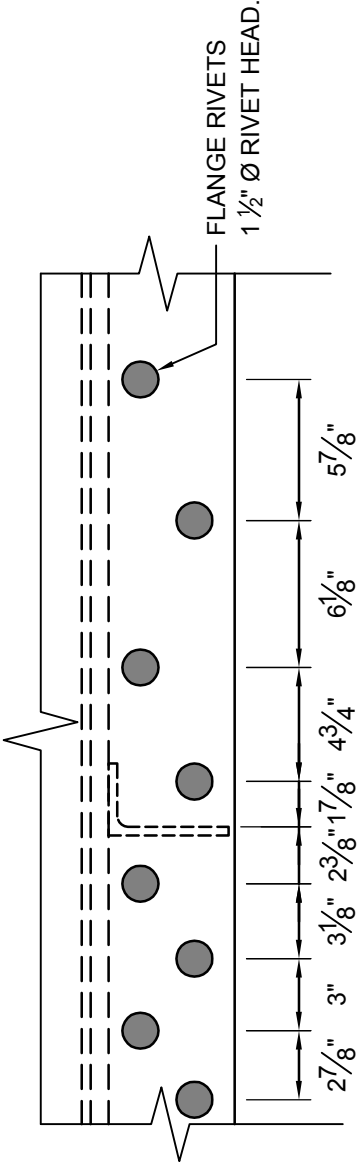
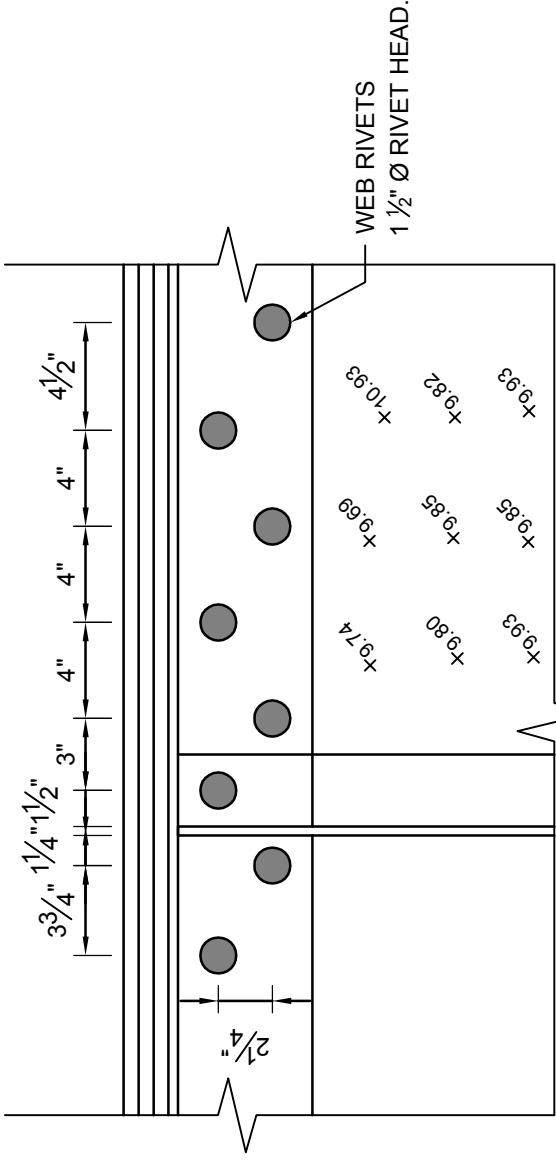
JLR NO: 25829  
DRAWING NO.: SK2

Very little surface rust was noted on the web plate. An ultrasonic thickness gauge was used to determine the thickness of the web plate. A number of readings were taken on both the east and west openings and can be found on Sketches SK2 and SK3, Appendix 'B'. The average web thickness was measured to be 10.3 mm (13/32").

2  
SK4  
ELEVATION  
1-1/2" = 1' - 0"  
THICKNESS OF WEB PLATE DENOTED BY: x 10.06
