## DESIGN DEVELOPMENT REPORT

### **Centre Block, Parliament Hill, Ottawa East and West Pavilions Rehabilitation**

July, 2013  
(Final version)

Project # R.027594.018

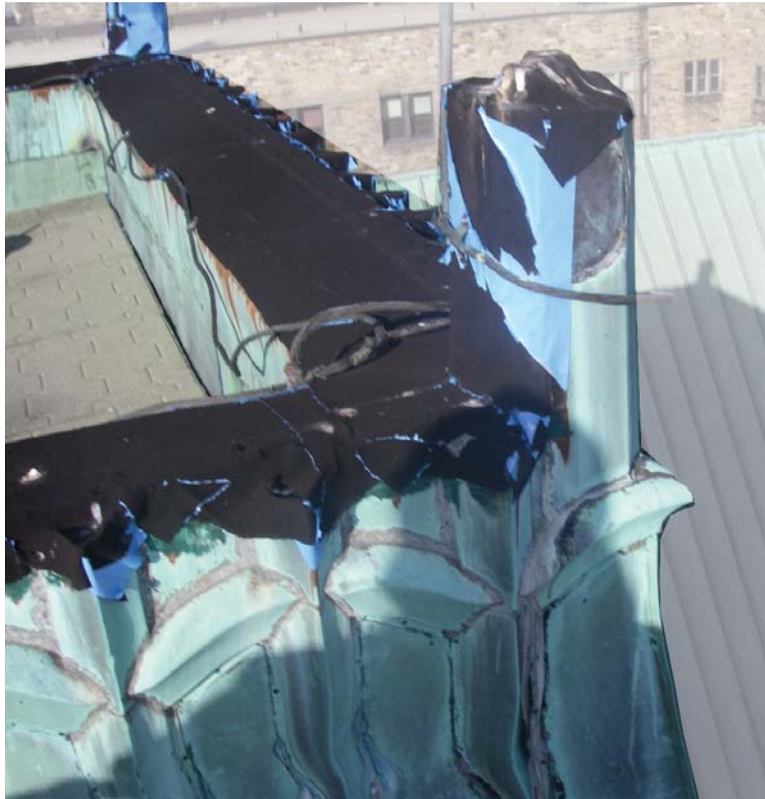
The original cresting and finials were removed and stored outdoors when they became so damaged they presented a falling hazard. Originally constructed out of copper and filled with concrete, the replicas will most likely be made of copper with a metal endoskeleton acting as a reinforcing agent.

The replicas will be based on surveys of the old cresting that has been conserved by PWGSC, and the drawings that were provided by PWGSC.

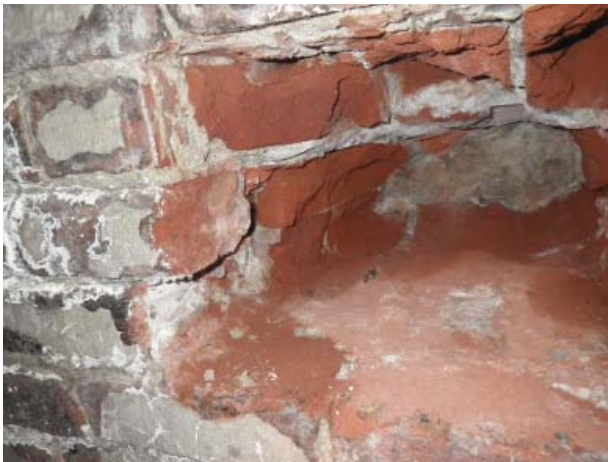
Figure 2-XI: Evidence of humidity towards the face stone.

- Some evidence of humidity was found inside the large opening which corresponds to the high levels of efflorescence noted on the exterior.

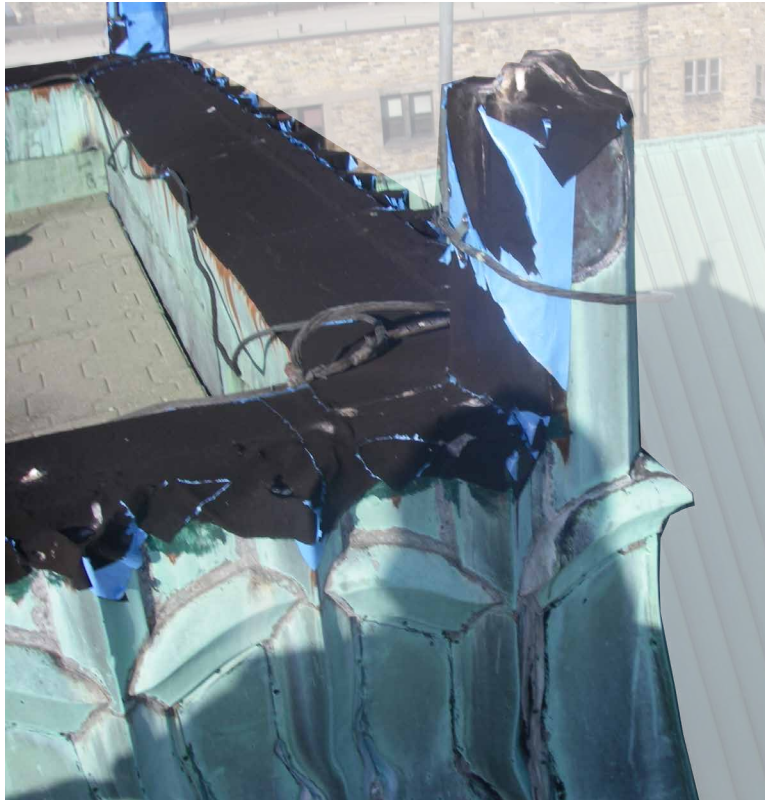
The original cresting and finials were removed and stored outdoors when they became so damaged they presented a falling hazard. Originally constructed out of copper and filled with concrete, the replicas will most likely be made of copper with a metal endoskeleton acting as a reinforcing agent.

The replicas will be based on surveys of the old cresting that has been conserved by PWGSC, and the drawings that were provided by PWGSC.

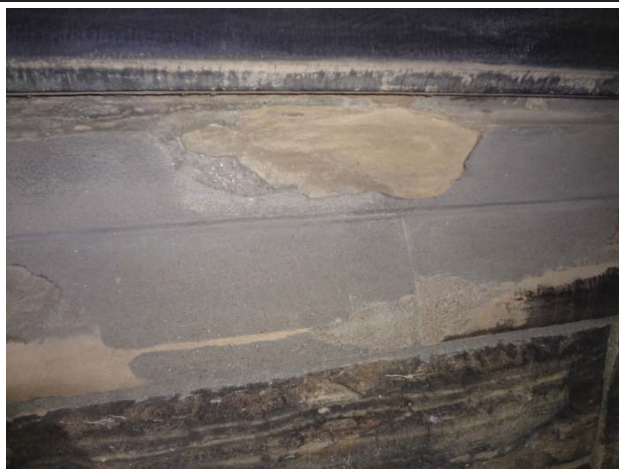
Pour les deux pavillonss, les tourelles montrent les signes de dégradation les plus importants. Nous avons observé des déplacements, de la fissuration des joints et des pierres, plusieurs interventions antérieures inappropriées, des pierres érodées et des joints ouverts.

Photo n° 4: Délamination de la réparation et pierre érodée sous la surface

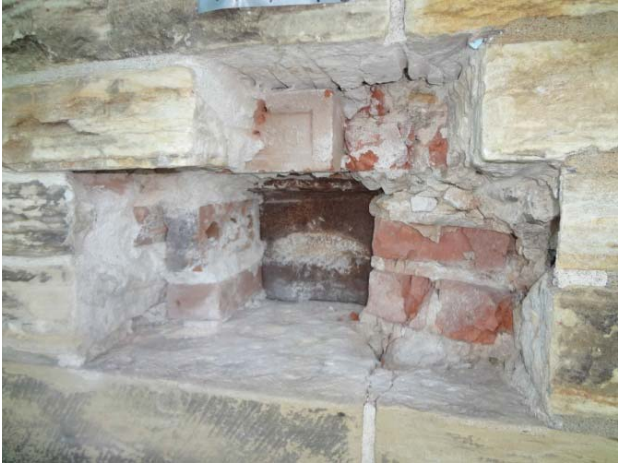
WT13 : La pierre de parement a été retirée ainsi que la maçonnerie de briques, exposant une poutre d'acier.

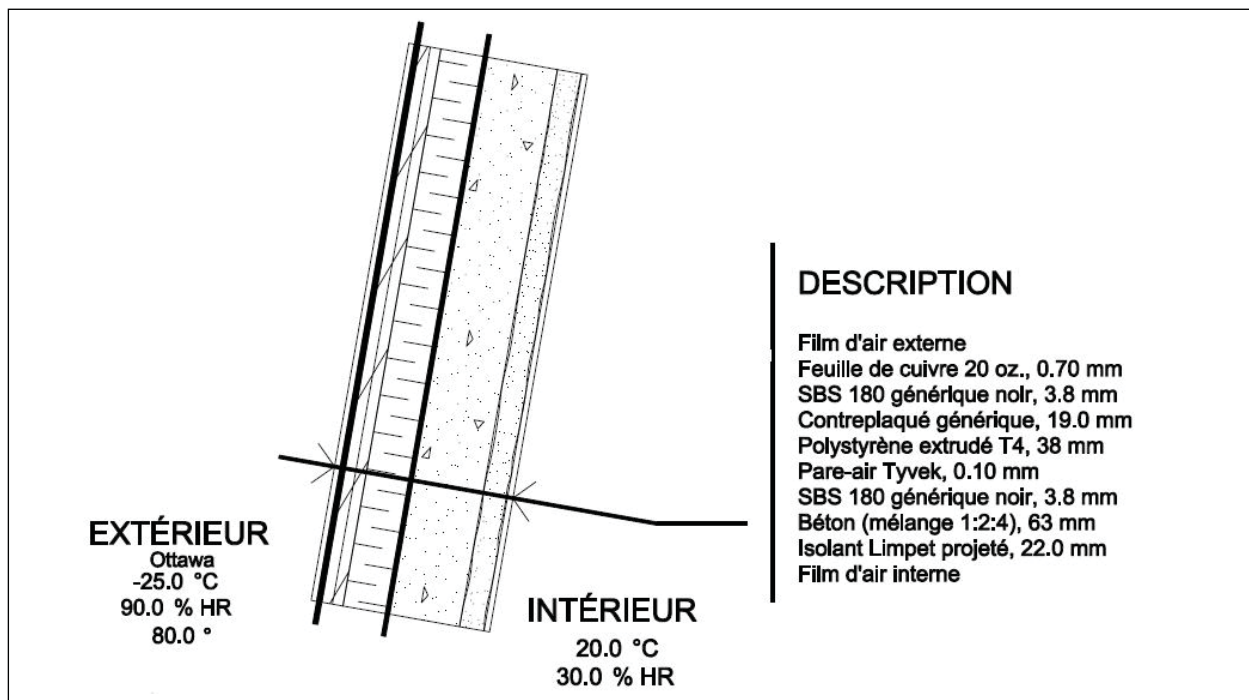
**Figure n° 5: Modélisation de l'assemblage n°1 modifié**

Les résultats indiquent néanmoins un risque de condensation au niveau de l'isolant de polystyrène extrudé. La couverture de cuivre et la nouvelle membrane de sous-couche de bitume élastomère offrent une grande proportion de la résistance à la vapeur d'eau totale de l'assemblage. Par conséquent, la pression de vapeur en diffusion dans l'assemblage ne chute pas suffisamment au niveau de la membrane existante sur la surface extérieure du béton, qui agit comme pare-vapeur, pour que l'atteinte de la pression de vapeur à saturation soit totalement évitée. Par conséquent, ces résultats indiquent un risque de condensation sur la surface intérieure du panneau de support en contreplaqué.
