# Designated Substances Survey Supplement for the Centre Block Building, 111 Wellington, Ottawa, Ontario

2013-06-07

Public Works and Government Services Canada  
Real Property Branch  
Professional and Technical Service Management  
Environmental Services Directorate

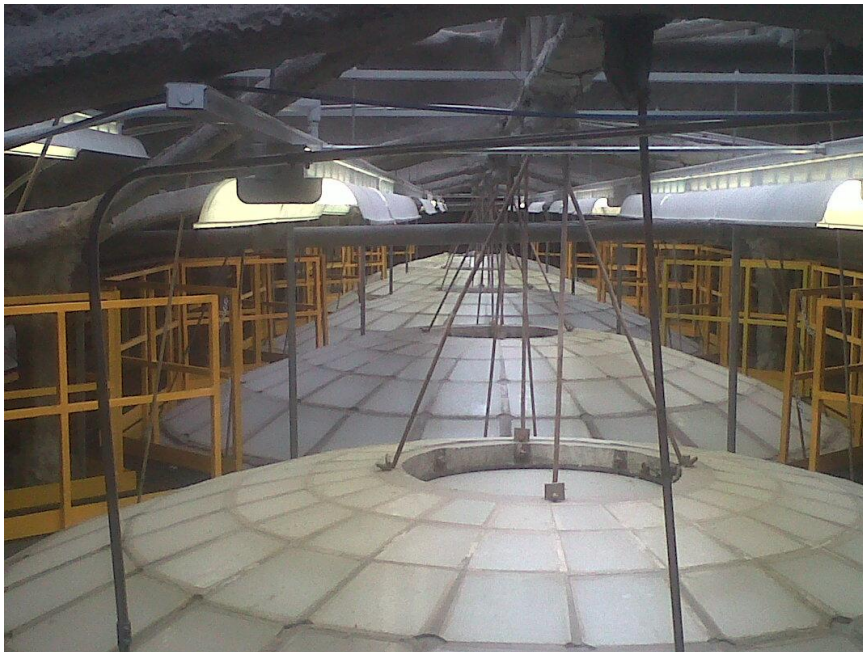
Across the catwalks, three grey terra cotta mortar samples were collected from the ceiling as well as three white plaster coat samples from the sloped exterior wall directly to the right of image 1's point of view.

Image 1: Kitchen and dining room catwalks on opposite side of kitchen ceiling hatch

Results showed that the white plaster coat of the exterior wall in the kitchen attic contained 1% Chrysotile asbestos. This extends to the exterior wall plaster coat in the Southeast corner of the crawlspace near Access 5. The mortar debris found on the floor of the Southeast corner of the attic also contains 1% Chrysotile.

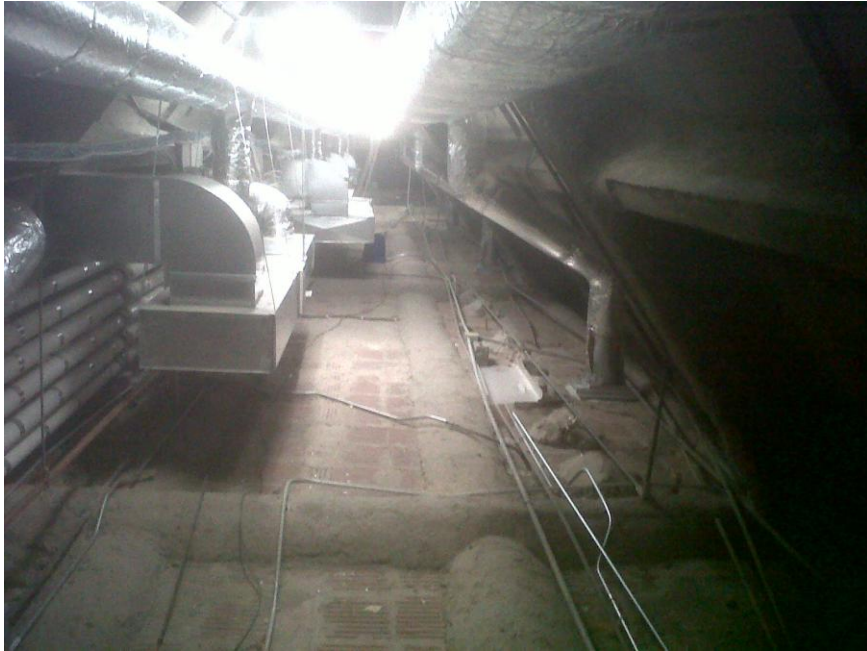
The east corridor (Image 2) was found to be similar to the south corridor.

Image 2: East corridor

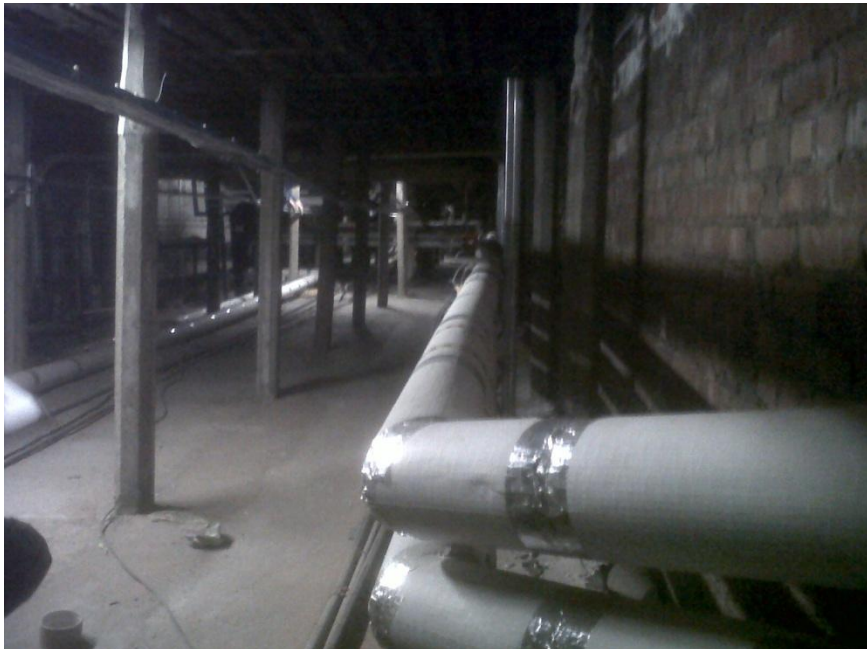
The space was accessed through a small access door in the wall of a stairwell, which is the North corridor of the crawlspace. The space had brick walls, terra cotta ceiling, cement floor and fibreglass mechanical insulation.

The vertical posts had the same granular cement coating as in the kitchen catwalk.

Image 3: North Corridor
