**REPORT
TO
PUBLIC WORKS AND
GOVERNMENT SERVICES CANADA**

**DEMOLITION WASTE SURVEY
FOUR BAY GARAGE**

**Lot 63, Group 1158, Plan 748,
NORMAN WELLS, NORTHWEST TERRITORIES**

November 2013

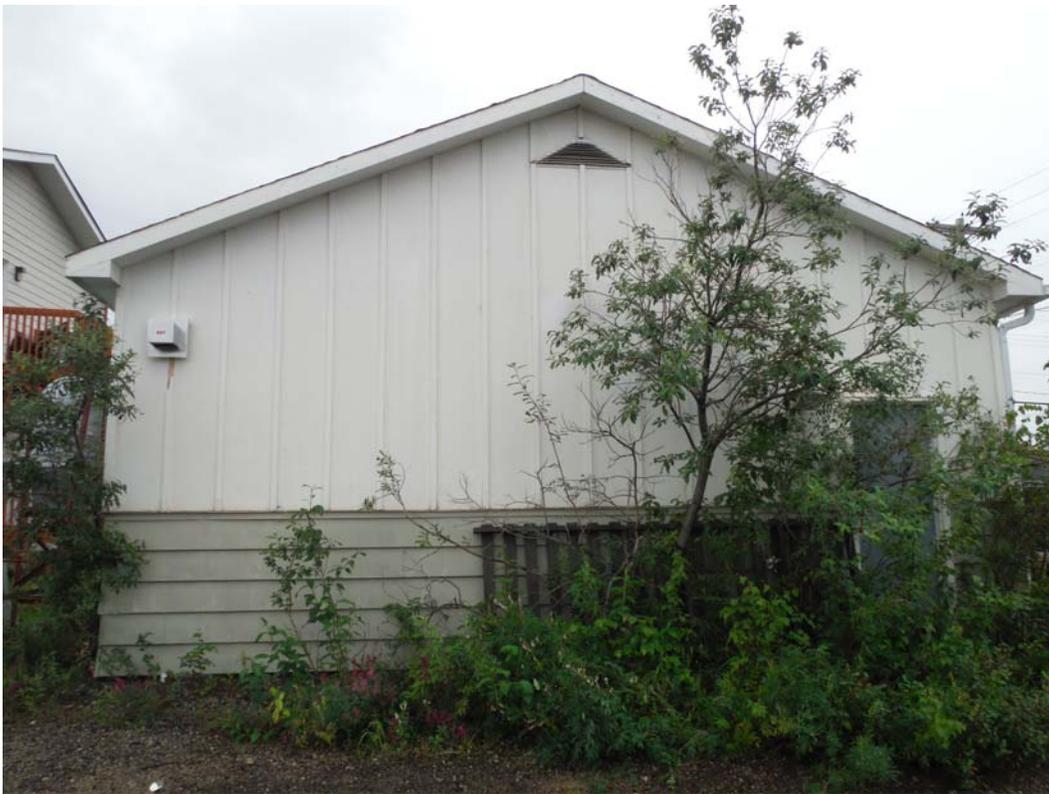
Photo 1: North side of the garage, note the oil fired heater exhaust.

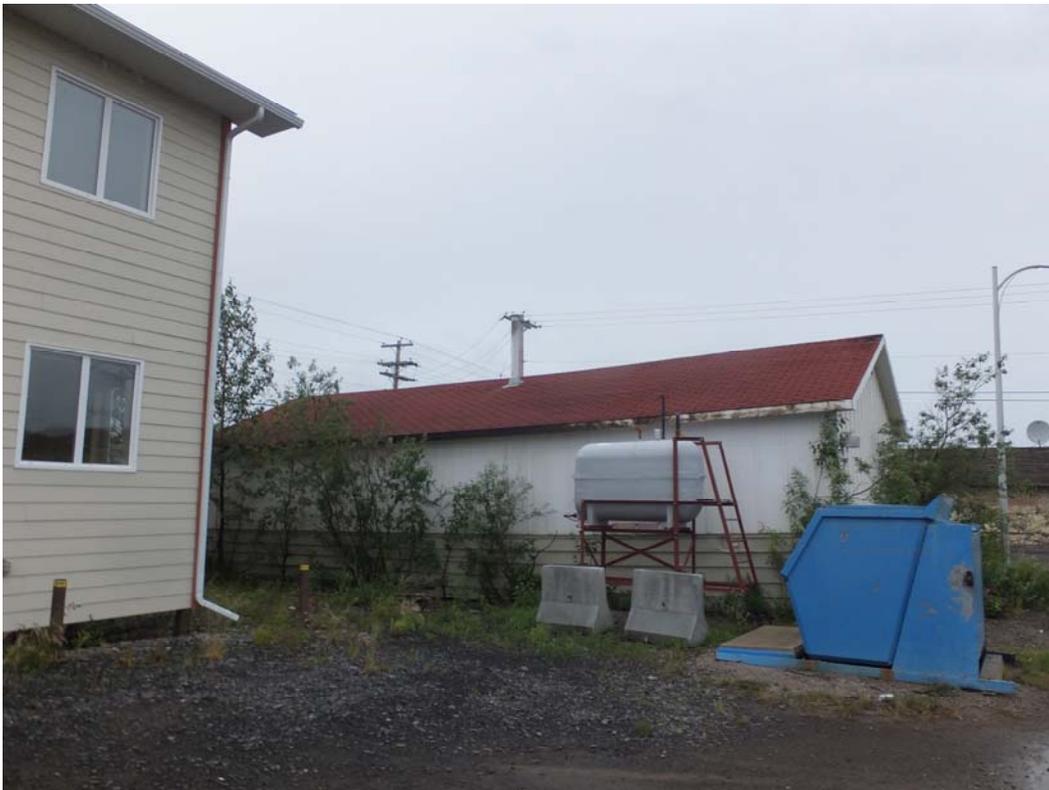
Photo 2: East side of the garage, note the above ground fuel storage tank and the chimney.

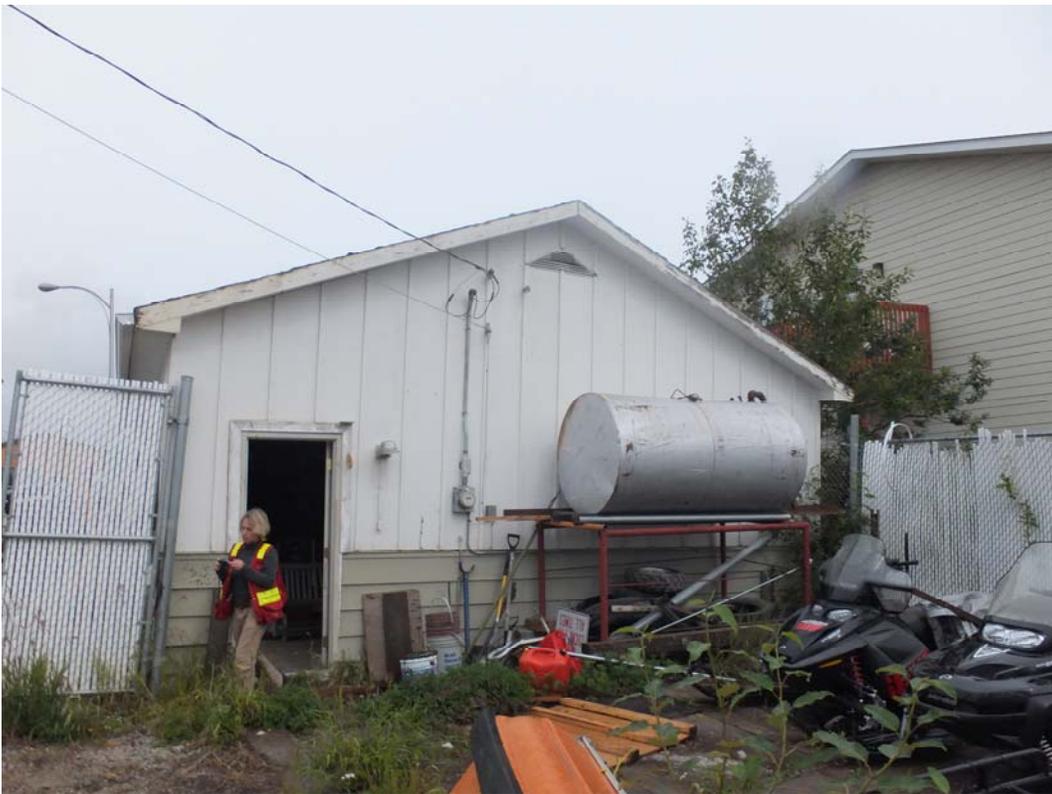
Photo 3: South side of the garage, note the 2000l water tank.

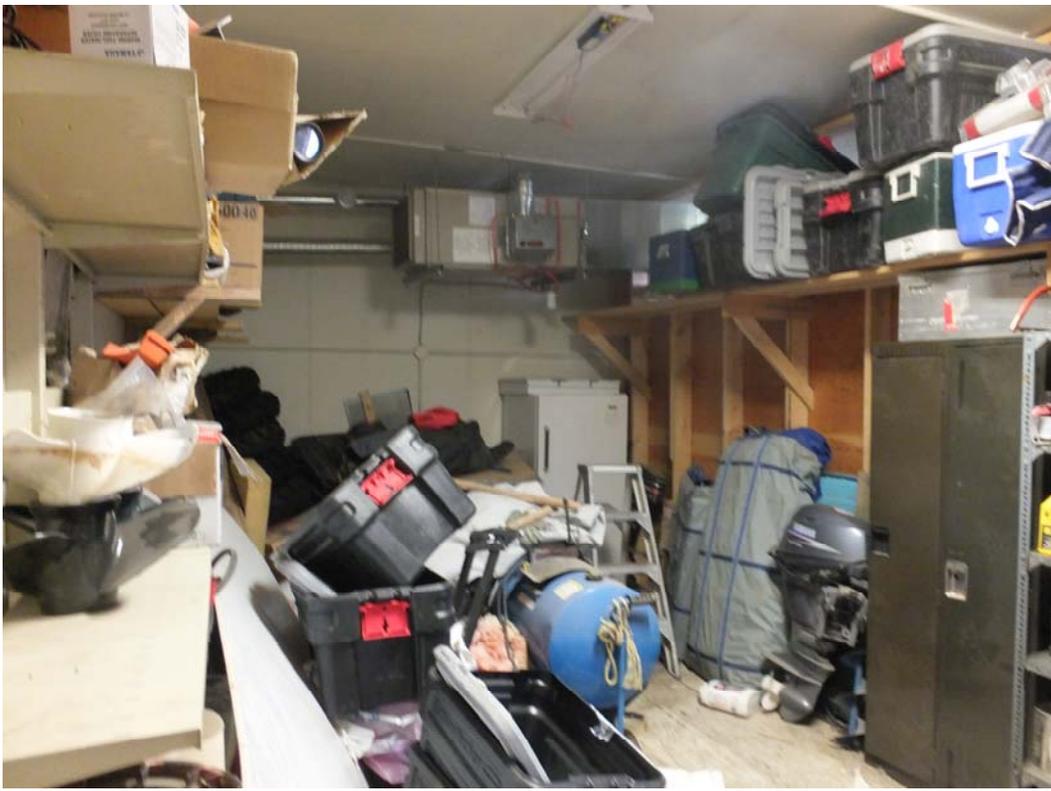
Photo 5: Inside of garage bay 1 facing east, note the ceiling mounted heater and associated ductwork, also the exposed light ballast and the freezer in the back corner.

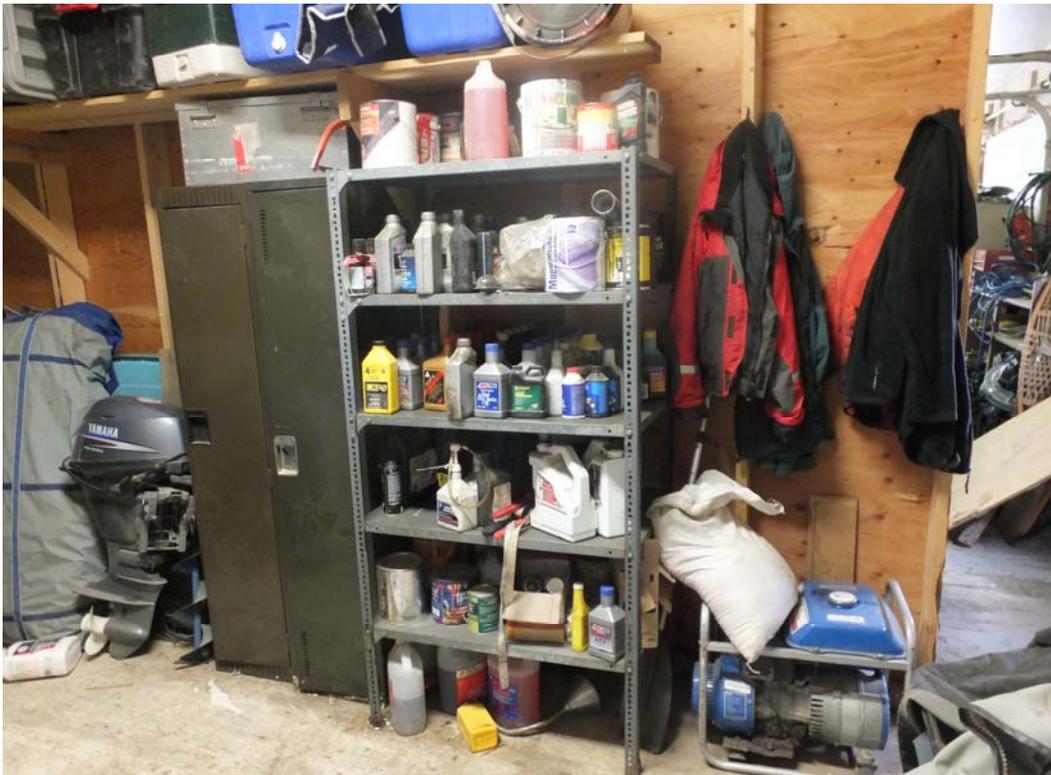
Photo 6: Lockers loaded with spray paint and paint thinner and shelving loaded with motor oil (for trucks, boats and ATVs).

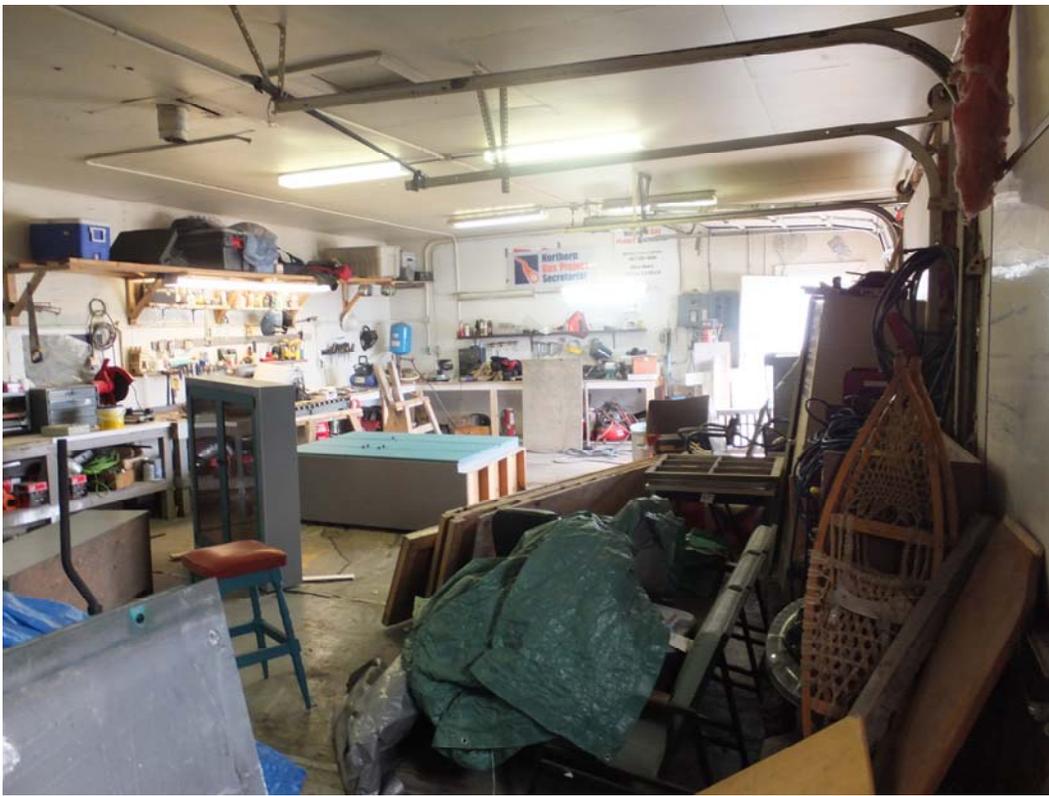
Photo 7: View south from bay 1 across the garage. Note the car batteries on the shelf below the work bench and the expansion tank for the water tank in the far corner.

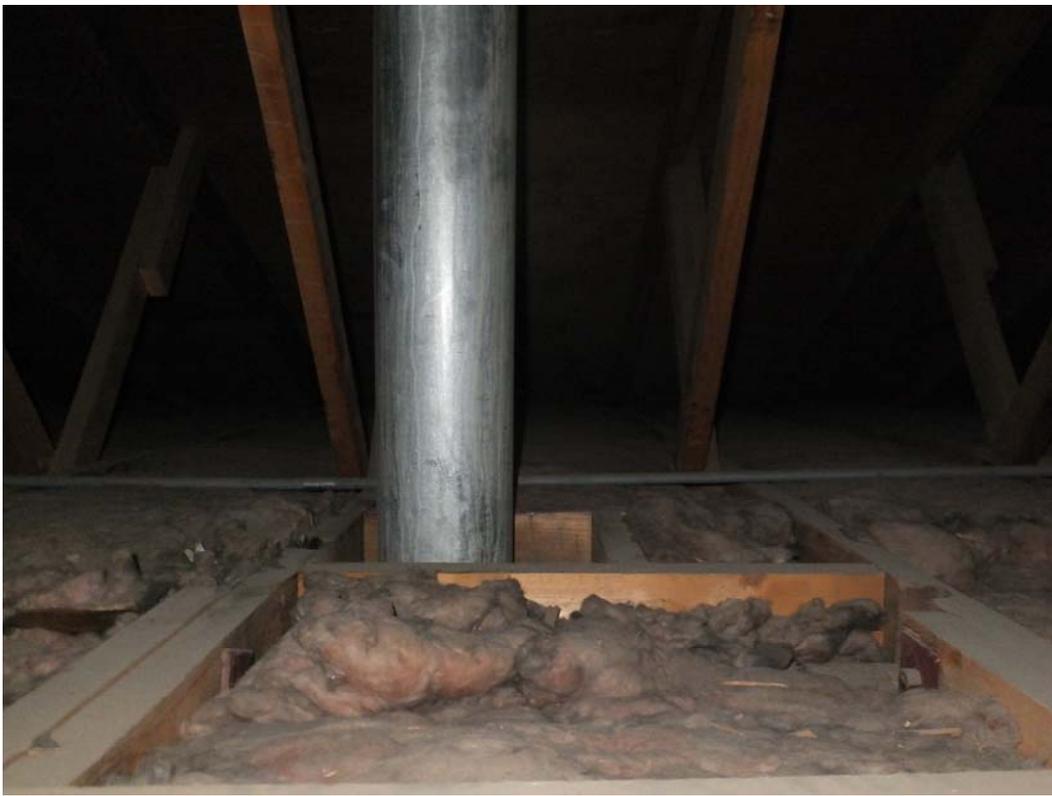
Glass fibre insulation was observed in the wall spaces of the exterior walls and the ceiling space.

Photo 9: Attic space, looking east from access hatch. Note the wood frame construction, glass fiber batt insulation and the abandoned oil stove pipe/chimney.

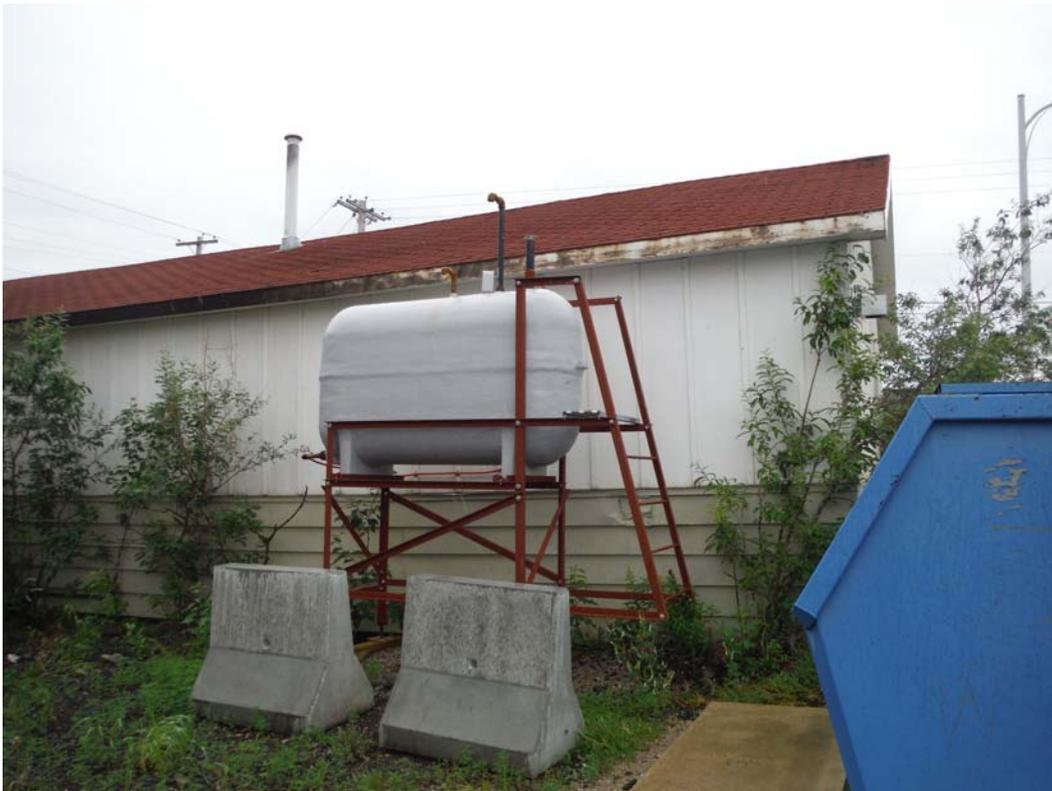
Photo 10: The above ground fuel storage tank located on the north side of the garage.

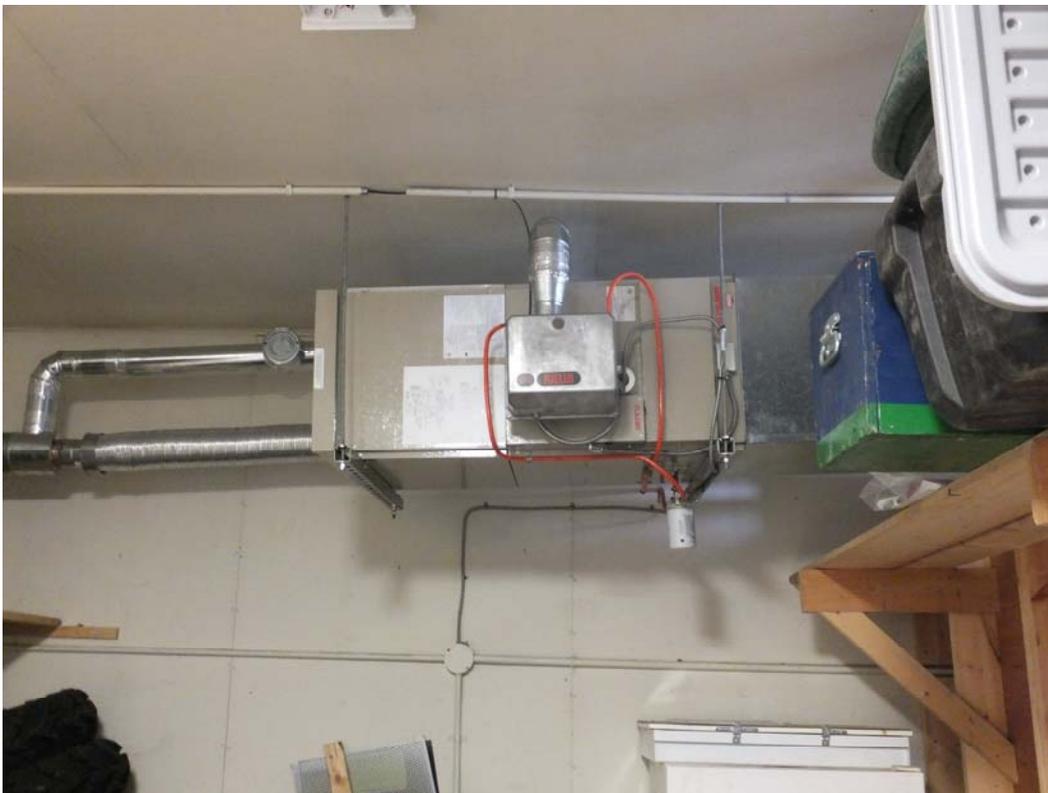
Photo 11: The oil fired ceiling mounted heater.

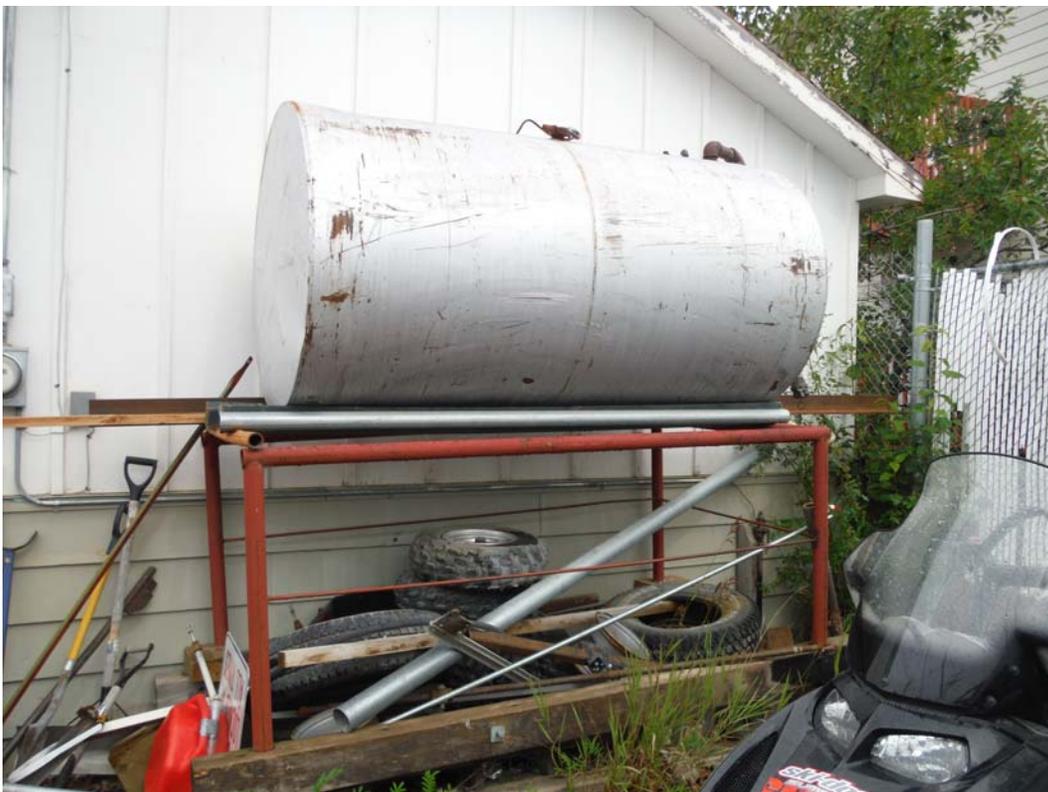
Photo 12: The water storage tank on the south side of the garage.

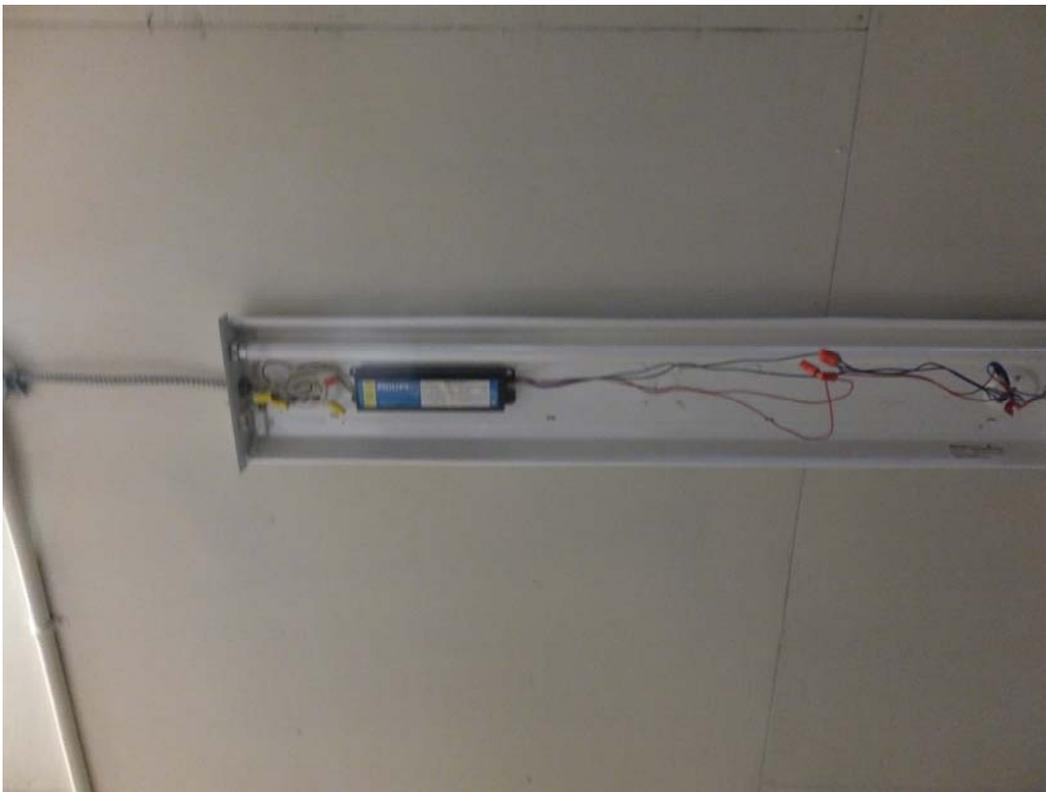
Fluorescent lights were observed throughout the facility during the course of our site inspection. A total of nine T12 type two tube fluorescent light fixtures were observed. The ballast from one fixture was inspected and the information on the face plate recorded. From the information on the face plate the ballast was label as being non-PCB containing. A summary of the information recorded from the one exposed light ballast is presented in Table 4.3. The remaining ballasts will have to be examined by a licensed electrician prior to disposal to confirm the presence of PCBs.

Photo 13: A typical T12 florescent light fixture, note that the ballast cover was removed prior to the inspection and that the ballast is a “NON-PCB” type.

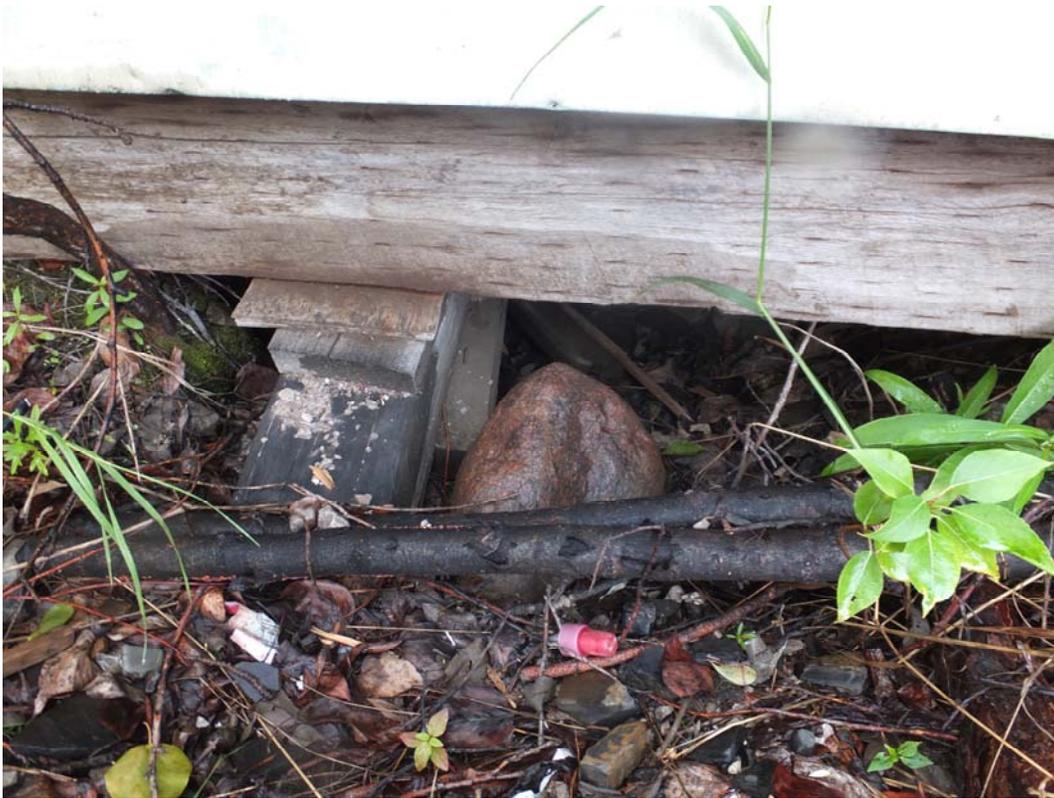
Photo 15: Footing of building.

Materials observed in the study areas which should be considered to contain silica included concrete blocks in the foundation.

Measures and procedures recommended for demolition activities, including dismantling and break up of concrete, masonry, etc. are as follows:
