FINAL  
**Hazardous Building  
Materials  
Assessment**

Canadian Pari-Mutuel Agency  
Jerseyville Research Centre  
115 Sunnyridge Road,  
Jerseyville, ON

**Agriculture and Agri-Food  
Canada**

February 5, 2015

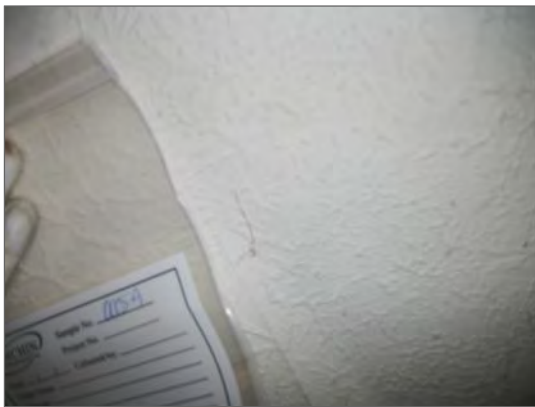
Texture finish is present on plaster ceilings in the Main Level Living Room. No asbestos was detected in the texture coat samples (samples 0005a-c).

Non-asbestos texture finish on ceiling (samples 0005a-c),  
Main Level Living Room

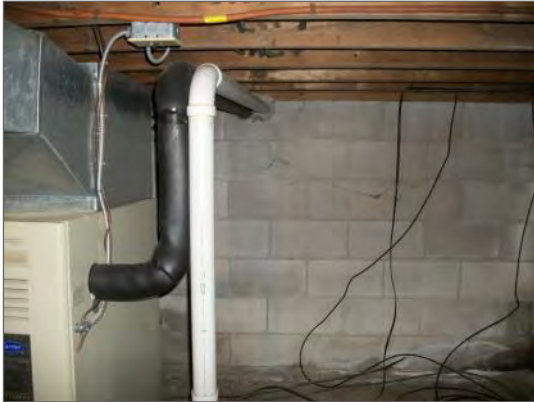
Non-asbestos Armaflex insulation on pipe serving the furnace, Crawlspace

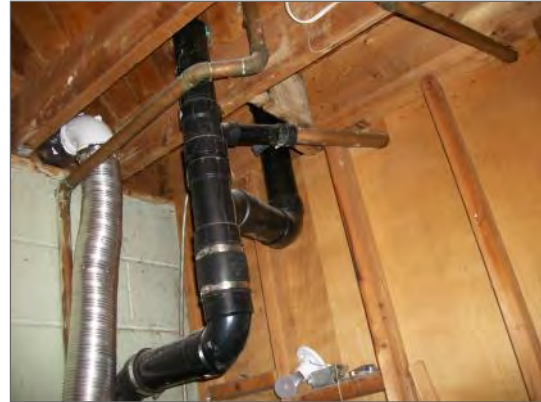
Uninsulated pipes, Basement Laundry Room

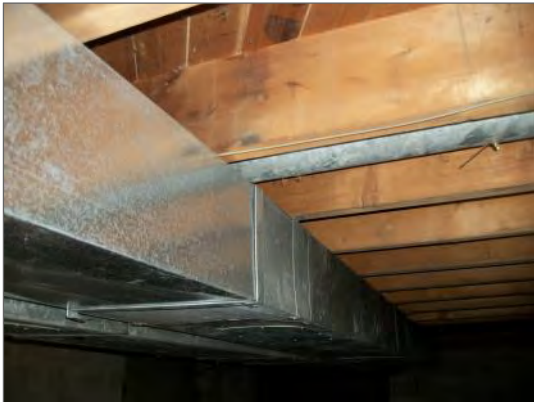
Uninsulated ductwork, Crawlspace

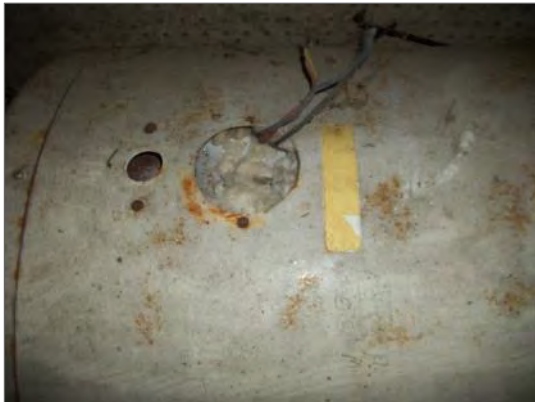
Redundant domestic hot water heater is insulated with fibreglass, Crawlspace

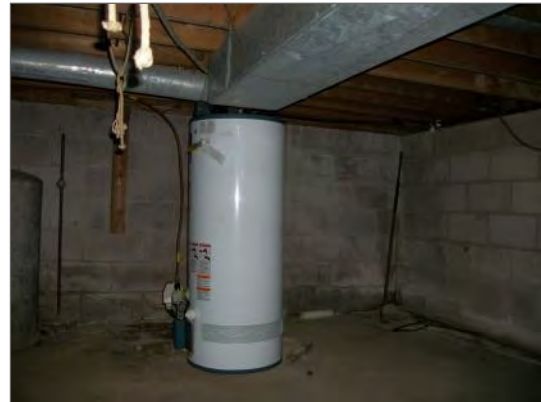
Domestic hot water heater is insulated with fibreglass, Crawlspace

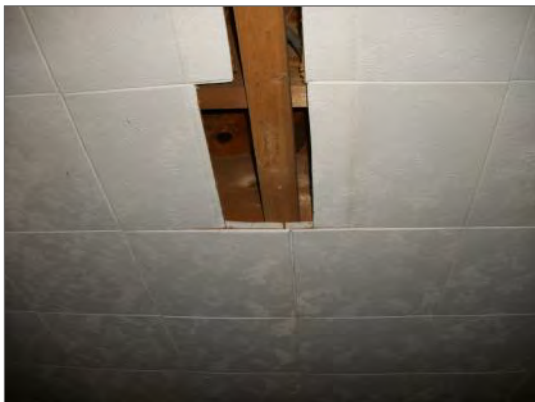
Non-asbestos 12" x 12" splined wood fibre ceiling tiles, Basement Rec Room

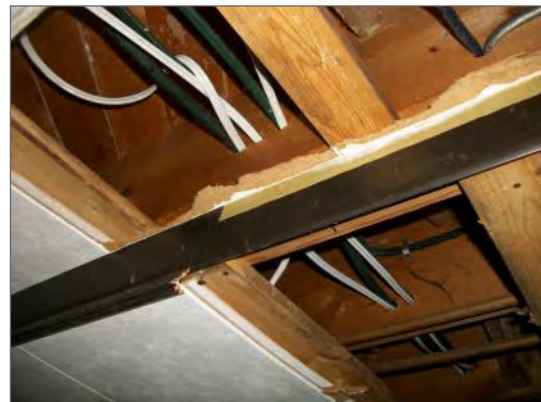
Non-asbestos 12" x 12" splined wood fibre ceiling tiles, Basement Rec Room

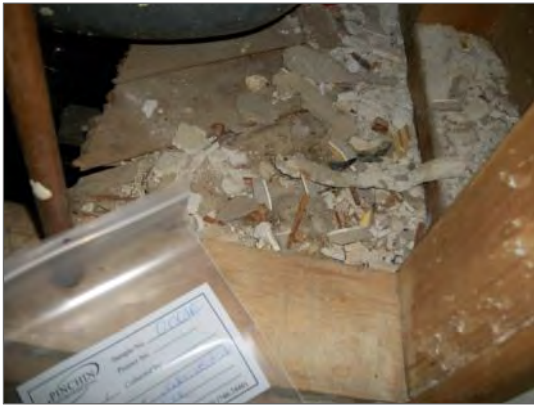
Yellow adhesive present behind ceramic tiles in the Washroom (sample 0001e, phase A), was determined to contain chrysotile asbestos. This adhesive is also present with plaster debris adjacent to the bathtub in the Upper Level Washroom, as accessed from the Closet in the Upper Level Office (approximately 1 m<sup>2</sup>). Adhesive is non-friable.

Non-asbestos plaster debris with asbestos-containing yellow adhesive (sample 0001e, Phase A), at bathtub as accessed from the Closet in the Upper Level Office

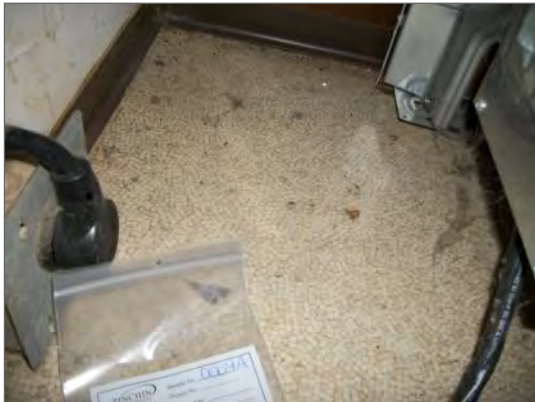
Asbestos in vinyl sheet flooring is present in the paper backing layer only. The vinyl sheet flooring is non-friable but can become friable upon removal. Vinyl sheet flooring is in good condition.

Asbestos-containing vinyl sheet flooring, beige square pattern, Kitchen

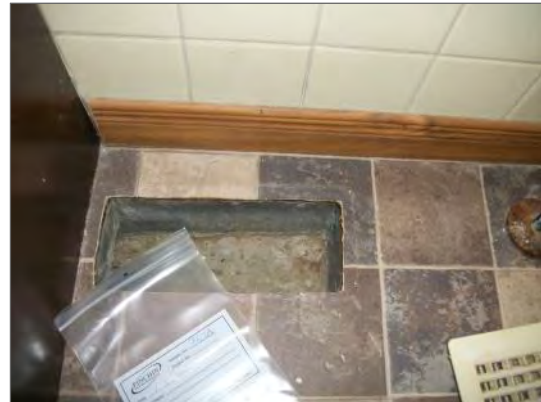
Vinyl sheet flooring with asbestos-containing vinyl backing, brown tile pattern, Upper Level Washroom

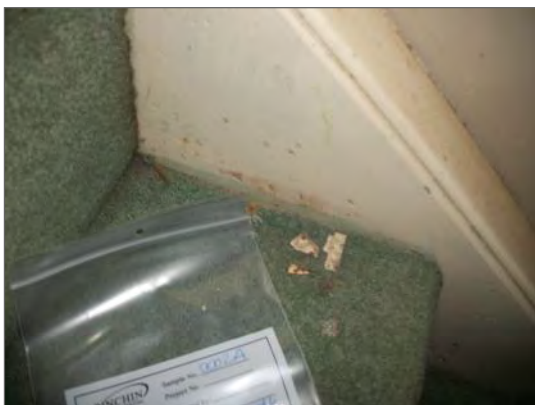
Beige and blue vinyl floor tiles are present below asbestos-containing vinyl sheet flooring in the Kitchen and Washroom, and below carpet on the stairs to the Basement. Vinyl floor tiles were determined to contain chrysotile asbestos (samples 0002a, phase A and 0007a, phase C). Vinyl floor tiles are a non-friable material and are in good condition (approximately 40 m<sup>2</sup>). All mastic is non-asbestos (samples 0002a-c, phase B and 0007a-c, phase D).

Asbestos-containing beige vinyl floor tiles, below carpet on stairs to Basement

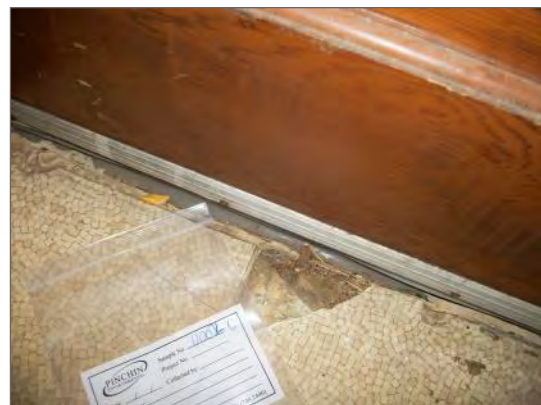
Asbestos-containing beige vinyl floor tiles, below asbestos-containing vinyl sheet flooring in Kitchen

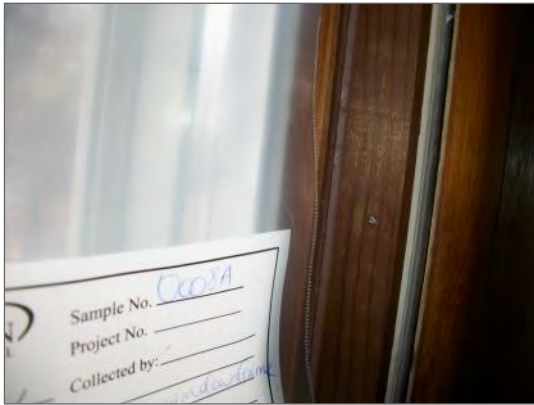
Brown caulking present within wood window frames on the 1982 date-stamped windows contains chrysotile asbestos (sample 0008a). Caulking is non-friable and in good condition (approximately 30 m).

Asbestos-containing brown caulking within wood window frame, Upper Level Office

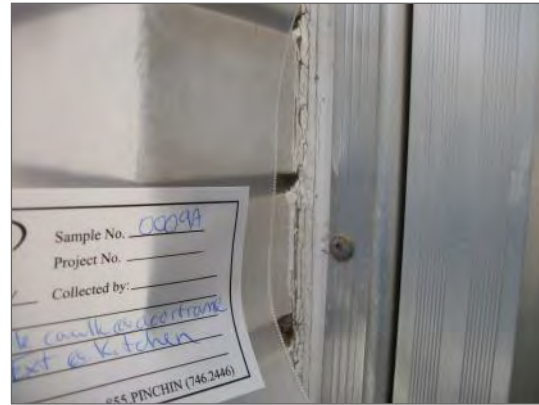
White caulking at exterior windows and doors contains chrysotile asbestos (sample 0009a). Caulking is non-friable and in good condition (approximately 40 m).

Asbestos-containing white caulking at door frame, Exterior at Kitchen Entrance

Exterior white caulking at doors and older windows (1982 date stamp within frame) is suspected to contain PCBs due to the date of installation (prior to 1985). This caulking contains chrysotile asbestos as described above.

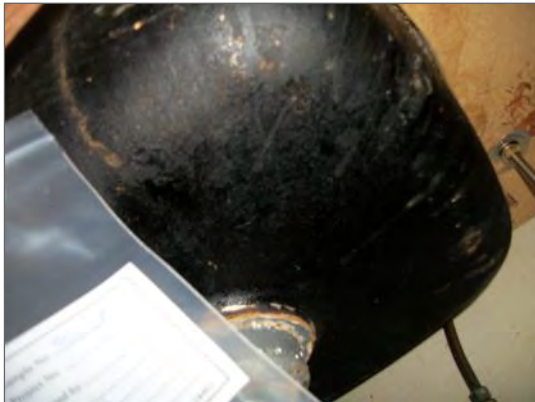
Black undercoating, containing chrysotile asbestos (sample 0003a), is present on the sink in the Kitchen. Undercoating is non-friable and in good condition (approximately 0.4 m<sup>2</sup>).

Asbestos-containing black undercoating on sink, Kitchen

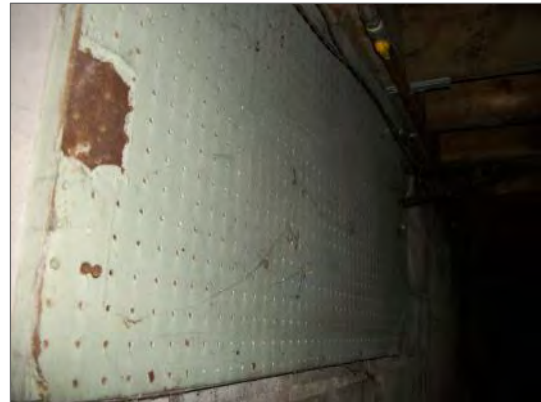
Non-asbestos wood fibre perforated board on wall, Crawlspace

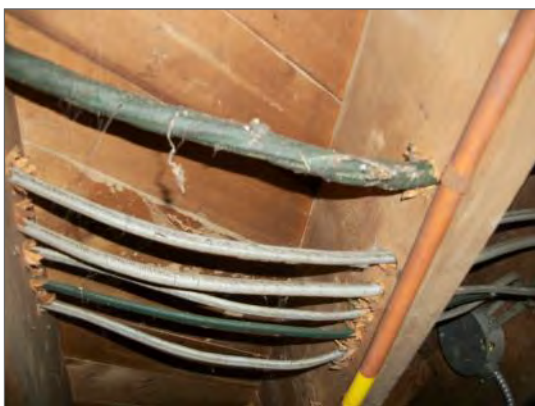
Presumed asbestos-containing textile covering on wiring, Crawlspace

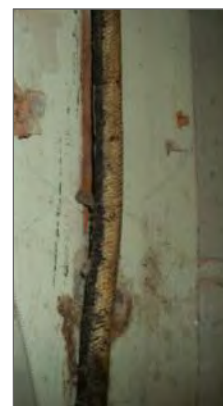
Presumed asbestos-containing textile covering on wiring, Basement Laundry Room

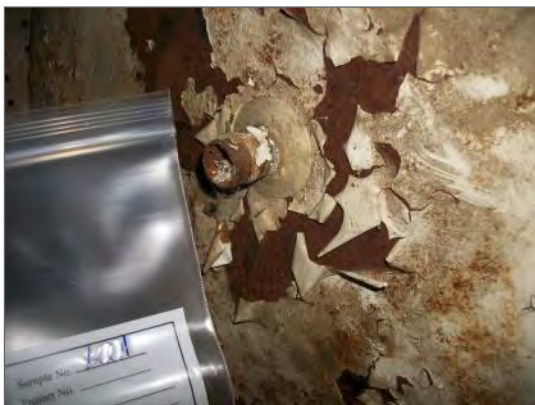
- Off-white paint on redundant metal water heater, Crawlspace (approximately 2 m<sup>2</sup>).

Flaking lead-containing off-white paint on redundant water heater, Crawlspace

Material and Quantity	Location	Recommended Procedure
Beige paint on redundant water heater, 2 m <sup>2</sup>	Crawlspace	Removal and clean-up following lead procedures
Mould on paper, 0.1 m <sup>2</sup>	Crawlspace	Removal and clean-up following Level 1 mould procedures
Mould on block walls, 5 m <sup>2</sup>	Crawlspace	Removal and clean-up following Level 2 mould procedures
Mould on block walls, 3 m <sup>2</sup>	Basement Laundry Room	Removal and clean-up following Level 2 mould procedures
Mould on plaster walls, 0.5 m <sup>2</sup> each	Upper Level Bedroom Closets	Removal and clean-up following Level 1 mould procedures

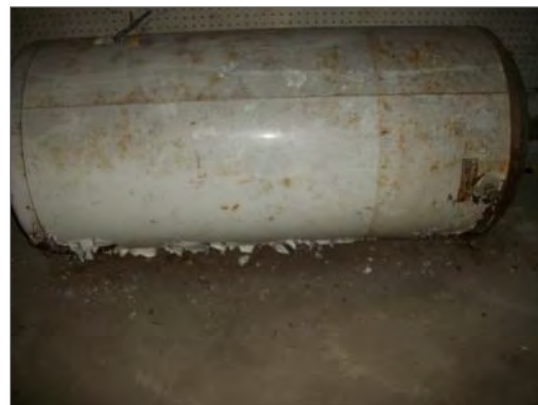
Flaking lead-containing off-white paint on redundant water heater, Crawlspace

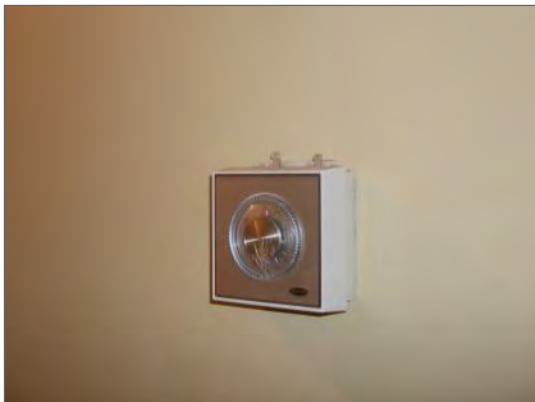
Mercury is present as a liquid in thermostat ampoules.

Mercury-containing thermostat, Upper Level Corridor

Do not break lamps or separate liquid mercury from components. Recycle and reclaim mercury from fluorescent light tubes and thermostats when taken out of service. Light tubes are accepted free of charge at many local recycling depots. Liquid mercury is classified as a hazardous waste and must be disposed of in accordance with local regulations.

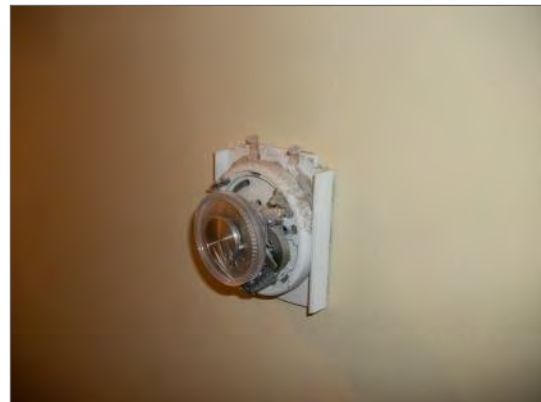
Mercury-containing thermostat ampoule, Upper Level Corridor

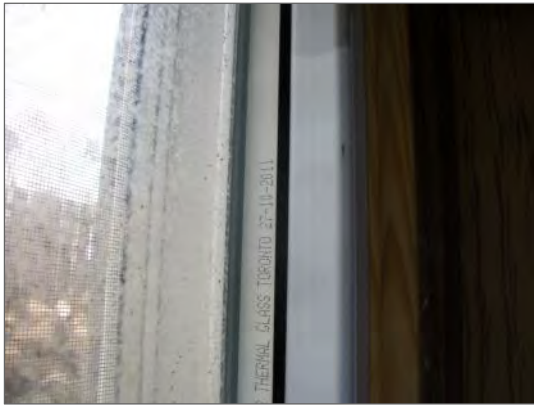
Remaining caulking is non-PCB based on the date of installation as per the stamps within frames (1995 and 2011).

2011 date stamp within window, Basement Rec Room

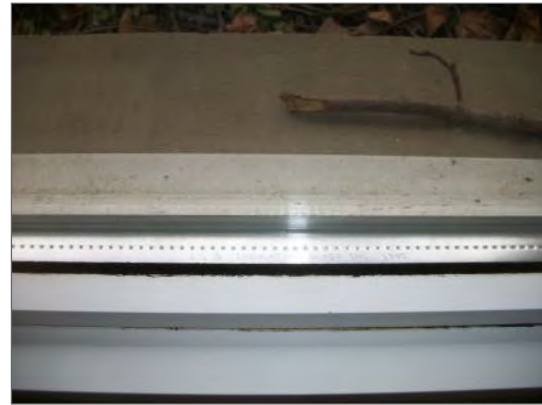
1995 date stamp within window, Ground Level Living Room

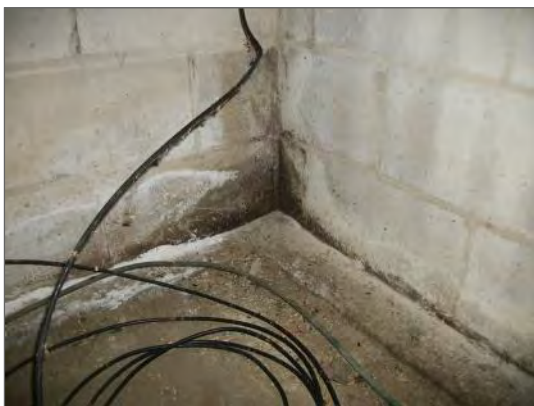
Suspect mould growth, efflorescence, and water staining was observed on concrete block wall surfaces throughout the Crawlspace and Basement Laundry Room. Mould growth was also observed on a sheet of paper present in the Crawlspace. Suspect mould growth is present on plaster walls within the Upper Level Bedroom Closets. Total affected area is approximately 20 m<sup>2</sup>.

Suspect mould growth on concrete block wall near furnace,  
Crawlspace

Mould growth was noted in areas affected by the planned work. Use appropriate precautions and protect workers using methods that comply with provincial guidelines during demolition. If the building will not be demolished, an intrusive mould assessment is recommended to provide a full remedial scope of work. A building condition assessment to determine the source of moisture causing mould growth is also recommended if the building is not demolished.

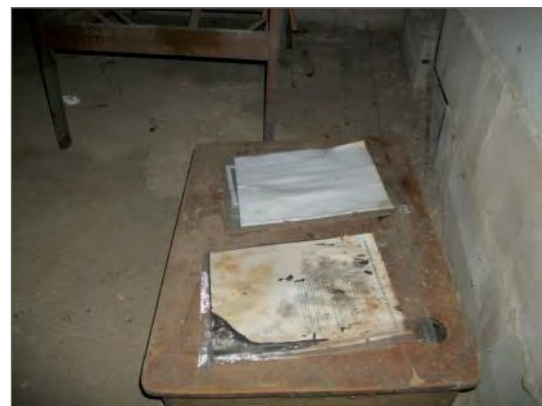
Visible mould growth on paper on desk, Crawlspace

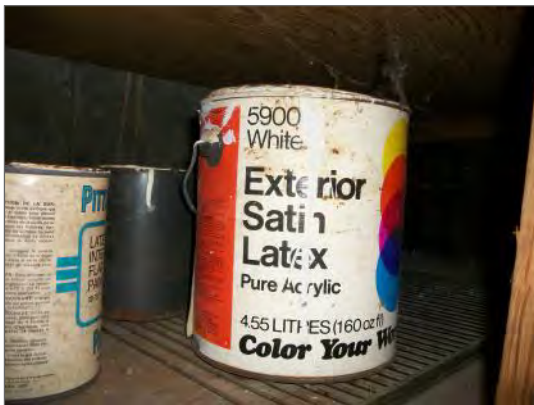
Stored paint can, Closet in Basement Laundry Room

Household chemicals and associated storage containers should be disposed of in accordance with regulatory requirements. Household hazardous wastes should be dropped off at a recycling centre for proper disposal. Ammunition should be dropped off at a police station for safe disposal.

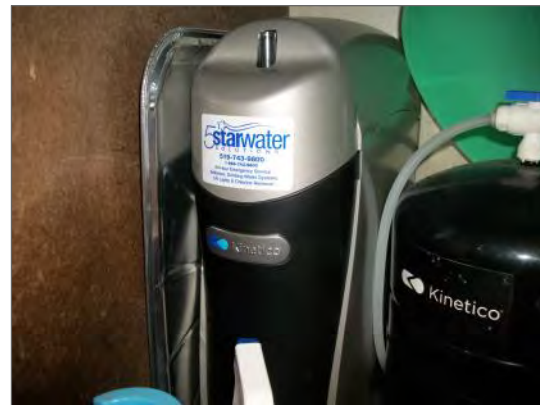
Water softener and associated chemicals, Ground Level Kitchen

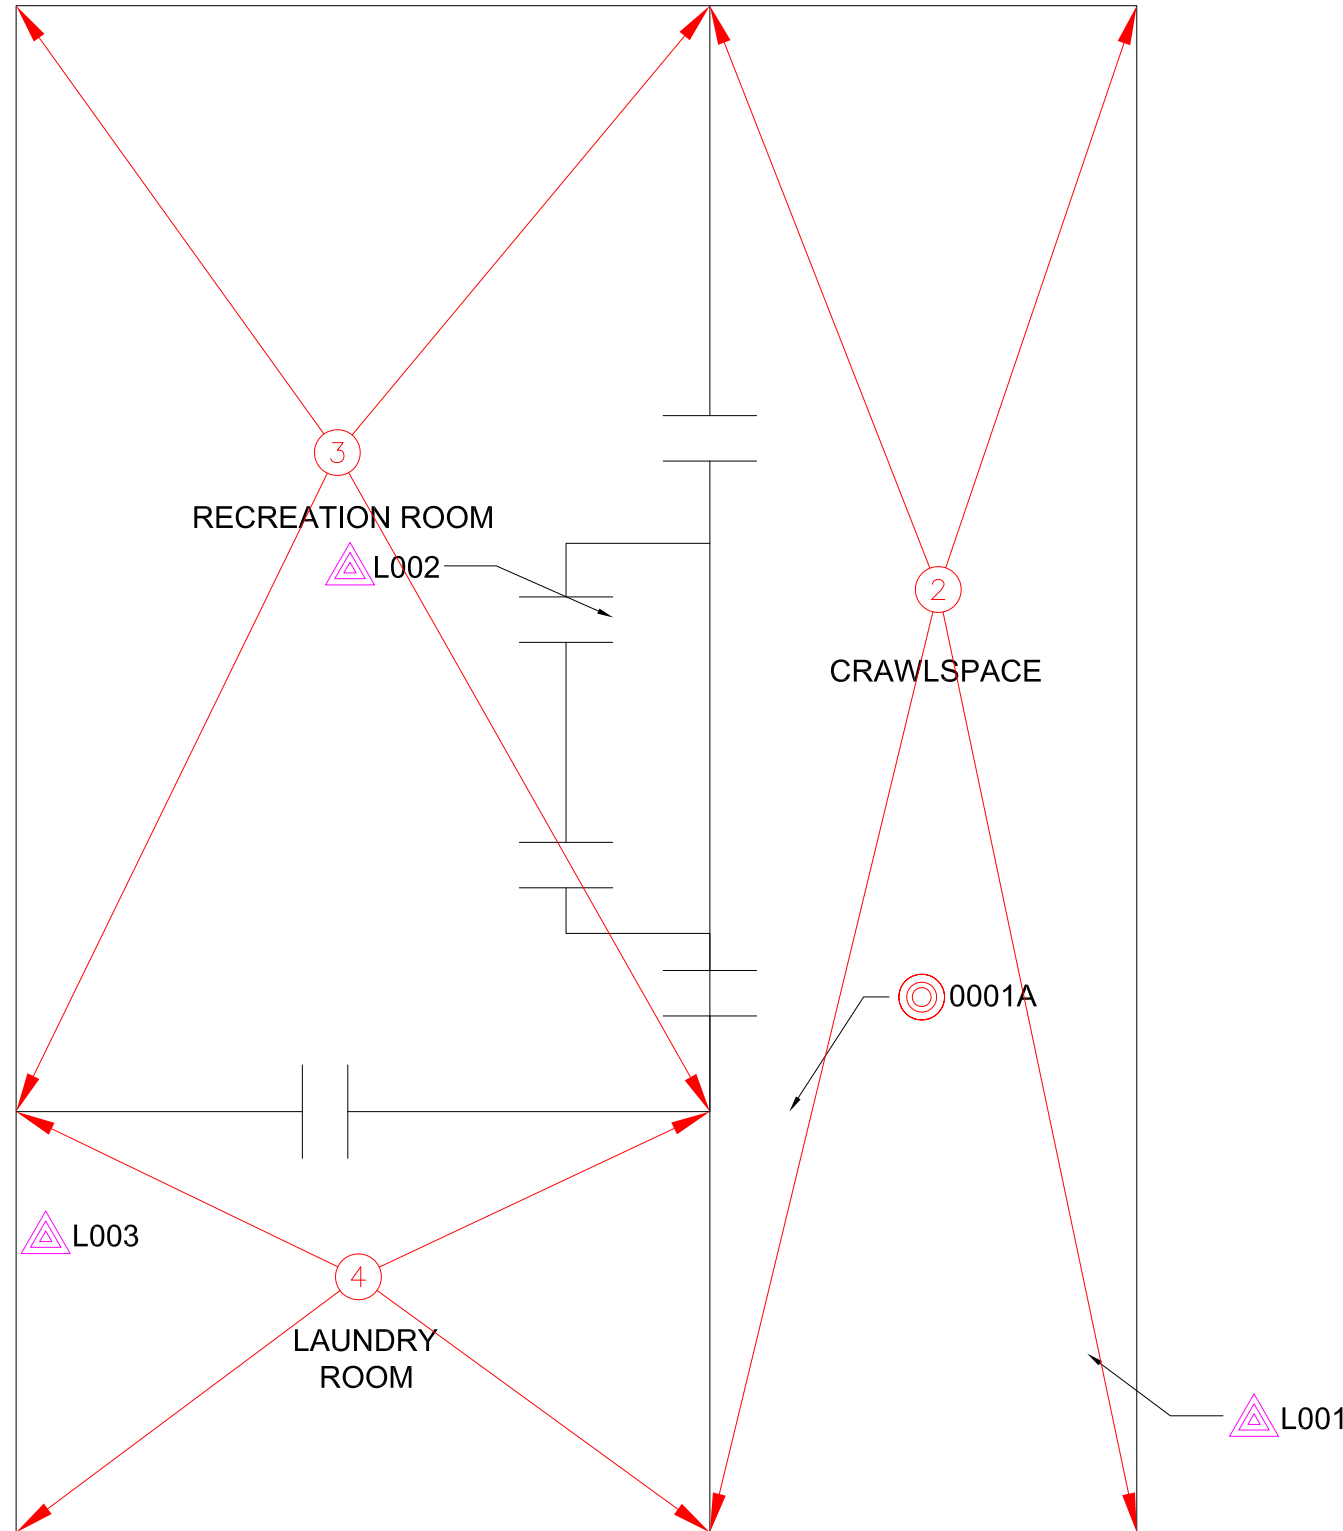
DRAWING NO:  
DS-01

NOTES:  
PRESUMED ASBESTOS-CONTAINING WRAP  
IS PRESENT ON ELECTRICAL WIRING  
THROUGHOUT.

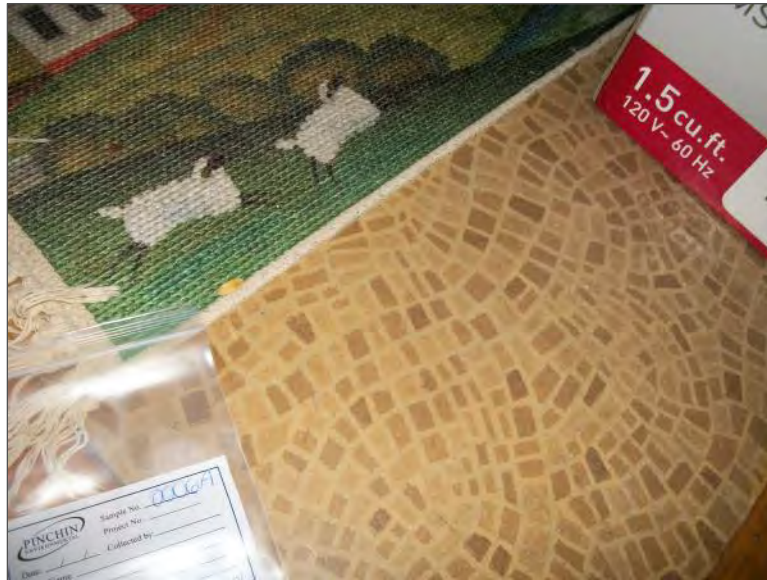
Non-asbestos vinyl sheet flooring, brown mosaic pattern (samples 0006a-c), Main Level Living Room

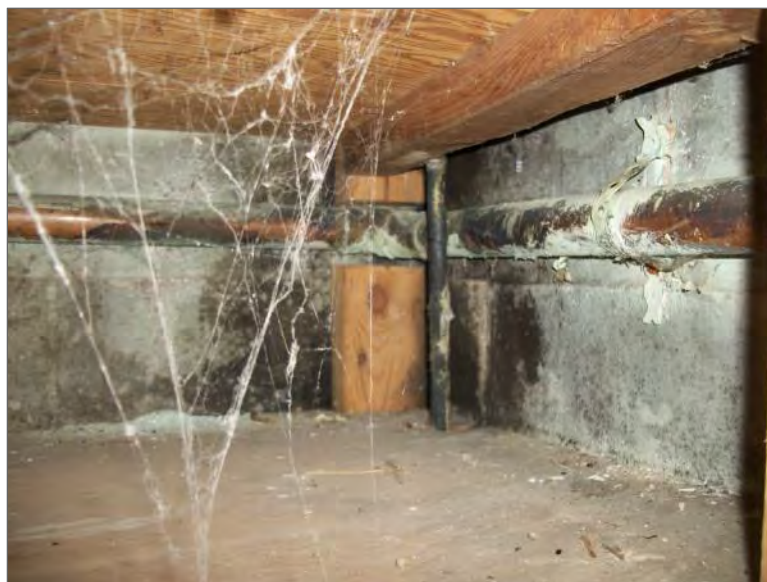
Suspect mould growth on concrete block wall, Closet within Basement Laundry Room

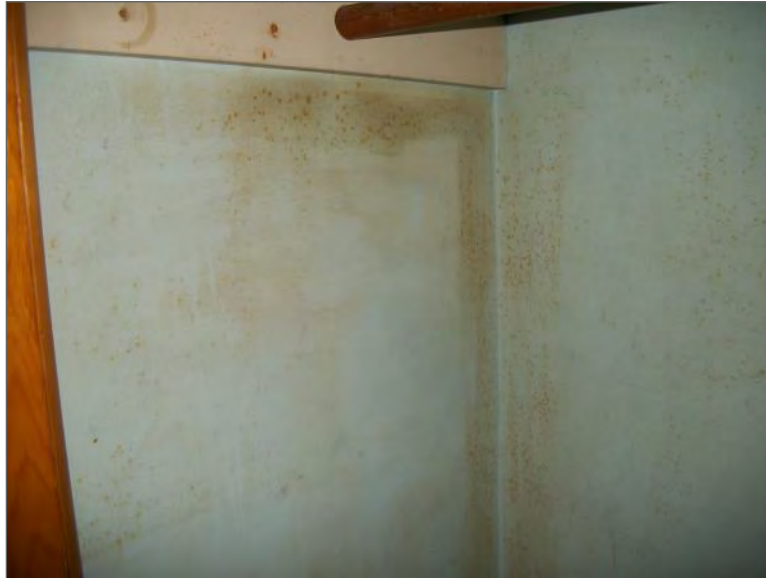
Suspect mould growth on plaster walls, Closet within Upper Level Bedroom

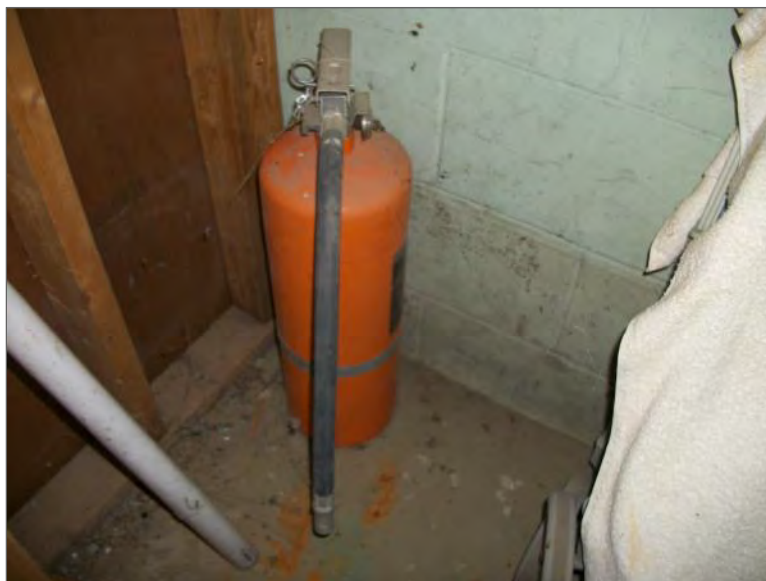
Fire extinguisher, Closet in Basement Rec Room

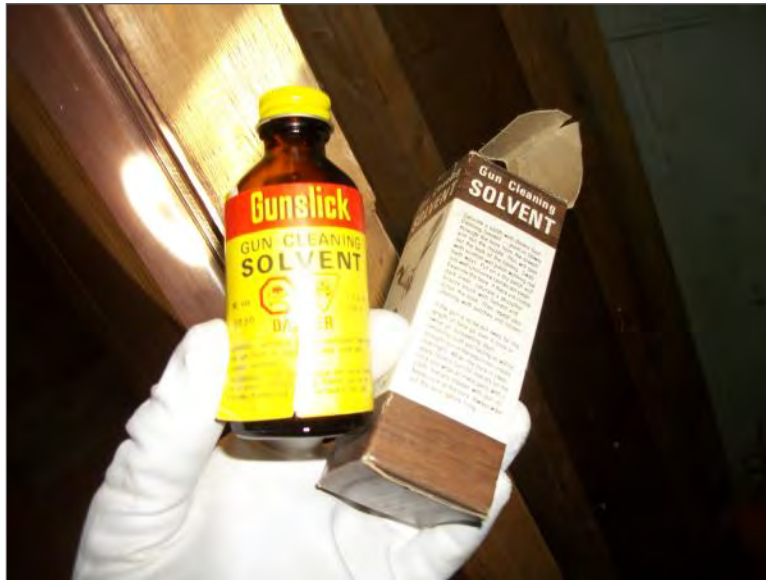
Gun cleaning solvent, Closet in Basement Rec Room

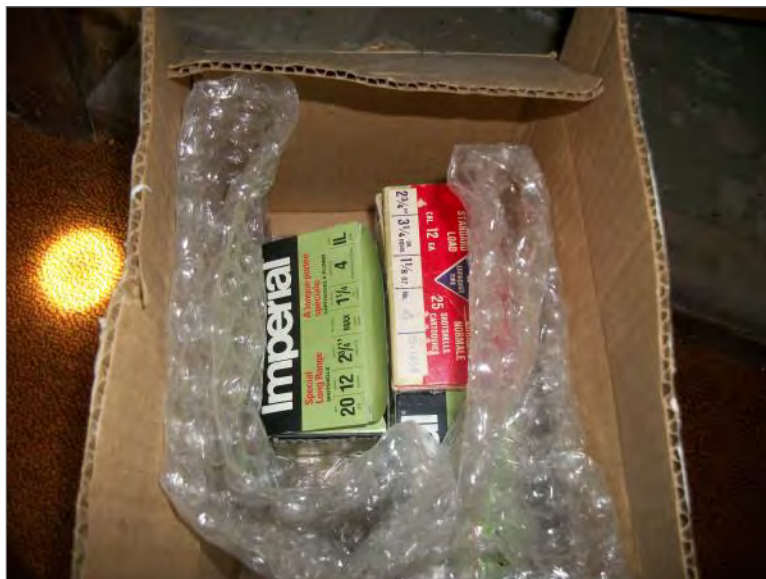
Ammunition, Closet in Basement Rec Room
