**ROOF INSPECTION REPORT
ENVIRONMENT CANADA BUILDING
STONY PLAIN UPPER AIR STATION**

Re: Stony Plain Upper Air Station
Roof Inspection Report

Stony Plain Upper Air Station

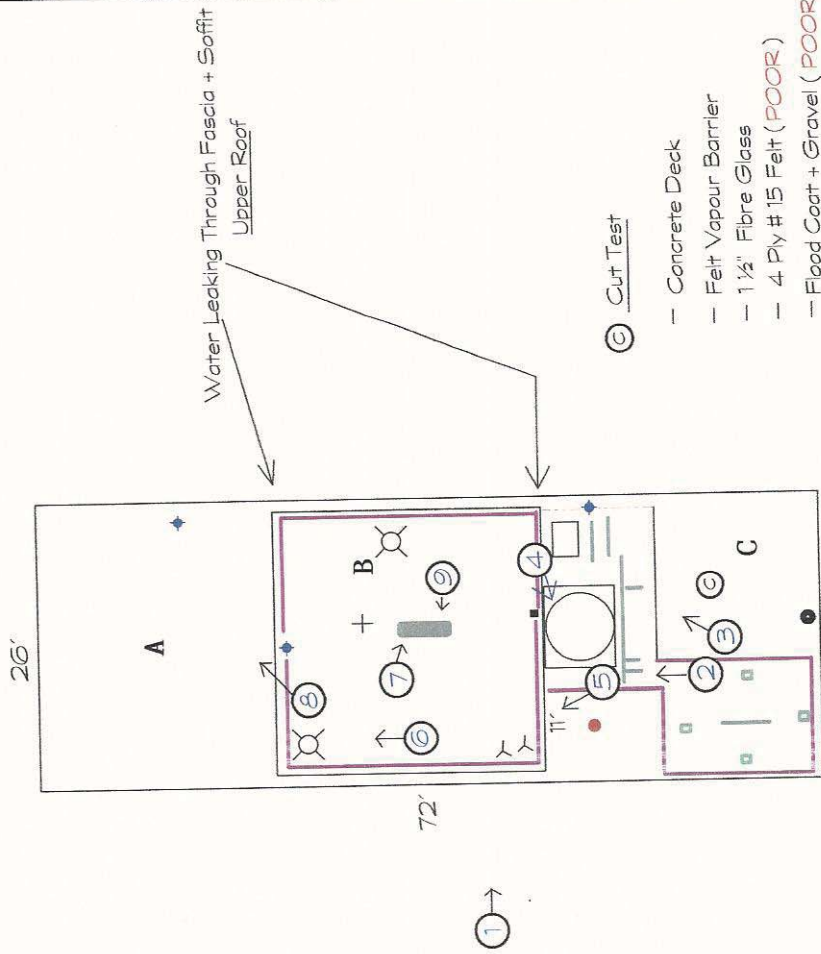
Water Leaking Through Fascia + Soffit
Upper Roof

- Concrete Deck
- Felt Vapour Barrier
- 1 1/2' Fibre Glass
- 4 Ply # 15 Felt (POOR)
- Flood Coat + Gravel (POOR)

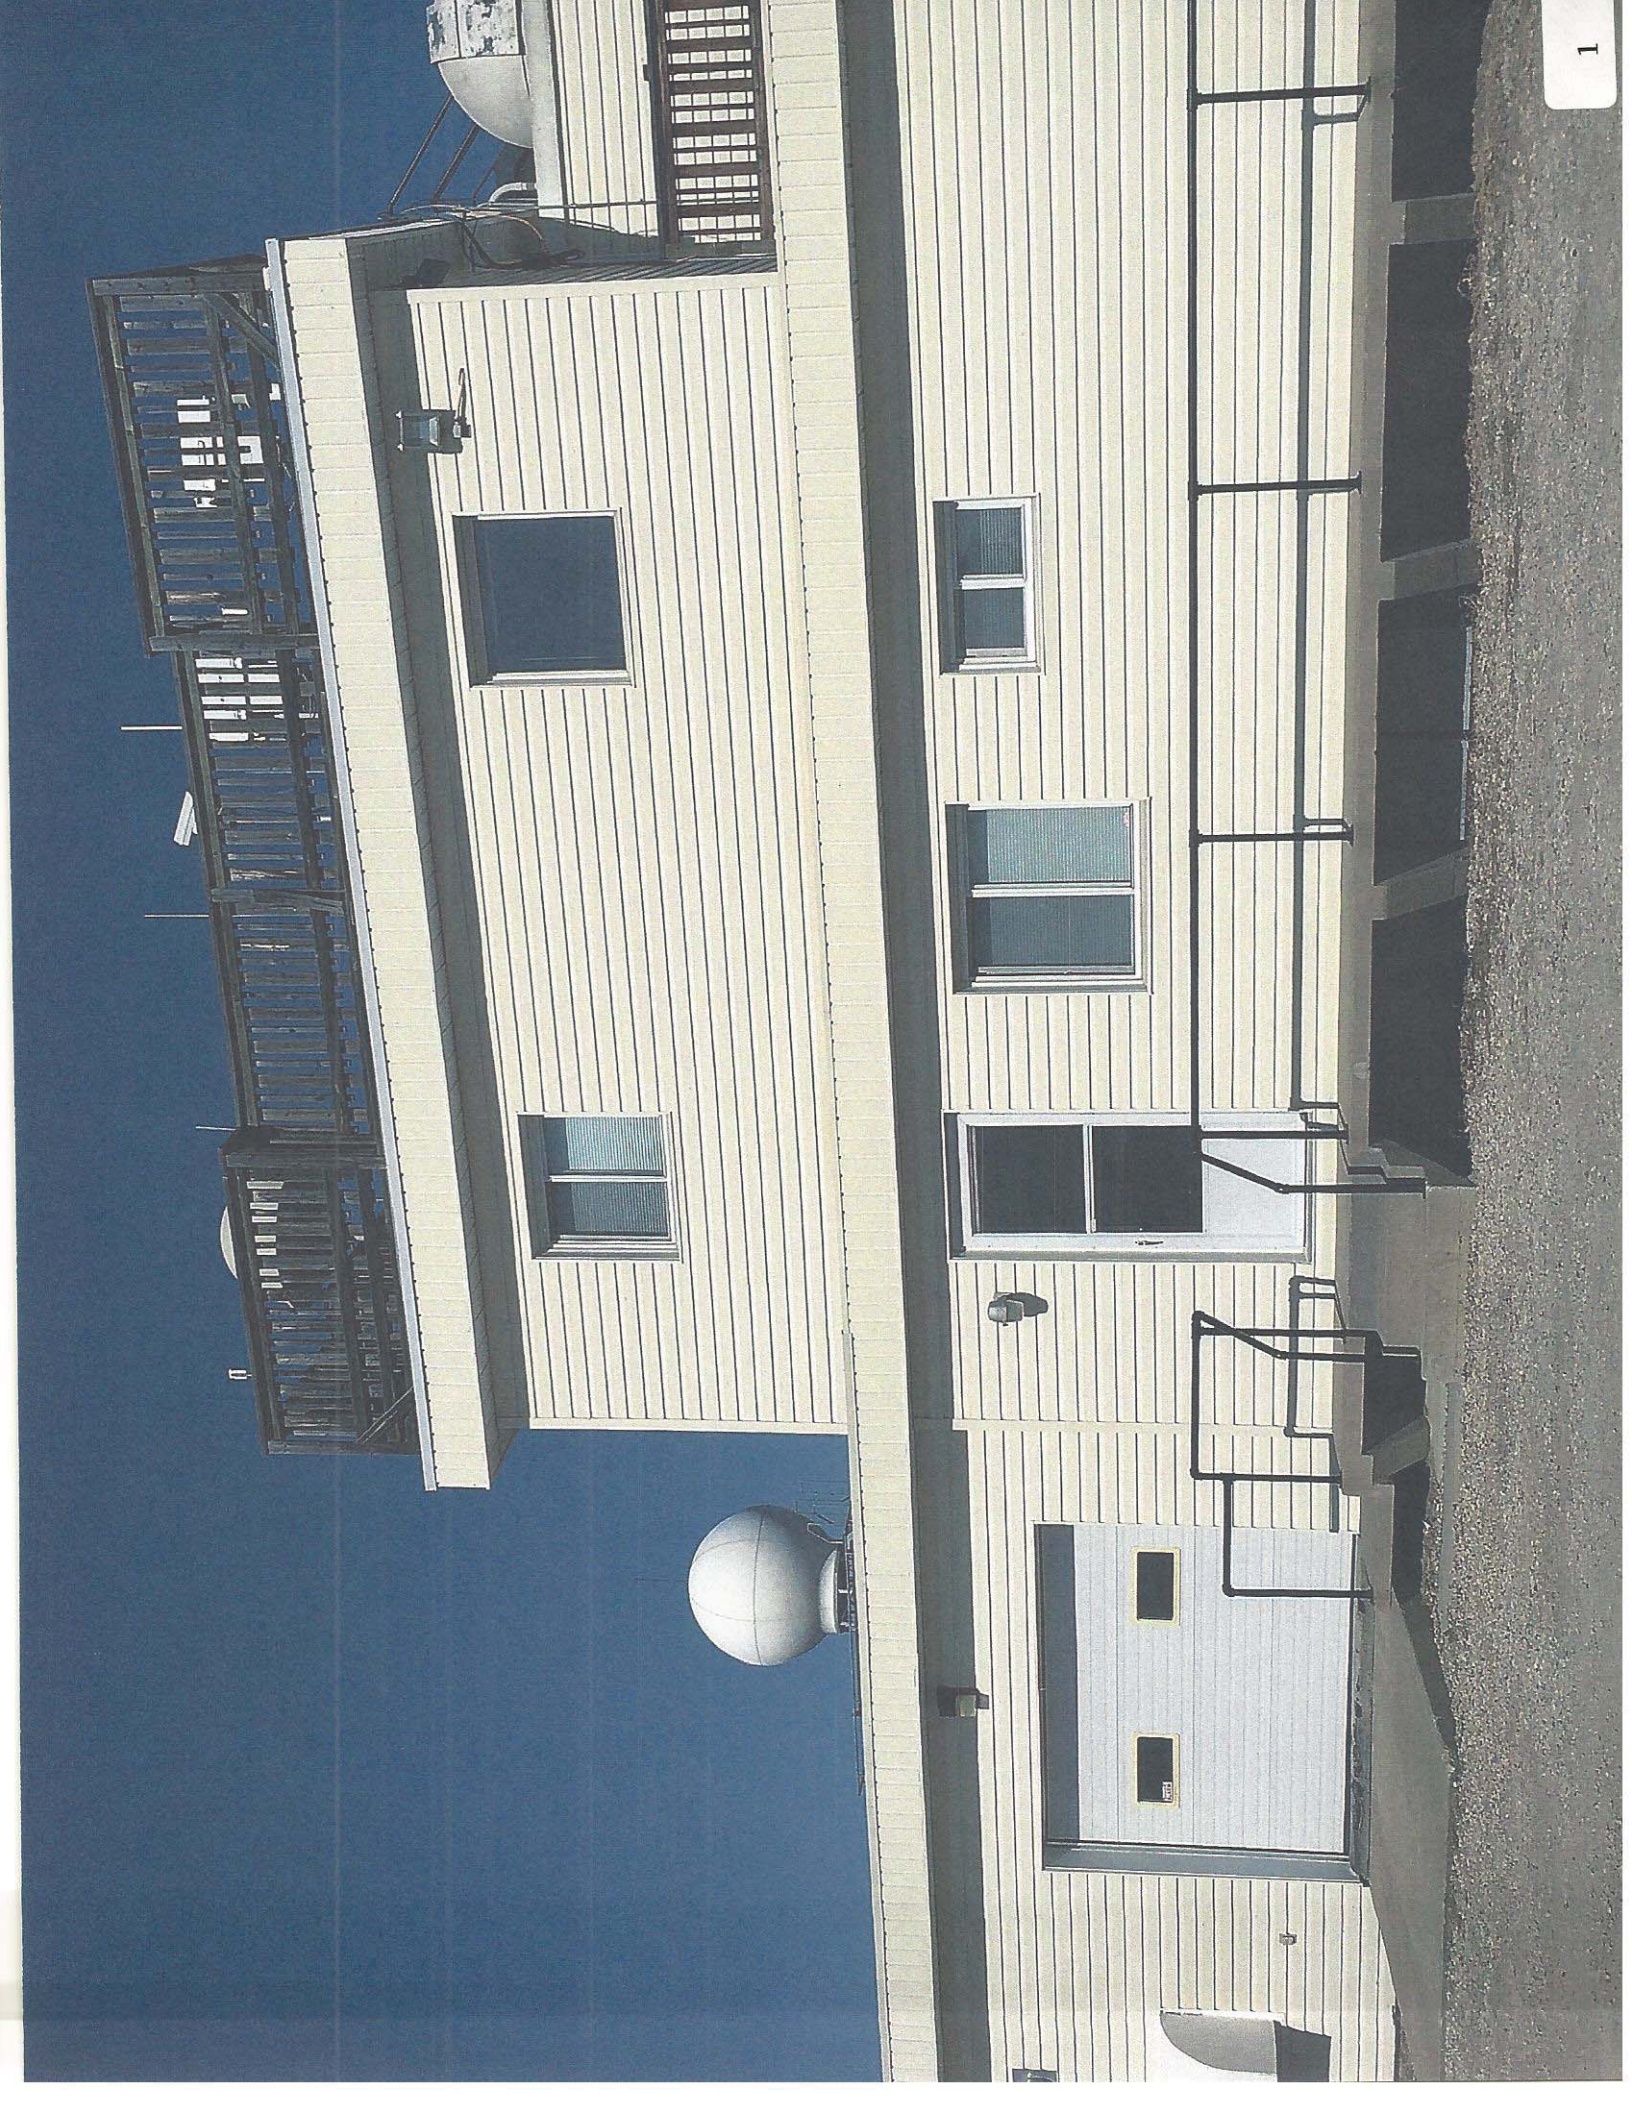
- Photo #1 Outside of building and fencing.
- Photo #2 Roof access, wood railing and wood walkway.
- Photo #3 Metal stair supports require gumboxes.
- Photo #4 Electrical lines, wood decking over upper roof.
- Photo #5 Electrical panel, wood decking over existing roof.
- Photo #6 Weather instruments, wood fencing.
- Photo #7 Electrical panel and other weather instruments.
- Photo #8 Discolouring indicates water ponding – Area C
- Photo #9 Plumbing vent and vinyl siding.

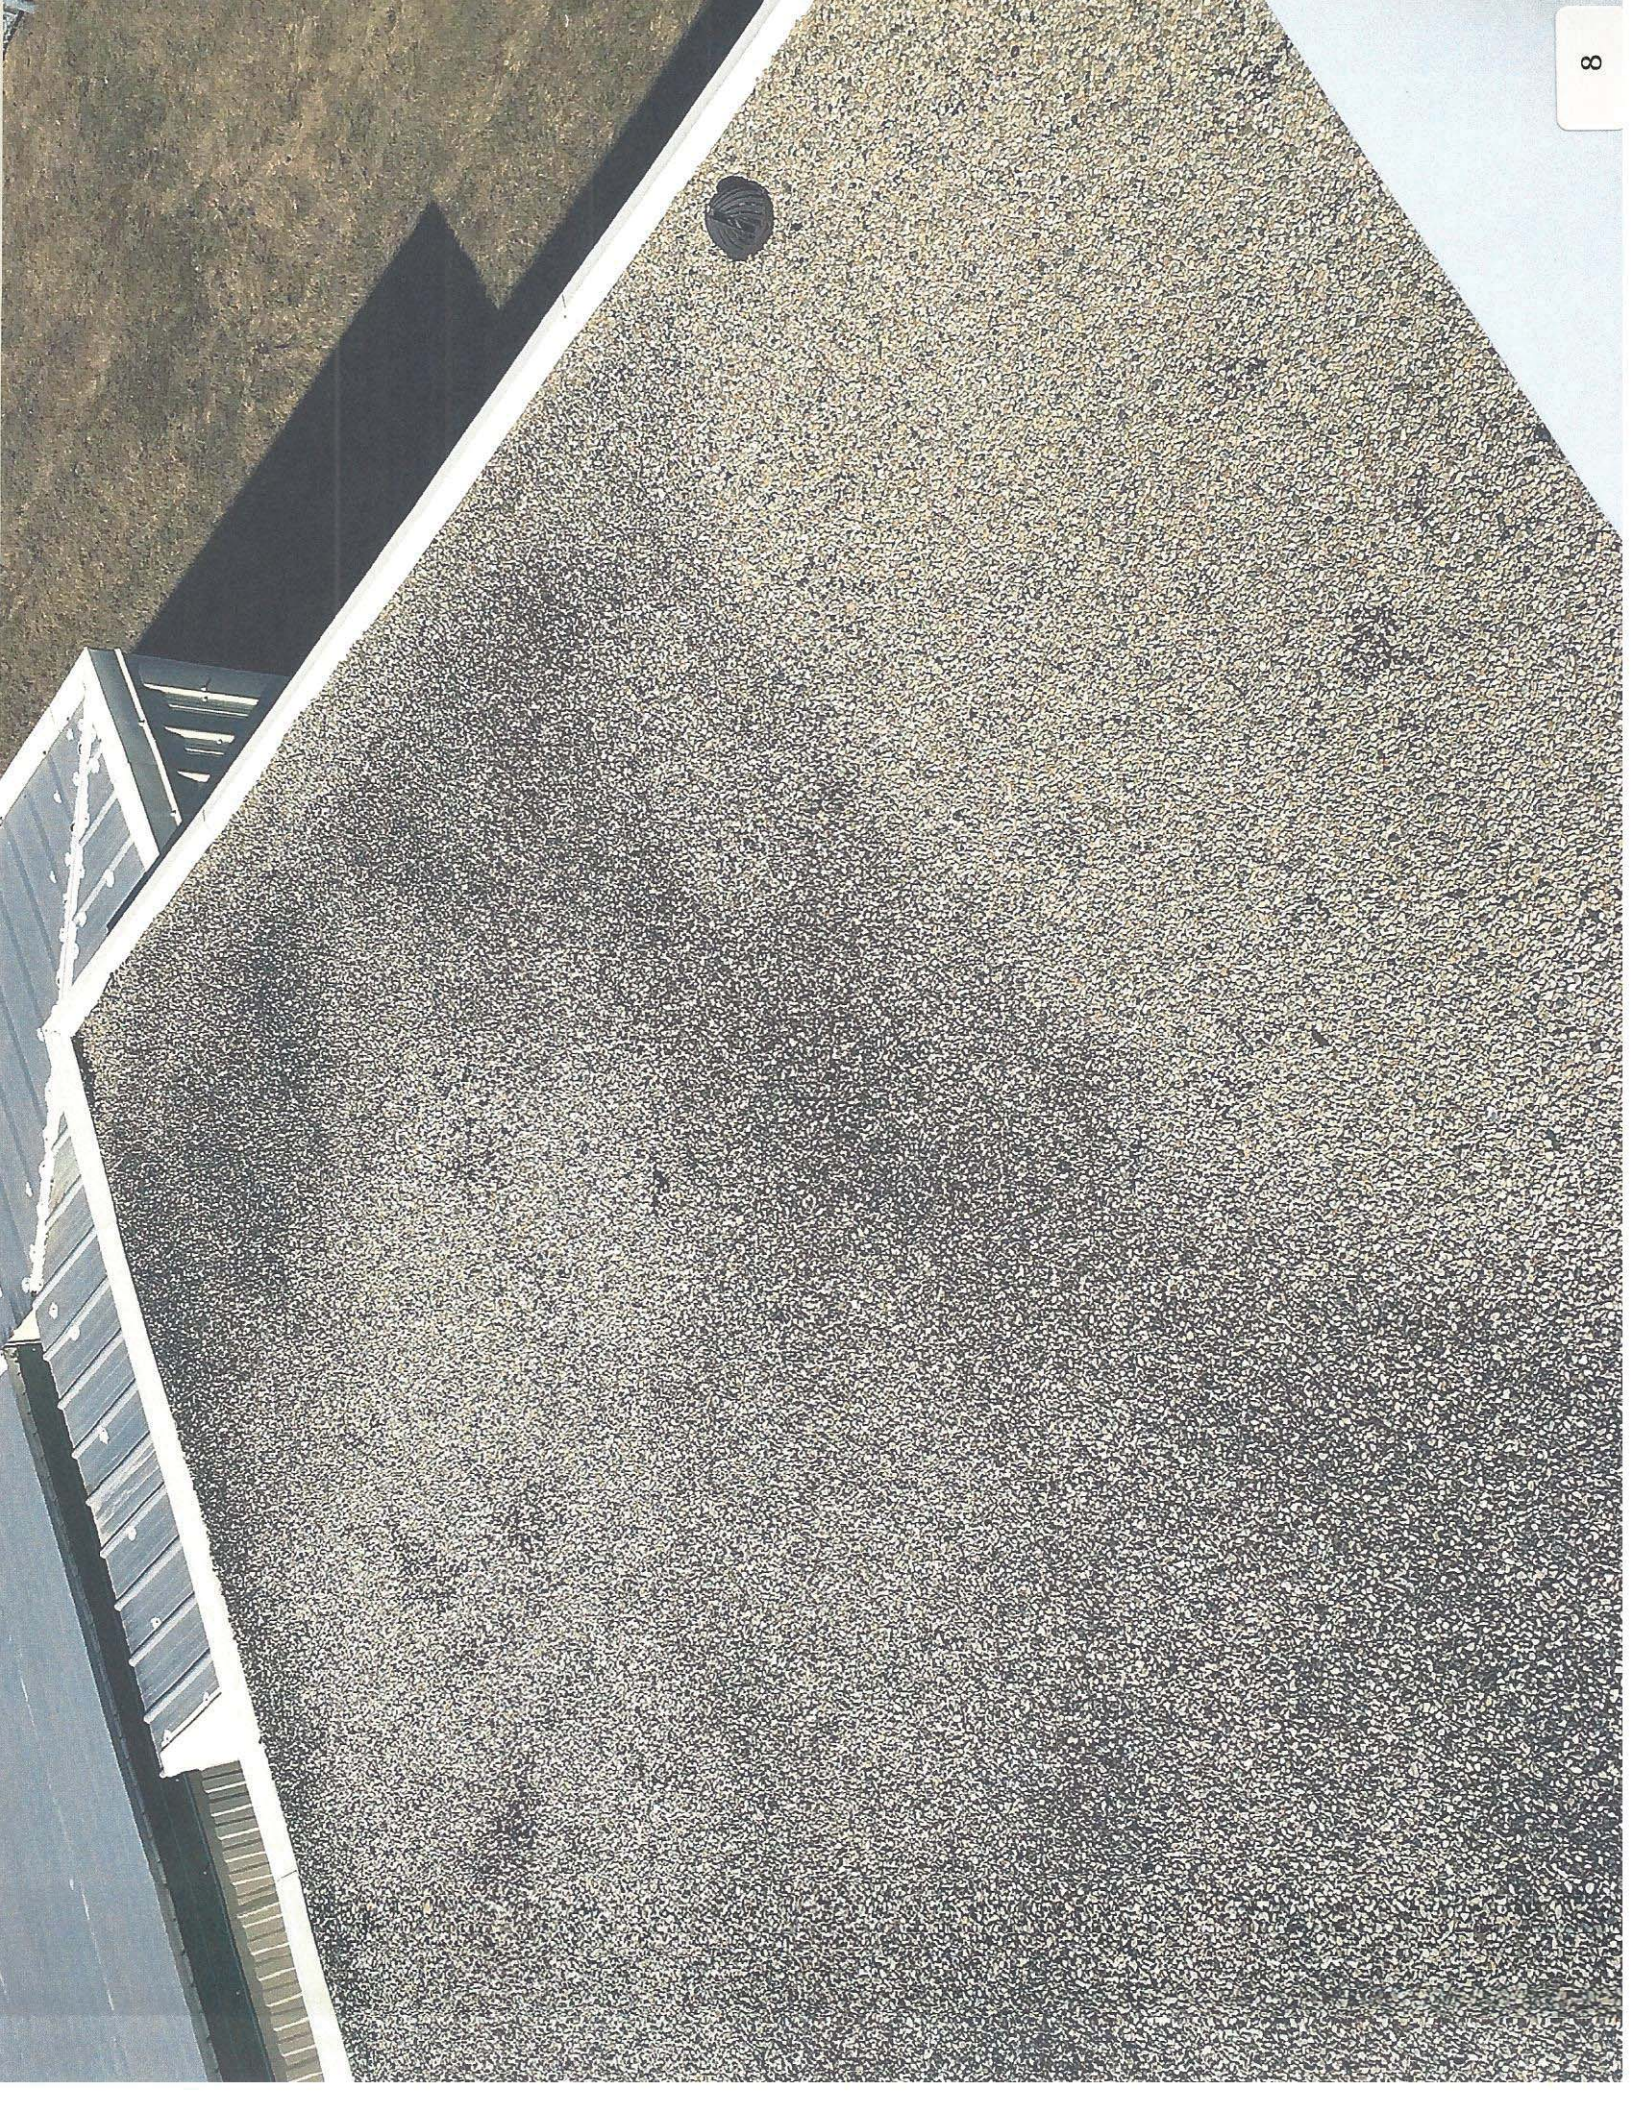
With these roof sections being flat, widespread ponding of water occurs.
