Pachena Light Tower Photos - WSP Inspection Trip Aug 2014

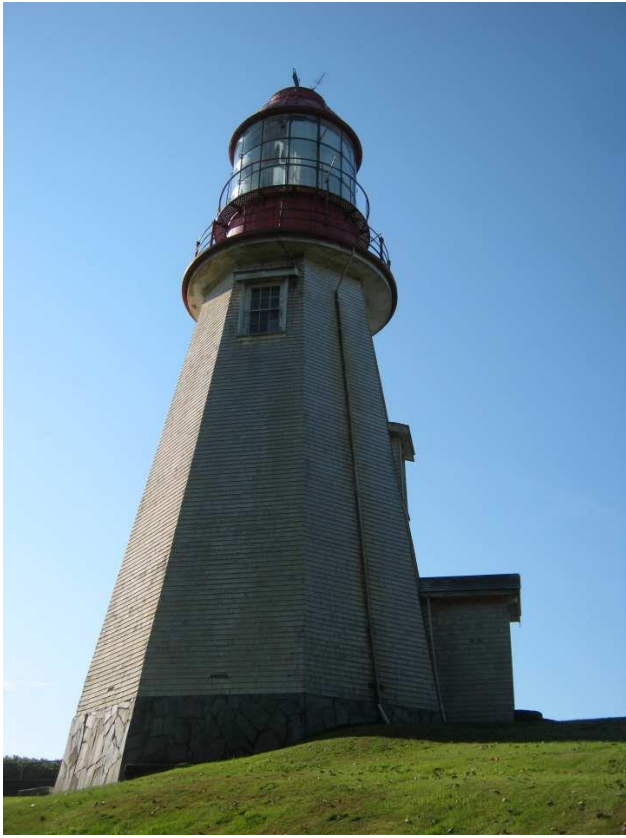
#1 - North Exterior Wall Elevation

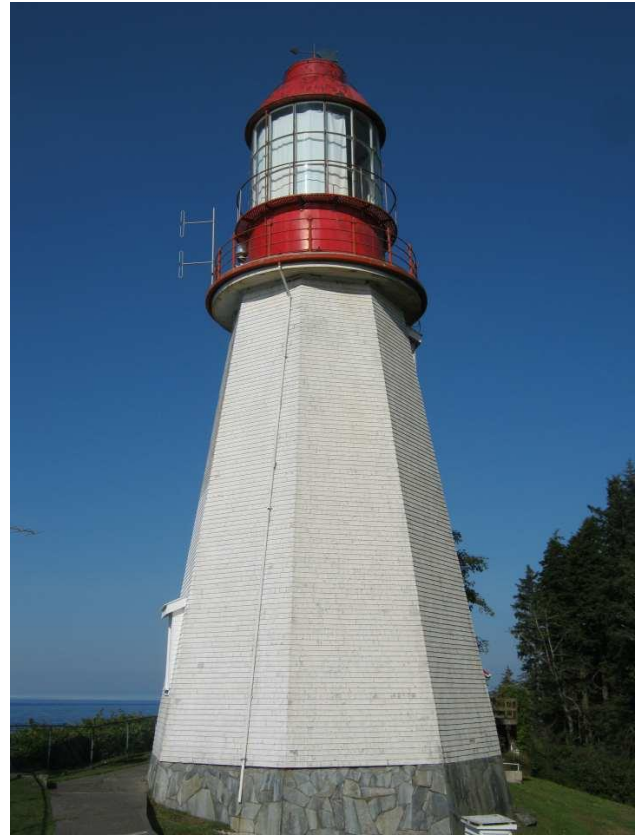
#2 - East Exterior Wall Elevation

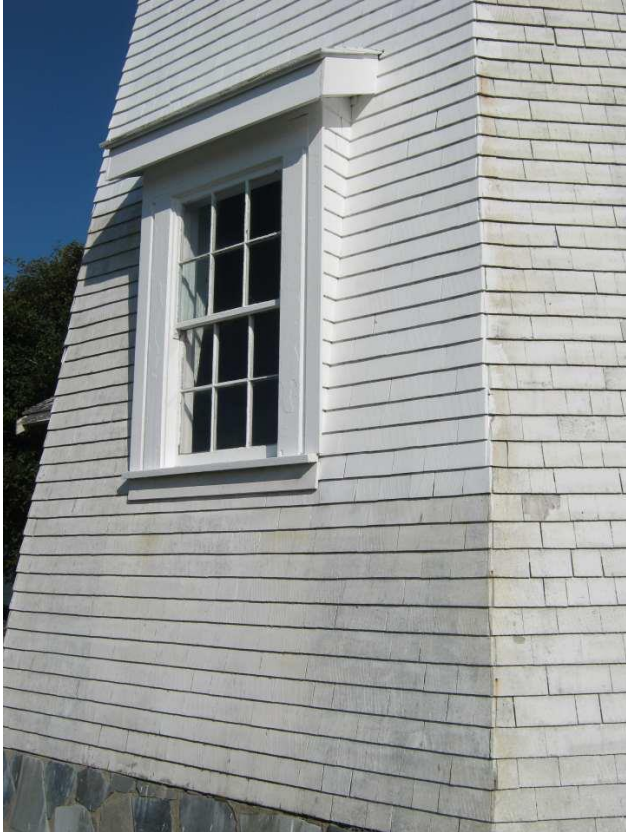
#3 - South Exterior Wall Elevation (Lower)

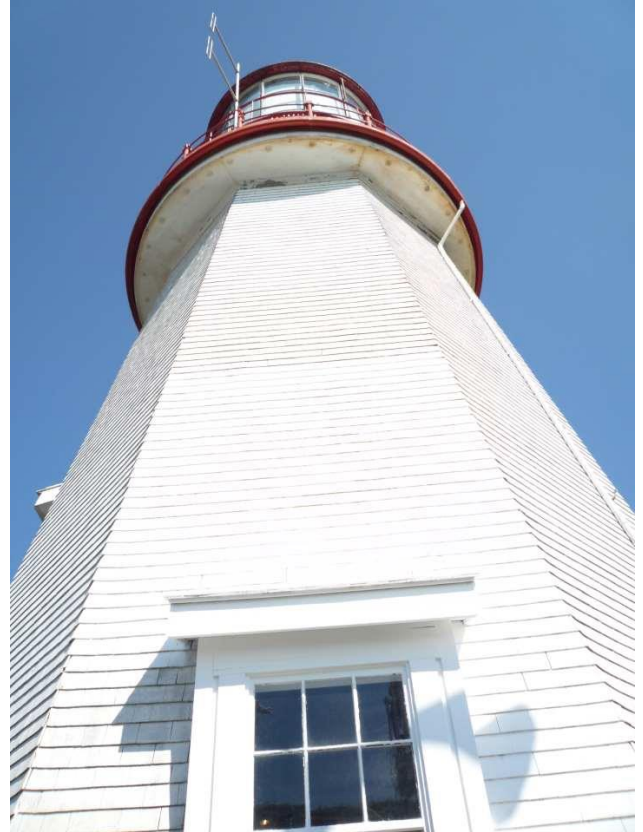
#4 - South Exterior Wall Elevation (Upper)

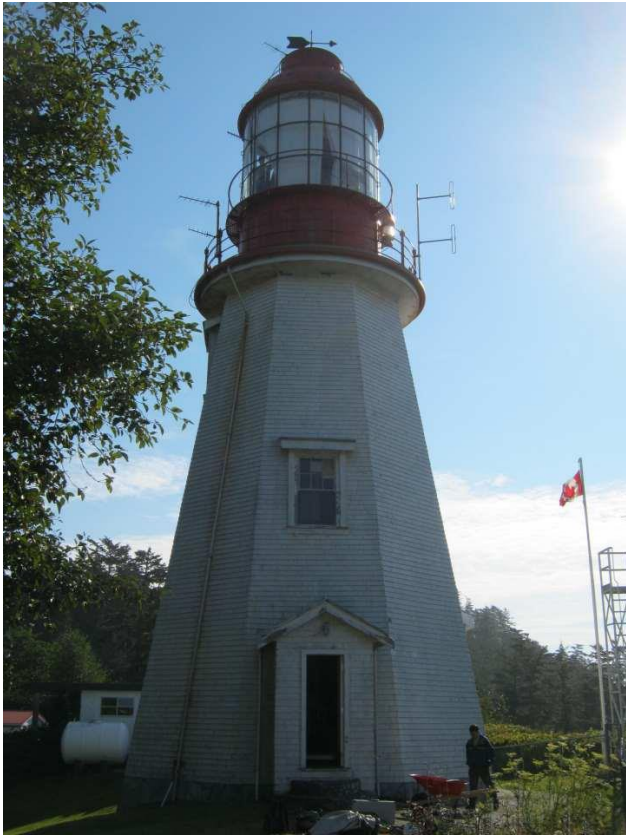
#5 - West Exterior Wall Elevation

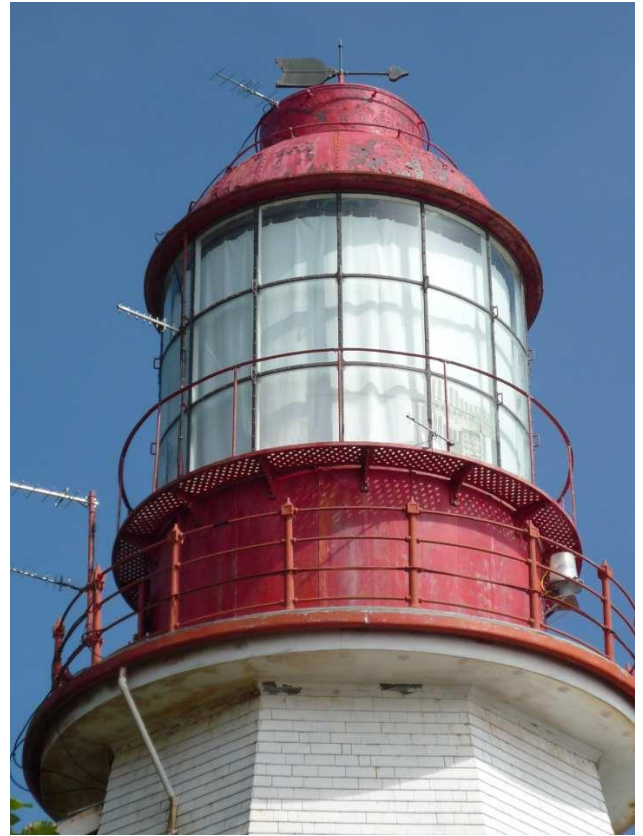
#6 - Lantern Room Exterior

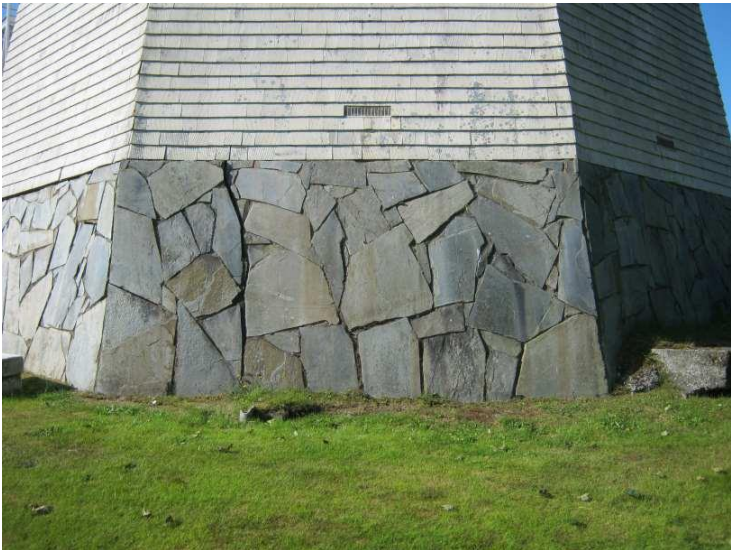
#7 - Stone Veneer North Wall

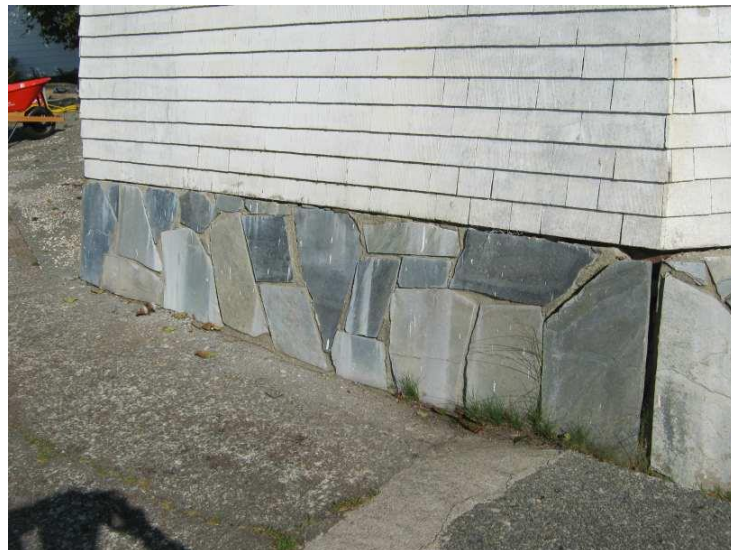
#8 - Stone Veneer South Wall

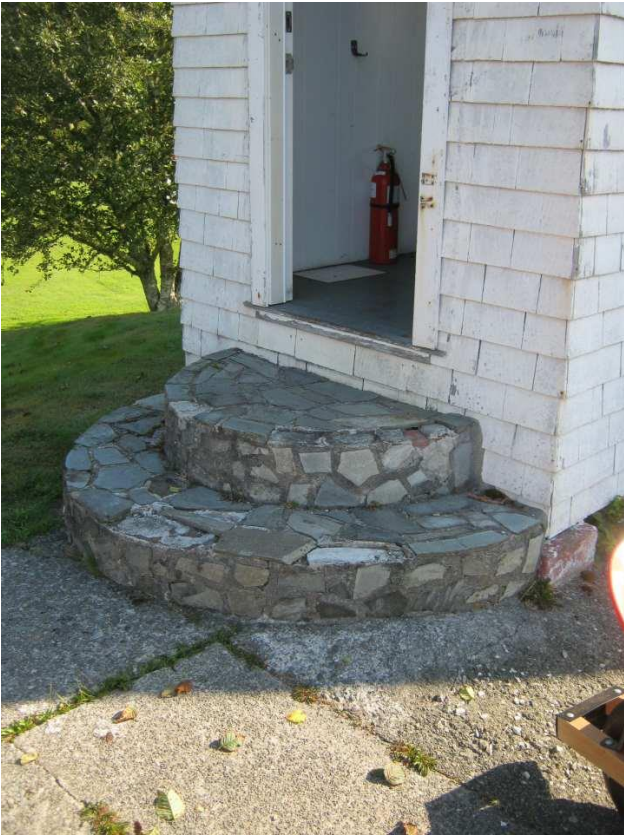
#9 - Exterior Entrance Stair

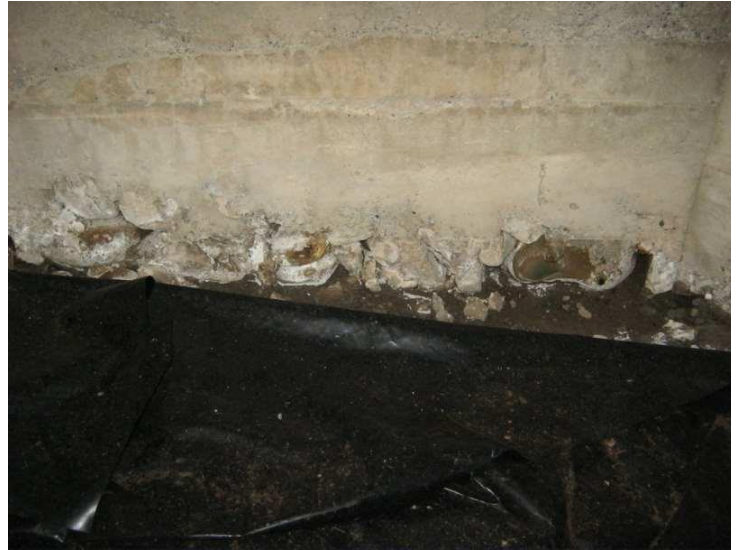
#10 - Foundation Soil Bearing Condition

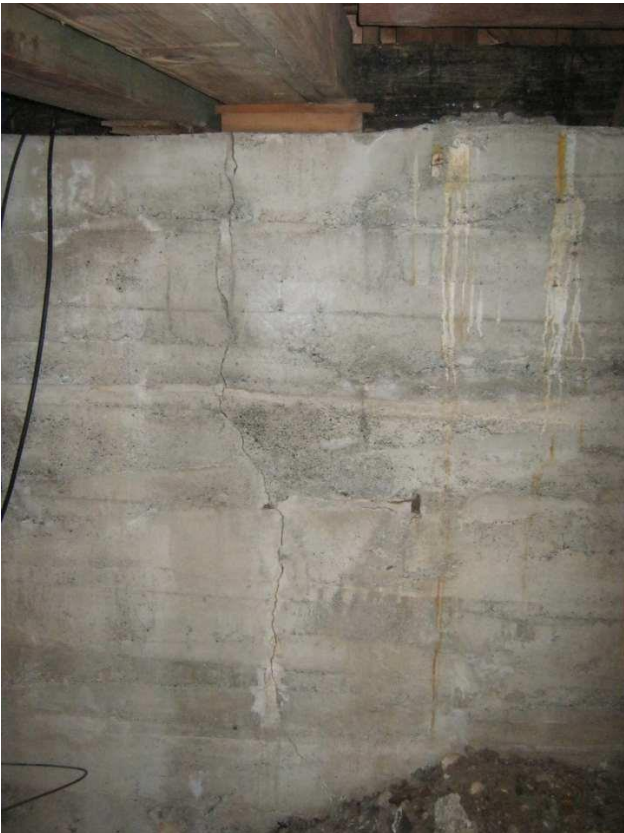
#11 - Foundation Crack - East Wall

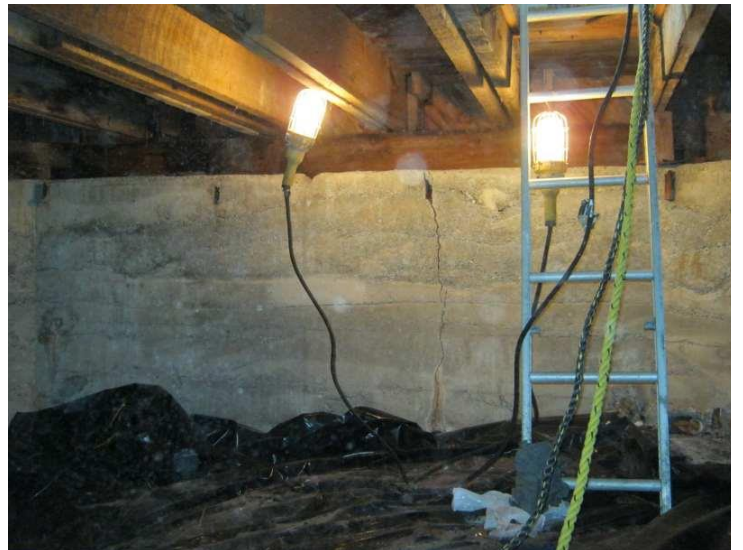
#12 - Foundation Crack - South Wall

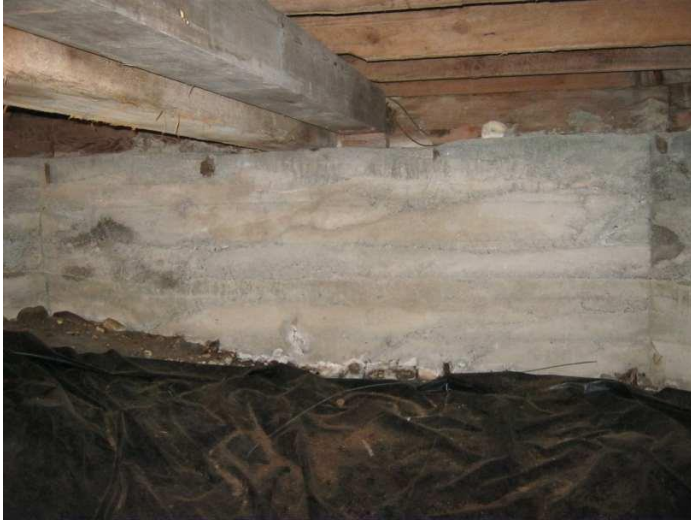
#13 - Foundation Crack - West Wall

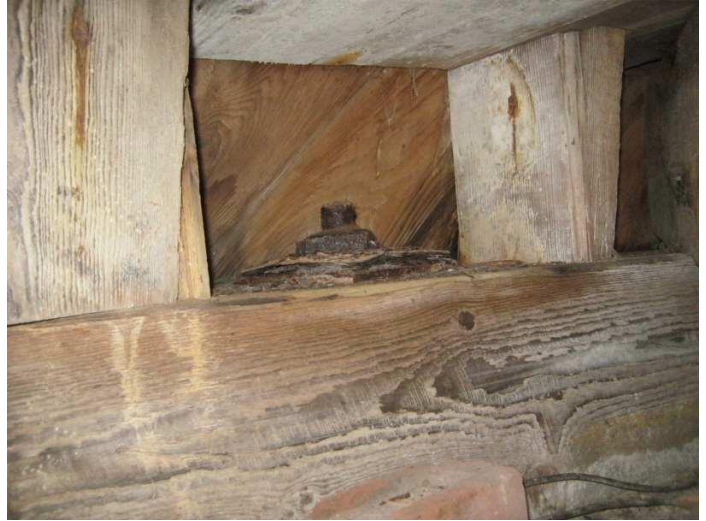
#14 - Anchor Bolt - Corroded

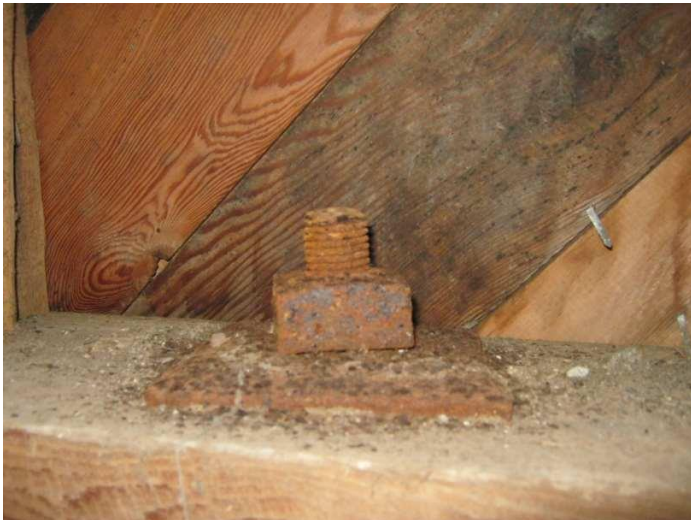
#15 - Anchor Bolt - Corroded

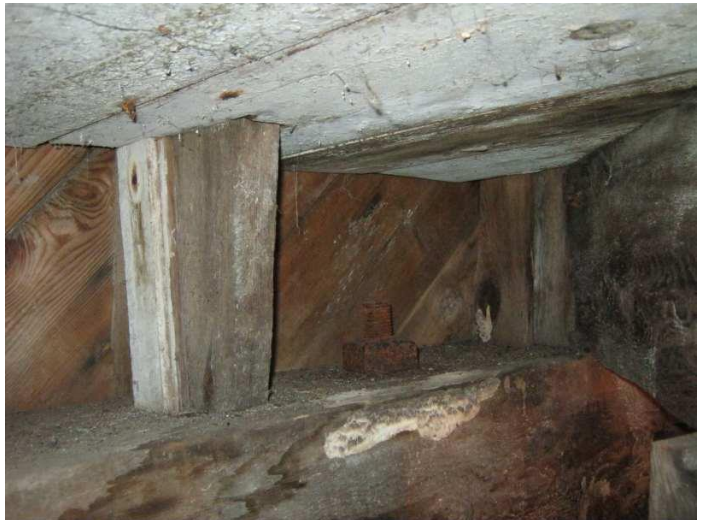
#16 - Anchor Bolt - Missing Plate Washer

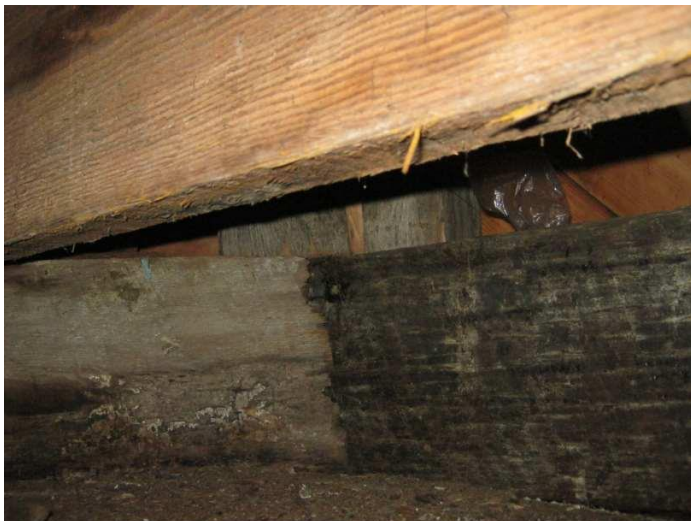
#17 - Bottom Wall Plate - Fire Damage

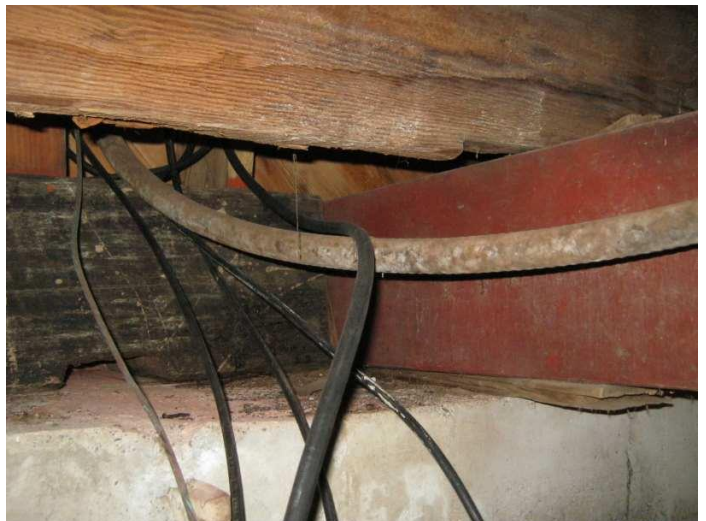
#18 - Bottom Wall Plate - Fire Damage

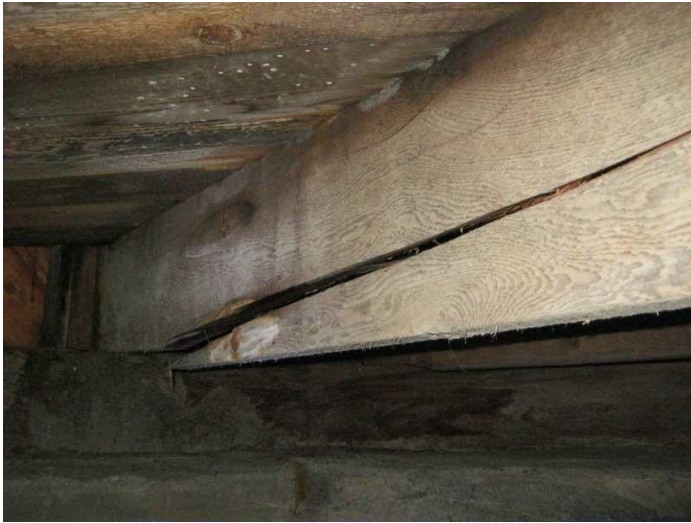
#19 - Main Floor Joist Failed

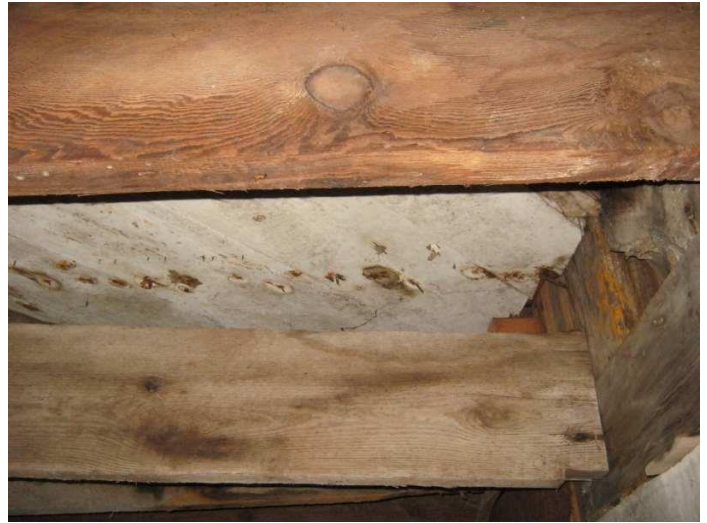
#20 - Main Floor Joist Connection Failed

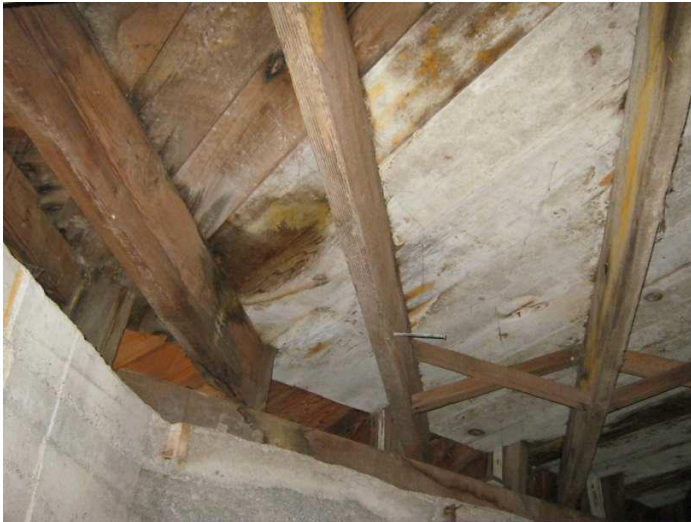
#21 - Main Floor Bridging Missing

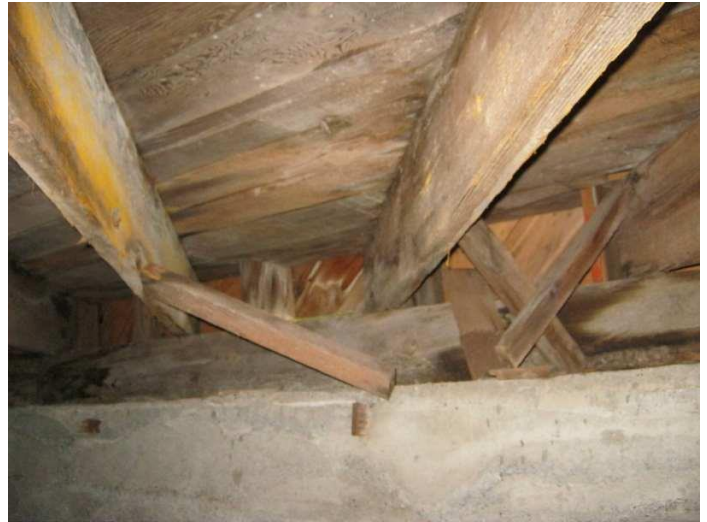
#22 - Main Floor Joist Bridging Deterioration

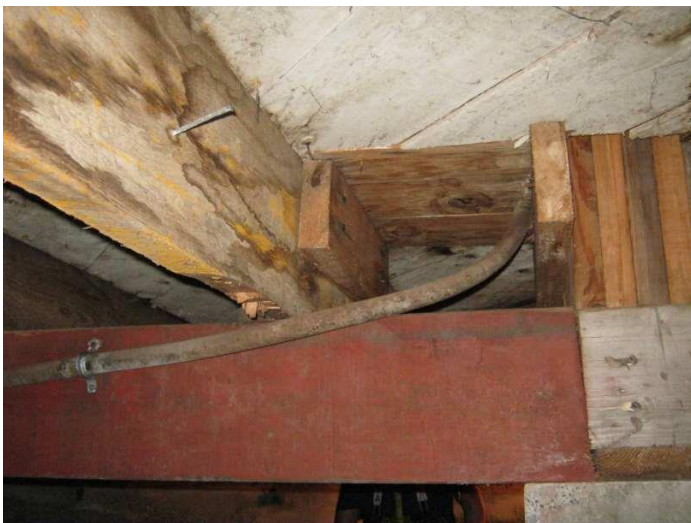
#23 - Main Floor Beam Replaced – Northeast

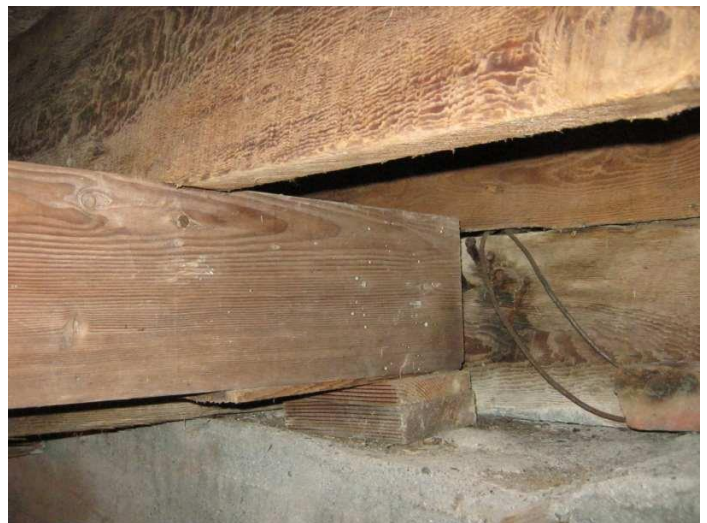
#24 - Main Floor Beam Replaced - Northwest

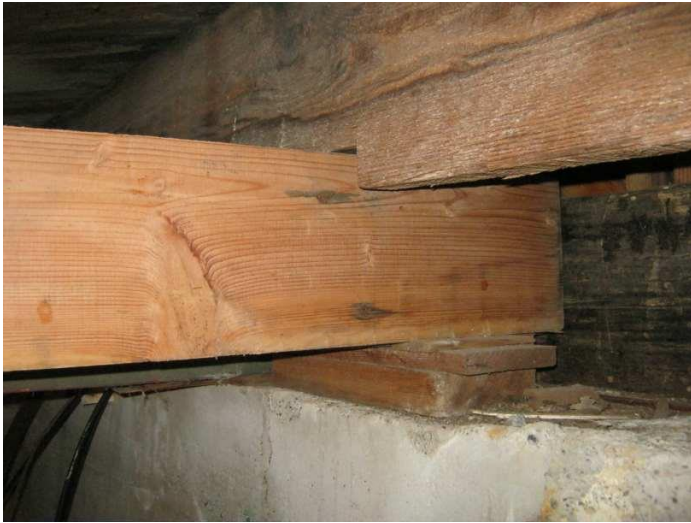
#25 - Main Floor Beam Replaced - Southeast

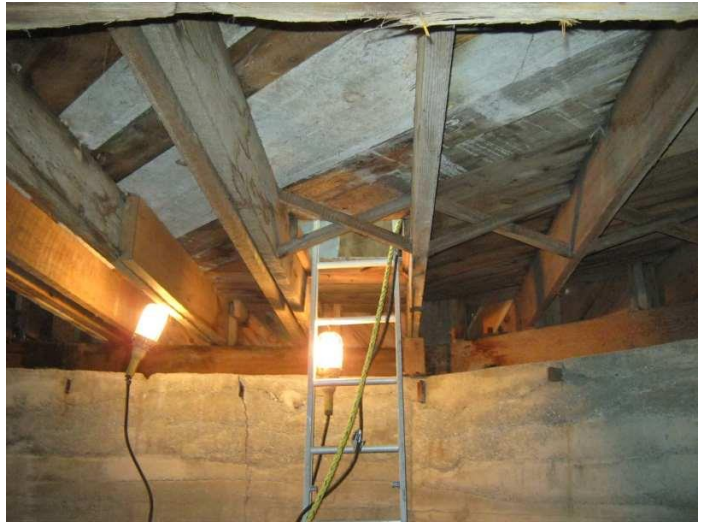
#26 - Main Floor Joist Repair - South

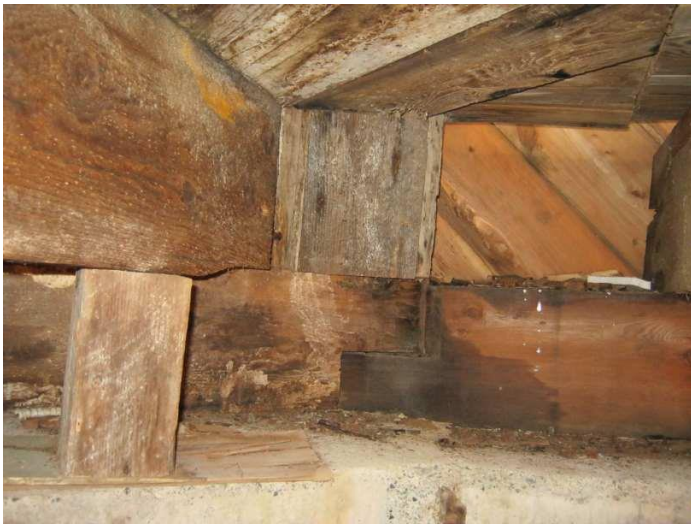
#27 - South Wall Plate Replaced - East End

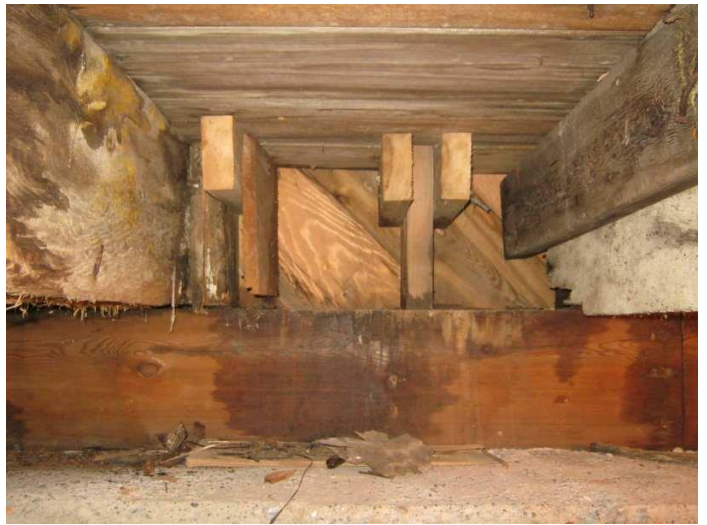
#28 - South Wall Plate Replaced - Centre

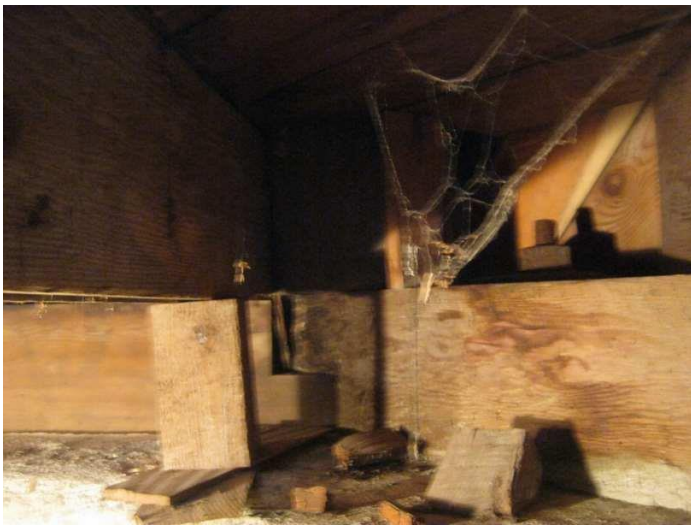
#29 - South Wall Plate Replaced - West End

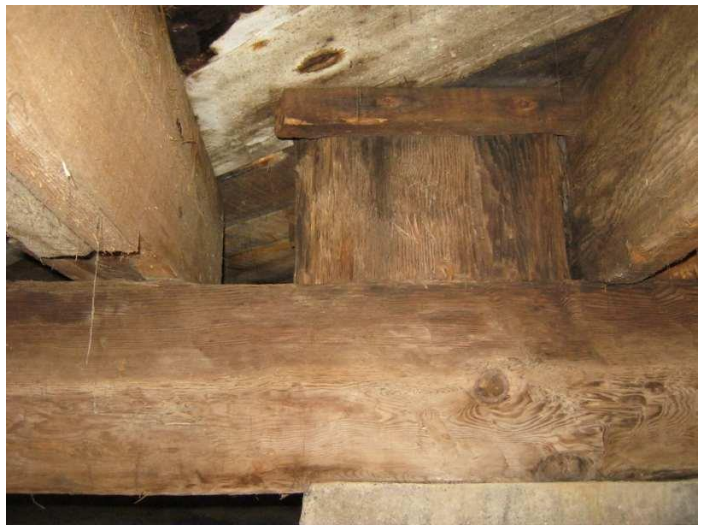
#30 - Interior Wood Column at Base Southwest  
- Original Construction

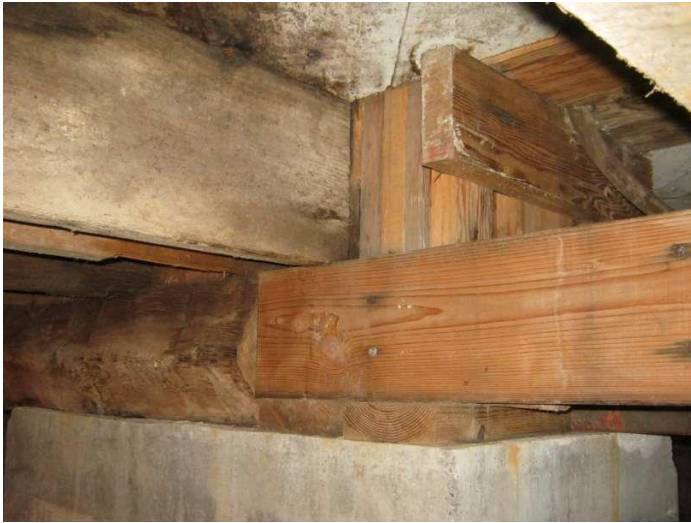
#31 - Interior Wood Column at Base Southeast - Repaired

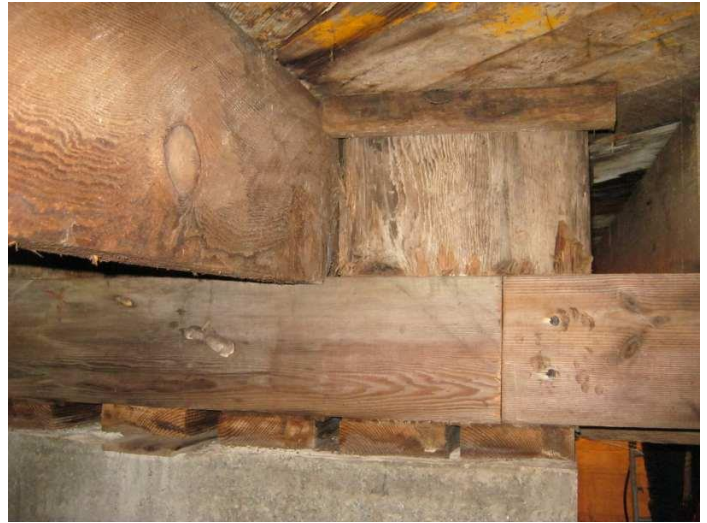
#32 - Interior Wood Column at Base Northwest - Repaired

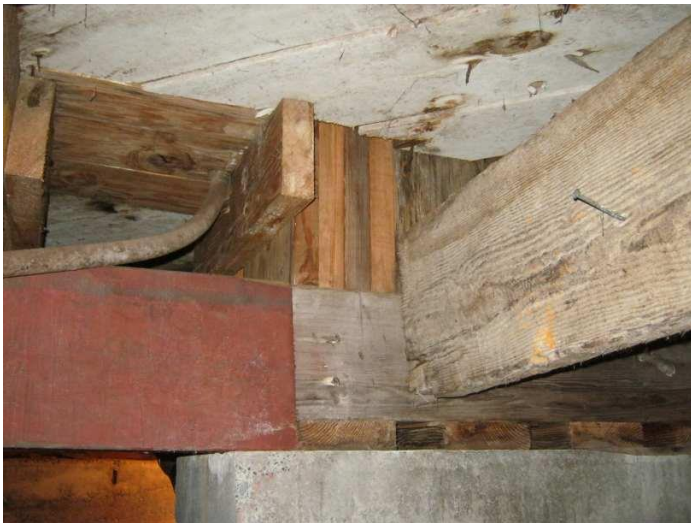
#33 - Interior Wood Column at Base Northeast - Repaired

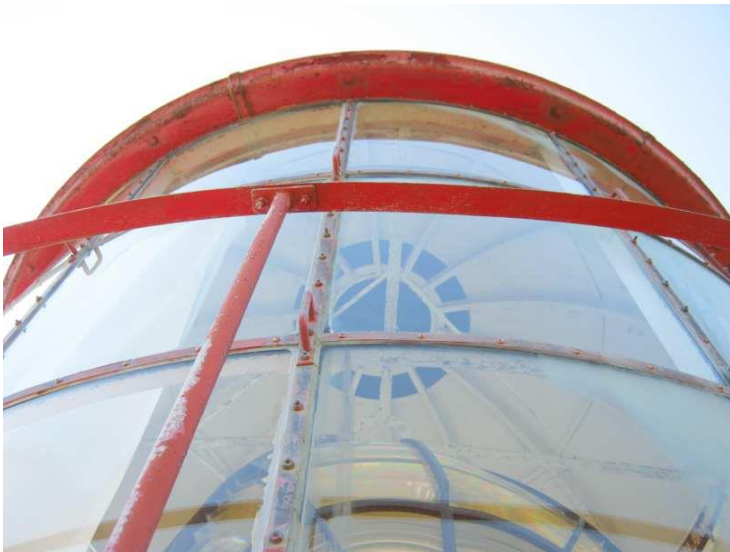
#65 - Lantern Room Window - Exterior

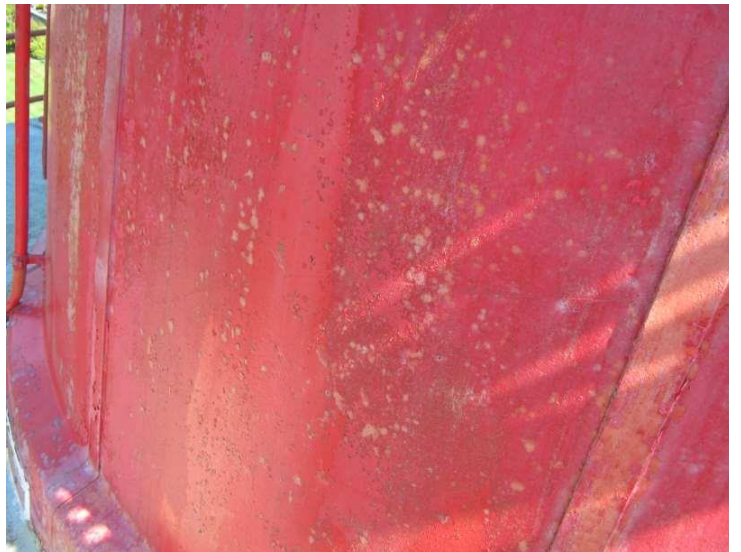
#66 - Lantern House Wall Panel – Crack

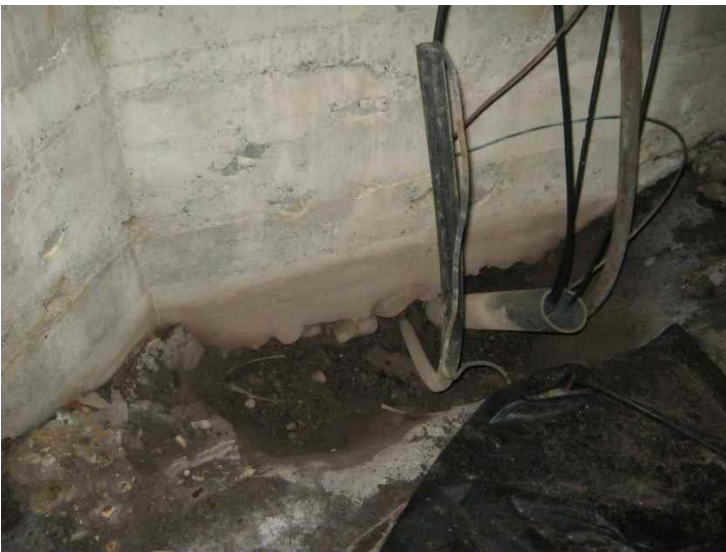
#73 - Foundation Soil Bearing Condition
