FINAL **Hazardous** **Building Materials** **Assessment**

Building M-20, 1200 Montreal
Road, Ottawa, ON

May 15, 2015

Pinchin File: 102254.001

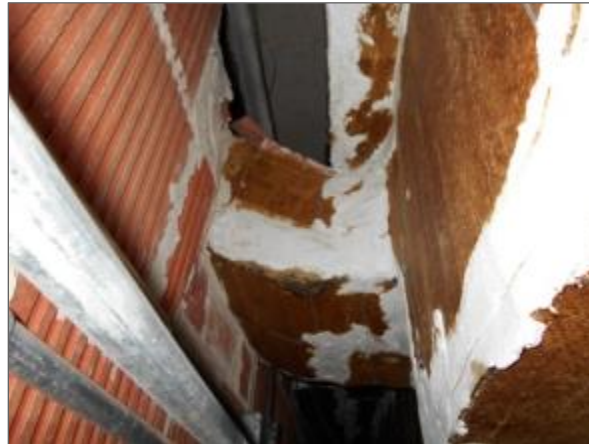
Ducts in corridor 154 and room 112 are insulated with non-asbestos brown tar paper faced fiberglass insulation (samples 003A-C). Parging cement, containing chrysotile asbestos, is present on the seams of the duct insulation (samples 002A-C). Parging cement is a friable insulation, and is in good condition. Approximately 50 linear feet of duct with parging cement is present in the corridor.

Photo 1, Asbestos containing parging cement on seams of the tar paper and fiberglass insulation on ducts throughout the main floor corridor.

Remove all asbestos-containing materials (ACM) prior to renovation if ACM may be disturbed by the work.

If the identified ACM will not be removed prior to commencement of the work, disturbance of ACM must follow the appropriate asbestos precautions for the classification of work being performed.

Asbestos-containing materials must be disposed of at a landfill approved to accept asbestos waste.

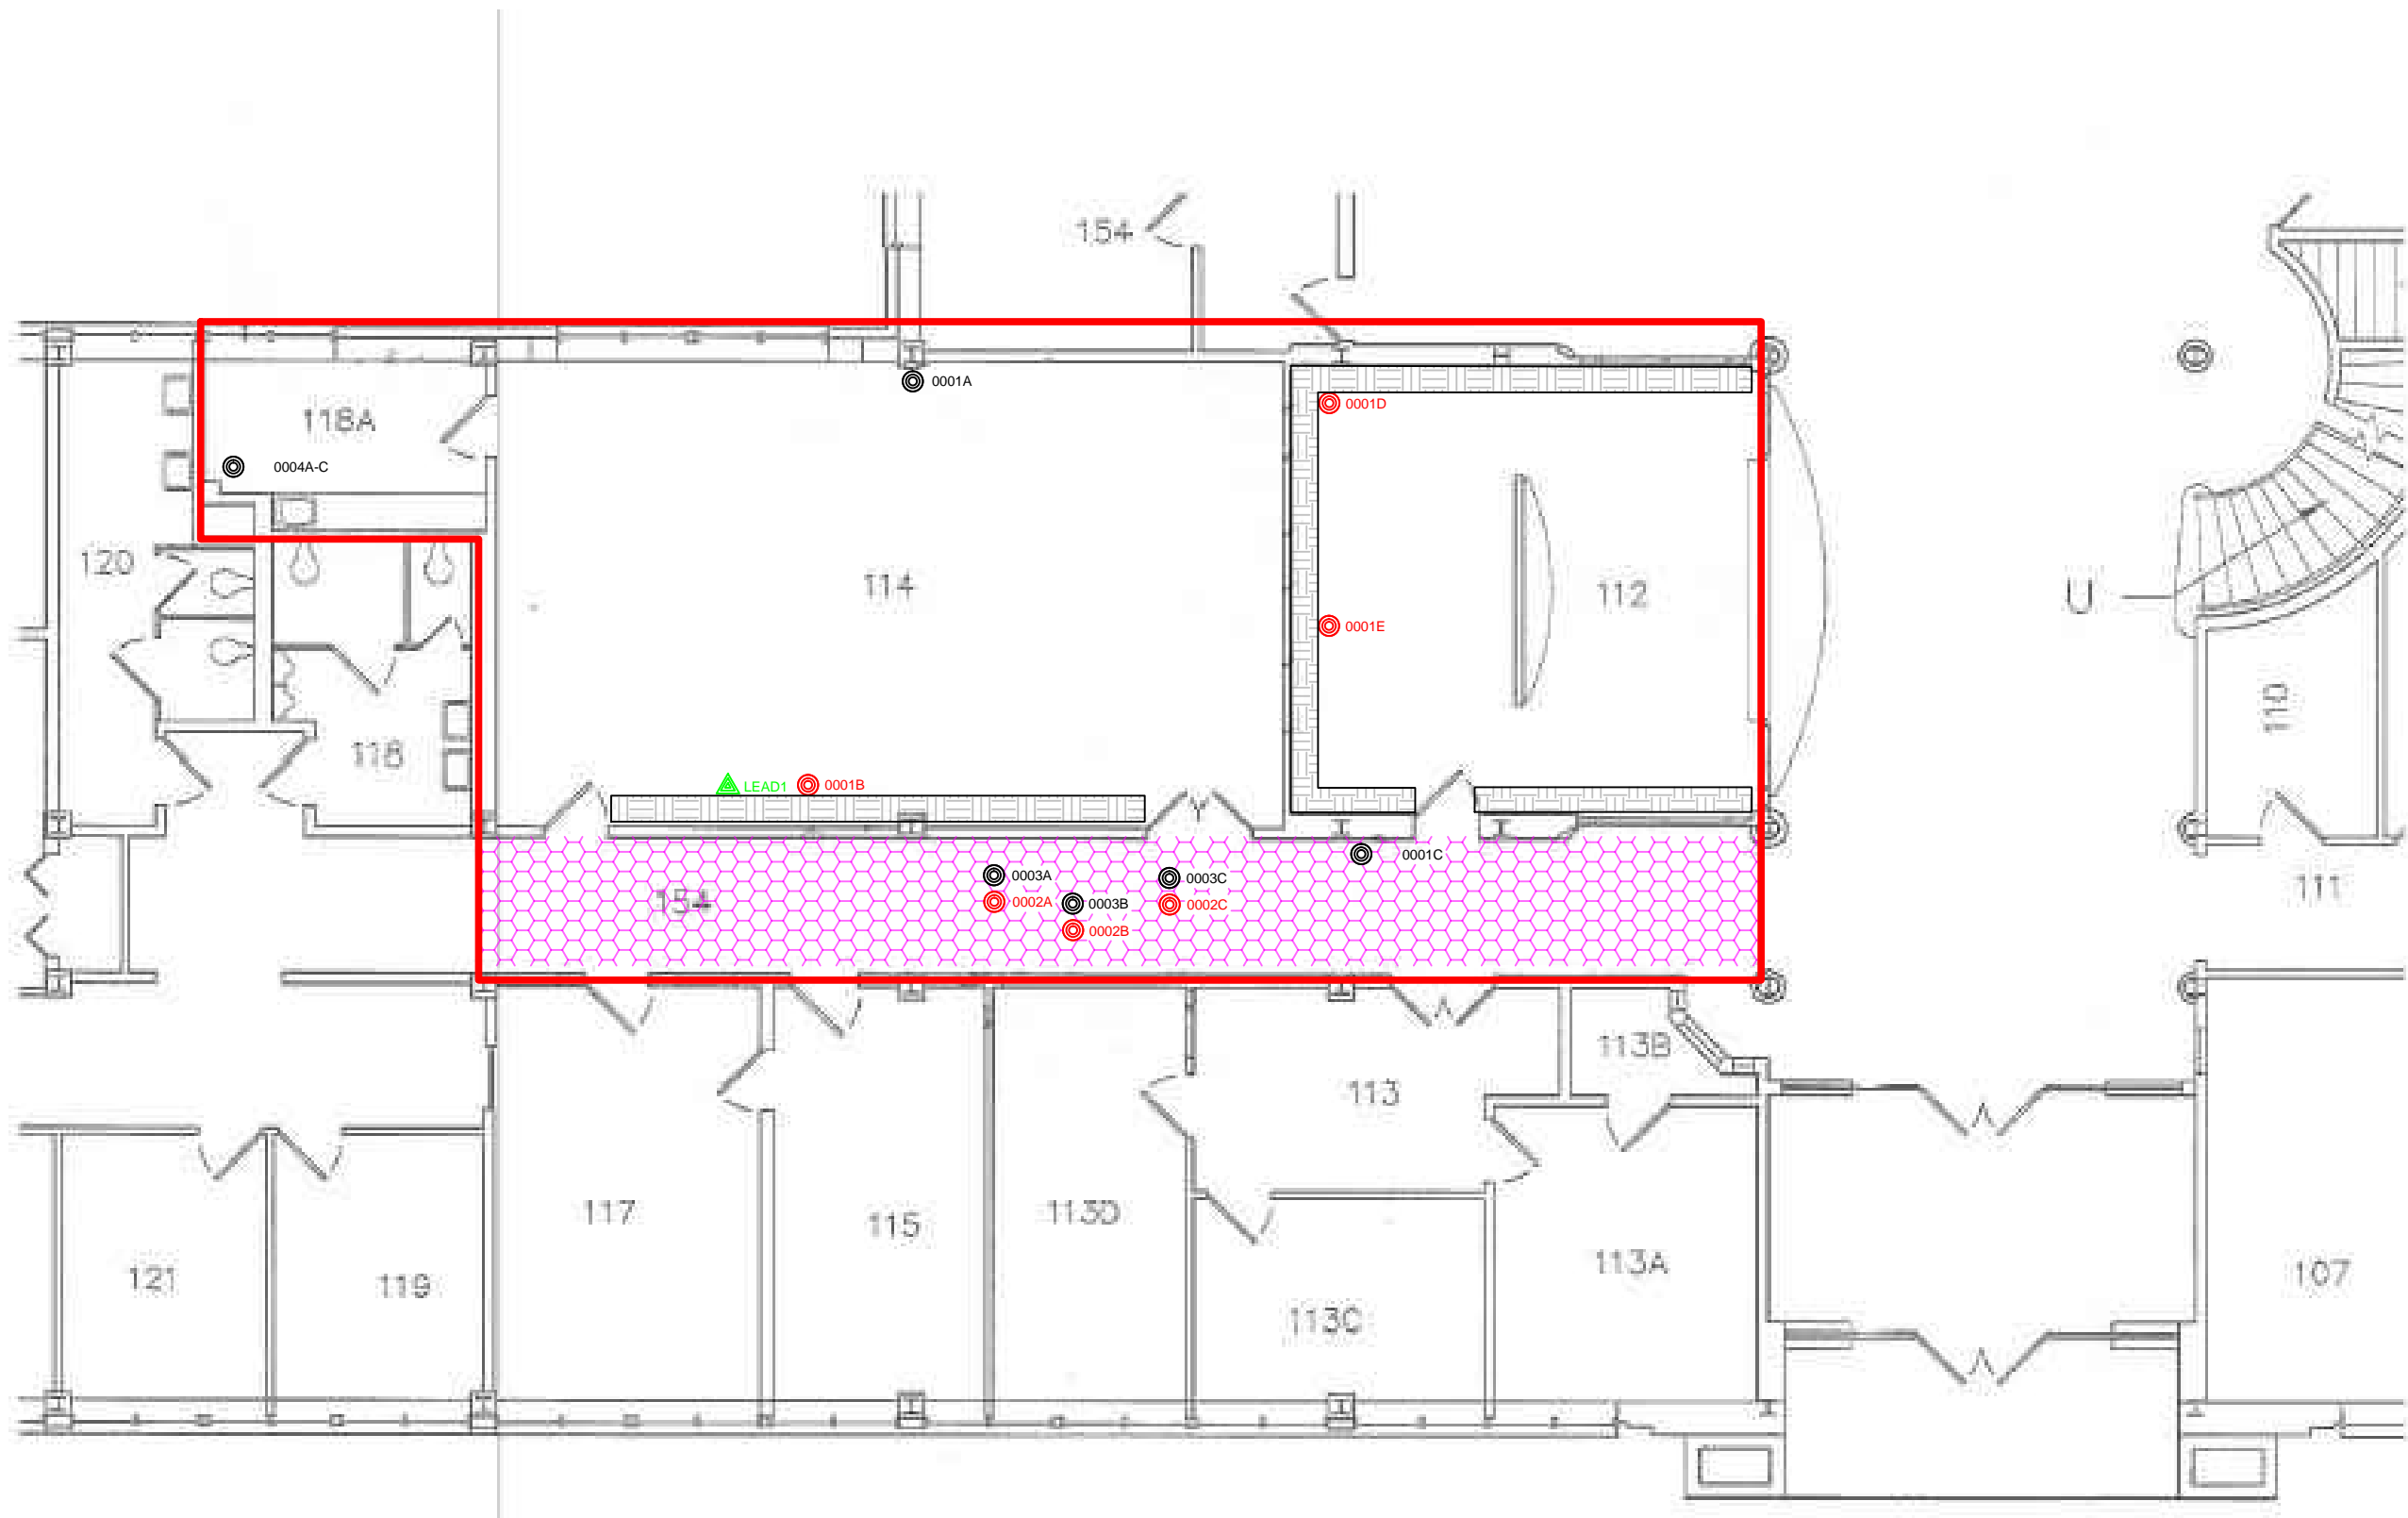
MAIN FLOOR
WORK AREA

- PLASTER
- DUCT INSULATION

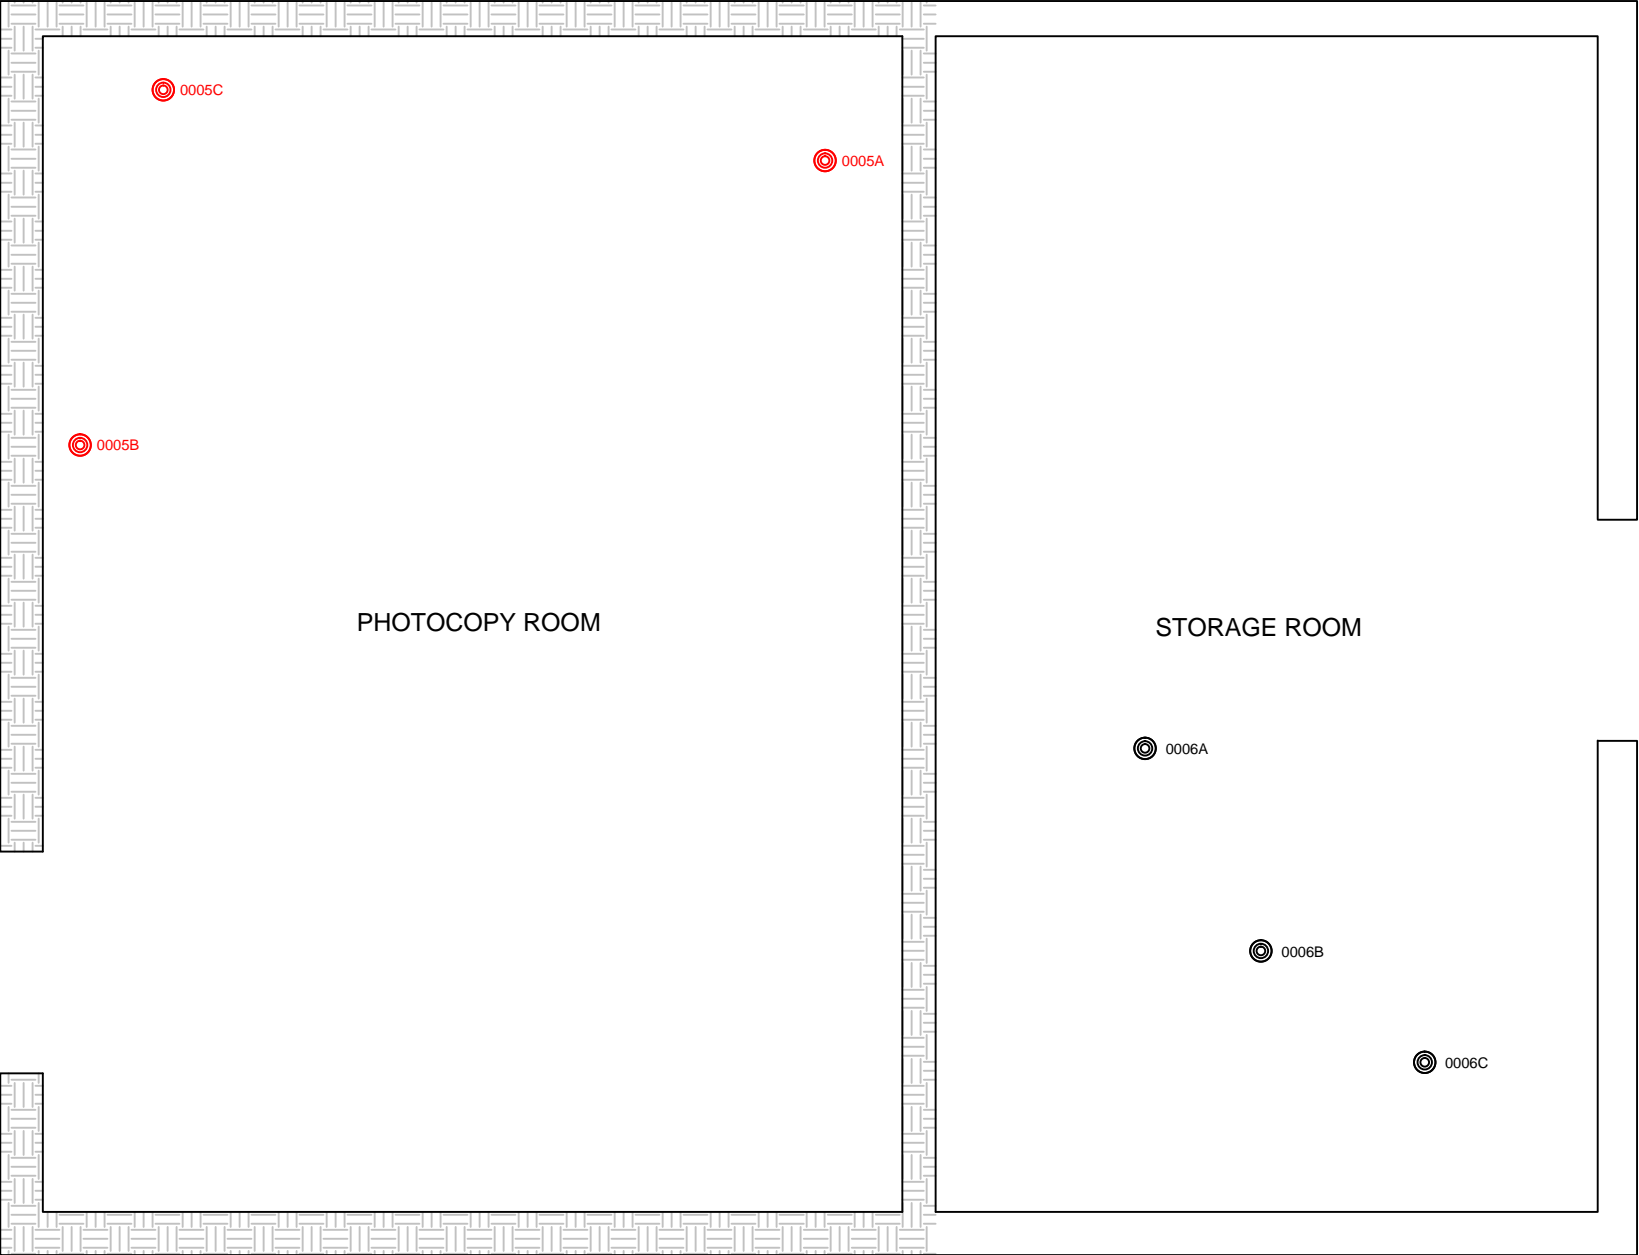
SECOND FLOOR
WORK AREA

- PLASTER
- DUCT INSULATION
