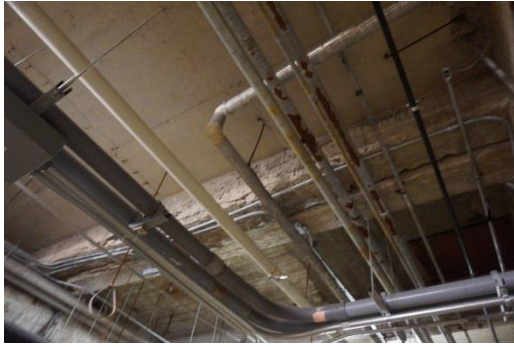
**Photo 1** – Existing damaged concrete encased steel beams at expansion joint (south side of expansion joint)

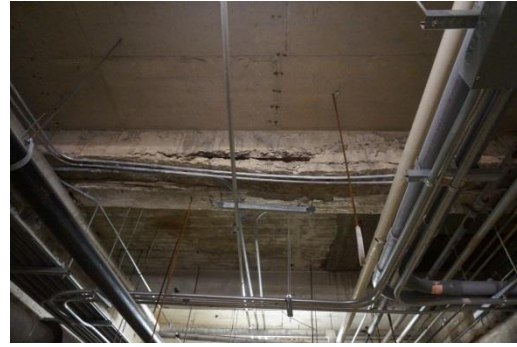
**Photo 2** – Existing damaged concrete encased steel beams at expansion joint (south side of expansion joint)

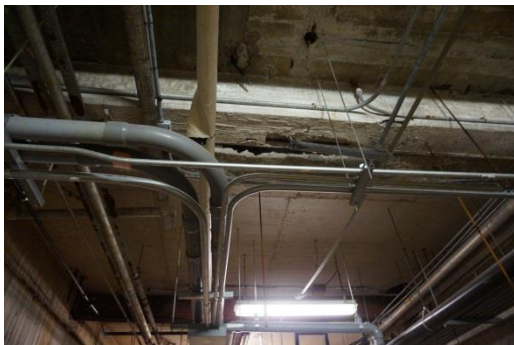
**Photo 3** – Existing damaged concrete encased steel beams at expansion joint (north side of expansion joint)

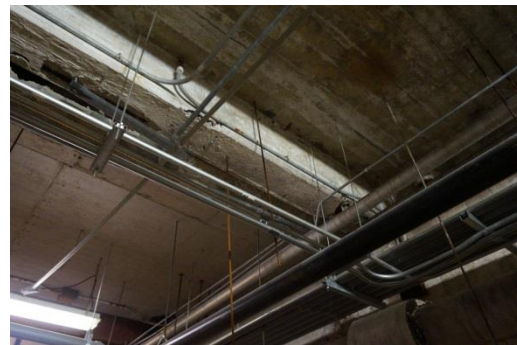
**Photo 4** – Existing damaged concrete encased steel beams at expansion joint (north side of expansion joint)

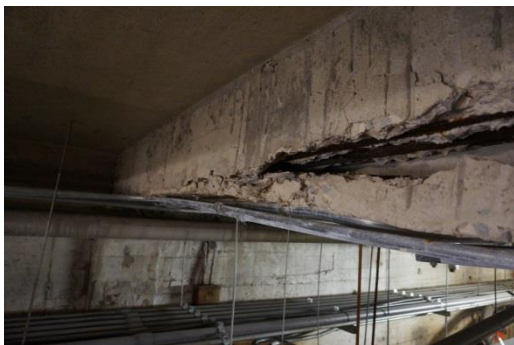
**Photo 5** – Existing damaged concrete encased steel beam at expansion joint (south side of expansion joint)

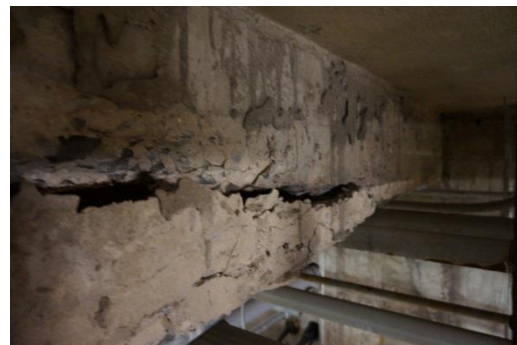
**Photo 6** – Existing damaged concrete encased steel beam at expansion joint (south side of expansion joint)
