FISHERIES AND OCEANS CANADA REAL PROPERTY AND TECHNICAL SUPPORT	
2015 WINGDAM WALL No. 2 TIMBER TRAINING WALL REPAIRS GENERAL NOTES AND SITE OVERVIEW	
SCALE	SHOWN
DATE	28-Jul-15
DRAWING NUMBER	307071-00778-00-MA-DAL-1500
REVISION	B

**2015 WINGDAM WALL No. 2
TIMBER TRAINING WALL REPAIRS
WINGDAM #2
PLANS, SECTIONS & DETAILS**

DESIGNED TJT	SCALE SHOWN
DRAWN AAL	
CHECKED OAM	DATE 4-Dec-14
RECOMMENDED RDR / CJA	DRAWING NUMBER 307071-00778-00-MA-DRD-1501
APPROVED OAM	REVISION B

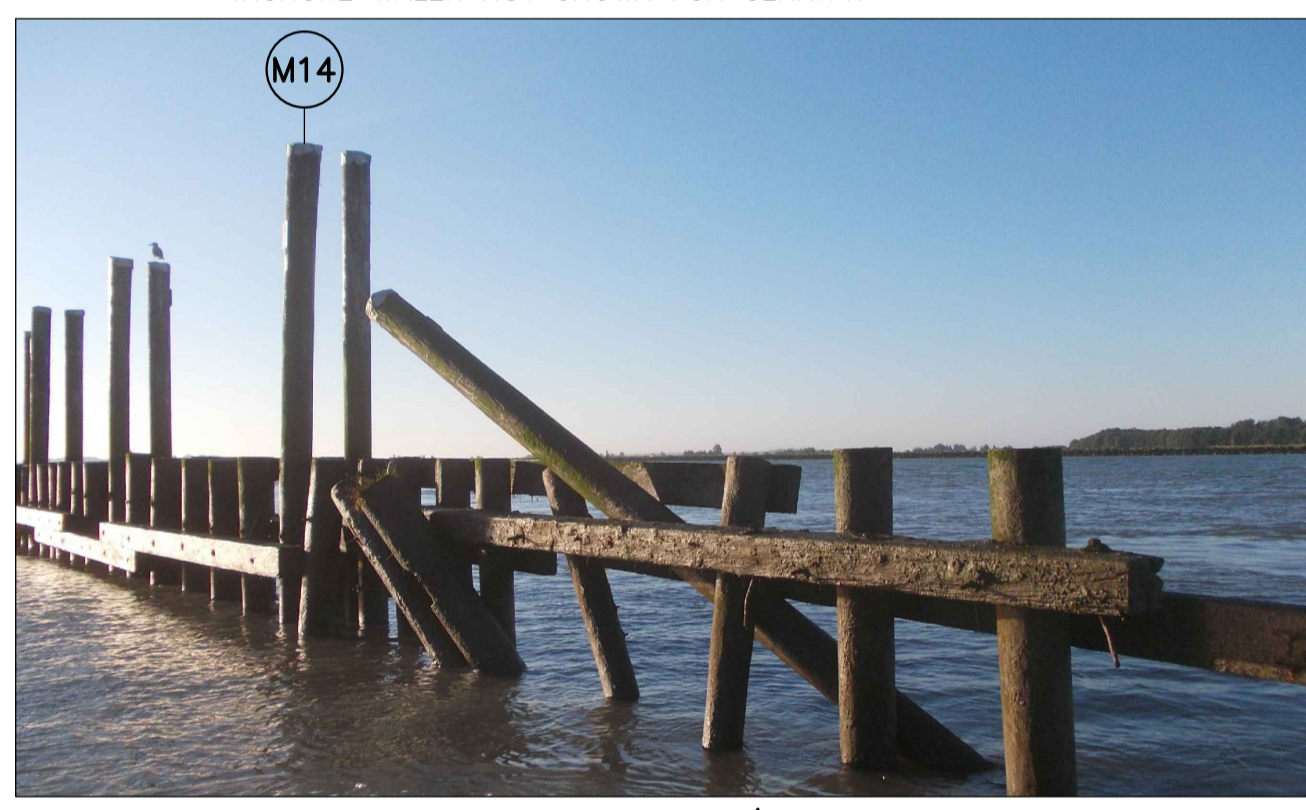
PHOTO No.3 - MISSING/DAMAGED
WALL SECTION EAST END

PILE REPAIRS		
LOCATION	QTY.	RECOMMENDATION
M6-M14	16	INSTALL MISSING OR DAMAGED OFFSHORE MARKER PILES IN MISSING SECTION OF WALL
M6-M14	37	INSTALL MISSING OR DAMAGED INSHORE LOWER PILES IN MISSING SECTION OF WALL
M6-M14	36	INSTALL MISSING OR DAMAGED OFFSHORE LOWER PILES IN MISSING SECTION OF WALL
M6-M7	2	REPAIR 3rd & 4th SPLIT OFFSHORE LOWER PILES EAST OF M6 MARKER PILE WITH GALVANIZED STEEL CLAMPS
M6-M7	4	RE-DRIVE OR REPLACE IF BROKEN OUT OF PLUMB 3rd, 4th, 5th, AND 6th OFFSHORE LOWER PILES EAST OF M6 MARKER PILE
M19-M20	2	RE-SECURE 2nd & 3rd INSHORE LOWER PILES WEST OF M20 MARKER PILE TO MIDDLE AND INSHORE WALERS
M20-M21	2	RE-SECURE 1st & 4th INSHORE LOWER PILE EAST OF M20 MARKER PILE TO MIDDLE AND INSHORE WALERS
M21-M22	2	RE-SECURE 1st & 3rd INSHORE LOWER PILE EAST OF M21 MARKER PILE TO MIDDLE AND INSHORE WALERS
M27	1	RE-SECURE M27 INSHORE MARKER PILE
M35.5	1	REPLACE 3rd BROKEN EAST LOWER PILE NORTH OF M35 MARKER PILE

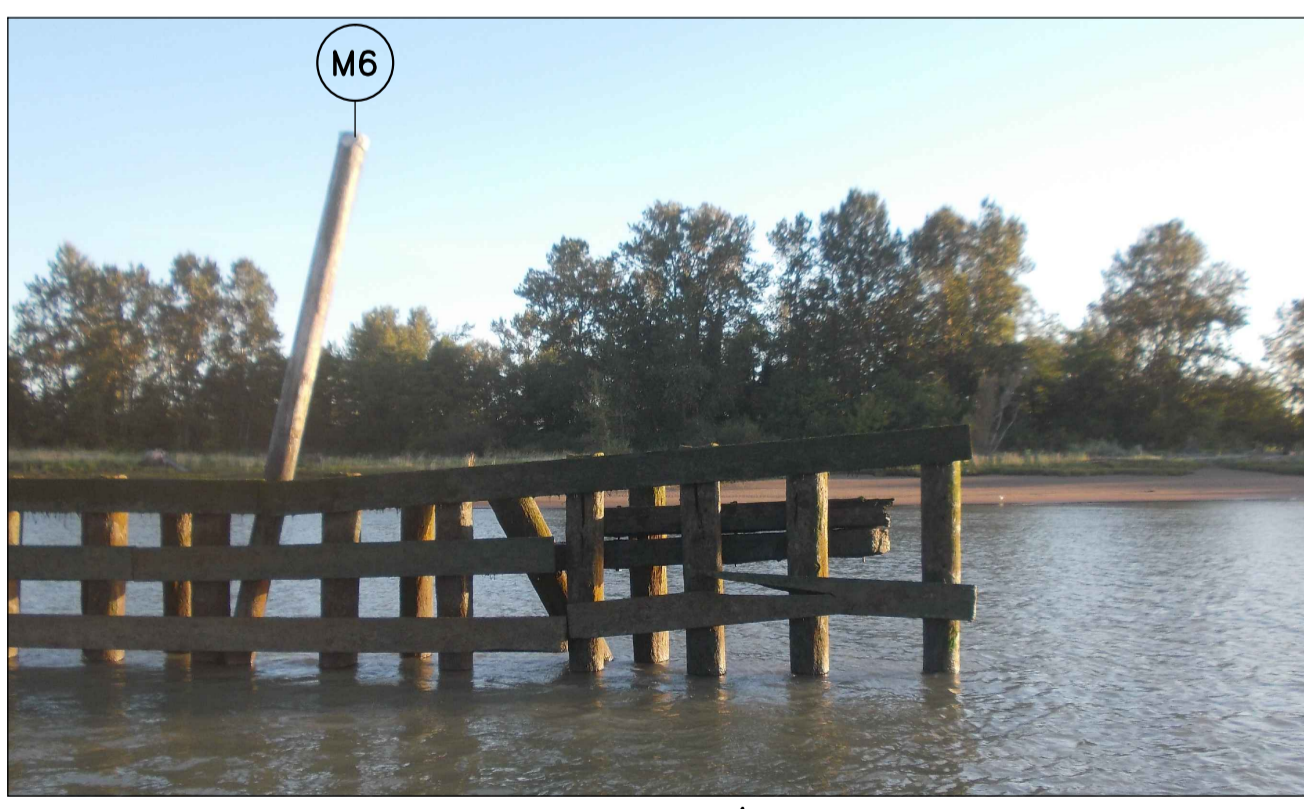
PHOTO No.2 - MISSING/DAMAGED
WALL SECTION WEST END
