Hazardous Building Materials Assessment

Point Pelee National Park
North Comfort Station, 407
Monarch Lane, Leamington, ON

June 11, 2015

Pinchin File: 104300

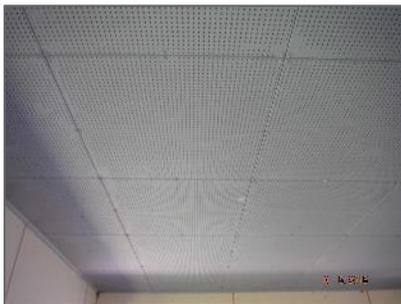
Transite cement board is used as a ceiling tile in the Men's Change Room (Location 4) and the Women's Change Room (Location 7). Three (3) samples were collected (samples 0004A-C) and were determined to contain chrysotile asbestos by laboratory analysis. Transite is a non-friable material and was observed in good condition.

Transite ceiling present in the Men's Change Room
(Location 4)

Remove all asbestos-containing materials (ACM) prior to renovation, alteration, maintenance or demolition work or if ACM may be disturbed by the work.

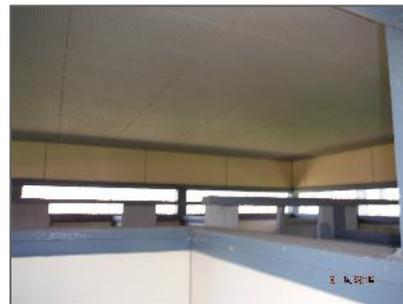
Transite ceiling present in Women's Change Room
(Location 7)

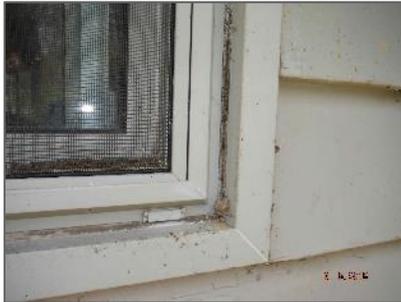
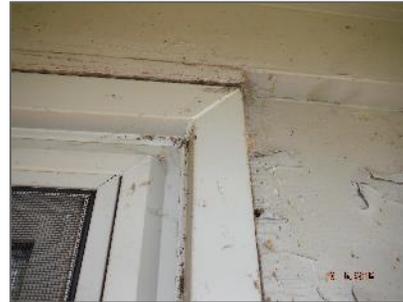
White caulking is present on the exterior windows of the building. Three (3) samples of white caulking were collected (samples 0001A-C) and were determined to be non-asbestos by laboratory analysis.

White window caulking present on exterior windows

The white caulking present on the exterior windows of the building were sampled for PCB content (sample PCB-01) and contains <0.5 ppm PCBs. The material is a non-PCB solid based on the threshold given in SOR/2008-273 (50 ppm).

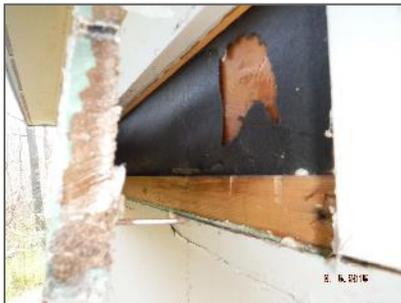
Tar paper is present on the inside surfaces of the exterior building walls. Three (3) samples were collected (samples 0002A-C) and were determined to be non-asbestos by laboratory analysis.

Tar paper present on the inside surfaces of building walls

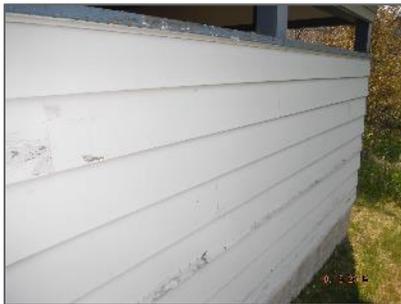
Sample Number	Colour, Substrate Description	Locations	Lead (%)
PT-01	Grey paint on wood siding	Exterior of building	0.18
PT-02	Dark grey paint on exterior trim of building	Exterior of building	< 0.08

All paints containing elevated levels of lead were found to be in good condition and not flaking, peeling or delaminating.

Grey paint on wood siding

Lead-painted items may be a hazardous waste. Test lead-painted materials for leachable lead prior to disposal.

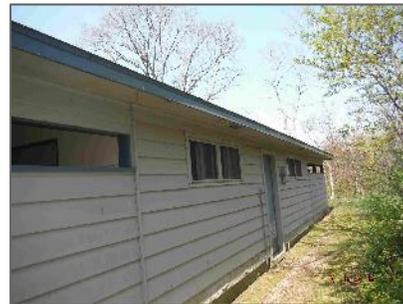
Dark grey paint on exterior trim of building
