DAMAGED STEEL PIPE PILE PHOTOGRAPHS

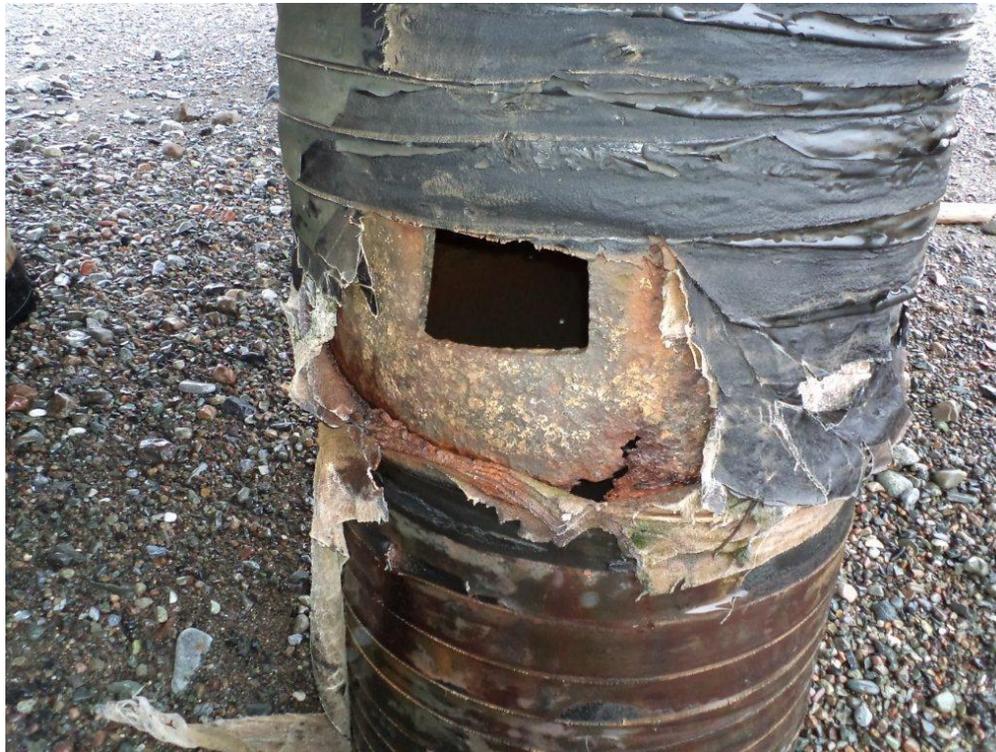
Figure 1-Coupon cut out of Pile Bent #2-Pile C10.

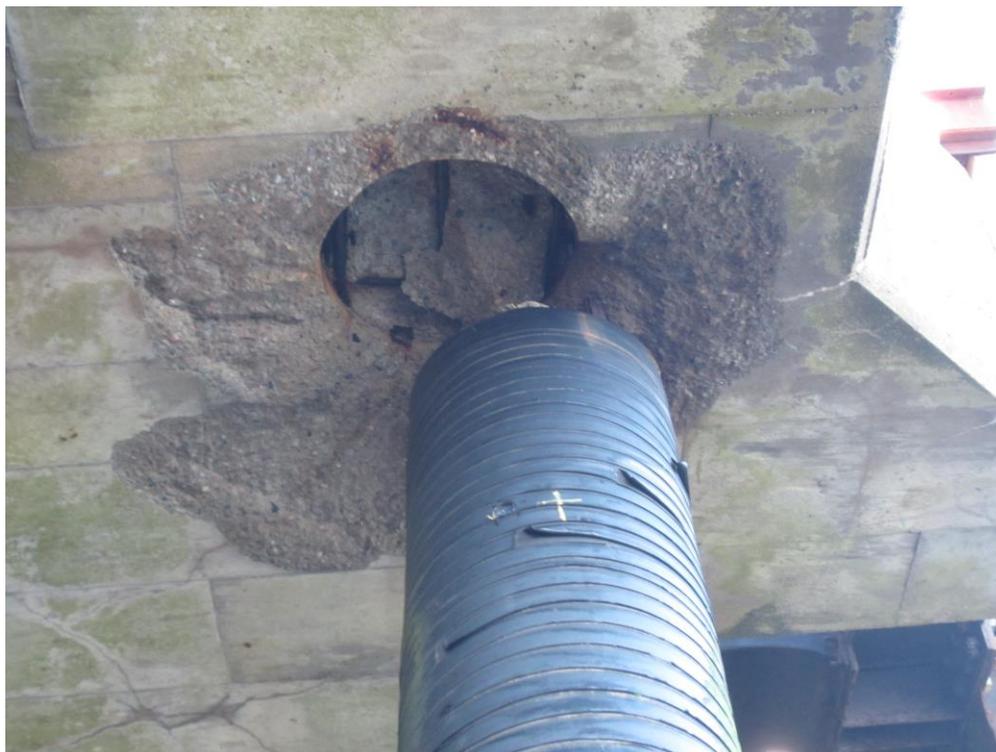
Figure 2-Pile dislodged from pile cap at BD3-K4.

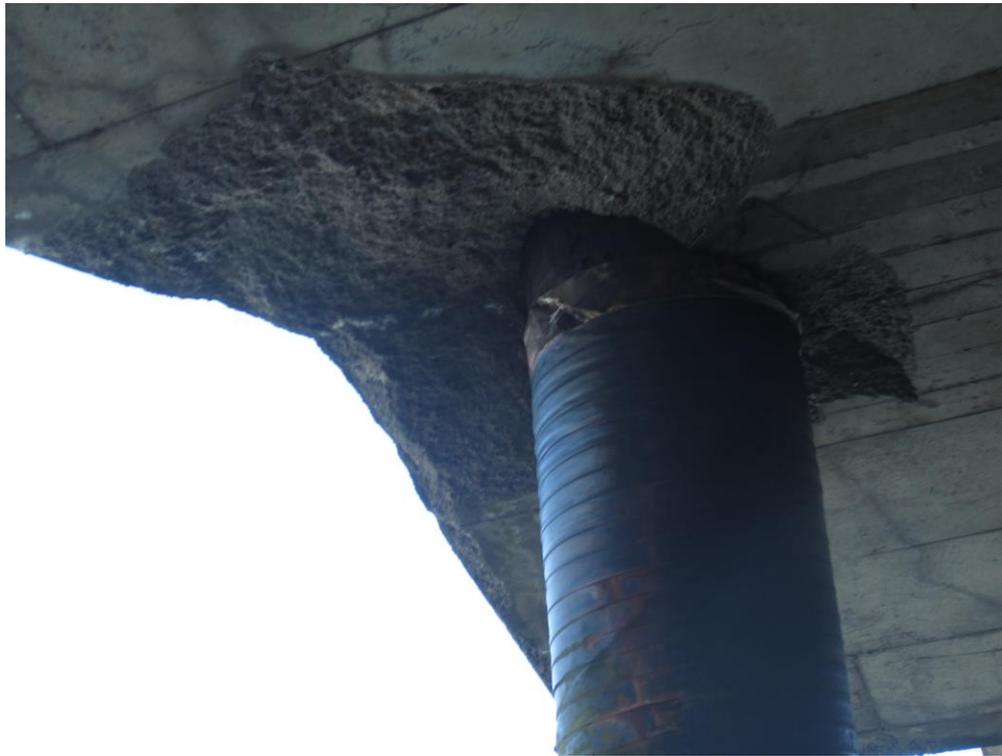
Figure 3-Large concrete spall from pile cap at BD1-I4

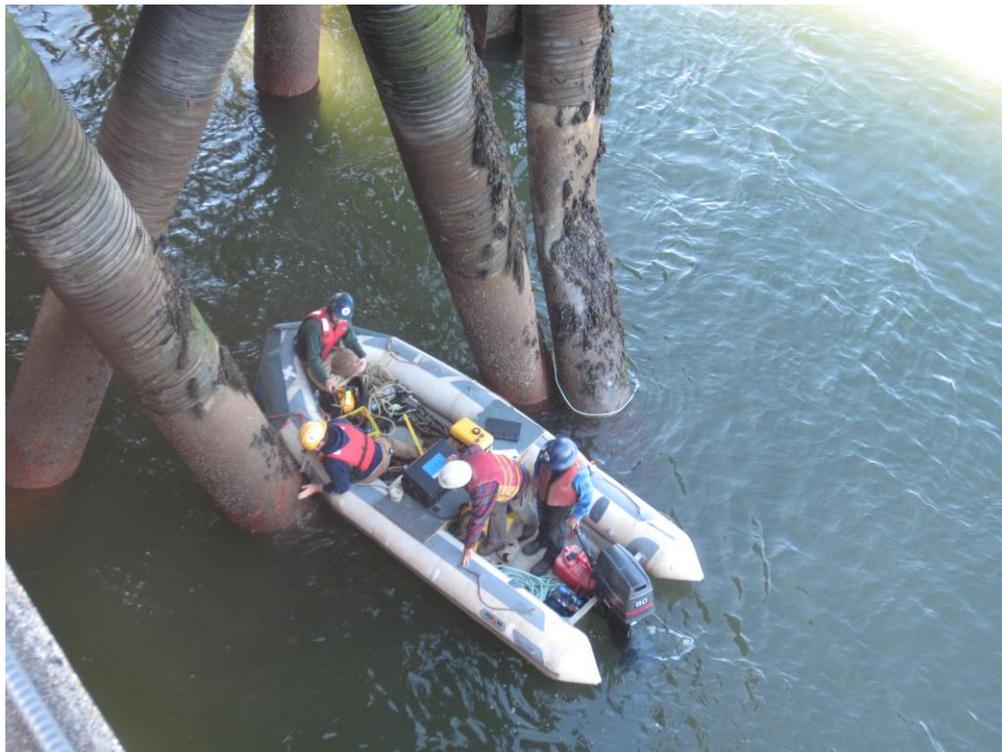
Figure 4-Buckled pile due to impact damage at BD2-J9.

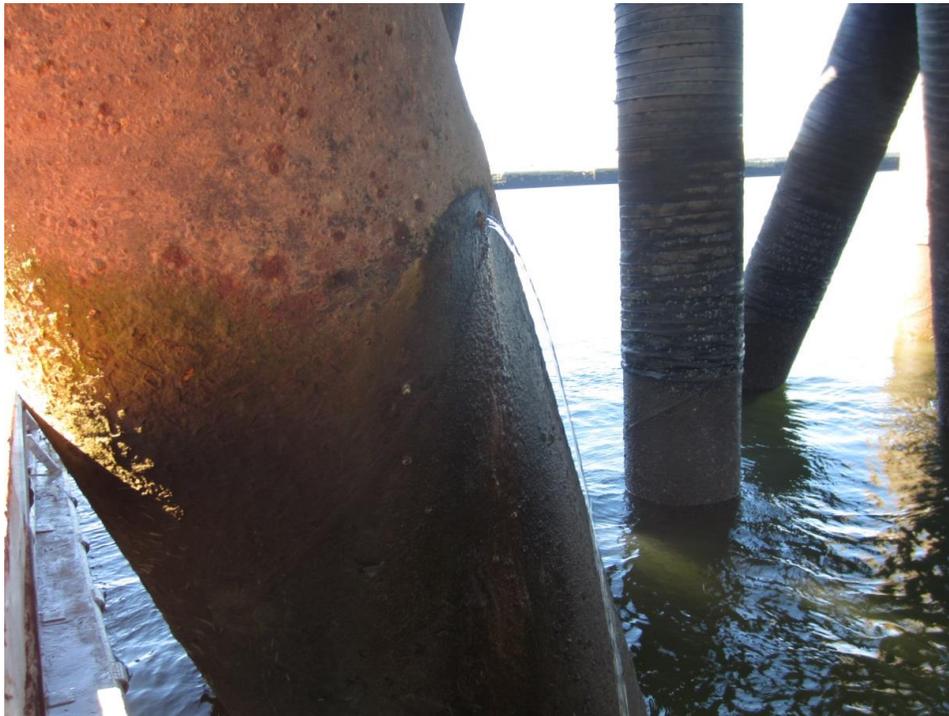
Figure 5-Hole in pile at Elev. +3.5m at pile WD1-L21.
